SEASCAPE NEWS BULLETIN

March 2023

CHAIRMAN'S REPORT

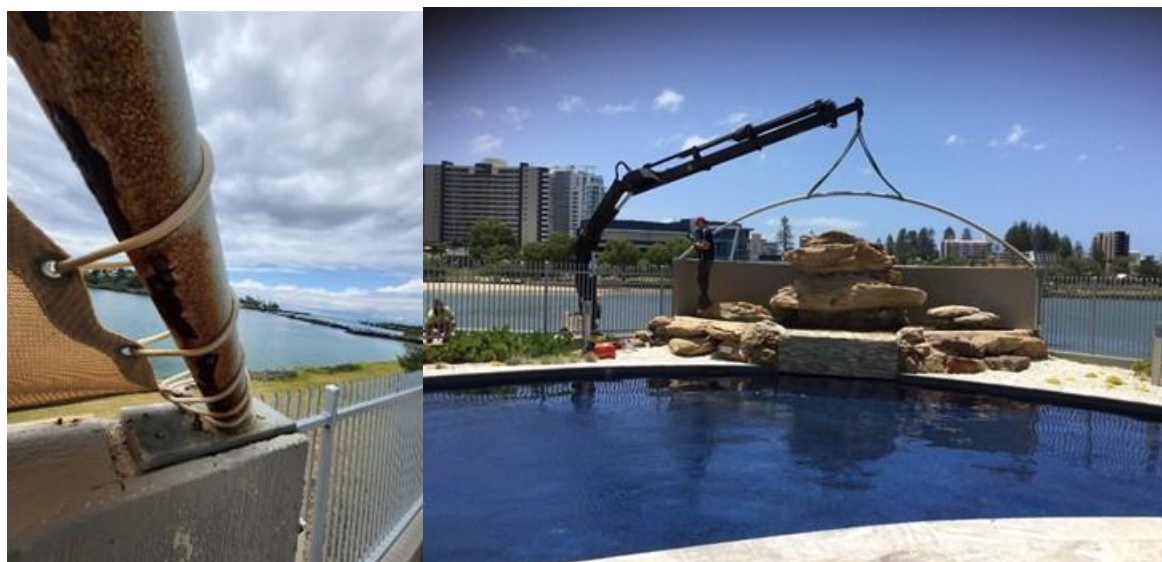
The shade cloth over the water feature was torn and needed replacing. On investigation the steel structure was found to be unsafe and corroded. This has been replaced and we are waiting on the cover to be installed.

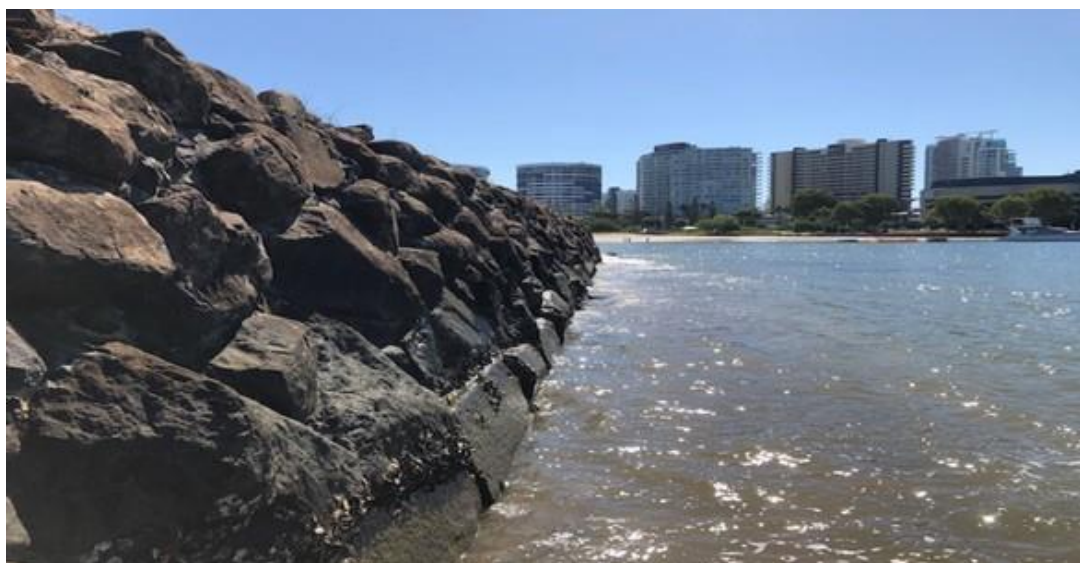
As above, the Seawall repairs are a major focus this year. The Committee has undertaken work necessary to ensure the wall is not in any threat of further damage by using geofabric, sand and gravel to stop further erosion behind the rock wall. This will be an ongoing activity until the wall is repaired.

Below is a seawall photo today showing amazingly how much sand has been washed away through years of constant tide and wave action.

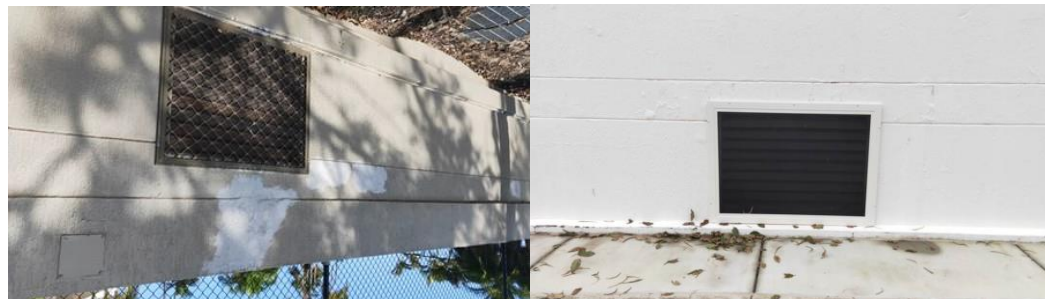
- *The old mission brown screens and grates* on the street side of the building have been replaced with white screens. Also, the sills behind the louvers have been cleaned and damaged concrete been repaired to stop water ingress into the wall cavities and basement.

Figure: Grills replaced.

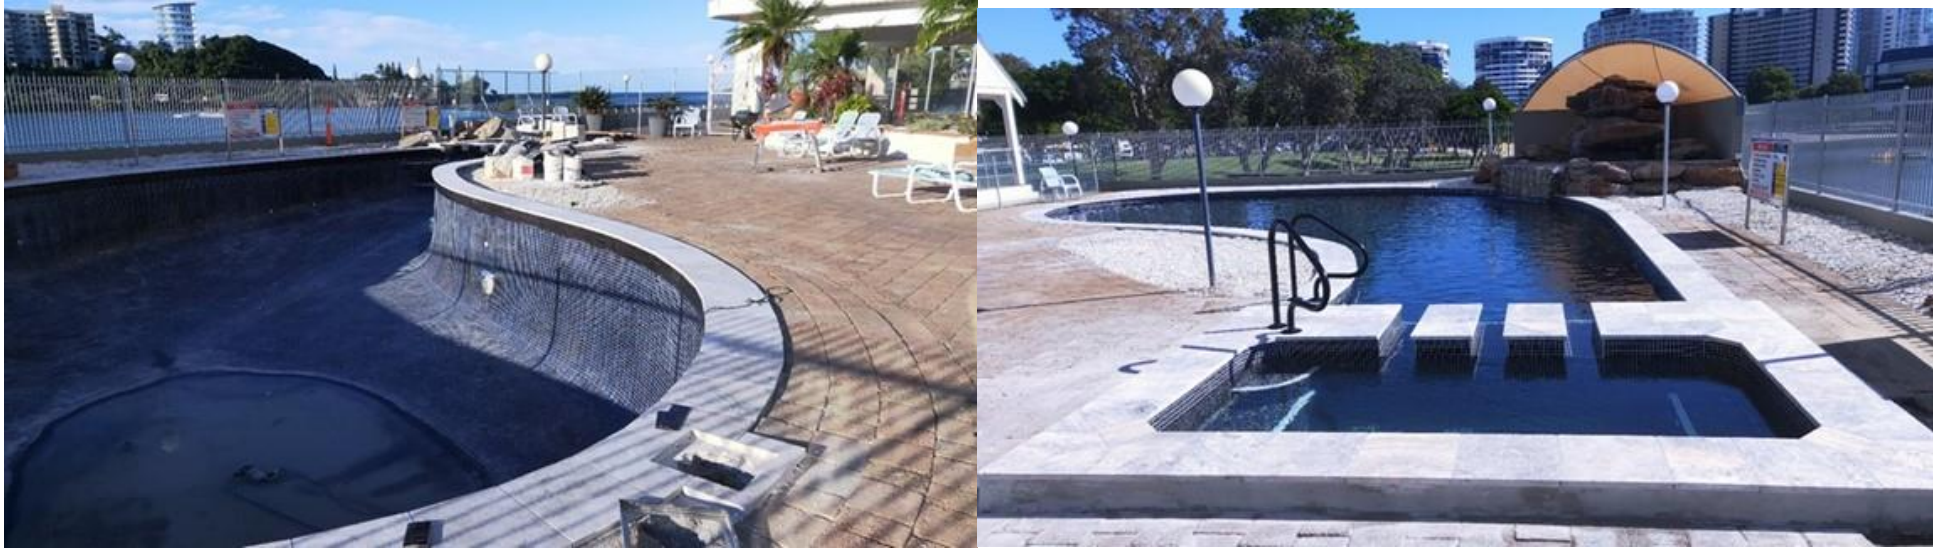
- *Swimming Pool and Spa Repairs. There were a number of issues with the swimming pool, namely: Only half the spa jets were working; Broken pipe from the pool room to the spa; Chlorinator and filters not working efficiently.*

Figure: Pool leaking pipes and coping upgrade.

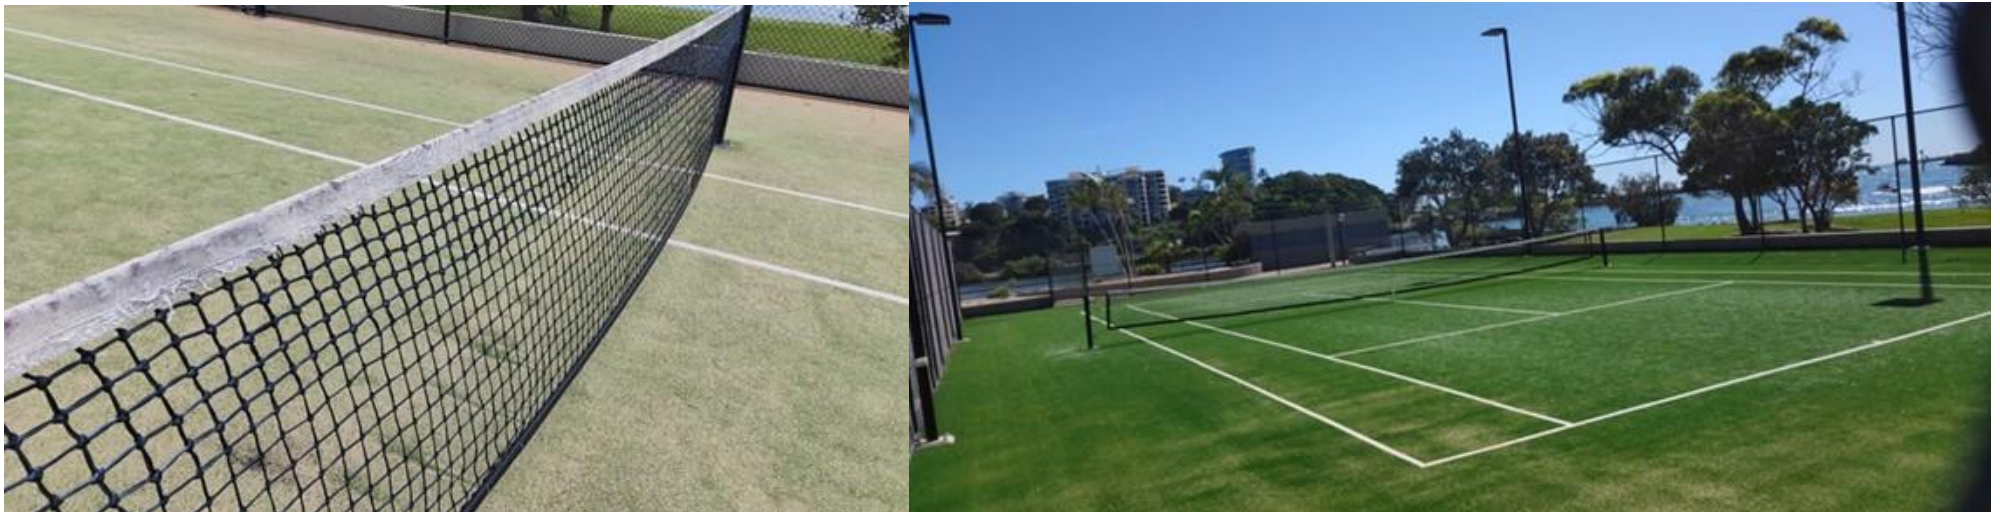
Once the old tennis court surface was removed the contractor advised that there was significant surface cracking and glue residue. He strongly recommended that if we wanted to protect the slab and for the new artificial grass resurfacing to last 30 years like the existing grass surface, then the slab needed thorough professional preparation, made up of:

Figure: Tennis Court upgrades with repair of slab crack and waterproofing.

1. Grinding the whole area to prepare the substrate and ensure a good key for new membrane adhesion. A saw would be used in each surface crack to clean, widen and deepen to provide sufficient cavity for the proper keying of structural epoxy filler.
2. Specialised Solvent based polyurethane waterproofing of the membrane.

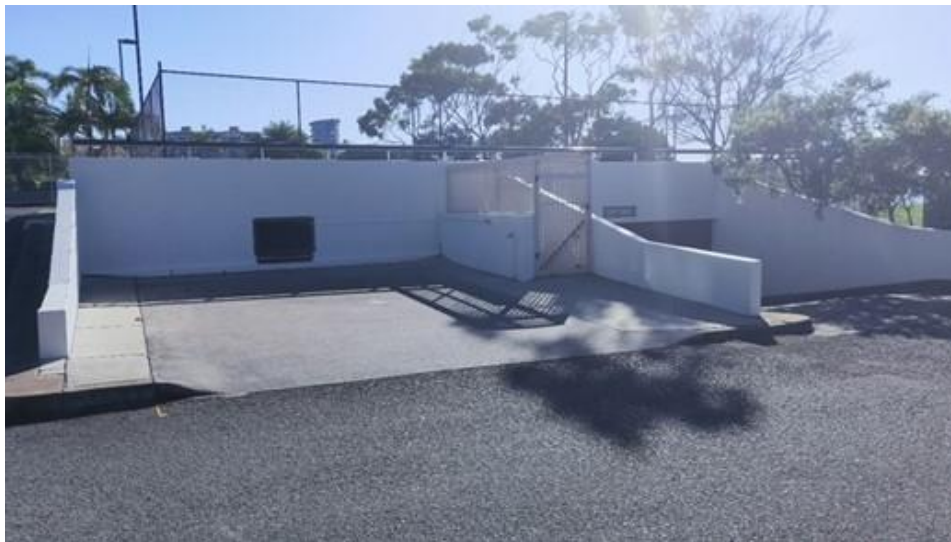
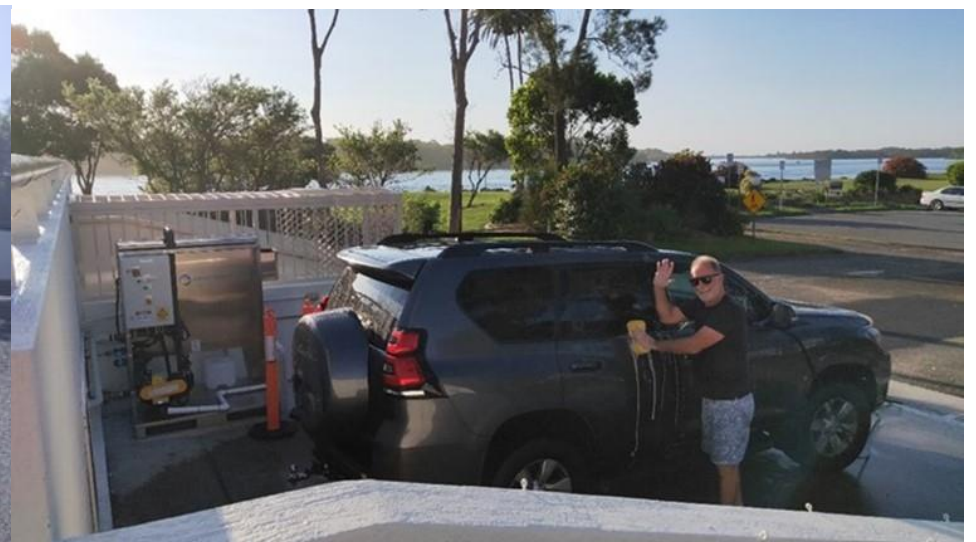
The cost to reinstate the car wash bay was approved in the Capital Works Budget. Whilst undertaking this project a number of items of additional work were uncovered. Namely,

1. Additional work involved jackhammering to remove a problem not known until excavation, of the sewer pipe being encased in concrete.
2. Soil and excess gravel were reused to fill and repair sink holes behind the rock wall instead of being dumped.
3. The relocation of bark that was a result of removal of the palm trees in the raised garden beds.
4. The asphalt near the exit driveway garden was uneven and cracked. To repair this issue further excavation of the asphalt, rectify and stabilise the subsoil and lay additional new asphalt to repair the total area.
5. A concrete delivery truck caused damage to existing asphalt on the edge of the excavation trench. Due to the collapse of this area, extra remedial work was required to remove asphalt, rectify and stabilise the area, and lay additional new asphalt.

Figure: Carwash Bay recommissioned.

Therefore, the Strata Committee looked at alternative approaches to meet the regulation by diverting the wash down waste water into the sewer with rain water disposed of into the storm water drain.

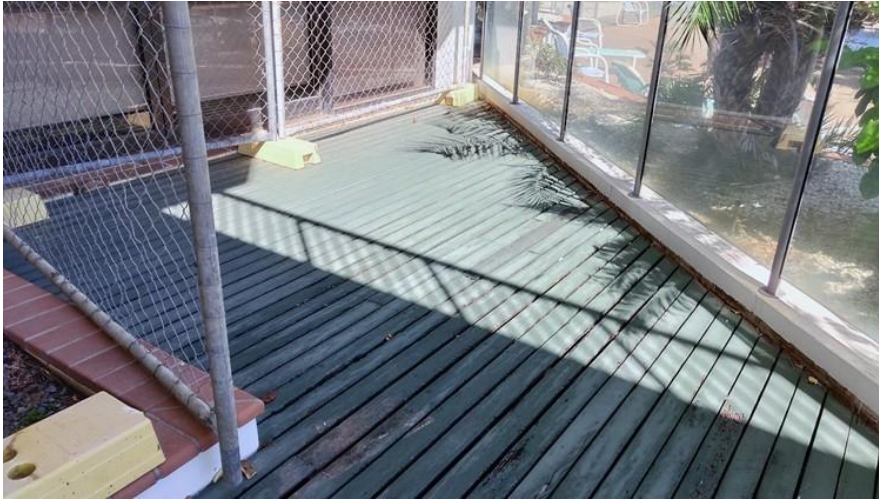
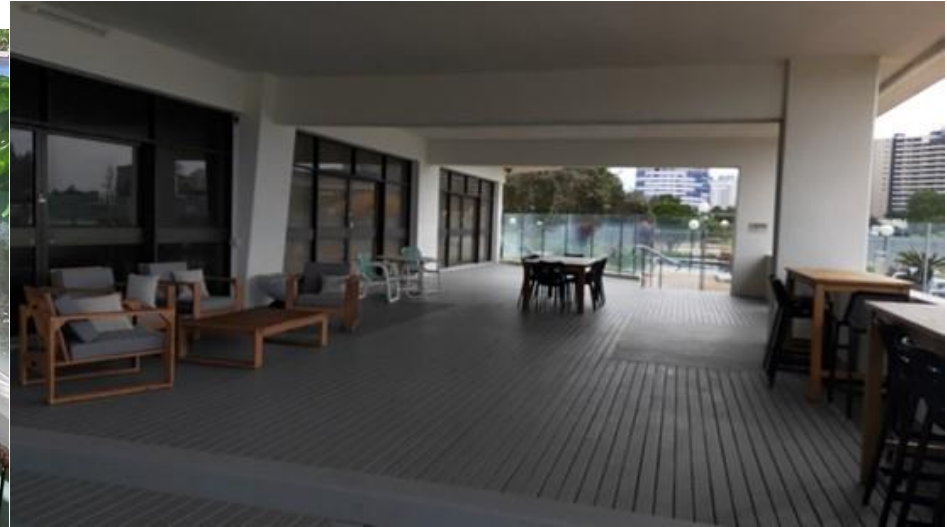
Figure: Deck repaired and furnished.

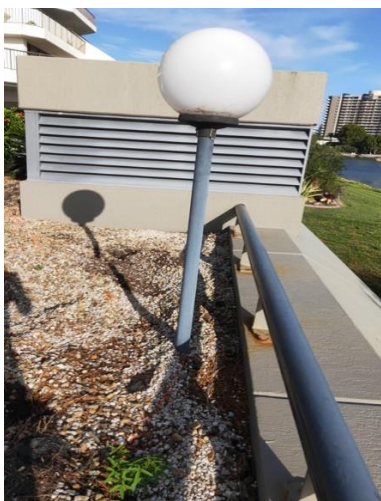
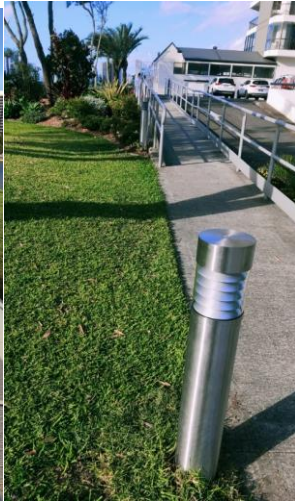
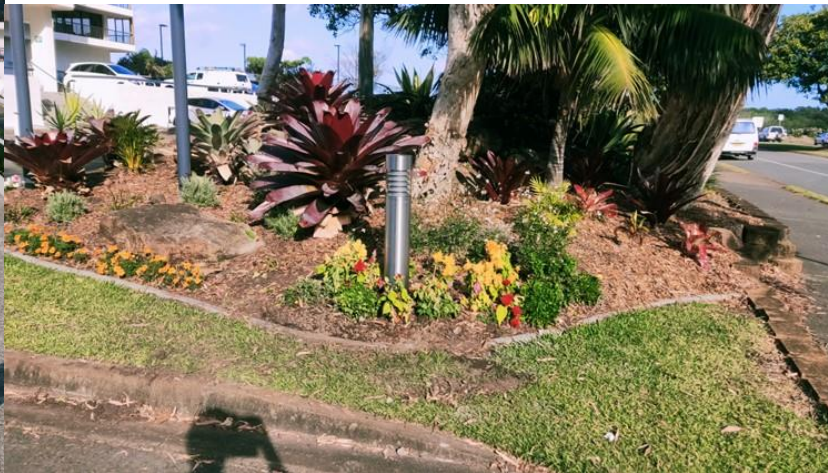
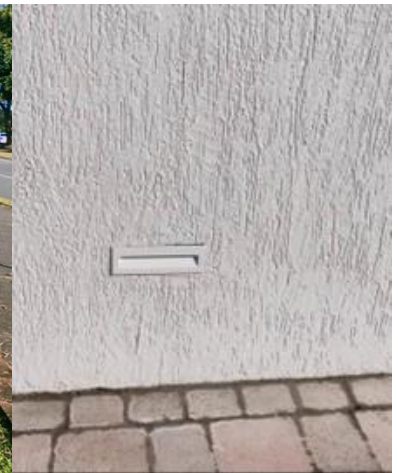
- *New exterior lighting.*
- *A number of old standard ball lamps have been replaced with modern LED bollard lamps or inset wall lights as work progresses over various areas. Also, where old ceiling lights have become faulty, they have been replaced with LED lights*

Figure: Lamps replaced with led lights.

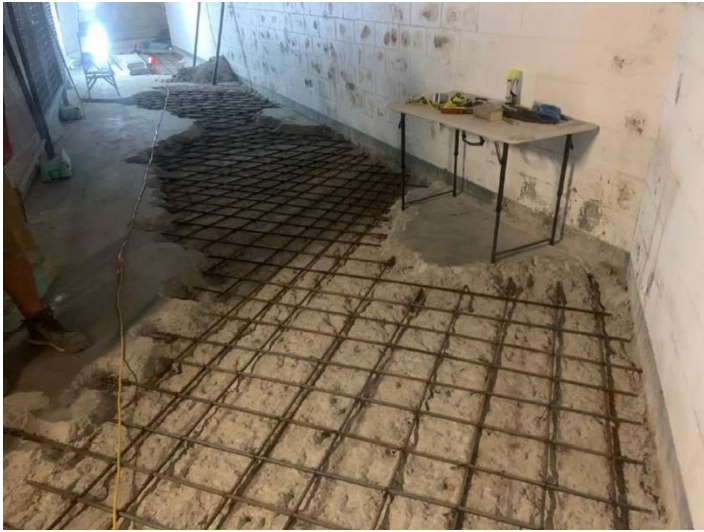
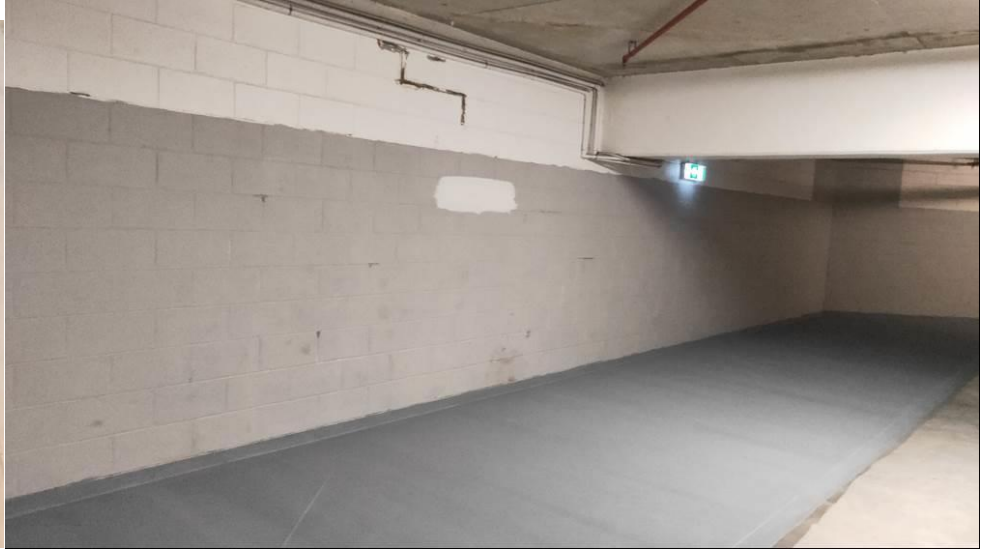
- *The concrete spalling in the basement near the bike rack has been finished with additional work undertaken to slope the slab to divert any surface water into the basement drains.*

Figure: Basement spalling bike rack area.

ARB Services Pty Ltd completed the concrete spalling repair. East Coast Engineering (David Wild (Director) B.E. (Hons), B. Bld Surv (Hons)) certified the work - Site Inspection Report, 12 July 2022.

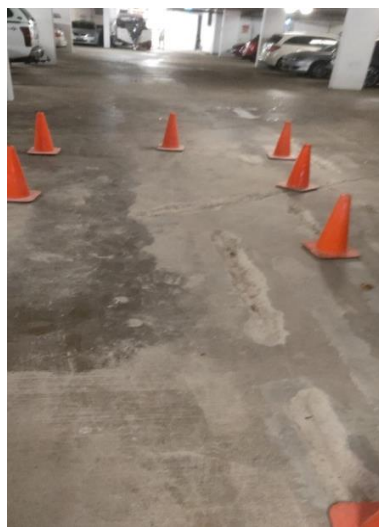
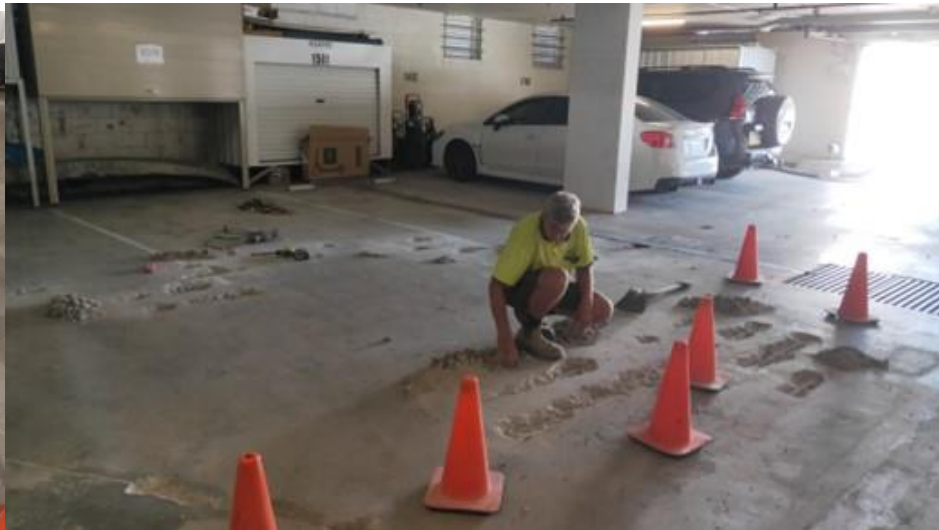
Figure: Areas of Concrete spalling (cracking concrete) have been treated and repaired.
