## **Report of Marine Survey**

Wee Leda

1995 Nordic Tug 32

February 22, 2024

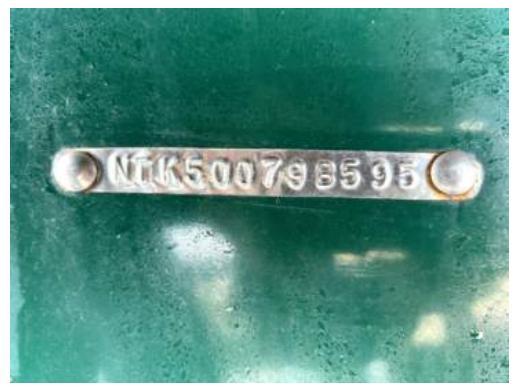
HIN at hull

According to the manufacturer, this 1995 Nordic Tug 32 was laid up with a solid fiberglass hull. She has a trawler shaped hull with hard chines, shallow full length keel and skeg hung rudder. The owner created the HIN, Hull Identification Number stamped within a stainless steel plate at the transom because the manufacturer gelcoat stamp was un-readable. The owner utilized the The US Coast Guard Documentation HIN number.

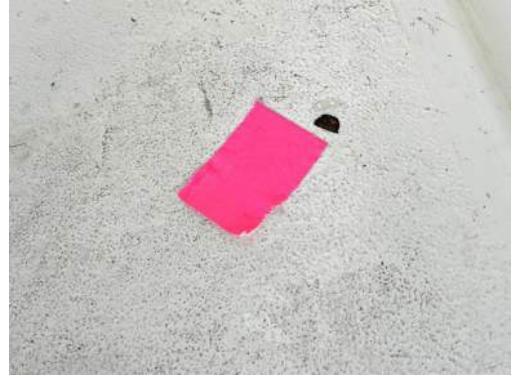
Deck gelcoat chip

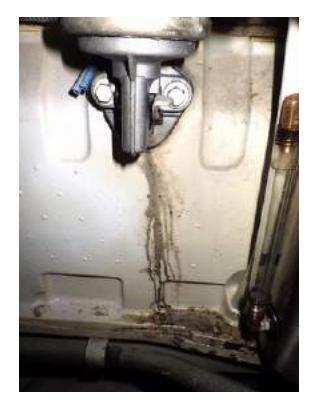
Slight engine oil leaks were sighted from the fuel pump attachment at the engine and at the aft valve cover gasket. No oil was found in the engine room bilge.

Oil leak from fuel pump

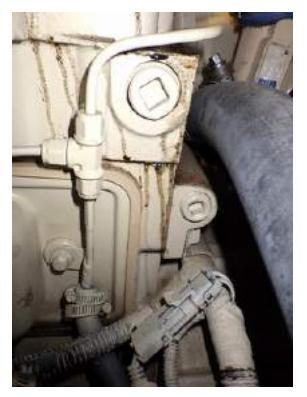
Oil leak from head

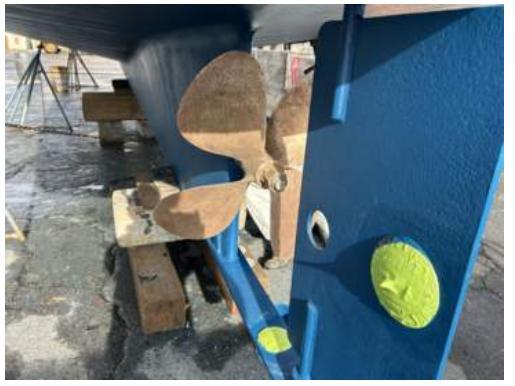
Slight corrosion pitting was found on the tip of one propeller blade.

**Propeller and rudder**

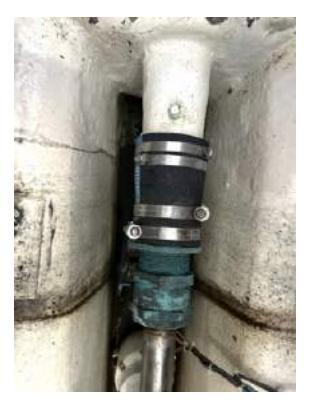
The engine's manufacturer recommended max RPM is 2500 - 2700 and the vessel reached 2700 RPM at full throttle. The steering, throttle and transmission operated normally. The vessel turned within 1-1/2 lengths of the boat at full rudder to port and starboard. No excessive vibration or leaks were detected from the engine and back down test was satisfactory. The engine reached 180 temperature after 45 minutes of operation and the alternator metered constant charge voltage while the engine was running. The stuffing box leaked approximately 3 drips per second while the shaft rotated.

Stuffing box
