# Digs Report

*Date of Certification: Date Report Delivered Property Address: Anytown, USA*

# Home Inspection Summary

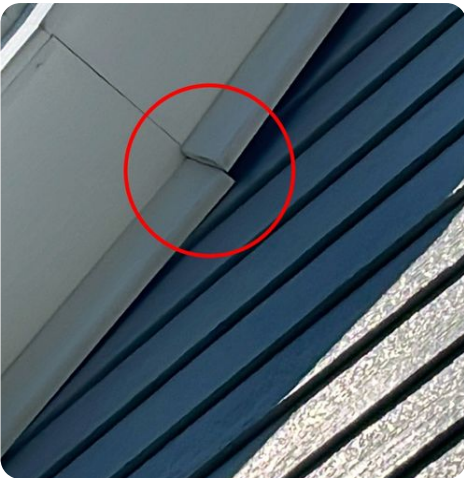
Location: Exterior

### 1 Overlapped Trim

There is a section of overlapped trim, which is caused by the PVC trim expanding during warmer weather. Minor adjustments can be made to secure the section.

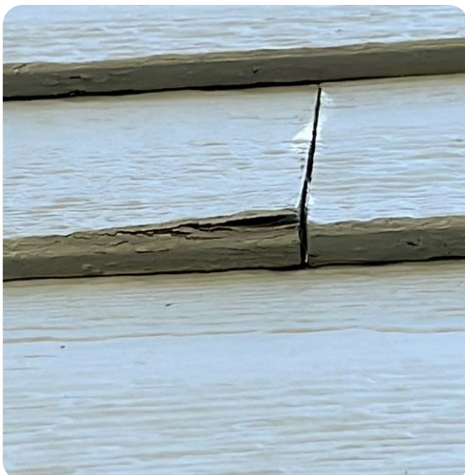
Location: Left Side of Home

### 2 Deteriorated Fiber Cement Board Repairs Recommended

One fiber cement board is showing early signs of deterioration. Repairing and sealing the area is recommended to prevent potential moisture intrusion. Contact a qualified contractor for maintenance.

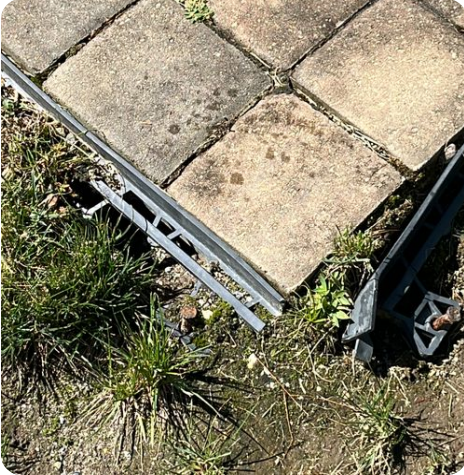
Location: Rear of Home

### 3 Minor Patio Settling

The inspector notes that a section of the rear patio has some erosion causing voids under the pavers. The inspector recommends having a qualified hardscape professional provide improvements to prevent further erosion and settling.

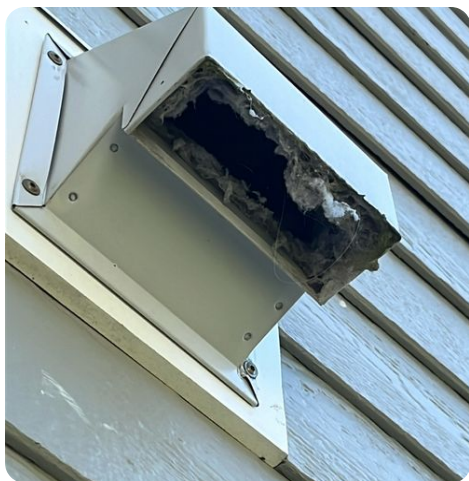
The dryer vent is in need of cleaning. A clogged dryer vent can pose a fire hazard and reduce the efficiency of your dryer. It is recommended to have a qualified HVAC technician or dryer vent cleaning service evaluate and clean the vent system to ensure proper functioning and safety. Regularly cleaning the dryer vent can also help improve the performance and lifespan of the dryer.

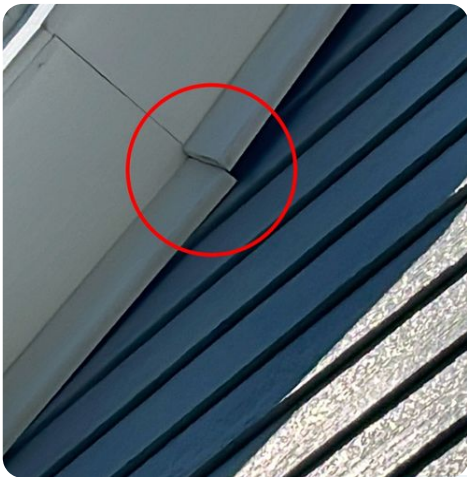
Location: Exterior

Overlapped Trim

There is a section of overlapped trim, which is caused by the PVC trim expanding during warmer weather. Minor adjustments can be made to secure the section.

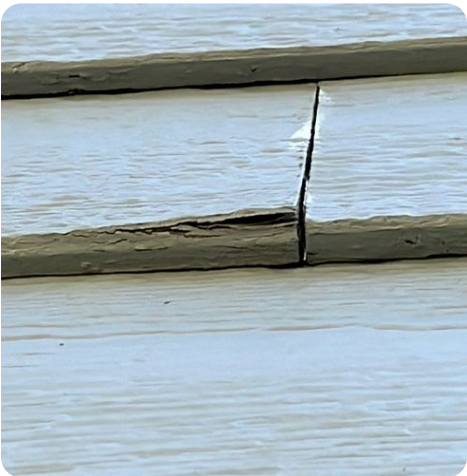
Location: Left Side of Home

Deteriorated Fiber Cement Board

One fiber cement board is showing early signs of deterioration. Repairing and sealing the area is recommended to prevent potential moisture intrusion. Contact a qualified contractor for maintenance.

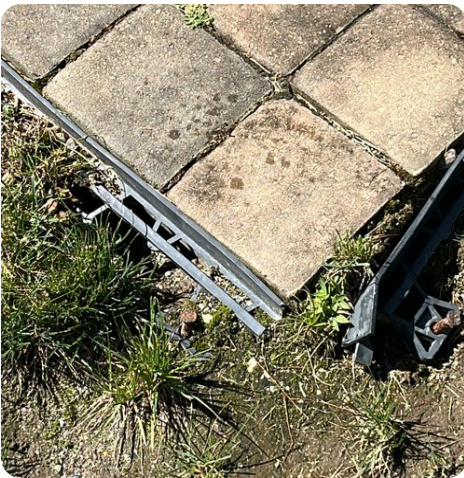
Location: Rear of Home

The inspector notes that a section of the rear patio has some erosion causing voids under the pavers. The inspector recommends having a qualified hardscape professional provide improvements to prevent further erosion and settling.

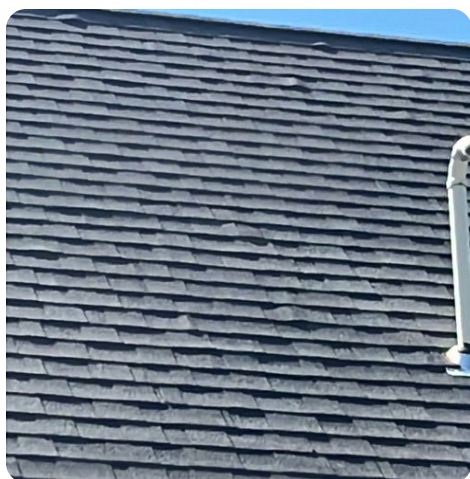
The presence of lifting shingles was noted on the rear of the structure. No signs of damaged or loose shingles were found. It is recommended to monitor this issue for any changes. Consider having a qualified roofer evaluate and repair as needed.

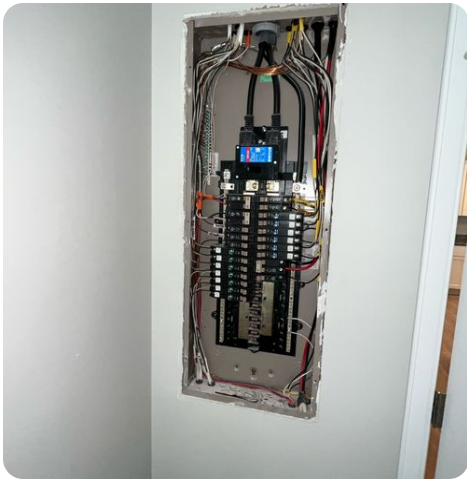
The interior components of the service panel were evaluated and found to be in satisfactory condition.

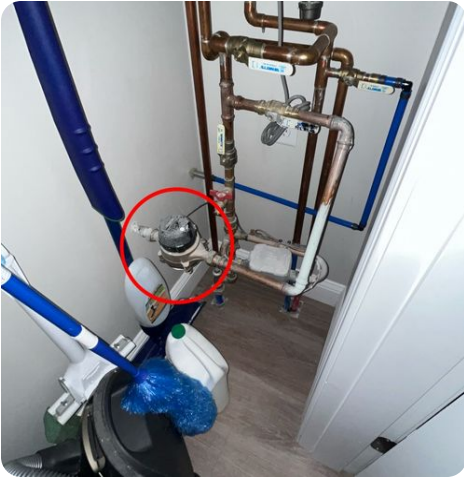
This property is equipped with a submeter which subtracts the exterior water usage from the sewage bill. These are typically installed for landscaping purposes.

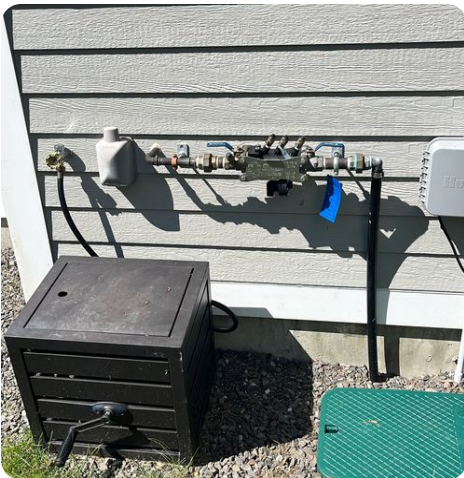
## Irrigation System

The property is equipped with an irrigation system. Testing these systems is not within the scope of practice for a standard home inspection. An unknown condition may exist. For further information, recommend contacting the owner or for further evaluation contact a qualified irrigation specialist.

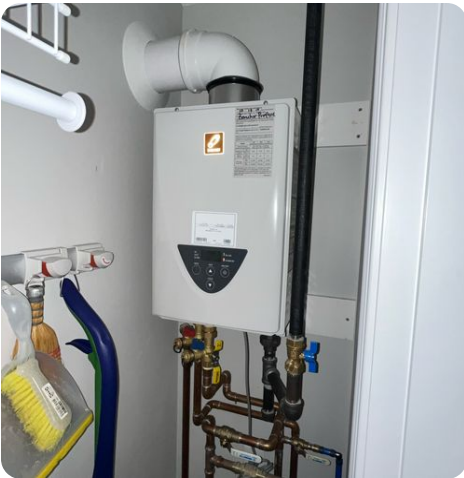
The gas on demand water heater was evaluated during the inspection and found to be in functional working condition.

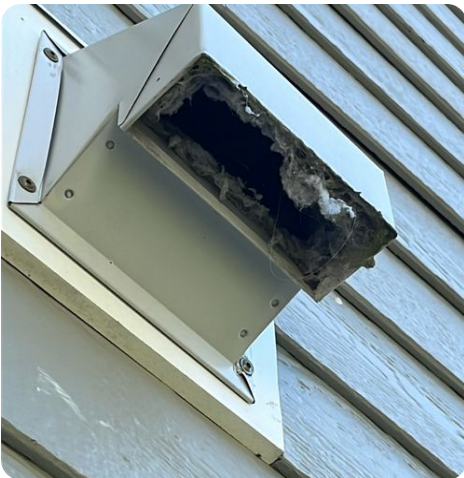
The dryer vent is in need of cleaning. A clogged dryer vent can pose a fire hazard and reduce the efficiency of your dryer. It is recommended to have a qualified HVAC technician or dryer vent cleaning service evaluate and clean the vent system to ensure proper functioning and safety. Regularly cleaning the dryer vent can also help improve the performance and lifespan of the dryer.
