# HOME INSPECTION REPORT

Address: \*\*\*\*\*

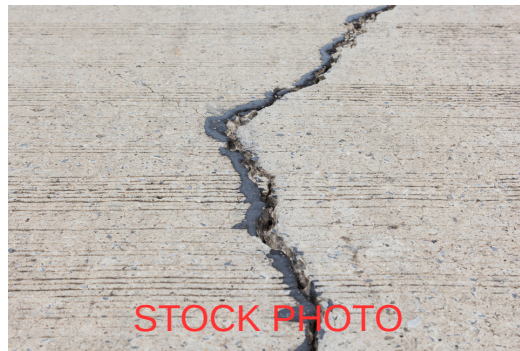
Page 3 Item: 1 Driveway/Parking

Large Crack was Observed in the Driveway. Cracks can allow water to seep below the slab causing further deterioration and possibly settling issues. Recommend sealing the crack with proper sealant.

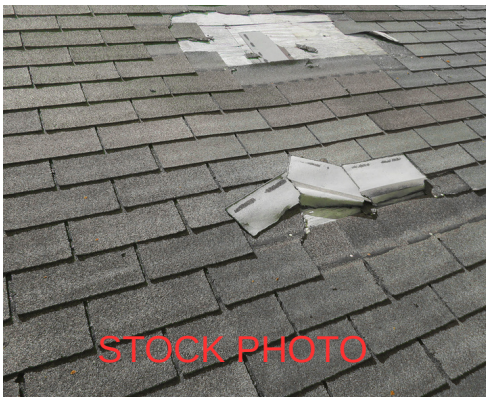
Observed damage to shingles. The observed damage has left the roof structure exposed and could lead to water leaking. Recommend roof contractor to repair the damage.

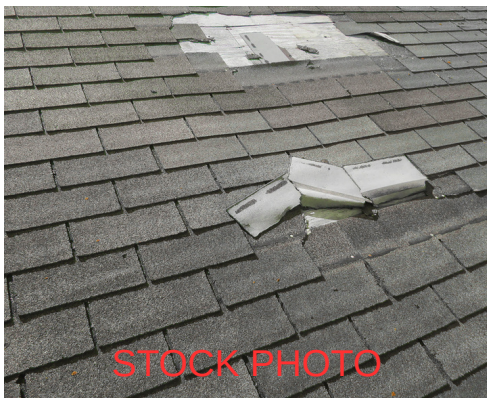
Observed damage to shingles.  
The observed damage has left  
the roof structure exposed and  
could lead to water leaking.  
Recommend roof contractor to  
repair the damage.

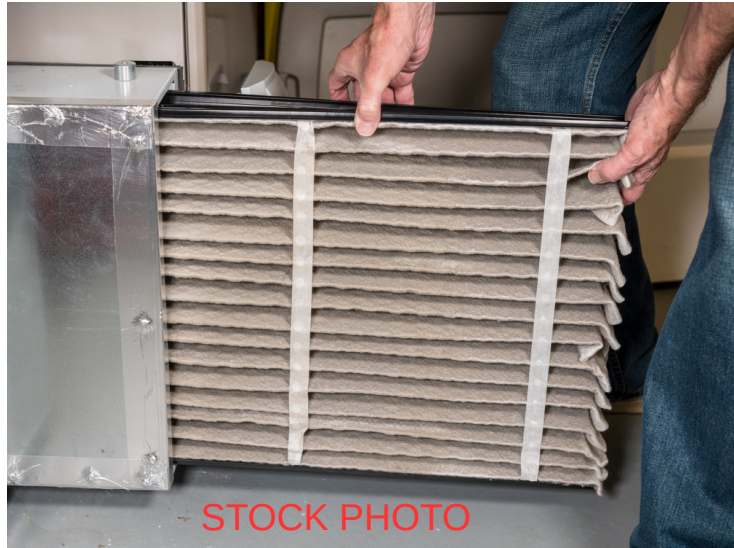
Observed dirty HVAC  
filter. Recommend  
replacement.  
Filter Size: 16x25x1
