# Case Study

Slave Lake, Alberta, Canada

## Multilateral Well

### Lateral Characterization & Mild Wash – 4 Laterals

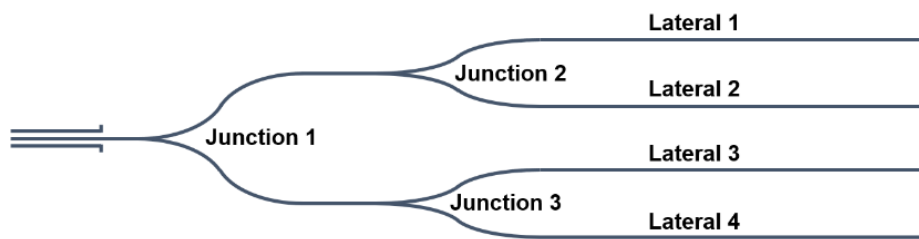
Figure 1

The well was drilled with an initial junction which joined two legs that also contained junctions as shown above in Figure 1. This resulted in two lateral windows having to be successfully navigated in order to reach any targeted lateral.

- Two laterals were unobstructed (2 & 3)
- One lateral had significant debris in the entry window (1)
- One lateral's window (4) was fully collapsed with material significantly reducing the diameter of the junction's natural bore path.

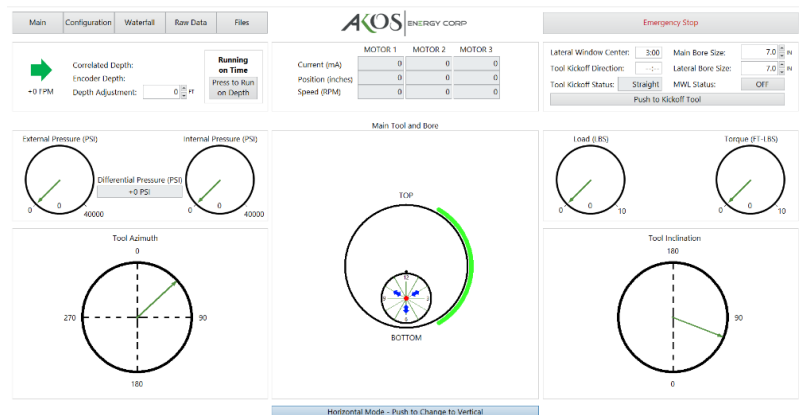
Figure 2

The well was assessed using the AKOS multilateral navigation tool in conjunction with the company's proprietary tool status and steering software shown in Figure 2. The results were as follows:

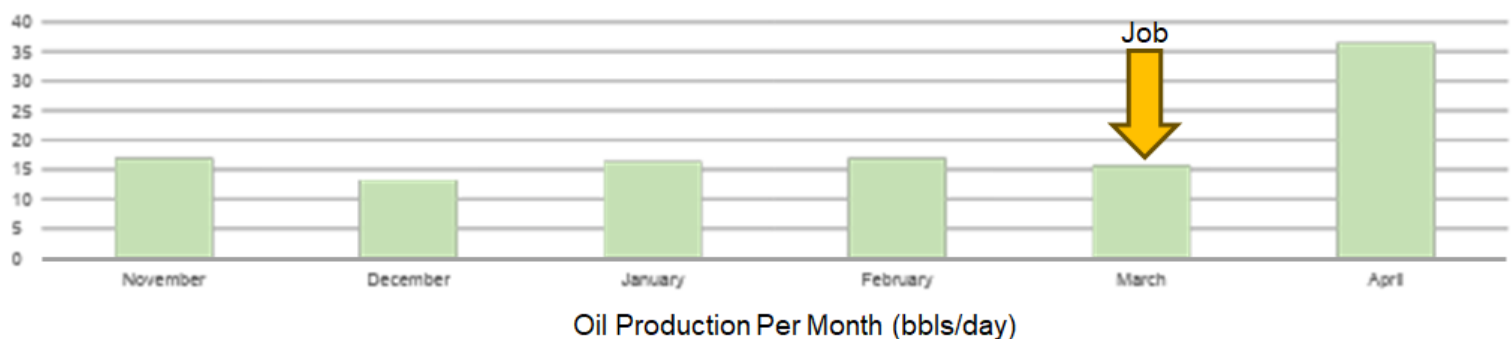
Figure 3

Publicly available production data from the well is shown in Figure 3. Monthly oil production more than doubled following the conclusion of the job. Most likely this increase is due to the successful re-opening of the window at Lateral 1.
