Existing Conditions

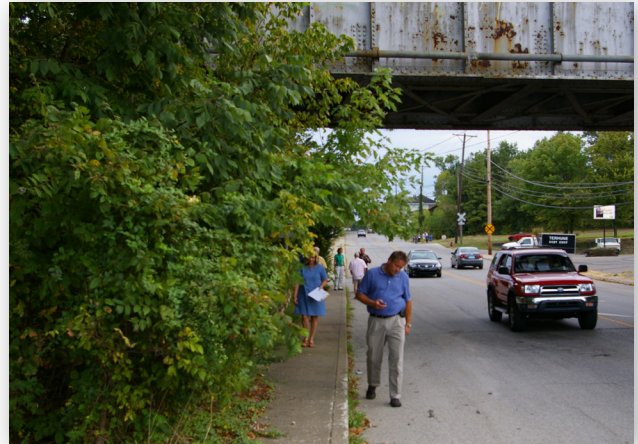
Poor maintenance of existing sidewalks, such as failure to remove obstructions, contributes to poor mobility

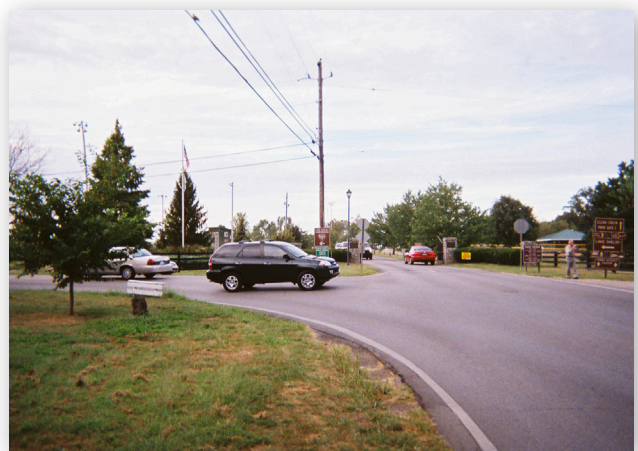
The current entrance to Clear Creek Park is a potential point of confusion for drivers who are not familiar with the right-of-way and intentions of other drivers entering the intersection

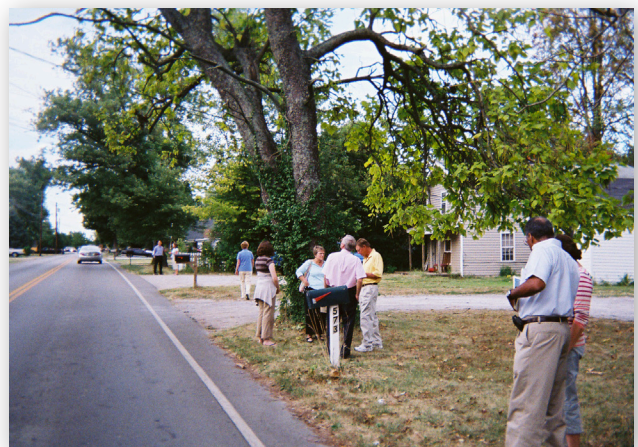
Mobility issues exist due to a lack of sidewalks on either side of the street
