Arsenal Inspection Services

Property Inspection Report

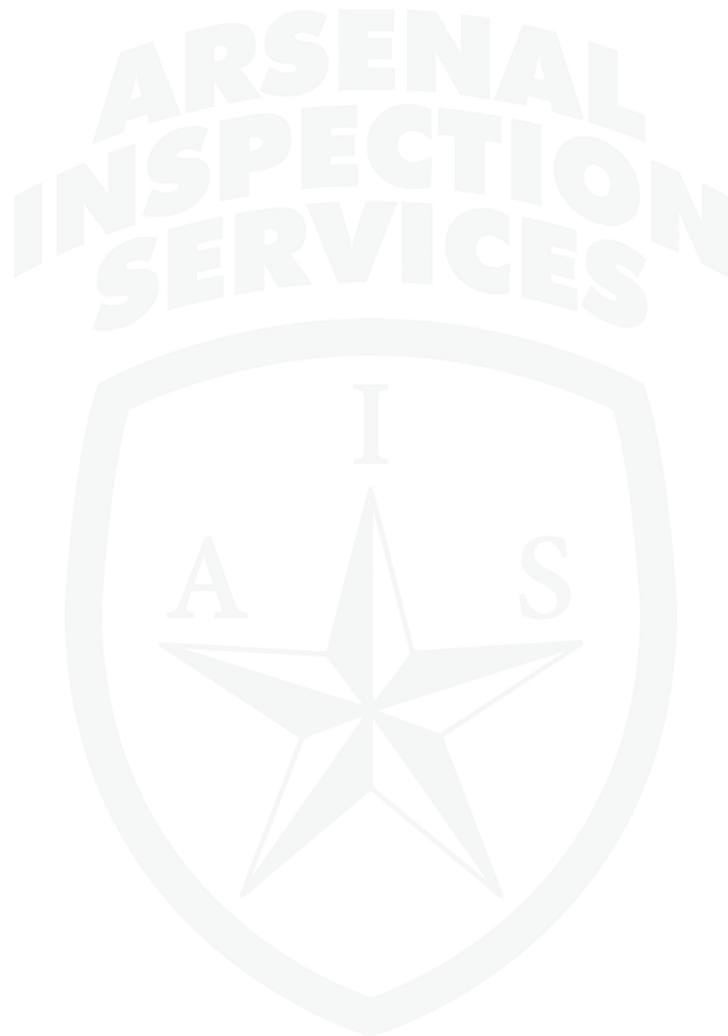
NOTICE CONCERNING HAZARDOUS CONDITIONS, DEFICIENCIES, AND CONTRACTUAL AGREEMENTS

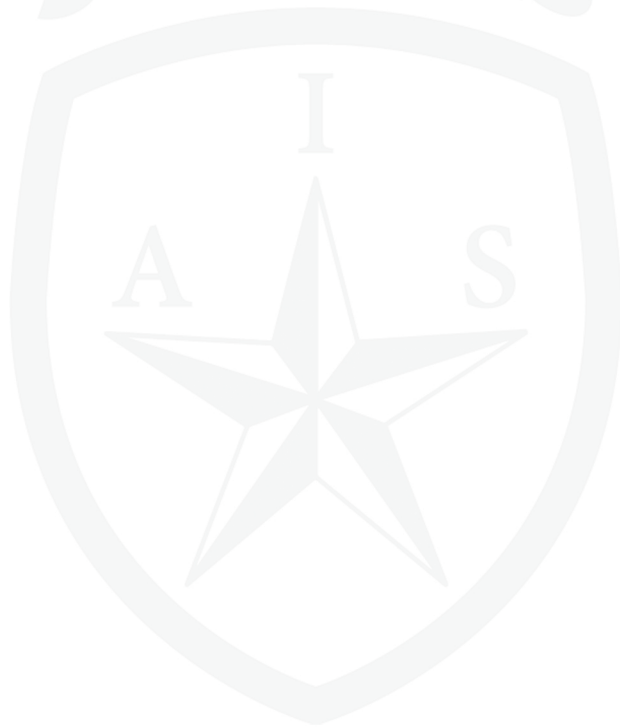
ARSENAL
INSPECTION
SERVICES

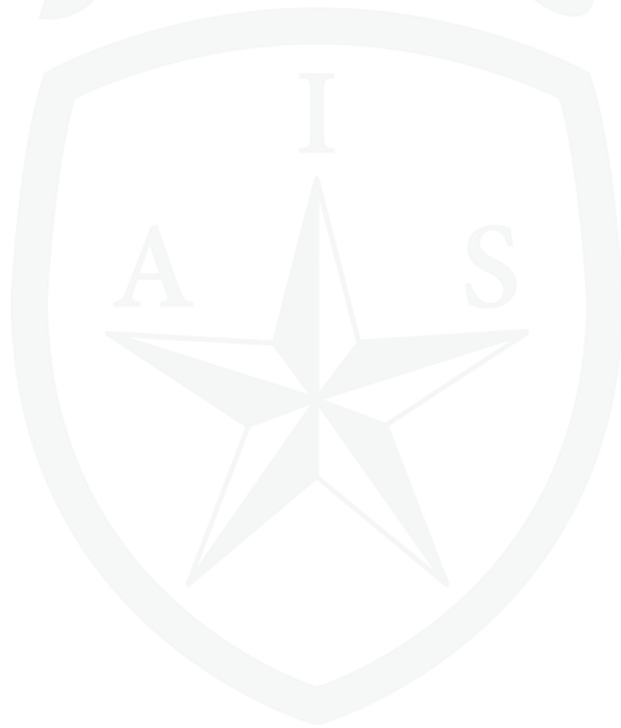
STRUCTURAL SYSTEMS	6-41
ELECTRICAL SYSTEMS	42-57
HEATING, VENTILATION AND AIR CONDITIONING SYSTEMS	58-68
PLUMBING SYSTEMS	69-81
APPLIANCES	82-97
OPTIONAL SYSTEMS	98-101
Report Summary	102-107

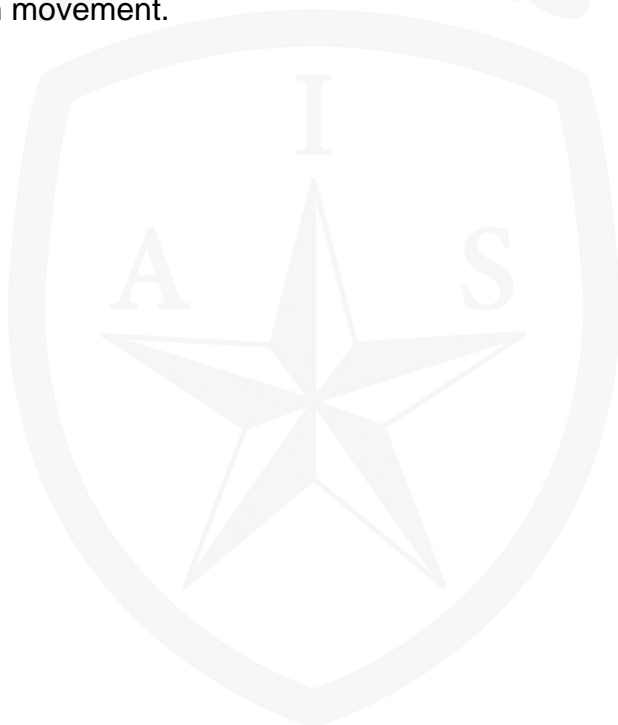
In examining the foundation and other components that make up the structural system, it is the opinion of the inspector that the foundation appeared to function without the need for immediate remedial leveling, providing adequate support for the structure based on a limited, visible observation. At the time of this inspection, there did not appear to be any evidence that would indicate the presence of significant movement in the foundation. This opinion is not to be applicable to future changing conditions. No accurate prediction can be made of future foundation movement.

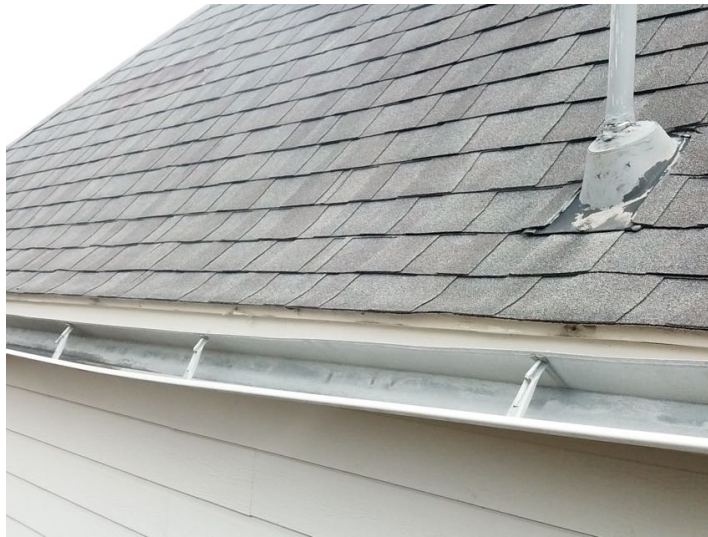
Gutter on roof left side shows extensive damage.

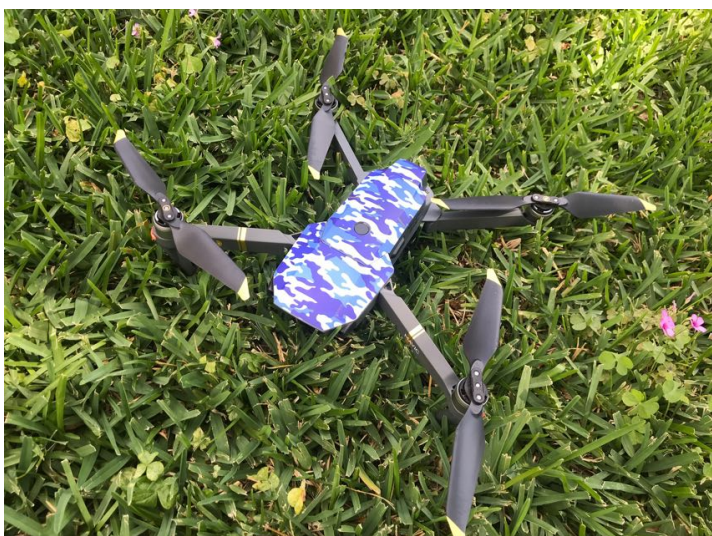
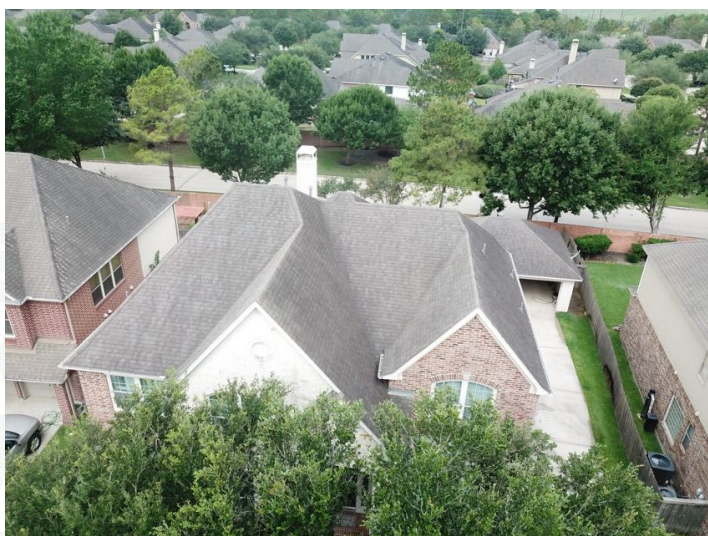
I	NI	NP	D
---	----	----	---

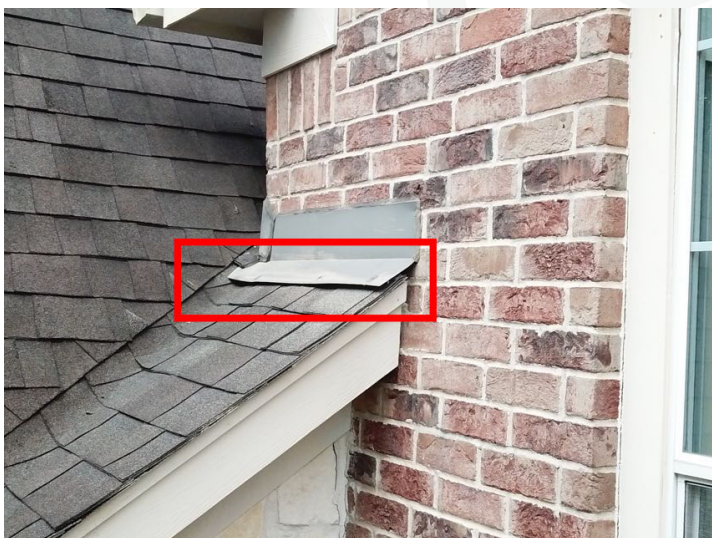
Due to the height, poor vantage point, lack of an adequate access point, and steep pitch of the roof, the inspector finds that the roof could not be safely walked and has partially inspected the roof through the use of aerial drone. This method, however, could more than likely not reveal smaller issues like exposed nails or other smaller deficiencies. The inspector does strongly recommend that for additional information about roof condition, maintenance and repairs that the previous owner or a roofing contractor be contacted.

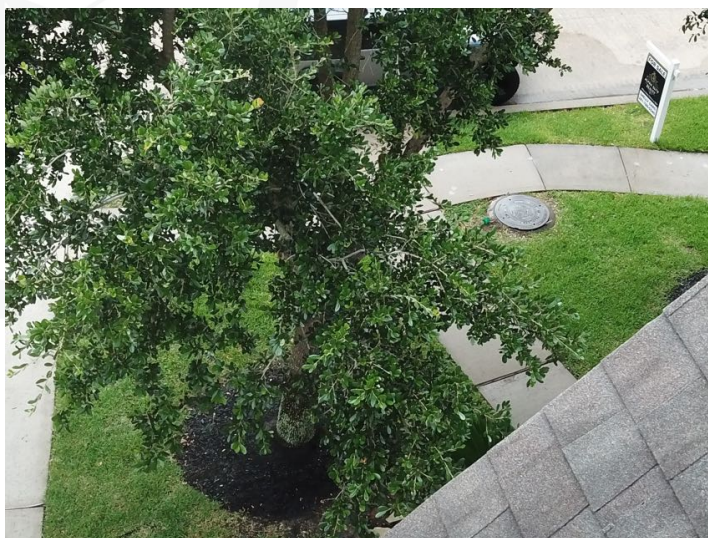
Special note: tree branches appear to be close to the roof, they are not actually touching the roof, I recommend contacting a tree service to prune back trees away from the roof so they will not damage the roof.

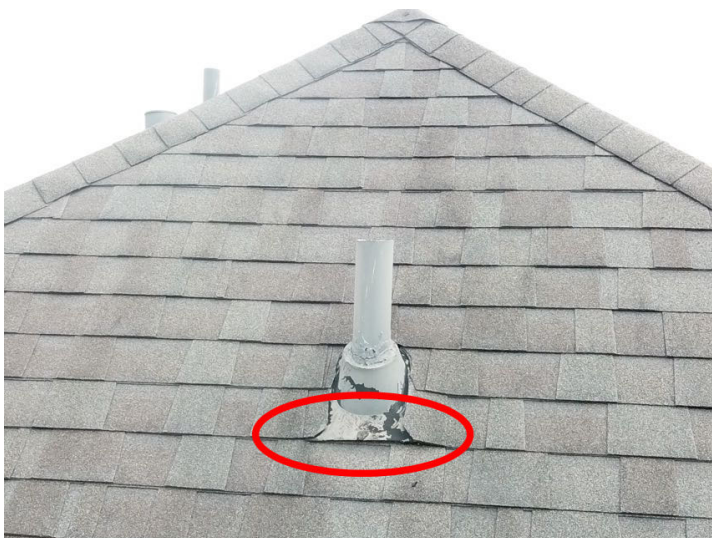
Plumbing vent pipe Perma-Boot flashing is lifting

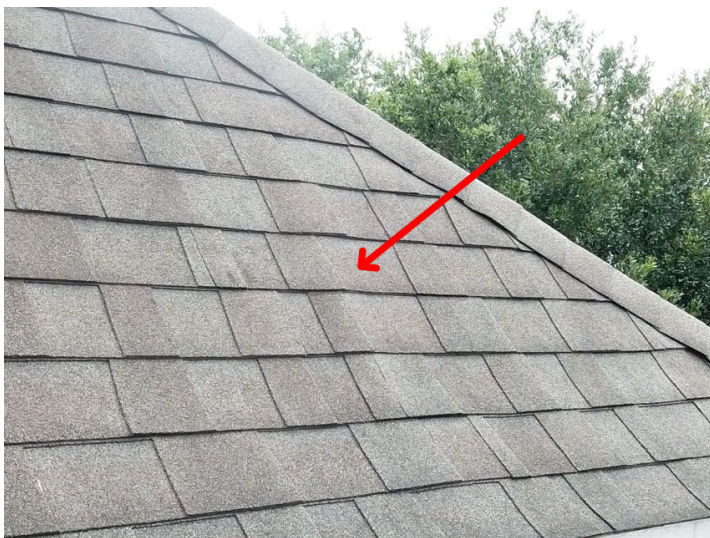
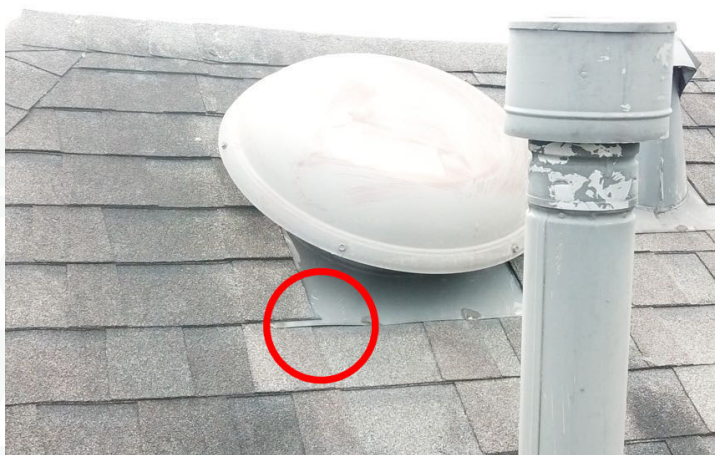
Deflections spotted in the roof covering. These deflections could be caused by a possible warping of the roof decking underneath or shingles buckling at different points of the roof covering.

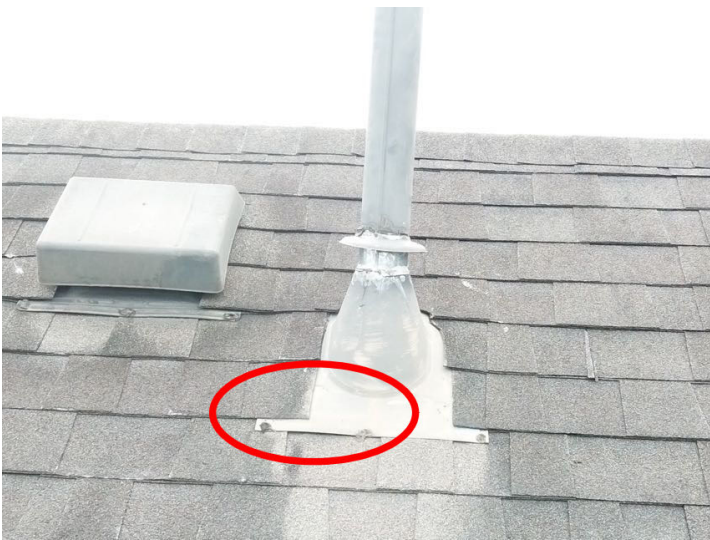
I	NI	NP	D
---	----	----	---

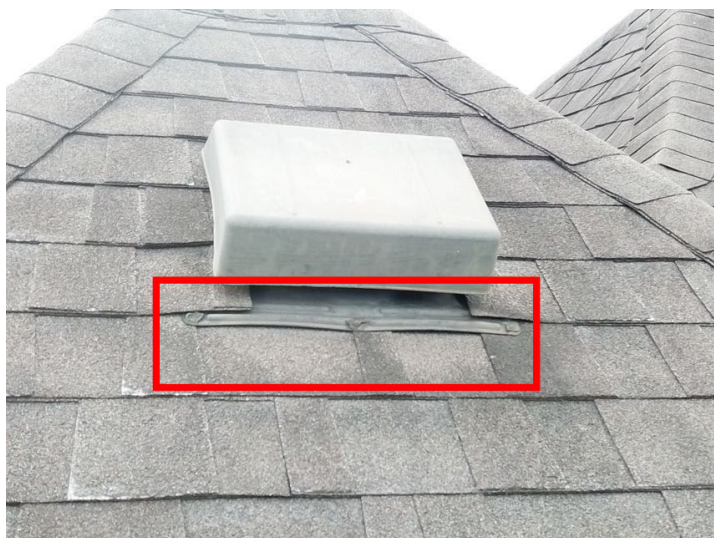
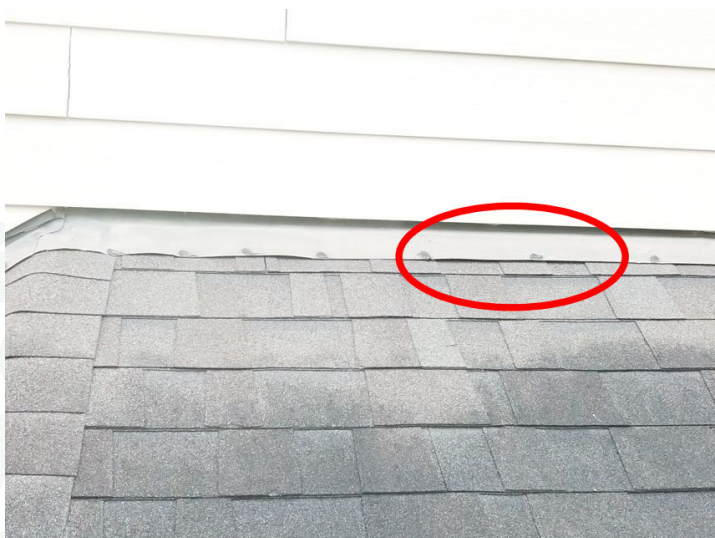
I	NI	NP	D
---	----	----	---

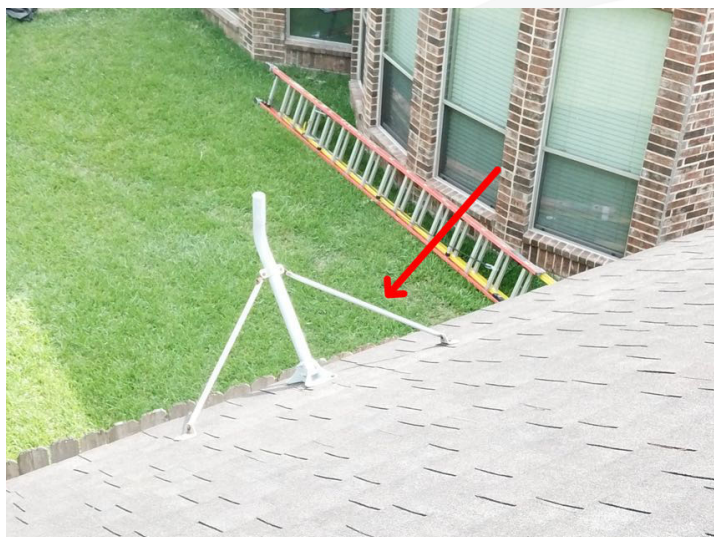
Satellite dish appears to be improperly installed. Fasteners appear to have been driven through the shingles compromising the roof covering.

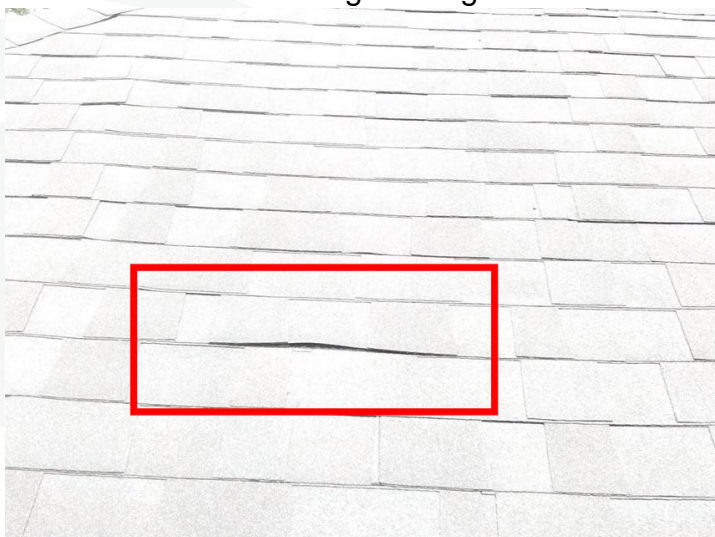
Shingles lifting, shingles are lacking the proper amount of adhesive to keep the roof integrity intact causing shingles to lift, because of this, the shingles could be damaged by high winds at some point.

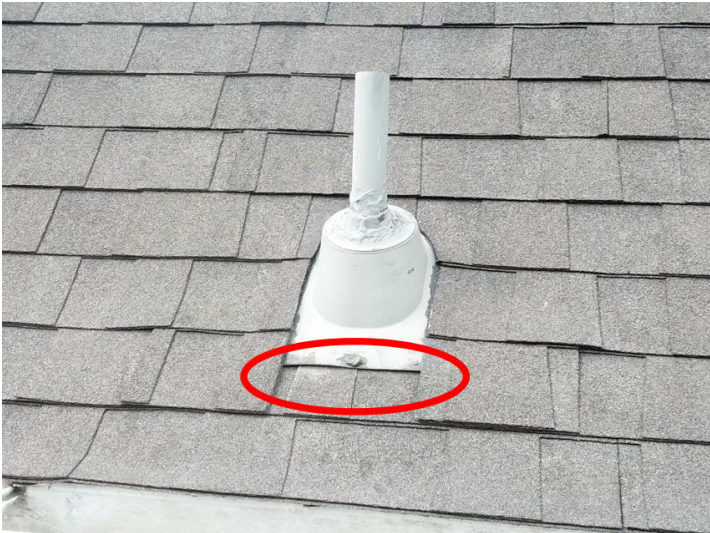
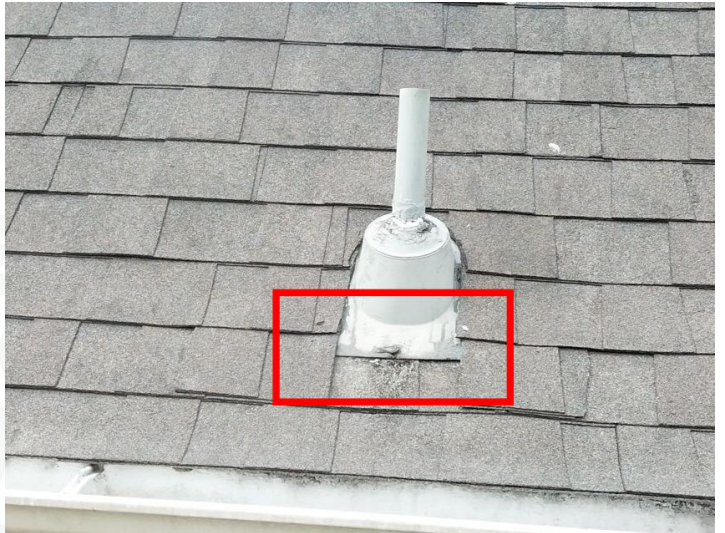
Plumbing vent pipe Perma-Boot flashing is lifting

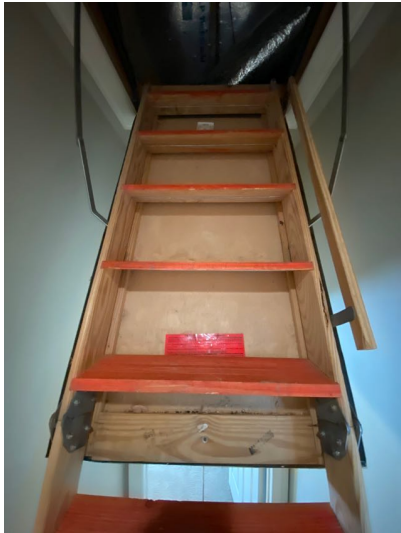
Missing insulation on the attic access door.

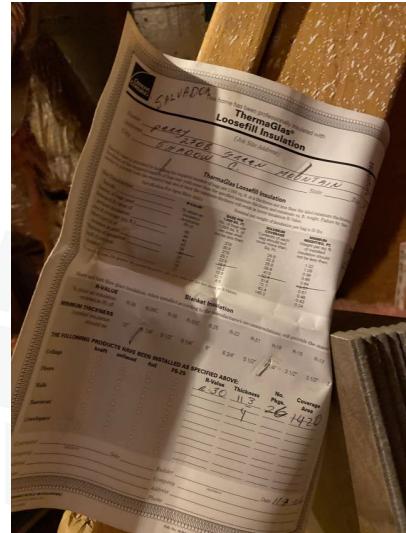
Insulation specifications

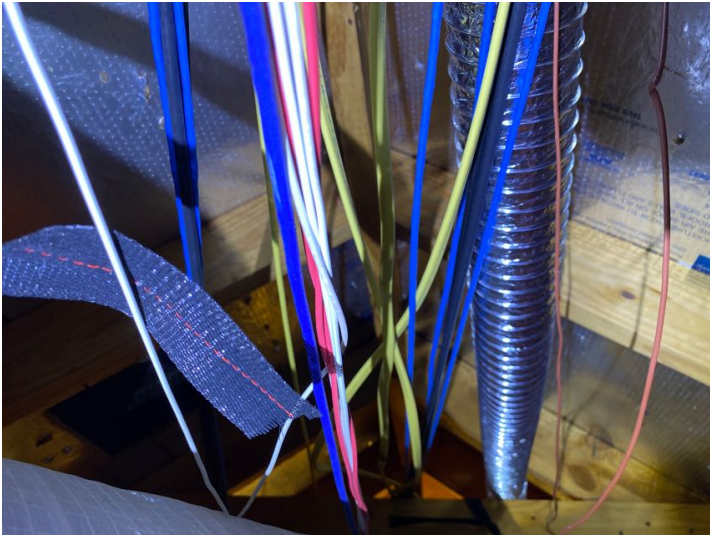
Roof Structures and Attic space

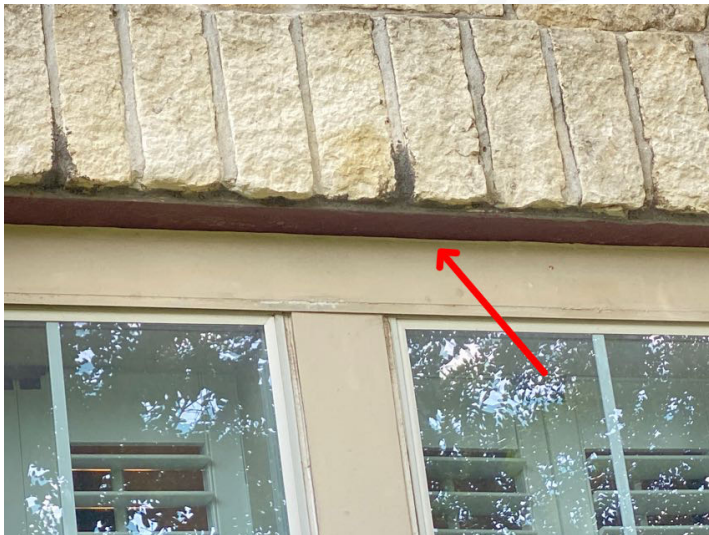
Note: This house has steel lintels above the garage doors, entry doors and windows. These lintels have been known to rust over time, I would like to recommend periodic painting with rust-oleum type paint to prevent rusting of lintel which supports the brick overhead.

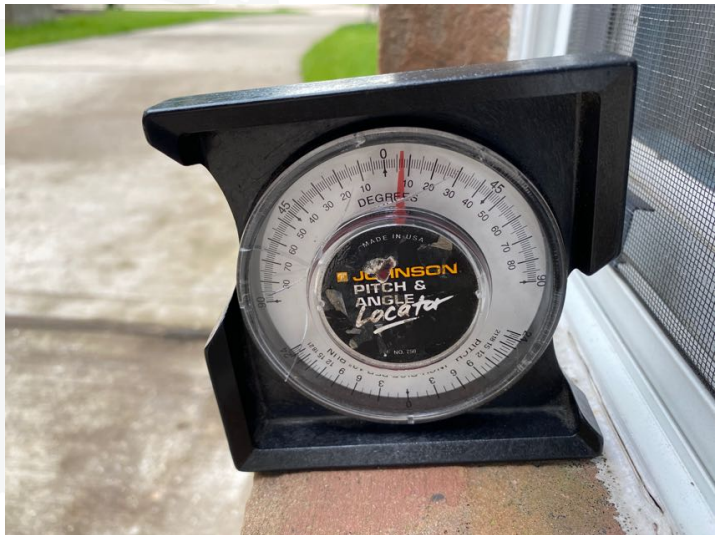
There are multiple locations around the house where the brick window sills on the exterior do not have the proper slope. The window sills should slope at a 15° angle away from the house.

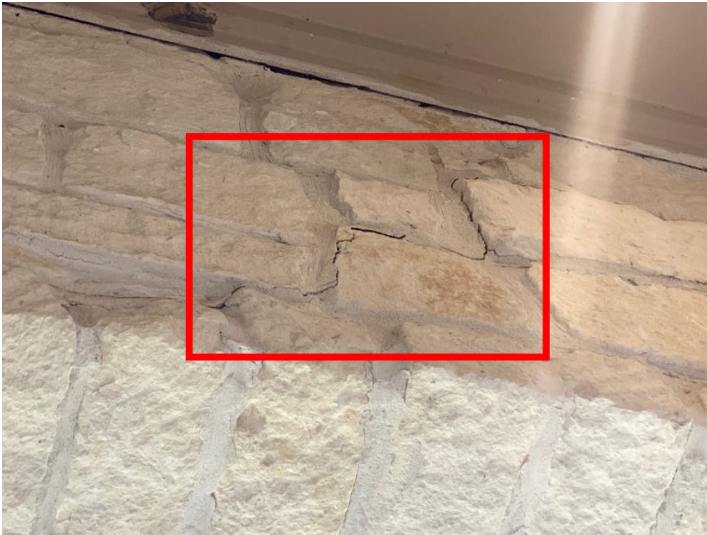
Missing or deteriorated mortar joints in between the brick(exterior)

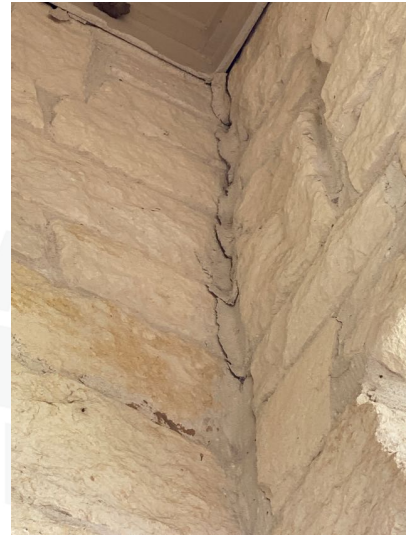
Missing or deteriorated mortar joints in between the brick(exterior)

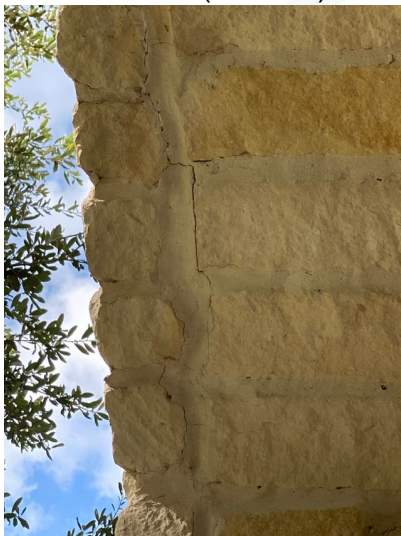
Missing or deteriorated mortar joints in between the brick(exterior)

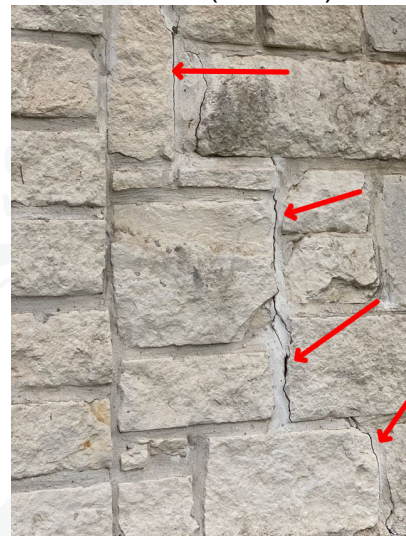
Missing or deteriorated mortar joints in between the brick(exterior)

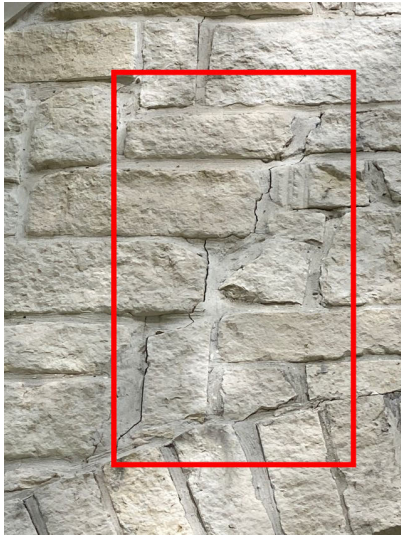
Missing or deteriorated mortar joints in between the brick(exterior)

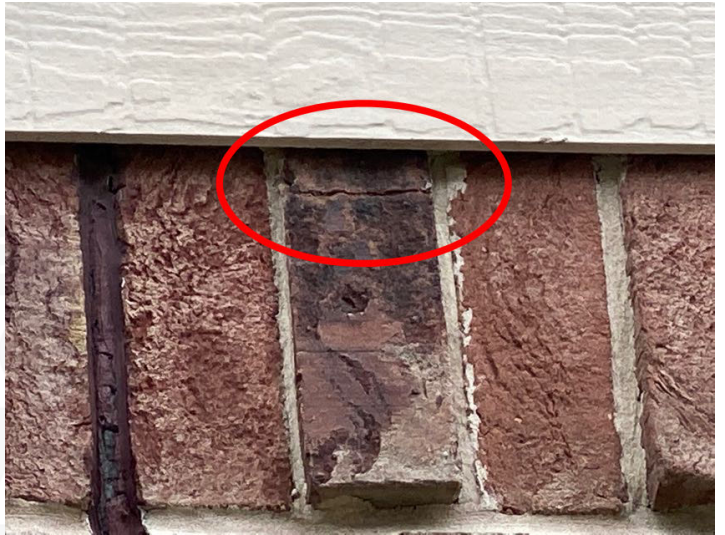
Cracking found in the exterior brick work

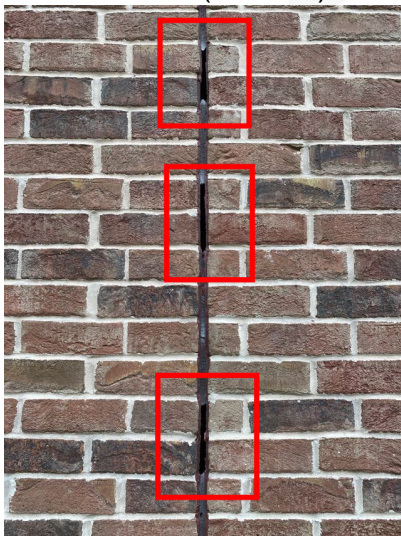
Missing or deteriorated caulking in between expansion joints in the siding(exterior)

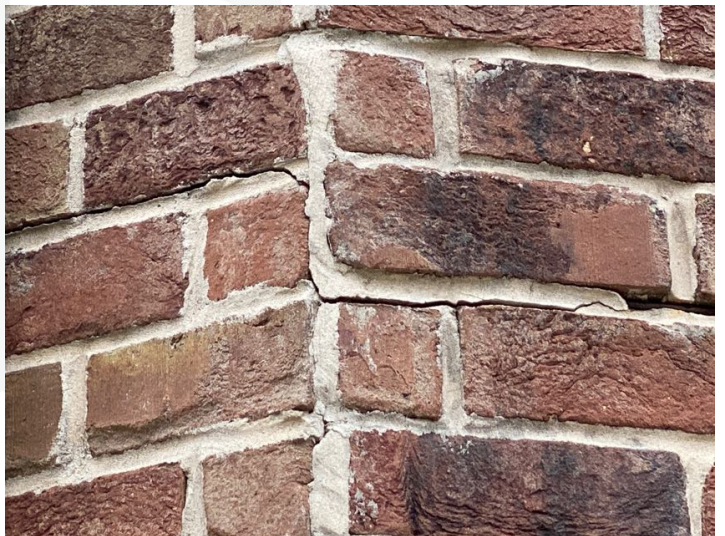
Missing or deteriorated mortar joints in between the brick(exterior)

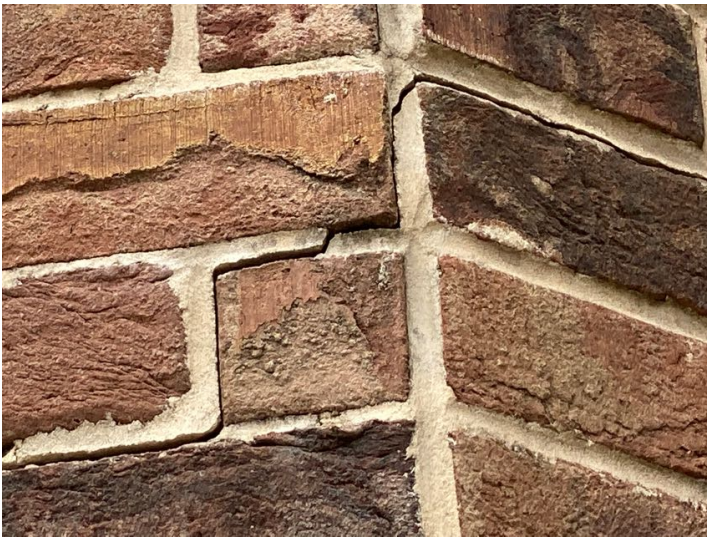
Missing or deteriorated mortar joints in between the brick(exterior)

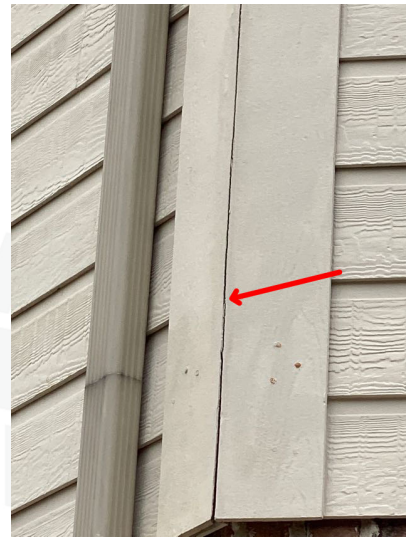
Missing or deteriorated caulking in between joints in the siding(exterior)

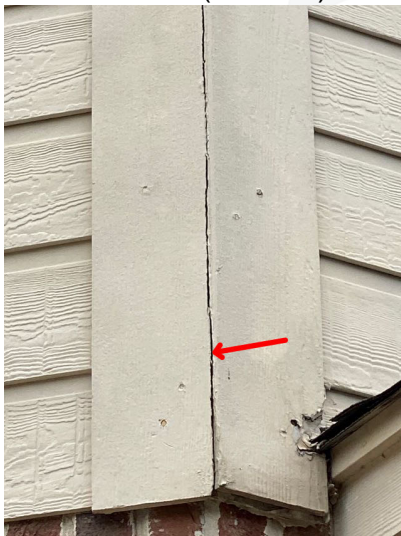
Missing or deteriorated caulking in between joints in the siding(exterior)

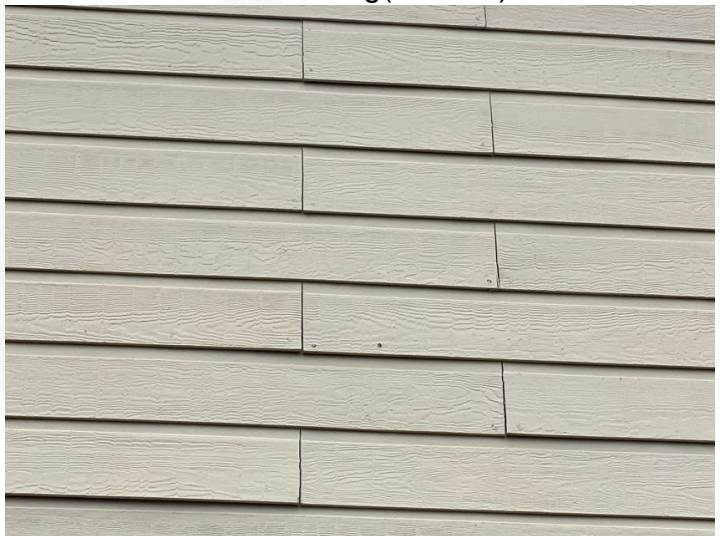
Missing or deteriorated caulking in between joints in the siding(exterior)

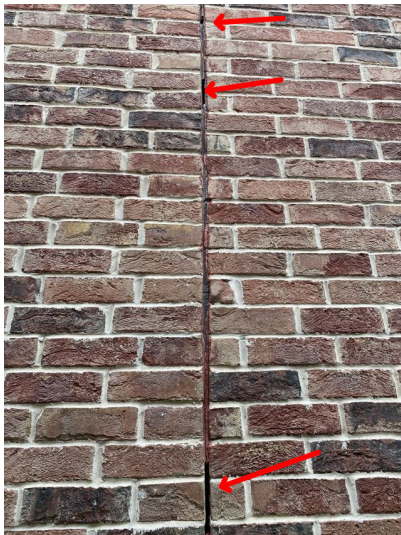
Missing or deteriorated caulking in between expansion joints in the siding(exterior)

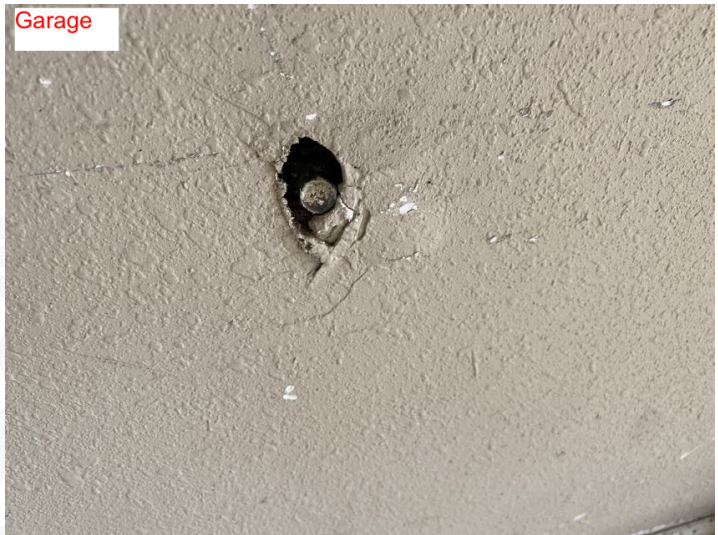
Damaged drywall observed.

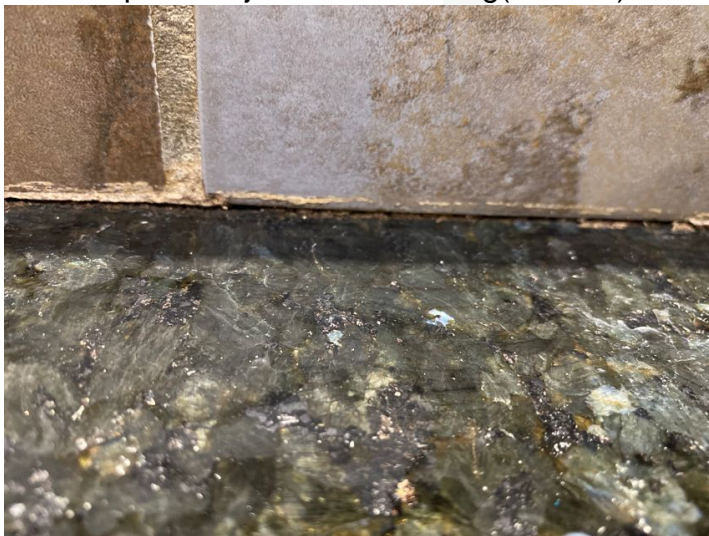
Missing or deteriorated grout lines around the kitchen sink area , this can allow water to penetrate behind the tiles and damage walls and or floor areas.

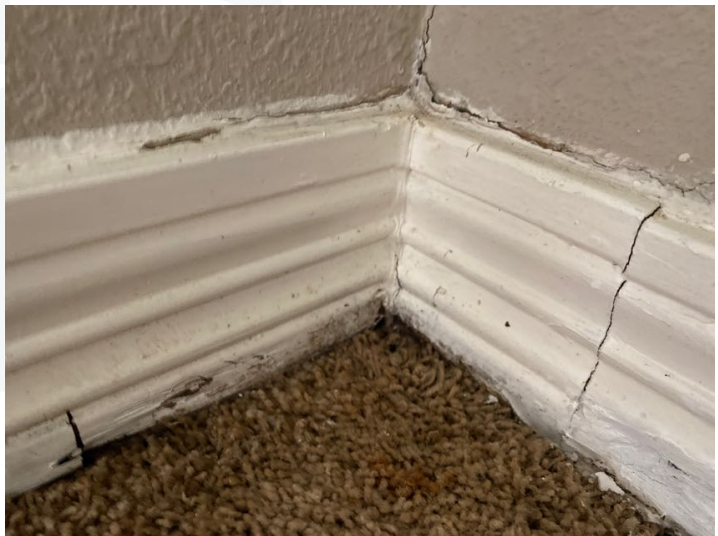
Deteriorated baseboards observed in the primary bedroom corner of a wall possibly due to apparent moisture damage coming from the primary bathroom shower.

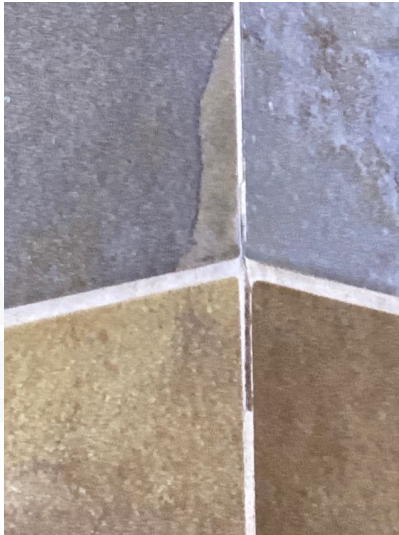
Missing or deteriorated grout lines around the upstairs guest bathroom tub area , this can allow water to penetrate behind the tiles and damage walls and or floor areas.

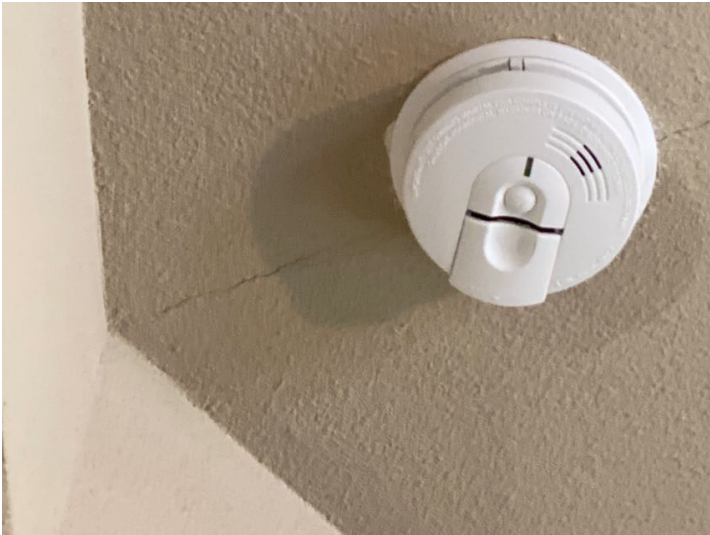
Small cracks on ceiling

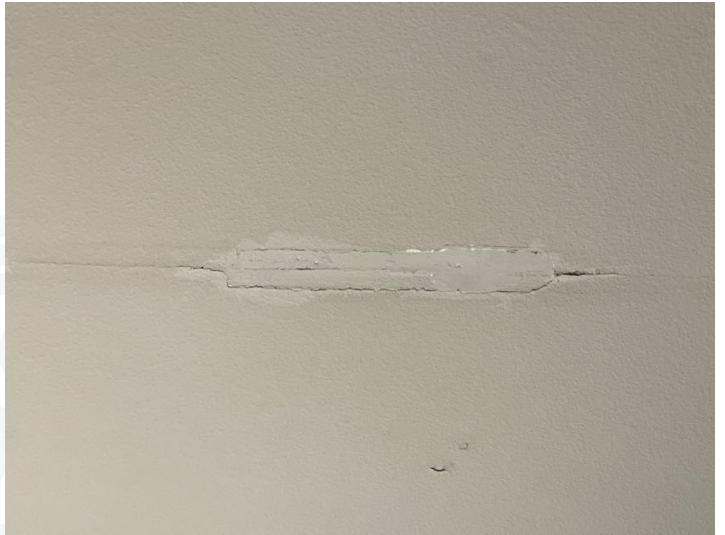
Ceiling damage observed in the primary bathroom.

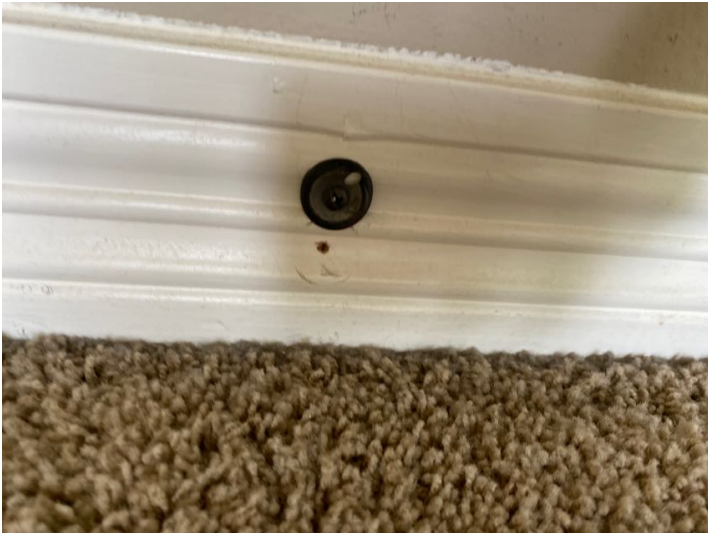
Missing doorstop (multiple areas)

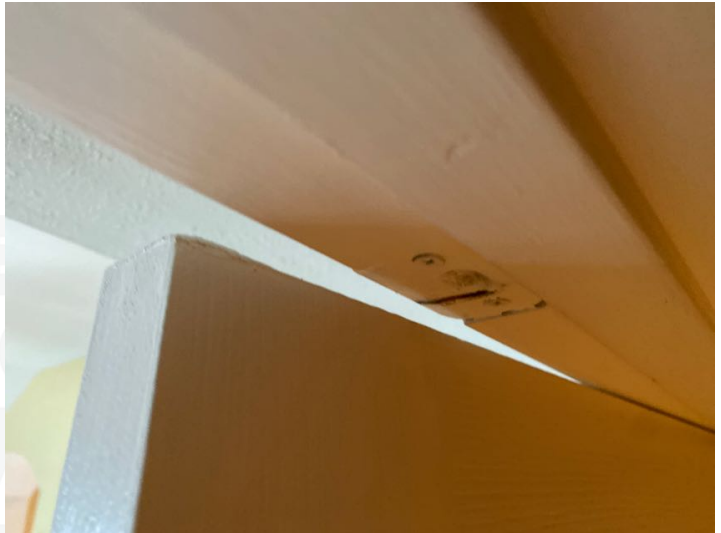
Doors to the upstairs media room do not latch properly

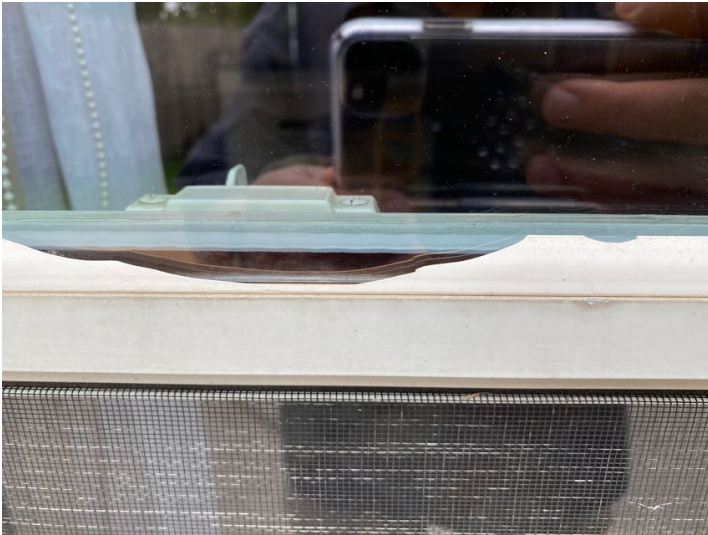
Damaged window frame beading observed.

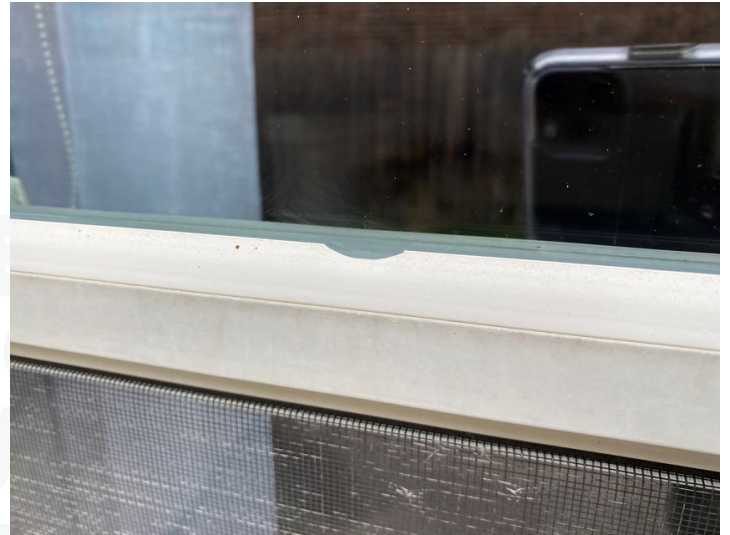
Damaged window frame beading observed.

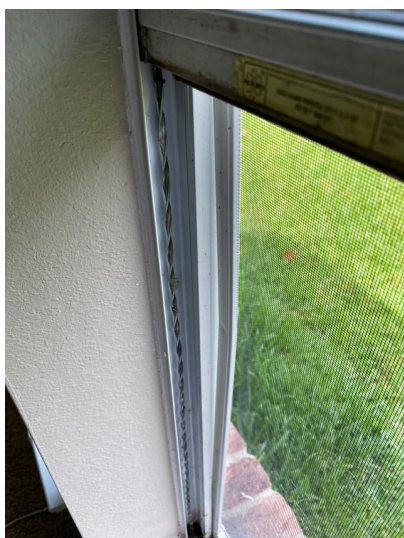
Broken/Damaged window channel balance rod assembly.

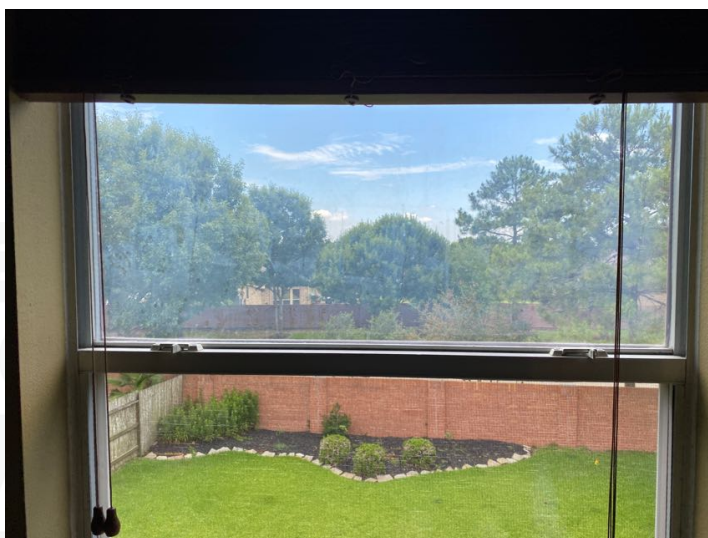
Fogged double pane windows present, When the window seals fail, your window actually has two seals. The desiccant within the window panes saturates with water. Now the insides of your window panes will fill with tiny amounts of water that we call: fog. This is an indicator of window failure, allowing the elements into the structure.

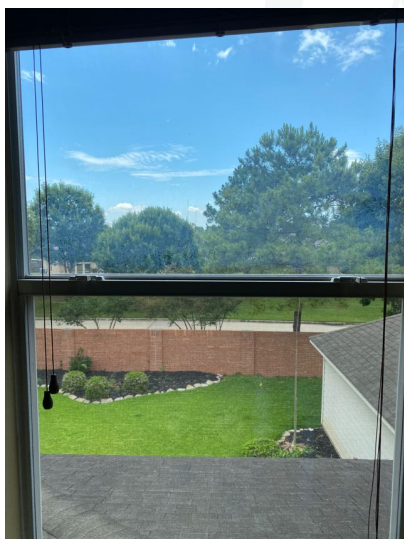
Fogged double pane windows present, When the window seals fail, your window actually has two seals. The desiccant within the window panes saturates with water. Now the insides of your window panes will fill with tiny amounts of water that we call: fog. This is an indicator of window failure, allowing the elements into the structure.

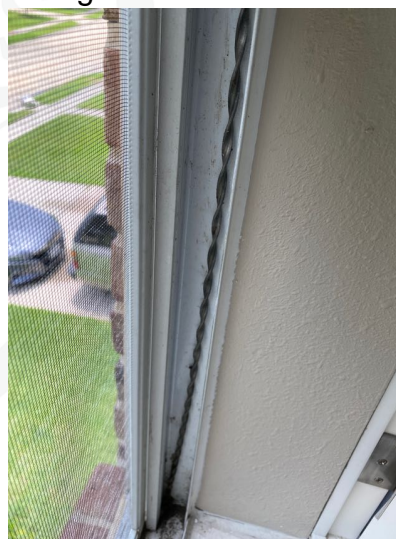
Broken/Damaged window channel balance rod assembly.

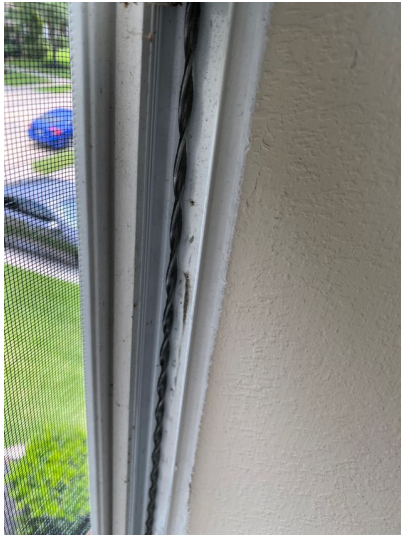
Broken/Damaged window channel balance rod assembly.

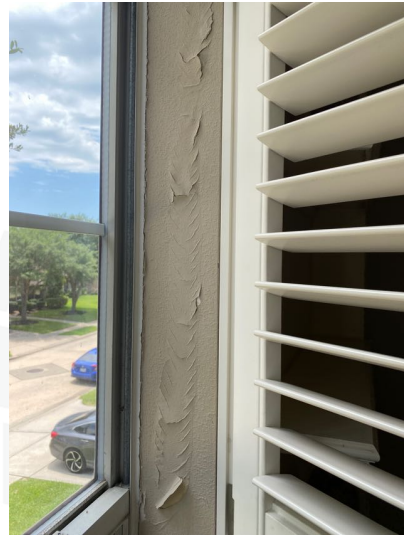
Peeling paint observed around upstairs office area window, this may be due to possible moisture related issues.

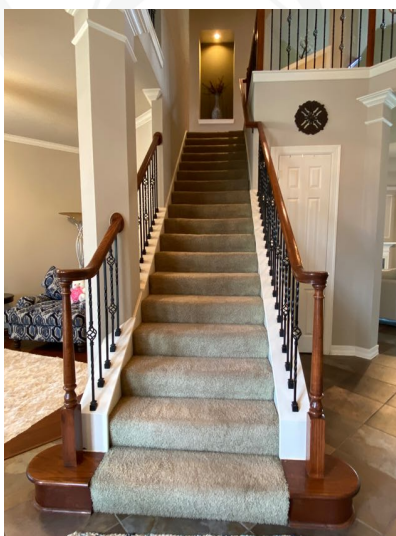
Functional, all treads, risers and handrails are of equal measurement according to current standards.

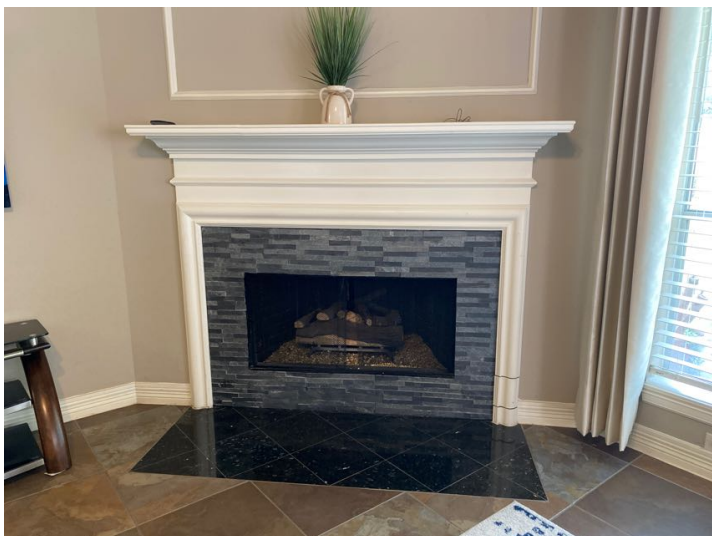
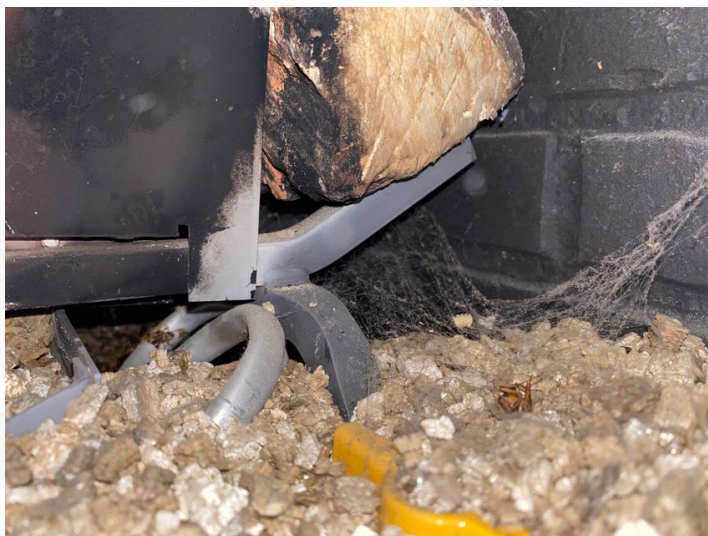
I	NI	NP	D
---	----	----	---

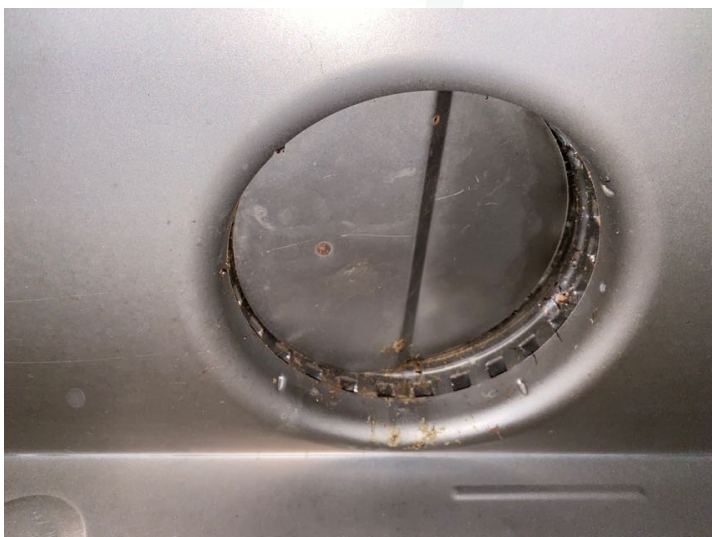
Note: Fireplace is a gas burning fireplace. Inspector does not test to see the actual operation of the fireplace, inspector looks for proper ventilation, positioning of dampers and fire stops within the structure.

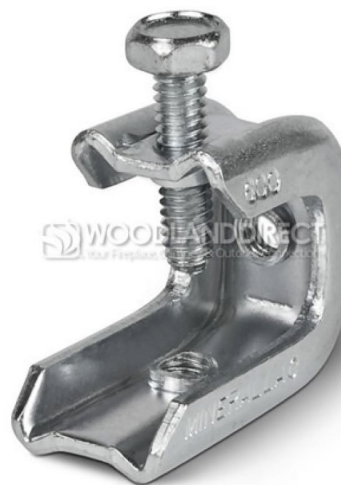
© Woodland Direct Inc.

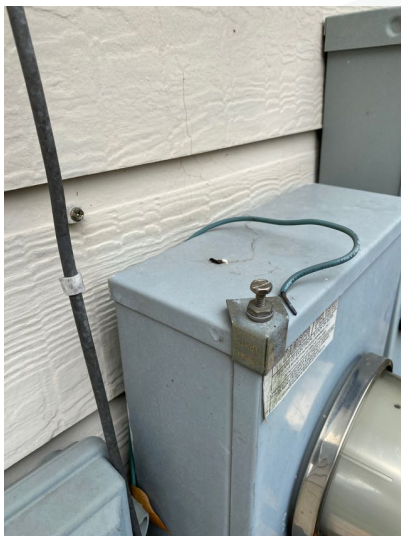
Electrical meter box is not properly secured to the wall.

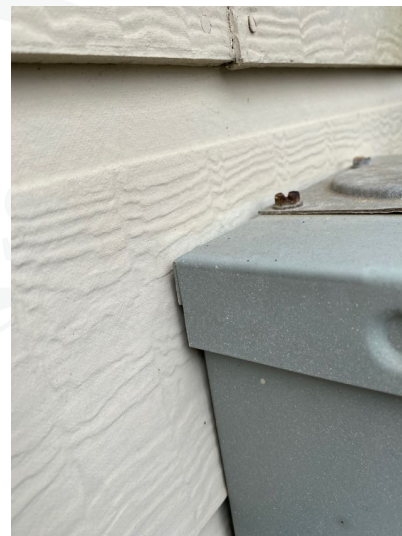
Electrical panel main disconnect box and electrical meter box lacks waterproof sealant at the top rear and side rear portions of the electrical panel to prevent moisture penetration from the rear of the electrical panel.

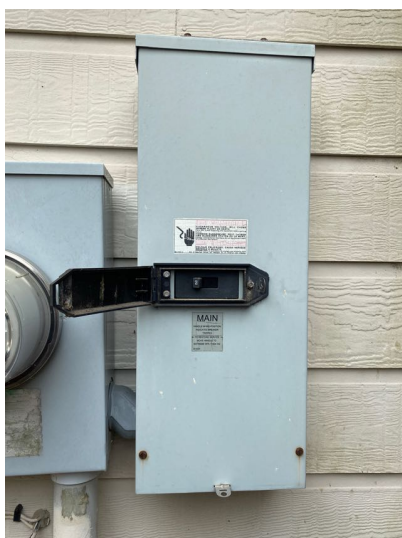
I	NI	NP	D
---	----	----	---

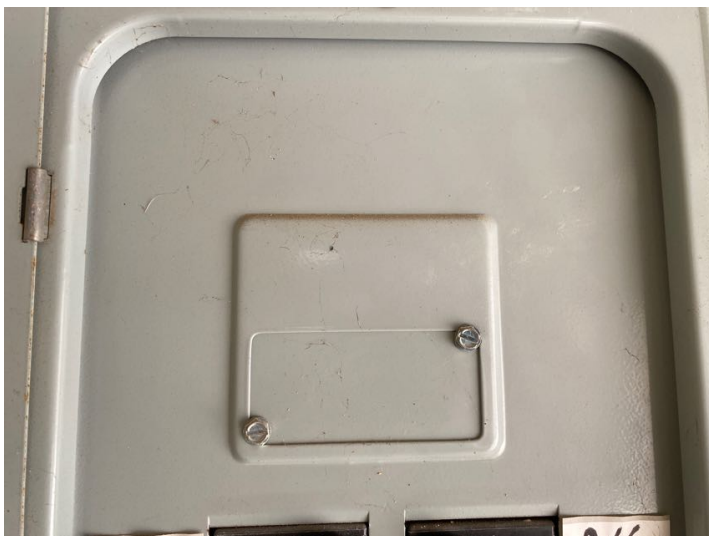
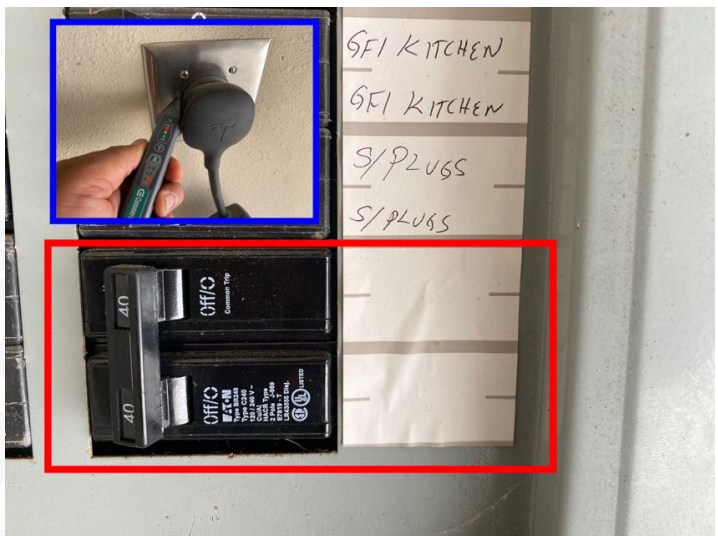
Electrical panel surge protector is missing. The conductors shall be protected against overload conditions by complying with one of the following:

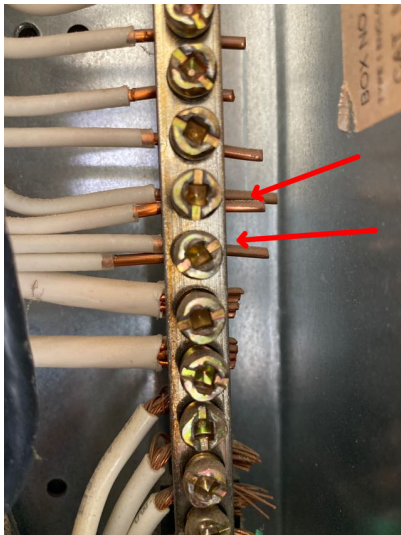
There are double tapped neutral wires in the panel. Each neutral wire should be individually lugged.
