Arsenal Inspection Services

Property Inspection Report

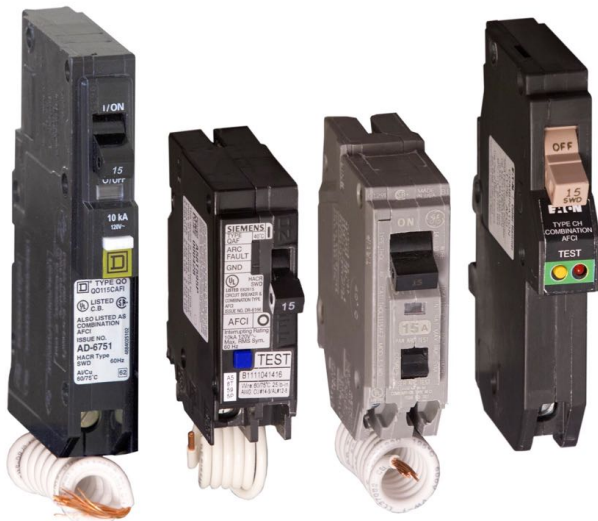
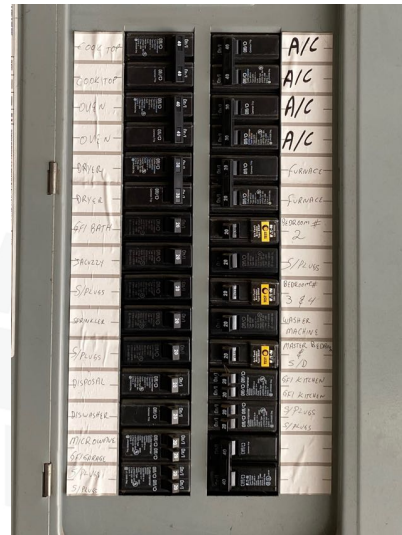
Arc Fault Circuit Interrupters (AFCI) may not have been in existence when this home was built. As of 2002, Arc Fault Circuit Interrupters were introduced for use in bedrooms only and as of September of 2008 the technology was implemented and required for all habitable rooms of houses that were newly built. Arc Fault Circuit Interrupters contain solid state circuitry that will recognize the unique voltage and current wave form combinations that are the signature of an electrical arc, like a loose connection or if a child inserts a paper clip into an outlet. The Arc Fault breaker will then trip, turning power to the circuit off immediately.

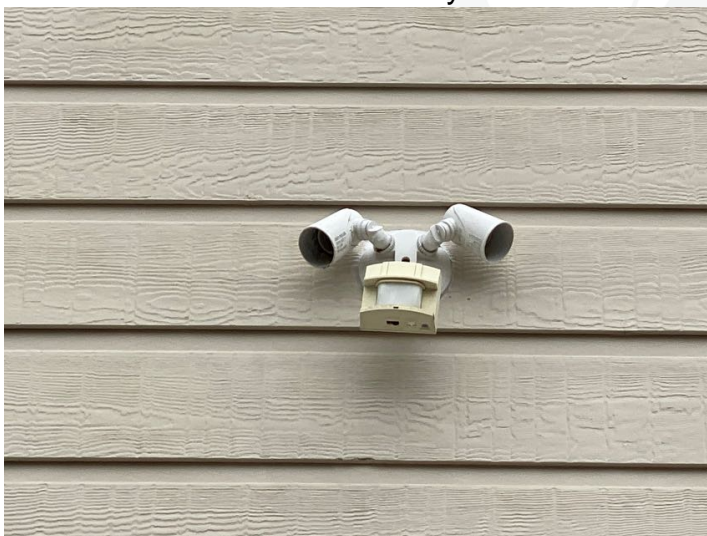
Light fixture not working properly, may have a short or may be in need of light bulb replacement.

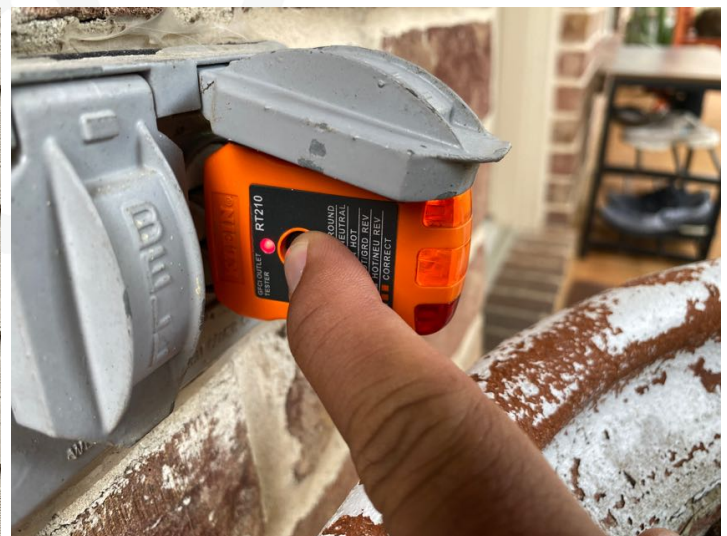
External house electrical outlets are not GFCI protected

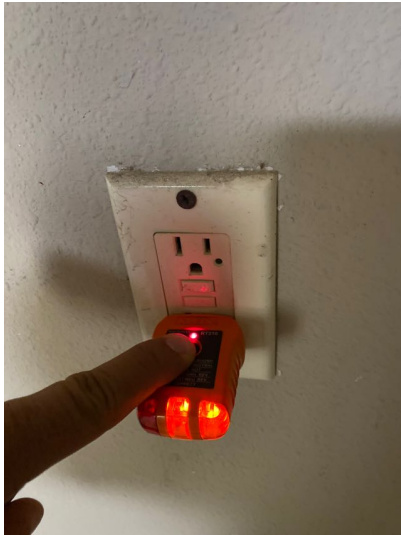
Garage electrical outlets are not GFCI protected

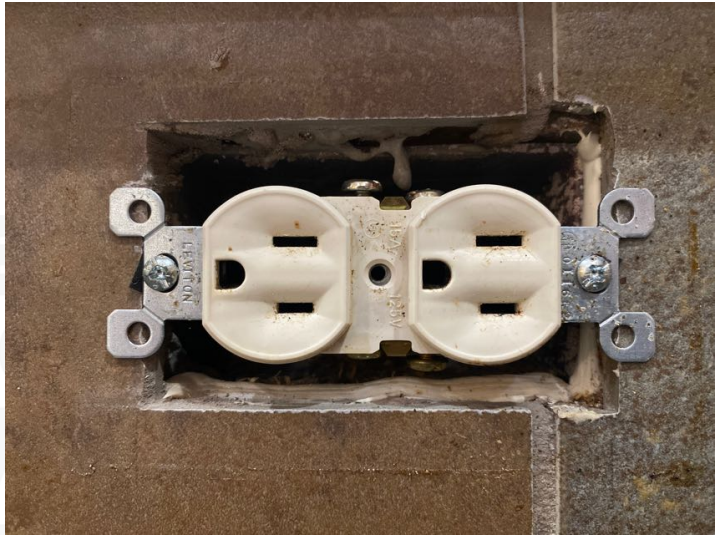
Missing box extender for electrical outlet in the kitchen area.

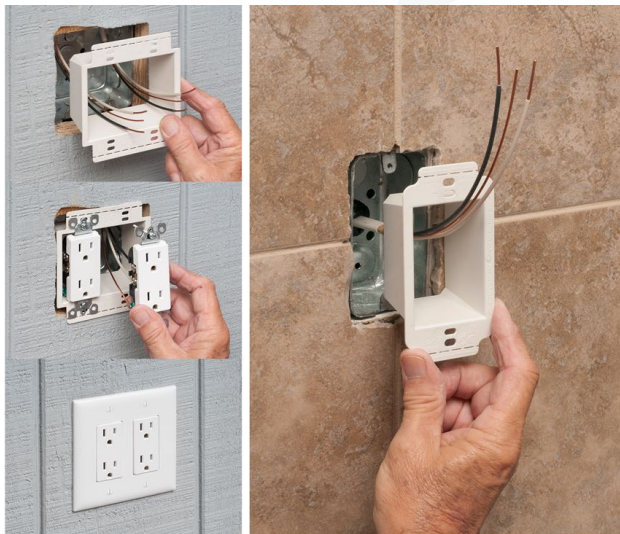
Example of a box extender

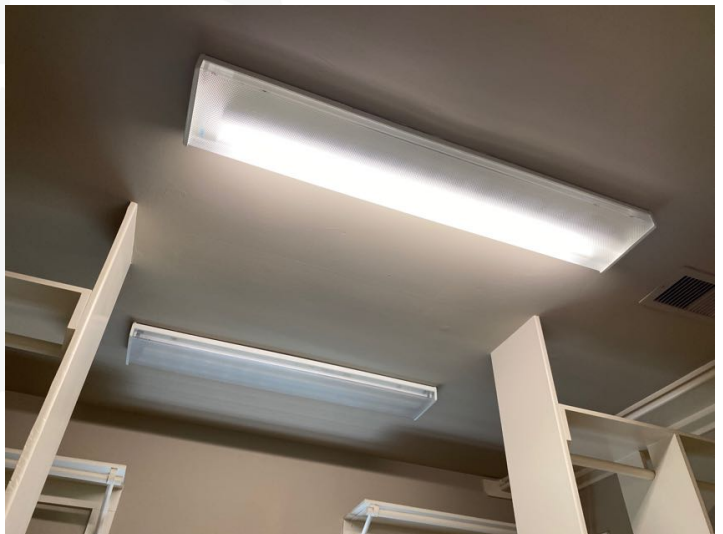
Light fixture not working properly, may have a short or may be in need of light bulb replacement.

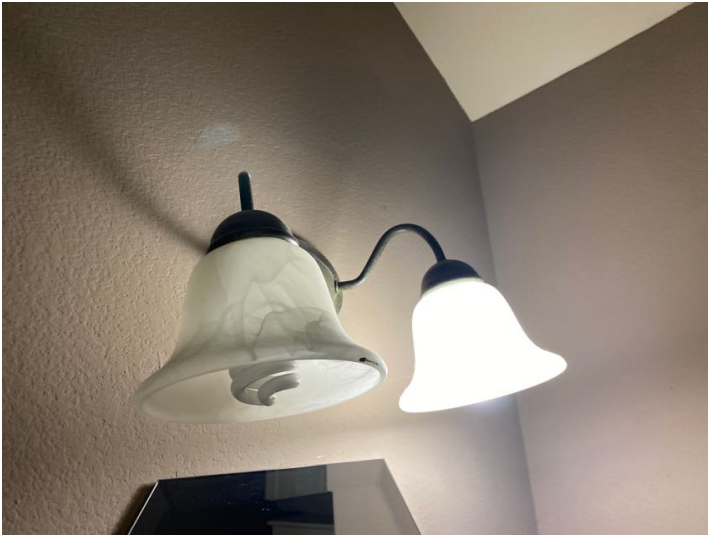
Light fixture not working properly, may have a short or may be in need of light bulb replacement.

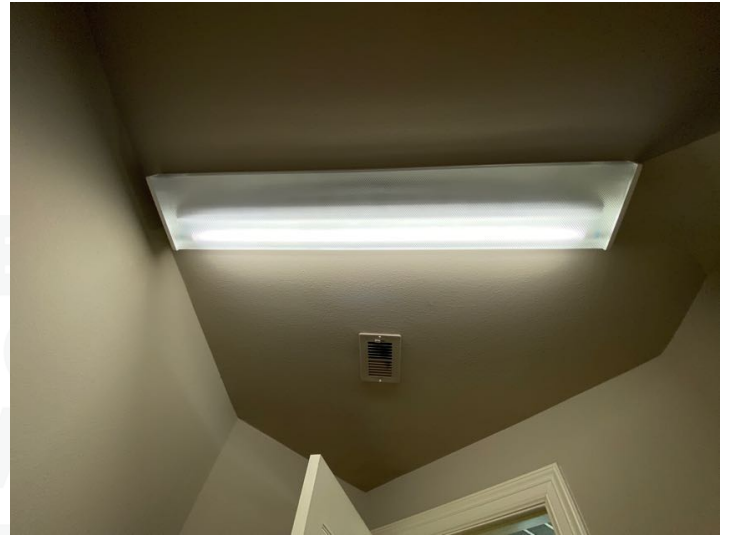
Light fixture not working properly, may have a short or may be in need of light bulb replacement.

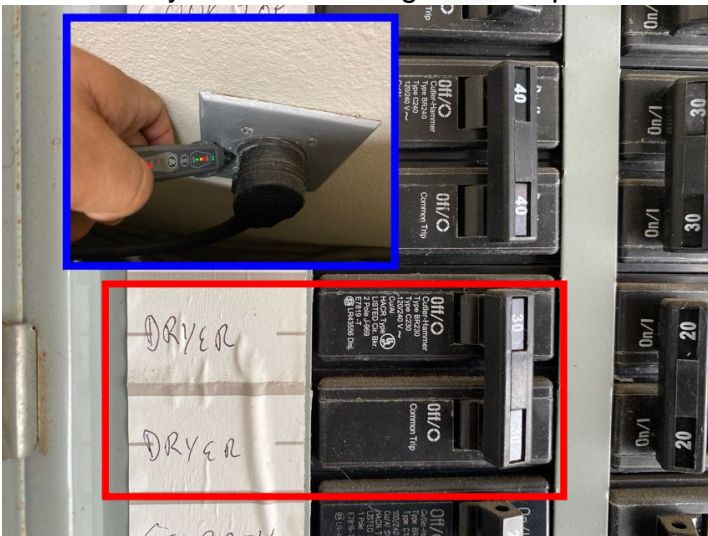
Breaker for the dryer unit is not GFCI protected. All 125-volt through 250-volt receptacles installed in the locations specified in the 2021 NEC 210.8(A)(1) through (A)(11) and supplied by single-phase branch circuits rated 150 volts or less to ground shall have ground-fault circuit-interrupter protection for personnel.

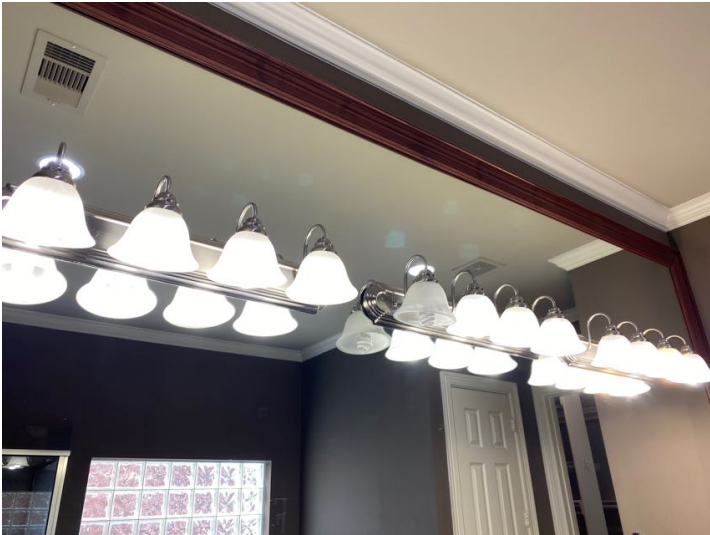
Light fixture not working properly, may have a short or may be in need of light bulb replacement.

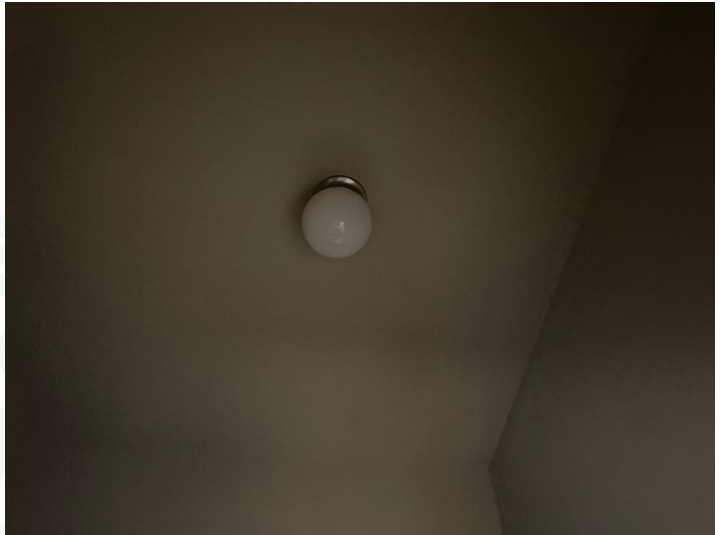
Light fixture not working properly, may have a short or may be in need of light bulb replacement.

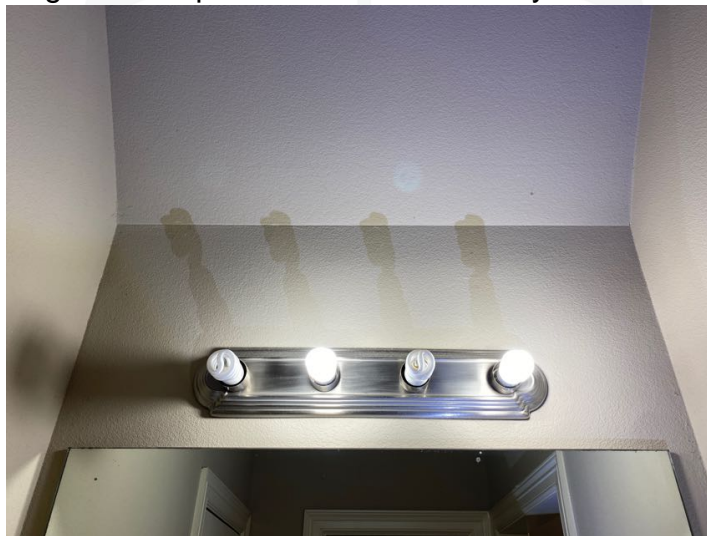
Light fixture not working properly, may have a short or may be in need of light bulb replacement.

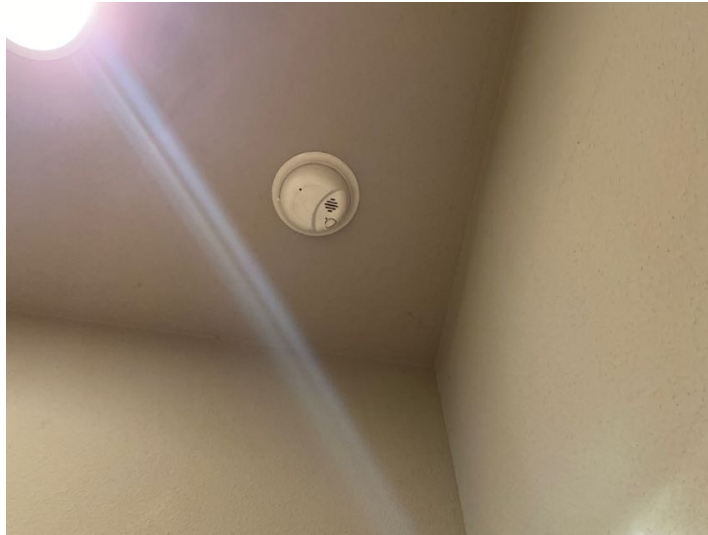
Smoke detector not operational in hallway adjacent to the upstairs guest bedroom(s)

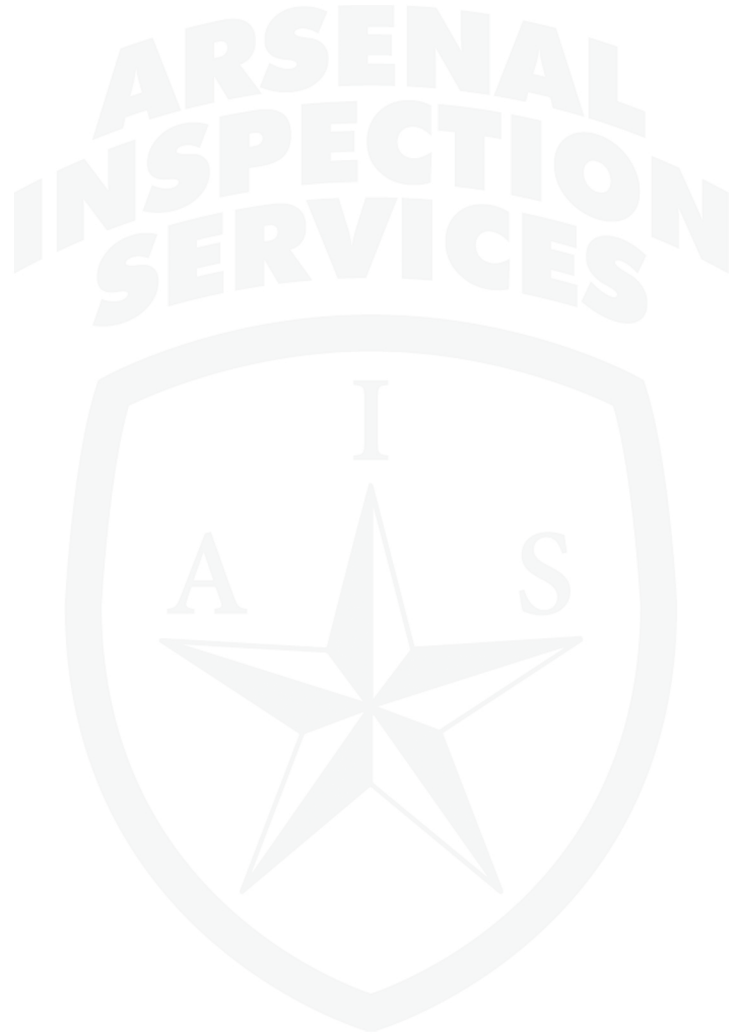
III. HEATING, VENTILATION AND AIR CONDITIONING SYSTEMS

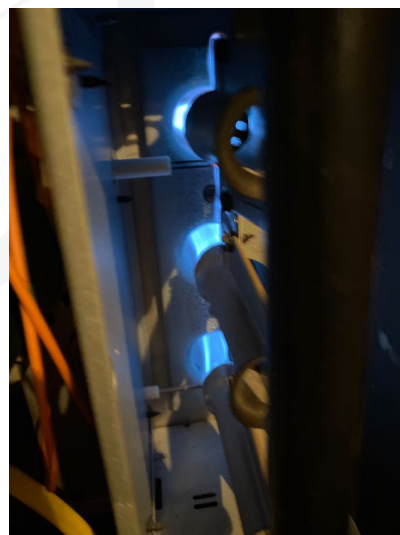
Upstairs heating equipment functions as intended

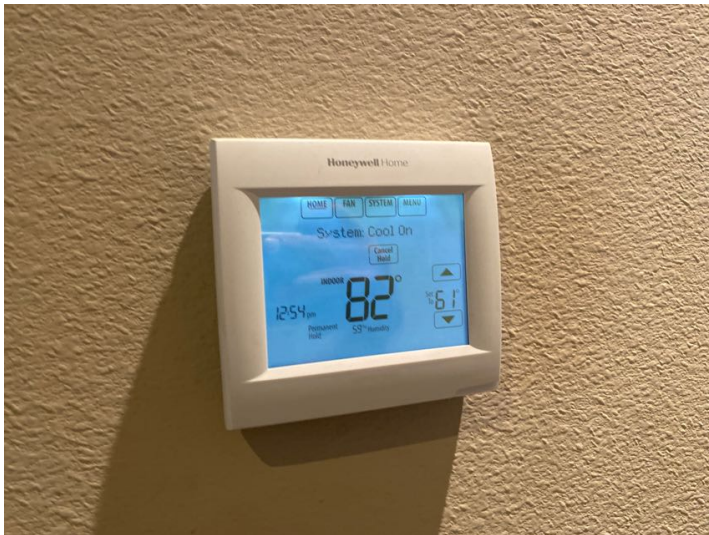
Thermostat(s) is/are functional

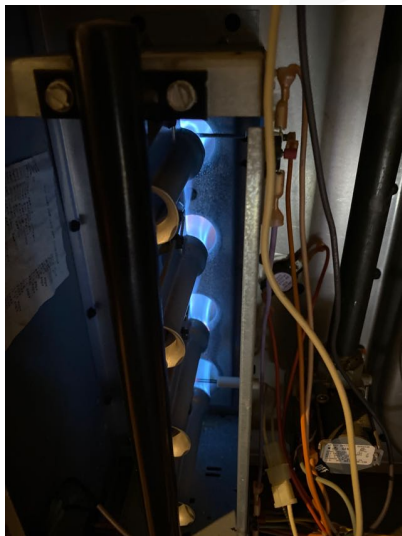
Downstairs heating equipment functions as intended

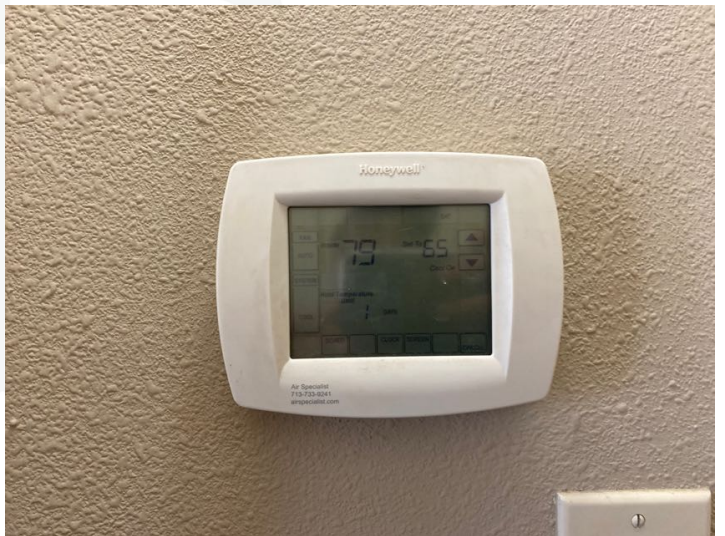
Thermostat(s) is/are functional

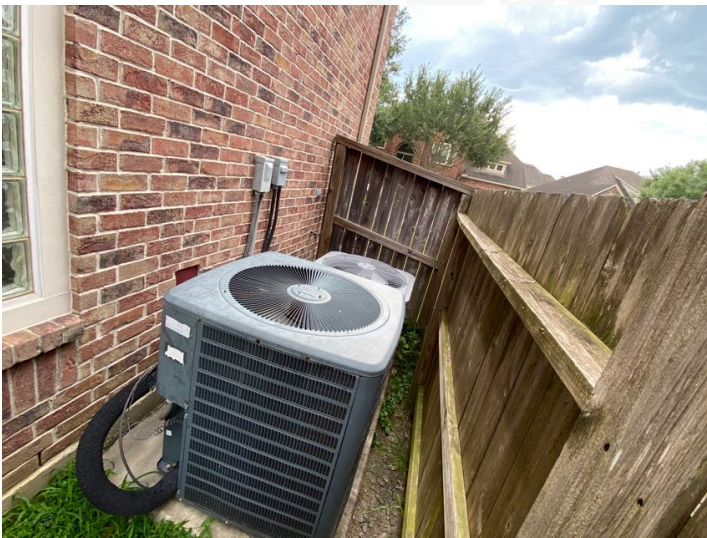
Recommend a HVAC technician to perform a complete system evaluation for any other possible hidden or unseen issues and repair of listed items.

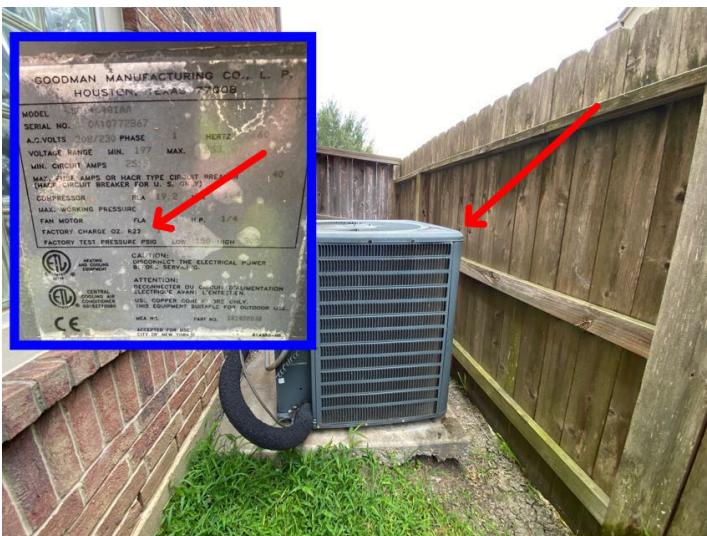
Special note: The outside condenser units displays the utilization of R22 freon (This type of coolant is no longer produced and servicing such systems may be more challenging). Condenser units should be cleaned and maintained annually to extend the life of the unit and keep it at optimal performance. The inspector recommends consulting an HVAC professional for options in regards to lifespan of the unit due to unavailable refrigerant.

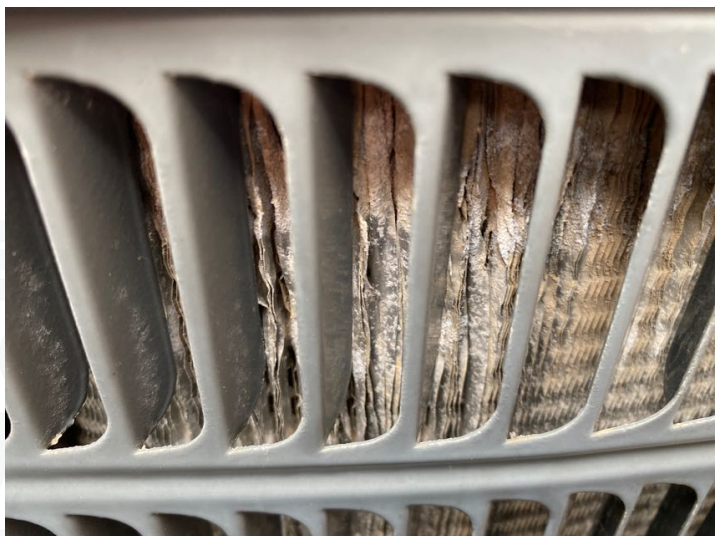
Air-conditioning unit condenser coil fins are damaged, recommend an HVAC technician to repair by combing the fins.

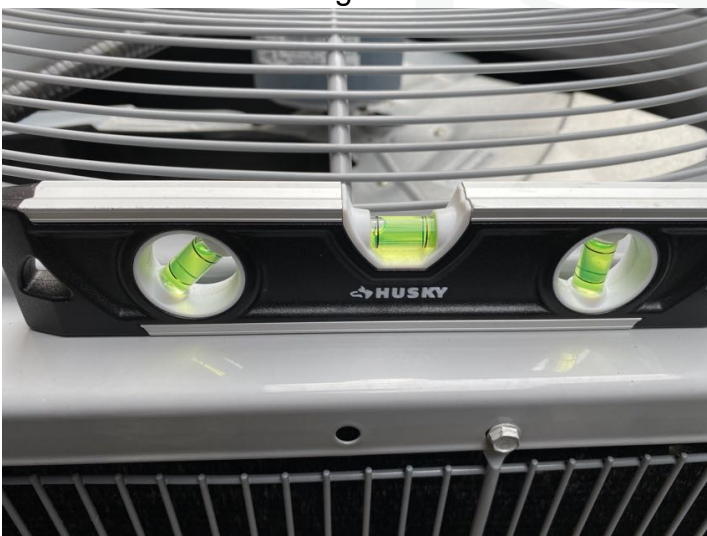
AC does not sit level, this can affect the movement of coolant through the lines. (both units)

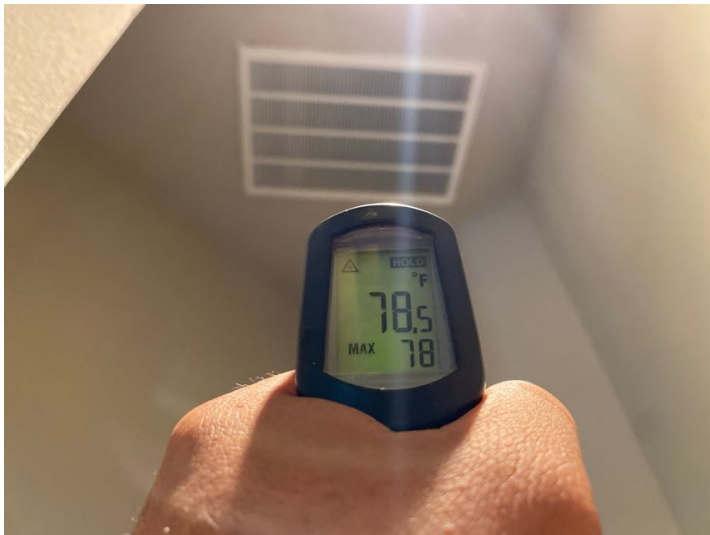
Delta T test at the return vent(upstairs)

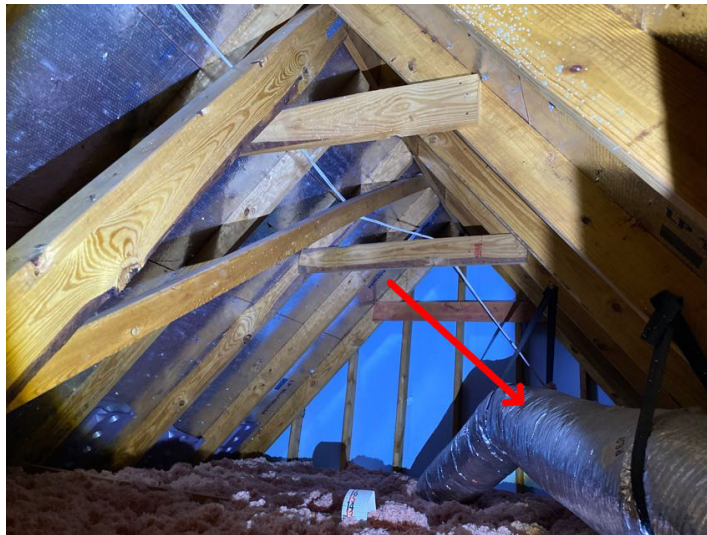
I	NI	NP	D
---	----	----	---

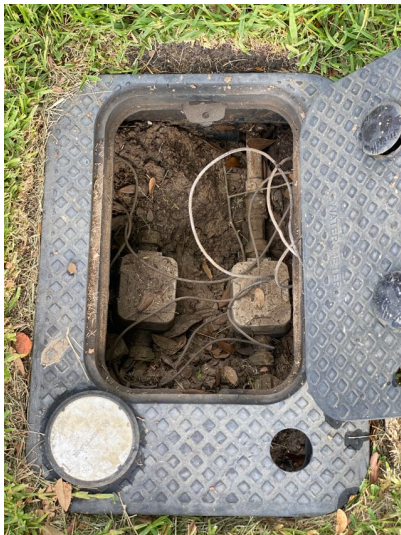
Recommend a plumber to perform a complete system evaluation for any other possible hidden or unseen issues and repair of listed items.

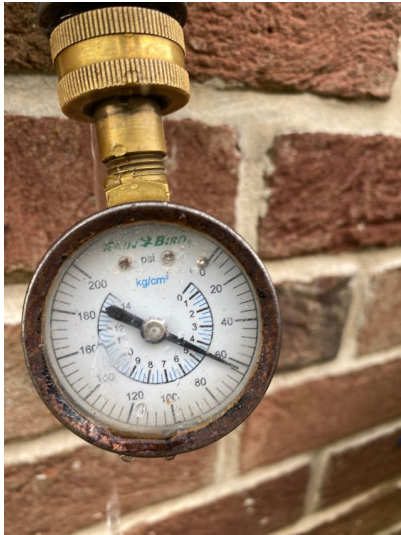
Static Water Pressure Reading: 63 PSI

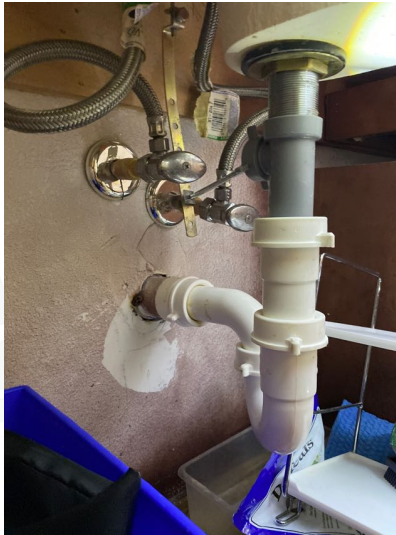
Drains function properly.

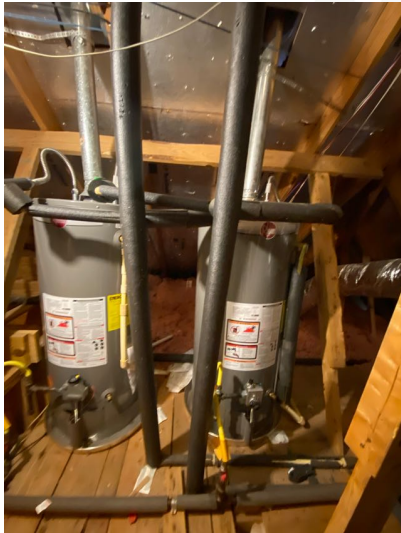
Recommend a plumber to perform a complete system evaluation for any other possible hidden or unseen issues and repair of listed items.

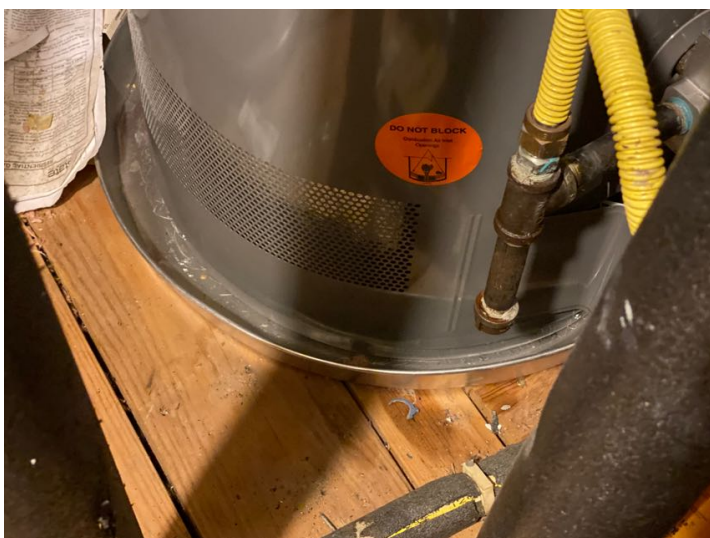
water heater drain pan

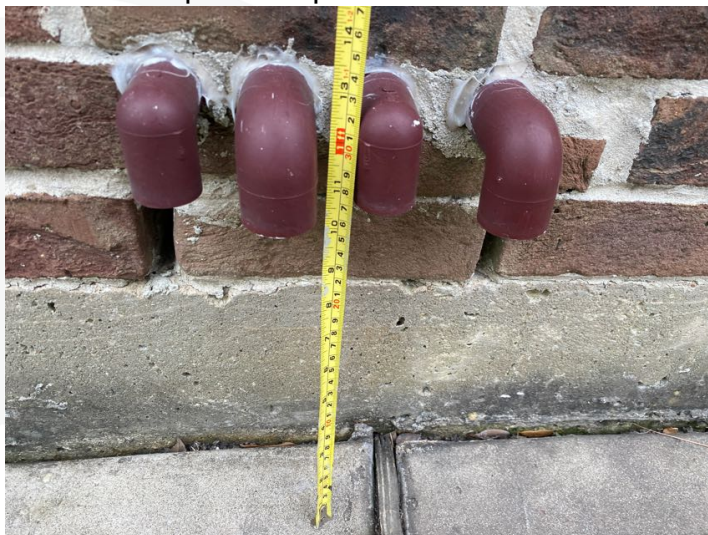
TPR valve and drain pan drain pipes discharges above six inches from grade/surface, an extension to the drain pipes for the lines is recommended to prevent possible injury from water discharged through these lines.

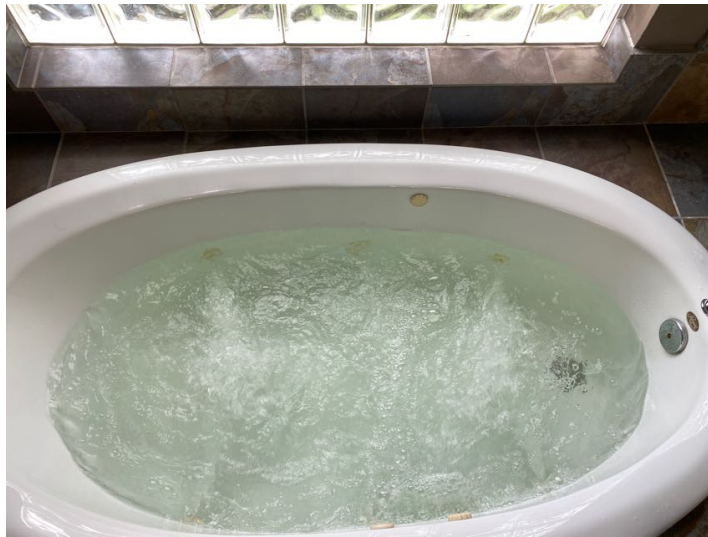
Hydrotherapy tub works as intended.

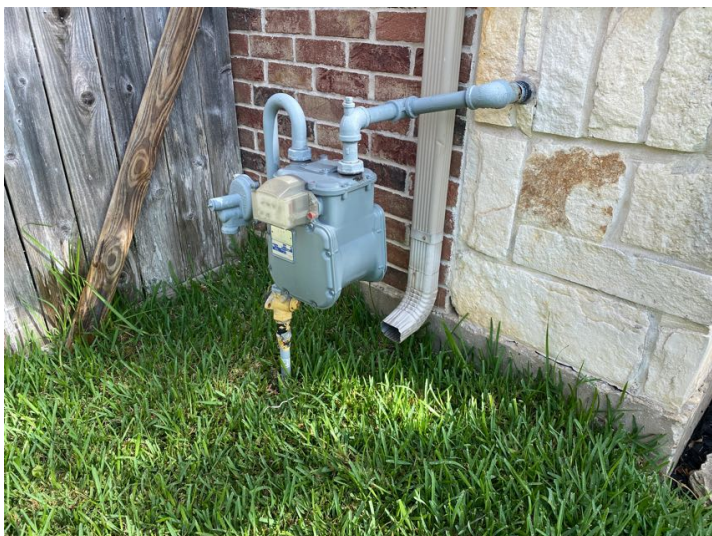
I	NI	NP	D
---	----	----	---

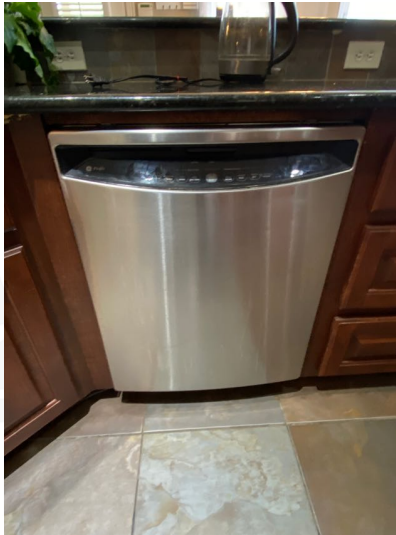
Dishwasher operated normally.

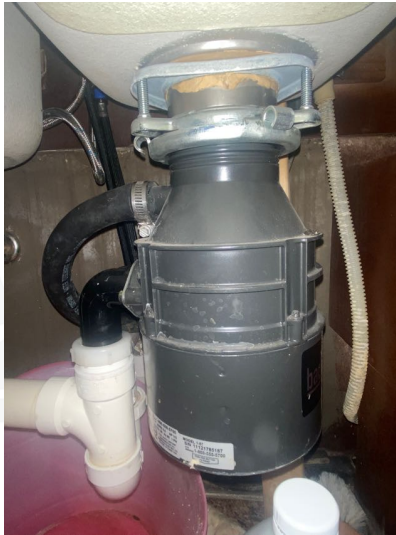
Disposal was inoperable at time of inspection.

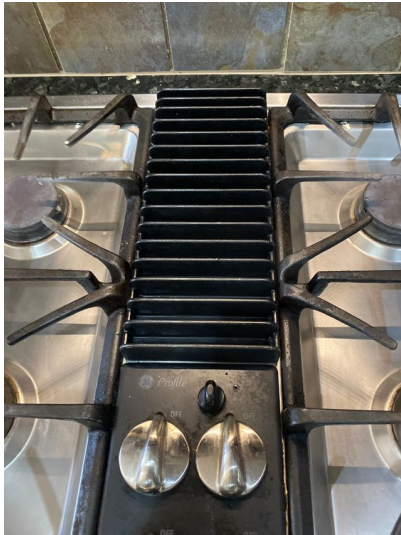
I	NI	NP	D
---	----	----	---

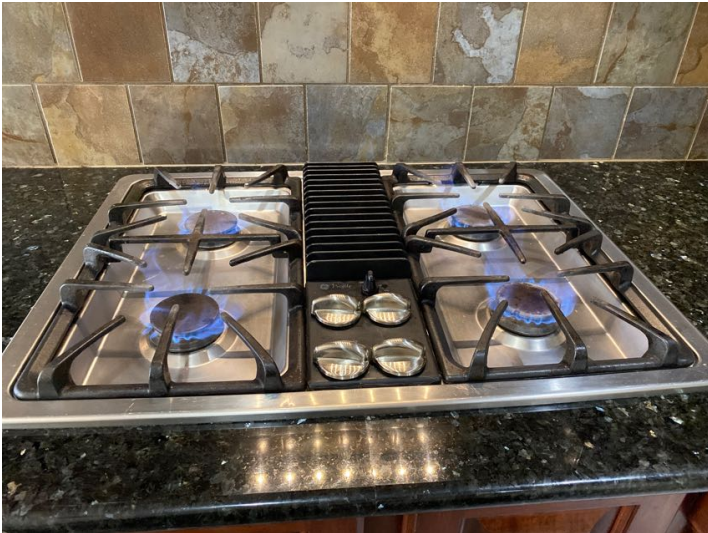
Cooktop:All heating elements operated when tested.

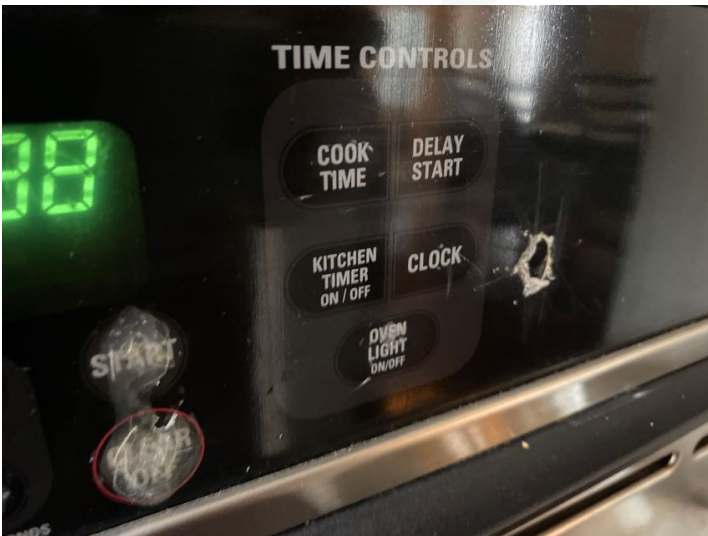
Oven control panel shows damage.

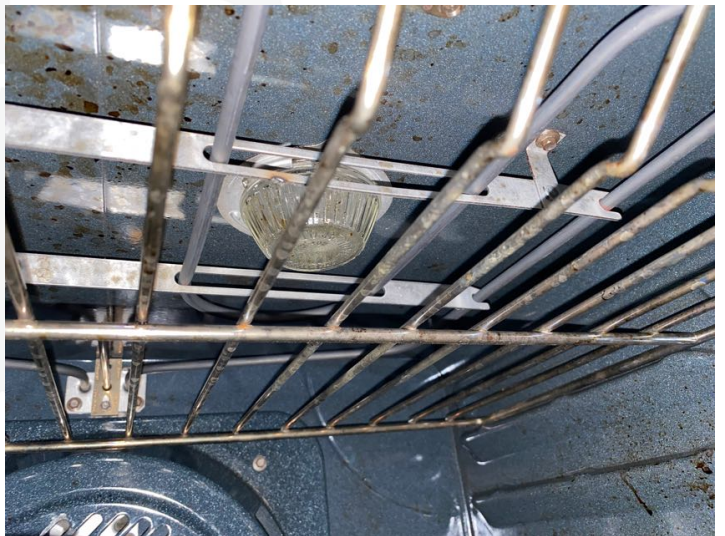
Oven light fixture did not operate

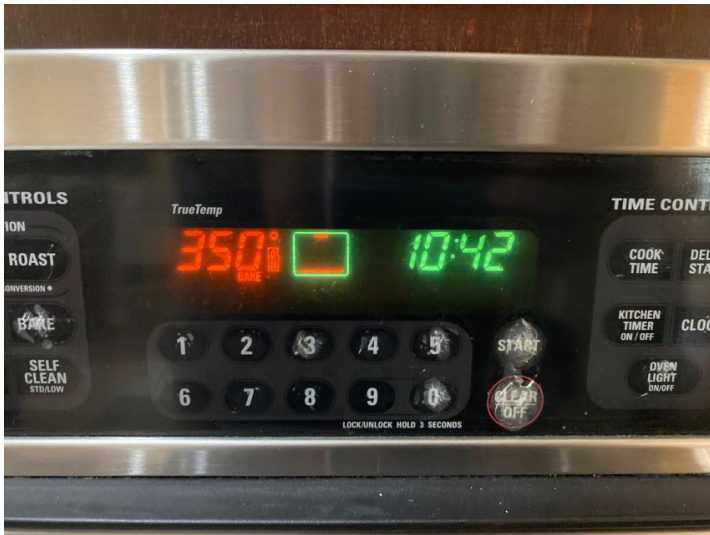
set oven temperature

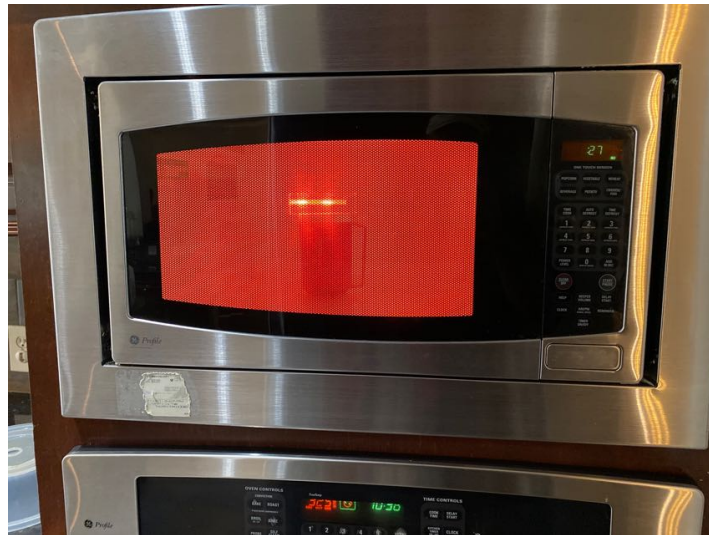
Built-in microwave ovens are tested using normal operating controls. Unit was tested and appeared to be serviceable at time of inspection. Leak and/or efficiency testing is beyond the scope of this inspection. If concerned, client should seek further review by qualified technician prior to closing.

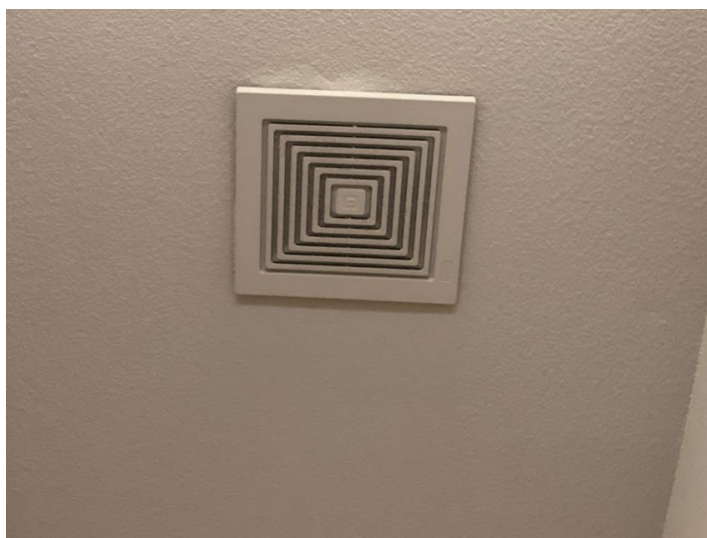
All bath and laundry fans operated normally

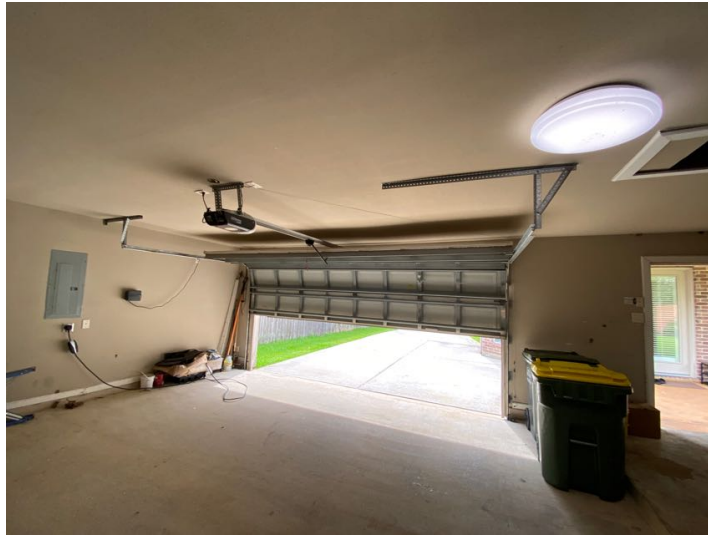
Automatic garage doors operated normally.

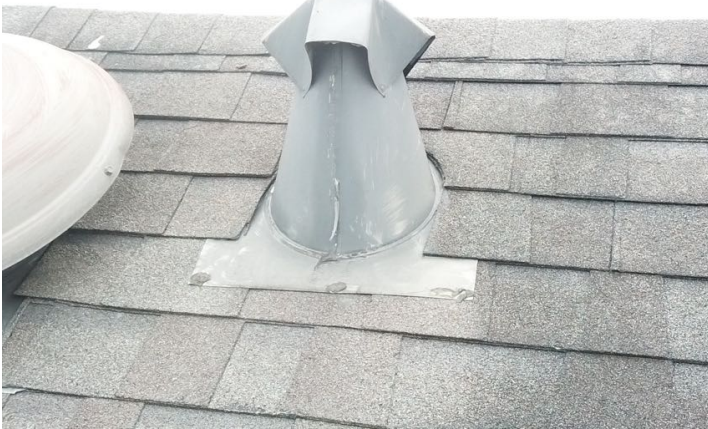
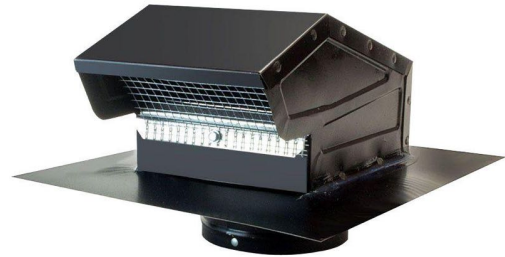
Use of a bonnet or t-vent cap is not an appropriate vent cap for dryer vents. Has to be an approved direct connect vent cap with a back draft damper. Exterior vents should have working flappers that open when the dryer is venting and closed otherwise. This will keep out cold air and pests.

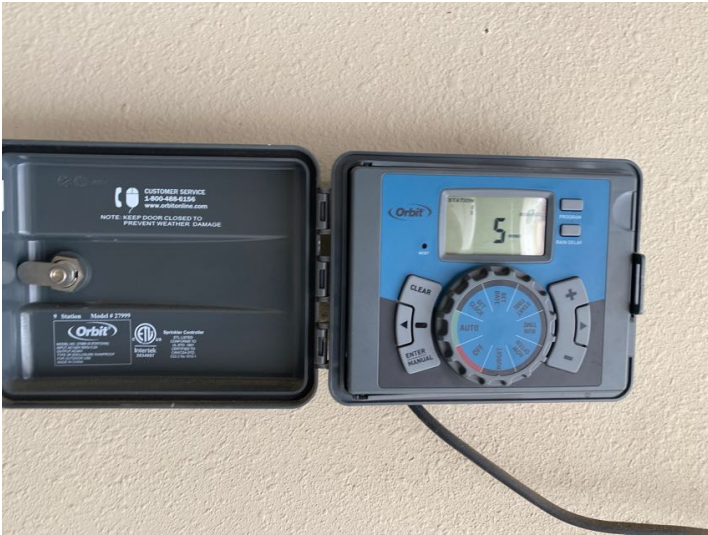
Sprinkler system head unit

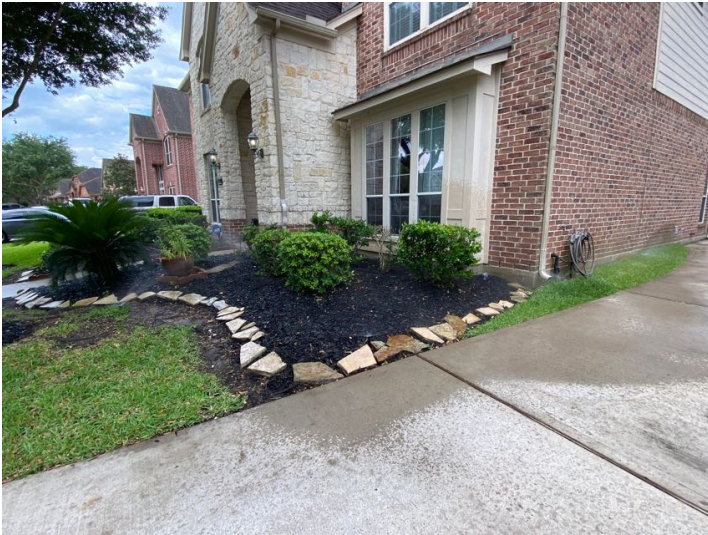
OPTIONAL SYSTEMS Landscape Irrigation (Sprinkler) Systems

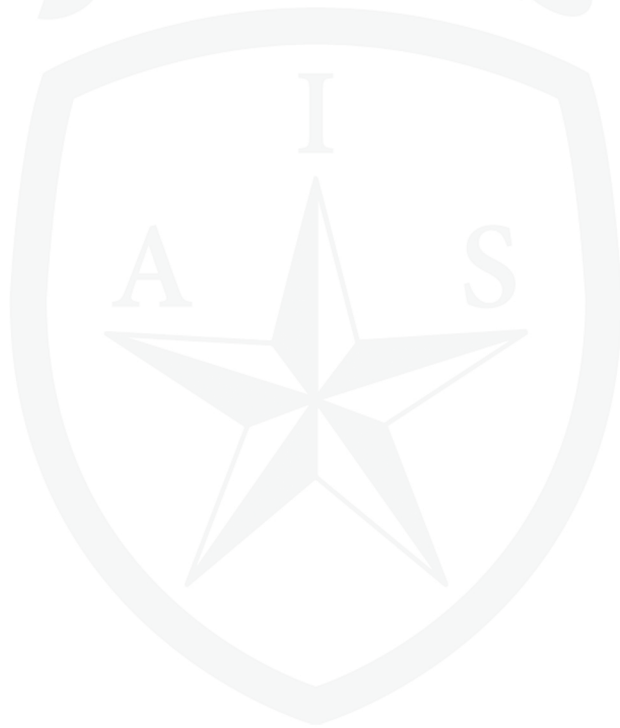
ARSENAL
INSPECTION
SERVICES
