CUMMINS PERFORATORS- MODEL # 53

By Stephan Grabowski (#3409)

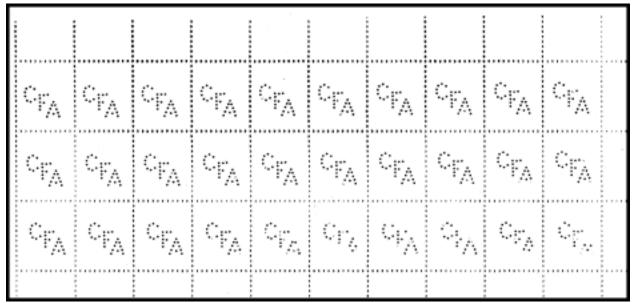
Figure 1: Three rows of perfin pattern C124 punched into stamps by a Cummins #53 10 die perforator.

I decided to try various handle strokes to see if the pins were of different lengths. For perforator C124 the first impression (top row, fig. 1) was made using a full stroke, the second (row, fig. 1) about a 3/4 stroke, and the third (row, fig. 1) about a 1/2 stroke. It can be seen there are some missing holes in both partial strokes (rows 2 and 3). The same operation was used for the L137 perforator with the same results. For this perforator the first (col. 1, fig. 3) is full stroke, the second about a 1/2 stroke, and the third about a 3/4 stroke. This confirms that the perforators were built with different pin lengths and that missing hole patterns might result from a shortened stroke.

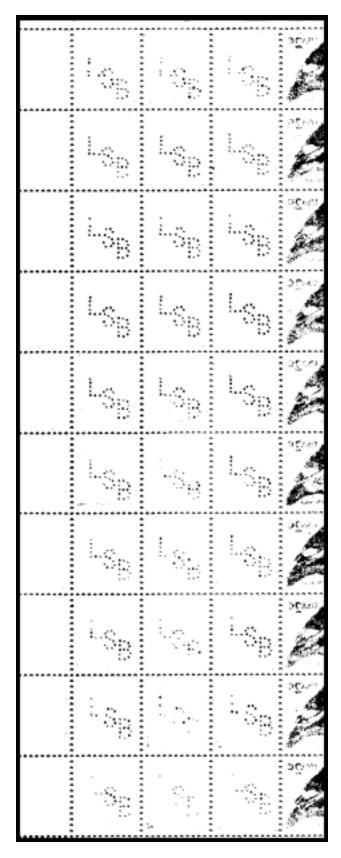
From the impressions made by the perforators I found that the C124 perforator still made clean holes in all impressions, while the L137 perforator punched no holes that were cleanly cut. Scanning the impressions with a black backup sheet produced a reasonable image. The perforator is either worn-out or the pins and holes are corroded accounting for the poor perforations.

Figure 3. Three vertical rows of pattern L 137.
