## Background

## Key point 1 – Continuity of the insulated plane (thermal bridge risk)

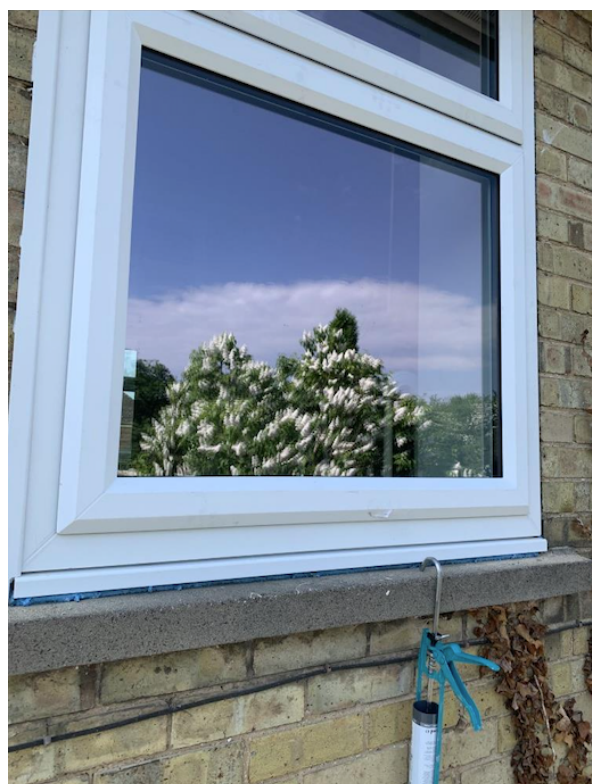
Where windows are not installed in the correct position, as below, this will need to be rectified. If there is a reason why the correct placement cannot be achieved then we will need to look at other options such as insulating the window reveals with a product like aerogel.

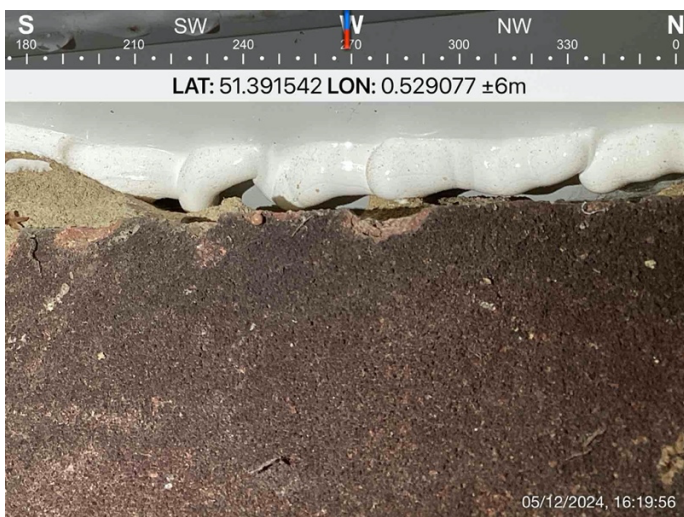
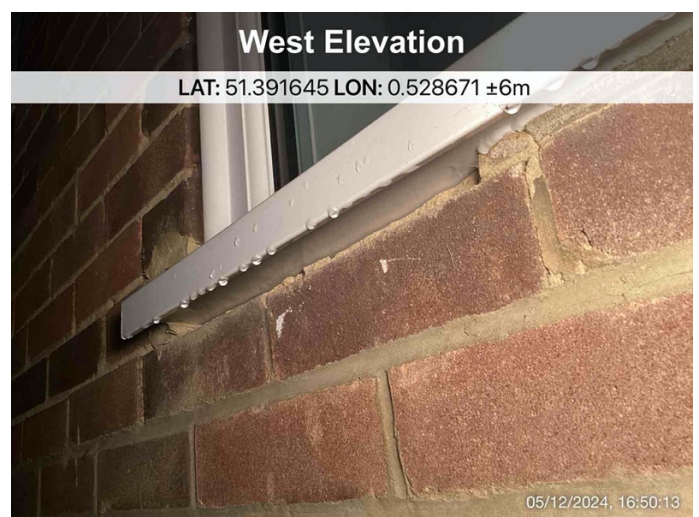
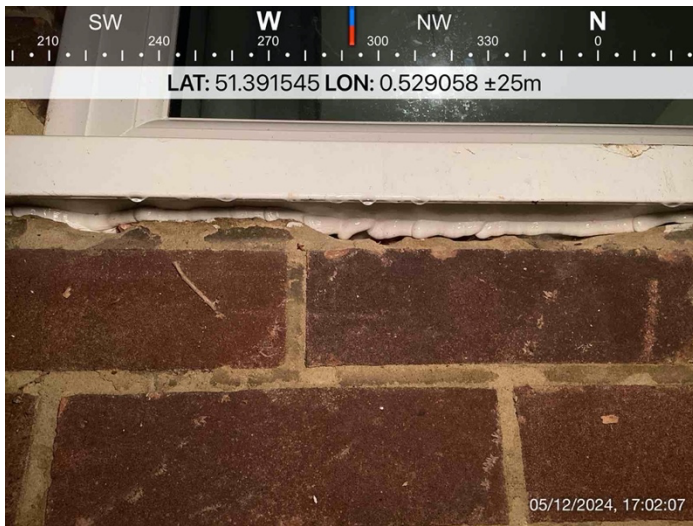
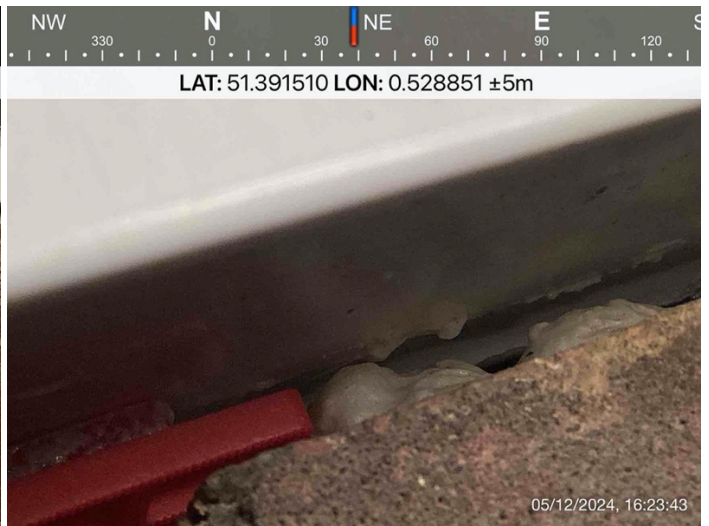
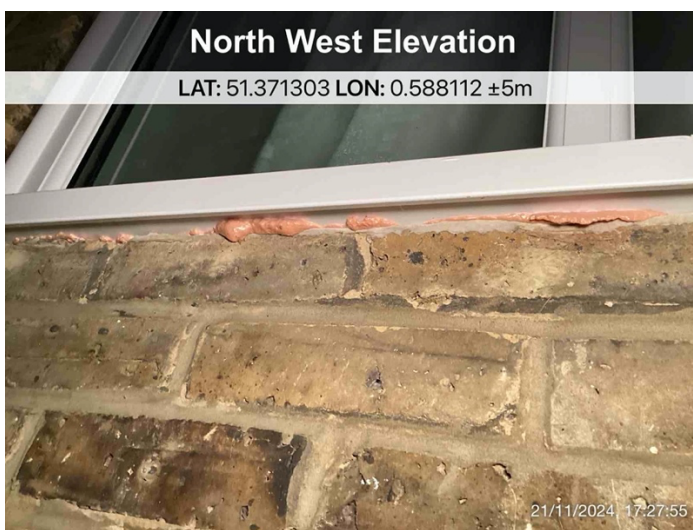
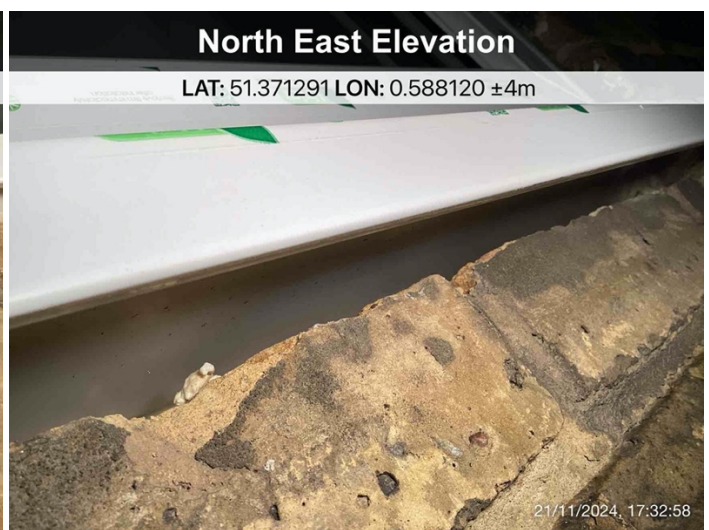
The guide is absolutely right to highlight the need for care beneath the sills and is a very common place for post install compliance surveys to discover issues such as the seal being either incomplete, or missing entirely.

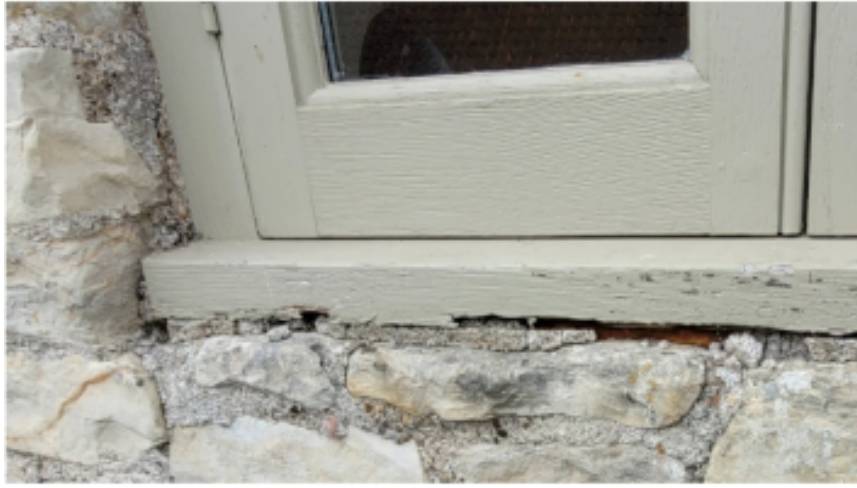
The below picture is an extreme example of what can happen when the sill is not installed correctly, the water has pooled on the stone work below causing the sill to rot along the bottom edge. This has left a large gap where rainwater can freely enter the beneath the sill and will make its way to the internal face of the wall, resulting in damp issues.

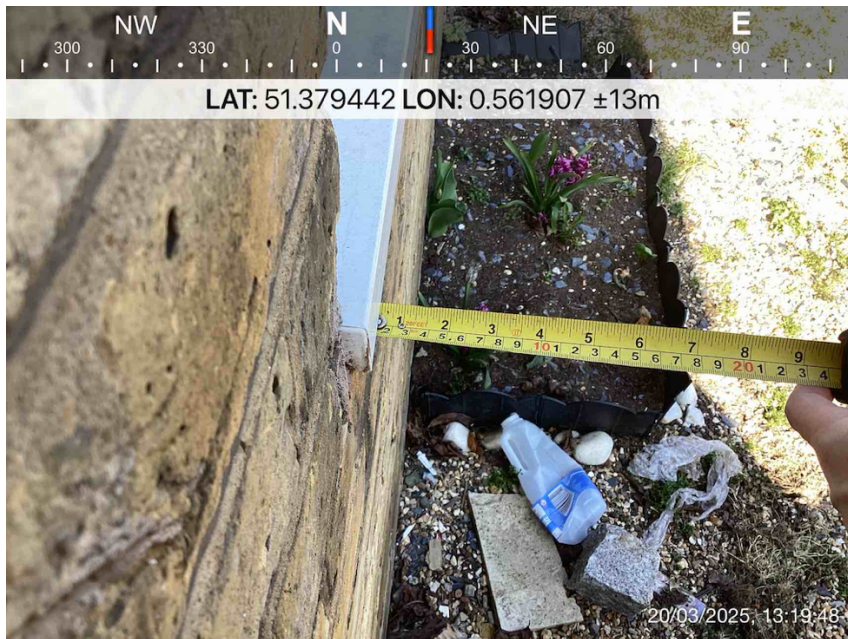
The window below has been installed with a sill which is non-compliant. It protrudes just 15mm from the external wall and the drip detail location will send rainwater running down the external face.
