Miry Run Ponds (Dam Site 21) Master Plan

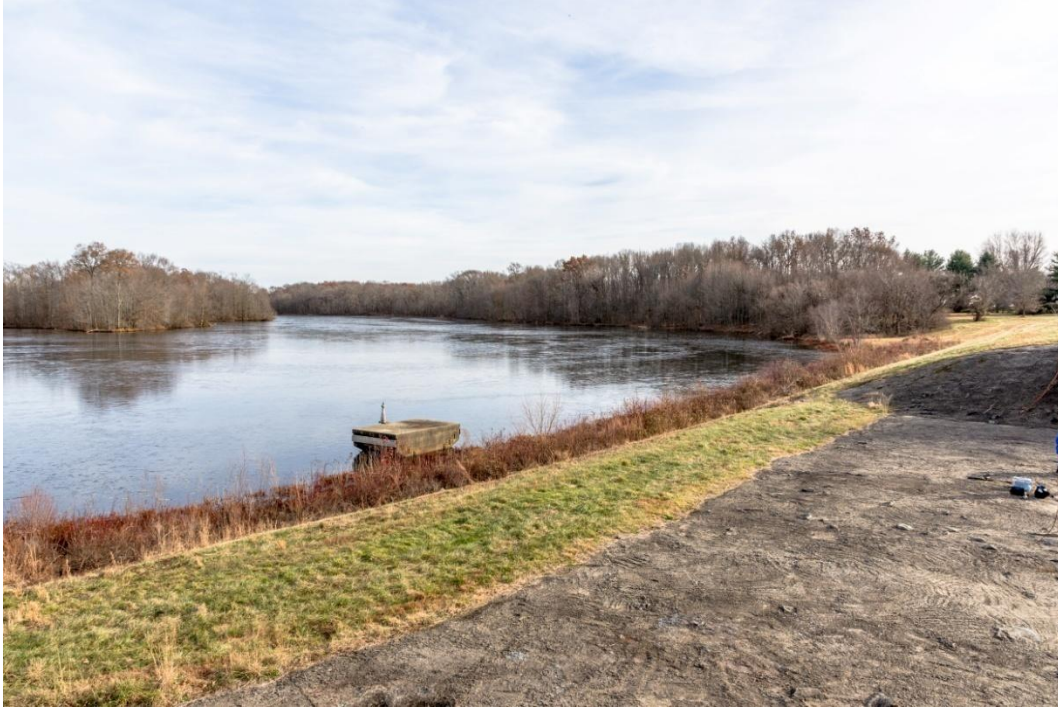
Looking at the lake from the top of the berm during normal lake levels.

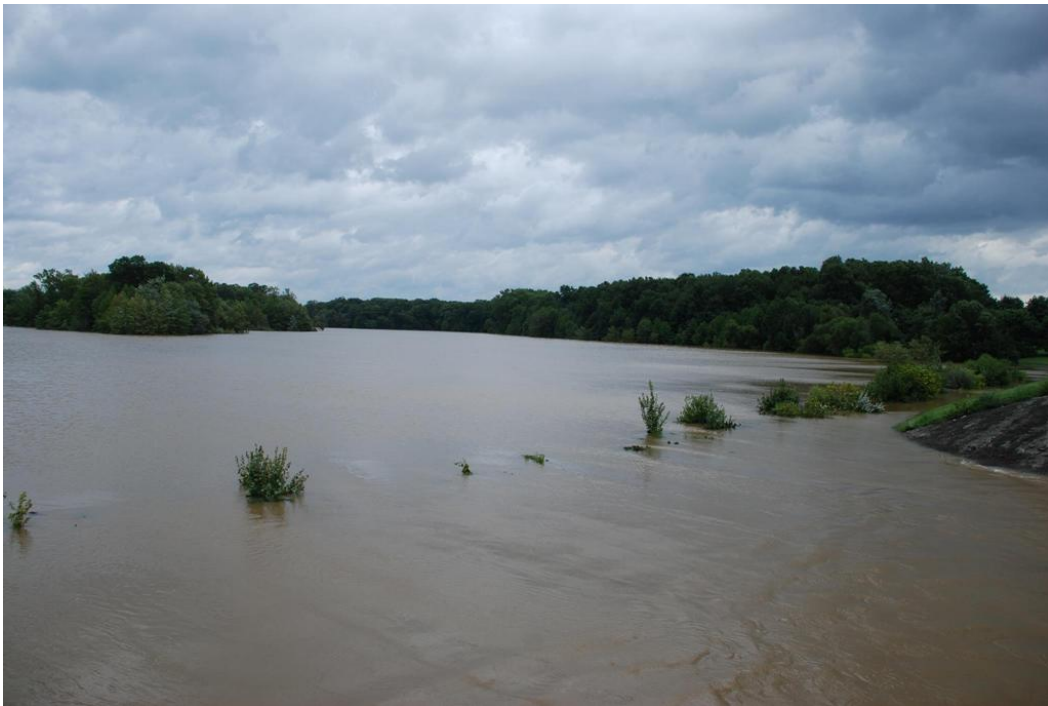
Same view as above during flooding.

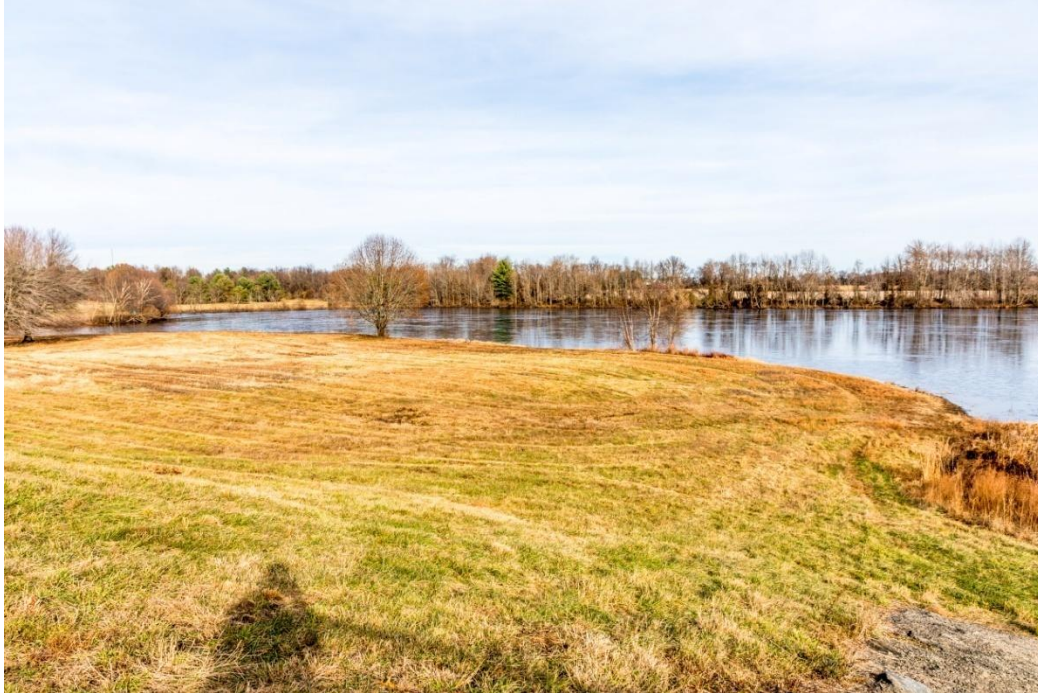
Looking from the top of the earthen dam standing next to the concrete dam

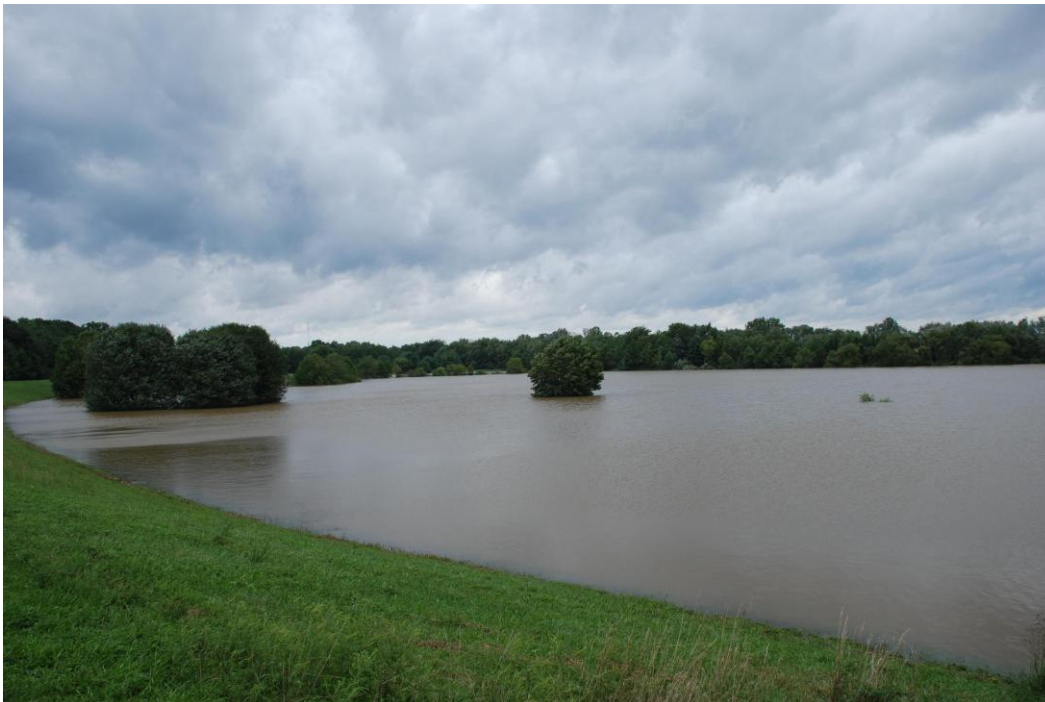
Same view as above during flooding. This is looking at the area of land that sticks out where the elevated walkway will end by the little bush (normal level mark) in the water towards the right side of the picture.

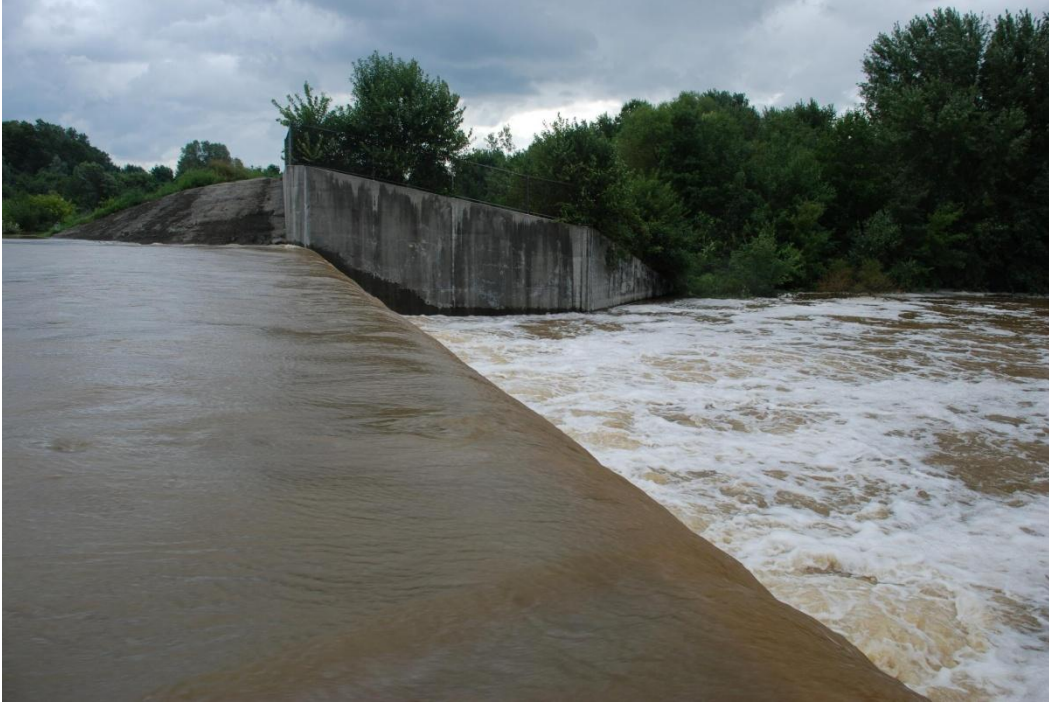
Looking from the top of the dam at the spillway during flooding conditions.

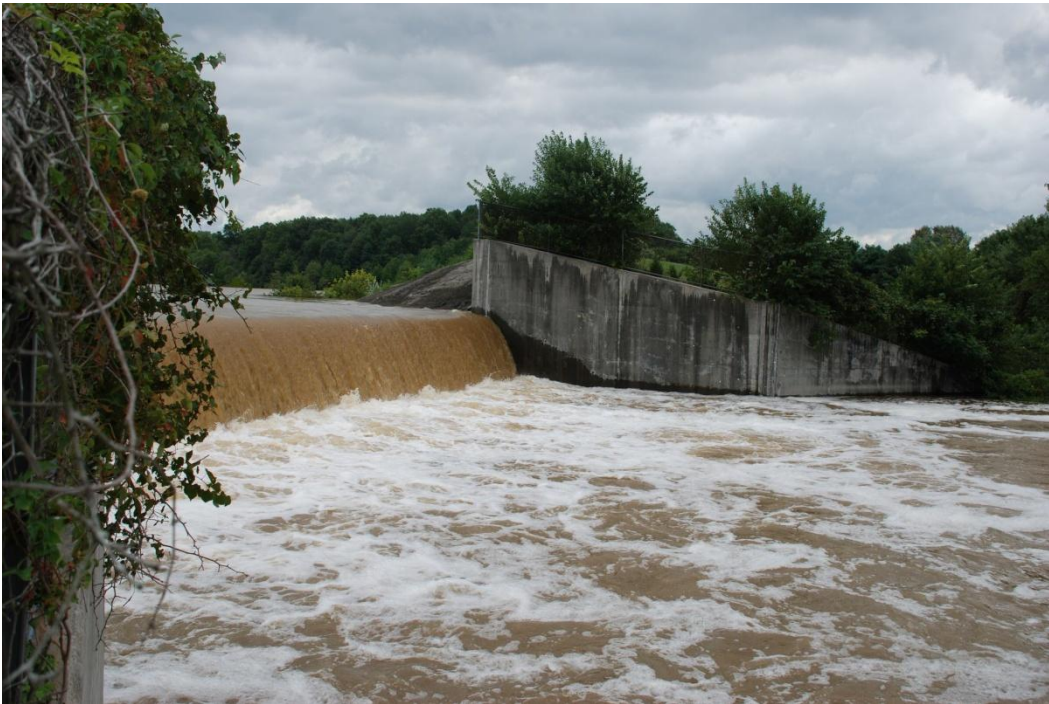
Looking from below the dam during flooding conditions.

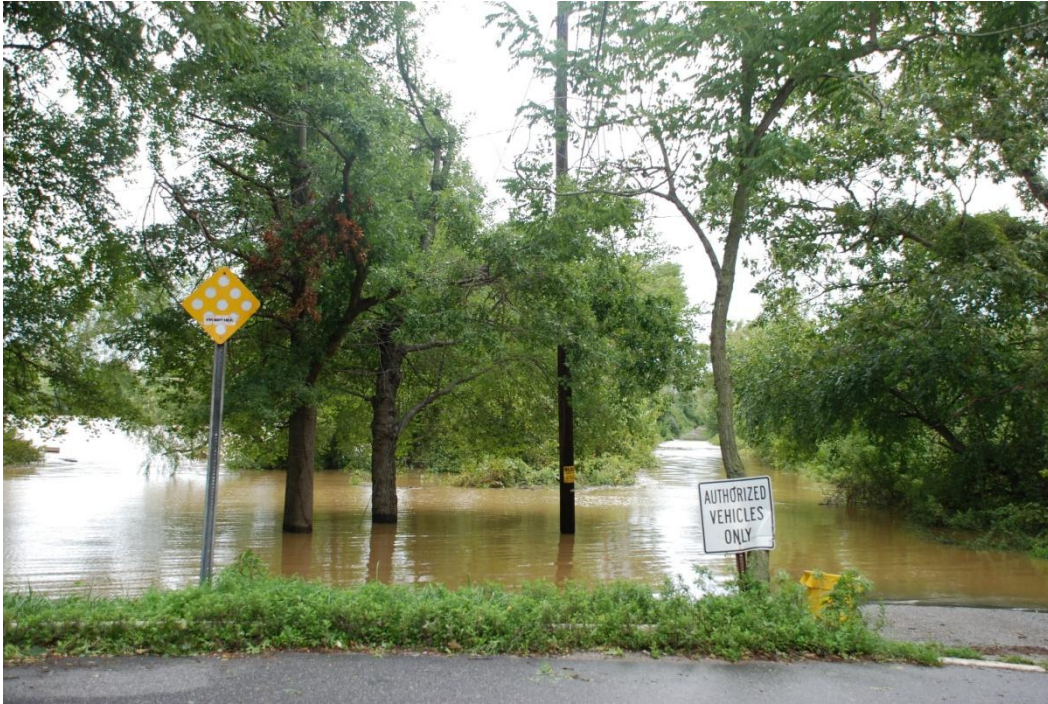
The lake during flooding at south part of Line Rd. in Robbinsville.

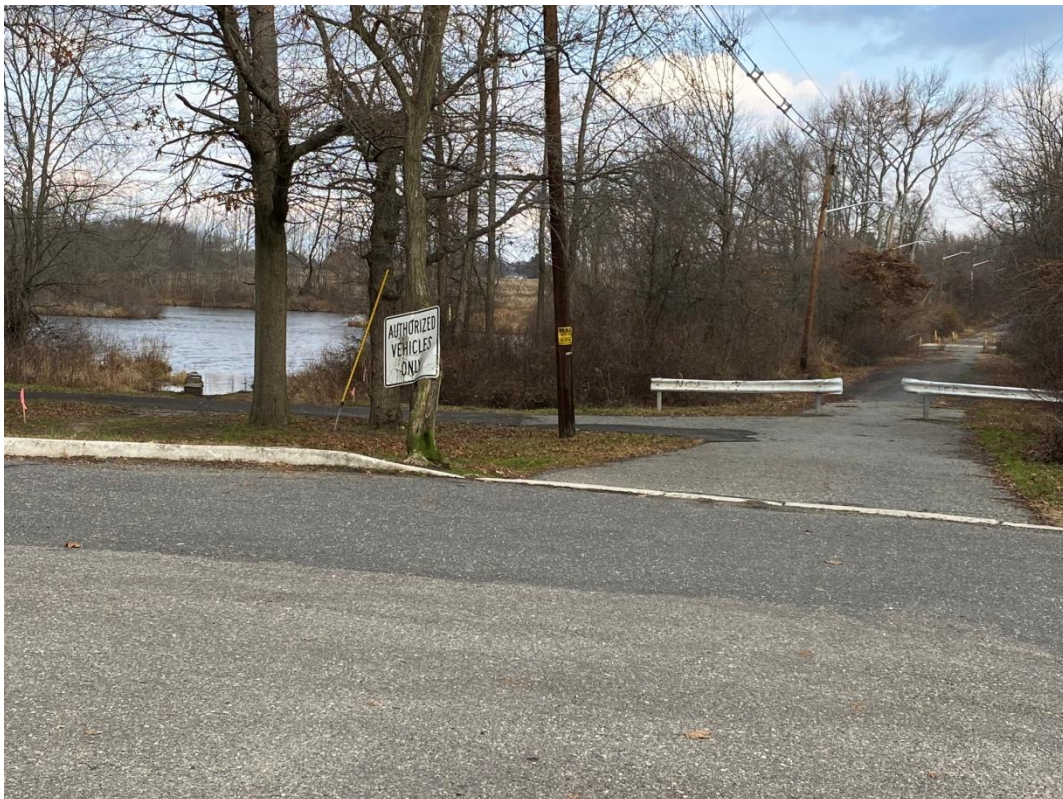
The lake during normal levels at south part of Line Rd. in Robbinsville.

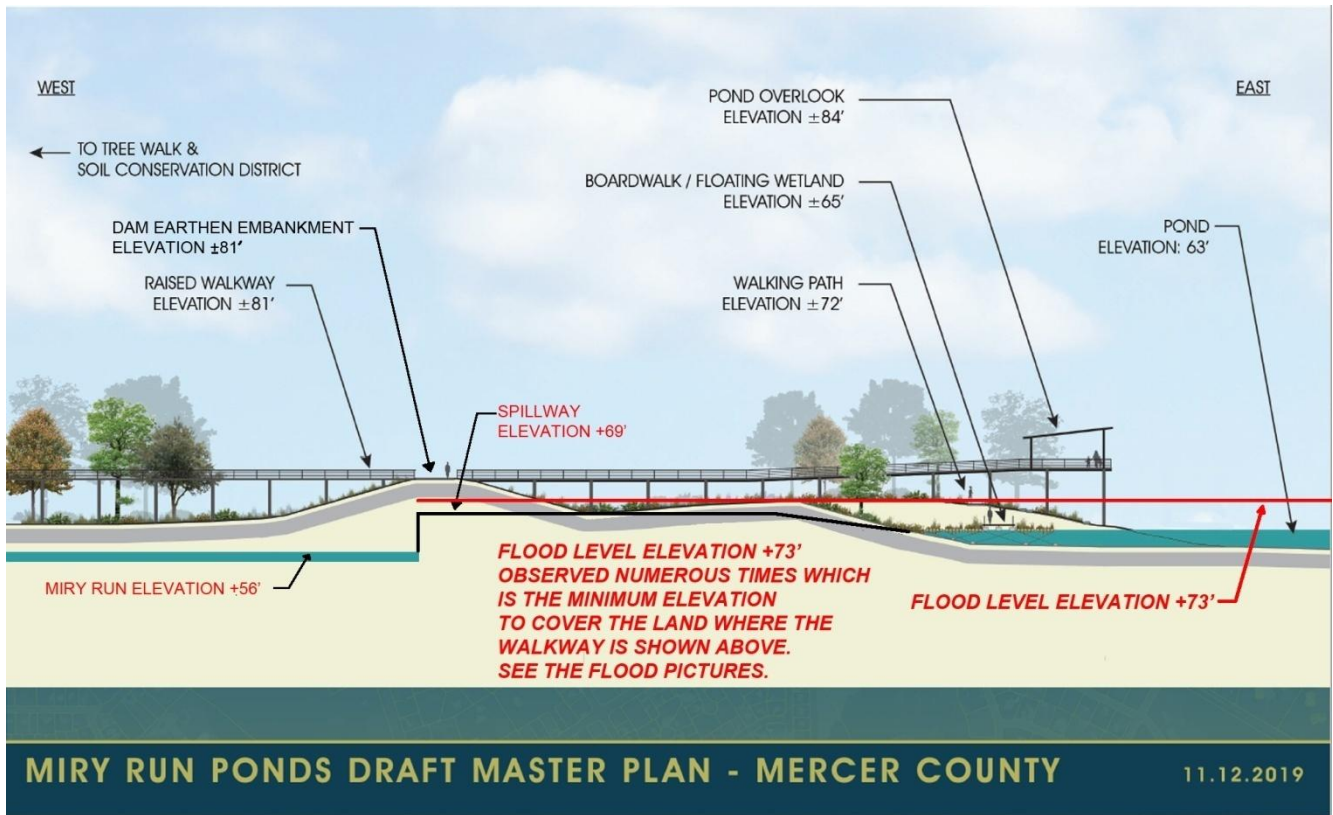
The red horizontal line shows the minimum lake level to completely cover the land where the pond overlook is planned. Notice the planned walkway and boardwalk will be completely under water. During my observations of flooding conditions shown in previous pictures, the lake level is higher than the red line. Realize the red line is 10 feet above normal lake elevation.
