# **St. George Industrial Development Erosion Threshold Assessment**

**DRAFT REPORT**

## **Panattoni Development Company**

December 21, 2021  
Project No. P2021-559

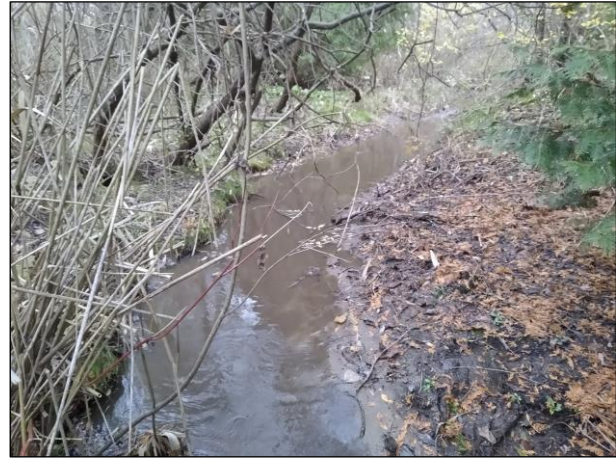
*Photo 8: Lateral bar, indicating sediment deposition*

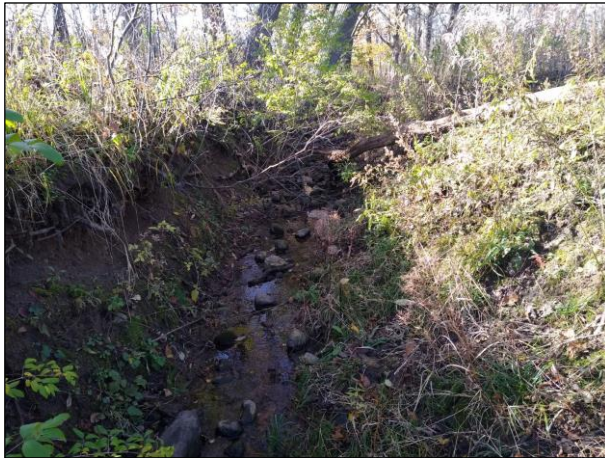
Reach FCT-2B is a very steep (5.5%) incised gulley. Mature tree roots are providing some stability (Photo 15), but the presence of leaning trees (Photo 14), large woody debris (Photo 19) and undercut banks (Photo 16) indicates that the gulley is actively widening. The substrate in this reach is composed of a mix of alluvial material ranging from silt to cobbles. Some evidence of incision was noted in this reach; in particular, a headcut located in the downstream half of the reach. Based on the field assessment, Reach FCT-2B was identified as the reach most sensitive to erosion.

*Photo 13: Incised channel*

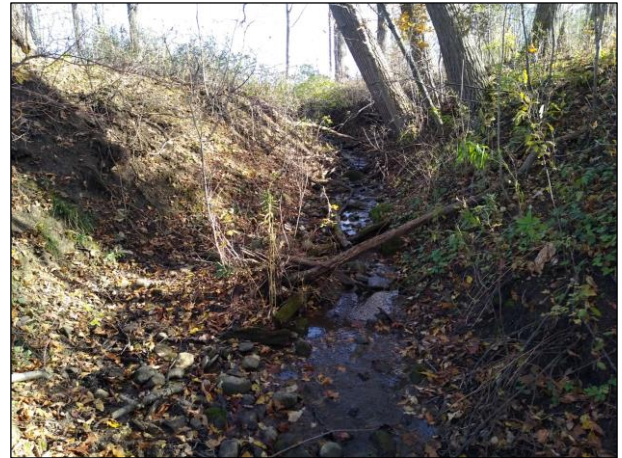
*Photo 14: Leaning trees*

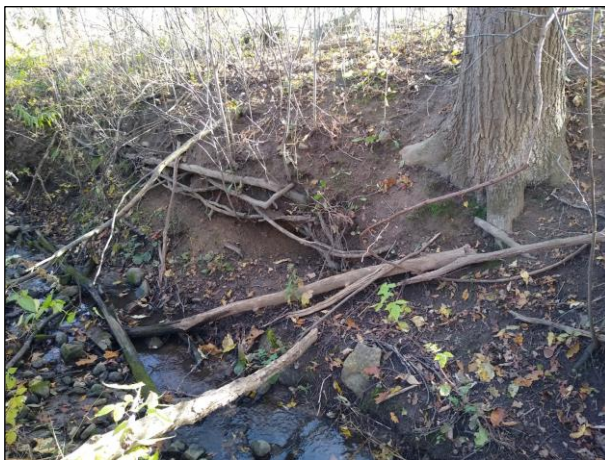
*Photo 15: Bank stability provided by roots*

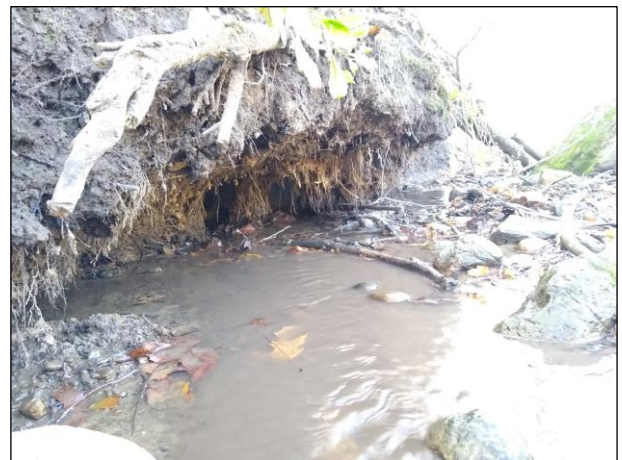
*Photo 16: Thalweg flowing under bank, undercut by at least 1.5 m.*

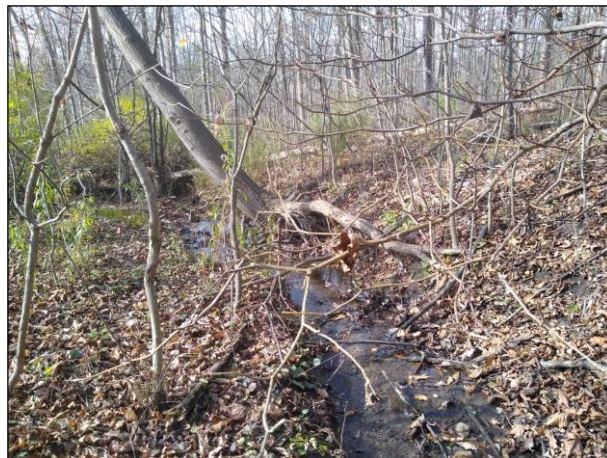
*Photo 18: Leaning tree*

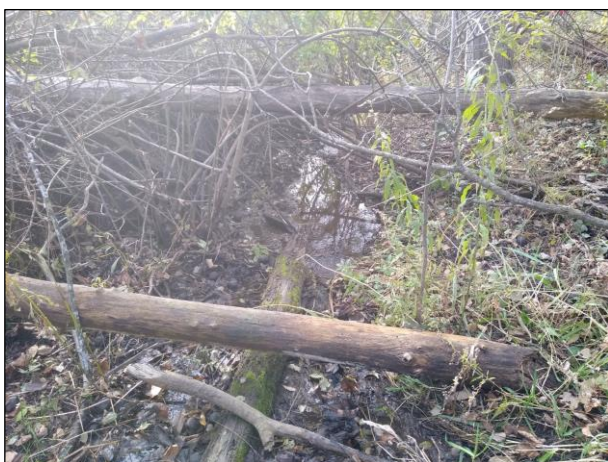
*Photo 19: Large woody debris in channel*

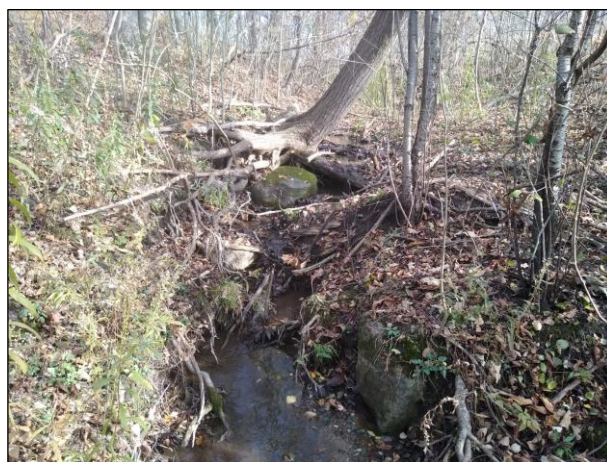
*Photo 20: Headcut*

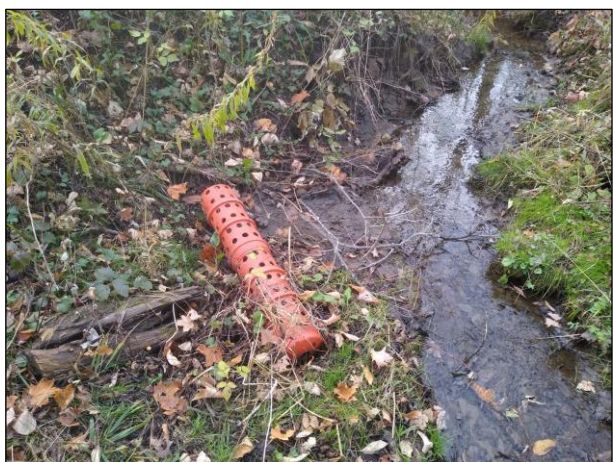
At the downstream end of Reach FCT-2C, a riser pipe has been constructed above the low-flow channel. On the date of the field assessment, the riser was lying on the ground, disconnected from the base (Photo 23), but the base of the pipe is intact (Photo 24). This riser pipe would not have sufficient

capacity to capture all water during larger flow events, and some flow would pass to the downstream field as overland flow. The location of the pipe outlet could not be determined by GRA field staff.

*Photo 23: Fallen riser pipe*

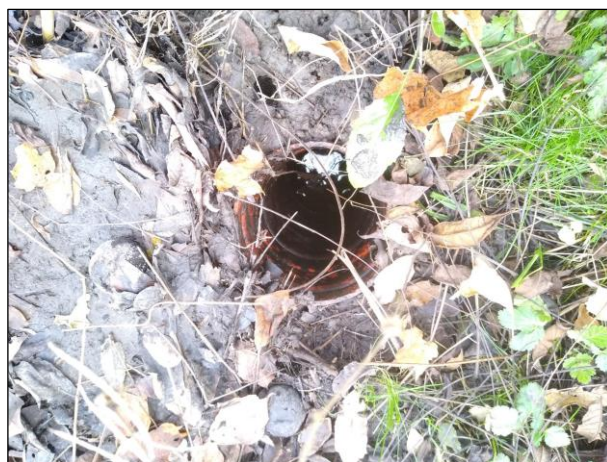
*Photo 24: Riser pipe base*

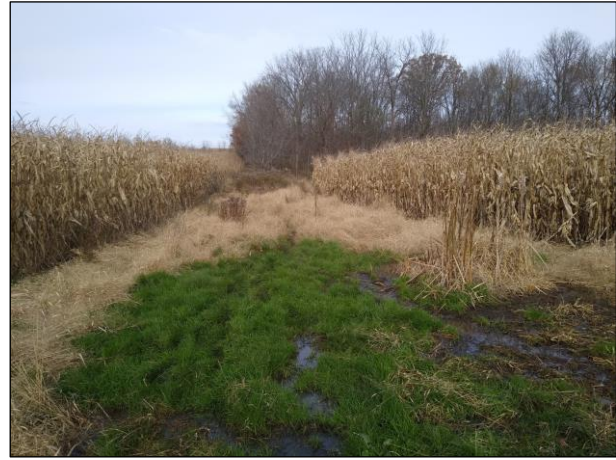
*Photo 26: Ponding in Reach FCT-2D (looking upstream)*

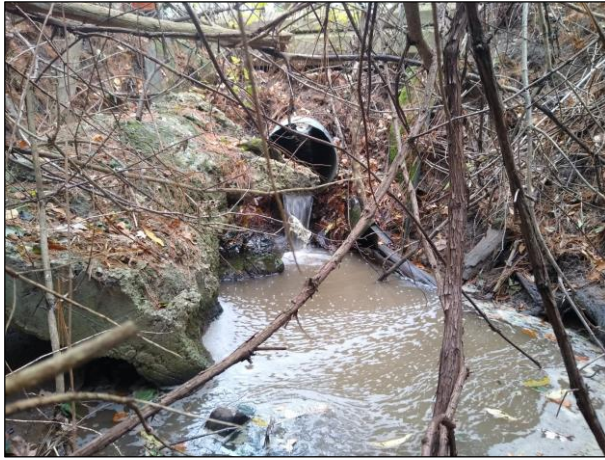
*Photo 33: Perched culvert and plunge pool  
(facing upstream)*

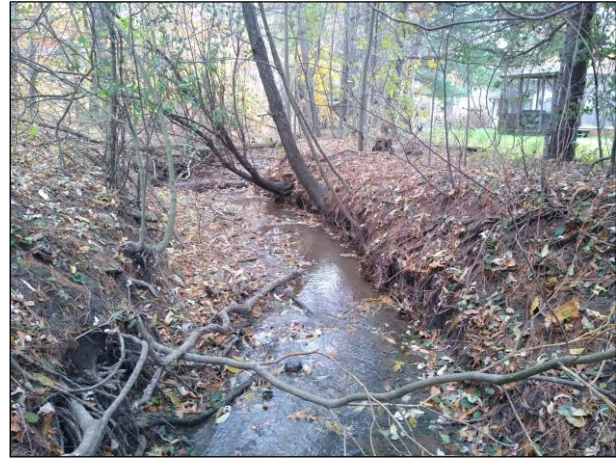
*Photo 34: leaning trees (facing downstream)*

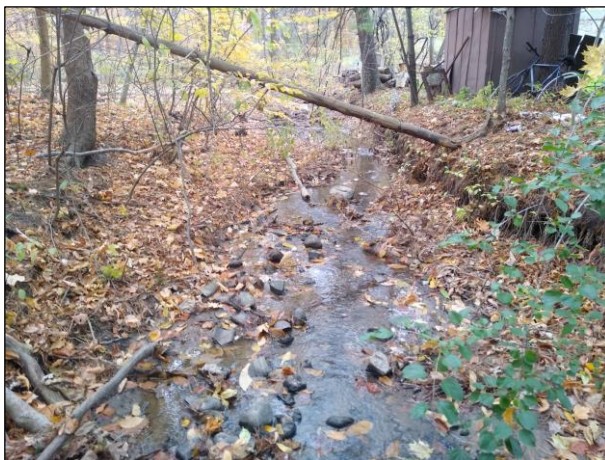
*Photo 35: leaning trees adjacent to private  
property*

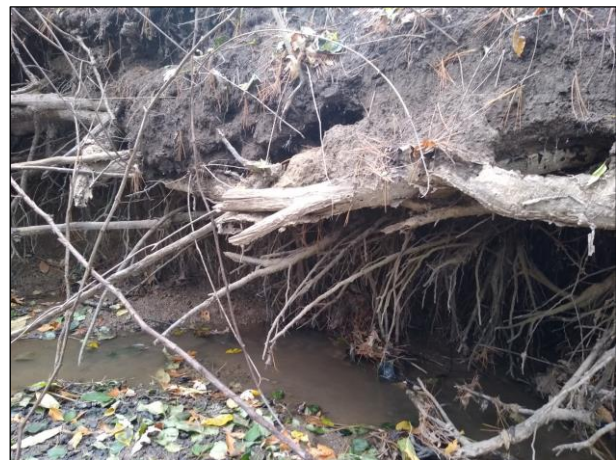
*Photo 36: Undercut bank*

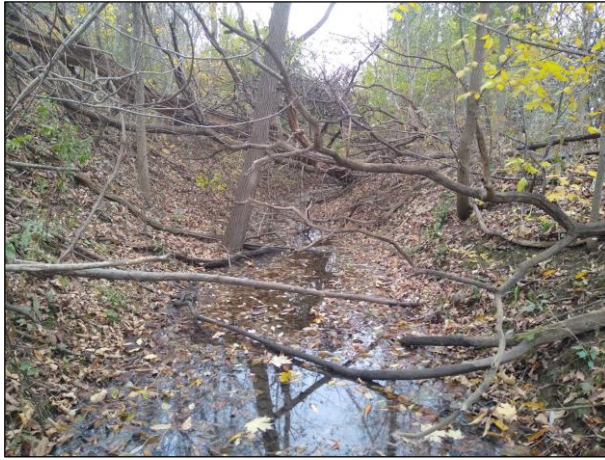
*Photo 40: Leaning trees, large woody debris*

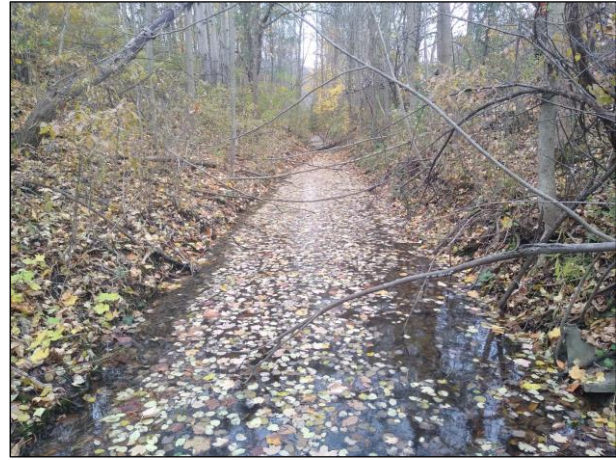
*Photo 41: Straightened channel with localized erosion on right bank*

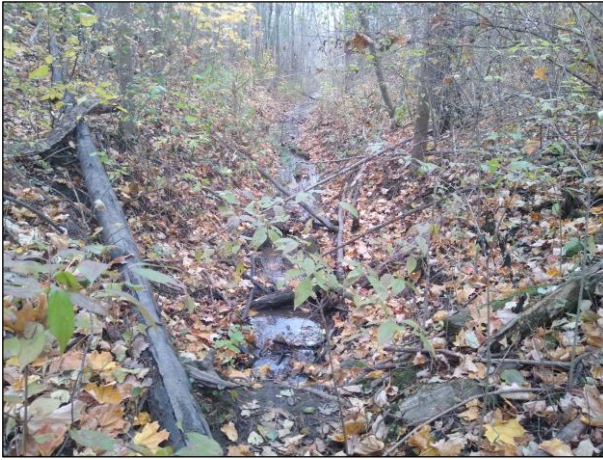
*Photo 43: Fallen trees, some woody vegetation*

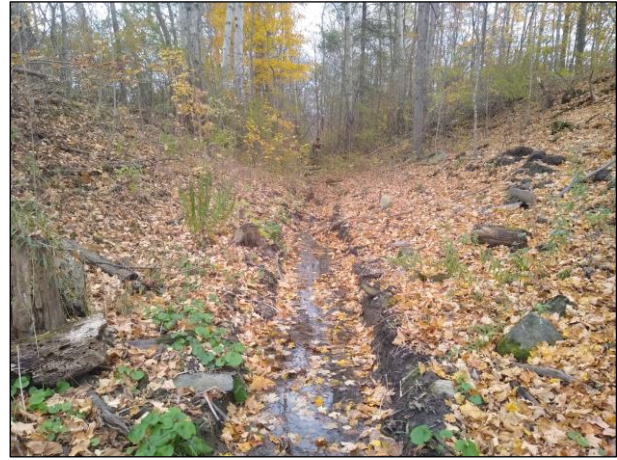
*Photo 44: Excavated low-flow channel with exposed banks*
