# Burke Station Citizens Association

Burke, VA • January 26, 2023

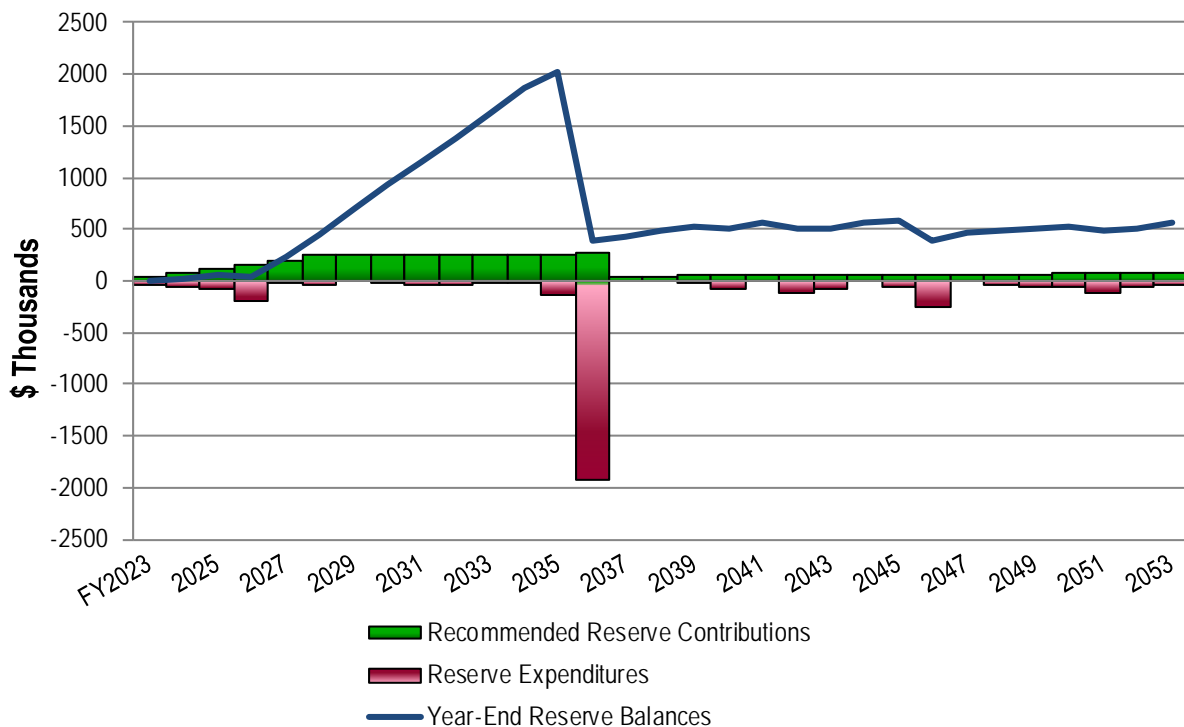
Year	Reserve Contributions (\$)	Reserve Balances (\$)	Year	Reserve Contributions (\$)	Reserve Balances (\$)	Year	Reserve Contributions (\$)	Reserve Balances (\$)
2024	72,900	23,471	2034	252,200	1,869,365	2044	57,800	573,887
2025	115,900	66,228	2035	259,800	2,025,860	2045	59,500	579,521
2026	158,900	37,218	2036	267,600	382,740	2046	61,300	395,872
2027	201,900	225,055	2037	47,000	435,021	2047	63,100	464,528
2028	244,900	441,685	2038	48,400	489,391	2048	65,000	494,895
2029	244,900	693,919	2039	49,900	523,365	2049	67,000	506,142
2030	244,900	925,913	2040	51,400	504,512	2050	69,000	525,182
2031	244,900	1,154,415	2041	52,900	564,315	2051	71,100	489,399
2032	244,900	1,384,856	2042	54,500	515,352	2052	73,200	513,342
2033	244,900	1,622,974	2043	56,100	509,093	2053	75,400	558,771

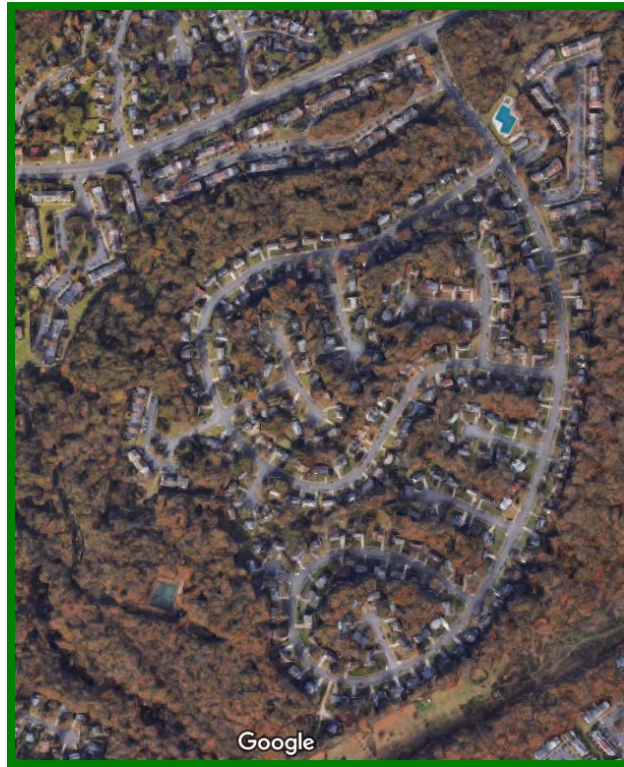
Our investigation includes Reserve Components or property elements as set forth in your Declaration. The Expenditure tables in Section 3 list the elements contained in this study. Our analysis begins by segregating the property elements into several areas of responsibility for repair and replacement.

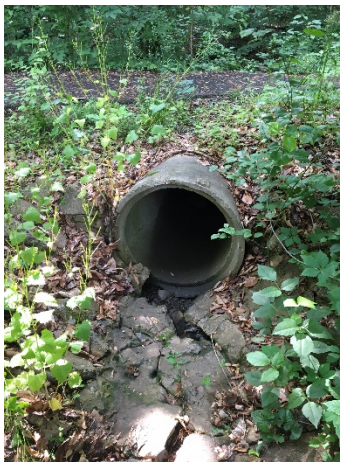
**Pipe underneath trails**

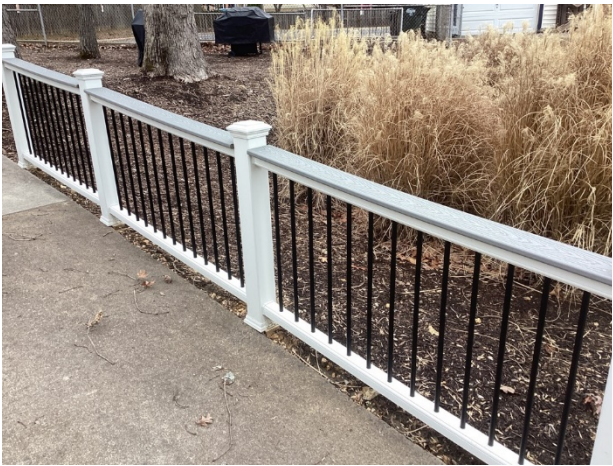
**Vinyl fence overview**

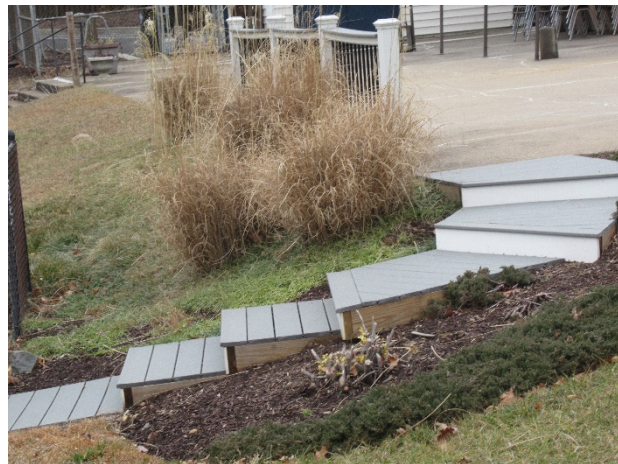
**Composite steps overview**

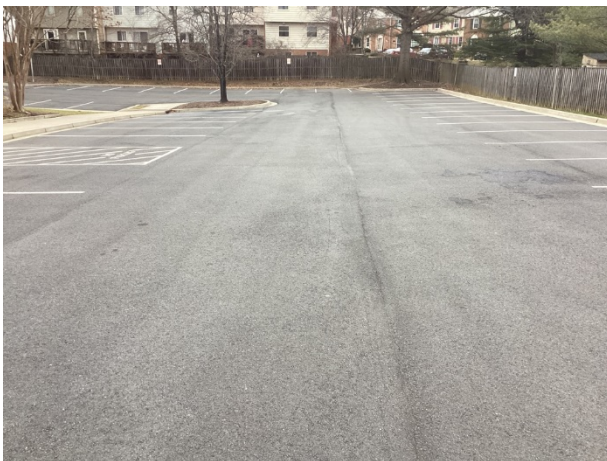
Asphalt pavement parking area overview

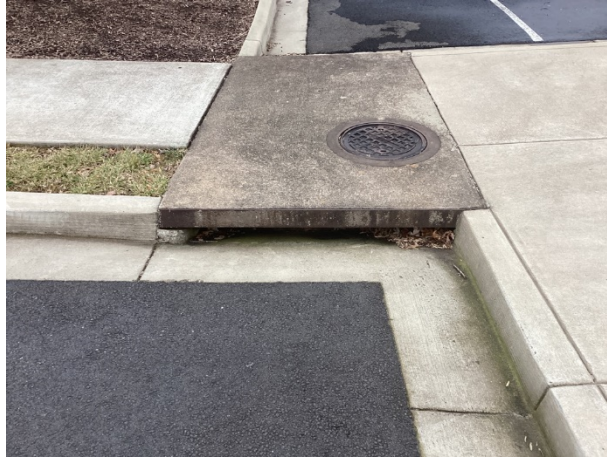
**Catch basin overview**

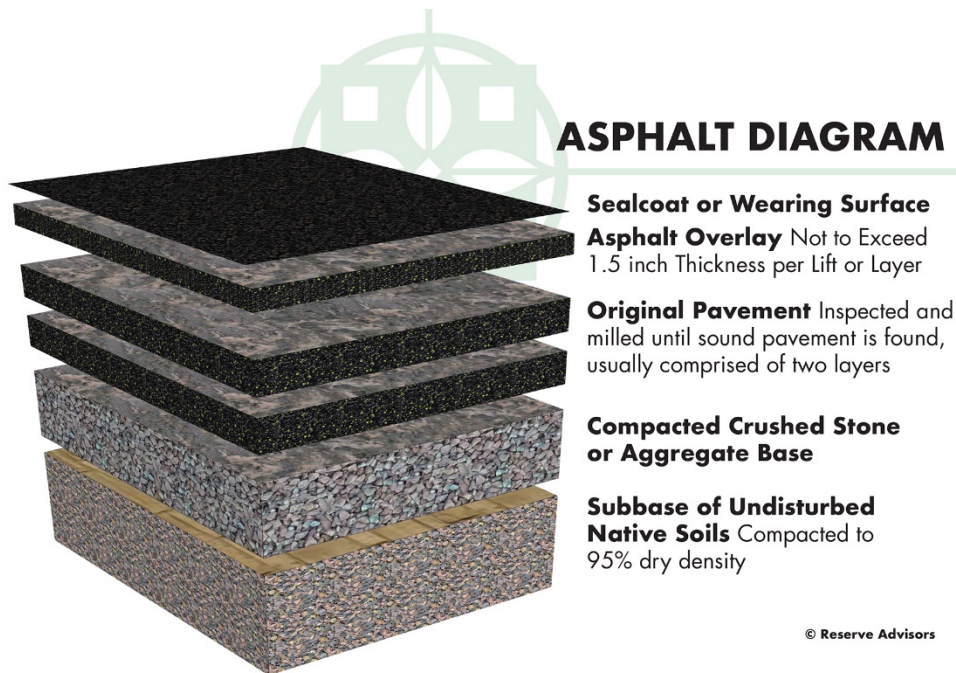
The manner of repaving is either a mill and overlay or total replacement. A mill and overlay is a method of repaving where cracked, worn and failed pavement is mechanically removed or milled until sound pavement is found. A new layer of asphalt is overlaid atop the remaining base course of pavement. Total replacement includes the removal of all existing asphalt down to the base course of aggregate and native soil followed by the

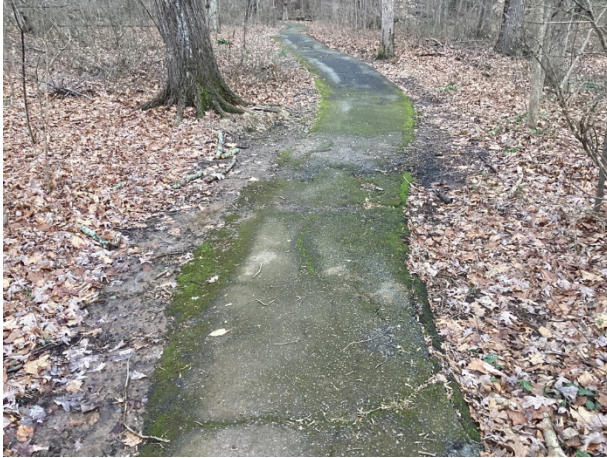
**Asphalt pavement walking path overview**

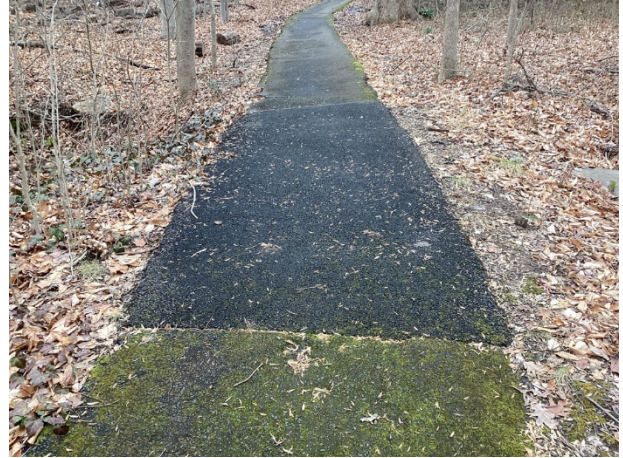
**Asphalt pavement walking path repaired section**

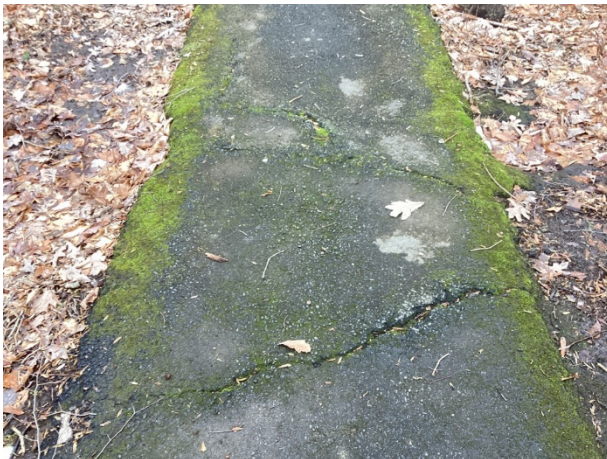
**Asphalt cracks and organic growth**

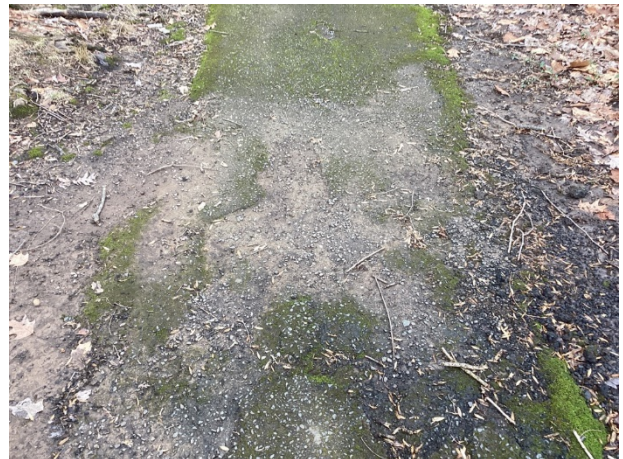
**Asphalt deterioration**

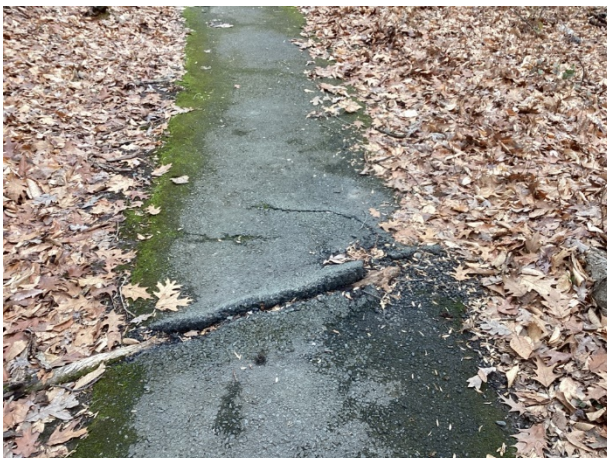
**Asphalt crack and tree root damage**

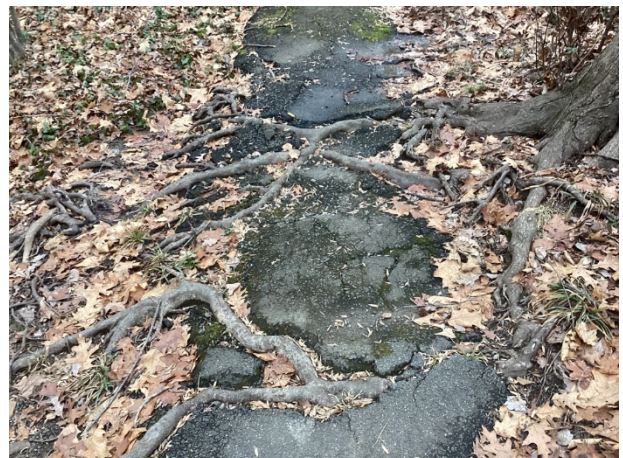
**Asphalt crack and tree root damage**

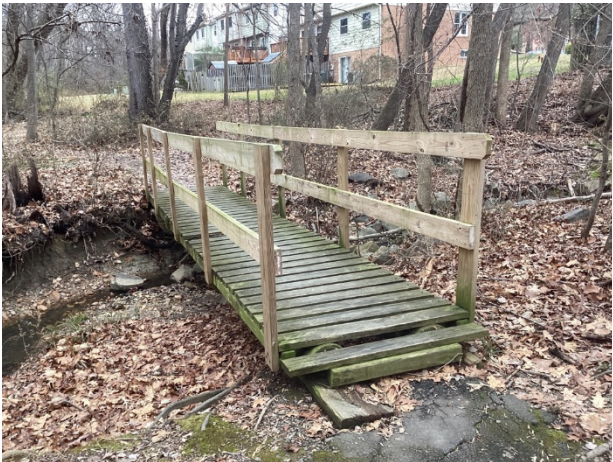
Wood bridge, North trail

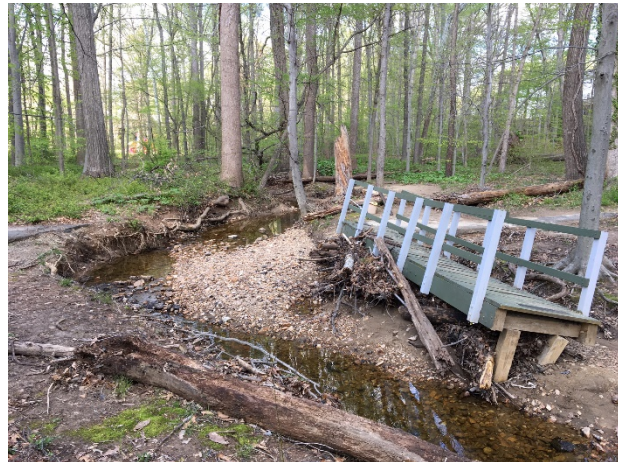
Damaged bridge connecting South trail and Kara trail

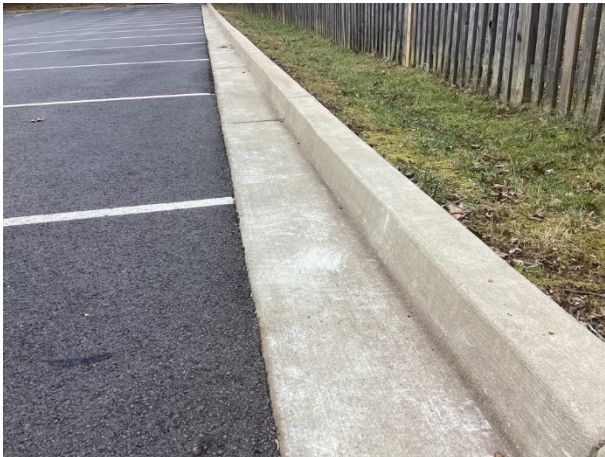
Concrete curb and gutter overview

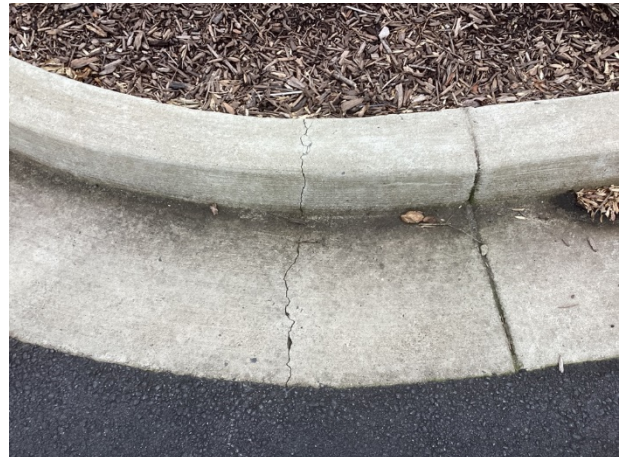
Concrete curb and gutter crack

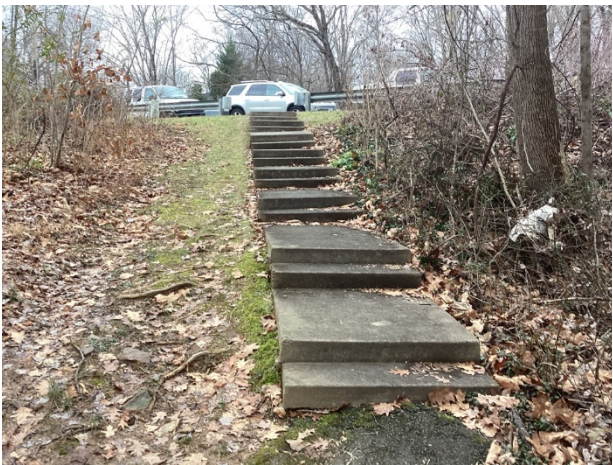
**Concrete stairs overview, North trail  
(Note: Uneven steps and landings.)**

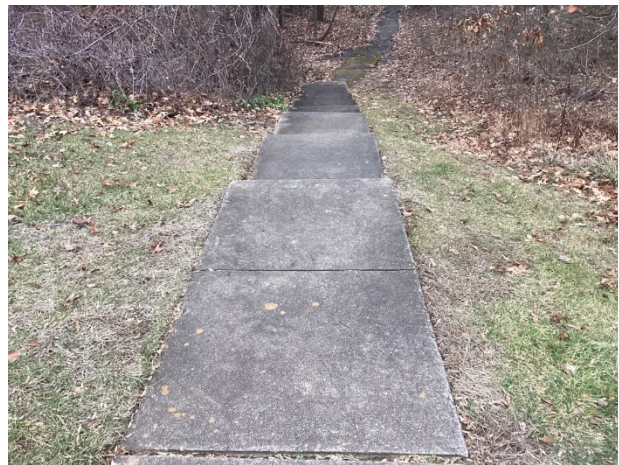
**Concrete stairs overview, South trail, #1  
(Note: General concrete deterioration and staining.)**

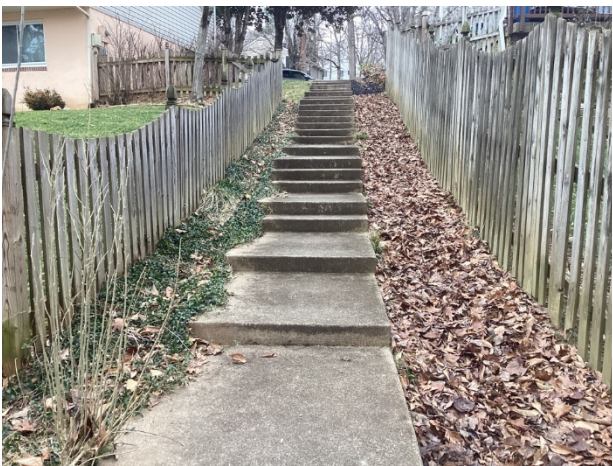
**Concrete stairs overview, South trail, #2**

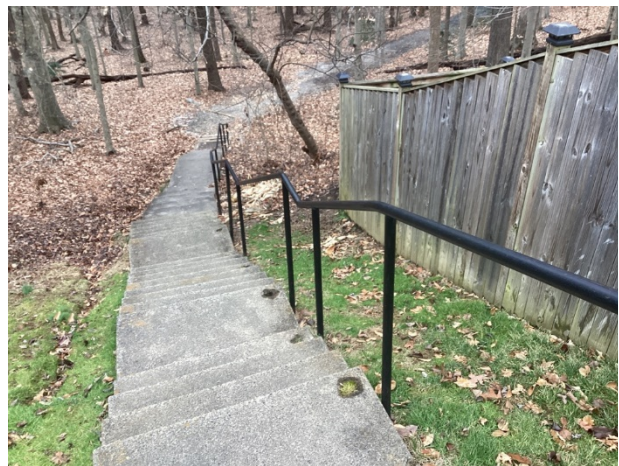
**Concrete stairs overview, Steps leading from  
Ridge Ford Drive to Burke Station Park  
(Note: This staircase is the responsibility of  
Fairfax County Park Authority.)**

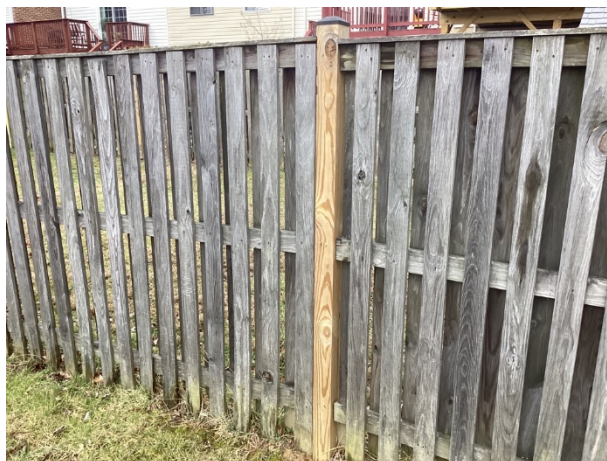
**Wood perimeter fence overview  
(Note: Previously repaired post.)**

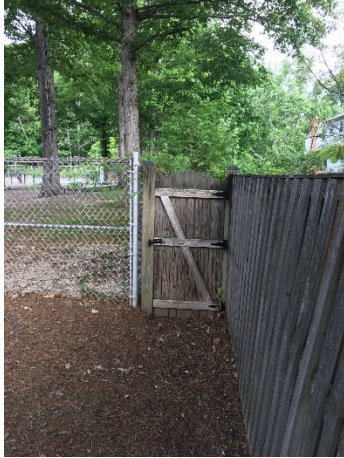
**Wood perimeter fence and gate overview**  
(Note: this image was provided by the Association)

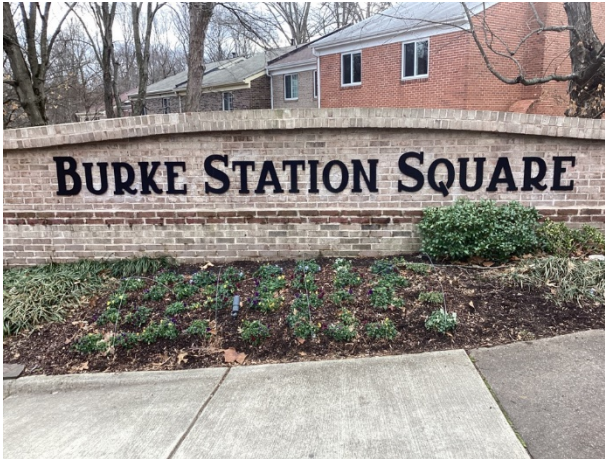
**Entrance monument overview**

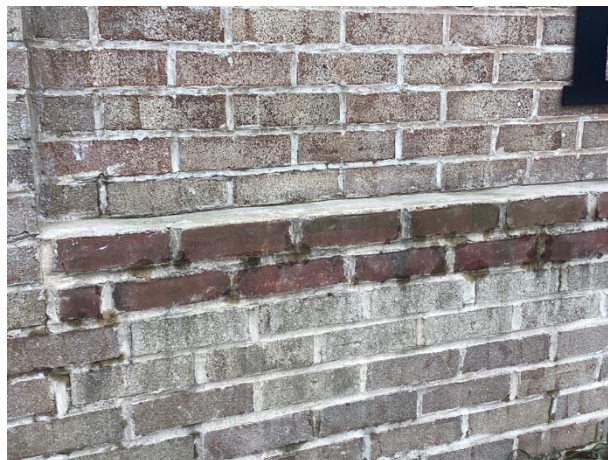
**Brick masonry efflorescence and deterioration**

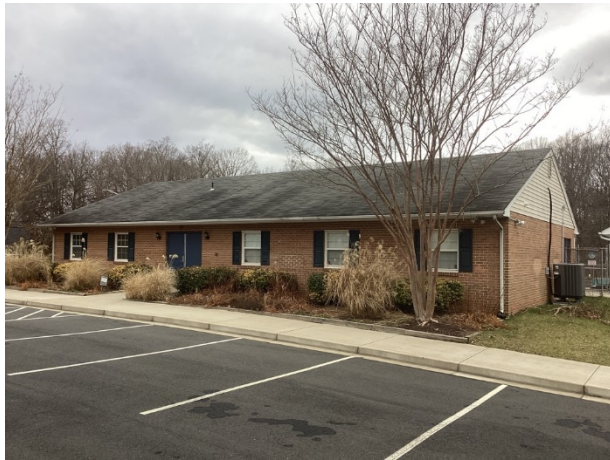
**Community Center overview**

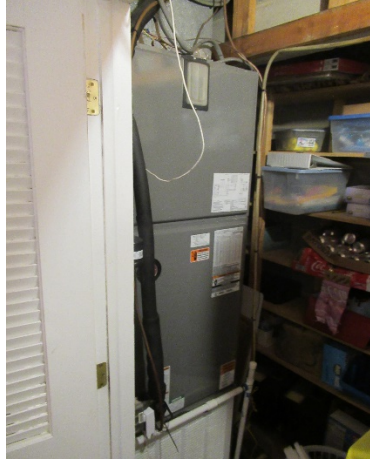
**Air handling unit overview**

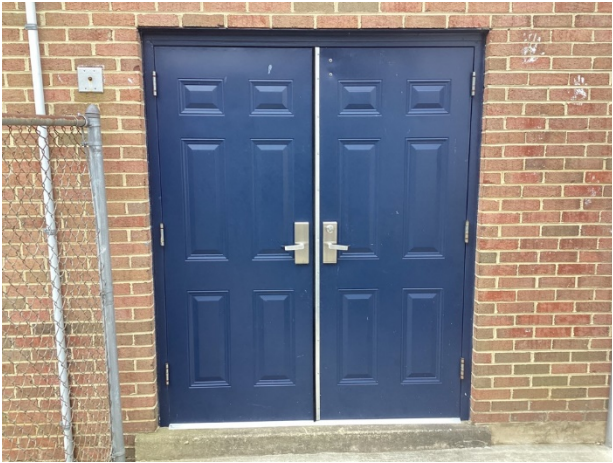
**Side entrance doors overview**

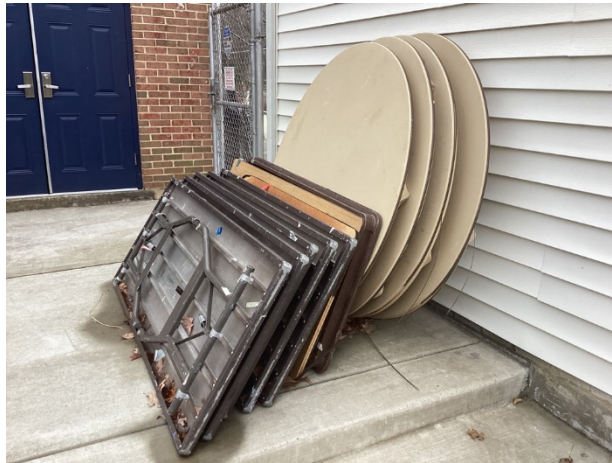
**Folding tables overview**

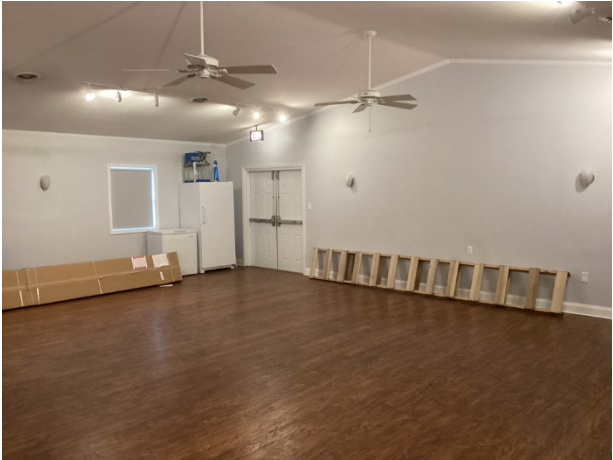
**Community Center interior overview**

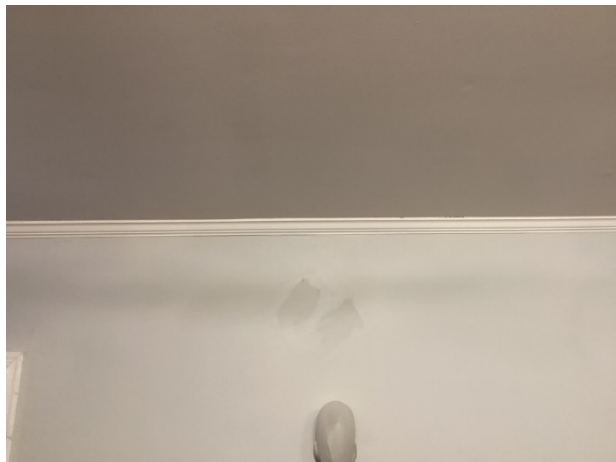
**Finish deterioration at the walls**

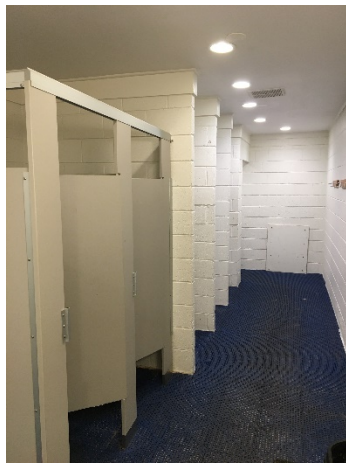
**Men's rest room overview**  
*(Note: this image was provided by the Association)*

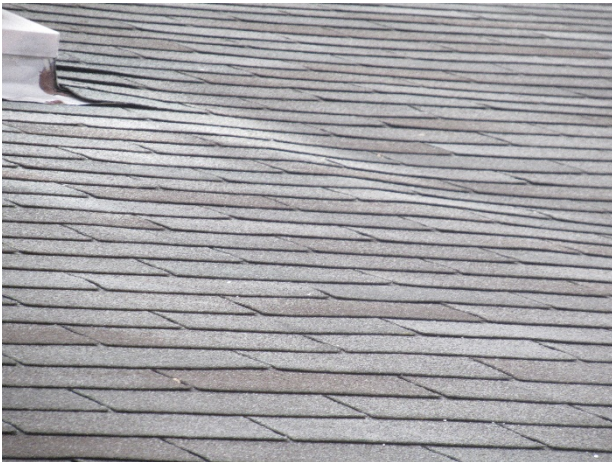
**Asphalt shingle roof overview**

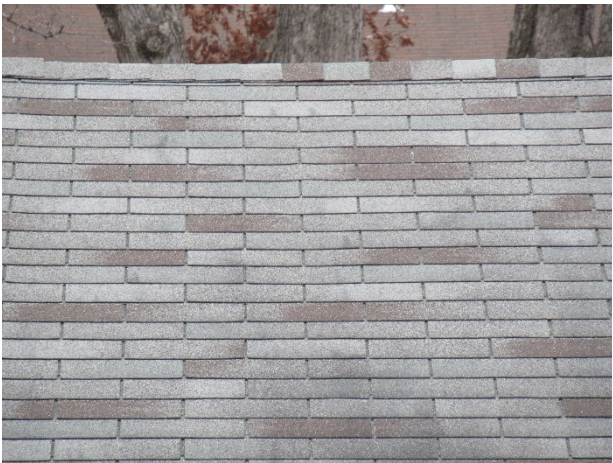
**Asphalt shingle deterioration and staining,  
wading pool shed**

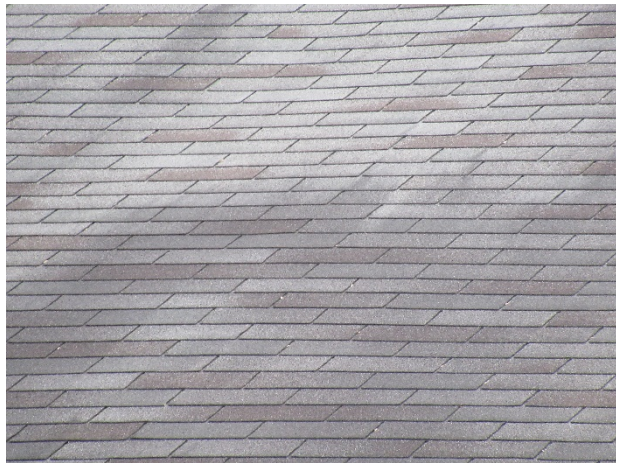
**Asphalt shingle deterioration and staining,  
storage shed**

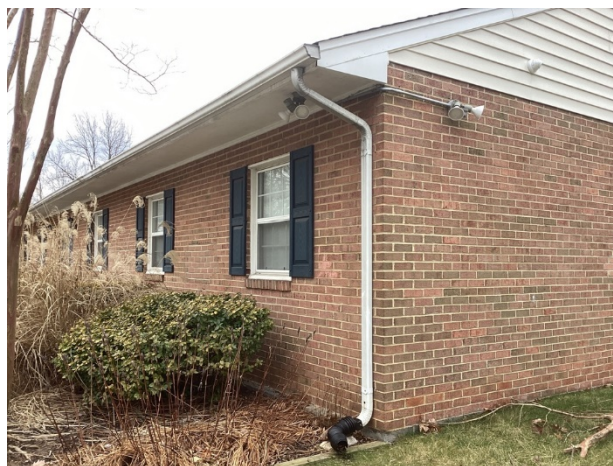
**Gutter and downspout overview**

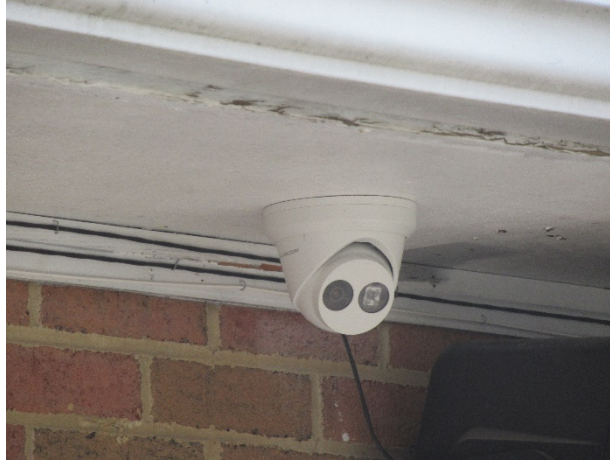
**Security camera overview**

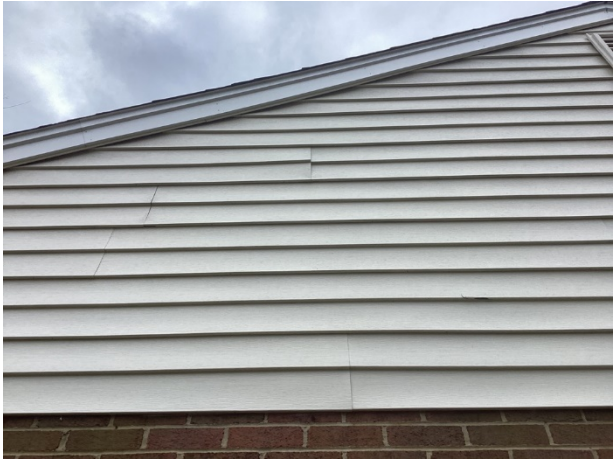
**Vinyl siding overview**

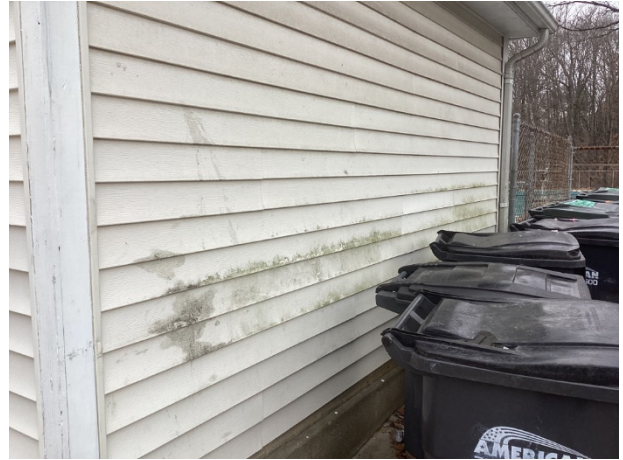
**Staining at the sheds**

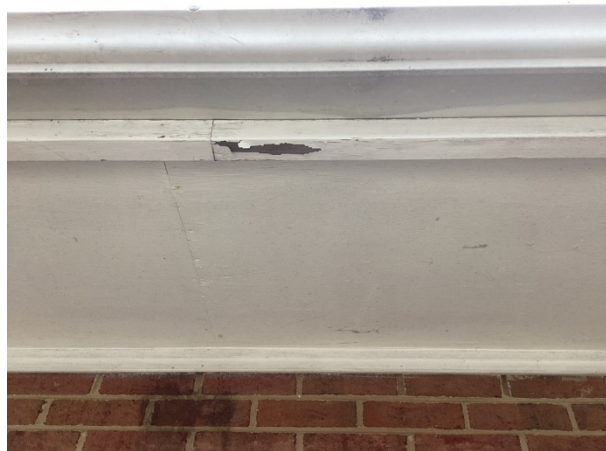
**Soffit finish deterioration overview**

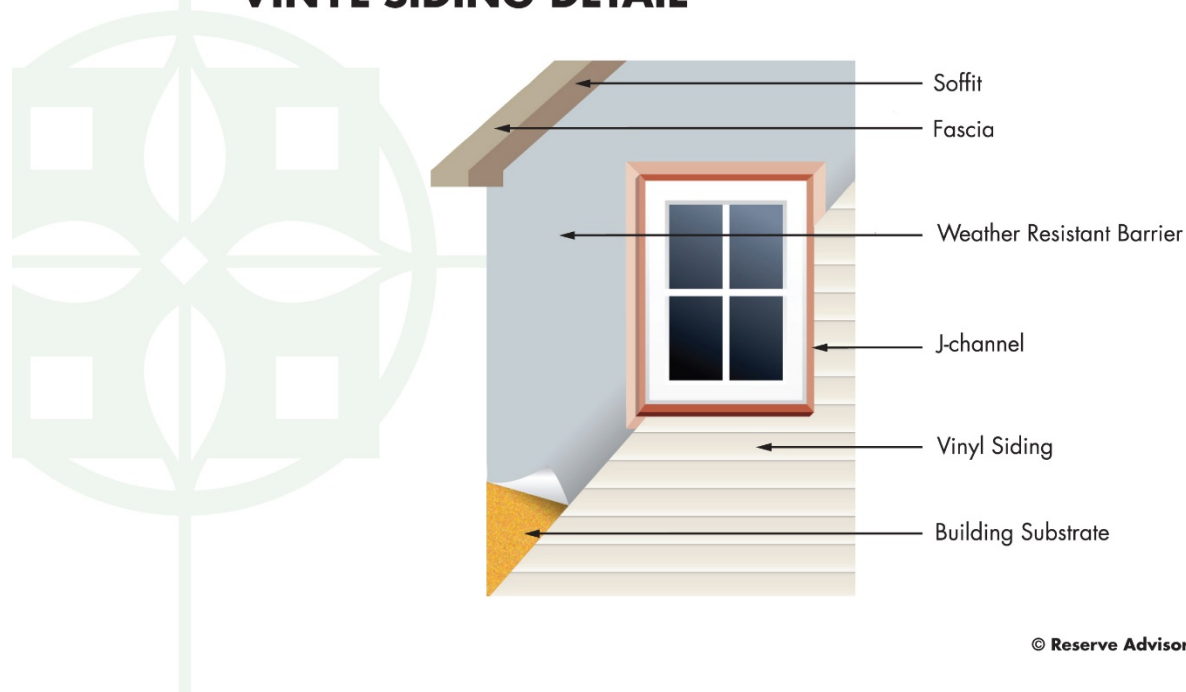
The Association should install new vinyl siding as recommended by the *Vinyl Institute, Inc.* The vinyl siding should be installed over a continuous weather resistant barrier and properly integrated flashing around all penetrations. Fasteners used should include aluminum, galvanized steel or other corrosion-resistant fasteners. Siding panels should overlap by approximately one inch. Joints should be staggered so that no two courses are aligned vertically, unless separated by at least three courses. The siding should not be caulked where the siding meets trim accessories, such as J-channel, or at overlap joints. J-channel should be installed a minimum of ½ inch off of roof lines.

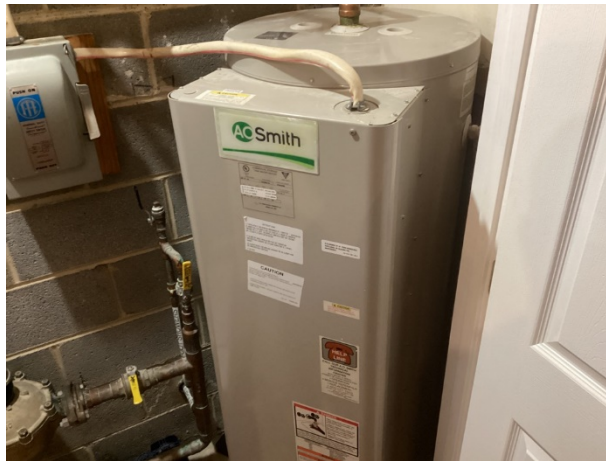
**Water heater overview**

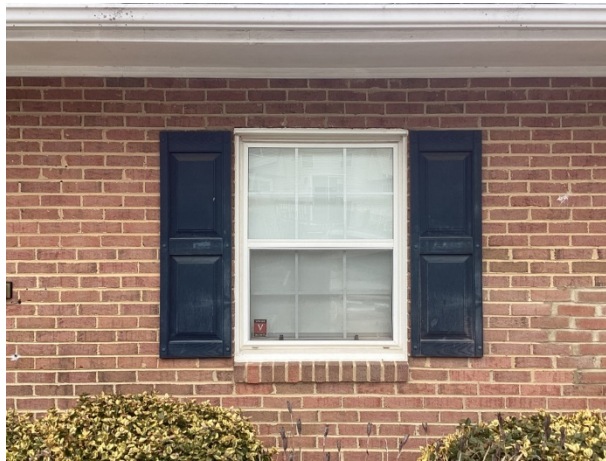
**Condition:** Good overall

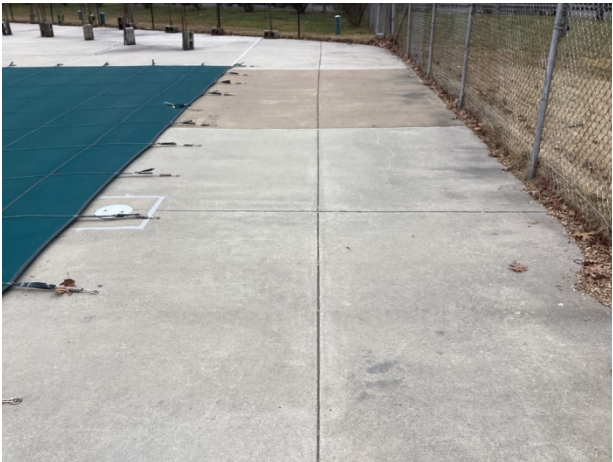
Concrete deck overview

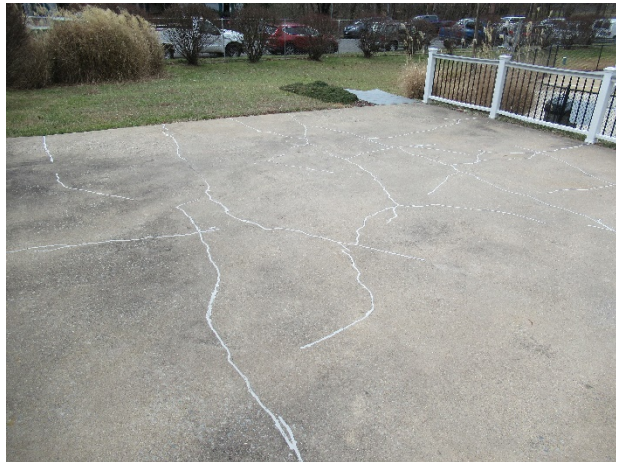
Concrete deck previous repairs

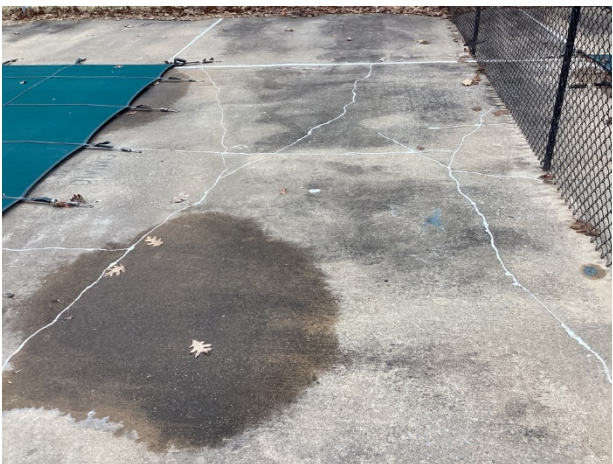
Concrete deck previous repairs and staining

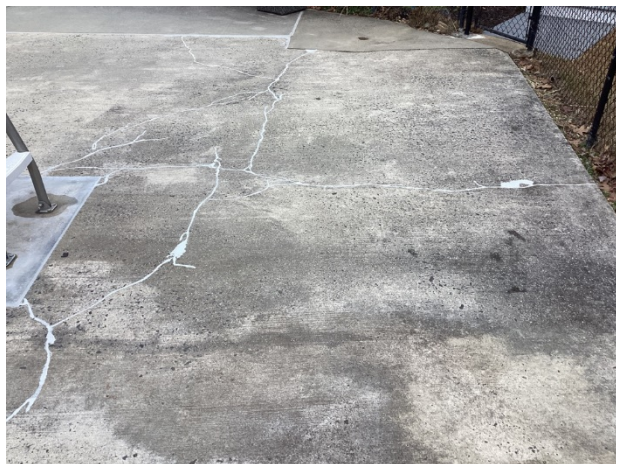
Concrete deck previous repairs and staining

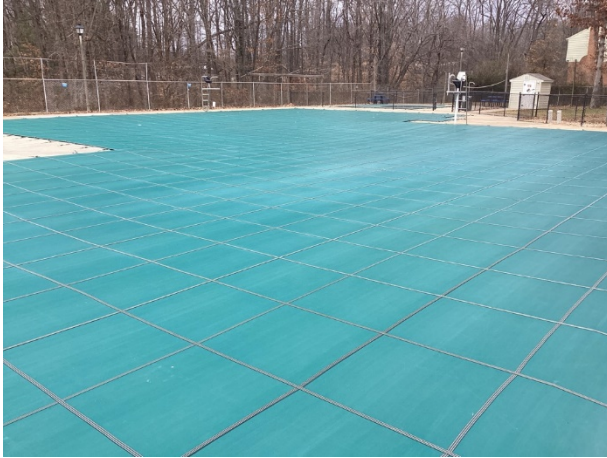
**Main pool cover overview**

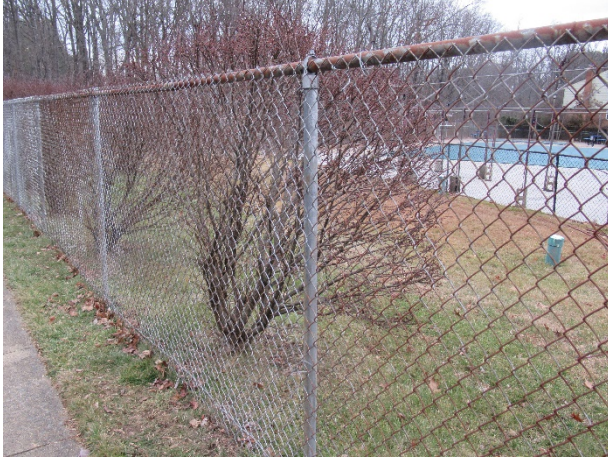
**Security chain link fence overview**

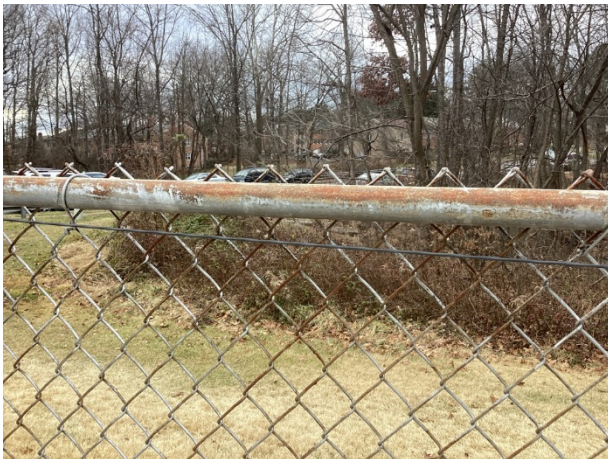
**Rust at security chain link fence**

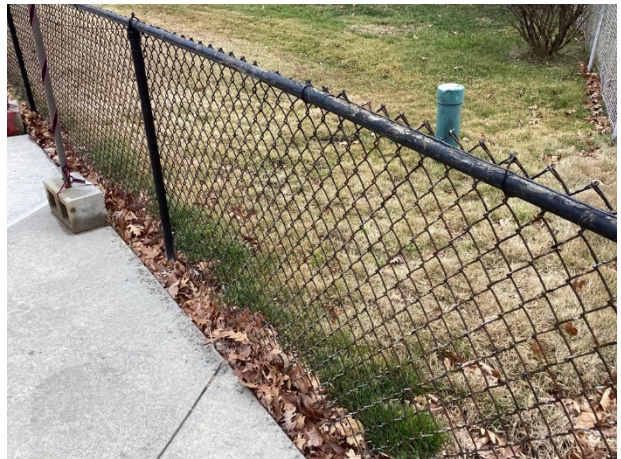
**Safety chain link fence overview**

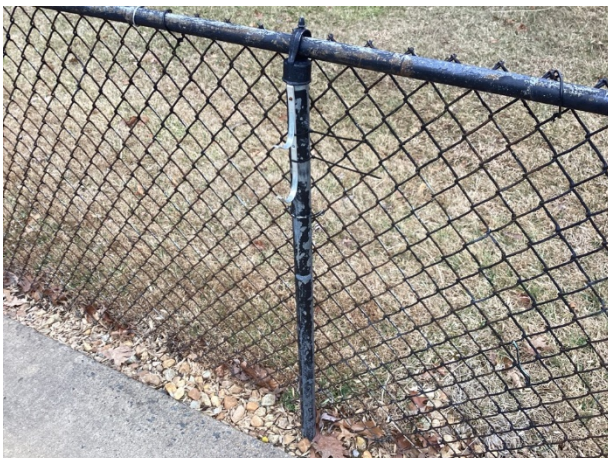
**Finish deterioration at wading pool fence**

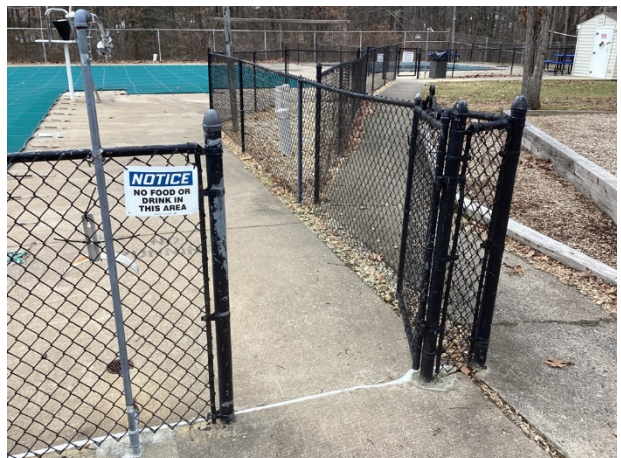
**Main pool chain link gate**

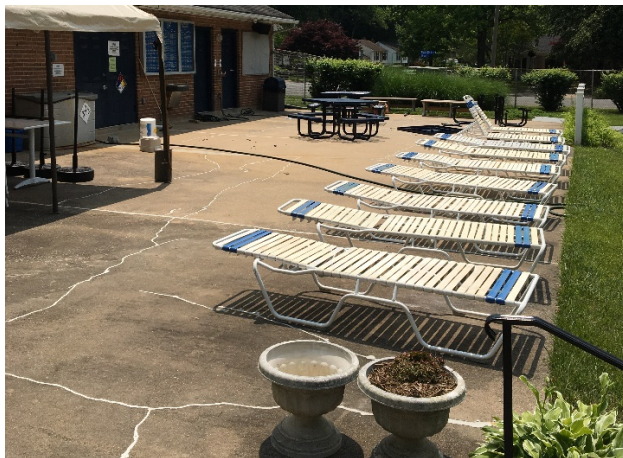
**Vinyl lounges overview**  
 (Note: this image was provided by the Association)

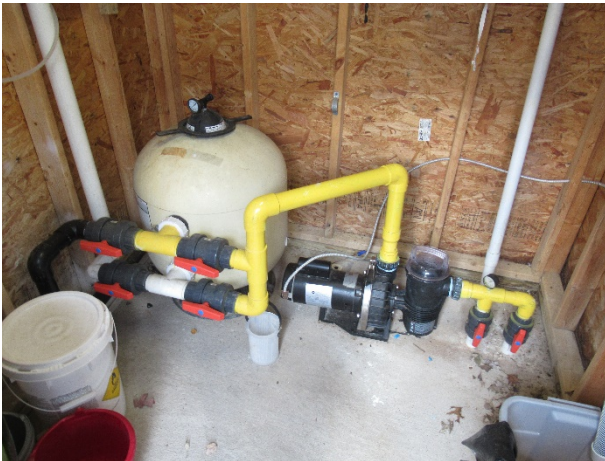
**Pump and filter overview, wading pool**

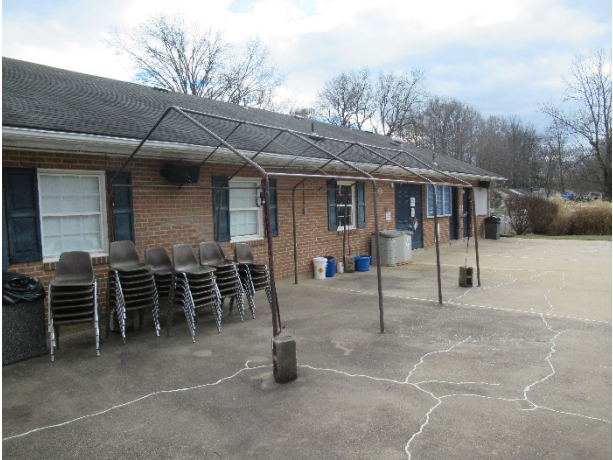
**Shade structure frame overview**

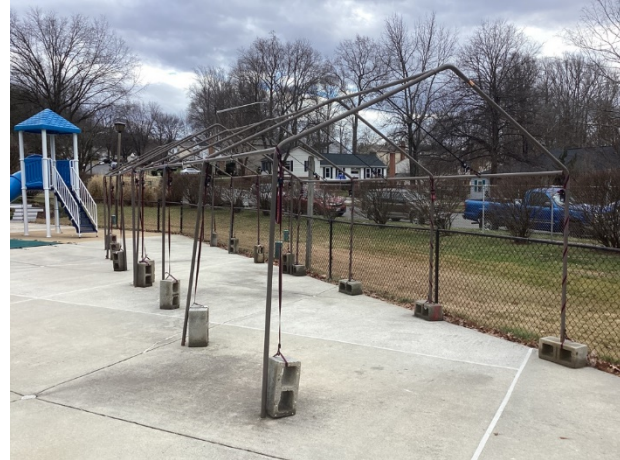
**Shade structure frame overview**

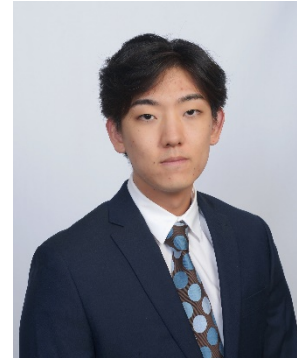
The following is a partial list of clients served by Gene Kim demonstrating his breadth of experiential knowledge of community associations in construction and related buildings systems.
