Railroad Ditch Remediation Project

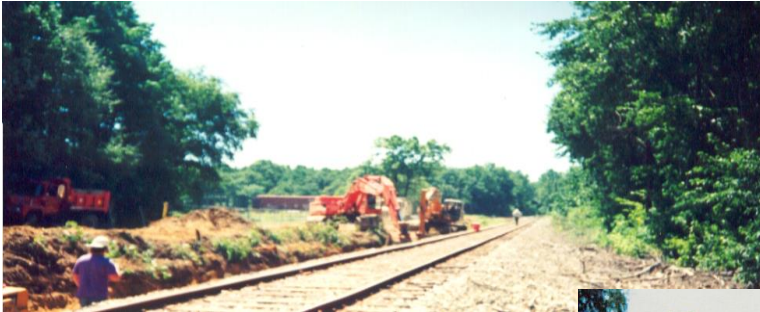
The remediation of the ditch is shown in the photograph on the left. The ditch was just less than 900 feet long. Arecon used controlled excavation and filling techniques.

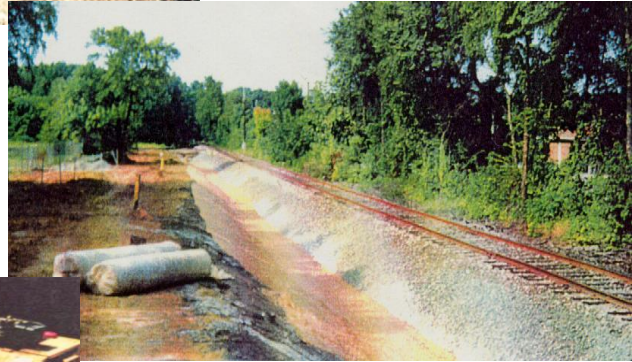
The ditch after remediation is shown in the photograph on the right. Topsoil is in place and it has been conditioned with lime, fertilized and seeded. Mulch blankets are shown on the top of the hill.

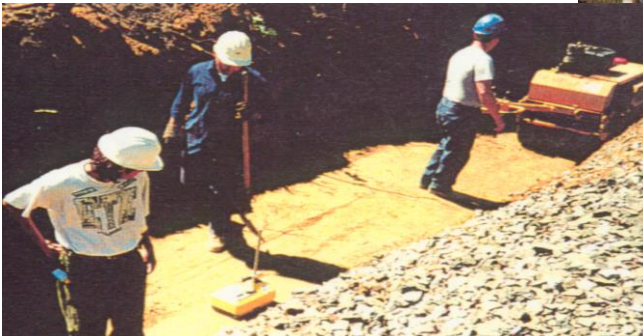
The photograph to the left shows part of the ditch, found clean by XRF analysis, being compacted and tested for compaction using a nuclear density-testing device.
