# Log Details - #5

Aurora Lake

### AQUA DOC - 6/25/2026 - Visitation 5

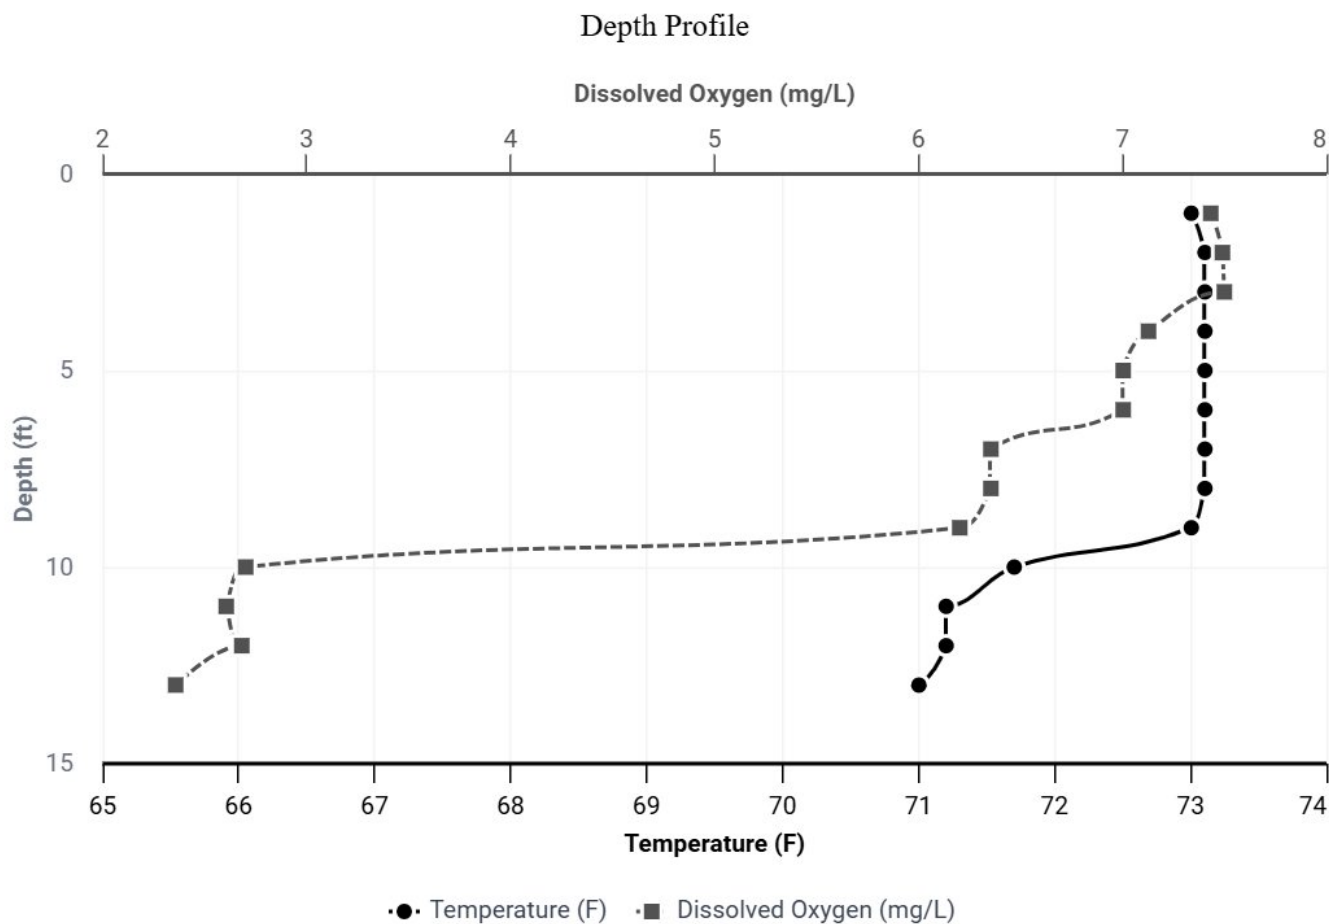
Aurora Lake 1 | 06/25/2026 10:54 AM

Depth profile data showcased relatively weak thermal stratification with a weak thermocline being present at approximately 10.0 ft. Below this, dissolved oxygen (DO) was significantly reduced to concentrations below 3.0 mg/L. Although this is below our normal safety threshold (4.0 mg/L), it was only present at the bottom 3.0 ft of water and the upper 10.0 ft of water was well within acceptable parameter thresholds. DO concentrations from the in-situ buoy do showcase occasional, temporary moments below 4.0 mg/L highlighting increased respiration. No management actions are currently suggested to address temporary moments of low DO as these moments are brief and spontaneous and not likely to significantly impact gilled organisms or internal nutrient release. All other collected parameters were normal for an Ohio kettle lake.

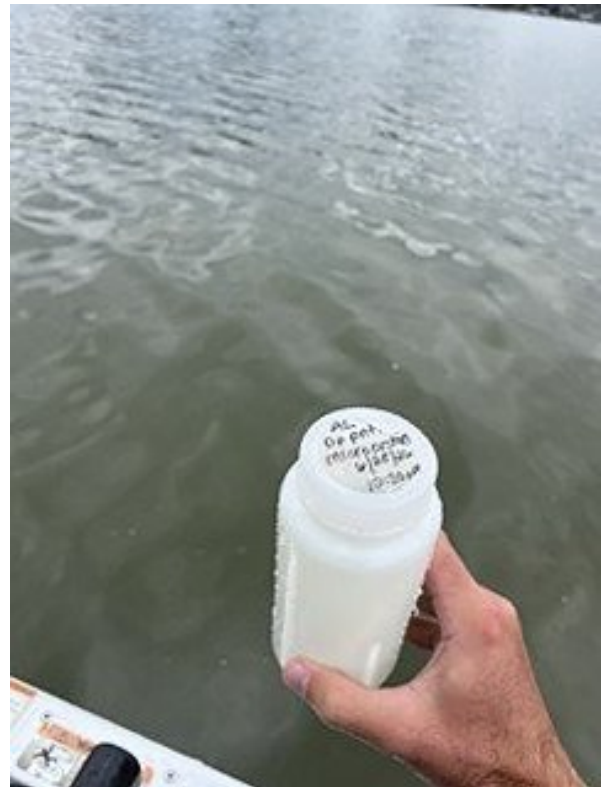
Microcystin Sample Collected 6/25/26

Also collected during our visit was a Microcystin sample at the deep point (AL6), a total phosphorus sample at the deep point, and an E. coli sample at both beaches. Previously collected Microcystin samples have been well below concerning thresholds (8.0) and should be available in the documents tab of the online portal. Previously collected E.coli samples were also below concerning human health thresholds.
