# HOME INSPECTION REPORT

May 2, 2018

STREET ADDRESS CITY, STATE

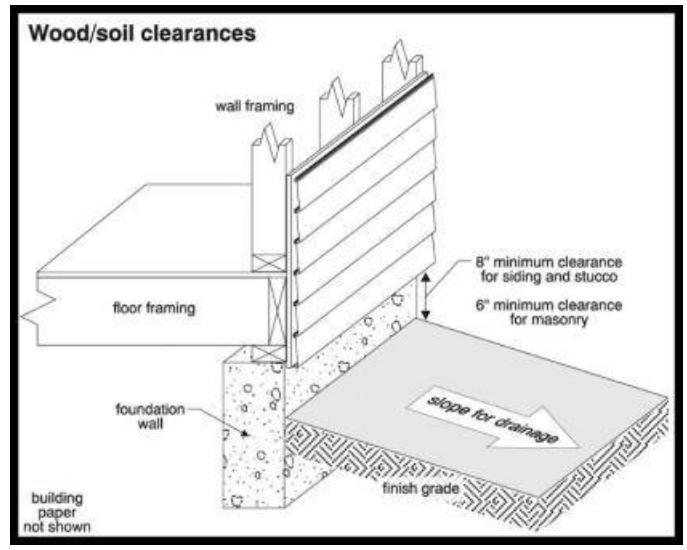
# 2.2 SOIL CONTACT WITH EXTERIOR SIDING

The siding is in contact with or installed below grade level/mulch. This condition commonly causes rot and is highly conducive to wood destroying insect (primarily termites and carpenter ants) infestation/damage. Our inspection for wood destroying insects was severely limited due to this condition. Damage, which may have resulted from this condition, should be repaired prior to closing. Many buildings with no ground clearance have hidden wood destroying insect infestation/damage that a competently performed wood destroying insect inspection may not disclose under these conditions. Have the soil/mulch removed to expose the foundation. There should be at least 6-8" of clearance between the siding and the ground/mulch. In addition, failure to maintain the grading adequately sloped away from the

foundation could lead to water in the structure. The exterior grade should be a minimum of four inches (8" is even better) below the top of the foundation. Soil above the level of the foundation should be avoided if at all possible as this too can result in rot of wood and wood destroying insect infestations.

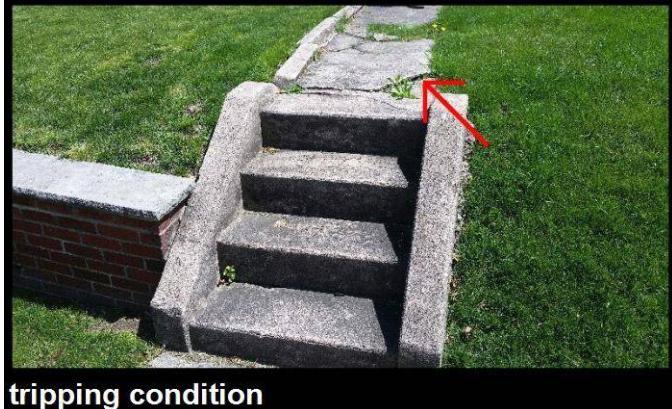
#### **2.9 STEPS**

The exterior steps are in some aspects, unsatisfactory condition. Deficiencies include, but are not limited to; There is cracking masonry: which represents a tripping condition that should be repaired.

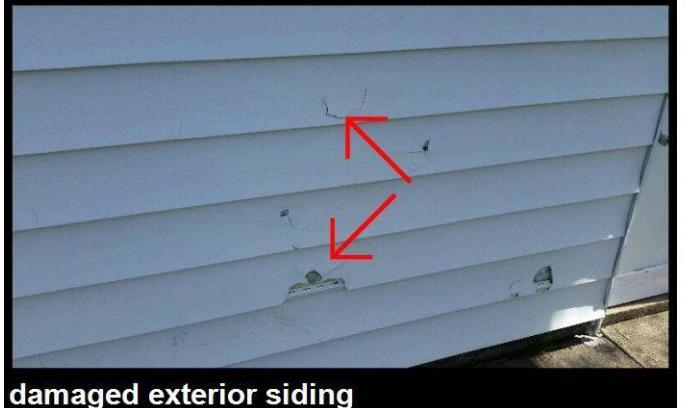
#### **3.2 SIDING CONDITION**

The exterior wood clapboard siding is in need of maintenance/repair, which represents a possible "material defect.", Deficiencies include, but are not necessarily limited to the following; There is some rot of the exterior siding. The extent of the damage through the wall system is un-determined. There is paint peeling. Have the exterior prepped and re-painted. The exterior vinyl siding is in need of maintenance/repair, which represents a possible "material defect.", There is damaged exterior siding; which could result in leakage. There is loose/inadequately fastened exterior siding. A competent contractor should be contacted to more

thoroughly evaluate these "material defects"/conditions and to perform repairs as necessary. NOTE: Vines/vegetation cover much of the exterior. The significance of this condition is; this limits the inspection. A competent contractor should be contacted to trim the vegetation as necessary. A re-evaluation of the conditions should be conducted when conditions permit (before closing).

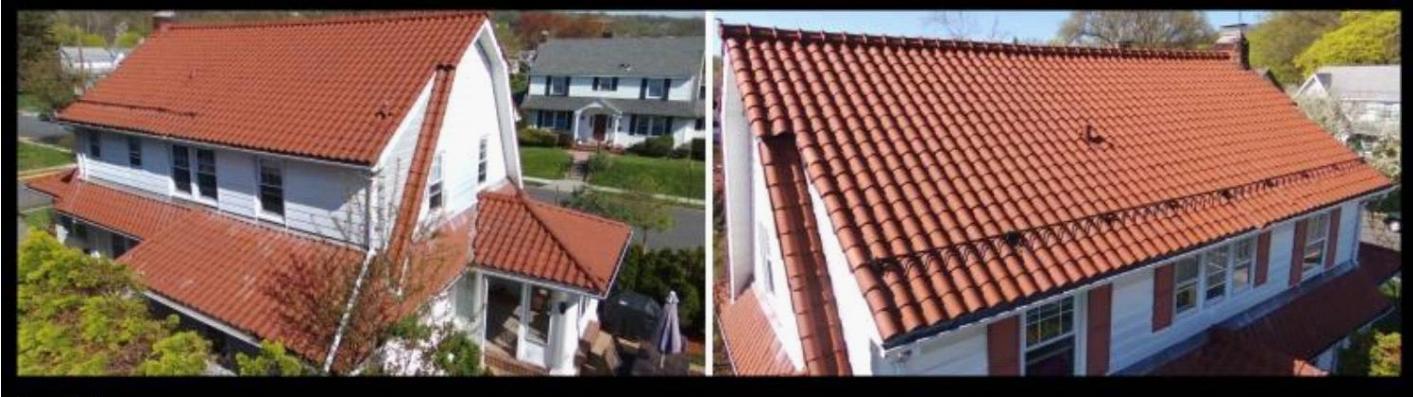
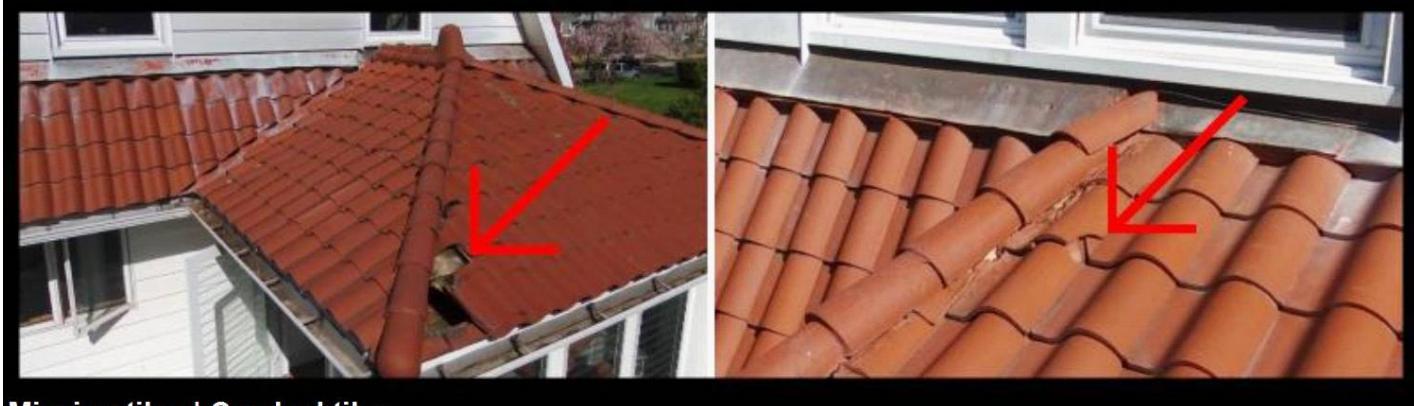
#### 4.3 ROOF COVERING CONDITIONS:

The Concrete/clay roofing tiles is in unsatisfactory condition, which represents a possible "material defect." Deficiencies include, but may not be limited to the following; The roof covering also shows signs of excess wear due to exposure. These conditions include, but are not necessarily limited to; Roof tiles are split. This condition may be a reflection of normal wear and tear and could result in leakage. There are missing tiles, which could result in leaks. There is rot along the edges of the roof. One or more of the tiles are cracked at the overlap. It is unlikely a leak will develop due to the tiles underneath, This is considered a cosmetic condition. Repair as desired. There are missing roof tiles at some locations. Replacement is recommended. One or more of the tiles are broken and water intrusion is likely. The best repair is to replace tile, mastics do not have the durability of the tile and is not considered a permanent repair. If tiles are not available, consider replacing the tile with a tile from the overhang where water intrusion is less of a concern. Use mastic to repair the damage tile. This is a suggestion only and your licensed roofing contractor is best able to advise you and make repairs. Portions of the roof have been patched indicating problems (leakage). Documentation regarding this repair should be obtained prior to closing and an independent roofing contractor should evaluate the effectiveness of the repair and the need for future repairs. A competent contractor should be contacted to more thoroughly evaluate these "material defects"/conditions and to perform repairs as necessary.

# Missing tiles | Cracked tiles

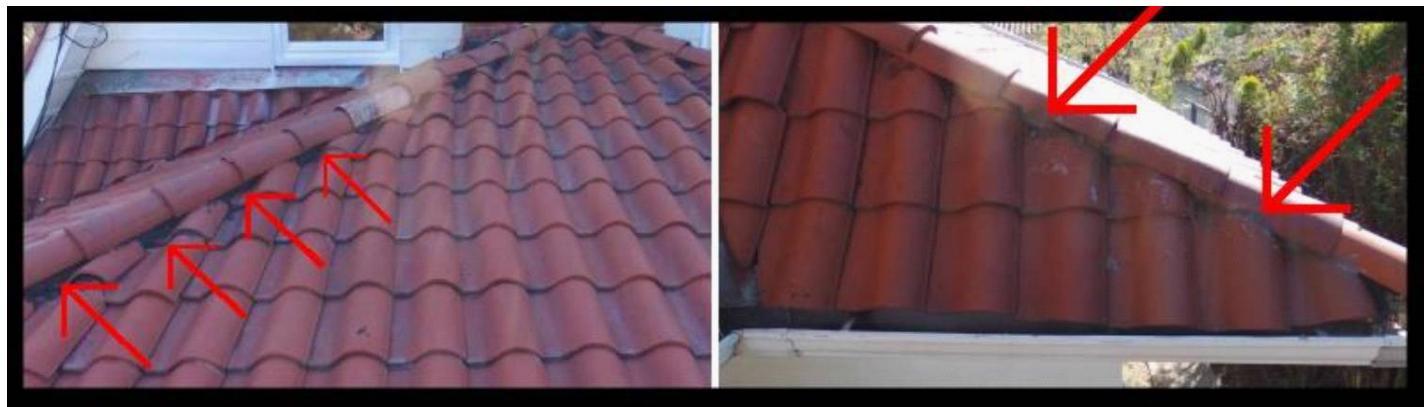
# 4.5 ROOF METAL/FLASHINGS CONDITION

Mastic indicates prior leakage

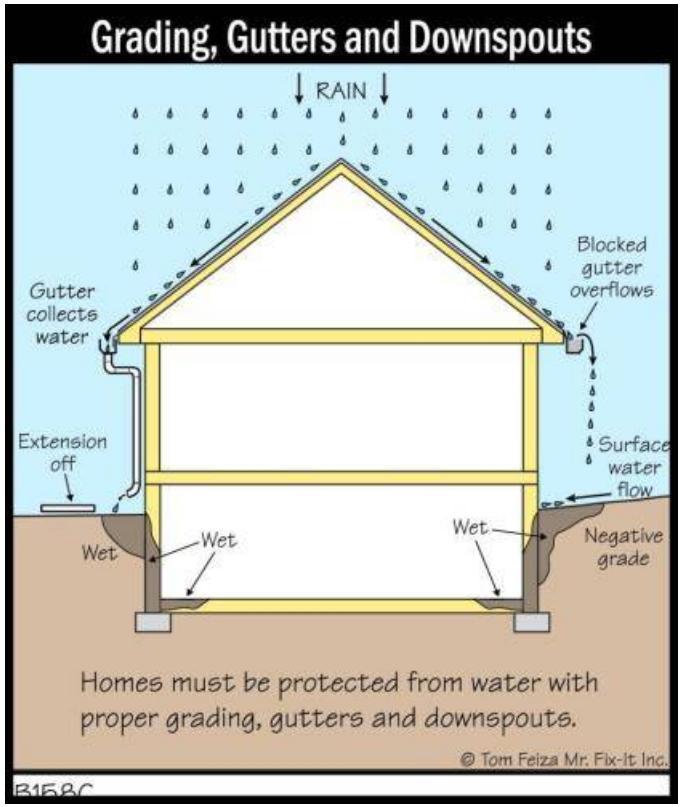
#### 4.6 ROOF DRAINS/GUTTERS CONDITION;

**NOTE:** Proper maintenance of the gutters is essential to caring for the home's exterior as well as the interior and basement/ crawlspace areas. In my opinion, the majority of water that seeps into basements comes from the roof system when the gutters are not adequately maintained. In addition, clogged gutters can allow for ice to accumulate causing leakage to the interior during the extreme winter months. Keep the gutters clean. Do not climb on the roof or hang from a ladder to clean gutters due to the danger associated with this type of work. Contractors are available to do this task for a nominal fee. Have the gutters professionally cleaned at least twice in the Fall and once in the late Spring. Check periodically for proper pitch. Gutter pitch problems are easily detected when it is raining. Consider checking the gutters during rainfall (after lightning stops) for over-flowing conditions. It is this kind of malfunction that saturates the soils adjacent the foundation and leads to water leakage into the home.

The gutters are in need of maintenance/repair. Deficiencies include, but may not be limited to the following: The gutters are clogged with leaves,

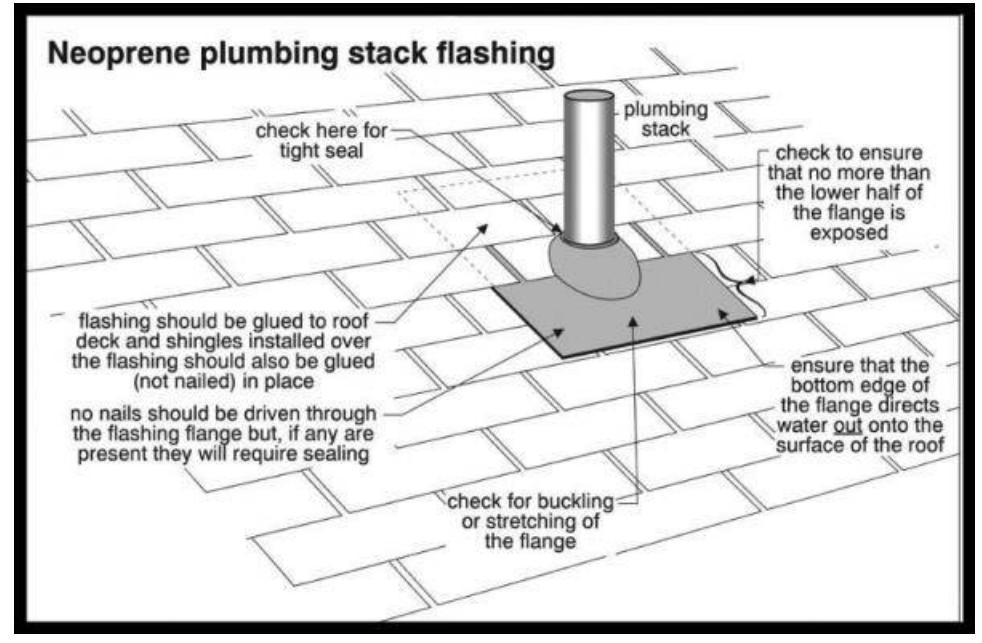
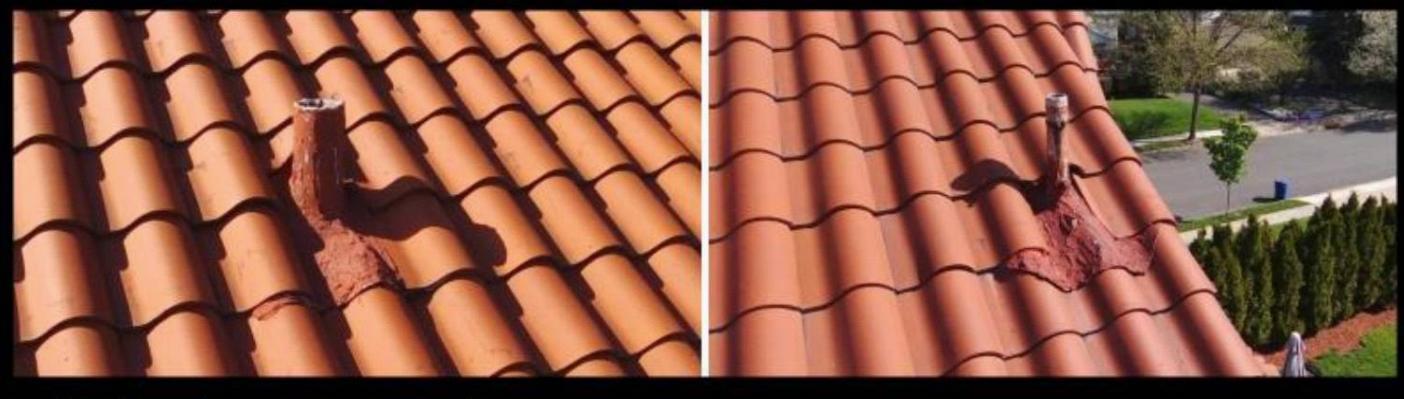
# 4.8 ROOF PENETRATIONS CONDITION:

The roof penetration flashings are improperly installed (material defect). This could result in roof **leakage.** The plumbing vent roof flashings have been repaired indicating some degree of problems at these areas in the past. The nature and scope of repairs should be discussed with the present home-owner and the repairman, who performed the repair. The flashings are rusted due to long-term exposure to the elements. Due to the overall age and condition of this component, a future serviceable life will

likely be limited.

#### roof flashings have been repaired

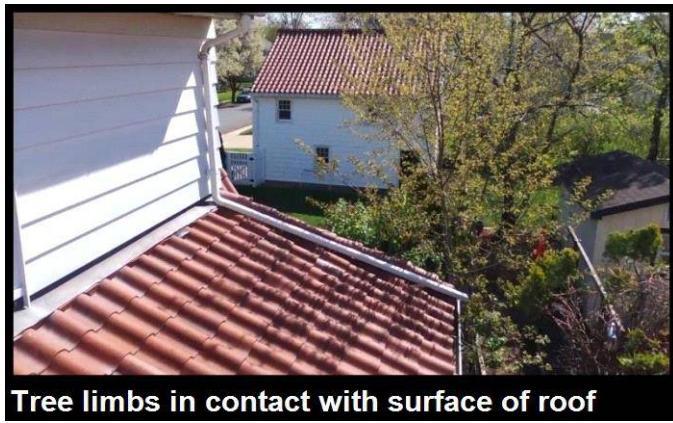
4.9 VEGETATION:

Tree limb(s) observed in contact and rubbing surface of roof. Trim to avoid excessive wear and damage to the roof covering.

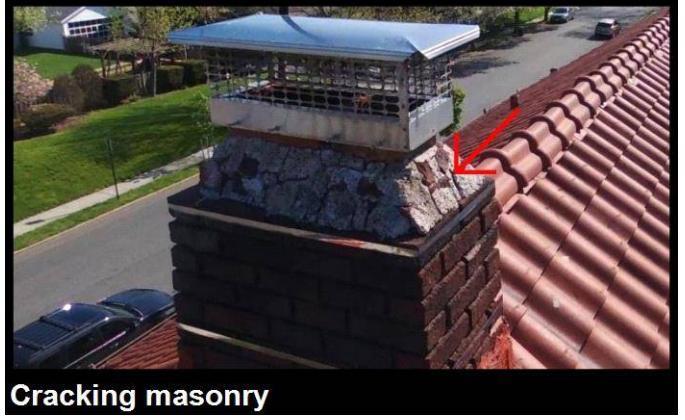
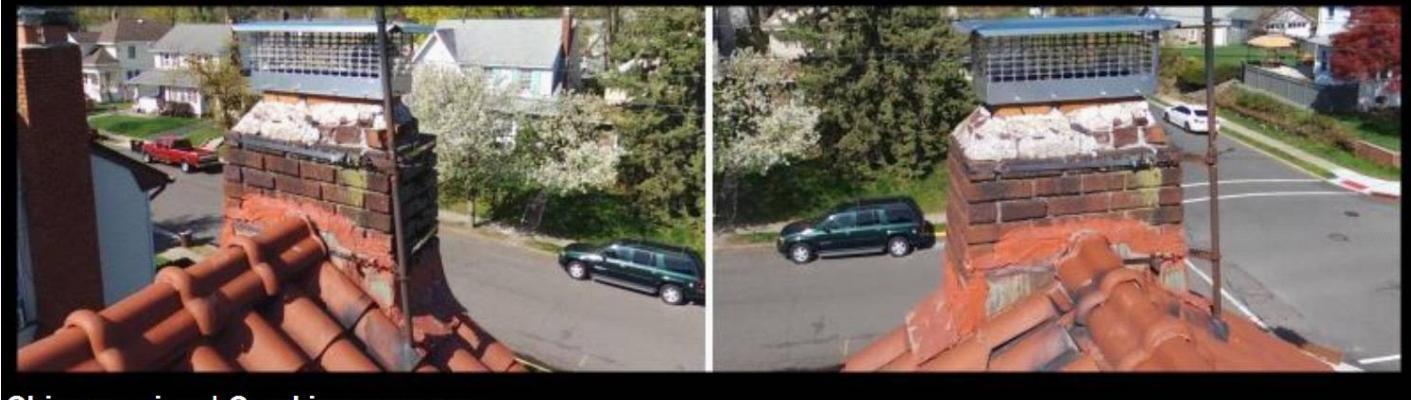
# 4.11 CHIMNEY CONDITION:

The masonry chimney is in some aspects, unsatisfactory condition (material defect). Deficiencies include, but may not be limited to the following: **There is cracking of the masonry structure.** Cracks could also be present inside the structure, which could represent a fire condition. The cracks could be a source of water leakage through the structure. This is common above the roof line where the materials are exposed to severe weather. Nonetheless, repair is recommended. **The ash clean-out door is not properly sealed and therefore, does not function properly.** Hot embers or ash can be swept from the fireplace to the "pit" at the bottom of

# Chimney view | Cracking masonry

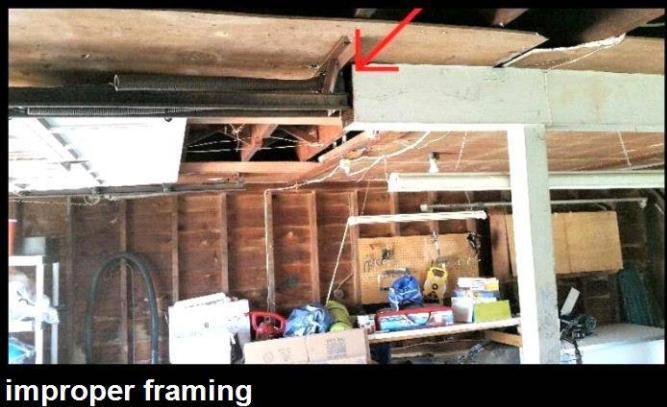
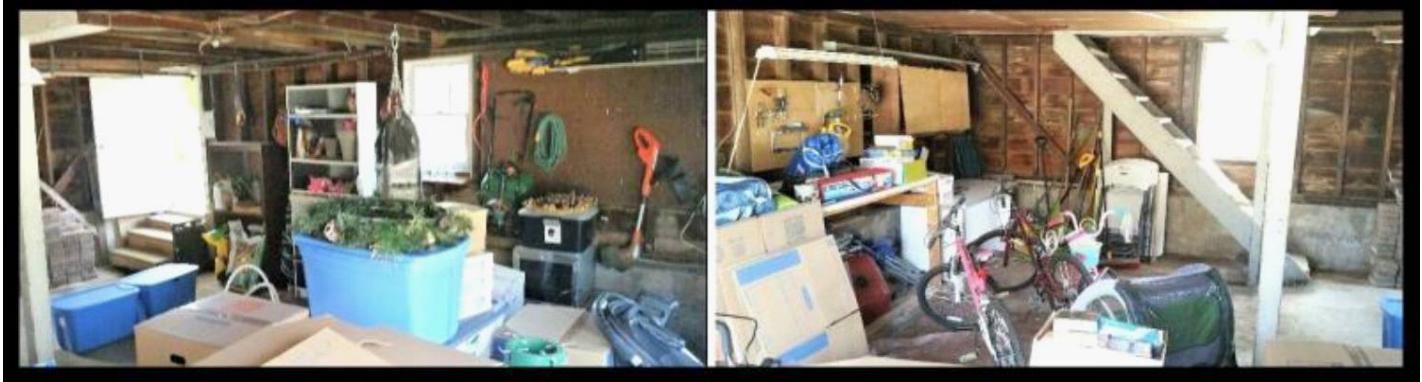
# 5.1 GENERAL CONDITION:

**unsatisfactory condition.** Deficiencies include, but are not necessarily limited to the following: There is contact between the garage siding and the soils. This condition has caused rot and probably wood destroying insect (termite) infestations/damage. The windows are in poor condition. Replacement is recommended. There are indications of pests. This is indicated by droppings in the area. Contact an exterminator in this regard. There is cracking of the foundation, which should be repaired. There is apparent water leakage into the garage from the exterior. This leakage has he extent of the defect and the necessary repairs. **There**

caused rot. Contact a competent contractor to evaluate the extent of the defect and the necessary repairs. There is improper framing of the garage structure; which weakens the structure. The system may not perform as intended or at optimum performance. A competent contractor should be contacted to more thoroughly evaluate these "material defects"/conditions and to perform repairs as necessary.

# Personal property prohibits full view

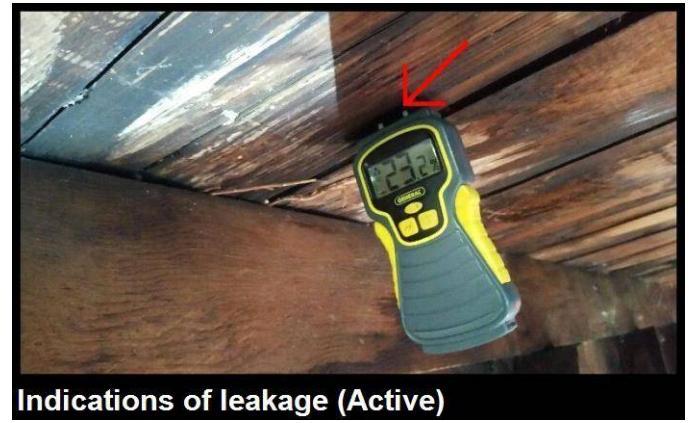
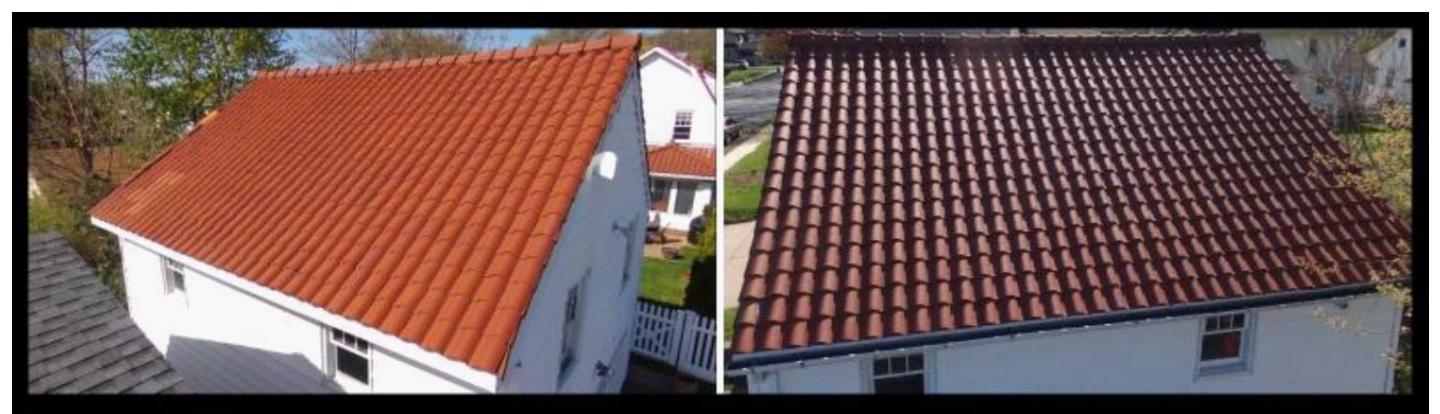
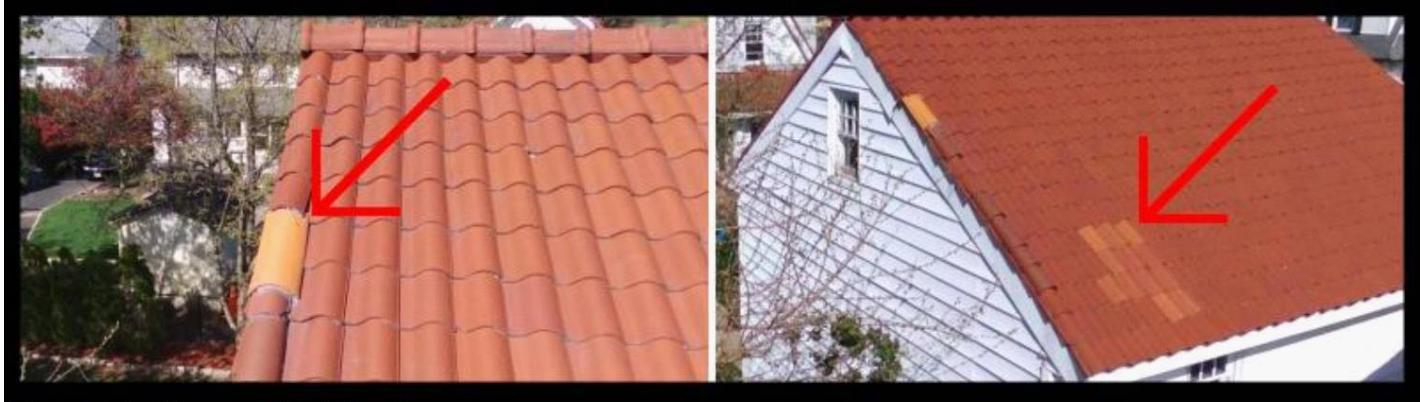
5.2 ROOFING MATERIALS/ CONDITION:

The roofing is in unsatisfactory condition. Deficiencies include, but are not limited to the following; **The roof decking/sheathing is rotted. The roofing on the garage is leaky.** Repair/replacement is recommended.

#### Repairs to the roof (Patched)

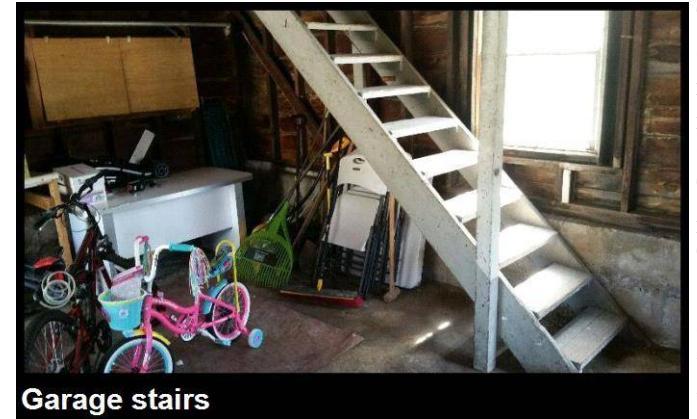
#### 5.4 STAIRS CONDITION:

The steps are in some aspects, unsatisfactory condition. The stringers are separating, which could result in staircase collapse and injury. There are no railings installed adjacent the stairs. This configuration would not comply with modern building standards. The stairs have loose components, which should be repaired. The riser/ tread dimensions are not uniform. The condition would not comply with modern building standards. The condition represents a potential tripping condition. Exercise caution and care when traversing the steps. A competent contractor should be contacted to more thoroughly evaluate these "material defects"/conditions and to perform repairs as

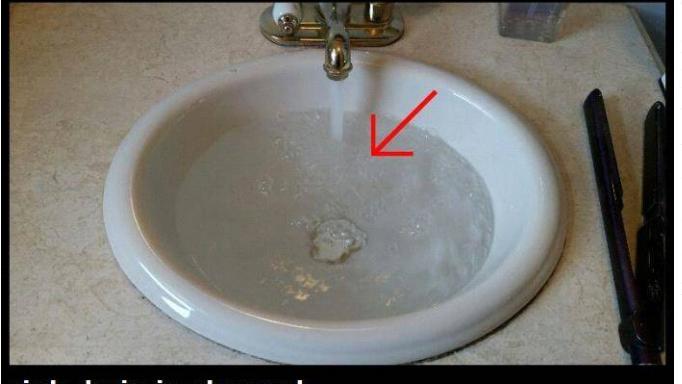
# 8.11 FAUCET, SINK AND DRAIN LINE

The faucet, sink and drain lines are in need of maintenance. Deficiencies include, but may not be limited to; The sink drain is clogged, which limits the use of the fixture. The flexible accordion drain below the sink should be replaced as this component is vulnerable to clogs. A competent contractor should be contacted to more thoroughly evaluate these "material defects"/conditions and to perform repairs as necessary.

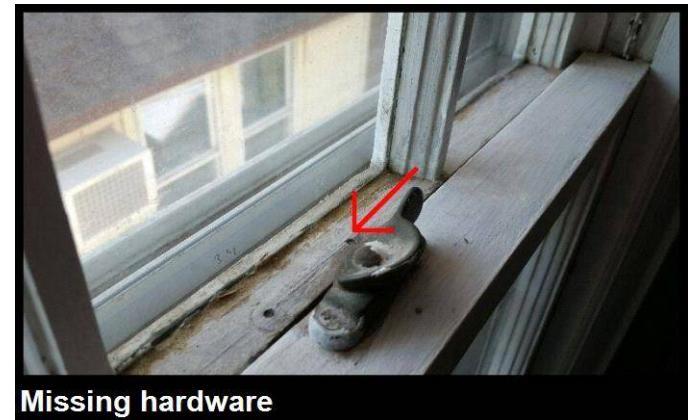
#### **10.6 CONDITION:**

The windows are in some aspects, unsatisfactory condition. Deficiencies include, but are not necessarily limited to the following: **Broken/cracked window(s) were observed.** This is common in older homes with single pane glass. The cracks normally do not result in significant heat loss and for this reason, are left "as-is" frequently. Replacement is easy and relatively inexpensive. **Some windows are stuck in the closed position rendering them inoperable.** This may create a safety concern regarding egress. Sometimes this occurs when the windows have been painted in the closed position. Windows should be restored to proper working condition. **Some window sash cords/chains**

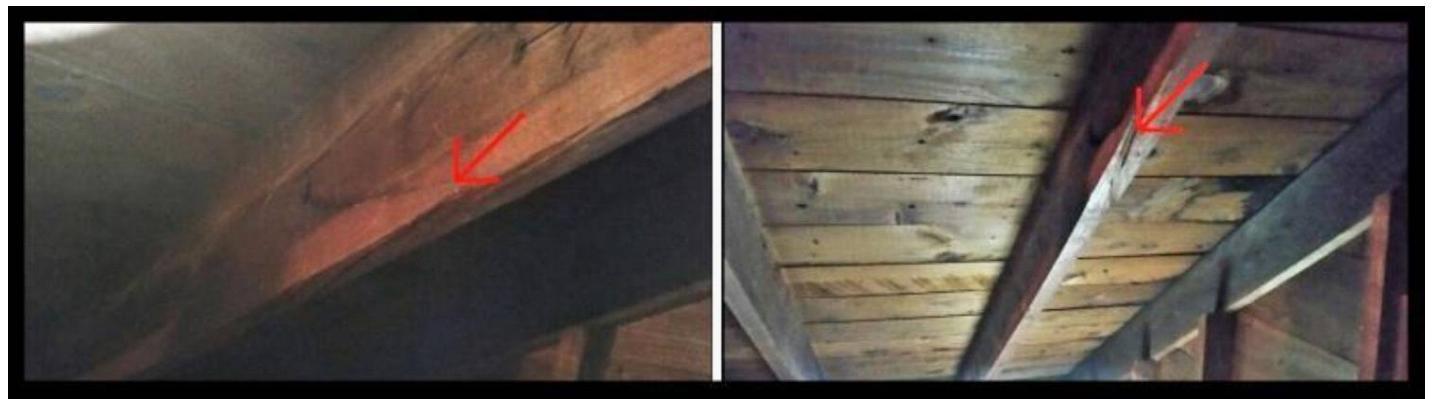
#### Cracked Rafter

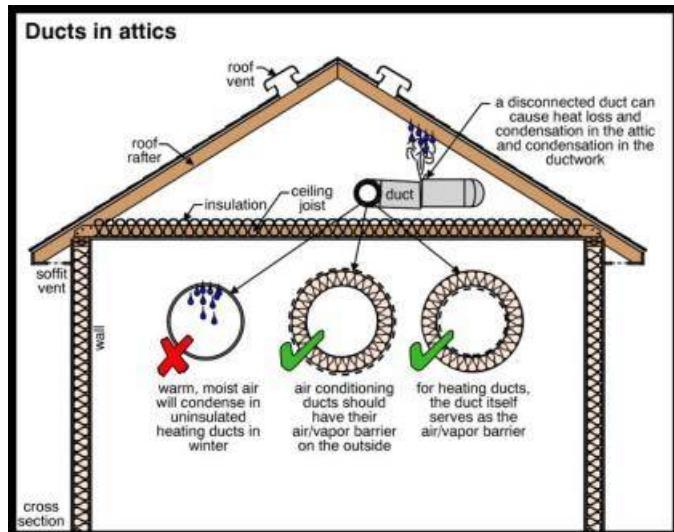
#### 11.10 DUCTWORK:

The insulating material on the flex ducting does not cover portions of the metal register box. This shortcoming may allow cool conditioned air to form condensation on the metal box during the warm, summer months and possibly allow warm conditioned air to leak during the colder winter months. Have the insulation properly installed for improved efficiency and to alleviate potential for water damage. A licensed HVAC contractor could best evaluate the condition. <u>HVAC ducts are loose and leaking in the attic area.</u> The condition indicates the need for maintenance. The complexity and the cost of this work is un-determined.

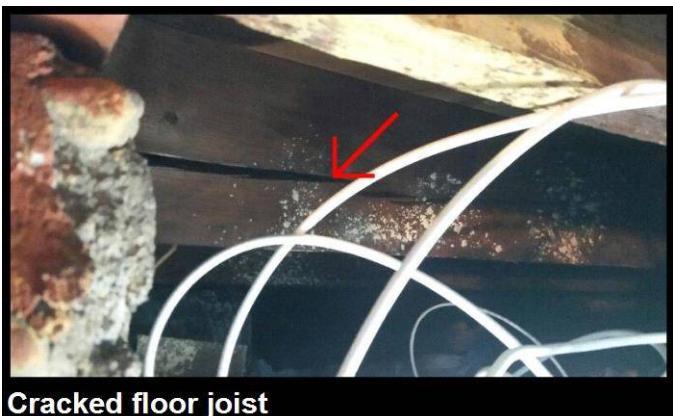
12.2 STRUCTURE:

There is cracking of the floor joists, which weakens the structure. A competent contractor should be contacted to more thoroughly evaluate this "material defect"/condition and to perform repairs as necessary.

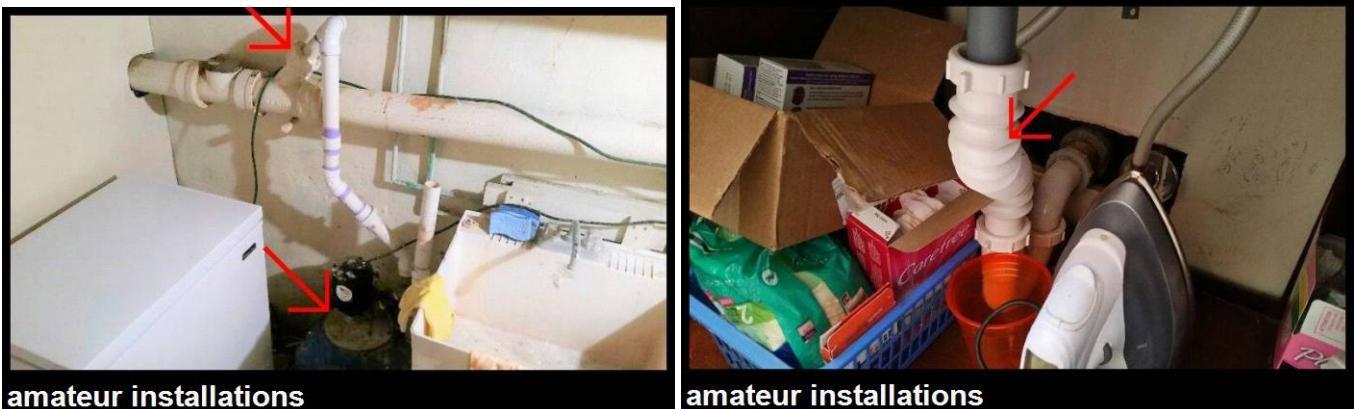
The plumbing system is in unsatisfactory condition. Deficiencies include, but may not be limited to the following; There are leaky plumbing fixtures. There are amateur installations, which may prove to be un-reliable. The plumbing system is older, but has been partially upgraded. Future upgrades and repairs should be anticipated. Consideration should be given to obtaining bids from a licensed Plumber to upgrade the home's plumbing system.

amateur installations

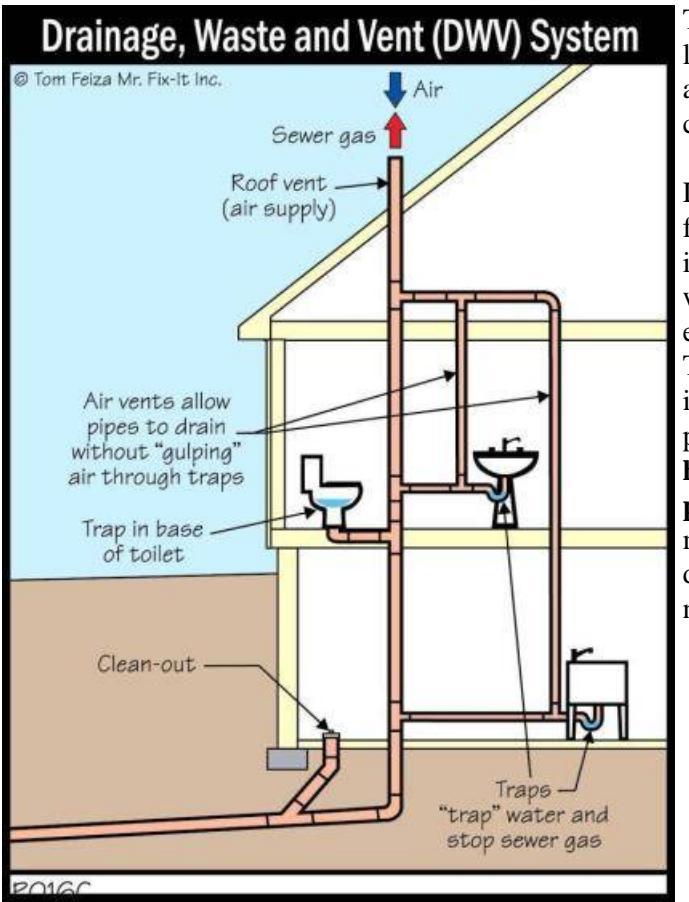
#### 13.7 WASTE PIPE SYSTEM:

The plumbing system includes; PVC, ABS (plastic), lead, galvanized, and iron piping. The waste piping appears to be in some aspects, unsatisfactory condition.

3. Due to the age and overall condition of this system/component, It is suggested that the interior of the waste piping be inspected by a licensed plumber, possibly utilizing a video camera from the house to the street connection.

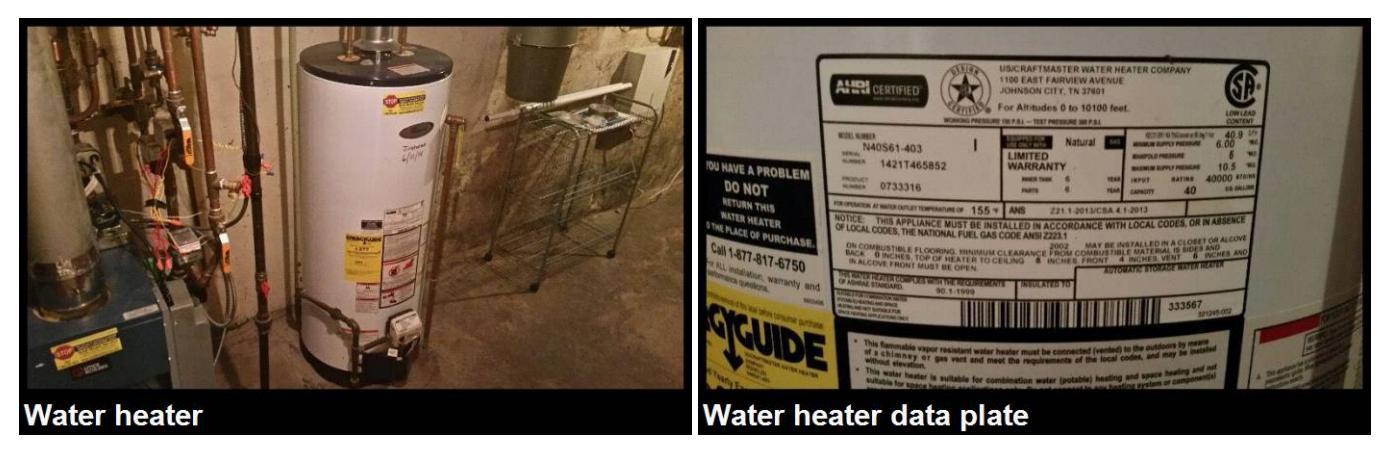
The water heater is in some aspects, unsatisfactory condition. Deficiencies include, but are not necessarily limited to the following; The pipes coming to the unit are corroded indicating a past/present leak. Replacement is recommended.

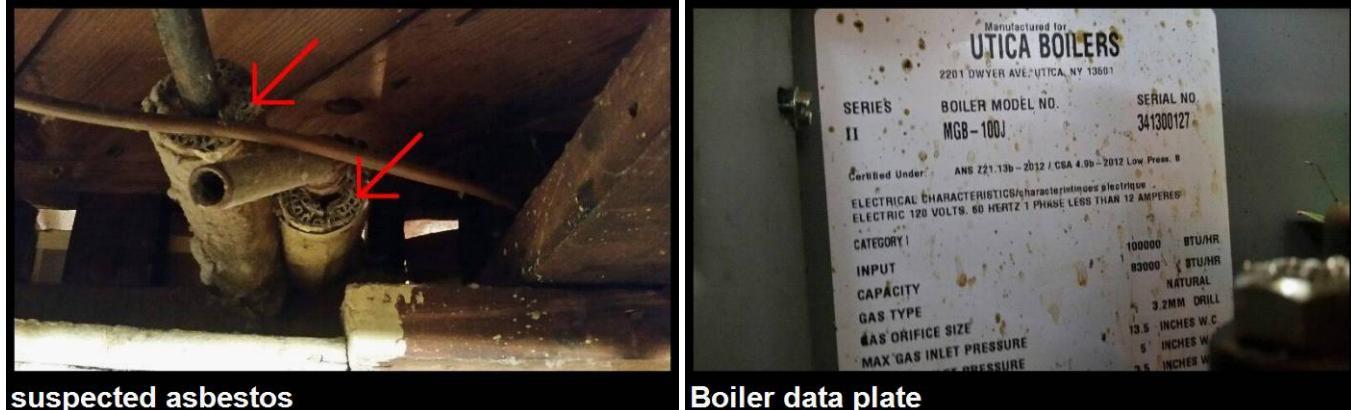
The boiler (heating system) is in need of maintenance. Deficiencies include, but are not necessarily limited to the following; The old pipes have suspected asbestos insulating material on them. The amount and extent of the suspected asbestos installation is undetermined. A qualified and licensed asbestos abatement specialist should be consulted to determine whether or not the suspected material is asbestos, the extent to which the material is installed throughout the house and to perform repairs/removal/remediation. NOTE: Asbestos is a controversial installation. Complete information concerning asbestos should be obtained from the NJDEP. Methods and recommendations vary depending upon the application, and may change with time as well. Only DEP officials can provide complete up to date information in this regard. The DEP will also provide a list of certified contractors to implement their recommendations.

suspected asbestos

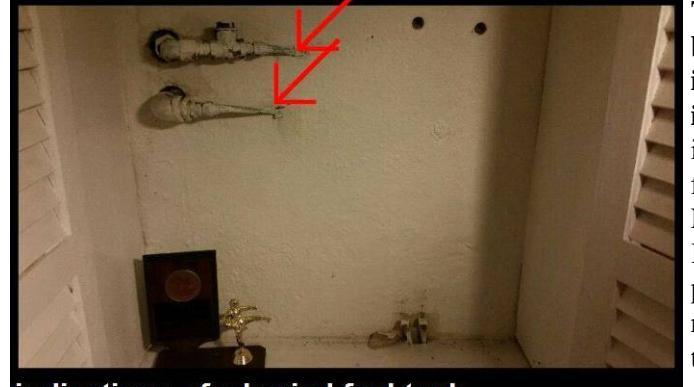
#### 15.5 REMARKS:

indications of a buried fuel tank

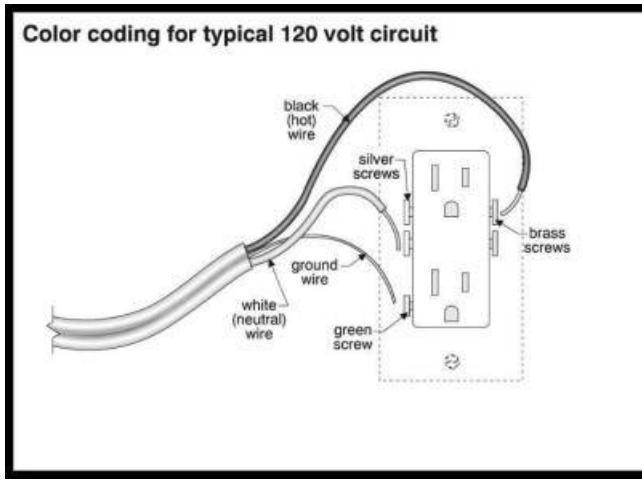
#### **17.9 RECEPTACLE GROUNDING**

Ungrounded outlet/s detected, which is considered potentially unsafe. Most outlets installed since the middle 60's have been the grounded type, having three holes for each outlet. Grounding is a reliability/safety feature which is part of the electrical system that should be properly maintained. Where testing of outlets shows no ground connection is present, the problem generally can be traced to a loose wire in the receptacle box or in the electrical panel and sometimes is easily corrected. In this case, it is possible that the cause of the un-grounded outlets is the use of old, antiquated knob and tube conductors. Contact a qualified electrician to determine whether or not these conductors are installed. If knob and tube conductors

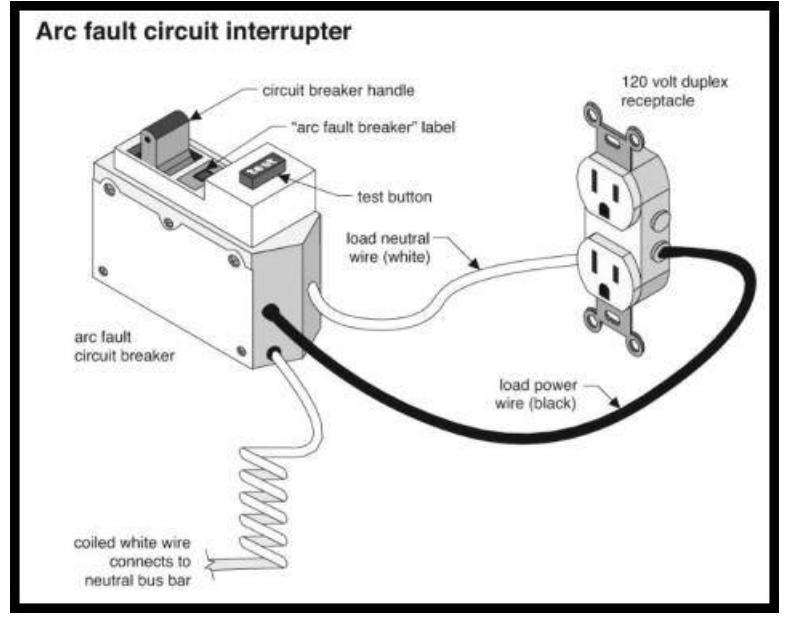
# 17.13 AFCI PROTECTION:

The electrical system does not have Arc Fault Circuit Interrupter (AFCI) protection. The installation of these safety components may not be required in existing structures, but should be considered as part of up-grading the electrical system and improving safety.
