# HOME INSPECTION REPORT

Home Inspector License # 24GI 153000 ASHI Certified Inspector 262871 KAUFMANN CONSULTANTS, LLC 17 Cook Avenue, P. O. Box 1222 Madison, New Jersey 07940 (973) 377-4747 FAX (973) 377-7755 www.KaufmannConsultants.com

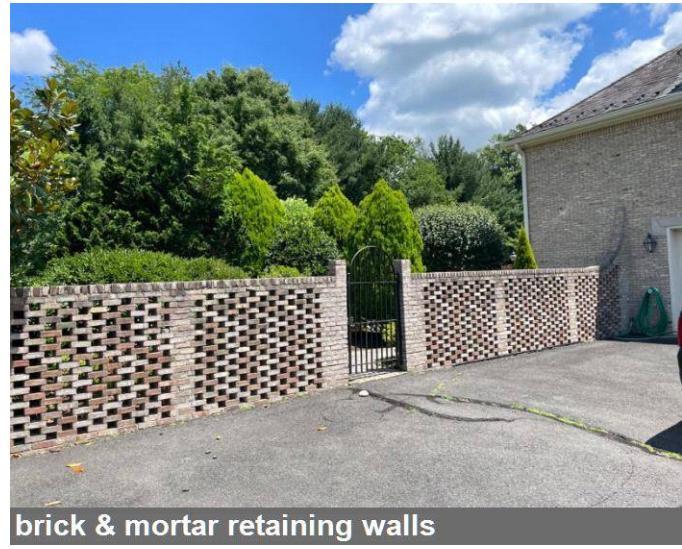
#### 2.2 RETAINING WALLS:

The brick & mortar retaining walls appear unsatisfactory. There are no visible "weep" holes to drain the soils behind the walls. This shortcoming could allow hydrostatic pressure to build and damage the walls. Install drains to alleviate the adverse affects of this condition. There is cracking/deteriorated masonry. A qualified contractor should be contacted to evaluate the walls and perform necessary repairs.

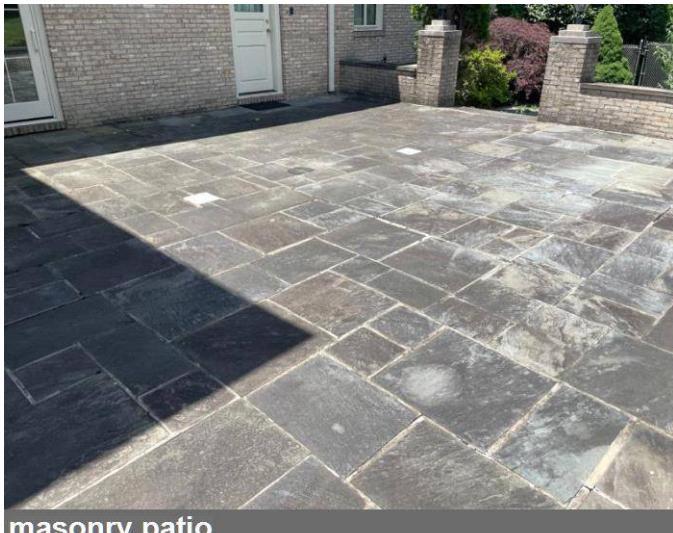
#### 2.8 PATIO:

The masonry patio is in some aspects, unsatisfactory condition. Deficiencies include, but may not be limited to; There are low points/depressions where water will accumulate during adverse weather conditions. Have the areas re-leveled for improved drainage. There are cracks that have developed in the patio. These cracks could result in raised edges and un-even surfaces, which may represent a tripping concern. Have the cracks repaired as necessary.

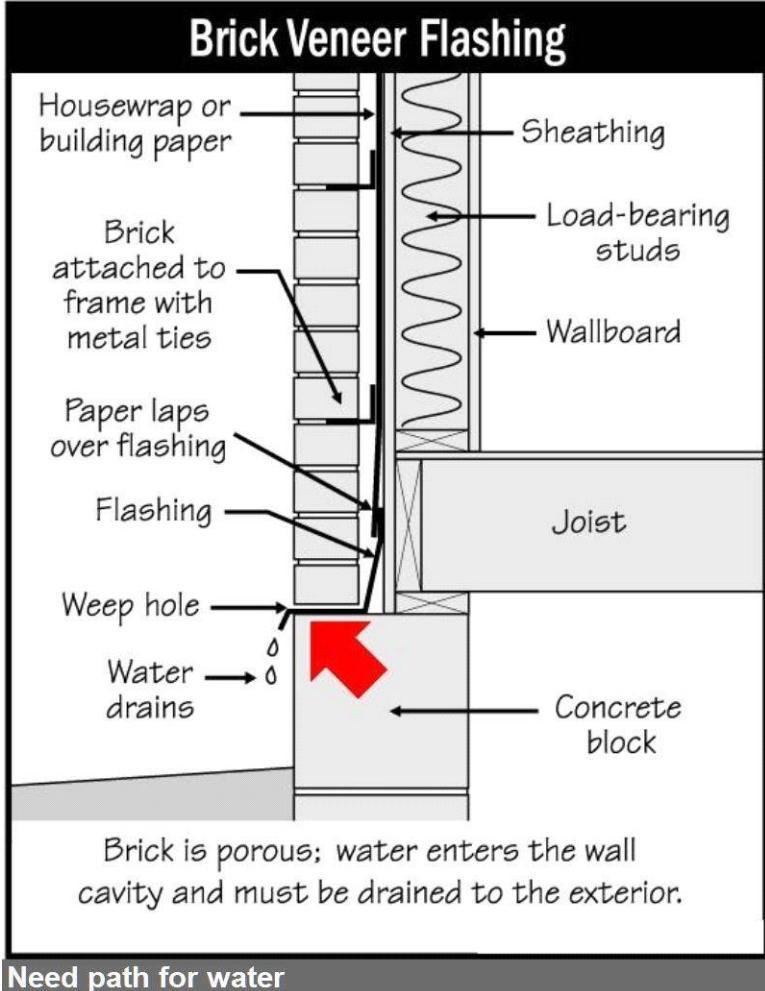
# **3.2 WEEP HOLES**

The required weep holes were not installed by the mason. The lack of weep holes (and flashings) prevents moisture that enters in behind the brickwork and condensation that forms under the veneer a path for escape. The underside of the veneer cannot be viewed at this time to verify if there is any moisture damage.

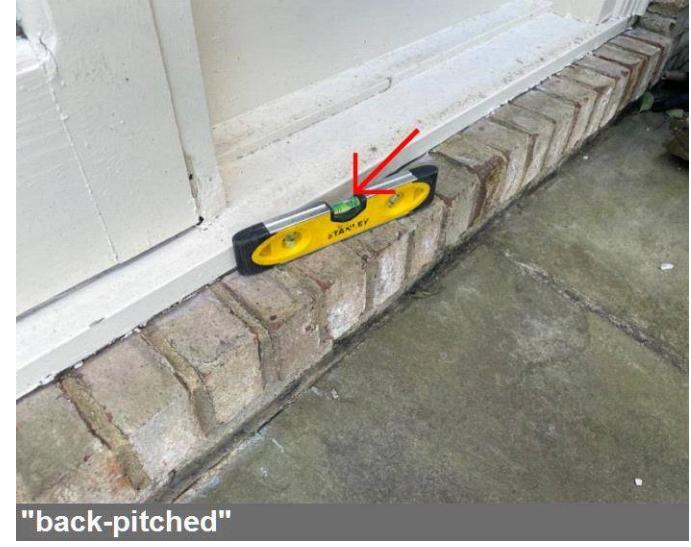
3.3 WINDOW INSTALLATION

In this case, this dynamic movement has caused the sills to be "back-pitched", which can allow for leaks through the wall system. Leaks through the wall system could cause rot/mold.

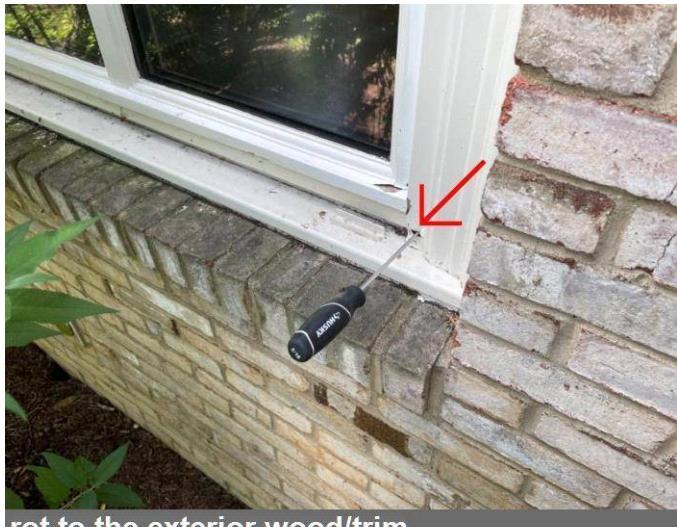
# 3.7 MOLDINGS & TRIM CONDITION:

The exterior trim/wood is in need of maintenance. Deficiencies include, but are not limited to the following; There is rot to the exterior wood/trim. Areas of rot include, but may not be limited to; Roof trim and adjacent doors/windows. Proper care to the home's exterior includes replacement of rotted pieces and periodic re-painting and caulking to protect the wood from the elements. Budget for this contingency. There are gaps between the trim components at roof edges. This is a concern because sometimes pests can enter the structure through these small gaps. Repair and/or replace any defective wood.

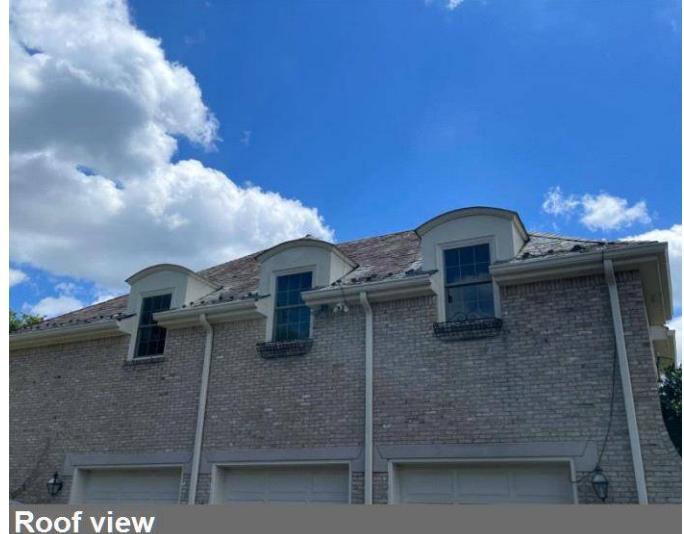
#### 4.3 ROOF COVERING CONDITIONS:

The slate roof is an older installation and is in some aspects, unsatisfactory condition, which represents a possible "material defect." There are cracked, loose and missing slates, which could result in leaks. This is an indication of inadequate maintenance or recent damage. Replacement of defective slates is recommended. There is shaling/scaling of the slate surfaces. This is the result of normal wear and tear, but also indicates that these deteriorated slates have reached the end of a normal serviceable life. Replacement of these slates is recommended. There is "tuck pointing" of the slates. This is the installation of metal flashings under slates that are suspected of being a leak problem. This is commonly done during the colder/wetter seasons when complicated slate roof repairs are difficult and expensive. Tuck pointing is only a "temporary" solution

Permanent repairs likely include replacement of defective slates, which is expensive. Permanent repairs should be undertaken as soon as possible and preferably, prior to the end of the inspection contingency period. The roof shows signs of active leakage indicating the need for immediate repair. There is moss mold and fungus forming on the old slates. This condition is primarily due to inadequate roof venting. Cleaning is expensive, but generally restores much of the slate's beauty. NOTE: Repair of slate roofs can be expensive. For this reason, estimates for repair should be obtained prior to the end of the inspection contingency period. Contact a competent slate roofing contractor to evaluate the conditions and to perform repairs as necessary.

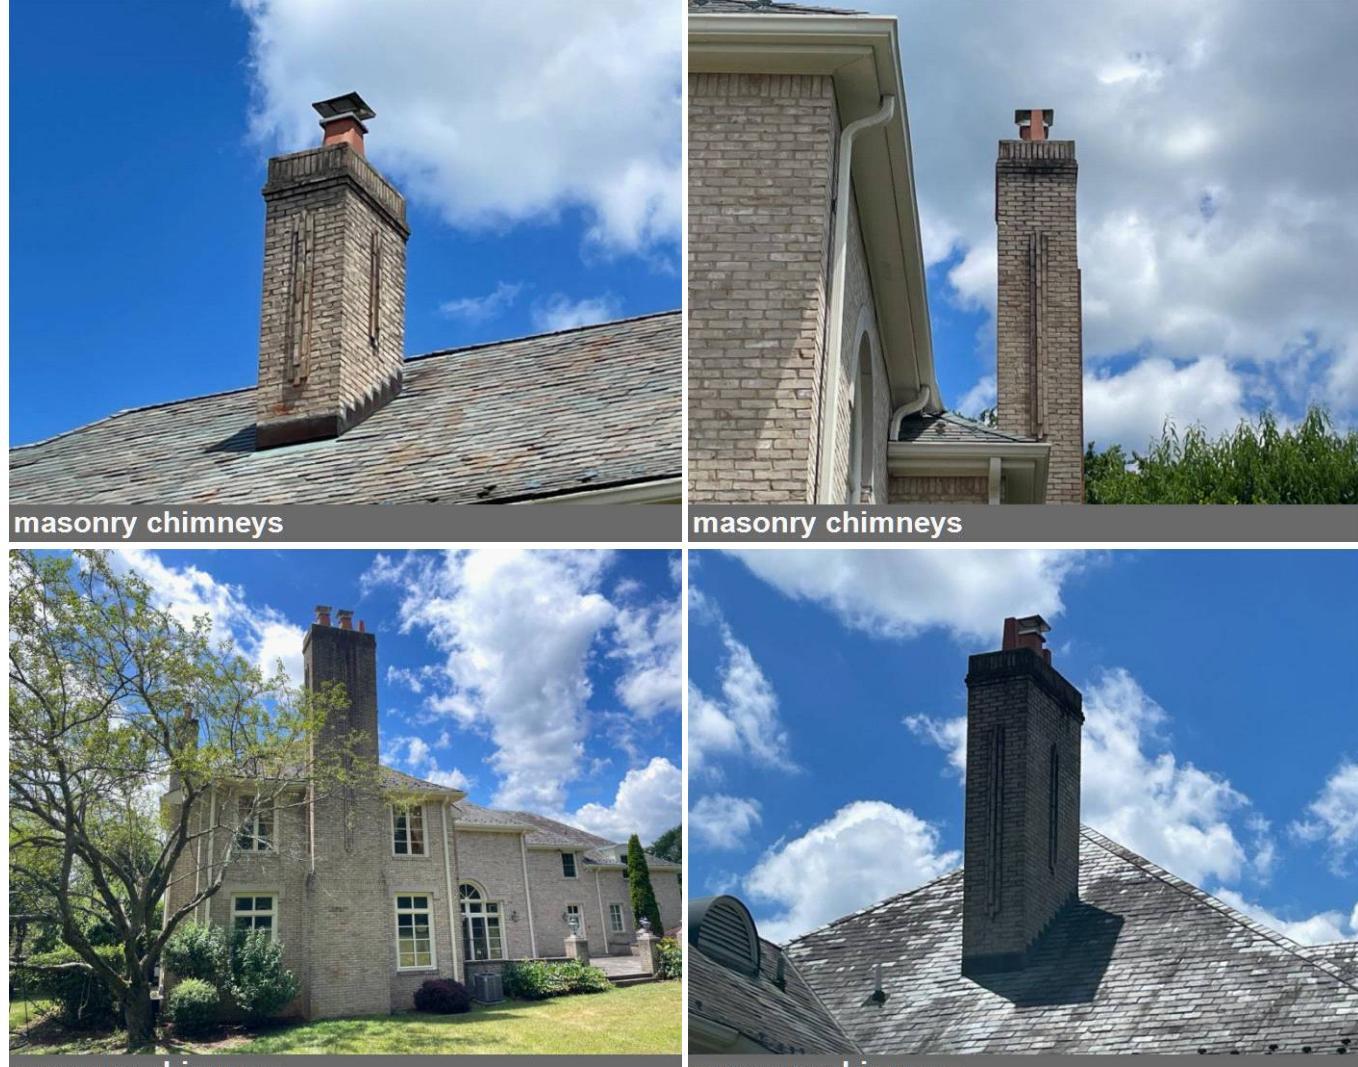
# CHIMNEY(S)

There is cracking of the masonry structure. Cracks could also be present inside the structure, which could represent a fire condition. The cracks could be a source of water leakage through the structure. This is common above the roof line where the materials are exposed to severe weather. Nonetheless, repair is recommended. The ash pit door is inaccessible (blocked), which restricts function. The wood form boards that were utilized for construction of the masonry hearth (adjacent the fireplace), and are visible from below, should be removed to alleviate potential for a fire condition. There is leakage through the chimney to the basement. The chimney is equipped with caps that appear to be secure. The caps are beneficial in that they can minimize water intrusion and restrict access to the chimney interior by pests. The chimney serves the fireplace. It is suspected the chimney flue that carries the exhaust out of the home may be inadequately sized. The significance of this condition is; The configuration could allow toxic exhaust to spill into the living spaces, which creates an unsafe condition. A licensed, Certified Chimney Sweep, contractor should be contacted to calculate the flue capability and to make repairs as necessary.

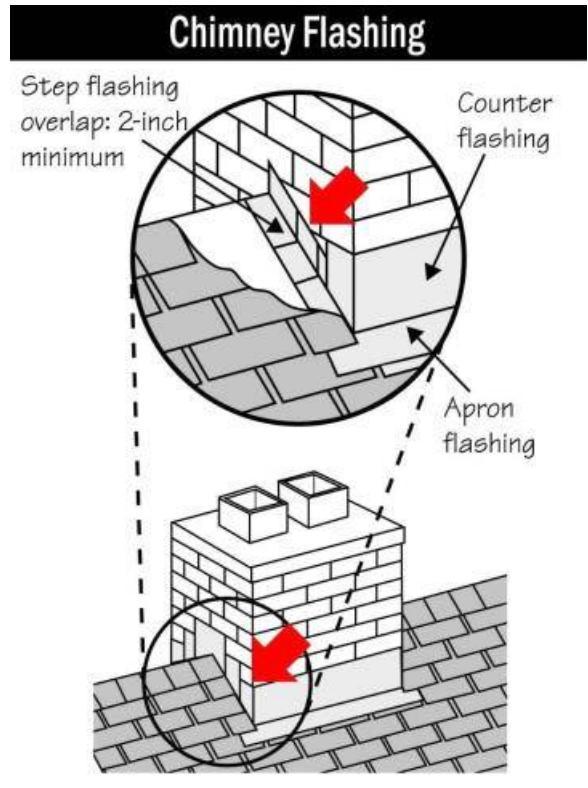
#### 4.9 ROOF FLASHING:

The application of mastic suggests past water intrusion. The nature and scope of repairs should be discussed with the present home-owner and the repairman, who performed the repair.

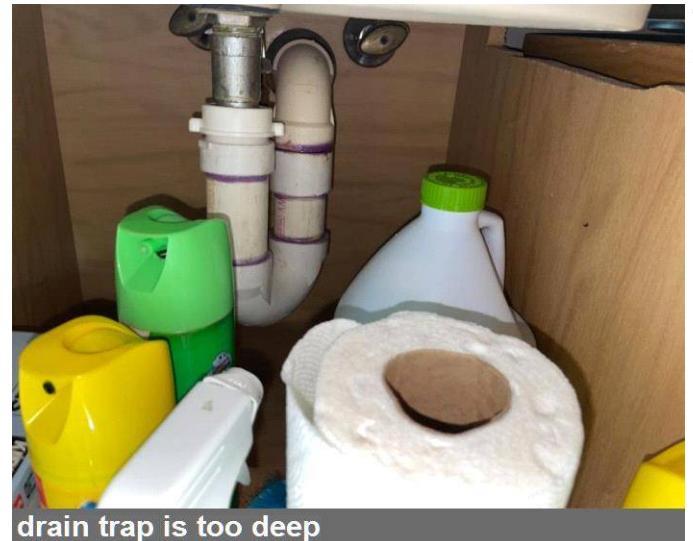
#### 9.16 FAUCET, SINK AND DRAIN LINE

The faucet, sink and drain lines are in need of maintenance. The drain trap is too deep, which can adversely affect drainage/function. This configuration would not comply with modern building standards.

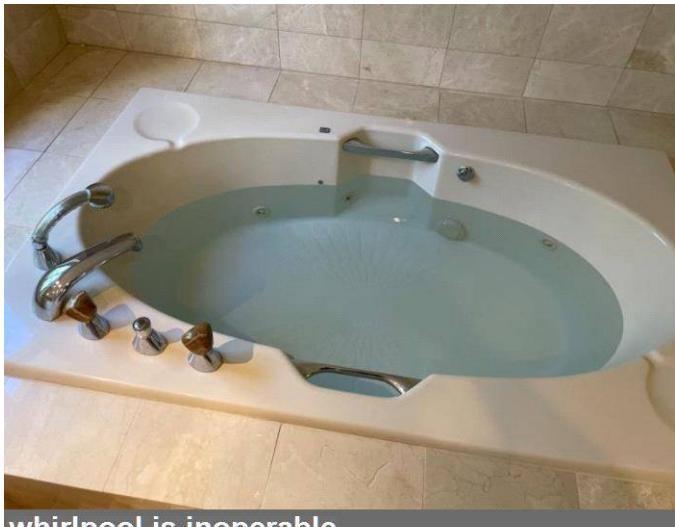
## 9.17 TUB AND SHOWER

The shower is in need of repair. The shower floor is cracked. The significance of this condition is; leaks may result. The water valve(s) are malfunctioning, which restricts function. Replacement is recommended. <u>The whirlpool is inoperable. \* NOTE: The whirlpool tub</u> was filled with water and was unable to be activated.

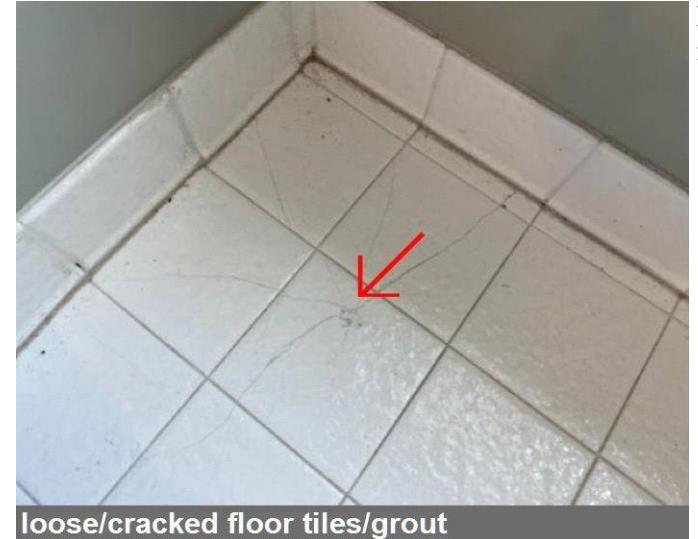
# 9.27 FLOOR, WALL AND CEILING SURFACES

Floor, wall and ceiling surfaces are in need of maintenance. There are loose/cracked floor tiles/grout.

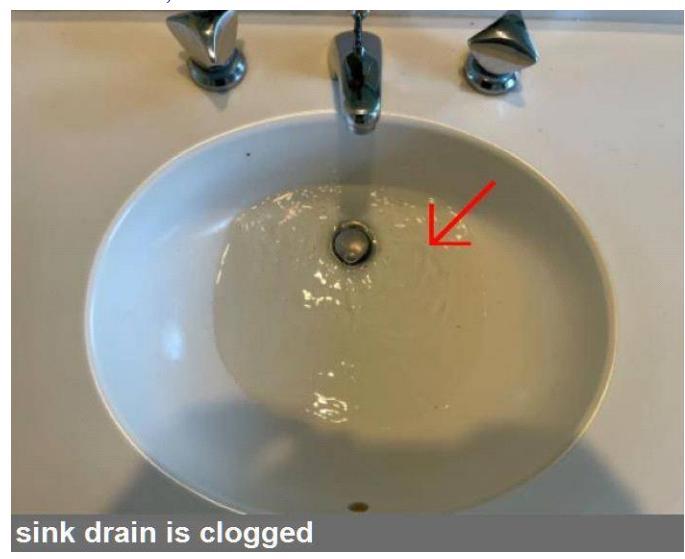
9.28 FAUCET, SINK AND DRAIN LINE

The faucet, sink and drain lines are in need of maintenance. The sink drain is clogged, which limits the use of the fixture. The condition indicates the need for maintenance/repair.

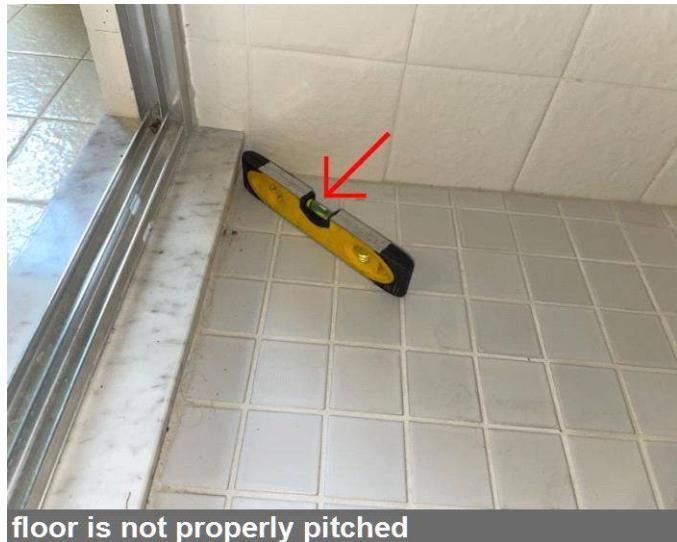
# 9.29 TUB AND SHOWER

The shower is in need of repair. Deficiencies include, but may not be limited to the following; The shower floor is not properly pitched. Water ponds on the shower floor after use. The configuration would not comply with modern building standards. The significance of this condition is; This could cause pre-mature failure (leaks) of the shower floor. A competent contractor should be contacted to more thoroughly evaluate the condition and to perform repairs as necessary.

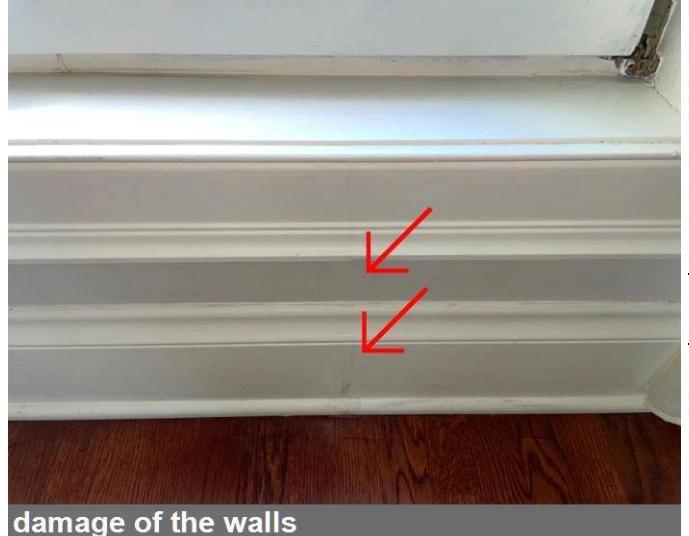
## 11.1 WALLS/CEILINGS:

There are numerous visual defects/conditions that indicate the need for routine maintenance (tape, spackle, priming, painting, etc..) NOTE: Repairs to address the underlying causes of the visual defects may prove to be more complicated and expensive to repair. There are nails popping through the surfaces indicating the need for repair. There is staining/damage of the walls/ceilings from leakage. Water leakage can cause mold. Have the source of the leak identified and the problem repaired as necessary. Cracking/tearing of the old, gypsum walls/ceilings is noted and believed to be mostly a reflection of normal wear and tear as well a settling of the old wood frame components of the home.

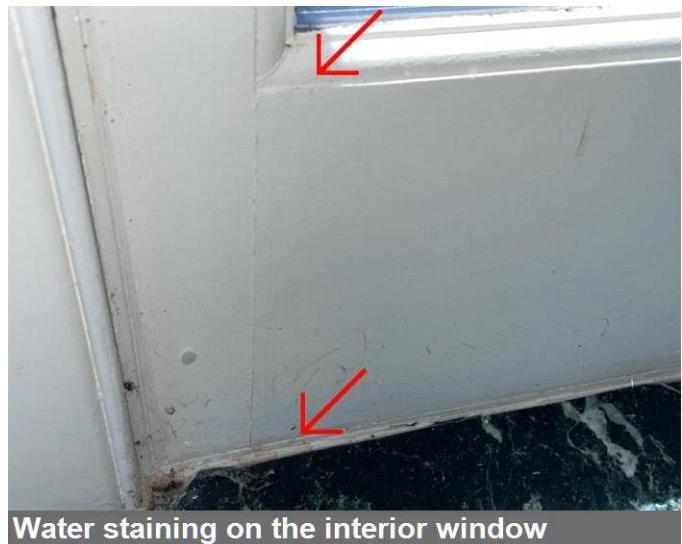
#### 11.6 CONDITION:

The windows are in some aspects, unsatisfactory condition. Deficiencies include, but are not necessarily limited to the following: Some windows are stuck in the closed position rendering them inoperable. This may create a safety concern regarding egress. Sometimes this occurs when the windows have been painted in the closed position. Windows should be restored to proper working condition. Leaky thermo-seals were noted. The identification of bad thermo-seals is beyond the scope of this visual evaluation because the defect is difficult to discover under some weather conditions. Defective windows may be visible today and not visible tomorrow. The defect manifests itself as a cloudy obstruction in the glass creating a cosmetic defect, but could also result in leakage through to the interior. In addition, the thermal performance of the window is degraded. As a courtesy I

have identified the obvious bad seals that were identified during the inspection. Repair is normally more expensive than replacement. The window hardware is inoperable. Replacement is recommended. Water staining on the interior window surfaces indicates leakage that should be repaired. A competent contractor (specialist) should be contacted to more thoroughly evaluate these "material defects"/conditions and to perform repairs as necessary.

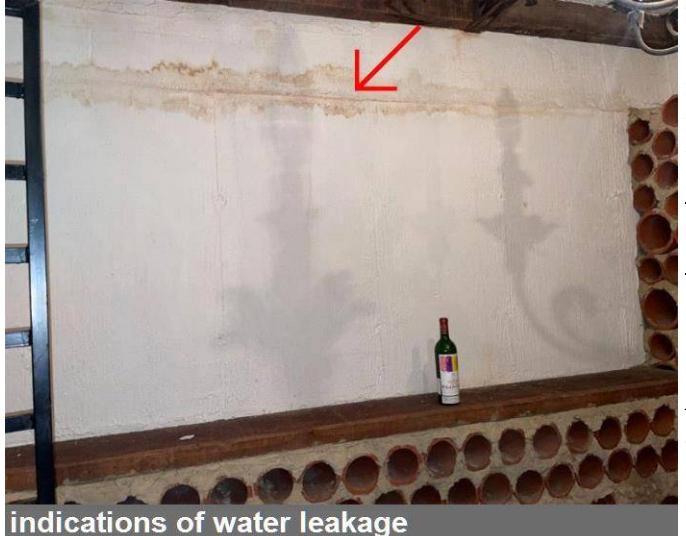
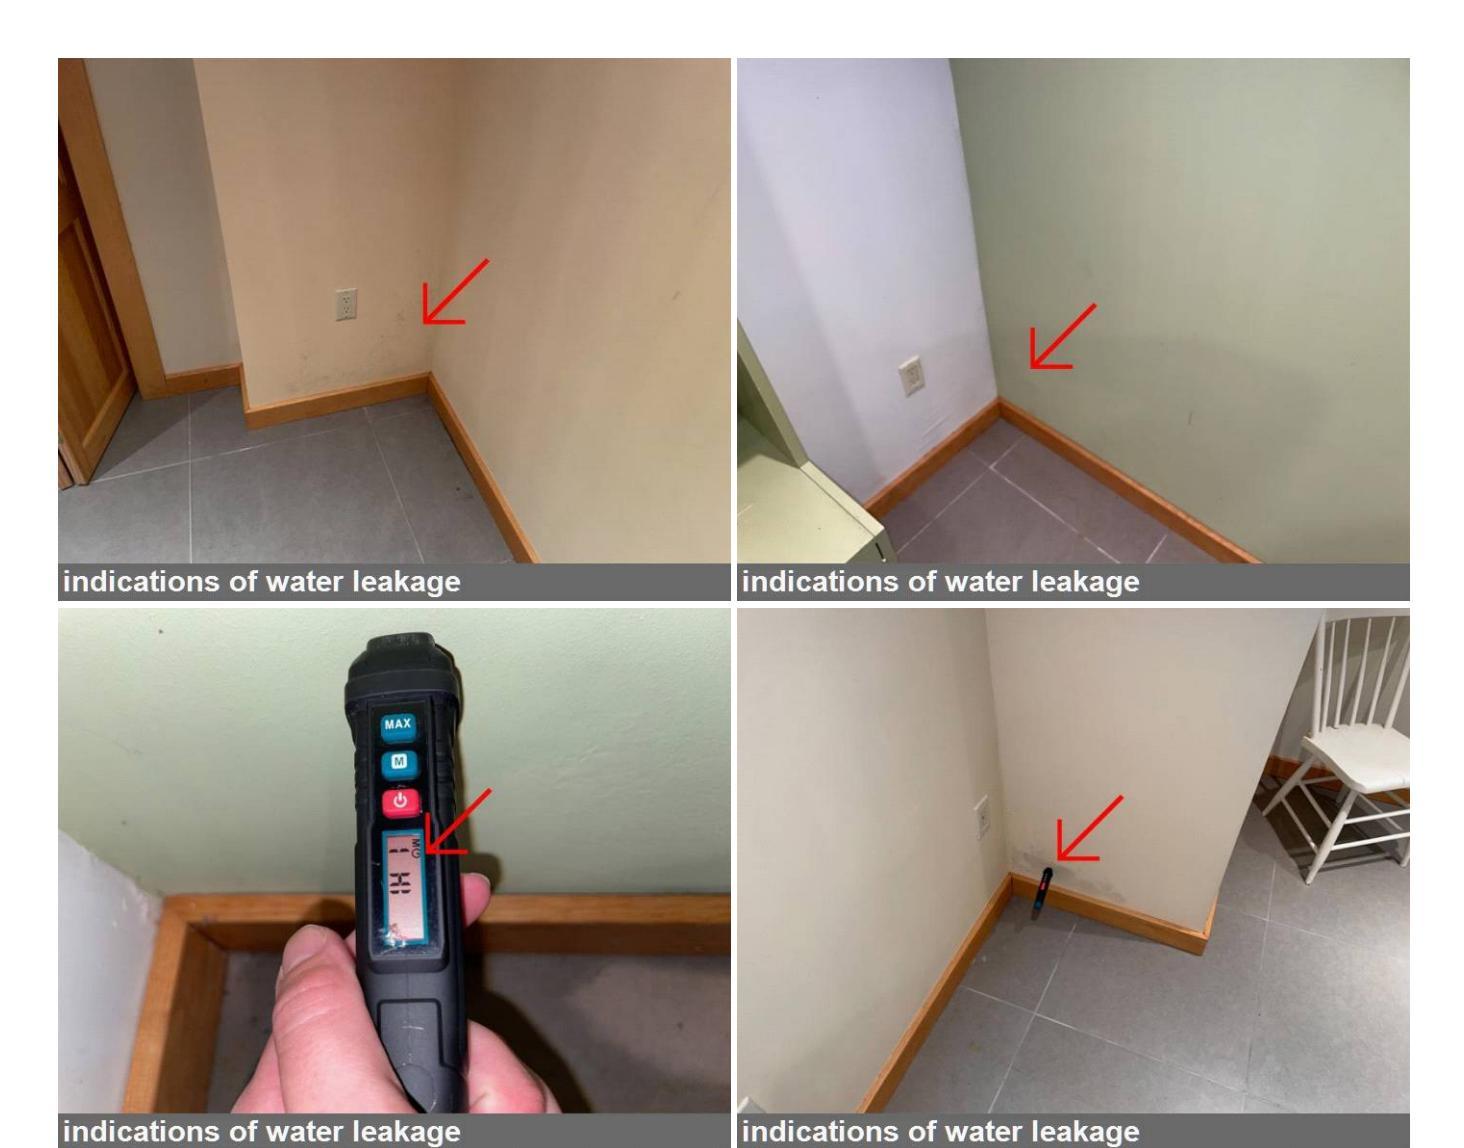
#### 13.6 MOISTURE:

The inspection for water conditions is dependent upon seasonal weather conditions. It is possible that the interior of the home could appear dry during the home inspection, but later develop water conditions. At this time, there are indications of water leakage through the foundation walls into the basement area, which is a "material defect". Indications are in the form of water stains/efflorescence on the floor/walls, suspected mold on the interior walls, rot of the walls, and a musty/damp smell.

indications of water leakage

8. If these measures have been taken and water penetration conditions persist, further interior and exterior masonry work may be required. In that case, it is recommended that a an architect and a contractor specializing in that type of improvement be contacted.

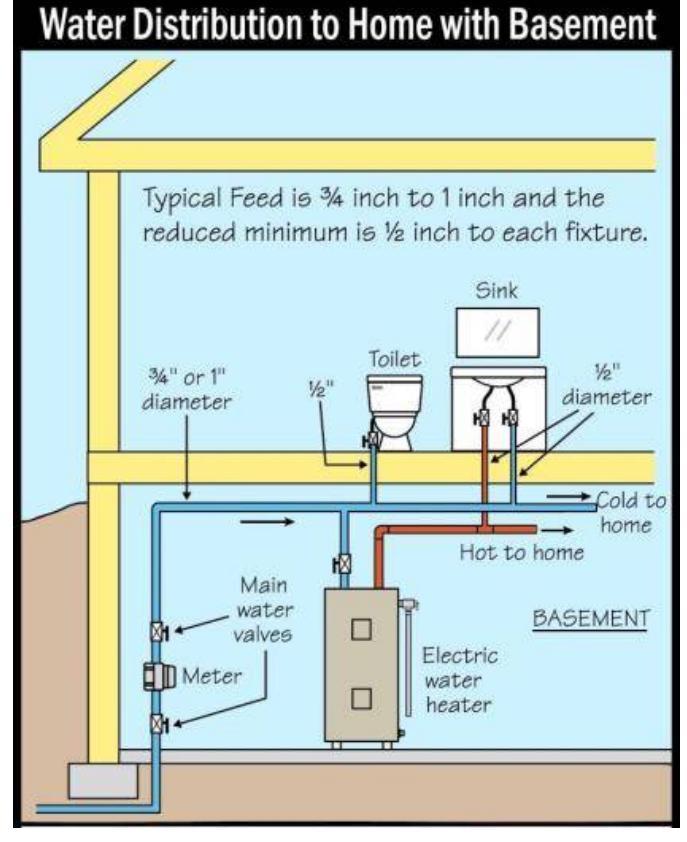
There is "pinhole" leakage from some of the piping. These pipes should be replaced. There are old corroded isolation valves/pipes. These are leak-free at this time, but may leak when operated. Eventual replacement should be anticipated. There is condensation forming on the water pipes. Condensing water could contribute to high levels of humidity inside the house and also cause water damage. The condition is normally alleviated by insulating the water pipes, which is easy and normally inexpensive. A competent contractor should be contacted to more thoroughly evaluate these conditions and to perform repairs as necessary.

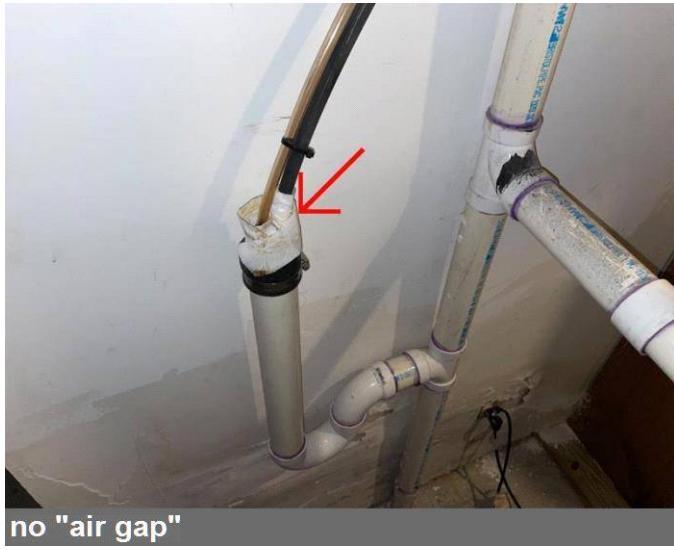
# 14.11 OTHER:

The condensate discharge connection to the sewer pipe has no "air gap", The configuration would not comply with modern building standards. The significance of this condition is; the "air gap" is required to isolate the air supply components from any direct contact with waste piping components. Such contact could contaminate the drinking water components.

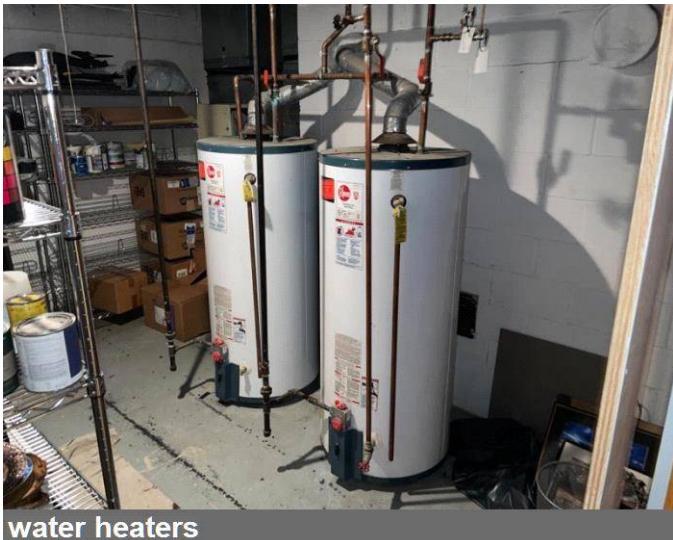
# **15.5 VISUAL CONDITION:**

The water heaters are in some aspects, unsatisfactory condition. Deficiencies include, but are not necessarily limited to the following; The pipes coming to the unit are corroded indicating a past/present leak. The water heaters are older units that have functioned beyond what would be considered a normal serviceable life. Replacement should be anticipated.

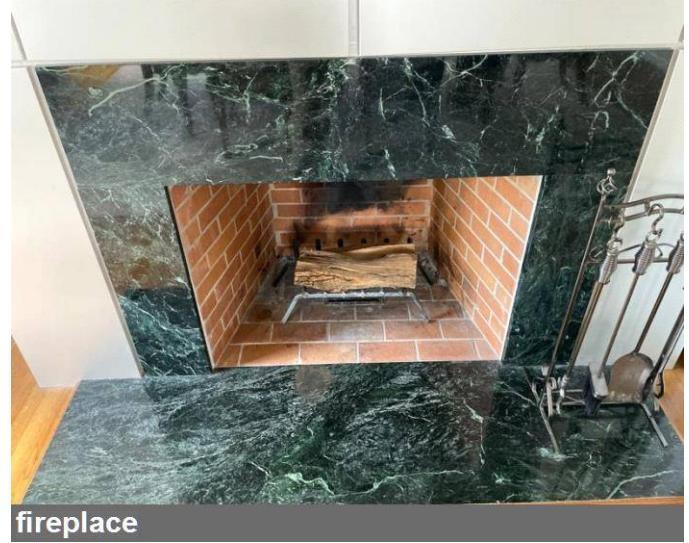
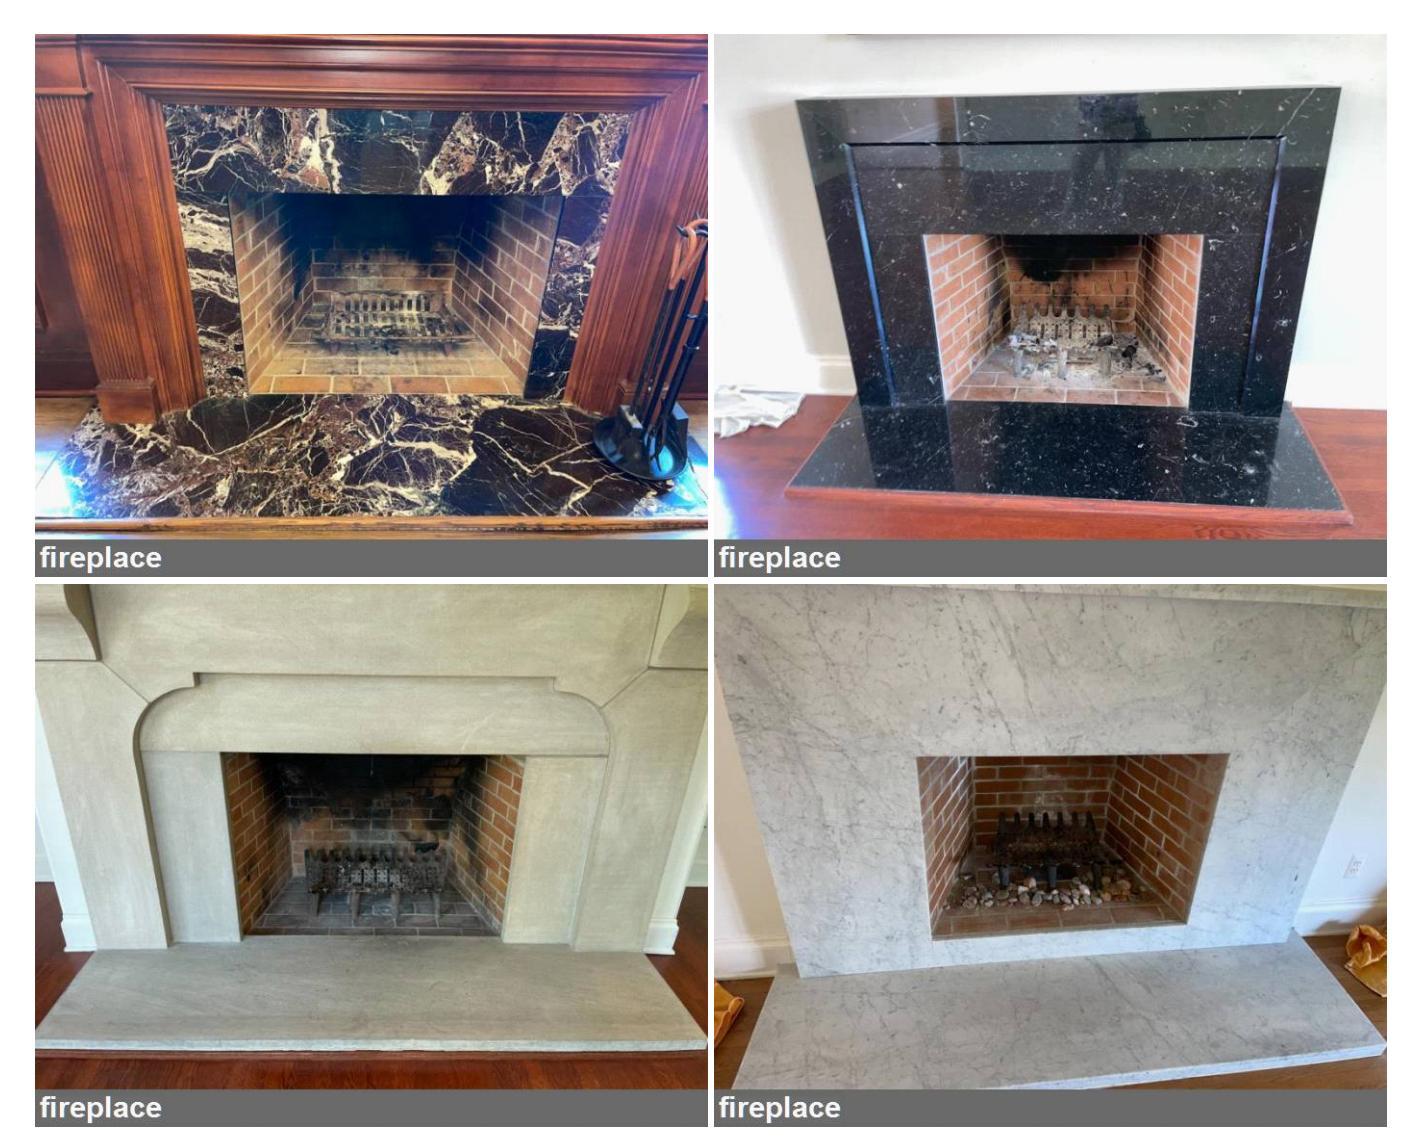
The fireplaces are in some aspects, unsatisfactory condition. Deficiencies include, but are not limited to the following; There is cracking of the mortar from between the firebricks and cracking of the bricks in the firebox area. This is a reflection of normal wear and tear, but should be addressed for safe operation of the fireplace. Repairs are needed to restore the integrity to the unit. It is recommended that a Chimney Sweep further evaluate and determine the extent of needed repairs.

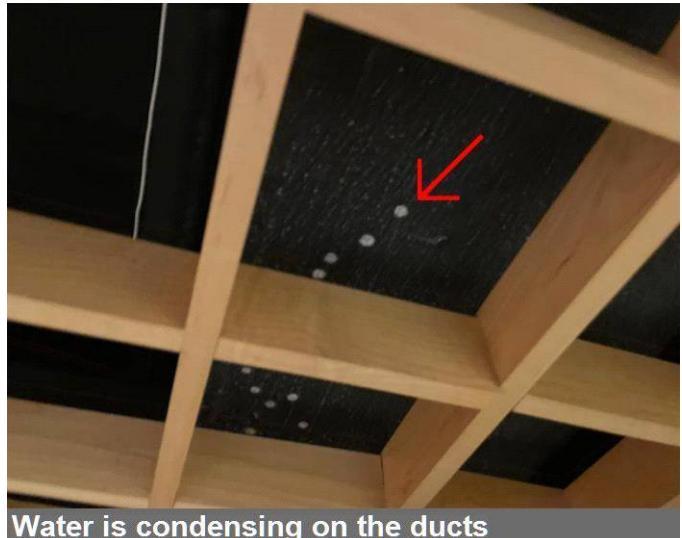
# **17.6 DISTRIBUTION:**

Cooling ducts are un-insulated. The configuration would not comply with modern building standards. The significance of this condition is; Water may condense on the ducts, which could result in damage to the ceilings, walls, floors and structure. In addition, this condition adversely affects thermal efficiency. Replacement with insulated ducts is recommended. There is a disconnected HVAC duct. The significance of this condition is; loss of thermal efficiency will result. Have the duct repaired. Water is condensing on the ducts, The significance of this condition is; this could result in damage to the ceilings, walls, floors and structure. In addition, this condition adversely affects thermal efficiency. Replacement with properly insulated ducts is recommended. Have an HVAC contractor check out the system and submit
