Planning Assistance to
States Technical Report

Valdez Glacier Stream and Mineral Creek Technical Assistance Valdez, Alaska

October 2020

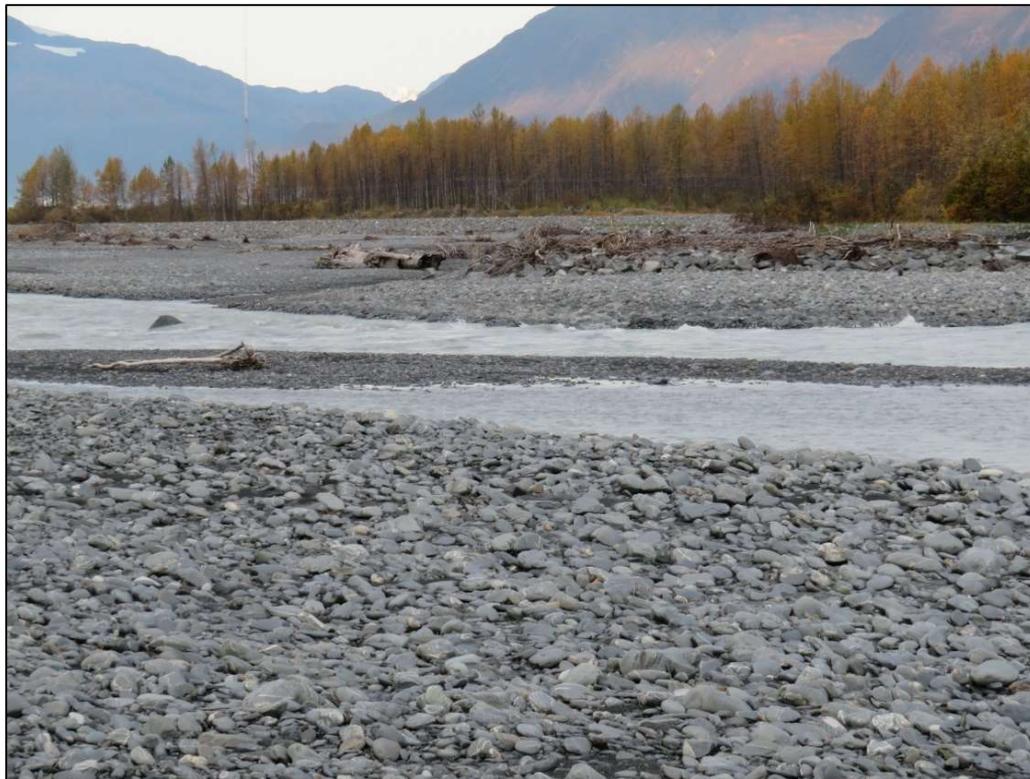
Figure 13. West bank of Valdez Glacier Stream directly below the bridge looking west (3 Oct 19). What remains of the washed-out control structure is covered in woody debris.

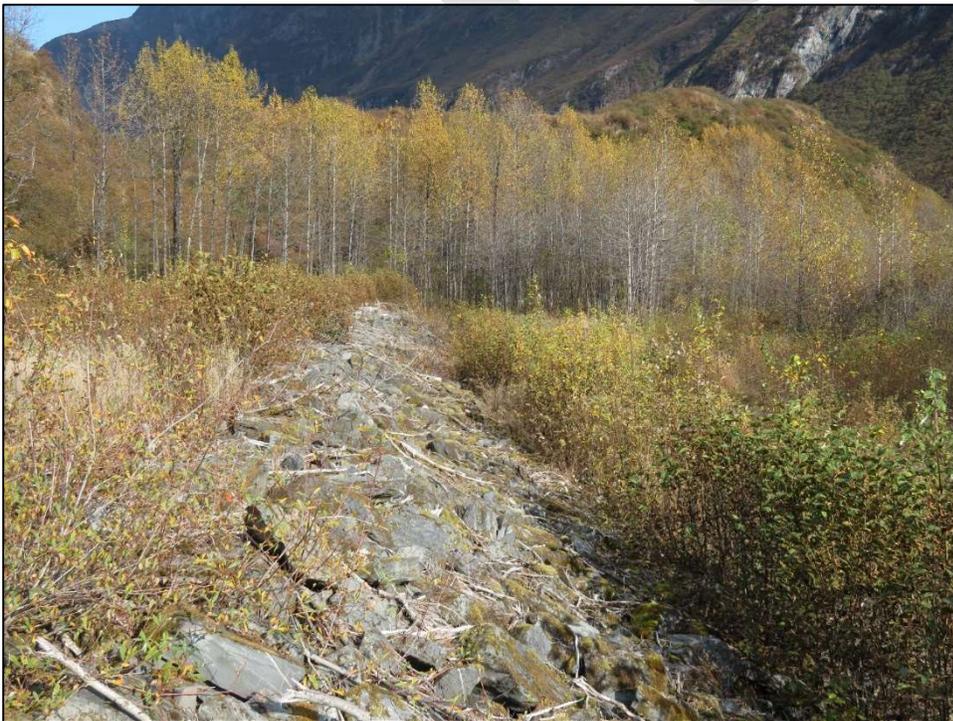
Figure 15: Bendway weir or Groin on the right bank.

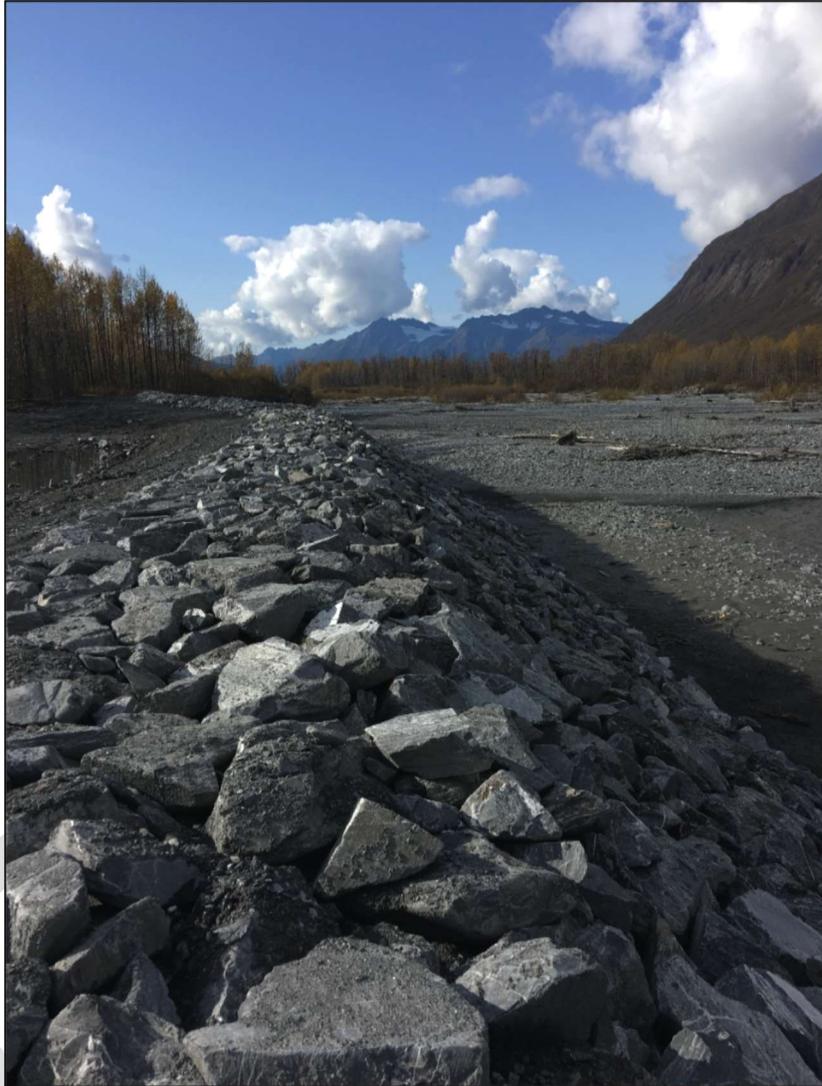
On the left bank, the earthen levee has an armored section on the far upstream section (Figure 16) that was upgraded and extended in 2019. In addition, there is a groin just upstream and downstream of the bridge to protect against erosion (see Figure 15).

Figure 16: Newly rebuilt and the armored section of the left levee, looking downstream.

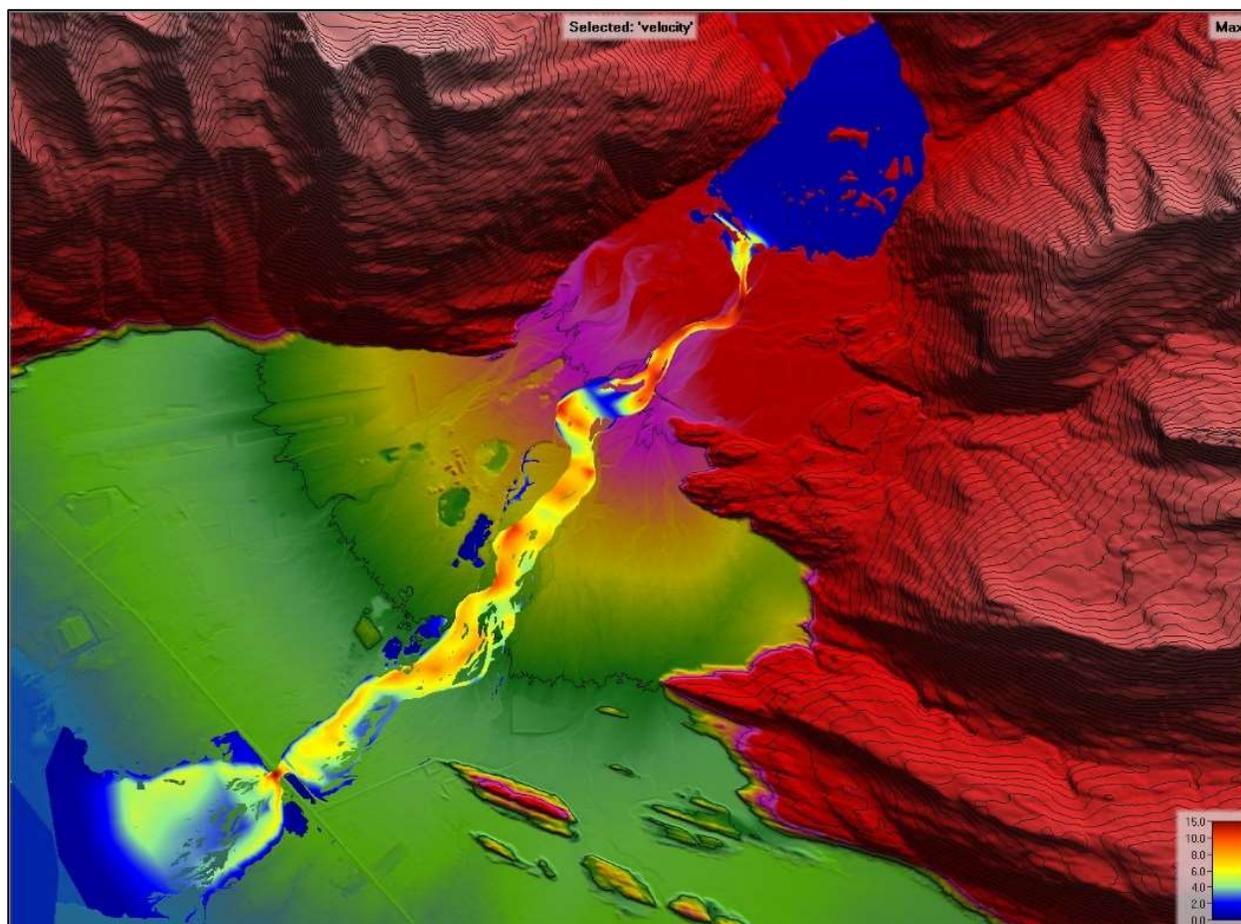
Figure 21. Peak flow velocity estimate for scenario 50-yr FEMA rainfall event

Peak flow velocities exceed 6 feet per second (fps) in most areas of the stream channel (Figure 21). Channel migration and bank erosion should be expected. Bridge channel velocities of up to 16 fps were modeled. Severe bridge scour during the event can be expected. Erosion of material from beneath the bridge could potentially reduce peak velocity.

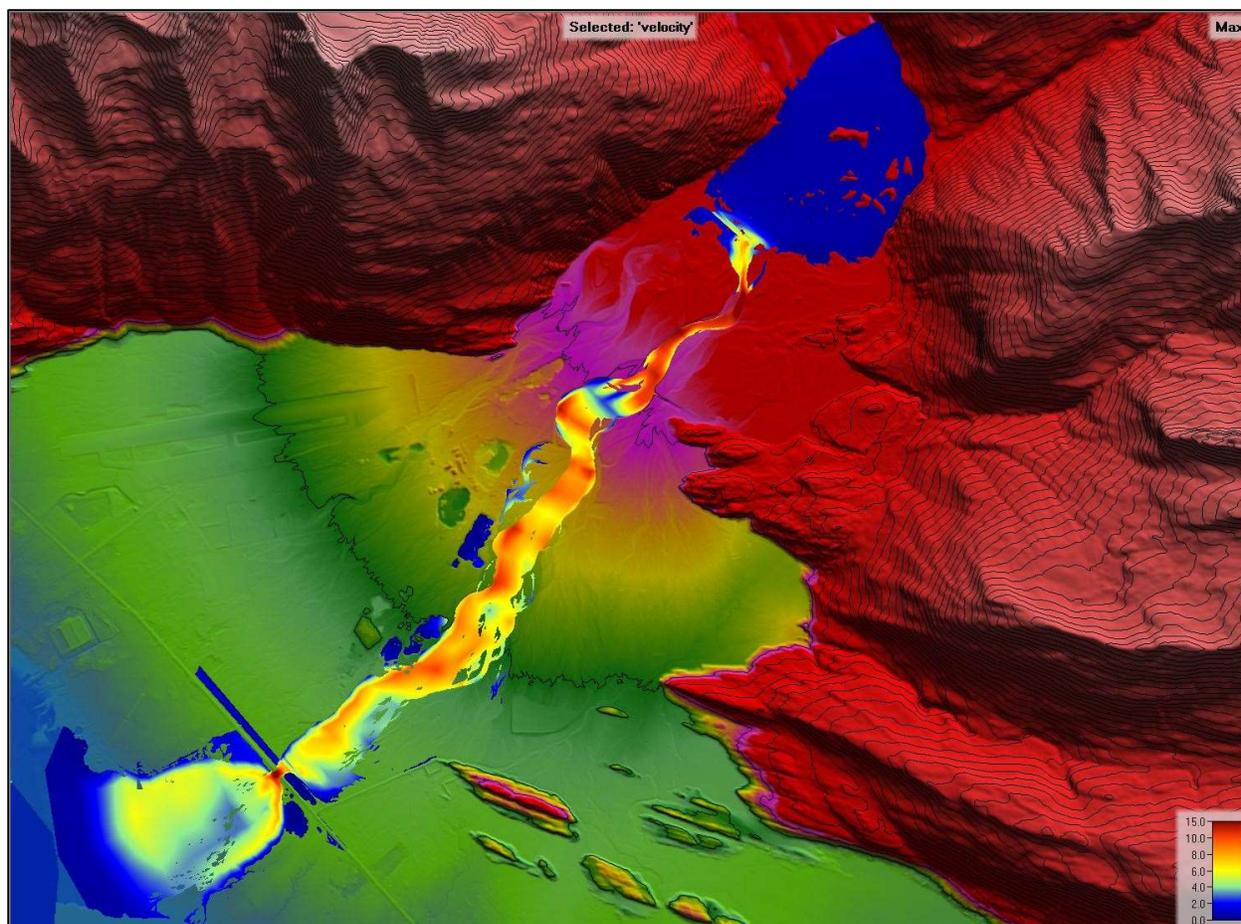
Figure 23. Peak flow velocity estimate for scenario 50-yr FEMA rainfall flood and 950-foot IDL outburst event

Peak flow velocities exceed 6 fps in most areas of the stream channel (Figure 23). Channel migration and bank erosion should be expected. Bridge channel velocities of up to 18 fps were modeled. Severe bridge scour during the event can be expected. Erosion of material from beneath the bridge could potentially reduce peak velocity.

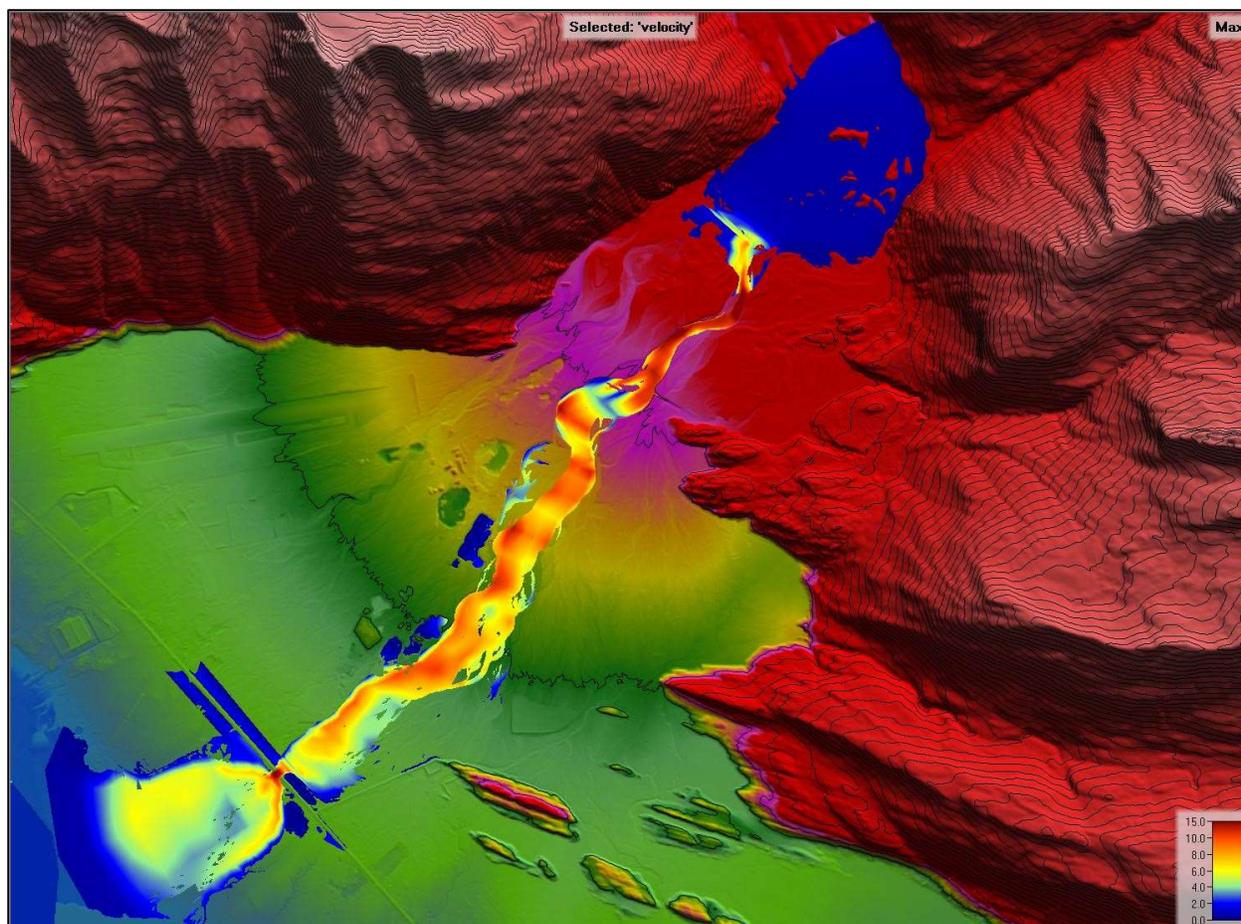
Figure 25. Peak flow velocity estimate for scenario 50-yr FEMA rainfall flood and 1000-foot IDL outburst event

Peak flow velocities exceed 6 fps in most areas of the stream channel (Figure 25). Channel migration and bank erosion should be expected. Bridge channel velocities of up to 19 fps were modeled. Severe bridge scour during the event can be expected. Erosion of material from beneath the bridge could potentially reduce peak velocity.

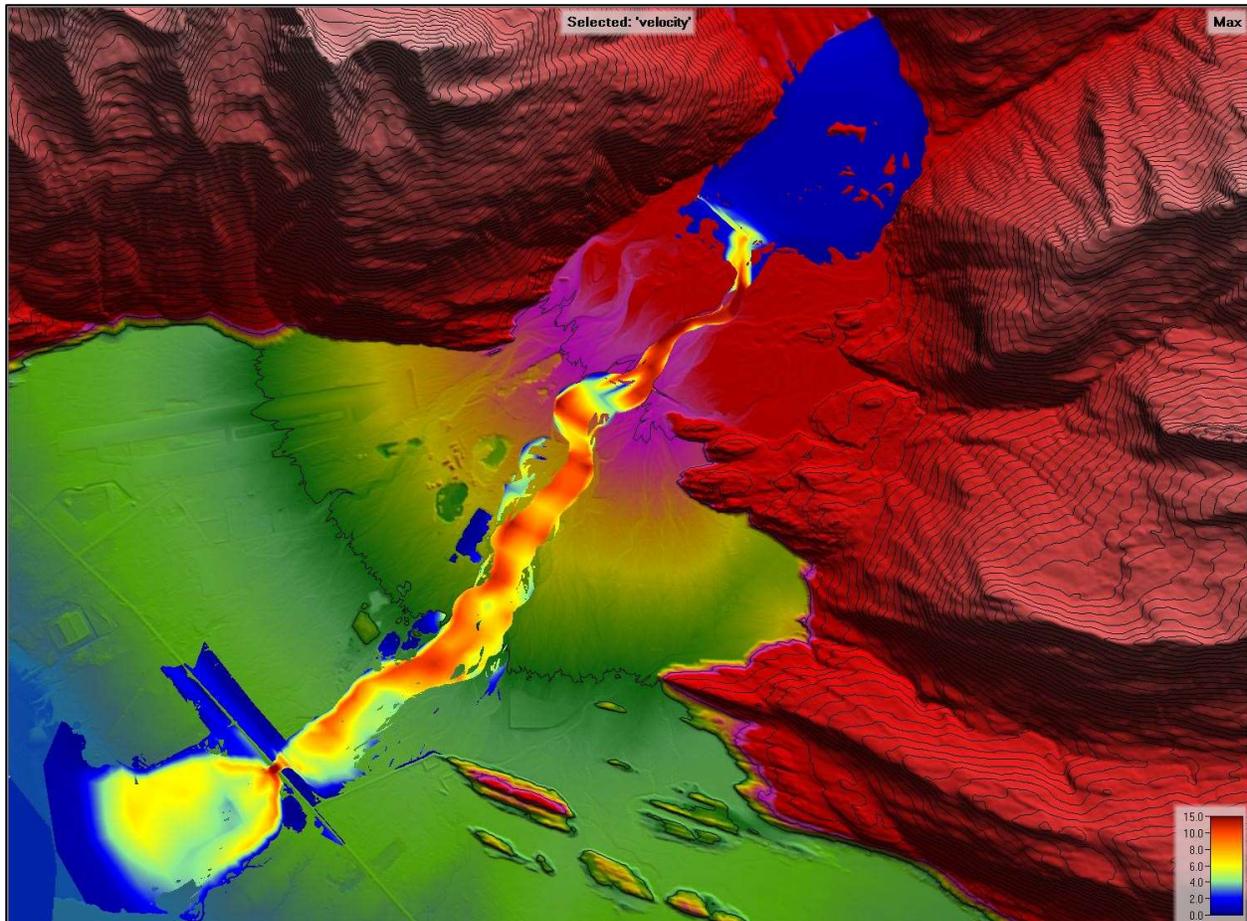
Figure 27. Peak flow velocity estimate for scenario 50-yr FEMA rainfall flood and 1050-foot IDL outburst event

Peak flow velocities exceed 8 fps in most areas of the stream channel (Figure 27). Significant channel migration and bank erosion should be expected. Bridge channel velocities of up to 19 fps can be expected. Severe bridge scour during the event can be

expected. Erosion of material from beneath the bridge could potentially reduce peak velocity.
