Conejos River Stream Management Plan

Rio Grande Basin Roundtable and the
Stream Management Plan Technical Advisory Team

2020

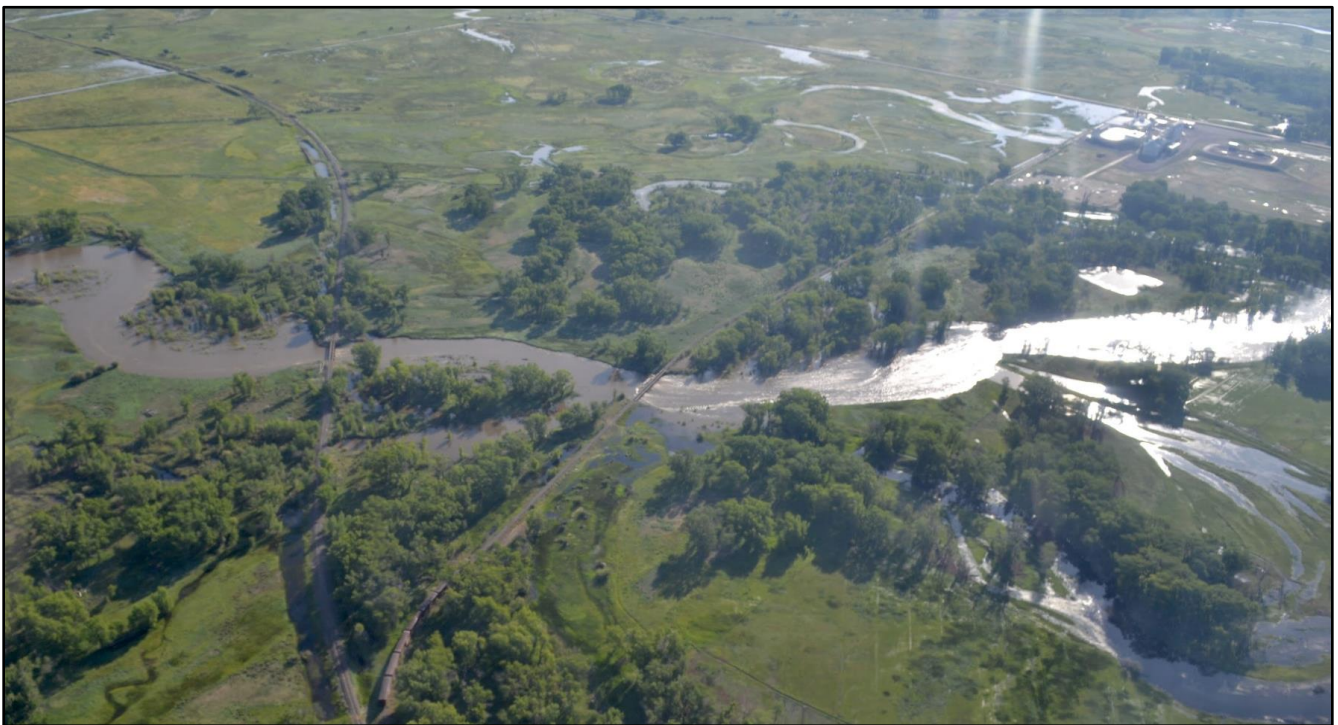
Figure 2.13: Railroad lines and bridges crossing the Rio Grande near flood stage, June 2019.

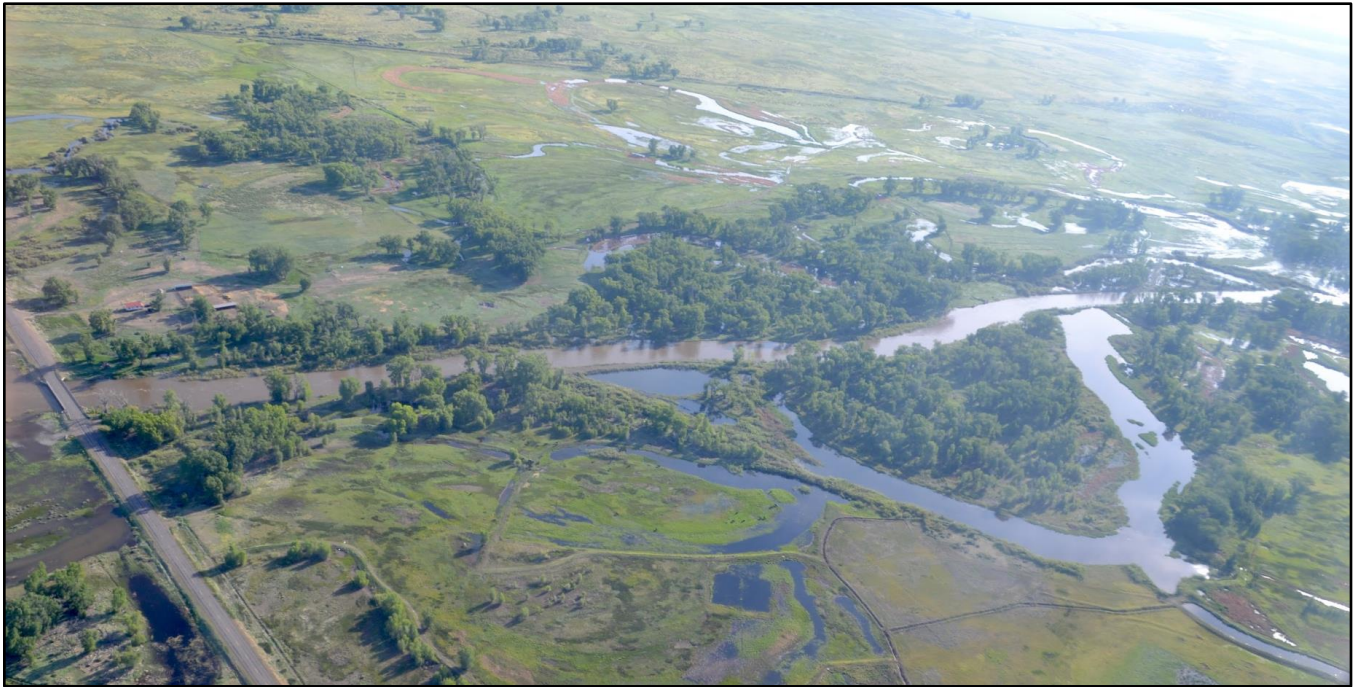
Figure 2.14: Channelization of the Rio Grande at the Soldiers Home Road (County Road 3E).

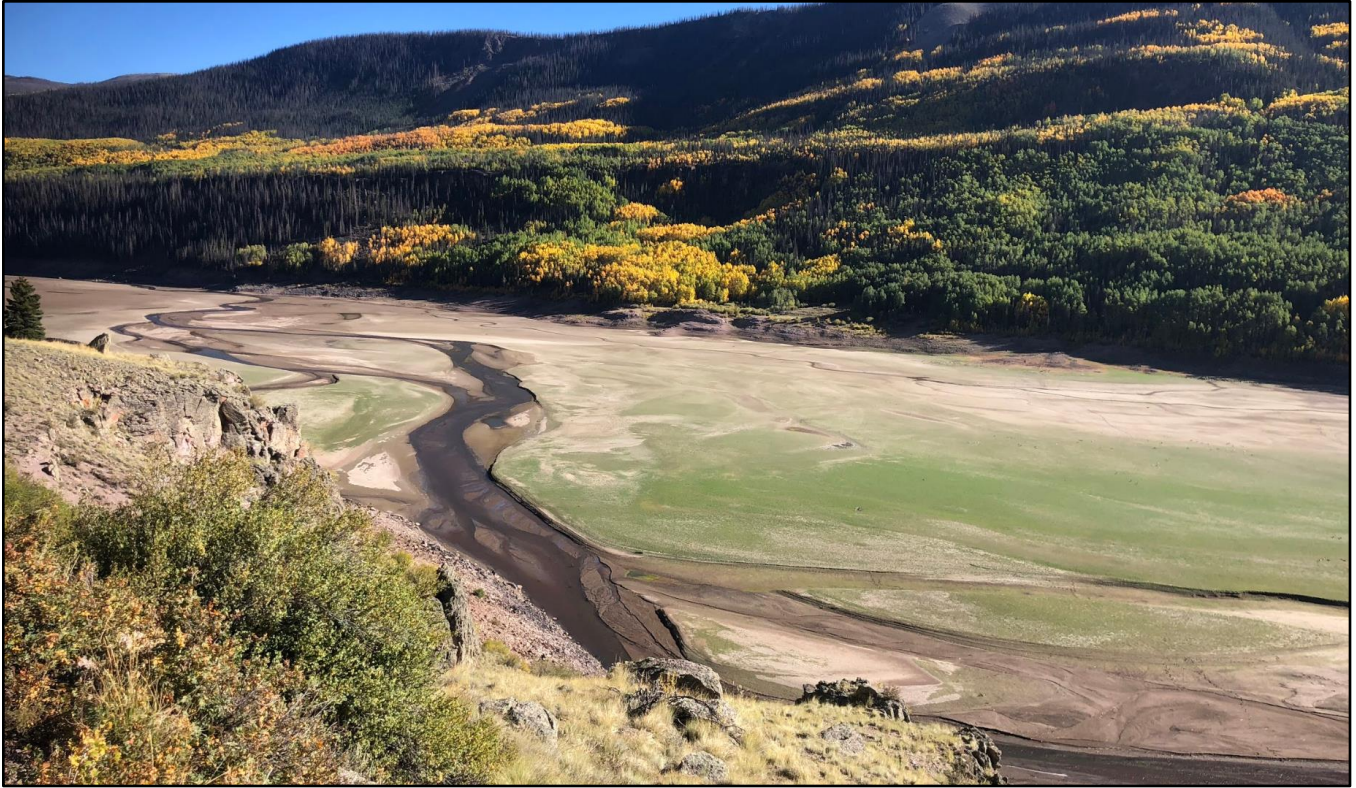
Figure 2.17: Sediment trapped behind the Rio Grande Reservoir (seen during dam repairs which had the reservoir drained during the fall of 2018).

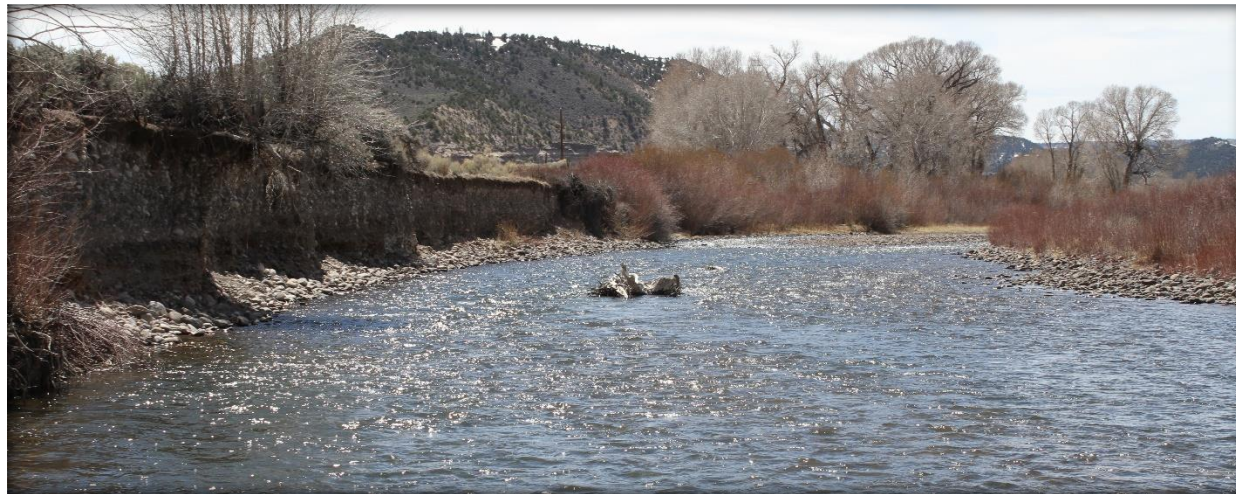
Figure 4.2: Floodplain disconnection on the mainstem Conejos River near Mogote

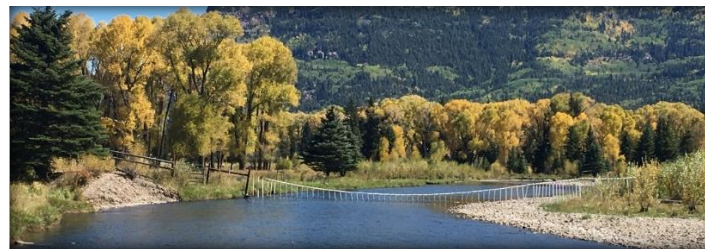
Figure 4.4: Example of recreation-friendly fencing in reach CR06. In this example, the fence could be raised to provide optimal passage.
