Arborist Appraisal of Trees [site address]

Tree Assessment Summary

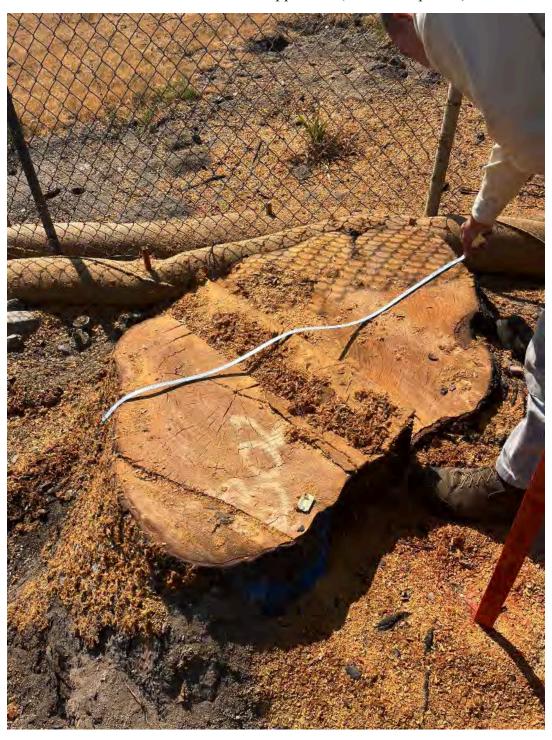
Tree No. 1 - Post-Fire: Aleppo Pine (Pinus halepensis)

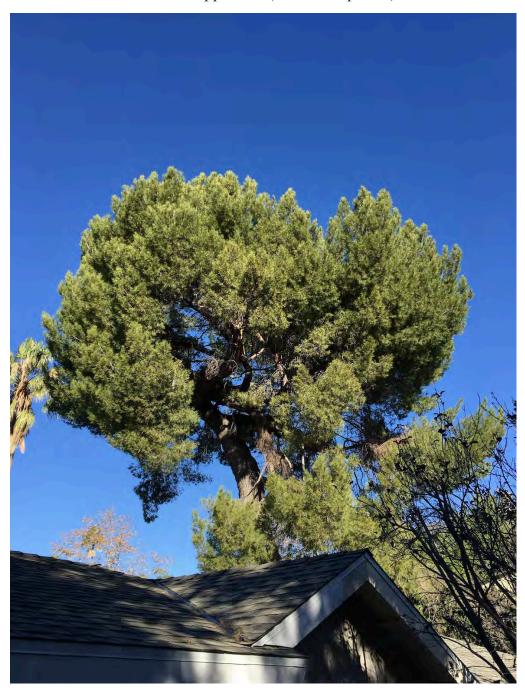
Pre-Fire: Aleppo Pine (Pinus halepensis)

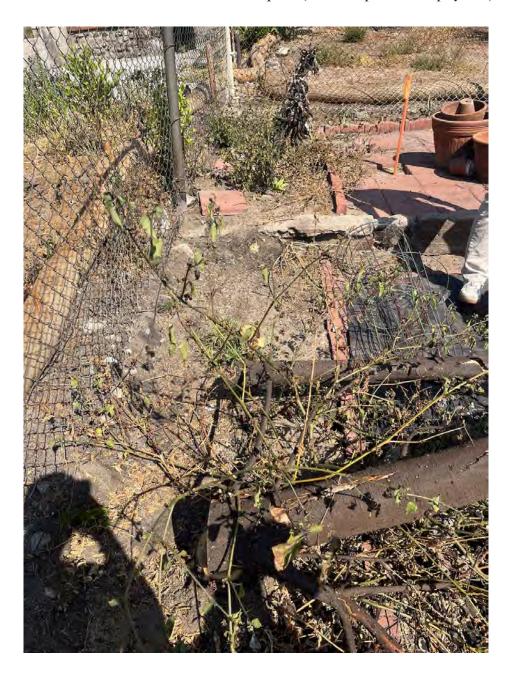
Tree No. 2-4 - Post-Fire: Buddhist pine (Podocarpus macrophyllus)

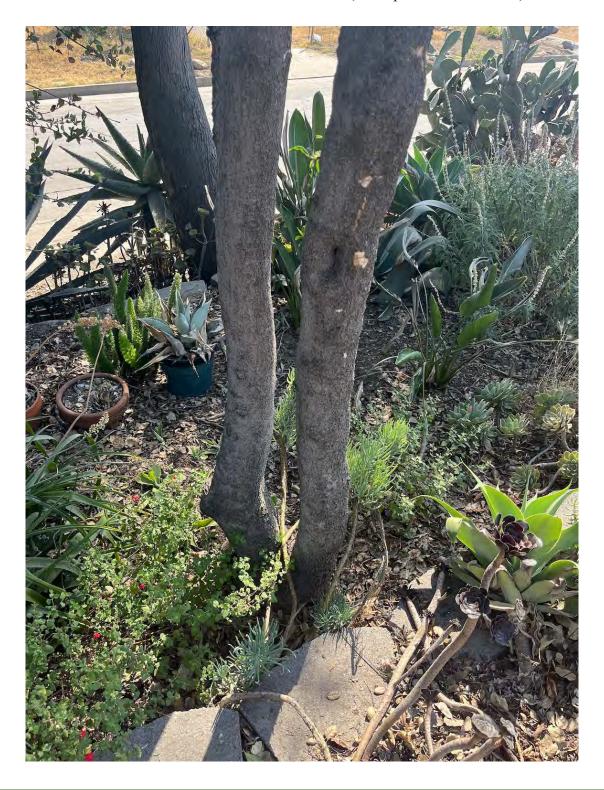
Tree No. 5 - Post-Fire: Victorian Box (Pittosporum undulatum)

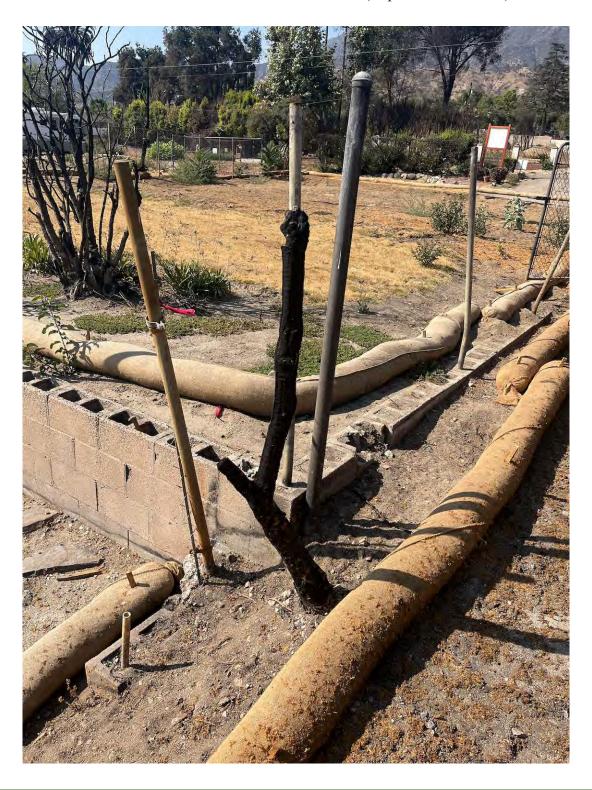
Shrub No. 1 - Post-Fire: 9 Pencil Cacti (Euphorbia tirucalli)

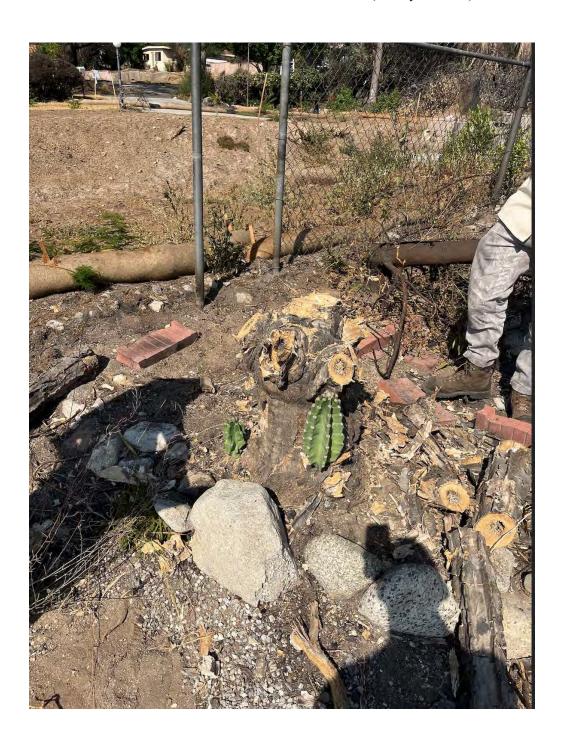
Shrub No. 2 - Post-Fire: Senita Cactus (Pachycereusi)

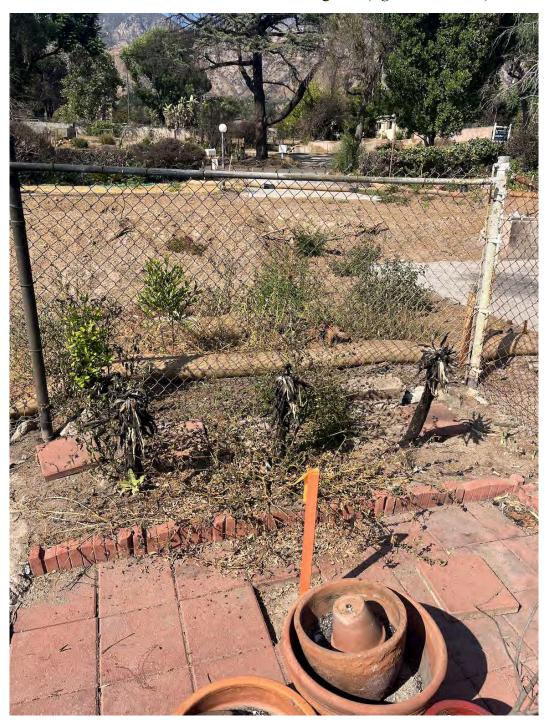
Shrub No. 3 - Post-Fire: 30 Foxtail agaves (Agave attenuata)

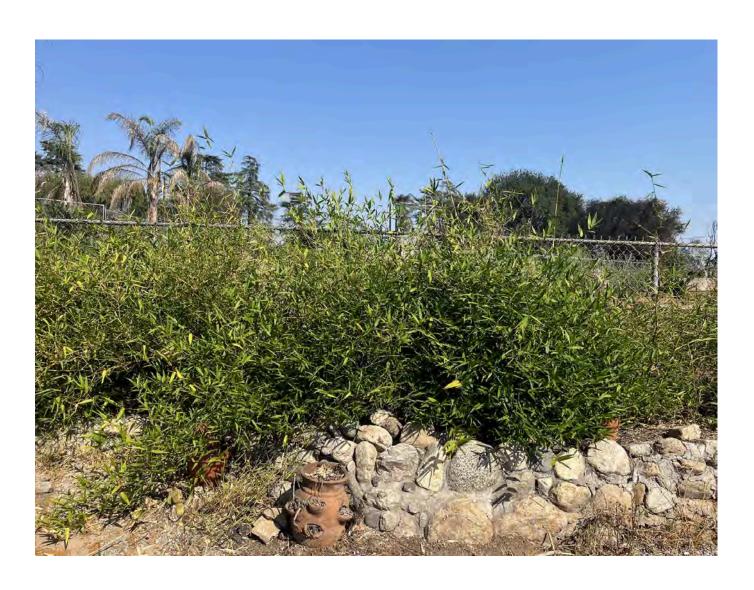
Shrub No. 4 - Post-Fire: 27 Golden Bamboo (Phyllostachys aurea)
