# Arborist Report of Trees

## [site address]

**Killian Vendler, Consulting Arborist & Pest Control Advisor**

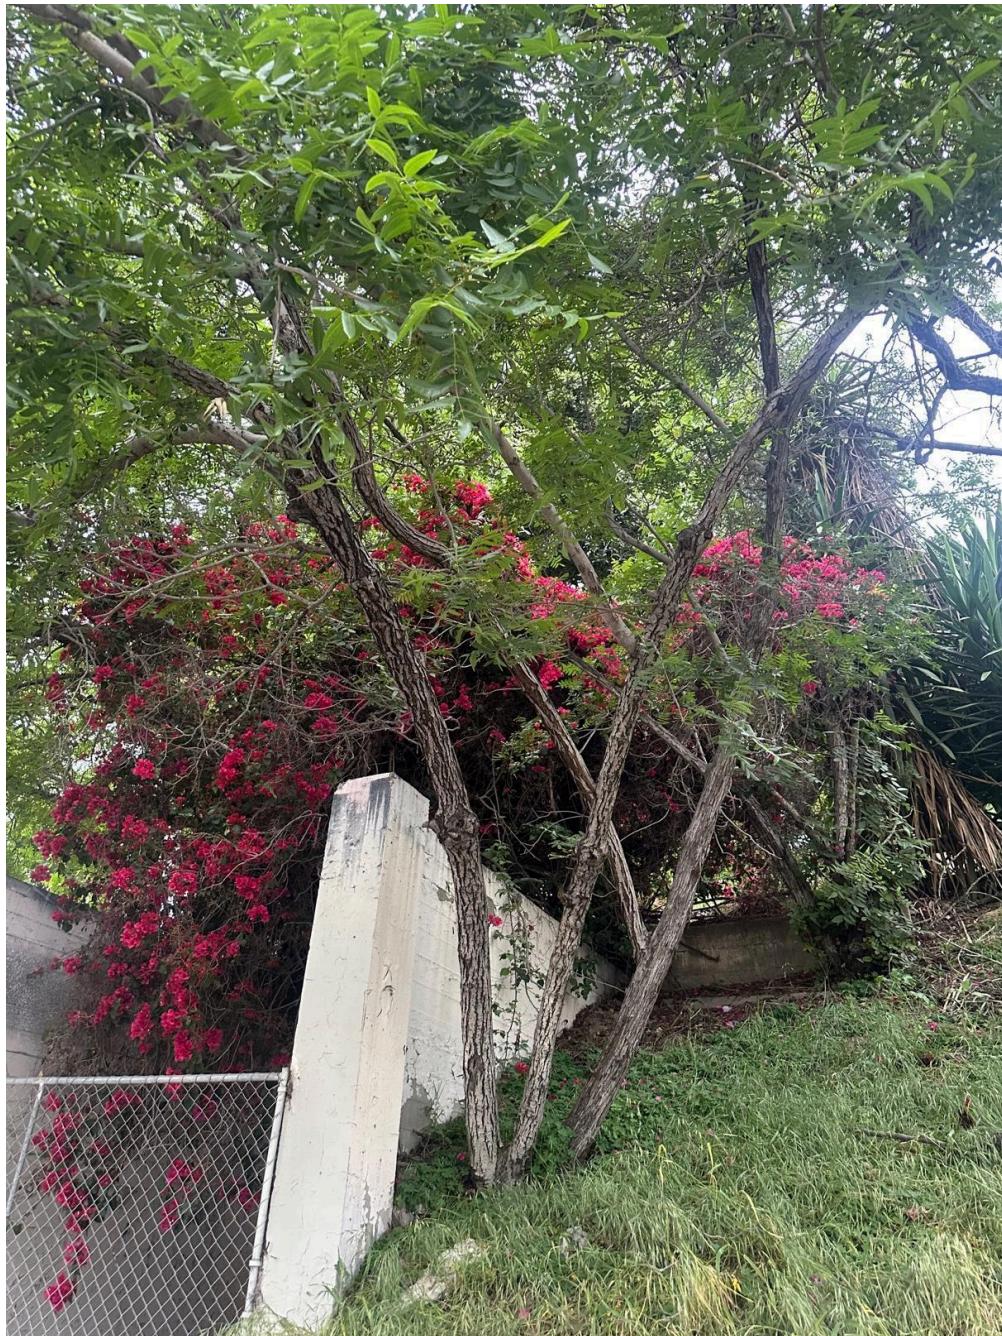
**Tree #1 – Black Walnut (*Juglans Nigra*)**

- **Trees #1 & #2:** Structurally hazardous due to overcrowding, lean, and “leggy” growth habit; both directly obstruct the required driveway per **LAMC 12.21.A.4 (covered parking)**.
- **Tree #3:** Structurally hazardous due to a **12-inch basal canker**; also obstructs required stair access for internal vertical circulation and egress pursuant to **California Residential Code (CRC) R311**.

**Remarks:** Multi-stem, total DBH 12". Health is poor. The tree exhibits hazardous leaning, elongated growth due to overcrowding, and structural instability. It also obstructs the required driveway location. This **protected** tree must be removed. The owner will voluntarily replant at a **4:1 ratio** (four *Juglans nigra* replacements on the rear hillside).

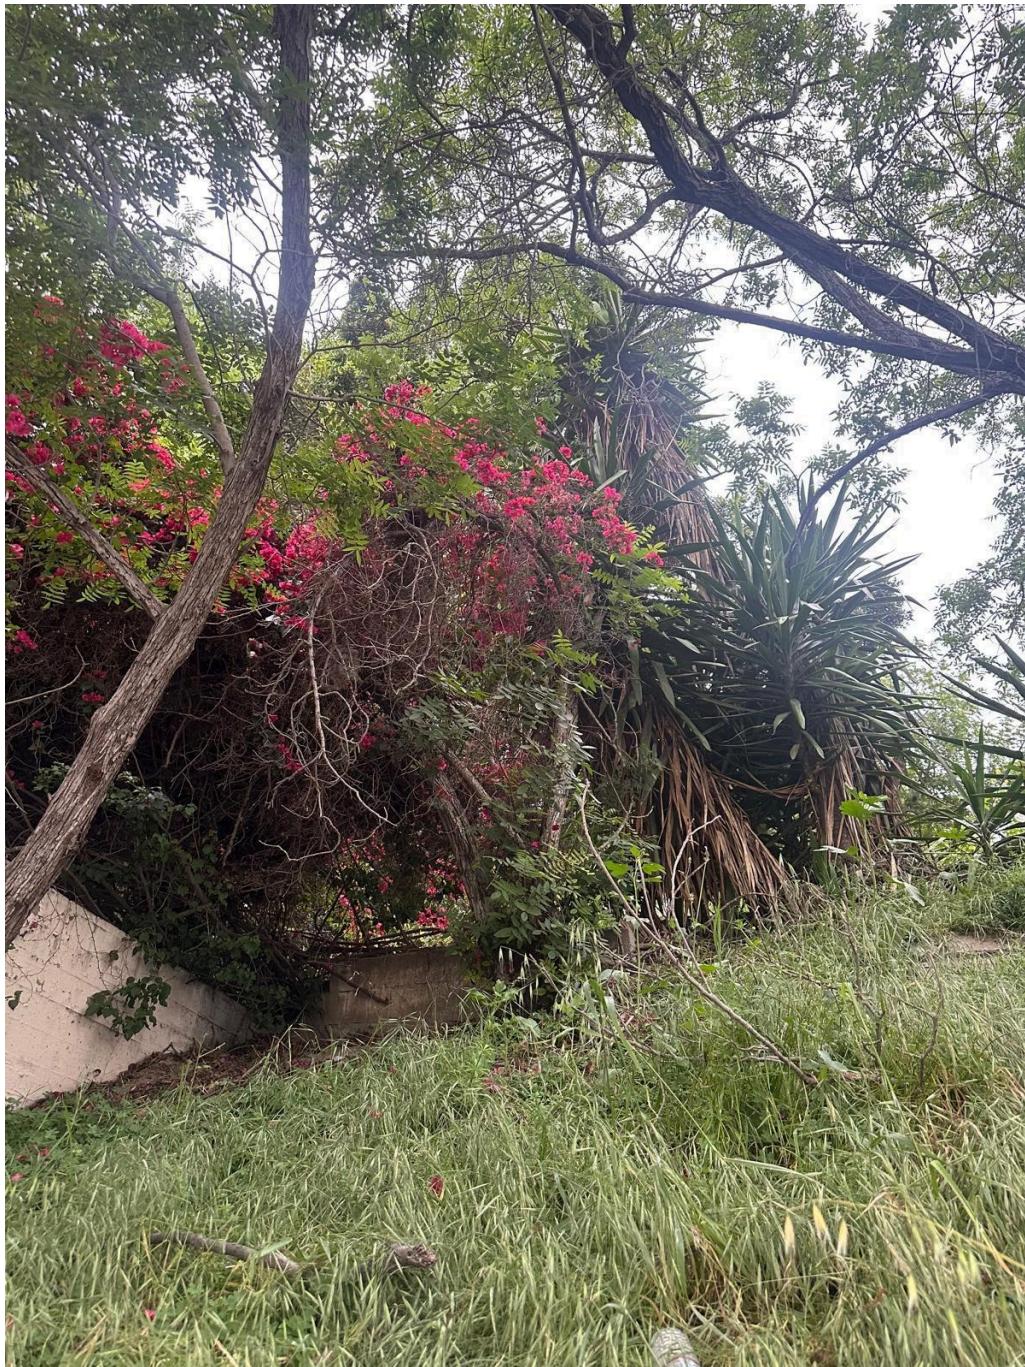
**Tree #2 – Black Walnut (*Juglans Nigra*)**

**Remarks:** Multi-stem, total DBH 12". Health is poor. Similar to Tree #1, this tree is elongated, unstable, overcrowded, and positioned within the required driveway alignment. This **protected** tree must be removed. The owner will replace this tree at a **4:1 ratio**.
