CENTER for SCIENCE in PUBLIC PARTICIPATION

August 15, 2022

Re: **BC EAO EAC Tenas Project Application – Comments on Management Pond Dams**

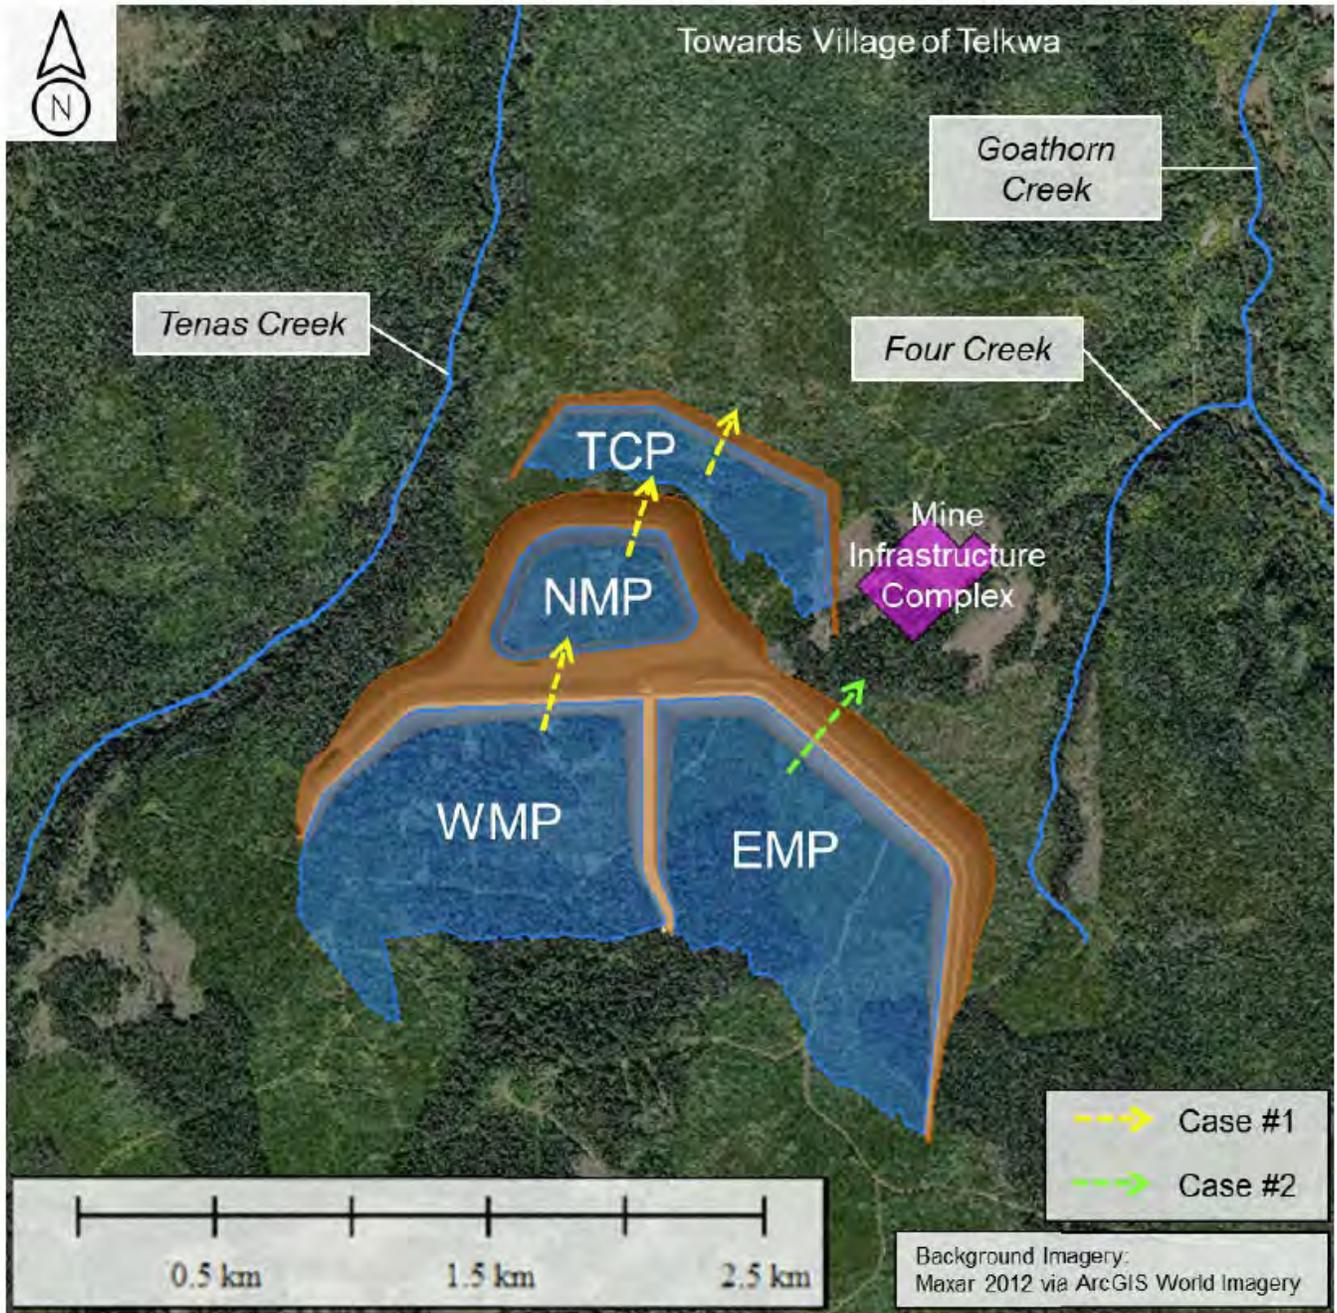
Figure 1-2: Management and Control Pond Site Plan

There are three Management Ponds proposed for the Tenas Project (Figure 1-2). These ponds will contain potentially acid generating waste rock, as well as the fine processing waste from cleaning the coal. During mine operation the Management Ponds will have a water cover to minimize the production of contaminants from the waste material. The East Management Pond dam, at 40 meters in height, is the same height as the failed Mount Polley tailings dam. The West Management Pond dam is 37 meters in height. During mine operation there is also the Tenas Management Pond, used for water management, which will be decommissioned after mine closure.

A fundamental design flaw for these dams is that they are in a cascading configuration (Figure 1-2). That is, the East and West Dams are located directly above the North Dam, and these three dams are located above the Tenas Dam. The failure of an upper dam, especially the West Dam, could also lead to the failure of a lower dam, making the results of the failure much more severe. During its participation in the development of the Global Industry Standard on Tailings Management, the United Nations Environmental Program strongly discouraged the use of cascading dams (UNEP 2020). A cascading dam failure at Stave, Italy, in 1985, led to one of the largest loss of life incidents caused by a tailings dam failure. Cascading failures were not modelled as a part of the Dam Breach Assessment.

The need for reassessment for seismic design, additional testing to assess whether the foundation and dam construction materials are of sufficient strength to use and support the construction of a dam, and the use of a dangerous cascading dam configuration, all suggest that the fundamental redesign of these waste disposal facilities is warranted.

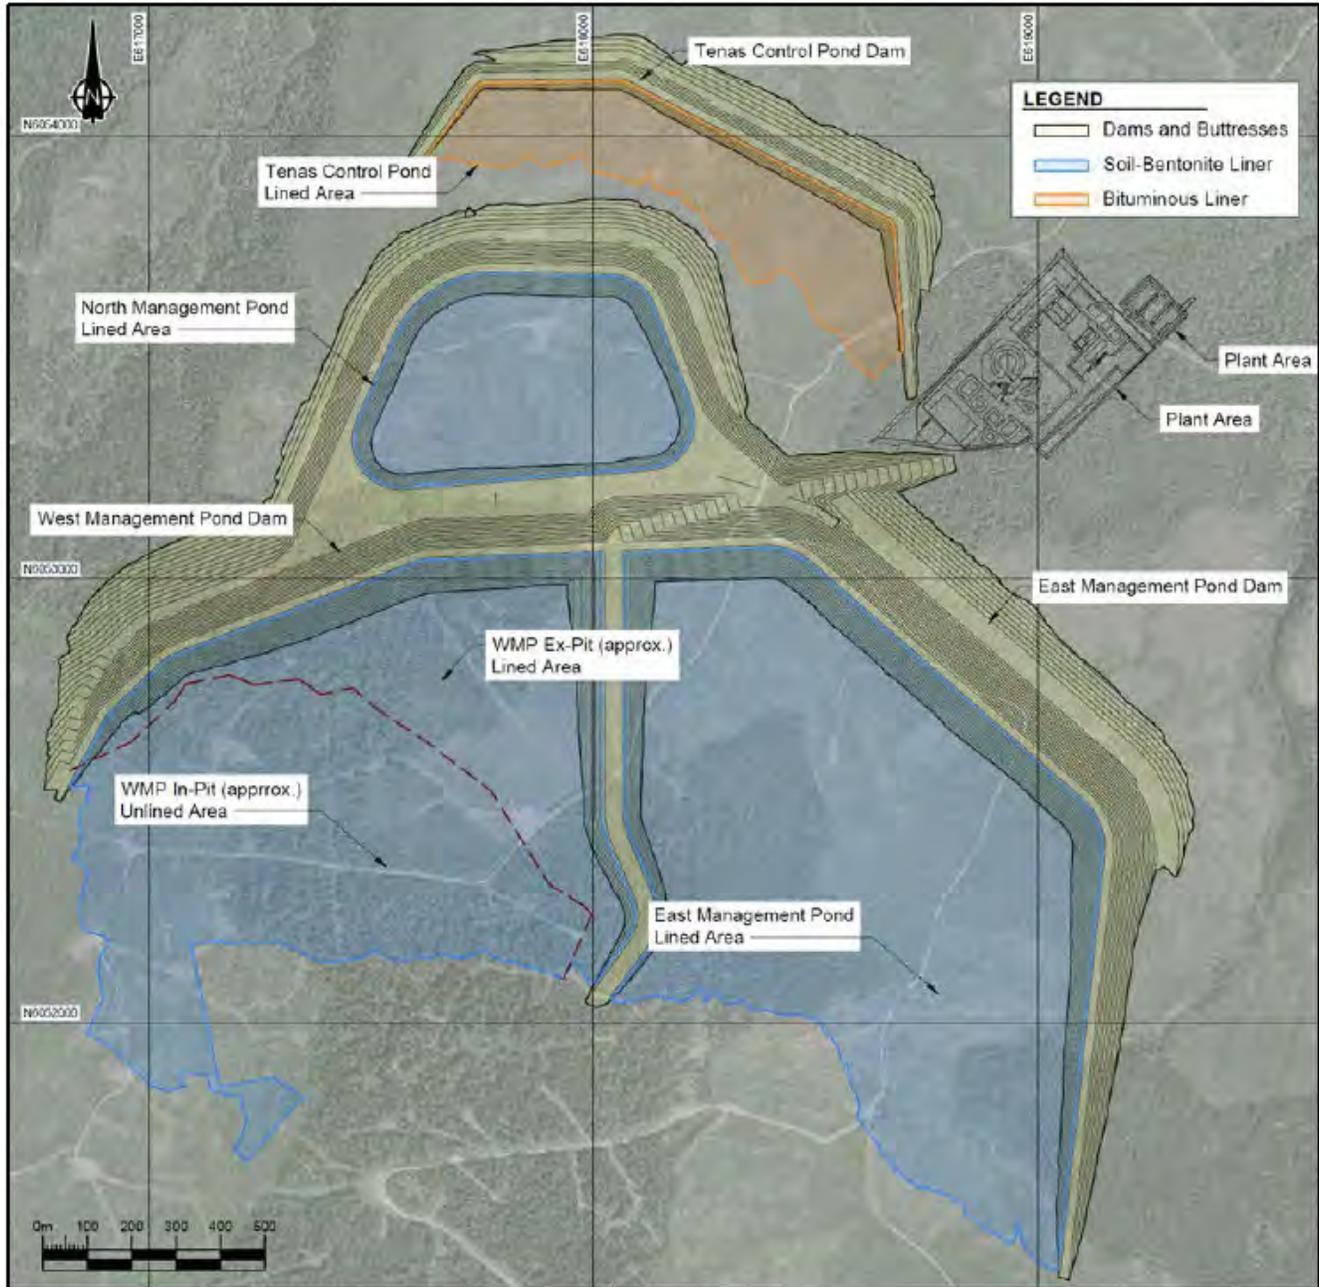
Figure 4: Plan view of the lined surface areas of the Tensas Control Pond and PAG management ponds at the Tensas Project

A soil-bentonite liner is proposed for the bottom of the East and North Management Ponds, and part of the West Management Pond (SRK 2020). The Tenas Management Pond would not have a soil-bentonite liner (Figure 4). The purpose of this liner is to limit the migration of contaminants from the waste leaching into groundwater, since the Ponds will have direct hydraulic connections to adjacent streams.

To achieve the proposed design criteria the soil-bentonite liner system will require a hydraulic conductivity of 1E-10 m/s (SRK 2021b). This requires a permeability that is two orders of magnitude lower than that most clay liner systems typically achieve. A typical bentonite-soil liner would have a hydraulic conductivity of 1E-8 m/s. The proposed hydraulic conductivity of 1E-10 m/s is achievable, but is approaching the limit of what is possible for this liner design. Additionally, achieving a hydraulic conductivity of 1E-10 m/s would be accomplished by disking bentonite into two 0.15 thick layers of soil placed at the bottom of the Management Ponds. The care in construction of these layers, and the quality control required to insure the required hydraulic conductivity is uniformly achieved, will be challenging.

SRK (2021b) also notes that the success of the liner in preventing seepage is important to dam safety. This is another reason the requirements for, and the design of, the liner need to be very conservative. A clay liner with a permeability requirement of $1E-10$ m/s is too risky. A double liner system, with leak detection/collection, is warranted.

A fundamentally sound approach liner design would be to use a double liner with a leak detection layer, and with at least the upper liner constructed of synthetic material. This approach could reduce the seepage rate to approximately 1/10th or less that of the proposed 2,800 m³/day. After mine closure, the seepage collected in the seepage collection layer could be passively treated in a wetland system constructed in the abandoned Tenas Management Pond.
