**ANNUAL
BIODIVERSITY
&
REHABILITATION
MANAGEMENT
REPORT
2019**

Prepared for Dixon Sand Pty Ltd

September 2019 V.1

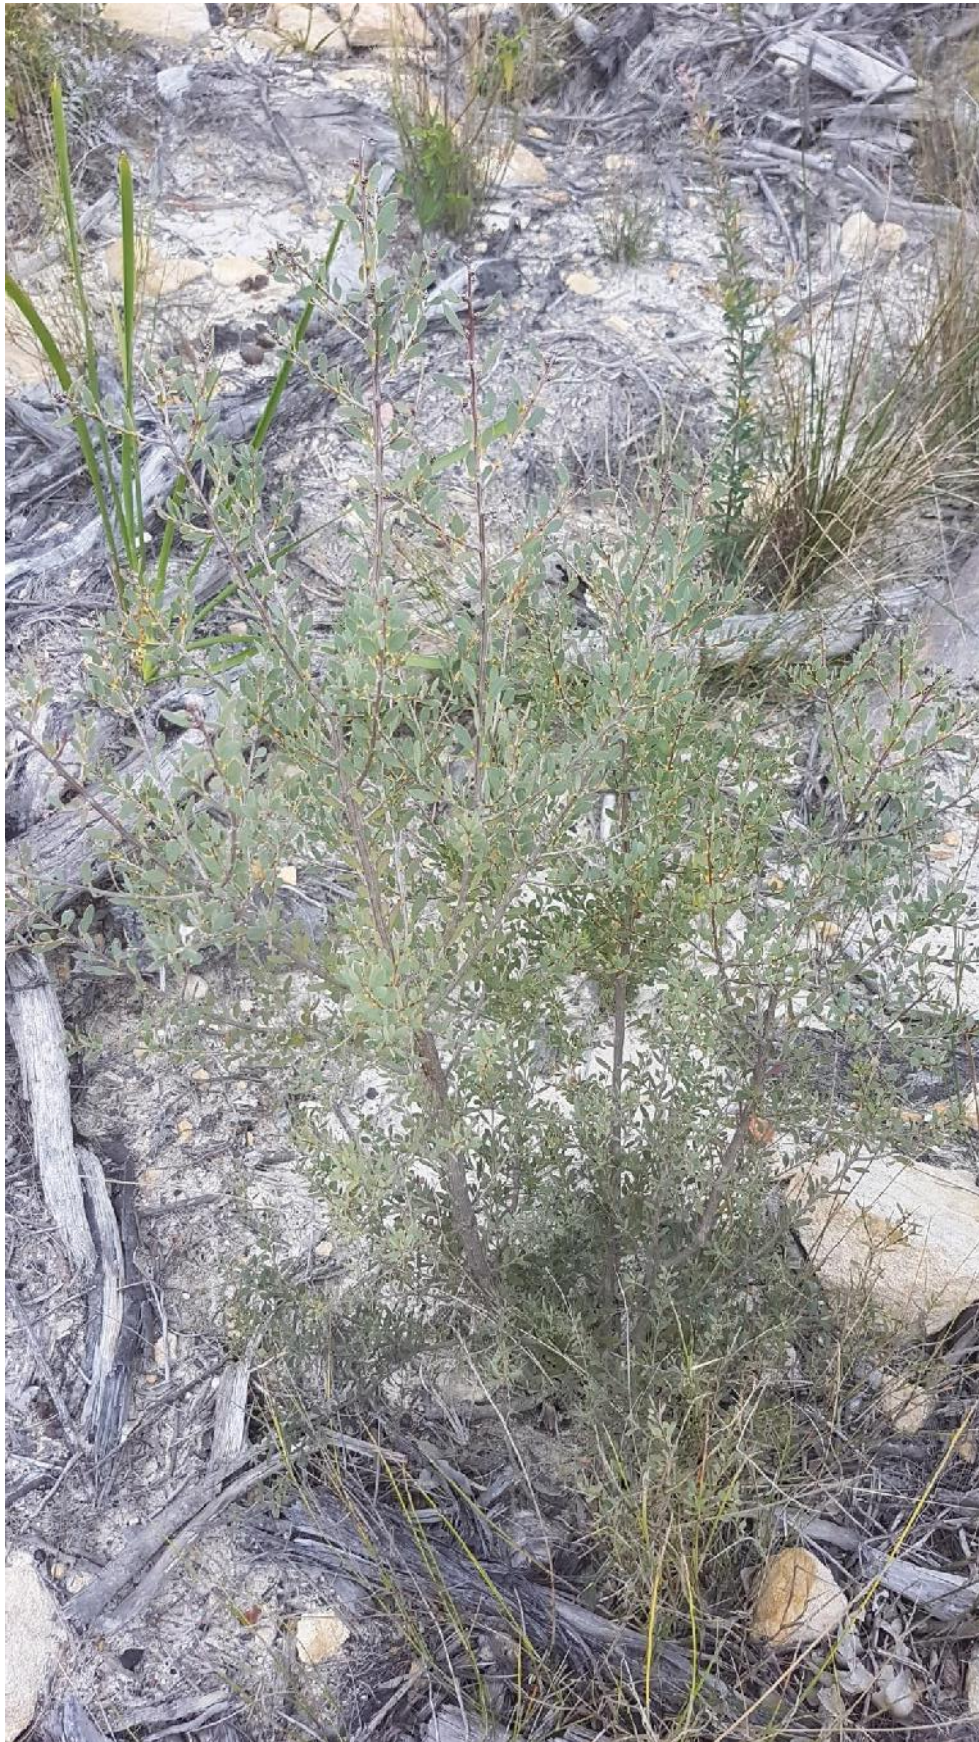
There were 16 live specimens of *Melaleuca deanei*, 25 live specimens of *Darwinia fascicularis subsp. Oligantha* and 4 live specimens of *Acacia byoneana* located within the planted rehabilitation area. Although there is a slight reduction of live specimens located this year it could be that these individuals were unable to be located due to the density of regrowth which has occurred throughout the site over the past 12 month period. The *A. byoneana* was showing signs of stress, most likely due to the weather conditions and predation by herbivores.

Image 5. Planted *Melaleuca deanei* within the planted rehabilitation area 2019

It was noted that several tree species still have stem support ties which are now beginning to restrict the outward growth of the stem. It is recommended these supports are removed immediately to reduce the risk of loss or deformity of these trees.

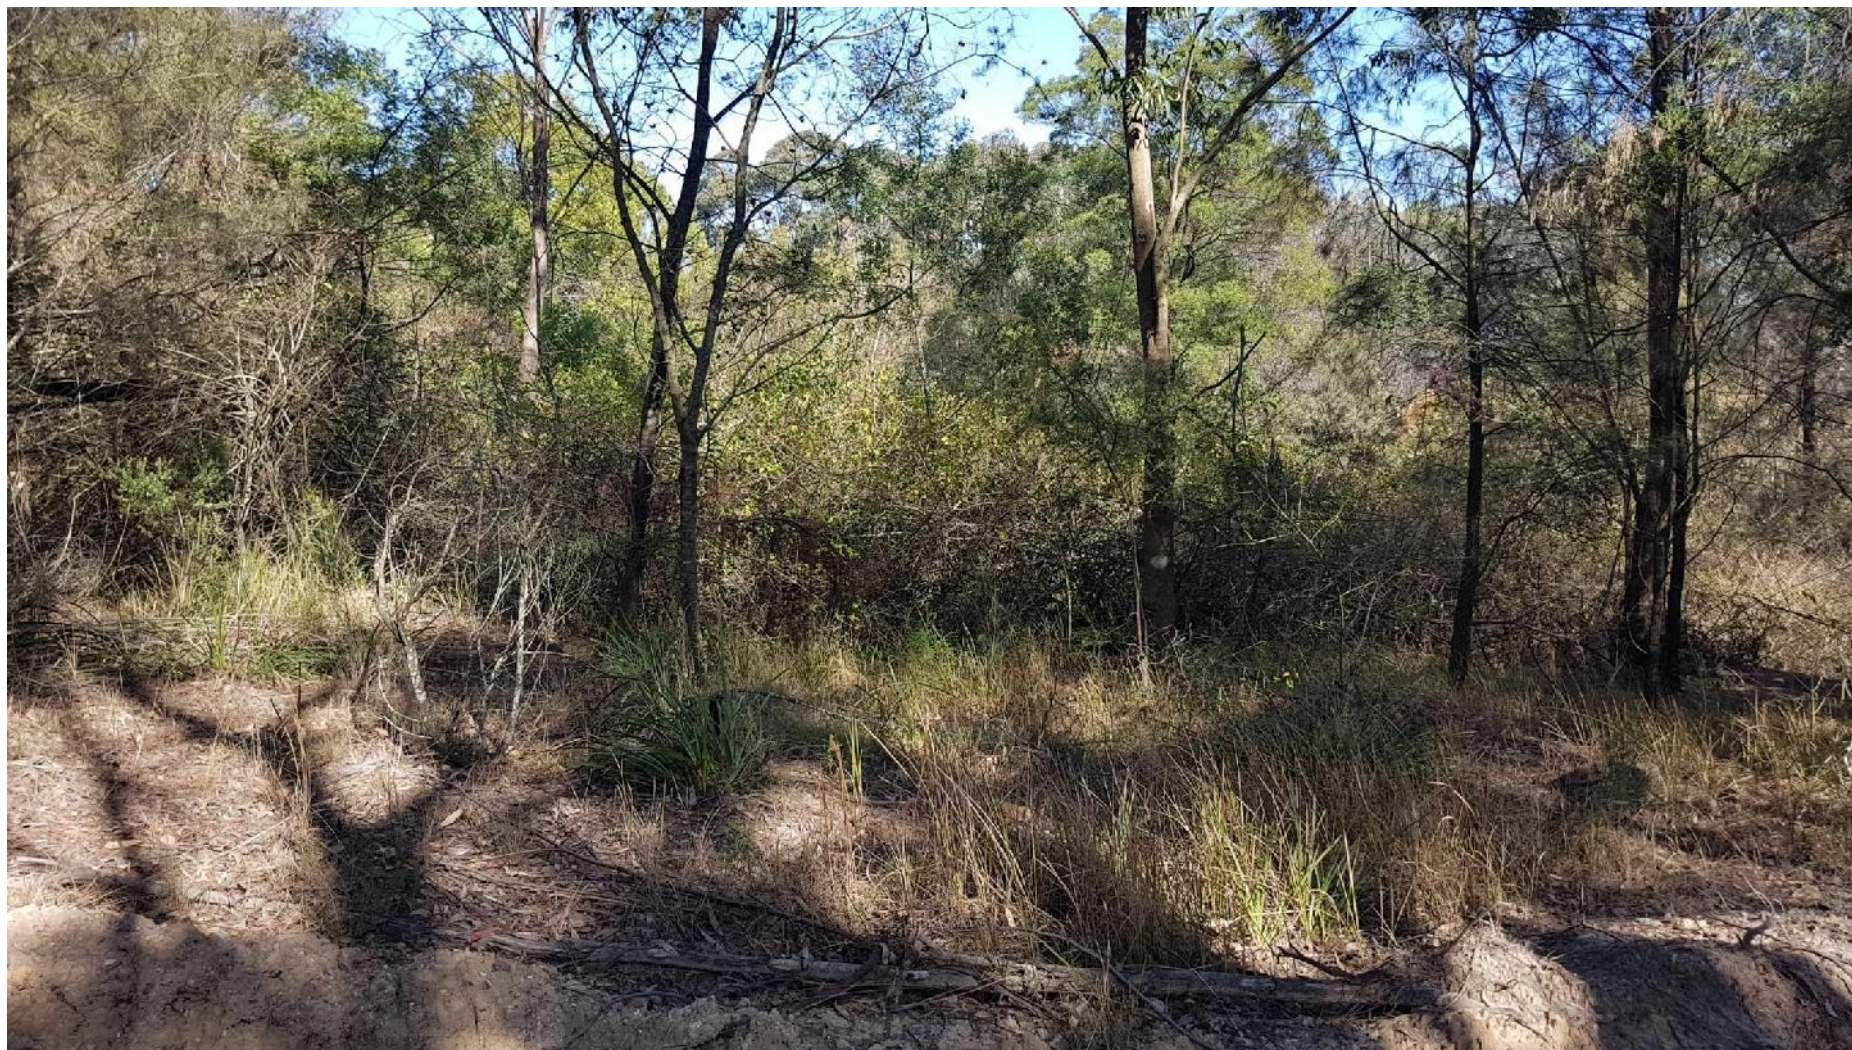
The fifth site also contained thickets of *Lantana camera* however a section of native vegetation adjacent to the marked location was surveyed to provide some detail of biodiversity condition within the NVC.

Image 19. Impenetrable thicket of *Lantana camara* within NVC 2019

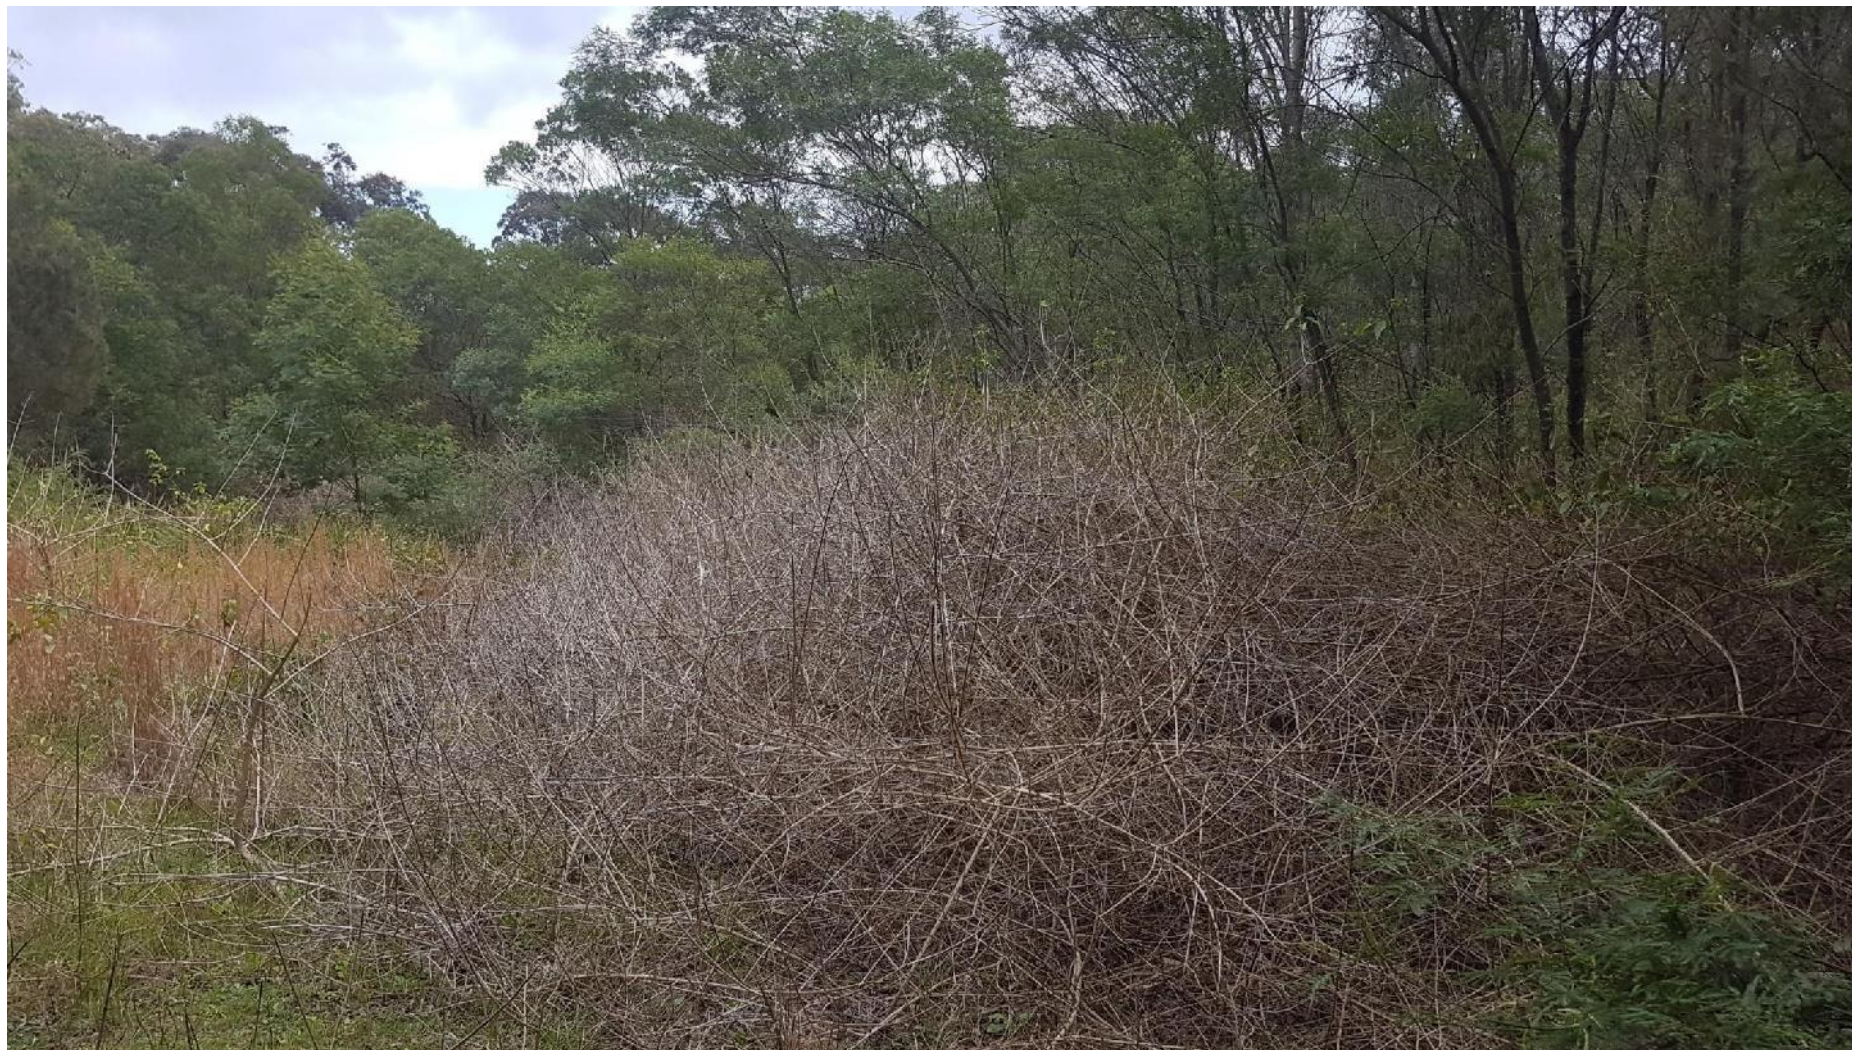
Image 20. Impenetrable thicket of *Lantana camara* which has been treated with herbicide and is awaiting removal by Bush Regeneration contractors within NVC 2019

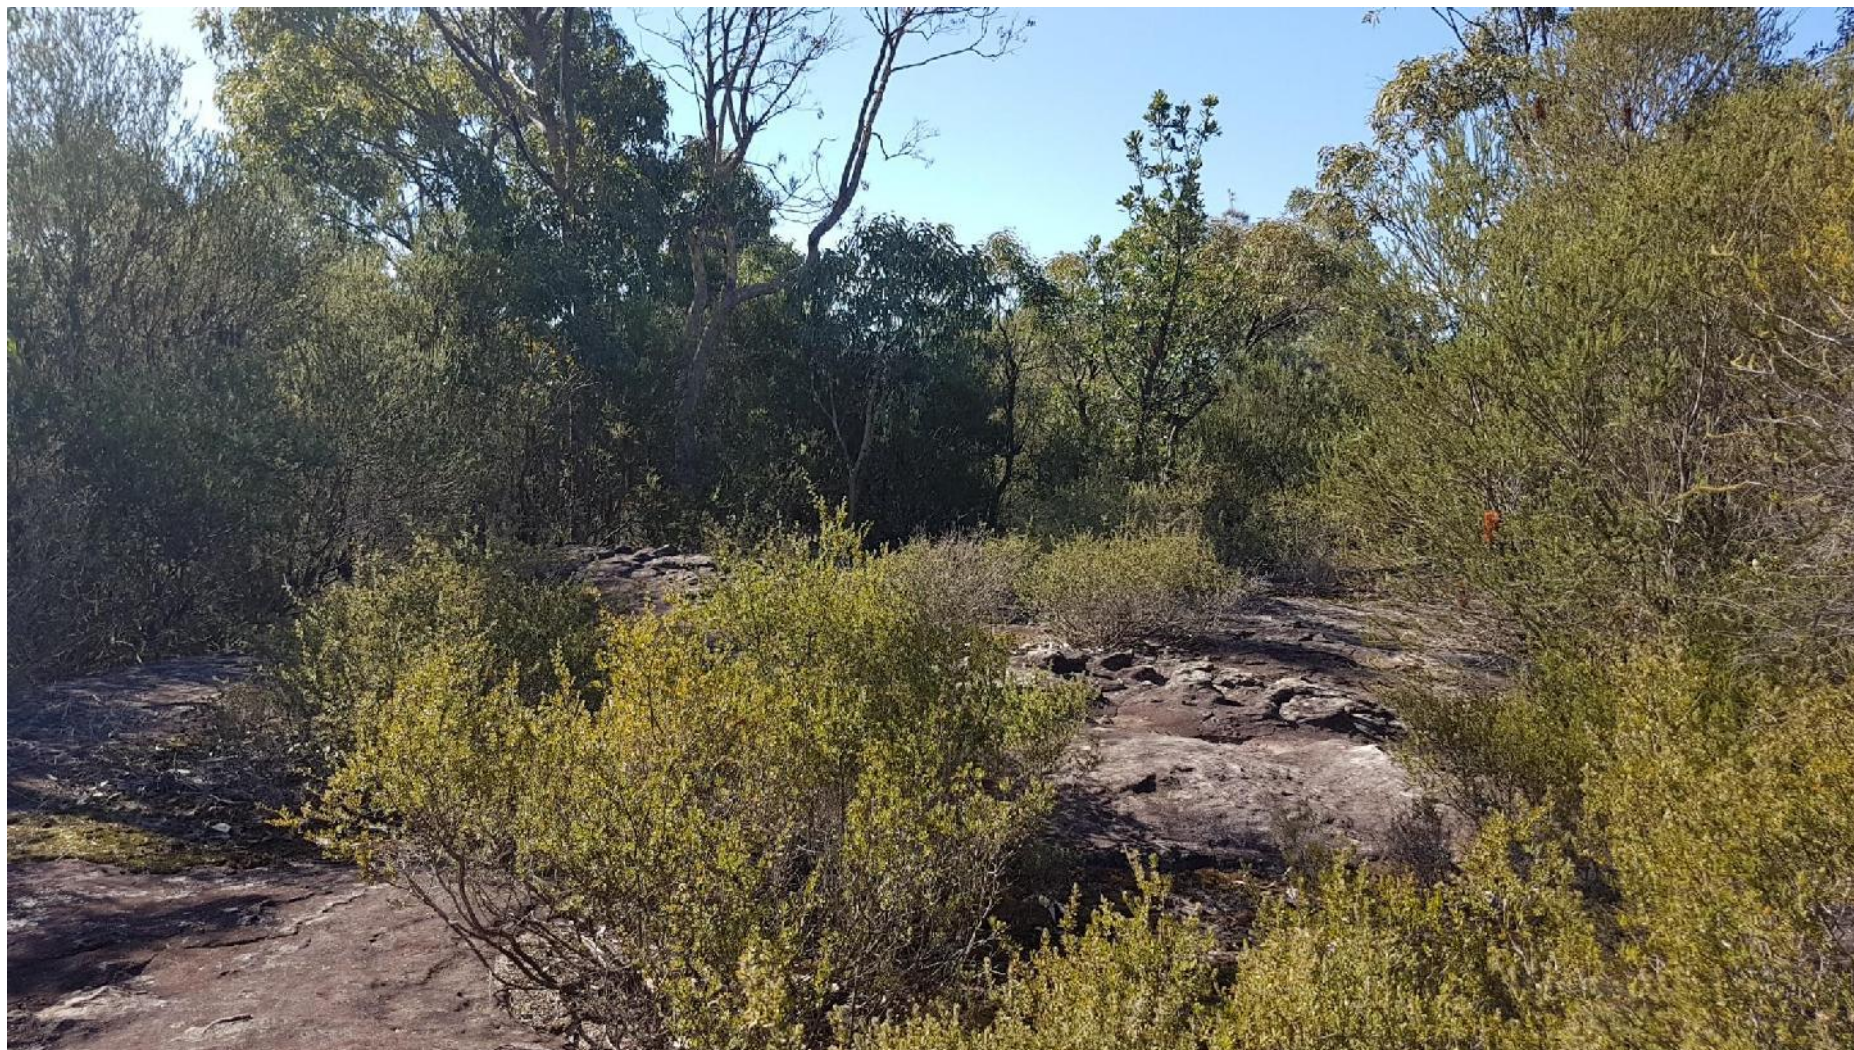
The overall health of the *Kunzea rupestris* population is reasonable considering the current dry weather conditions. Some dieback and plant loss was observed however the remaining plants appeared to be in good health. Some recruitment was evident, particularly on the western rock platform where vacant soil is available. Budding and some flowers were observed during the survey period. Mosses and lichens were present in each patch on both platforms although extremely dry.

Image 33. *Kunzea rupestris* monitoring eastern rock platform photo location 1 2019

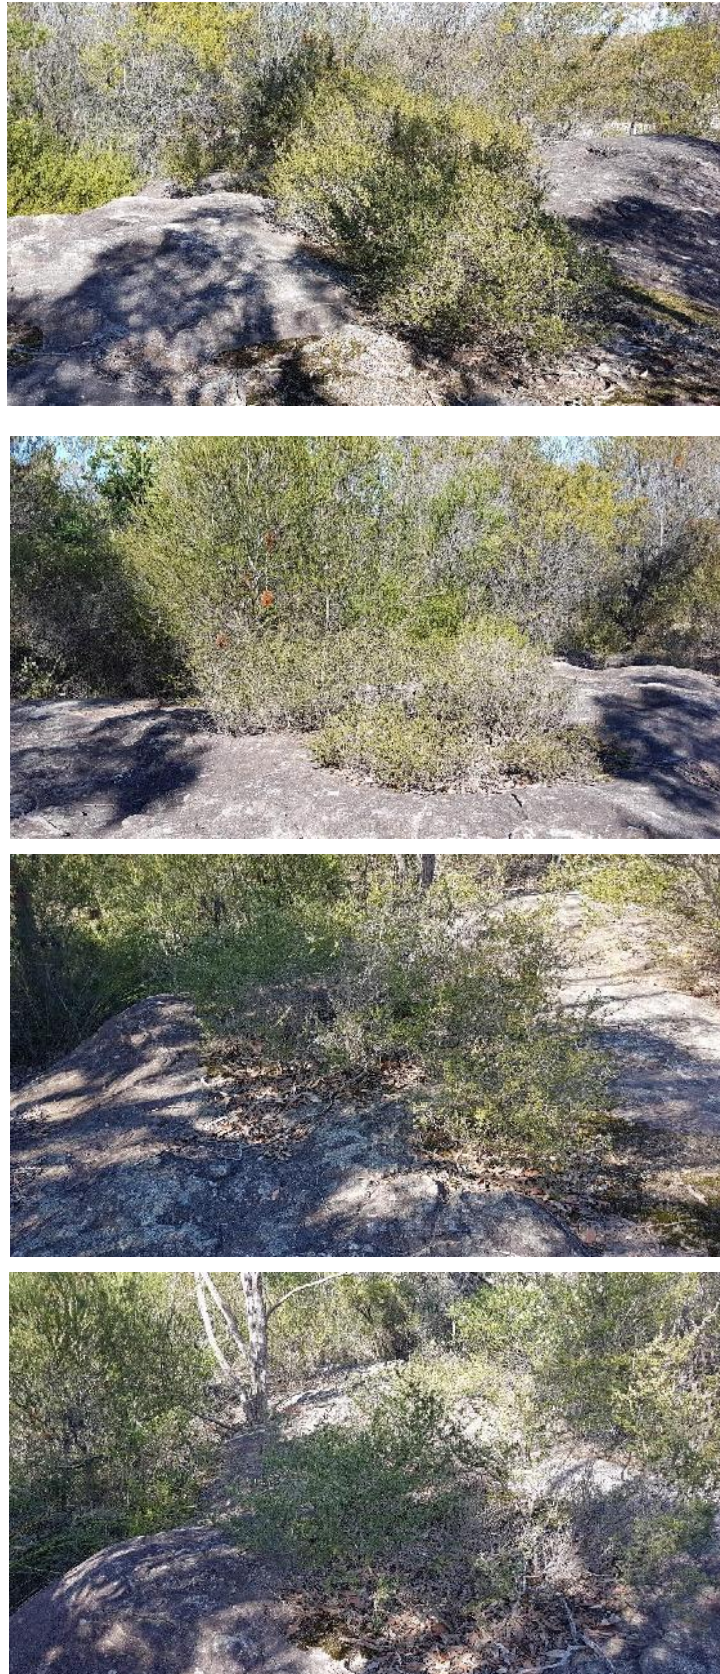
The eastern rock platform has been divided into four individual patches. Patch one had previously identified twenty six individual plants which were all accounted for in 2018. However, most likely due to the current dry weather conditions and the extreme temperatures during the summer months over 2017/2018/2019, two plants had died and a further two are showing signs of dieback. These plants were outliers from the main clump which is most likely why they were affected. The remaining patch is in relatively good health given the extreme dry weather conditions. *Darwinia fascicularis subsp oligantha* was also present within this patch although the *Calytrix tetragona* appears to have perished from the adverse weather conditions.

Patch two is much smaller with only three plants present. All three are demonstrating signs of dieback and the *Calytrix tetragona* previously identified within this patch appears to have died. Within patch three, only two plants, also showed signs of dieback mostly on the lower limbs where reflective heat from the surrounding sandstone is the likely cause. Within patch four only the five *Kunzea rupestris* appears to have survived despite showing some signs of minor dieback. The *Entolasia stricta* and *Calytrix tetragona* previously recorded as present have perished in the dry conditions.

Image 35. 2019 eastern rock platform patch number 1-4, top 1 - bottom 4
