# REPAIRING ALUMINUM WIRING

U.S. Consumer Product Safety Commission  
Bethesda, MD  
[www.cpsc.gov](http://www.cpsc.gov)  
[www.SaferProducts.gov](http://www.SaferProducts.gov)

**Publication 516**

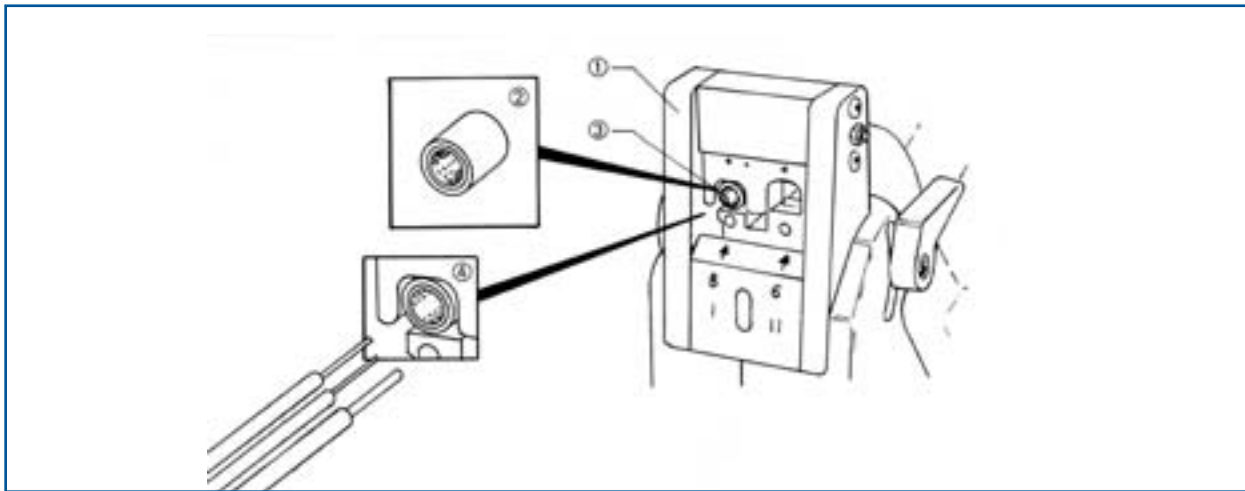
**COPALUM Crimp Connector and its Specialized Installation Tooling**

The COPALUM connector is a specially designed system that includes a metal sleeve intended to be installed only with a dedicated power tool and crimping die to make a permanent connection, that is, in effect, a cold weld (the precision dies in the COPALUM tool compress the connector and wires using upwards of 10,000 pounds of force, as required to make the permanent aluminum wire connection).

The tool is shown in the illustration below. An insulating sleeve is placed around the crimp connector to complete the repair. The copper wire pigtail is then connected to the switch, receptacle, or other termination device. An example of a repaired receptacle outlet is also illustrated below.

Only electricians who are trained by the manufacturer to use the tool properly are authorized to install COPALUM connectors. CPSC staff emphasizes that this training is necessary to ensure that the electrician uses the careful, professional workmanship and thoroughness required to make the crimp connector repair safe and permanent.

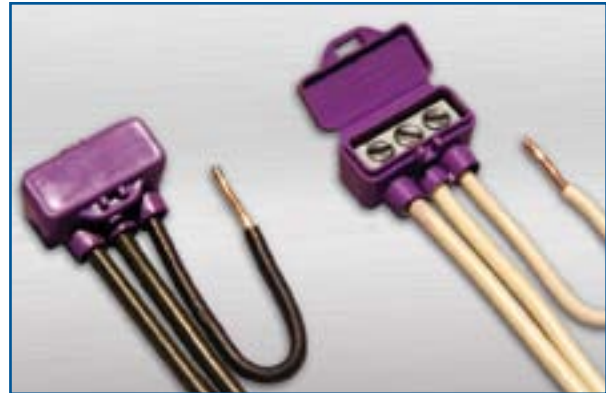
**The AlumiConn Connector**

CPSC staff recognizes that copper replacement may be cost prohibitive and that the COPALUM repair may be unavailable in a locality. Based upon an evaluation that was, in part, CPSC supported,<sup>5</sup> consumers are advised that, if the COPALUM repair is not available, the AlumiConn connector may be considered the next best alternative for a permanent repair. This repair method involves pigtailing using a setscrew type connector instead of the COPALUM crimp connector in the repaired connections. The AlumiConn connector has performed well in initial tests, but is too new to have developed a significant long-term safe performance history as the COPALUM repair. The repair should be conducted by a qualified electrician because careful, professional workmanship and thoroughness are required to make the AlumiConn connector repair safe and permanent.

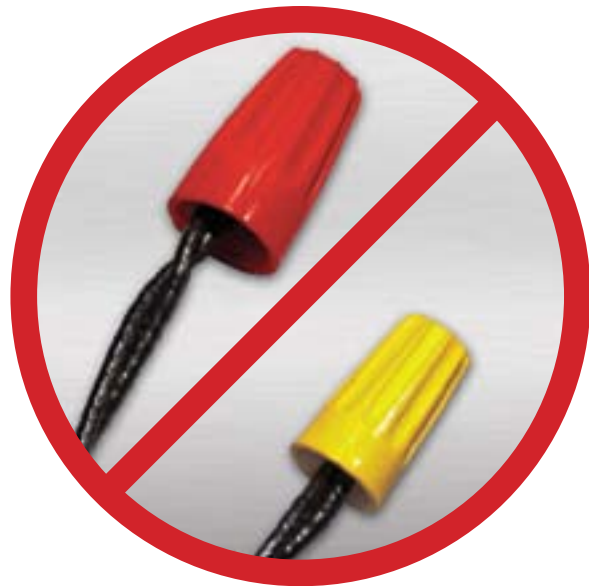
The first temporary repair involves pigtail with a twist-on connector. The effectiveness of “pigtail” using twist-on connectors has been evaluated by CPSC staff. In CPSC-sponsored laboratory testing and life tests, substantial numbers of these connectors overheated severely.

of twist-on connectors with aluminum wire. It is possible that some pigtail “repairs” made with twist-on connectors may be prone to even more failures than the original aluminum wire connectors. Accordingly, CPSC staff believes that this method of repair does not solve the problem of overheating present in aluminum-wired branch circuits.

### **“Pigtail” with Twist-on Connectors Is Not a Recommended Repair**

AL/CU twist-on connector pigtails or CO/ALR devices may be used as an emergency, temporary repair for a failed aluminum termination. Should such a repair be performed, CPSC staff recommends that a complete repair of the aluminum-wired system be performed using the CPSC-recommended methods as soon as possible.
