1100 GRAND CONCOURSE 2014-2019 (10-17a)

1100 GRAND CONCOURSE BRONX, NY 10462

LANDMARK: GRAND CONCOURSE HISTORIC DISTRICT

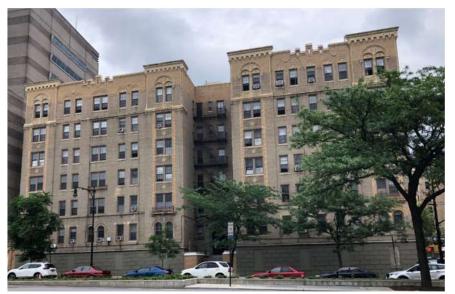
HISTORICAL EXTERIOR RESTORATIVE WORK, consisted of exterior restoration throughout the all facades, which included repairing deteriorated terracotta units utilizing a patching compound; selective replacement of damaged decorative terracotta with new architectural cast stone units; selective replacement of deteriorated masonry; installation of waterproofing membranes beneath select locations of replacement masonry; and selective replacement of deteriorated structural steel window lintels and a portion of the adjoining brickwork with new galvanized steel lintels and new brickwork, as well as rebuilding the damaged northeast corner of the building; rebuilding the brick and terracotta parapets; selective replacement and repointing of brick; selective sill replacement; selective terracotta replacement with GFRC or cast stone; exterior alterations at the roof, including replacement of the roofing membrane, the installation of control joints on the inside facing walls of the parapets; and cladding the bulkheads in stucco.

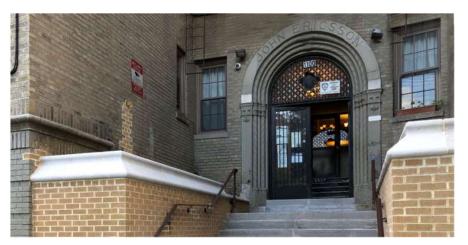
HISTORICAL ENTRANCE RESTORATION WORK, patch and repaint of the concrete planters flanking the primary entrance at the first floor to match parapet.

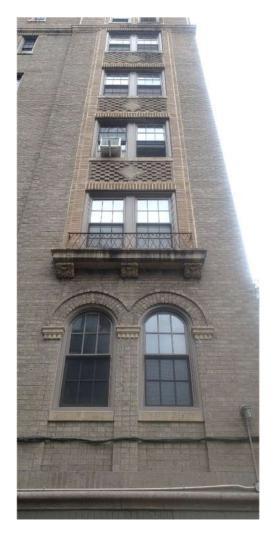
HISTORICAL WINDOW RESTORE,

including replacement of 726 white painted, straight-headed, one-over-one, double hung metal windows throughout all of the building facades with light brown painted double hung windows, including 30 arch-headed, six-over-six, wood windows at the second floor level; 63 straight-headed, one-over-one, metal windows at 11 vertical rows of small windows at courtyard, including 5 vertical rows at the street facing courtyard façade; and 633 straight-headed six-over-six metal windows at all of the remaining windows openings.
