39-60 54TH STREET

39-60 54TH STREET
WOODSIDE, NEW YORK 11377

GARAGE REPAIRS

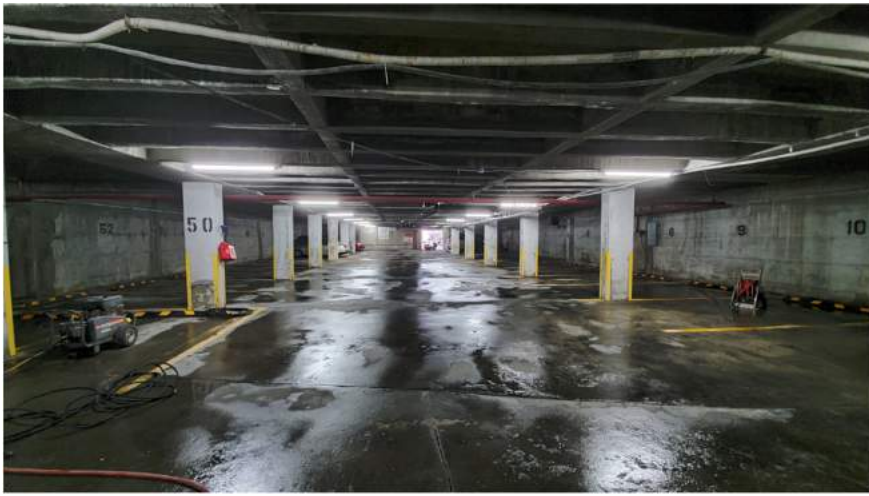
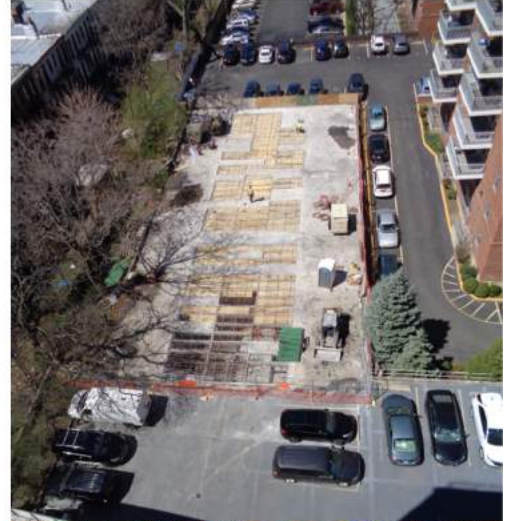
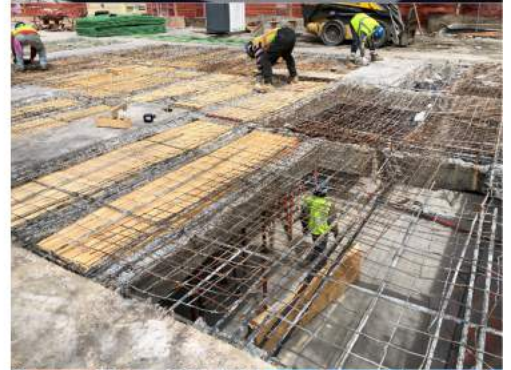
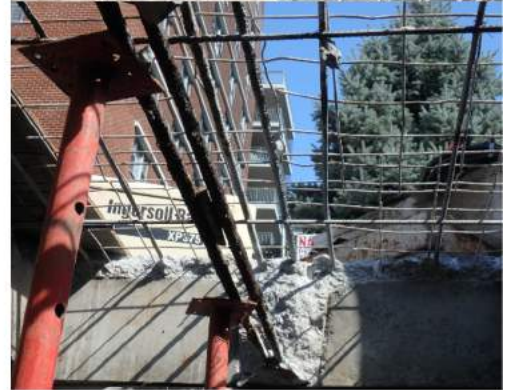
STRUCTURAL CONCRETE REPAIRS: ongoing leaks at the topping slab of the partially submerged concrete parking structure caused substantial cracking and spalling of the rib joists in the one-way concrete slab. Sound testing of the existing joists was performed and patching repairs or complete form and poured replacements of deficient beams conducted. Once structural repairs were completed a new waterproofing membrane was applied to the structural slab, and a new concrete topping slab poured in place. Existing drains were replaced, and additional drain inlets installed to improve the systems overall drainage capacity.

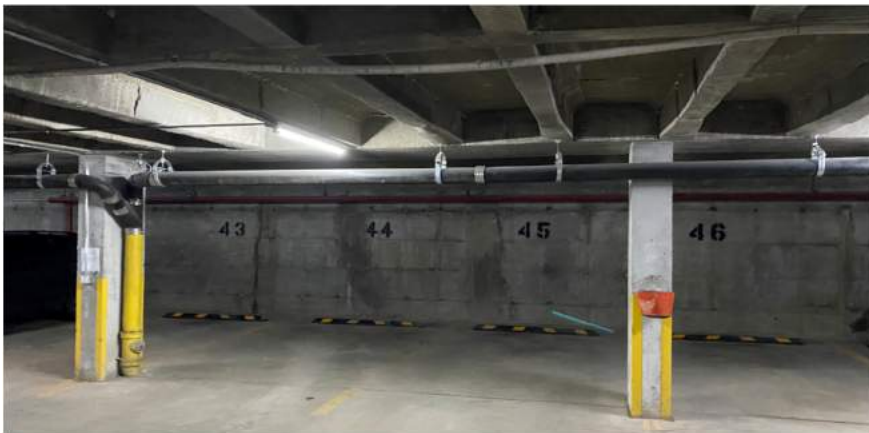
IMPACT RATED GUARDRAIL: the partially submerged structure had a steep drop along one side where the topography fell off that was only protected by a curb and a broken guard-rail. To reduce the risk of vehicular accidents a new impact rated guardrail was installed along the entire length of the roof edge.
