**IVIE RISK SOLUTIONS**

# RISK CONTROL ASSESSMENT

Property Address:  
**Full Property Address**

This is a 4-unit apartment building located in (city), California. Constructed in 1980, the property has remained under the same ownership since original construction and demonstrates long-term stewardship through ongoing maintenance and capital improvements.

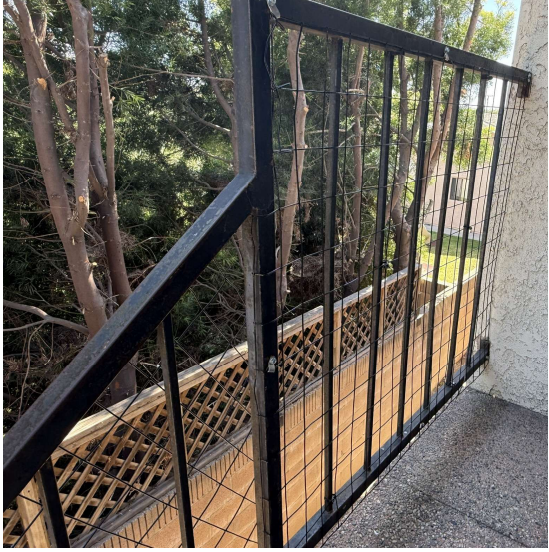
Handrail openings

The exterior stairway has guardrails with wire mesh covering the openings.

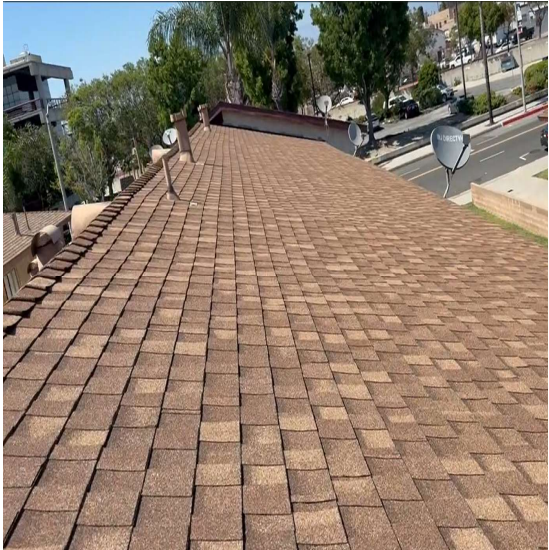
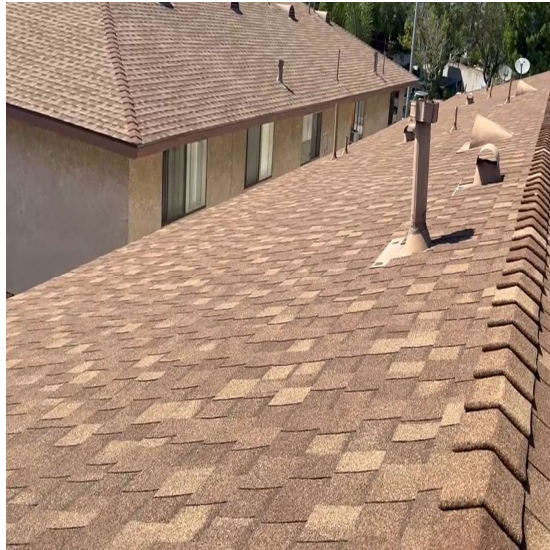
## Roof

| Age of roof:<br>Roof age unknown. Based on visual observations, the composition shingle roof appears to be in good condition and is estimated to be approximately 10–20 years old. | |
| Roof updates:<br>Minor roof repairs, including patching, were completed within the past year. | |

| Any roof hazards or deficiencies observed:<br>No hazards or deficiencies were observed to the roof structure. | |

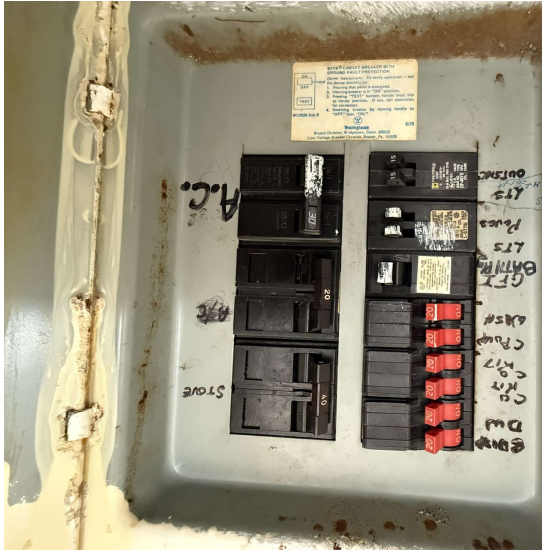
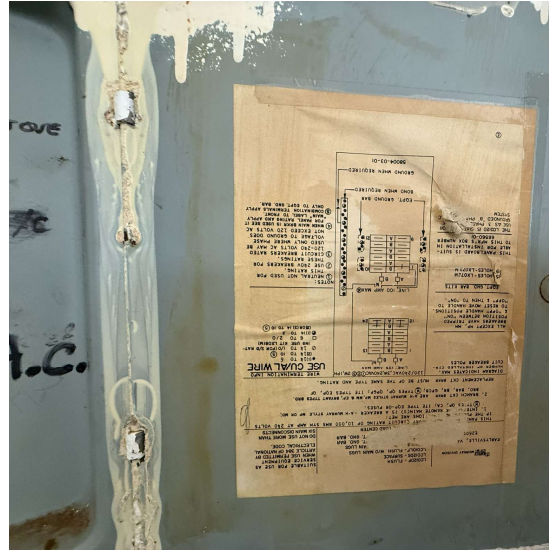
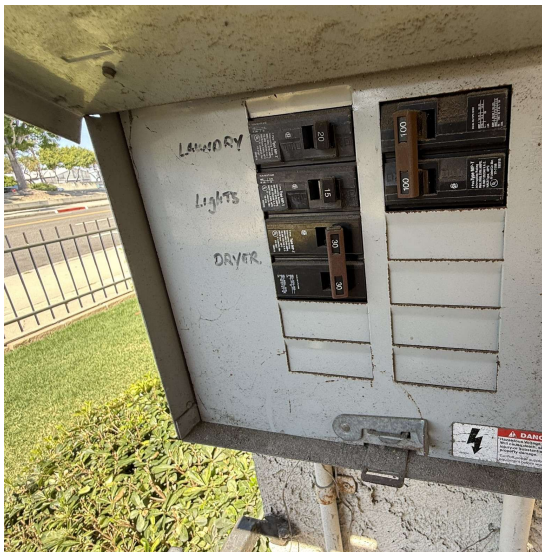
## Electrical

An electrical inspection was conducted in 2026 by a licensed electrician to evaluate the condition of the electrical system and determine whether aluminum branch wiring was present within the property. The electrical distribution panel appeared to be an older Westinghouse load center. Multiple breaker manufacturers were observed within the panel, including Westinghouse, Challenger, and Square D. No evidence of overheating, arcing, damaged breakers, or other adverse conditions was observed at the time of inspection. According to management, the licensed electrician did not identify aluminum branch wiring and no deficiencies requiring corrective action were reported.

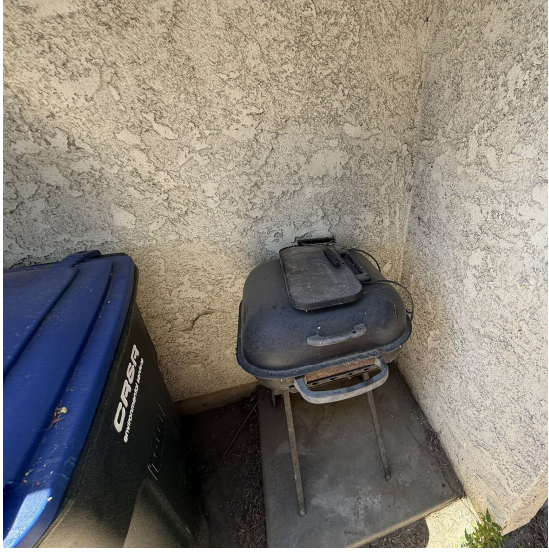
A charcoal grill was observed adjacent to the building. Open-flame grills present a fire hazard when used or stored near structures and combustible materials. Property management should prohibit the use and storage of charcoal, propane, and other open-flame grills within 10 feet of buildings and combustible materials, in accordance with applicable fire safety guidelines. These restrictions should be communicated to tenants in writing and enforced by management. Electric grills may be permitted where allowed by local regulations.

Charcoal barbecue grill (Rear of building)

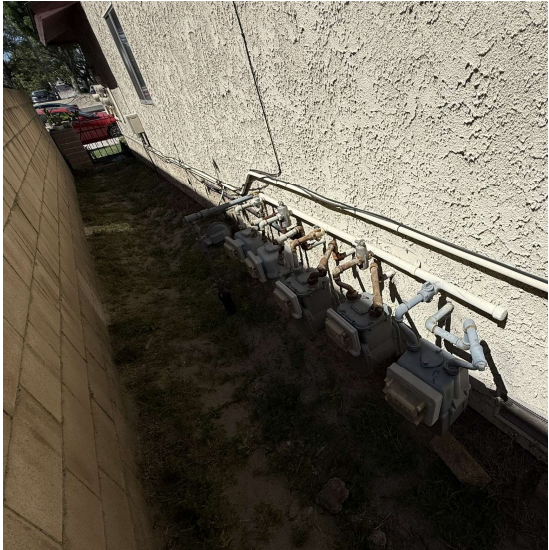
Gas meter with no earthquake shut off valve

It is recommended that earthquake shut-off valves be installed on the gas meters to automatically stop gas flow during seismic activity, reducing the risk of fire or explosion.

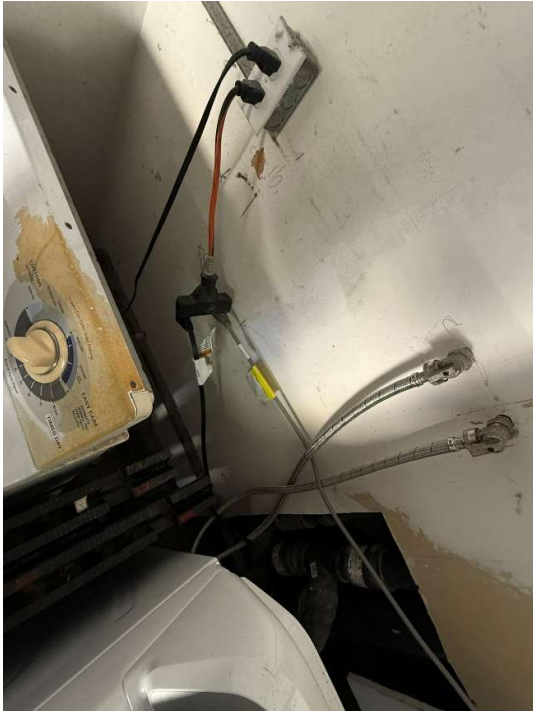
An extension cord was observed supplying power to the washing machine. Extension cords are not intended for permanent appliance use and may increase the potential for electrical failure. Direct connection to a properly rated receptacle is recommended.

Extension cord supplying washing machine

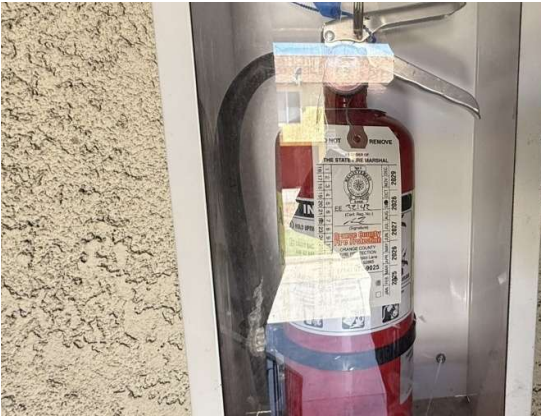
Fire extinguisher currently serviced
