Filing the tabs down.

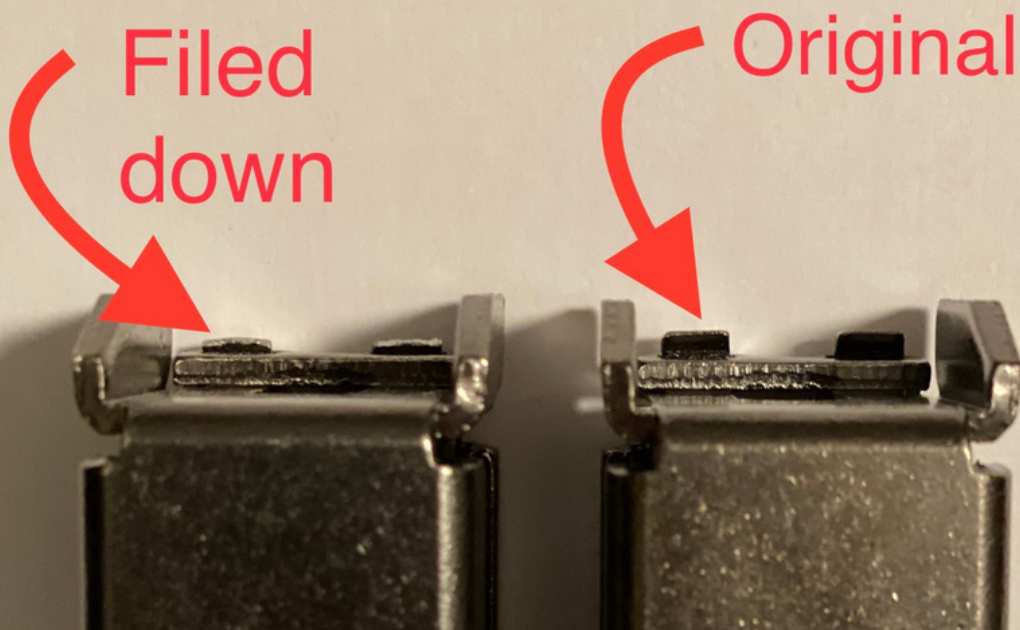
SOME USERS MAY ENCOUNTER THE ISSUE OF NOT BEING ABLE TO HOOK THE SECOND PIECE/TAB AFTER TIGHTENING DOWN THEIR ROTOPAX TANK, THIS CAN HAPPEN DUE TO TOLERANCES BETWEEN ROTOPAX AND THE GORILLA CLAMP MANUFACTURING, THE GOOD NEWS IS THE GORILLA CLAMP HAS MANY ADJUSTMENTS THAT CAN BE MADE BY THE USERS TO FIT THEIR SETUP. PLEASE SEE BELOW FOR THE MODIFICATION TO THE CLAMP WHICH INVOLVES FILING DOWN THE TWO HOOKS TO A HEIGHT OF 1/4" OR WHAT'S NEEDED FOR YOUR SET UP. SOME TOUCH UP PAINT TO COVER THE EXPOSED METAL HELPS CORROSION. USUALLY THIS HEIGHT RESOLVES THE ISSUE.

IF THIS DOES NOT RESOLVE YOUR ISSUE PLEASE REACH OUT TO US VIA EMAIL AT [SUPPORT@GORILLACLAMP.COM](mailto:support@gorillaclamp.com)

WE CAN ALSO OFFER AN EXCHANGE OF A NEW CLAMP WITH THE MODIFICATION IF YOU ARE UNABLE TO MAKE THIS UPDATE AS LONG AS THE ORIGINAL CLAMP IS STILL IN AN UNMODIFIED STATE.
