Inspection Report

Michael J. Turner Home Inspections LLC

FRENCH QUARTER New Orleans, Louisiana 70116

1 Report Information

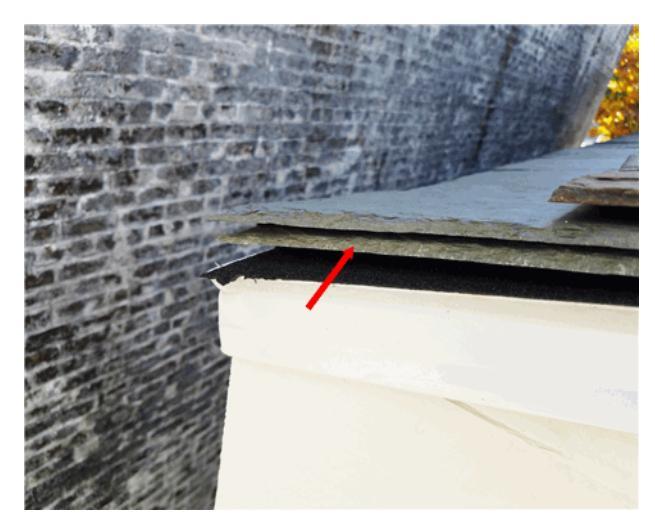
1) Roof - Repair Conditions	1. The slate roof had little to no head-lap at the edge. Natural slate starter course was installed upside down or with the back side facing down. The starter slate is normally installed with the back side (smooth surface) facing up in order for the beveled edge to merge flush with the beveled edge on the first course. The starter slate is the only slate on the roof with the back side facing up. Although this will not adversely affect the function of the roof system it does indicate non-professional installation. Further evaluation by a licensed expert slate roofing company.

1. Natural slate strater course was installed upside down. Large head lap opening

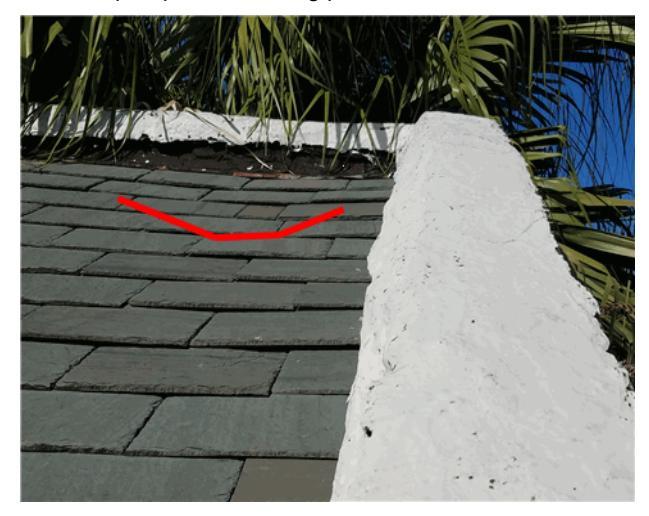
Depression "sag" @ right side back quarters roof. Support in attic recommended

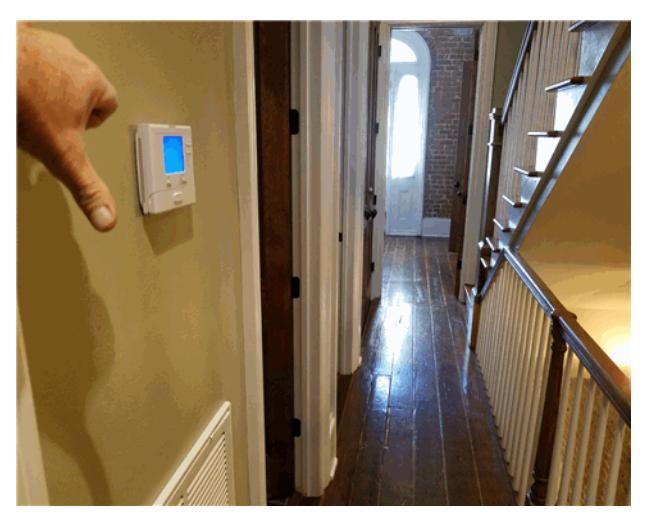
2) Heating - Repair or Safety Conditions	1. Second floor main building thermostat was inoperable. The inspector replaced (6) AAA batteries in all three thermostats since digital display was non-operational and showed low battery levels. Second floor thermostat even after replacing batteries was non responsive to cooling and heating. Only the fan worked in on position. No numbers were displayed on thermostat. The inspector being a state licensed mechanical (HVAC/R) contractor #58032 performed about 20 minutes of troubleshooting to determine the cause and found the thermostat was inoperable.

Compressor and heater did respond when jumped out @ the circuit board. 24 VAC control signal does reach the wires @ the thermostat. Recommend replacing the thermostat.

1. Second floor main building thermostat was inoperable

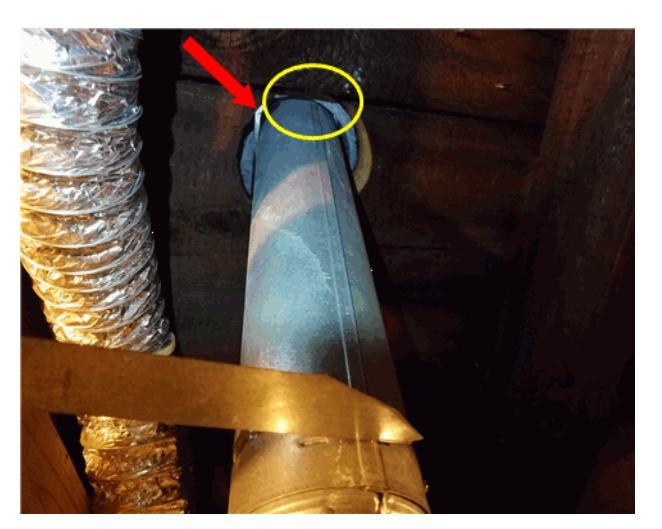
2. The gas flue vent for the furnace does not vent pass the roof jack, rather stopping inside the roof jack. This type of venting is no longer performed today. Recommend the vent pipe penetrate through the roof jack and into the atmosphere. The vent pipe for the gas furnace was touching the wood sheathing in attic. Recommend a one inch clearance be provided and the pipe secured/strapped for safety.

2. Daylight - Opening @ roof. Improper 1-inch clearance to wood (combustible material)

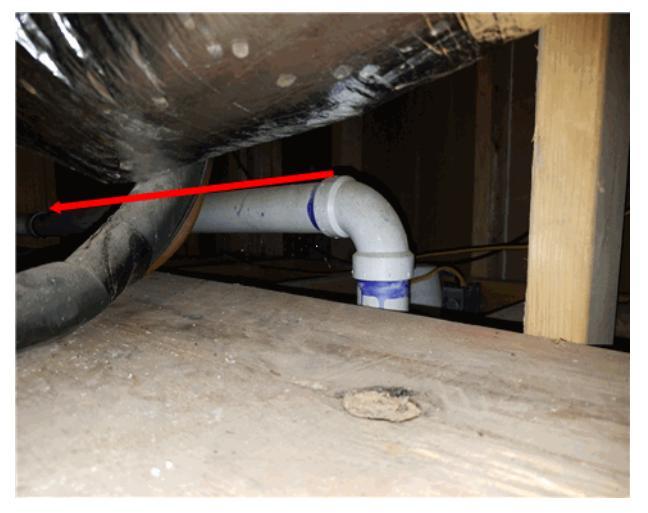
2. Attic areas: Multiple areas of the plumbing drain, waste and vent lines lacked support straps, limited slope to drain water. Horizontal to horizontal connection was noted at condensate drain line without using proper WYE or 1/8" bend radius and lacked P-trap @ back building. Evaluate and repair

2. Attic areas: A few areas of the plumbing drain, waste and vent lines had a lack of support straps

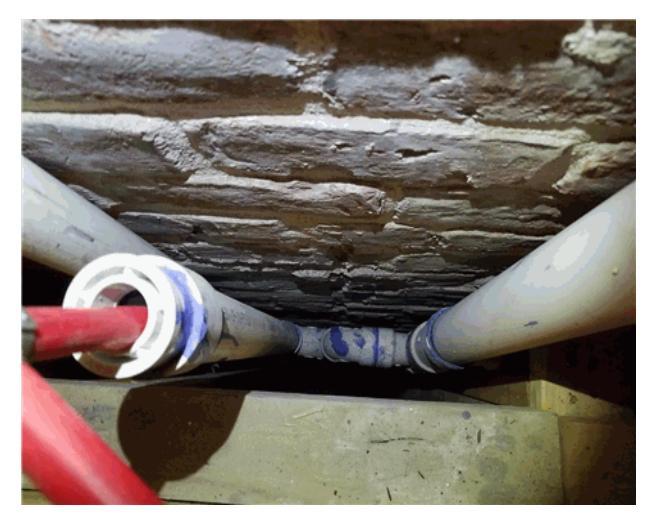
Improper slope and lack of straps for support

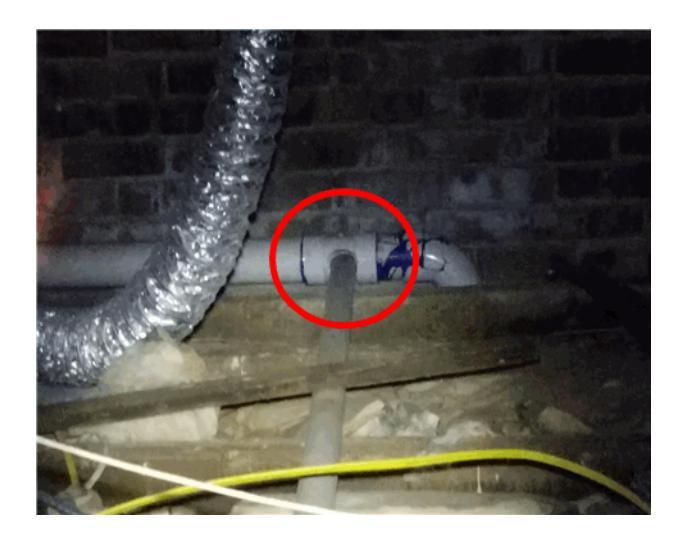
2. Attic areas: A few areas of the plumbing drain, waste and vent lines had a lack of support straps

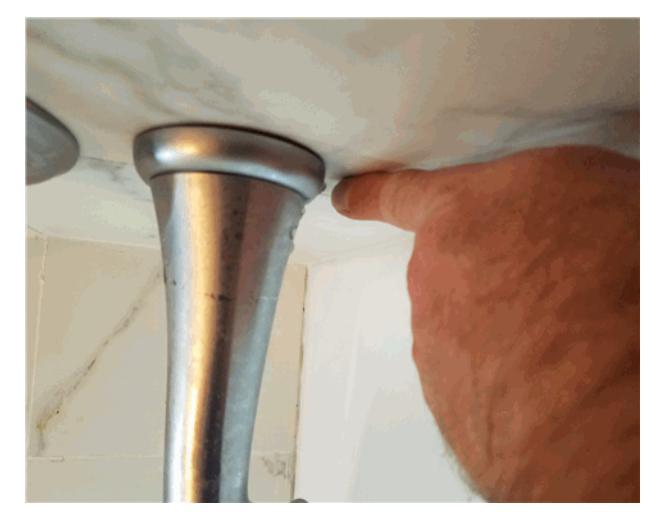
3. Second floor bath shower valve / handle leaks intermittently and the tub spout leaks which has a gap at wall, in which water can enter. Evaluation suggested

3. Second floor bath shower valve / handle leaks intermittently and the tub spout has a gap in which

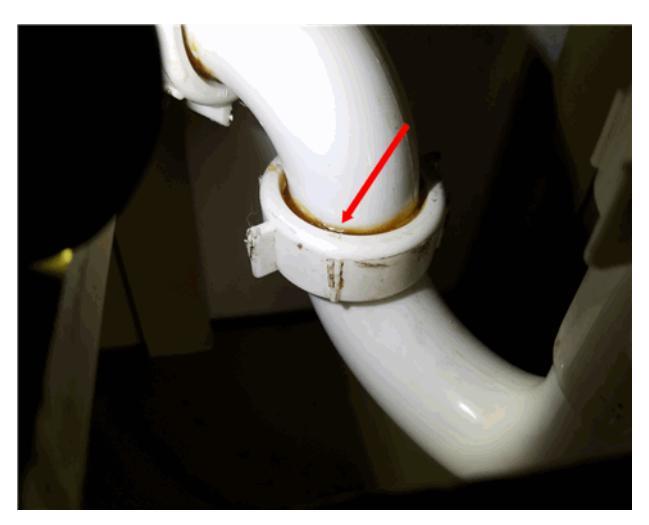
5. Leak / seepage at drain line under main building bath sink master bath in back.

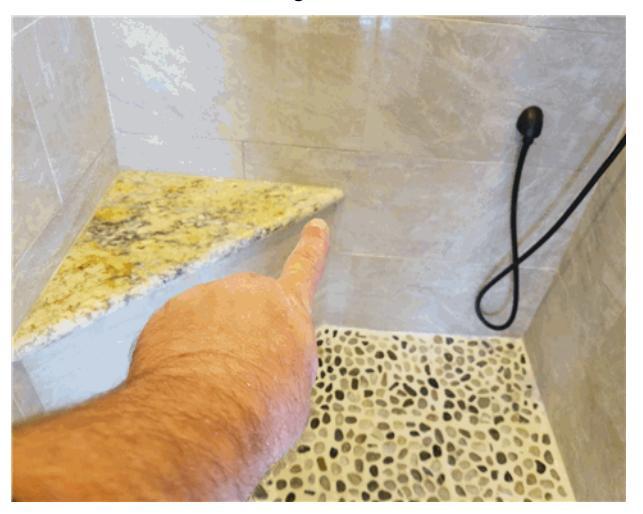
7. Multiple gaps / openings noted @ grout lines @ shower tiles. To prevent moisture related damage. Improve as part of general maintenance by sealing. Conditions behind walls were hidden / concealed and were not visible or accessible for inspection. The reveal of the tiled shower wall at back building protrudes further than the pan and was not uneven due to wall. Caulked used to fill gap underneath. Monitor and maintain wall system to prevent water intrusion.

7. Multiple gaps / openings noted @ grout lines @ shower tiles. To prevent moisture related damage.

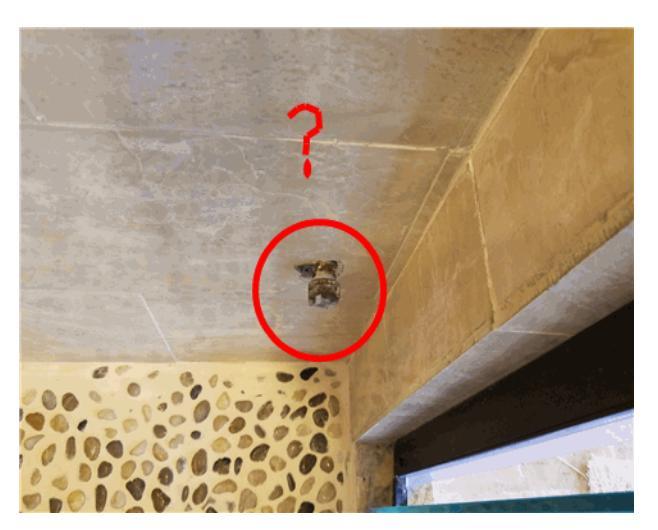
7. Multiple gaps / openings noted @ grout lines @ shower tiles. To prevent moisture related damage.

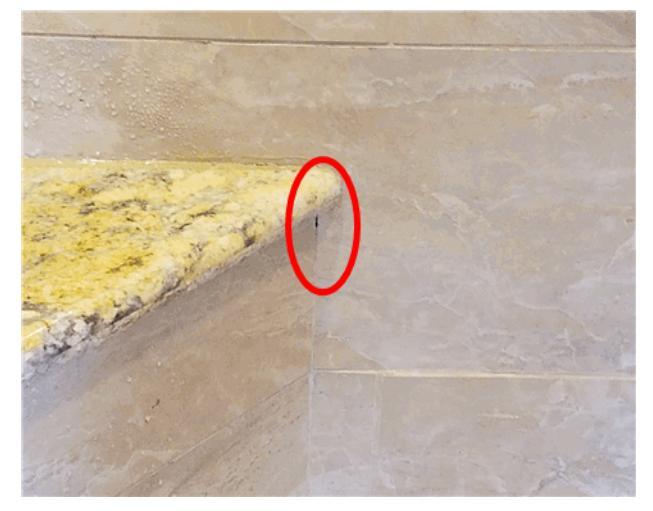
7. Multiple gaps / openings noted @ grout lines @ shower tiles. To prevent moisture related damage.

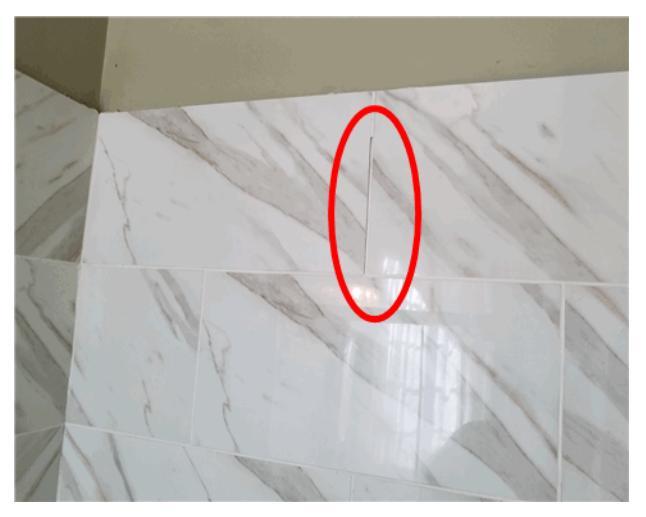
7. Multiple gaps / openings noted @ grout lines @ shower tiles. To prevent moisture related damage.

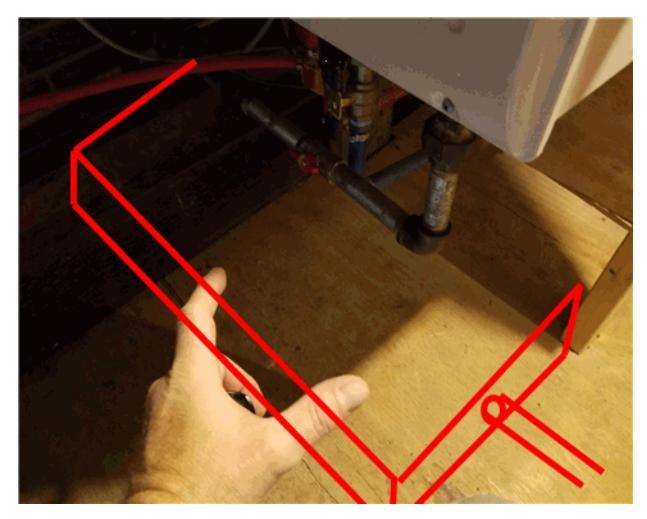
1. Drain or catch pan was not present under the on demand water heater in attic of main building. This can cause damage if the water heater leaks. Suggest a licensed plumber install this emergency water heater drain pan in attic with a pipe to drain to exteriors where visible. If a pipe cannot be installed due to location an audible alarm can be installed with a water shut off valve tied into the water system and alarm and warning float switch. Evaluation and repairs suggested

1. Drain or catch pan was not present under the on demand water heater in attic of main building.

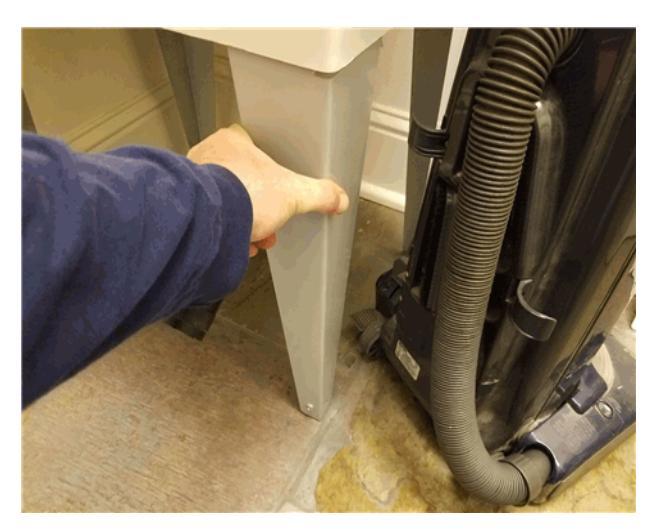
1. Laundry mop sink was loose @ wall / floor at main building - recommend securing to prevent movement / leaks.

1. Laundry mop sink was loose @ wall / floor at main building

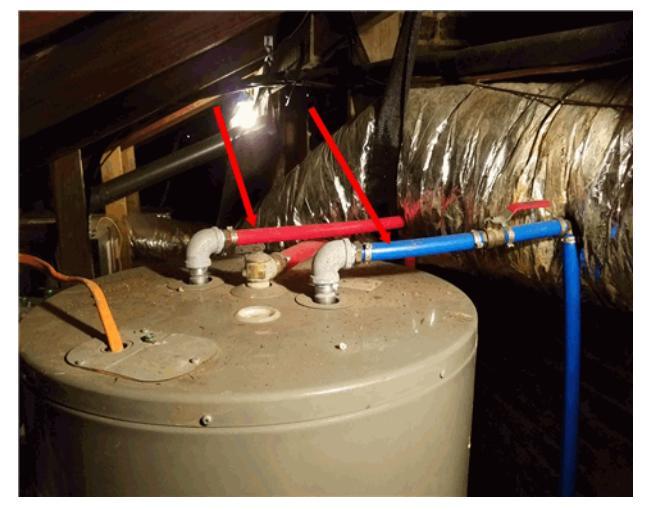
2. Ideally, 18-inch metal (usually 3/4" copper) extensions should be installed before connecting water supply lines directly to top of water heater tank. Although the manufacturer does allow direct contact - it has been known to be problematic when temperature exceeds manufacturers recommendations. Improvements are suggested.

2. Ideally, 18-inch metal (usually 3/4" copper) extensions should be installed before connecting wat

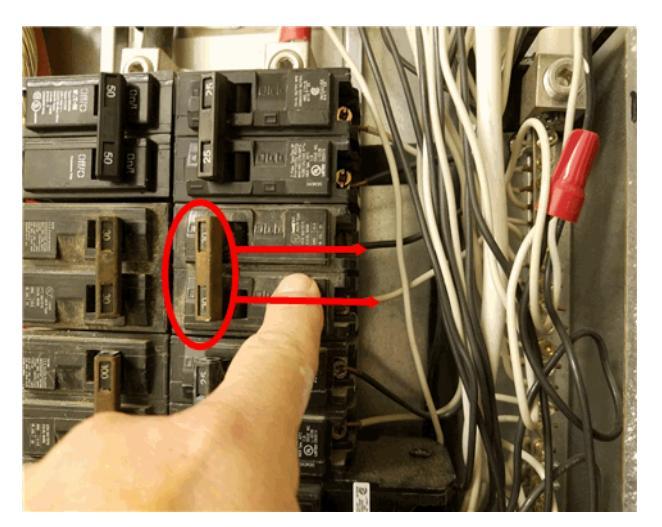
9) Repair Conditions 1. Wire(s) @ laundry room sub panel breaker box was undersized for the attached circuit breaker. All wires should coincide and/or be rated with breaker amperage. 30 amp breaker should be replaced with a 20 amp two-pole breaker.

1. Wire(s) @ laundry room sub panel breaker box was undersized for the attached circuit breaker.

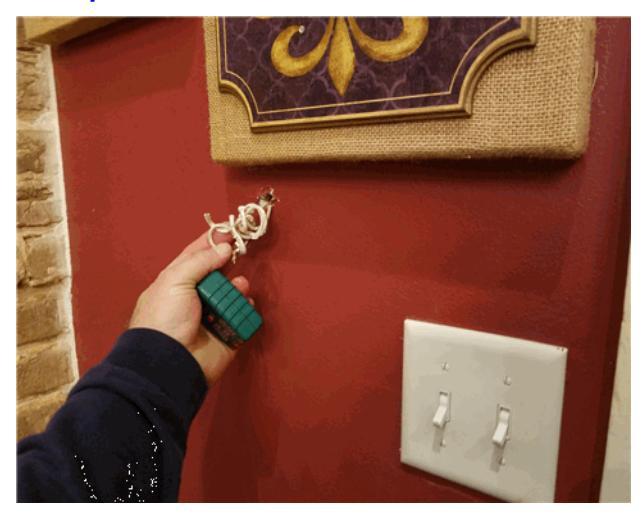
1. Unknown wires noted at main building wall and near ceiling wood trim beams. This appears to be low voltage type wiring for security cameras, or control device. Verify with owner and if not used install in junction box with cover.

1. Unknown wire noted at main building wall.

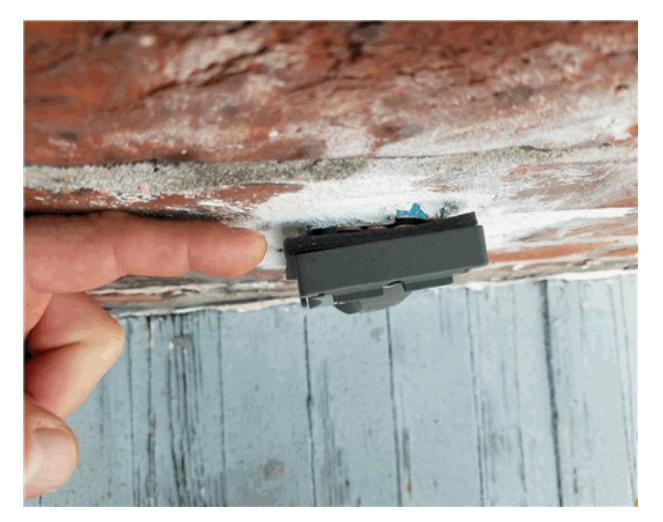
3. Exterior GFCI outlet cover was loose at front balcony, leaving a gap for water to enter. Secure cover plate @ outlets

3. Exterior GFCI outlet cover was loose at front balcony, leaving a gap for water to enter.

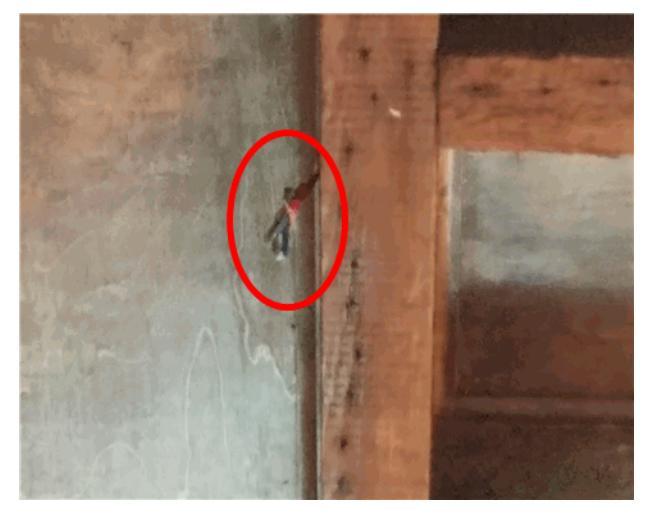
1. Unknown wires noted at main building wall and near ceiling wood trim beams.

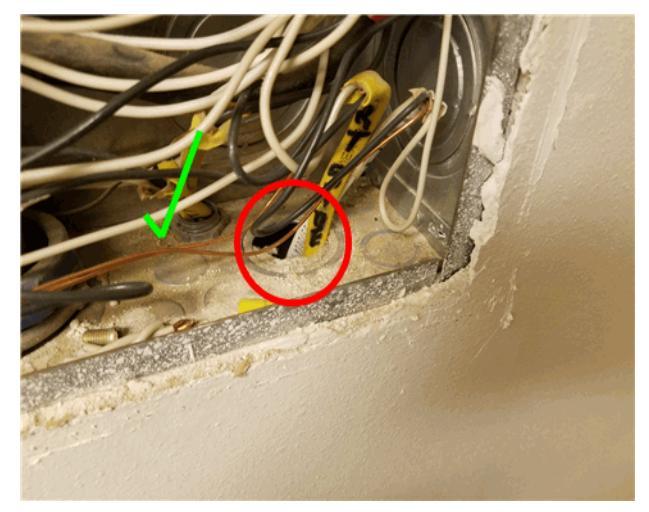
5. Wire(s) entering the bottom of laundry room sub panel breaker box was missing the plastic bushing or wire clamp. Improve for safety

5. Wire(s) entering the bottom of laundry room sub panel breaker box was missing the plastic bushing

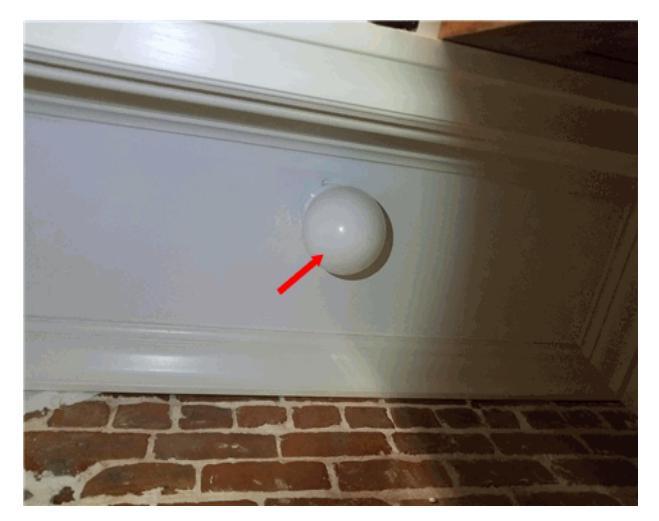
7. Light at 2nd floor closet light and study room ceiling surface mount light was inoperable using normal switch controls and pull chain. Power was present @ the fixture when tested with volt meter at the light fixture. Replace lamp and test before closing

7. Light at 2nd floor closet was inoperable using normal switch controls and pull chain.

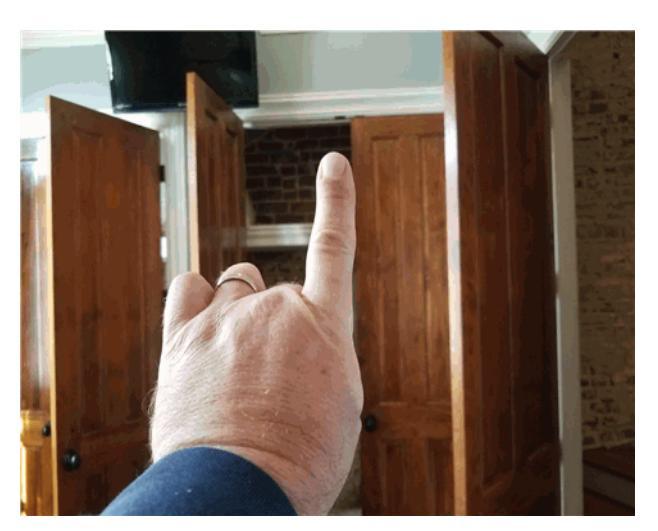
7. Light at 2nd floor closet was inoperable using normal switch controls and pull chain.

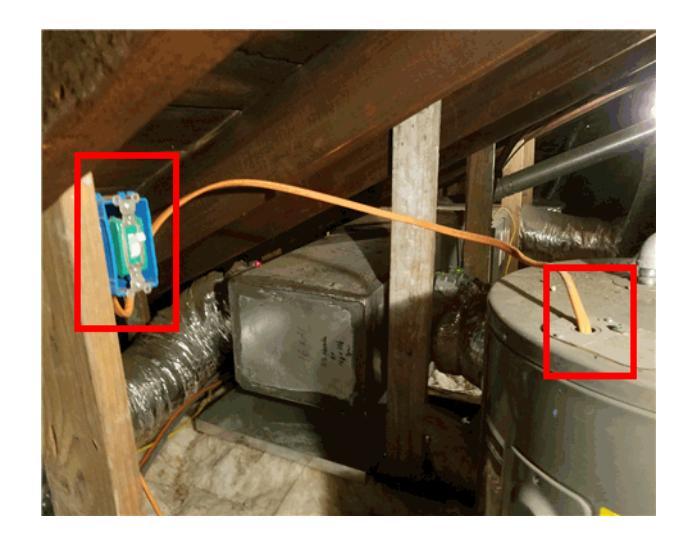
9. Plastic bushing or wire clamp should be installed at the electric water heater at back building. Improve for safety

9. Plastic bushing or wire clamp should be installed at the electric water heater at back building.

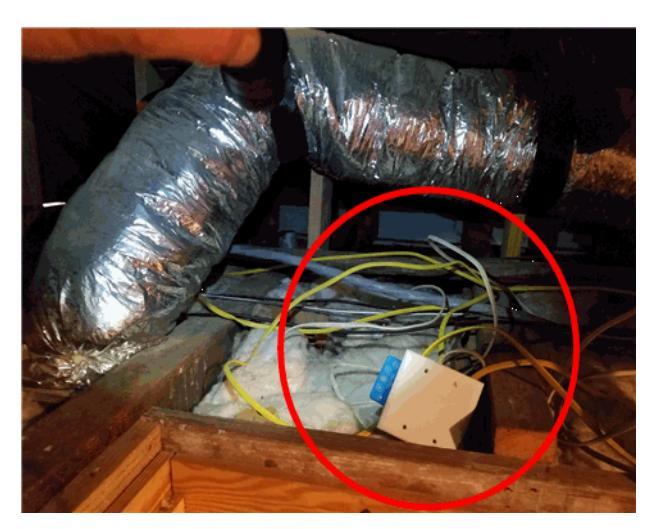
6. The wires were loose in attic. Securing wires every 4-5 feet with proper staples and keeping away from metal

6. The wires were loose in attic.

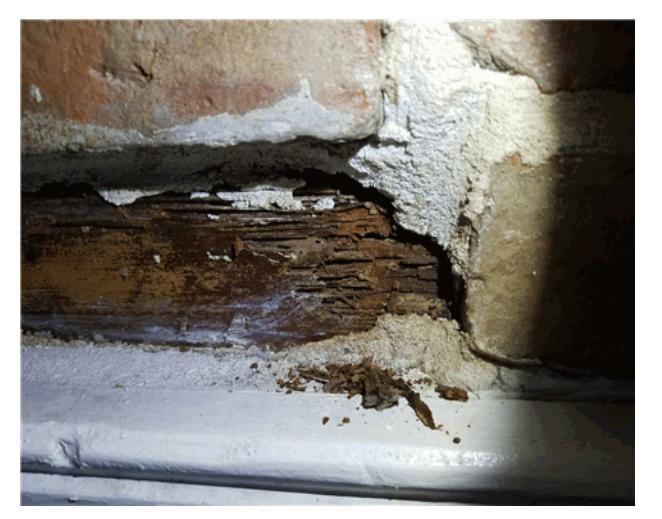
Moisture - Termite damage

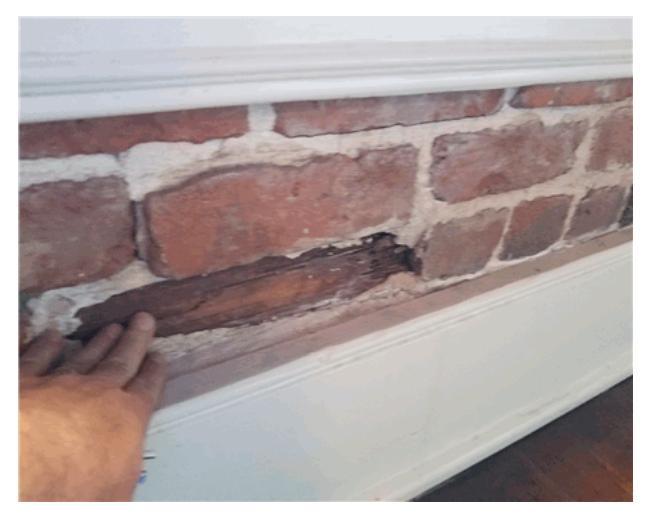
Moisture - Termite damage

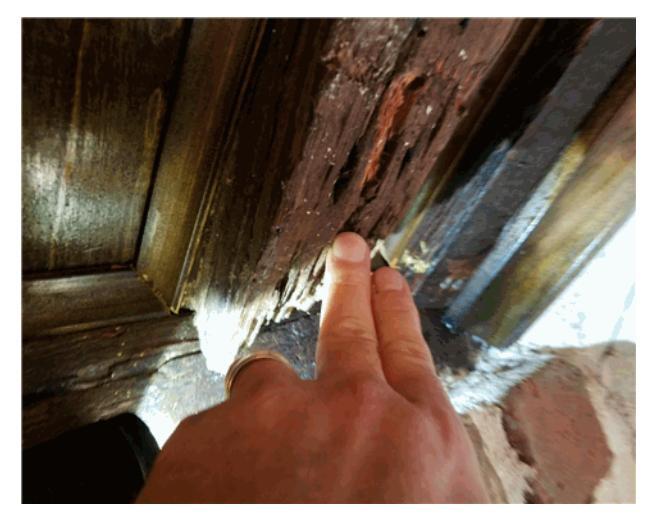
Moisture - Termite damage

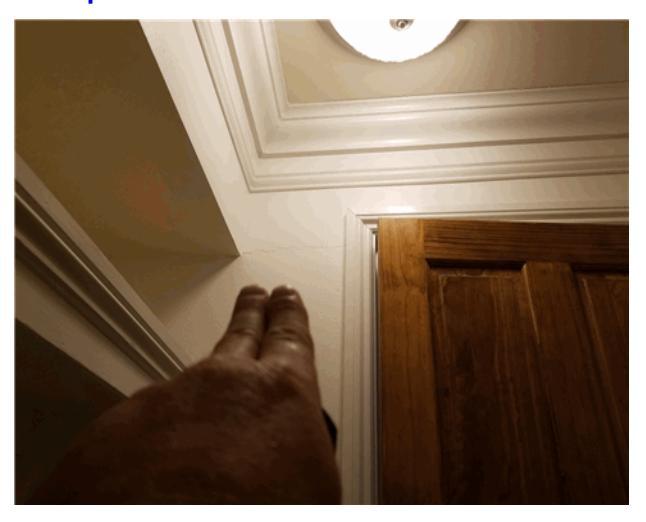
1. Typical crack noted at main building between door and closet shelf.

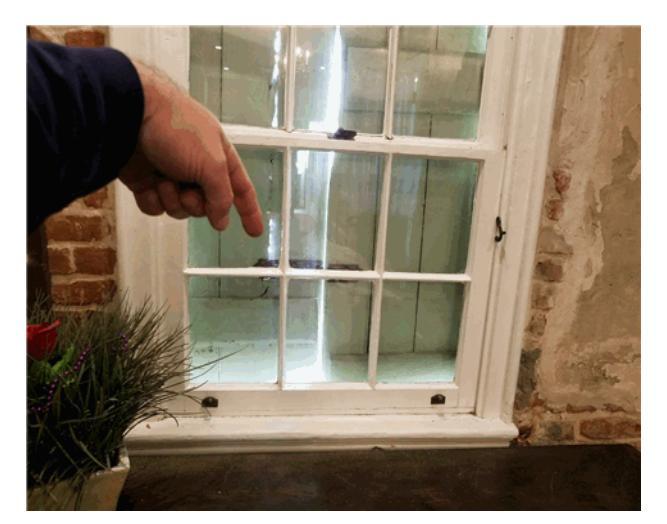
2. Cracked glass pane(s) were observed @ abck building.

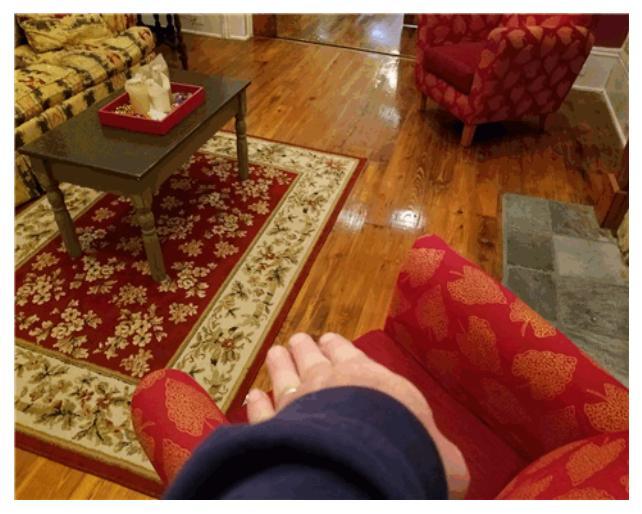
1. Slight sloping was noted to the floors both at the front and rear buildings.

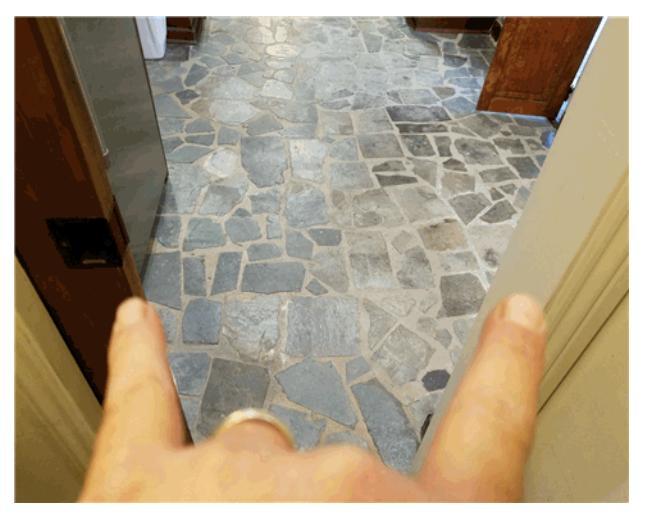
2. Door hardware missing at pocket doors.

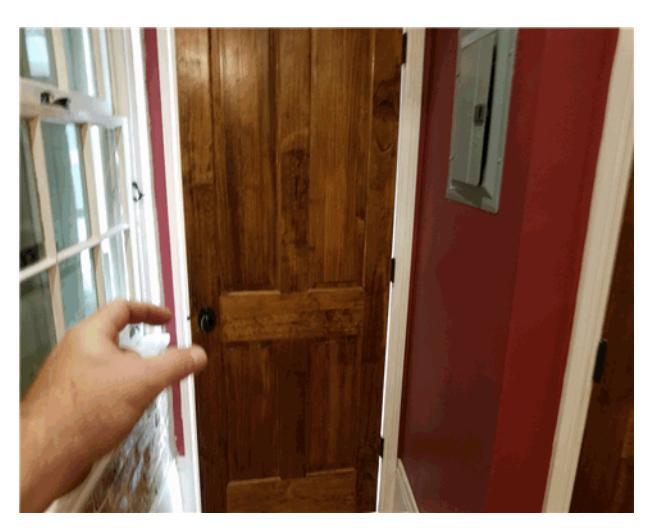
3. Wood door @ hall near electrical sub-panel mounted on wall @ back building did not stay close or align with the strike plate and latch. Adjustments suggested.

3. A few doors did not stay close or align with the strike plate and latch.

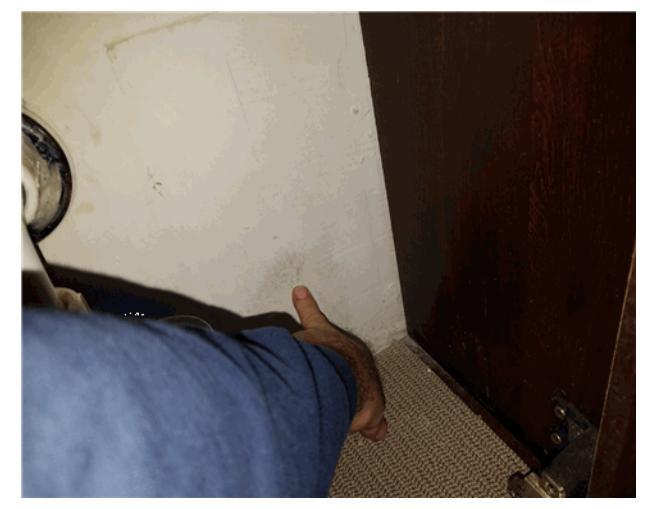
1. Suspected mold was noted to the interior wall inside the bath vainty sink of front home.

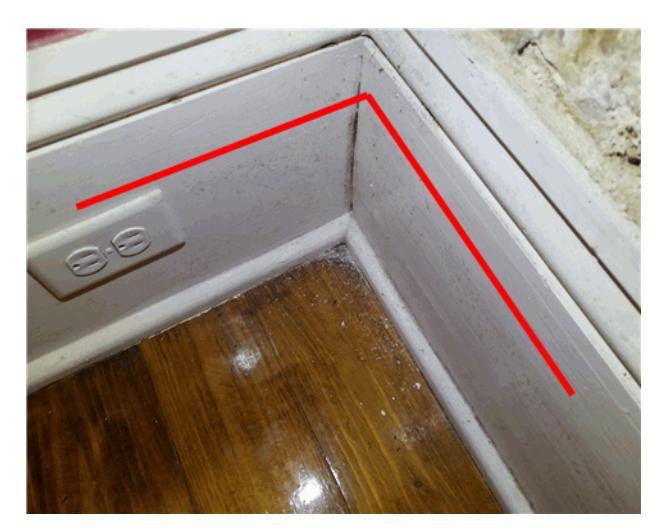
Moisture wicking into brick wall - wood base trim showed growth. White powder = brick degradation

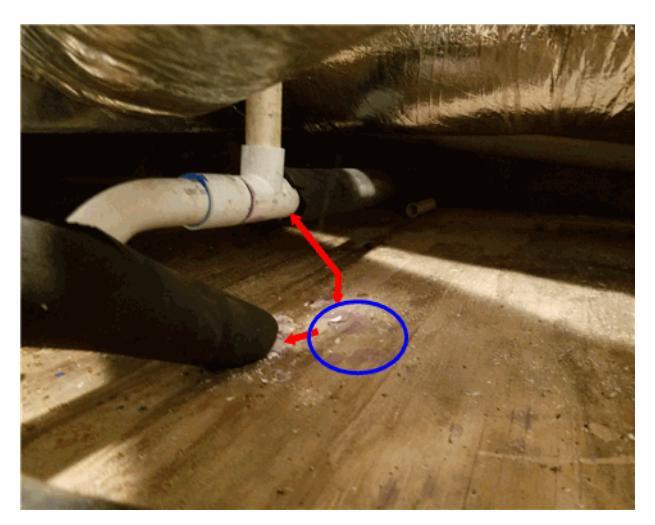
Improper slope of AC condensate - Missing pipe insulation and-P-trap, stains

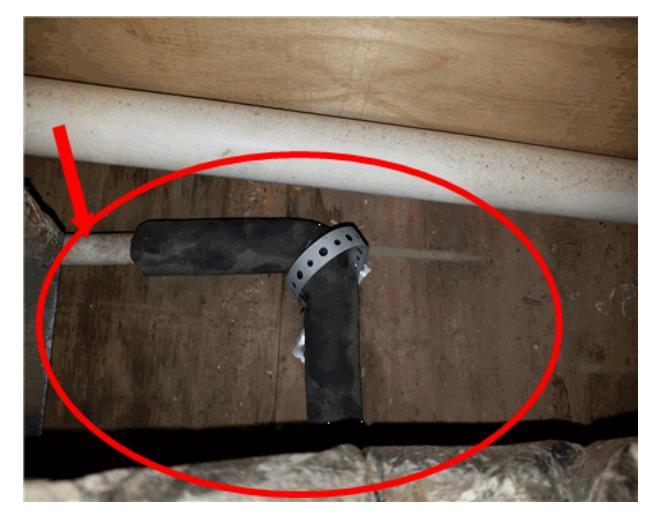
Stains to wood sub-floor. Condensate from AC condensate drain line missing pipe insulation

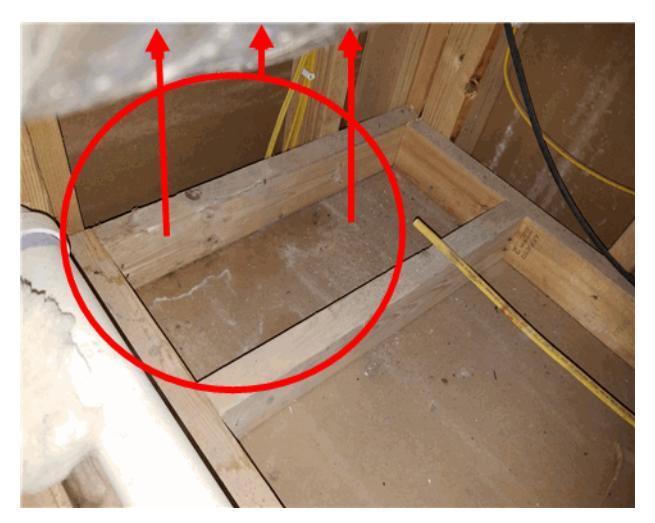
Growth to back of drywall (white stains) - wall backs up to solid brick wall cracks allow water 3. Further evaluation is needed at the main home 2nd floor attic

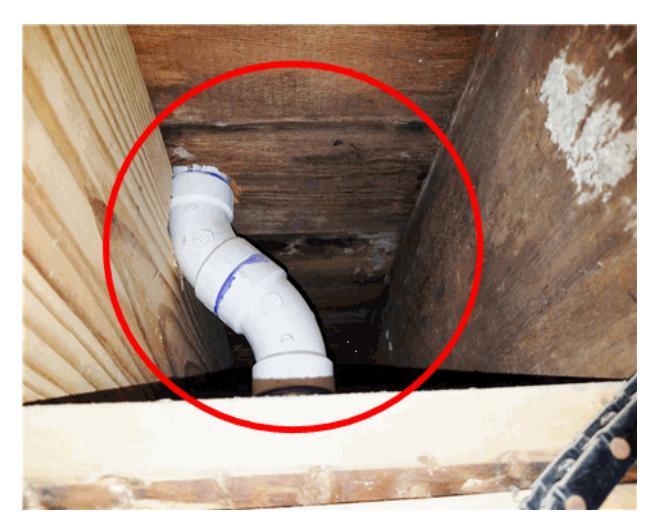
Stains @ 2-inch PVC drain for bath sink above. Floor joist partially notched

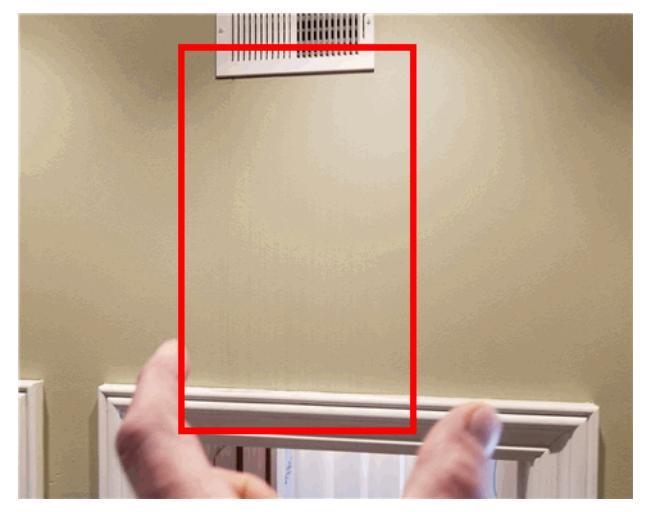
5. Many walls under air registers showed condensation drips with rust noted to metal air registers.

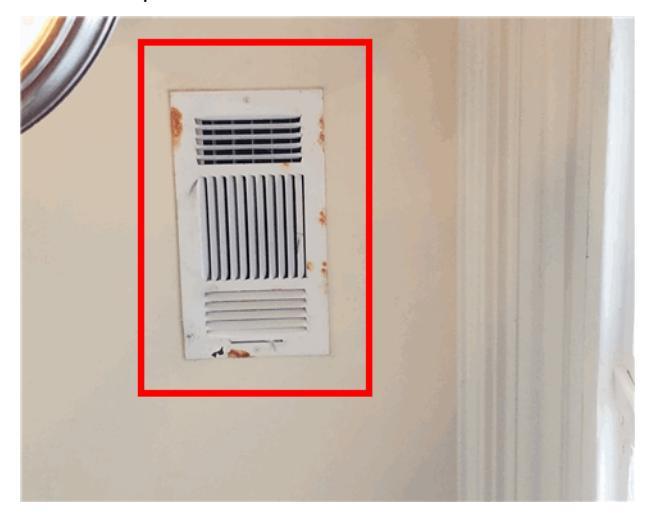
5. Many walls under air registers showed condensation drips with rust noted to metal air registers.5. Many walls under air registers showed condensation drips with rust noted to metal air registers.

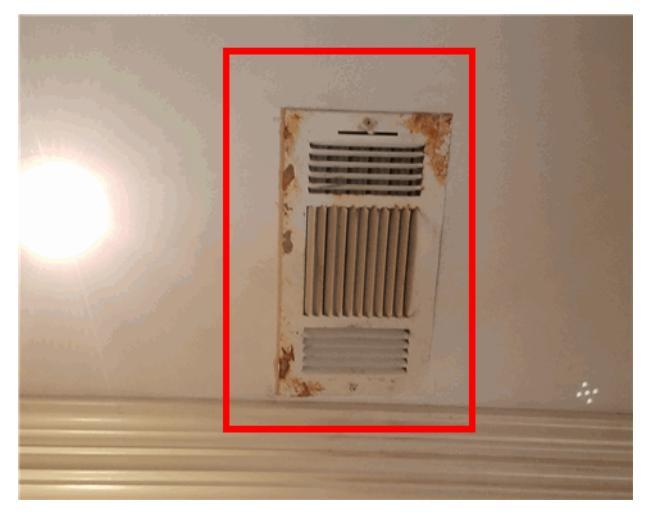
5. Many walls under air registers showed condensation drips with rust noted to metal air registers.

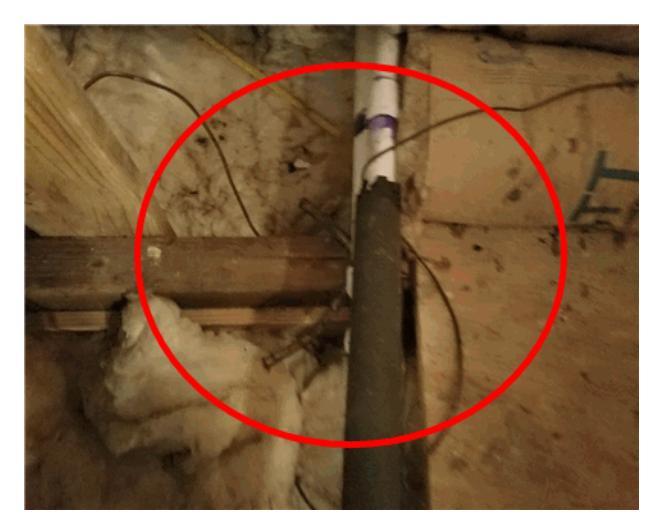
7. Evalaute and repair cause and damage to suspected mold growth in back building attic.

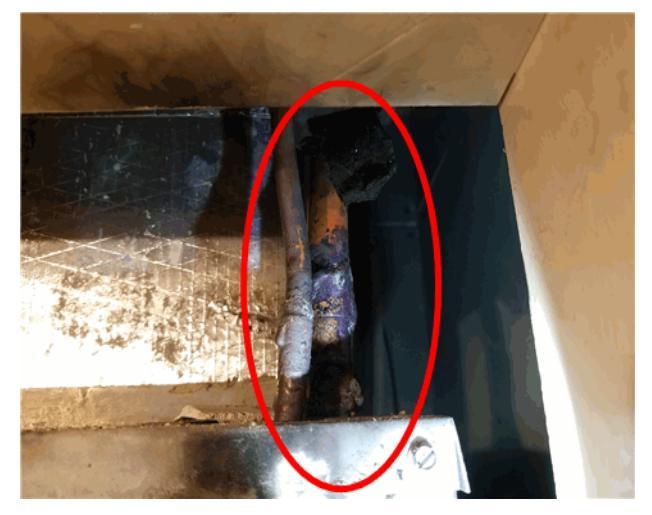
1. The insulation @ refrigerant line was partially missing @ all indoor evaporator coils. To prevent condensation from dripping onto ceilings and attics and to increase the efficiency - Suggest pipe insulation be added. (Refer to Interiors - Suspected Mold section)

1. The insulation @ refrigerant line was missing, torn @ indoor evaporator coils. 1st floor

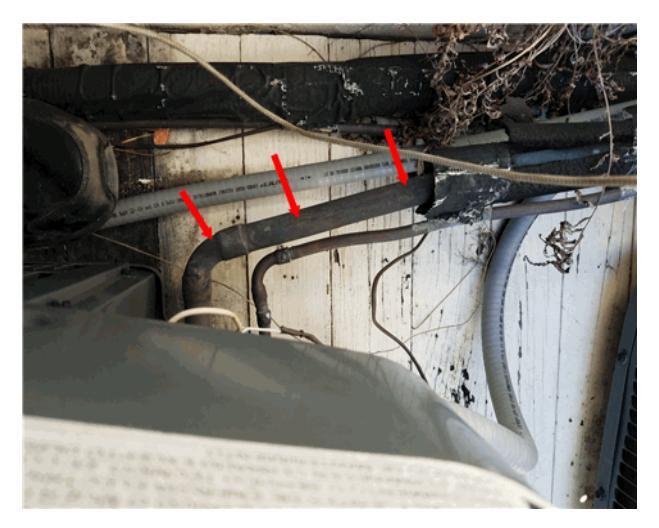
1. The insulation @ refrigerant line was torn and/or deteriorated at outside AC units.

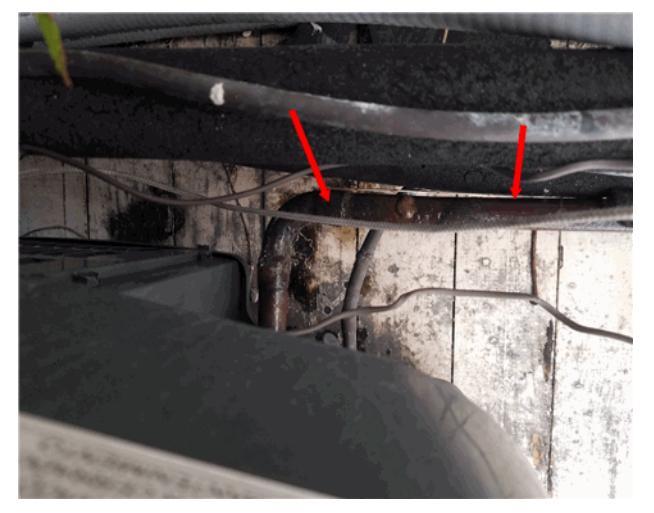
1. The insulation @ refrigerant line was torn and/or deteriorated at outside AC units.

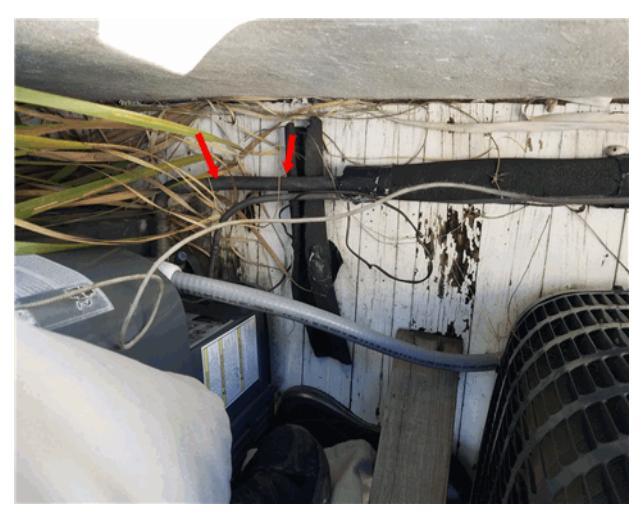
1. The insulation @ refrigerant line was torn and/or deteriorated at outside AC units.

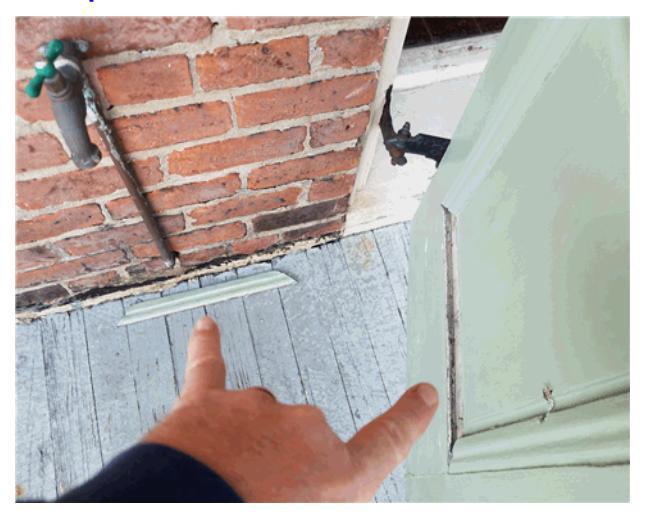
1. Wood trim at balcony shutter was lying on the wood deck, horizontal shutters missing and glazing

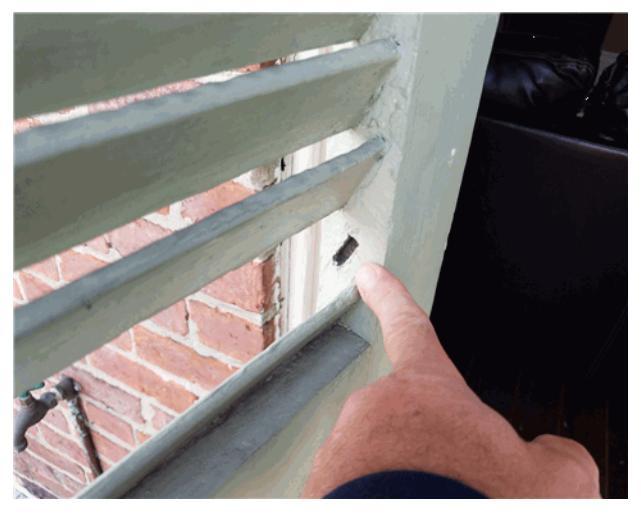
1. Wood trim at balcony shutter was lying on the wood deck, horizontal shutters missing and glazing

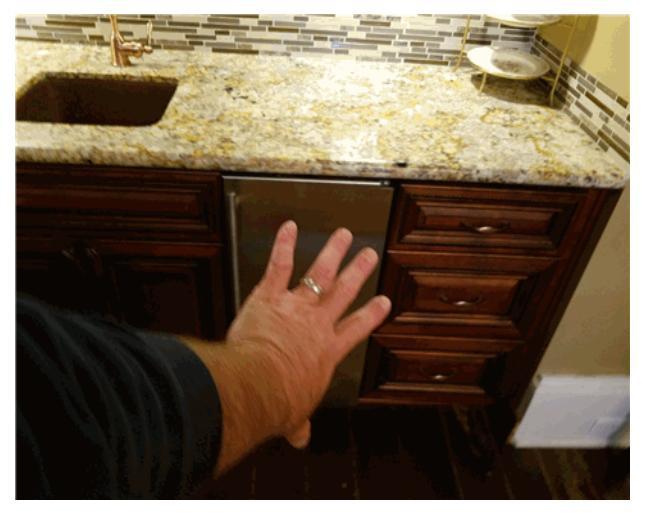
1. Ice machine on 2nd floor of main building front room was turned off

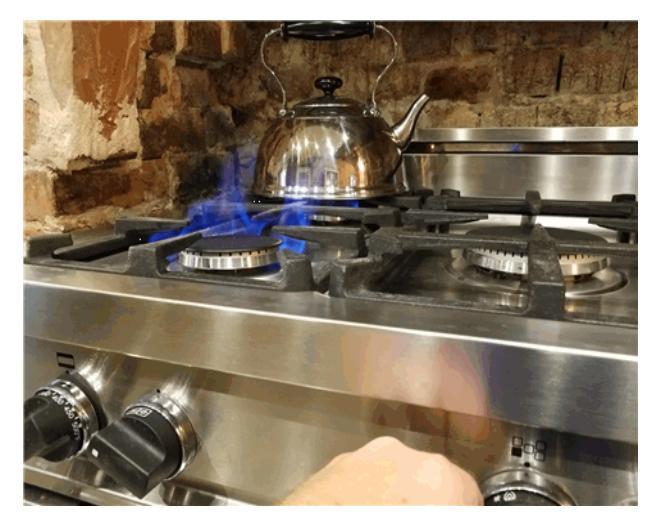
2. Multiple gas burners were inoperable @ gas range due to spark igniters. Using a Bid lighter - burner was manually tested. Uneven and distorted flame pattern noted. Recommend replacing igniter's and port - flame tube adjustments. Evaluate and repair

2. Uneven and distorted flame pattern noted
