Figure 1 Chapman Beach Study Area

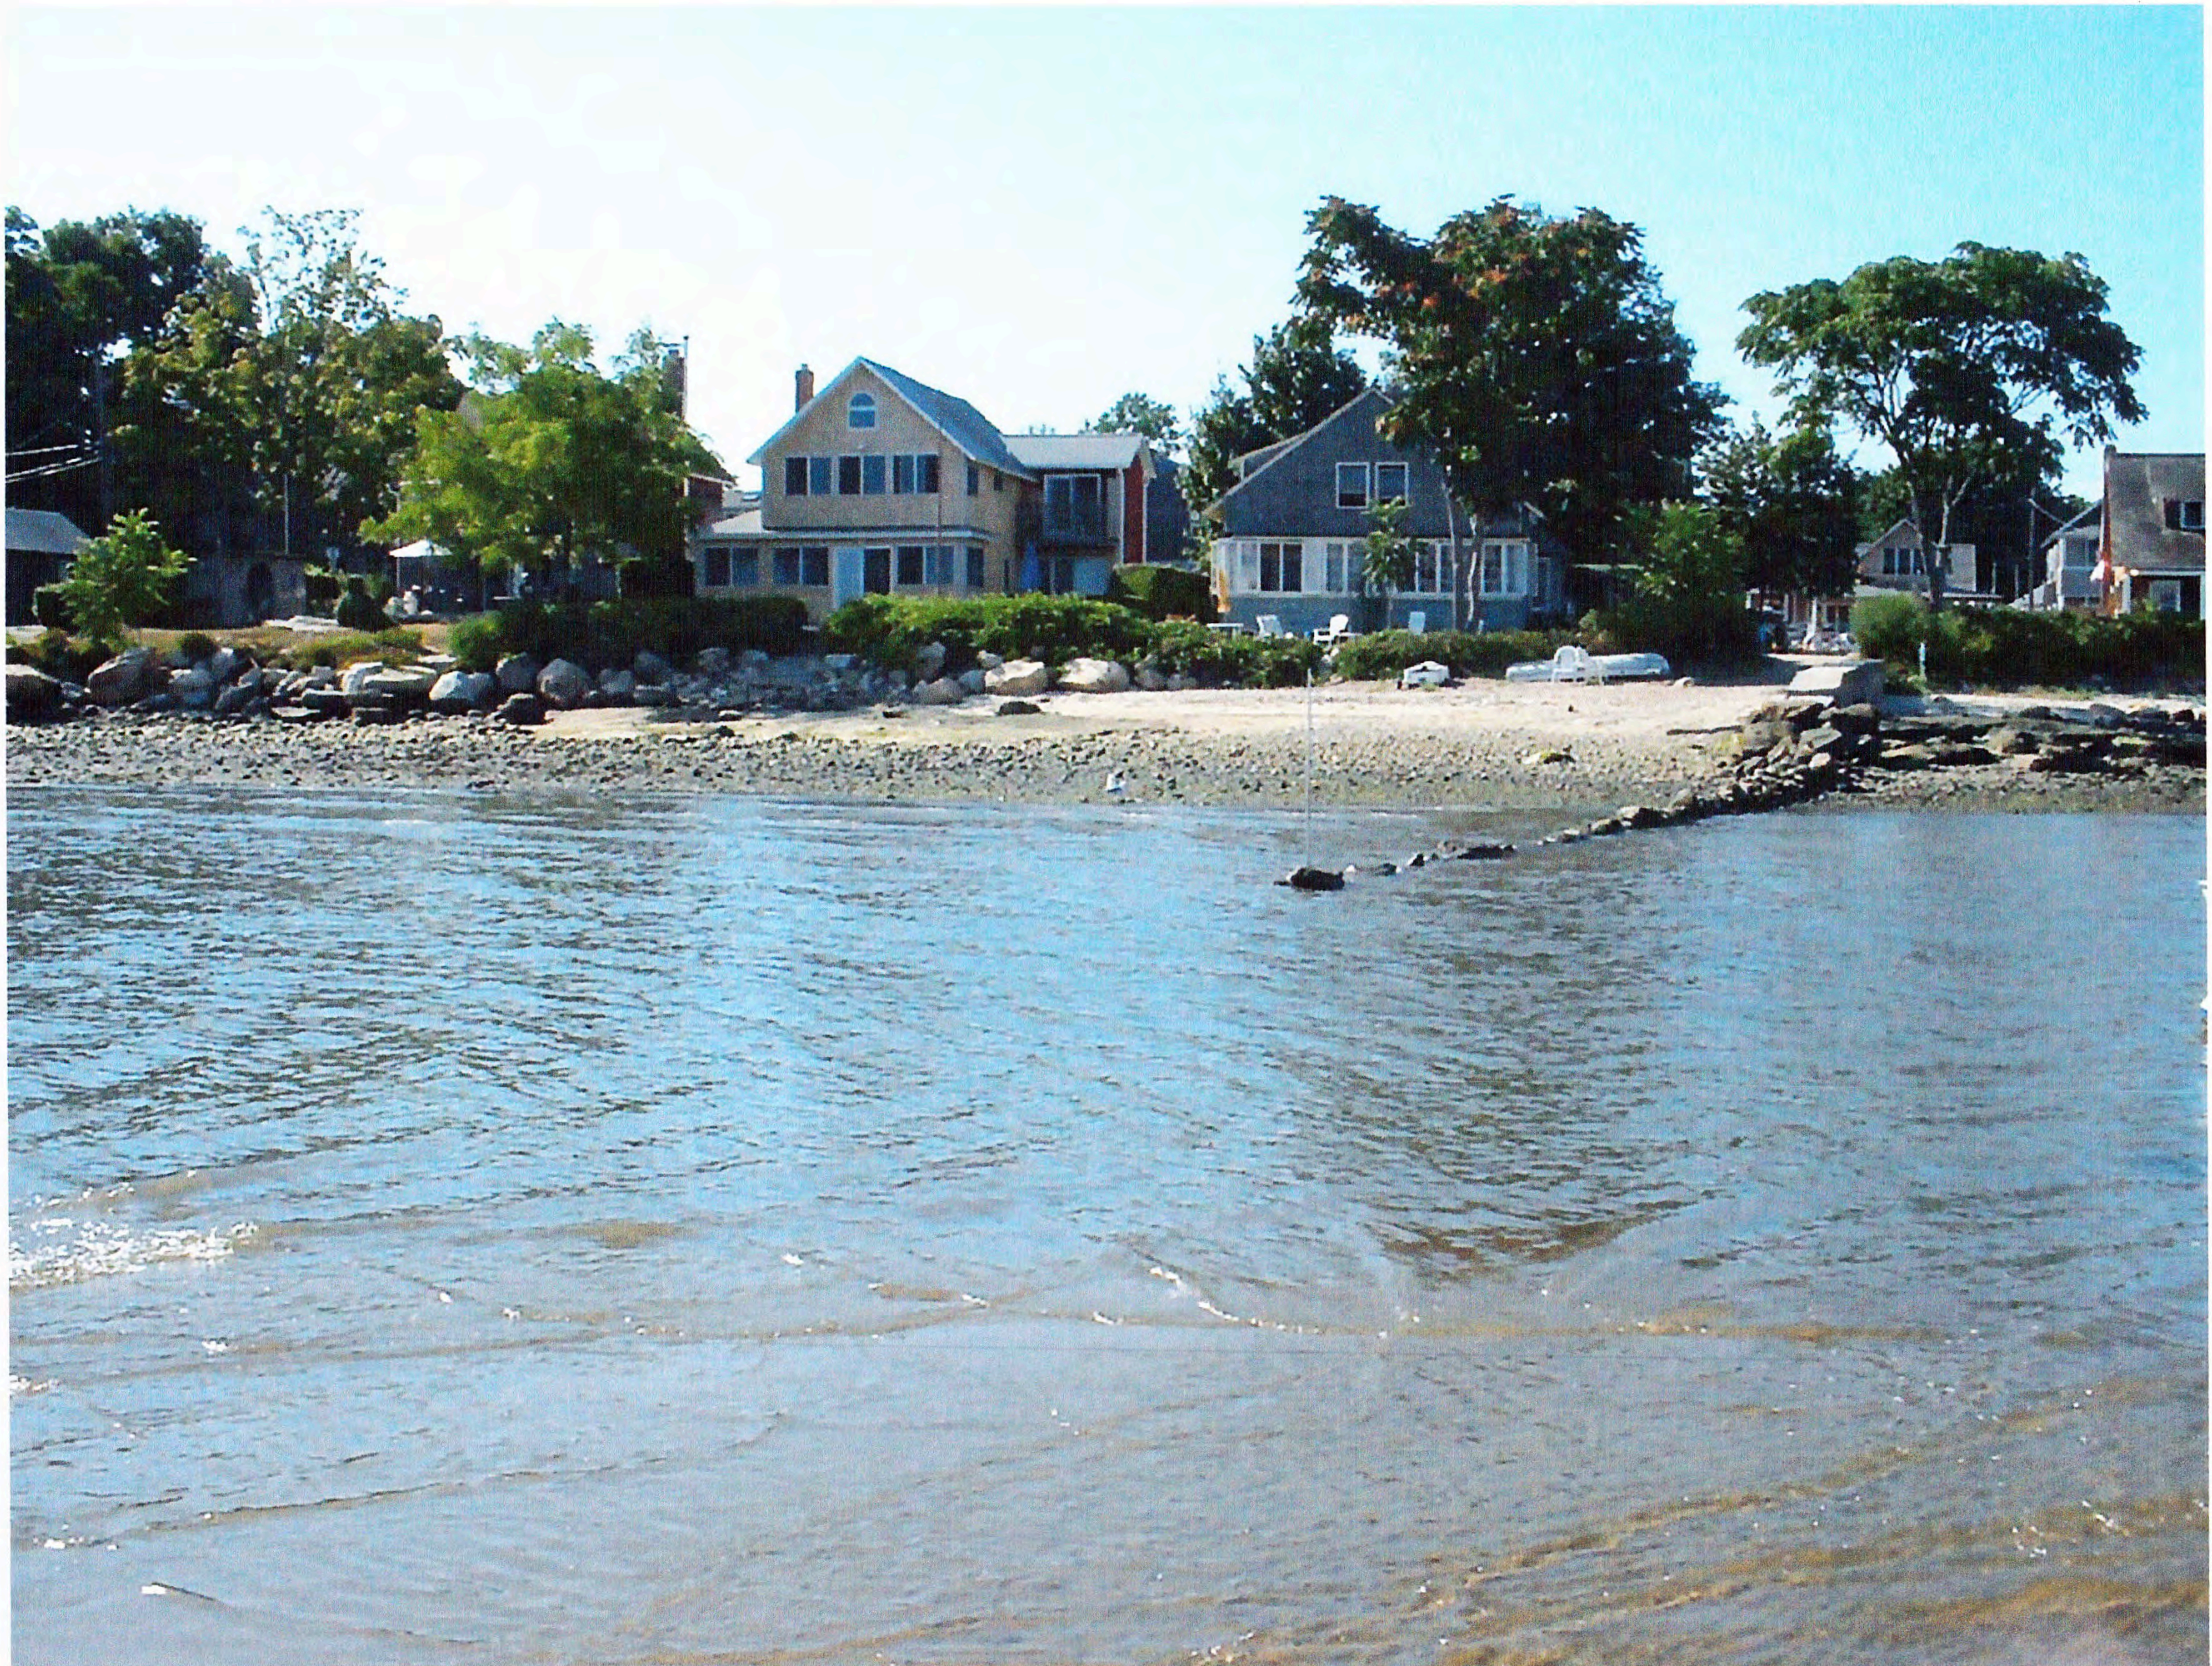
Figure 2 View East Along Barrier Beach Adjoining Cold Spring Brook
High Water Conditions - August 24, 2002

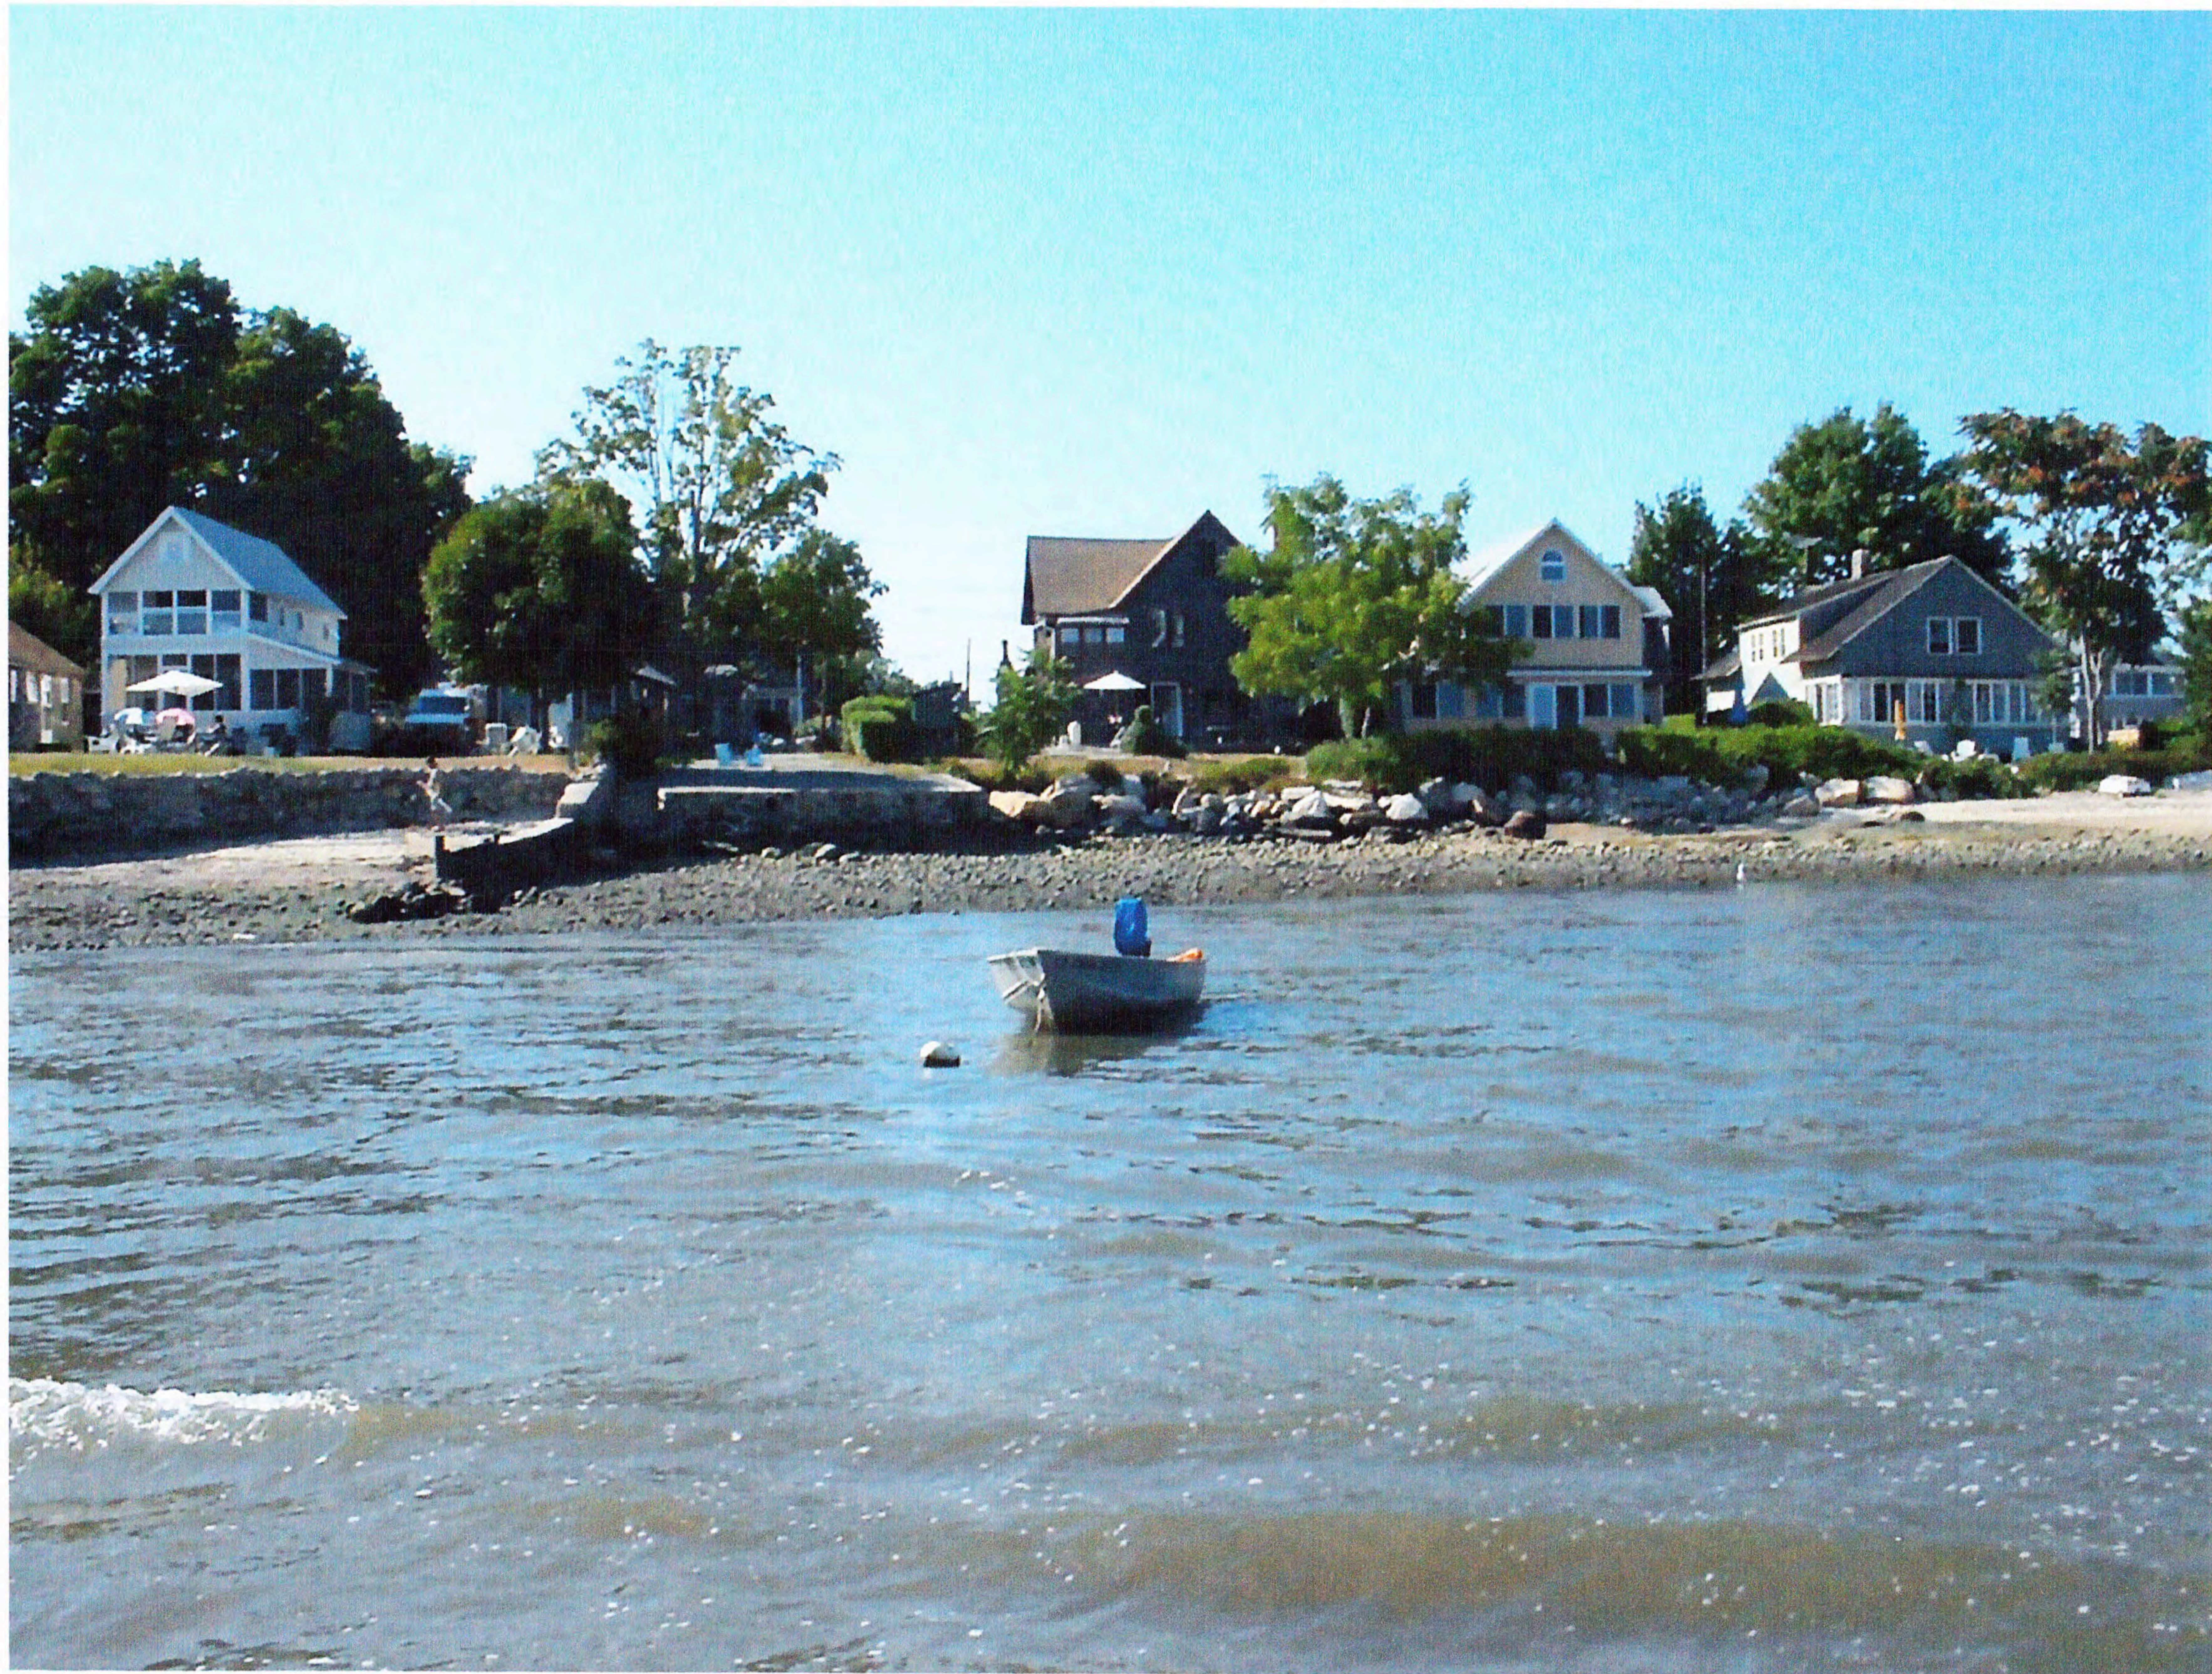
Figure 3 East End of Chapman Beach Adjoining Barrier Beach
Area Near Chapman Drive and Hogan Drive August 21, 2002

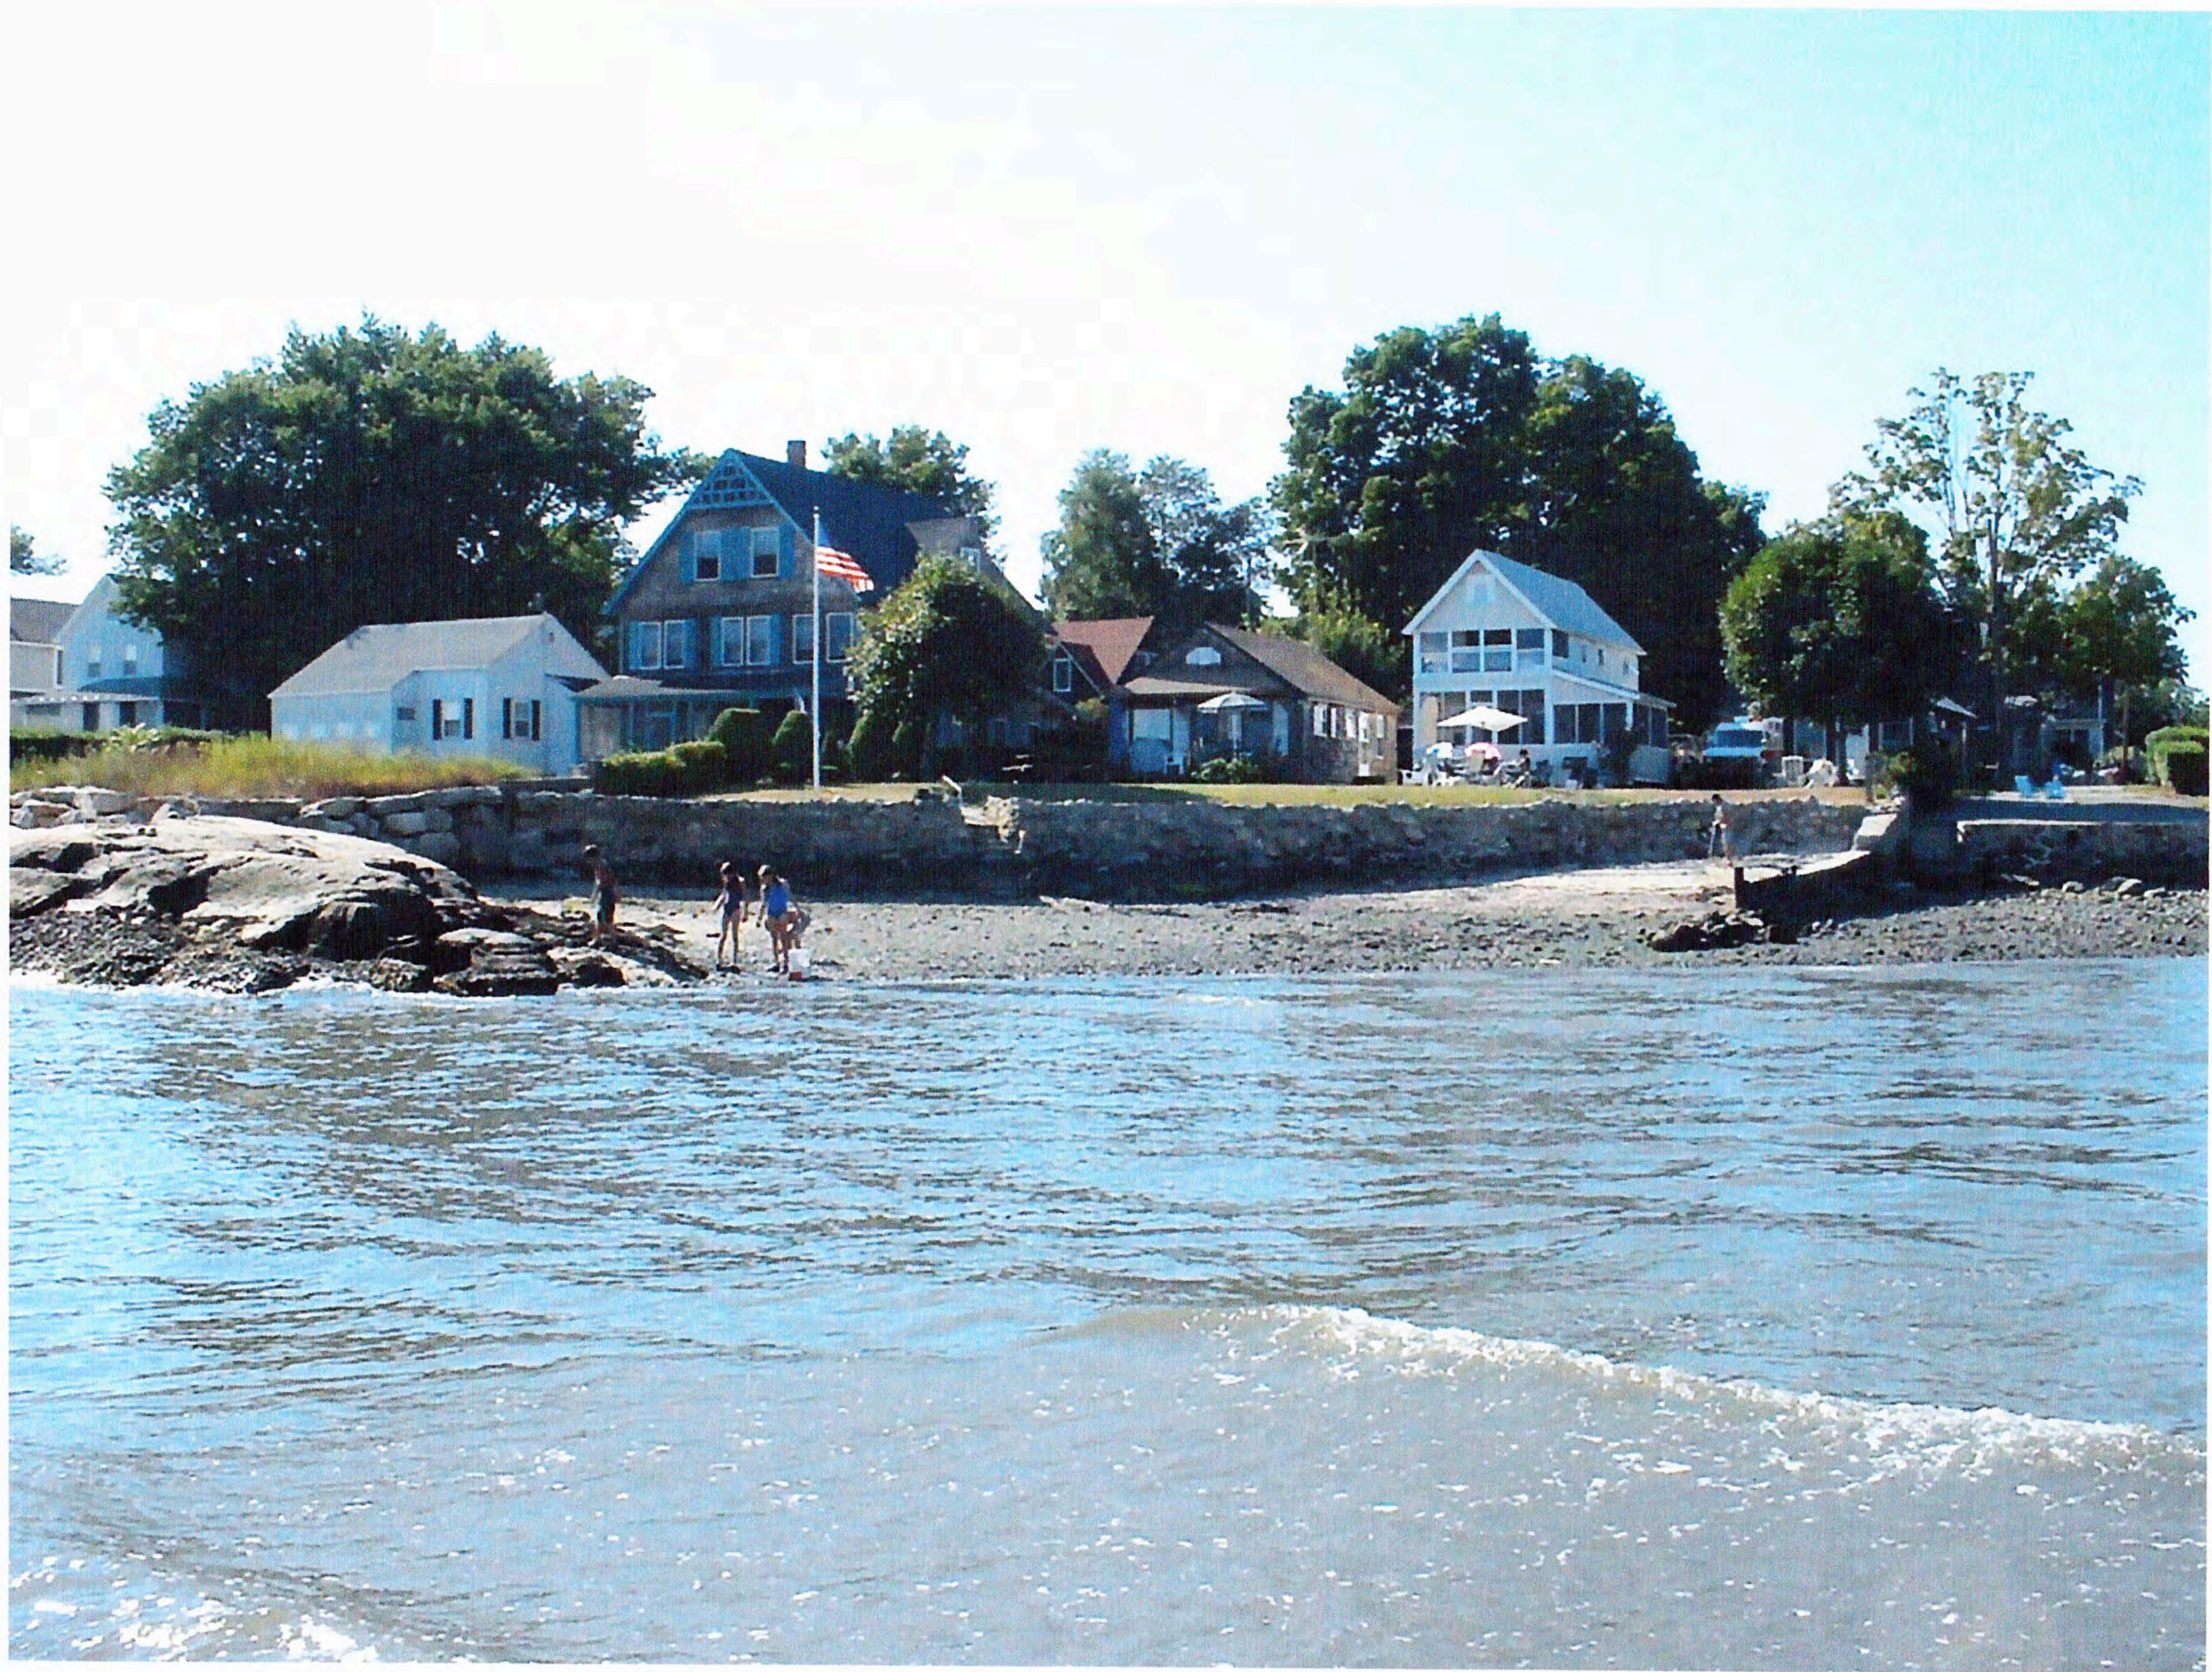
Figure 4 East End of Chapman Beach -- Proceeding to the West
Note Sandy Pockets Along this Reach August 21, 2002

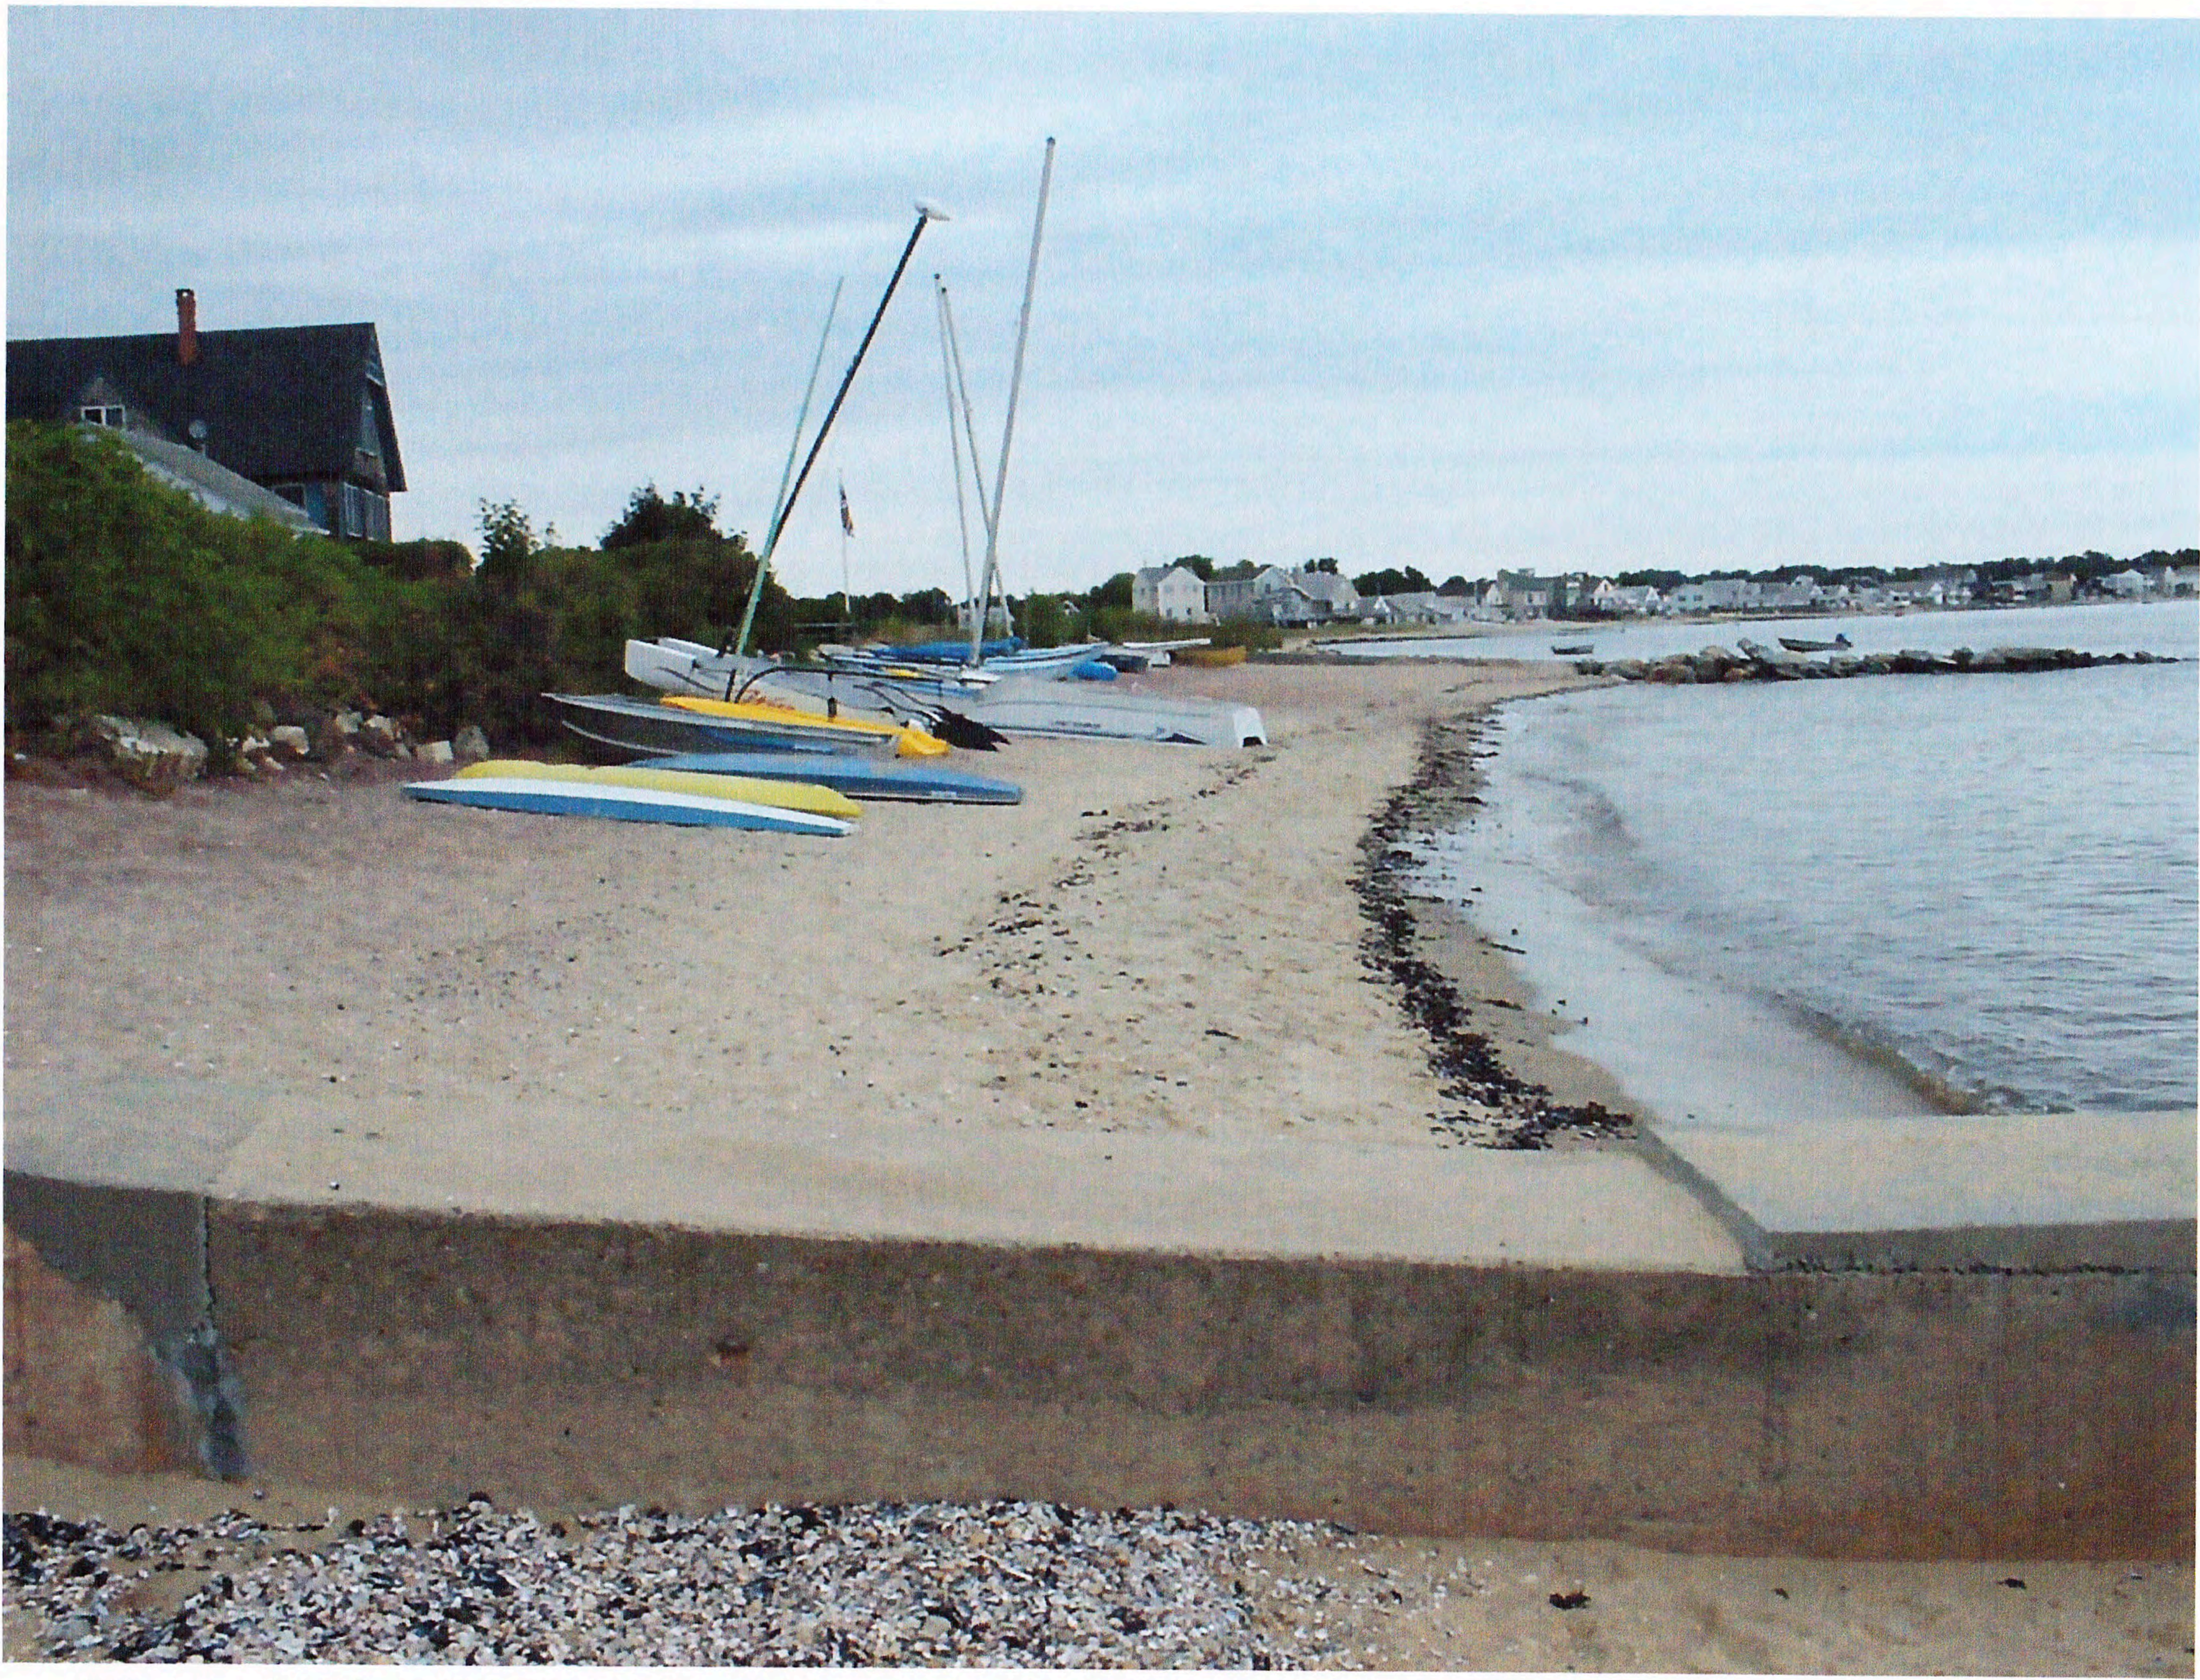
Figure 7 Surface Sediment Grain Size Distributions – Mid Segment 7
Grab Sample Obtained at High Water Line

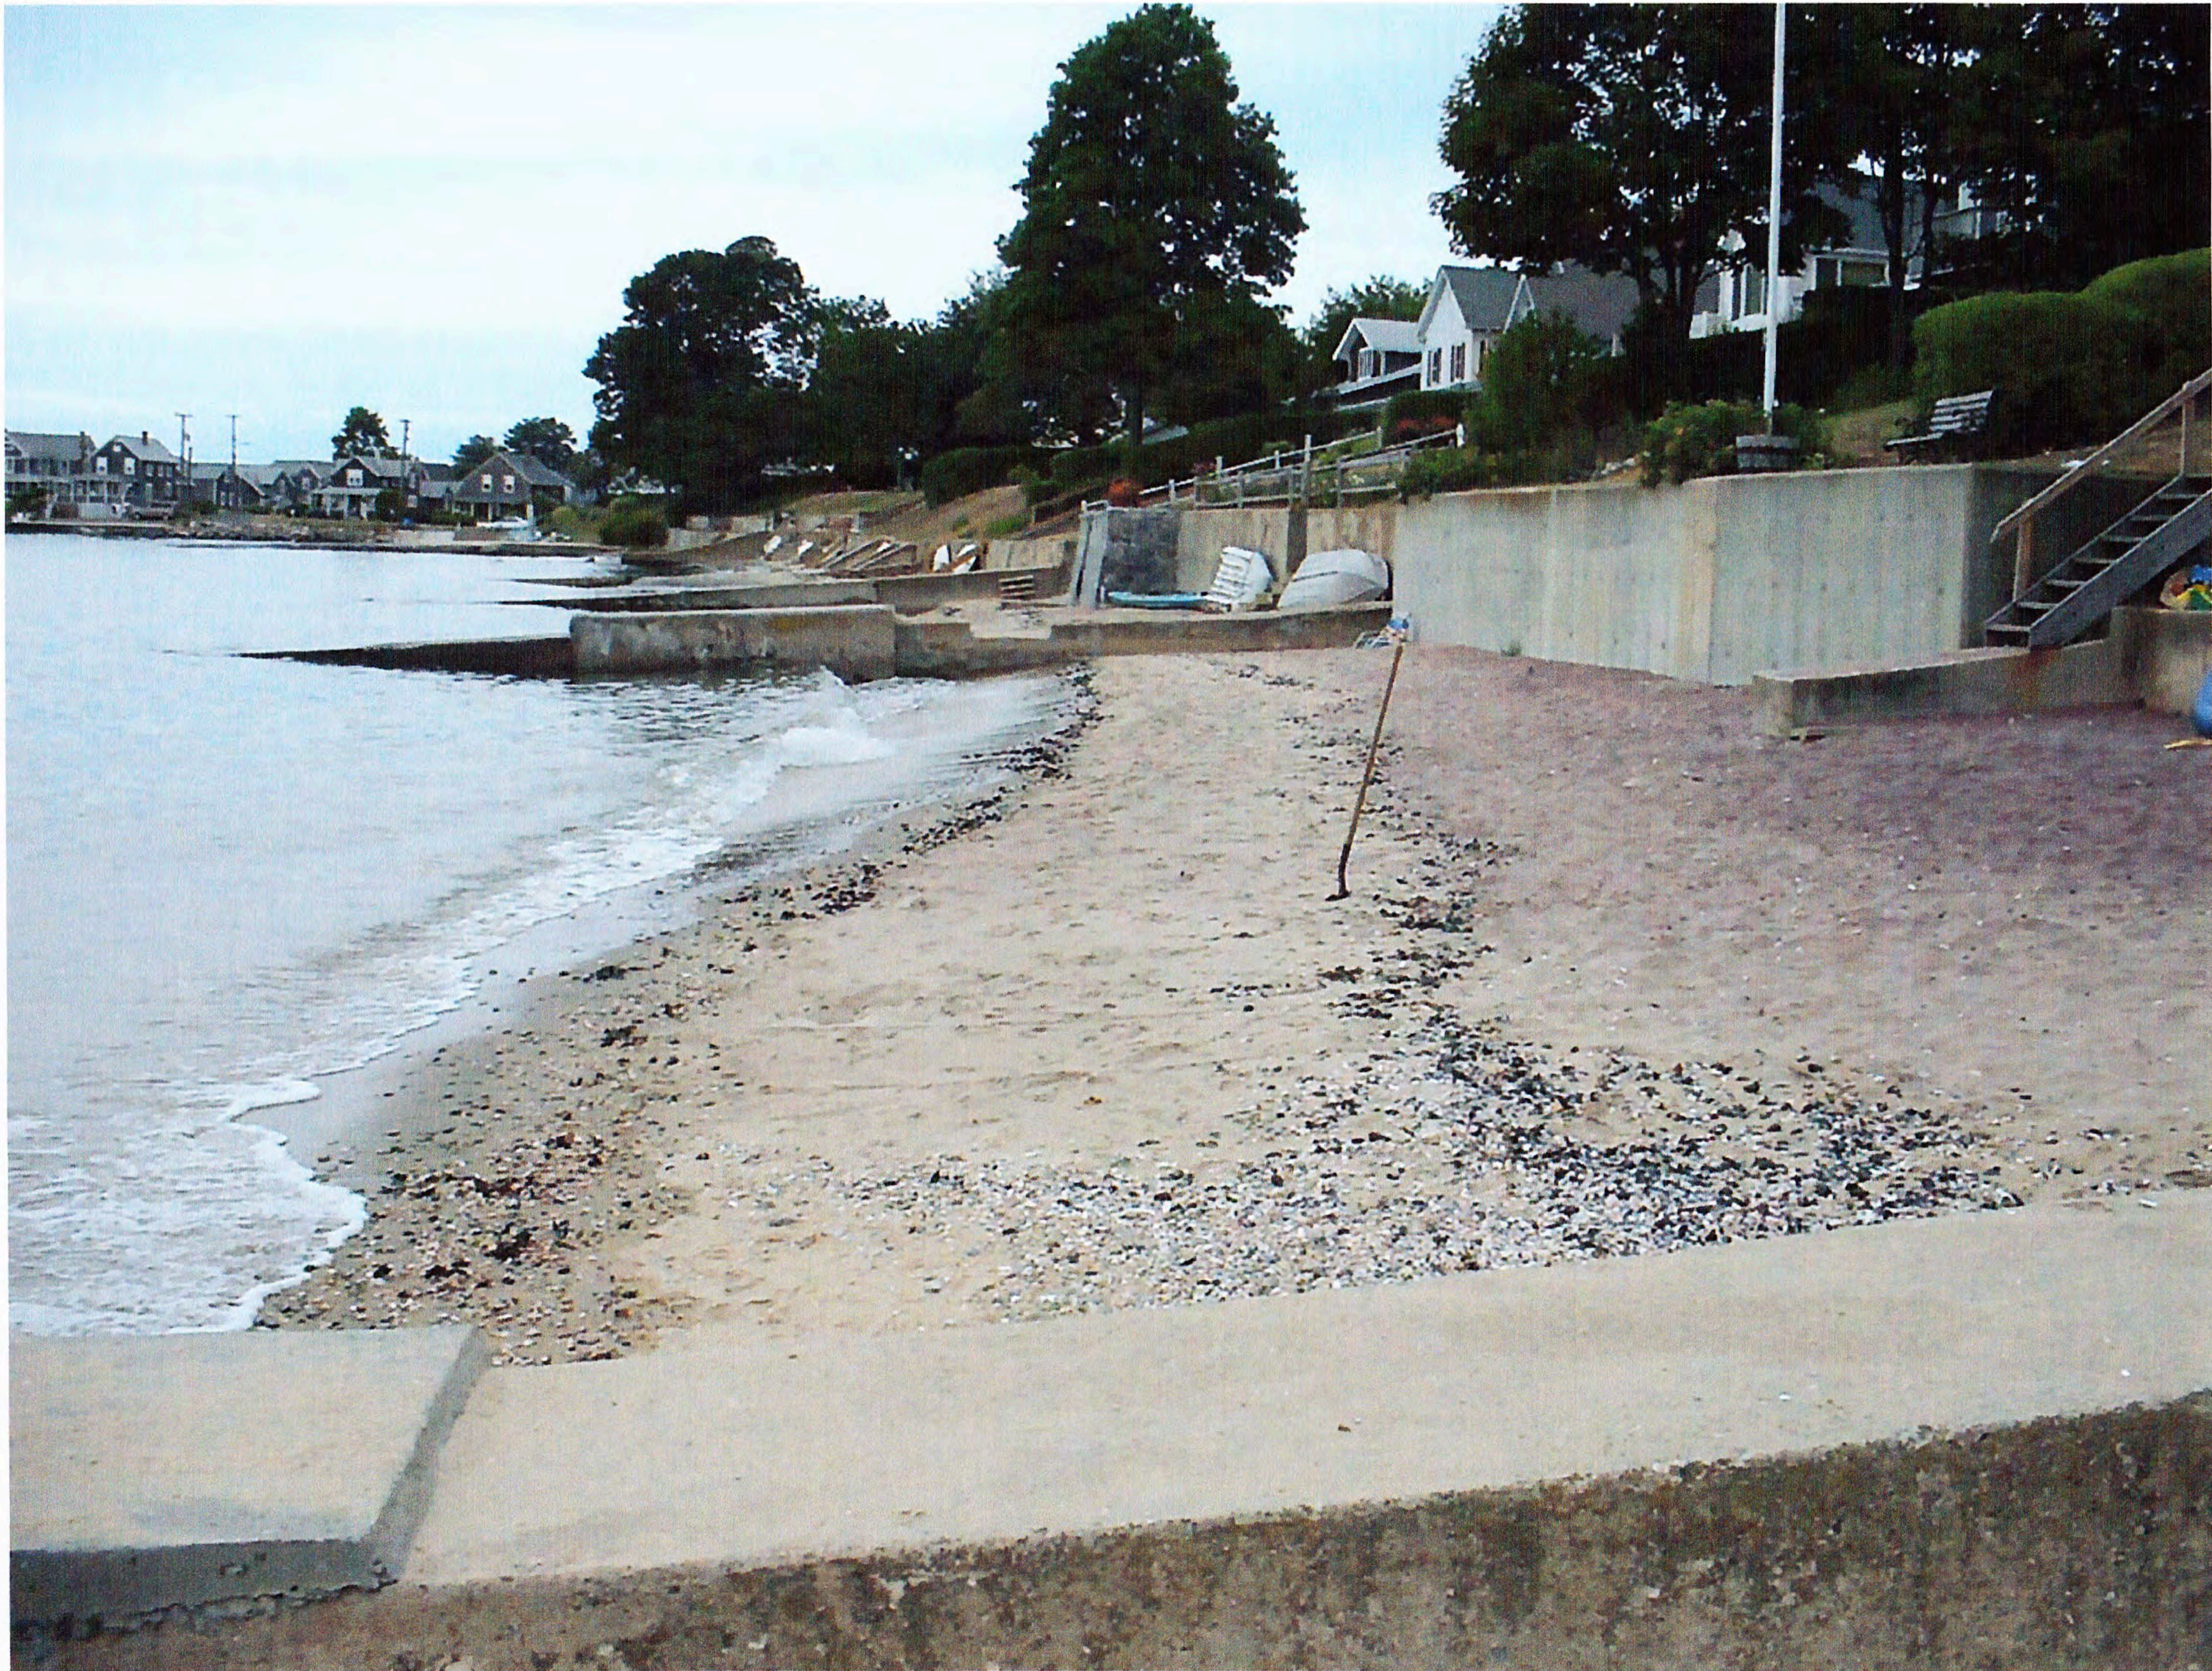
Figure 8 View East Along Segment 7 - High Water Conditions August 24,2002
