RV Inspection Report

Prepared for: Jorge A. Pegueros

8400 Brookview Dr., North Richland Hills, TX 76182

Inspection Date: 9/16/2021

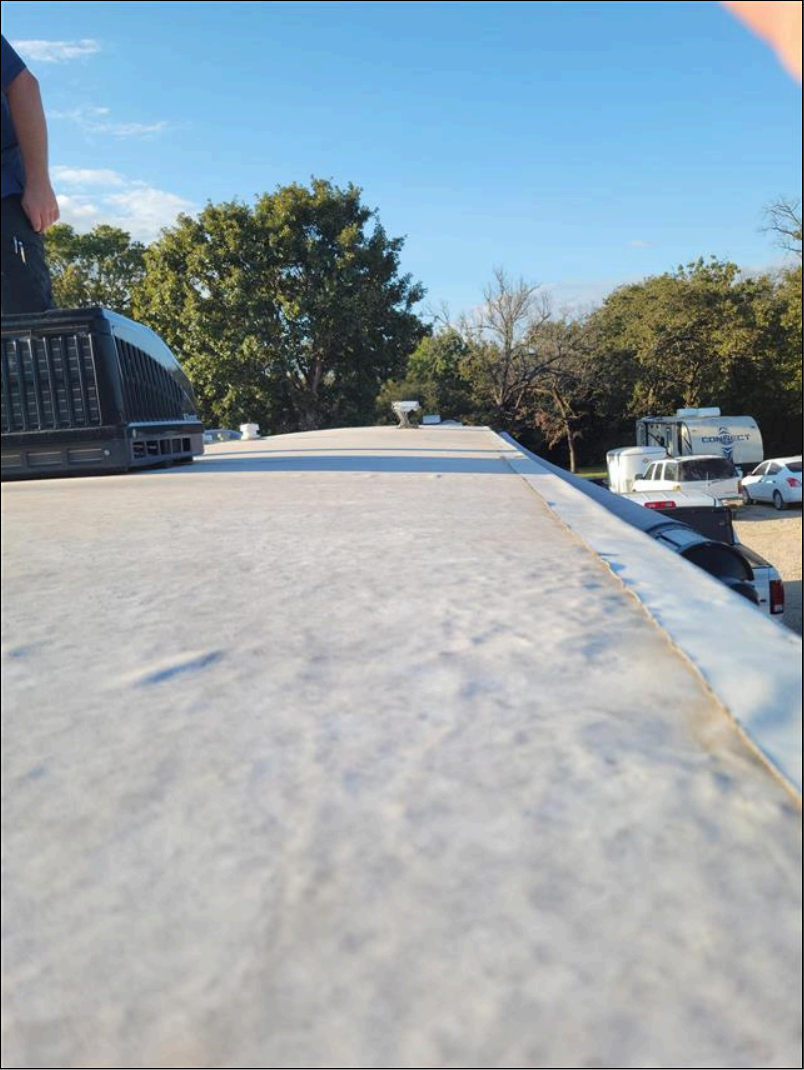
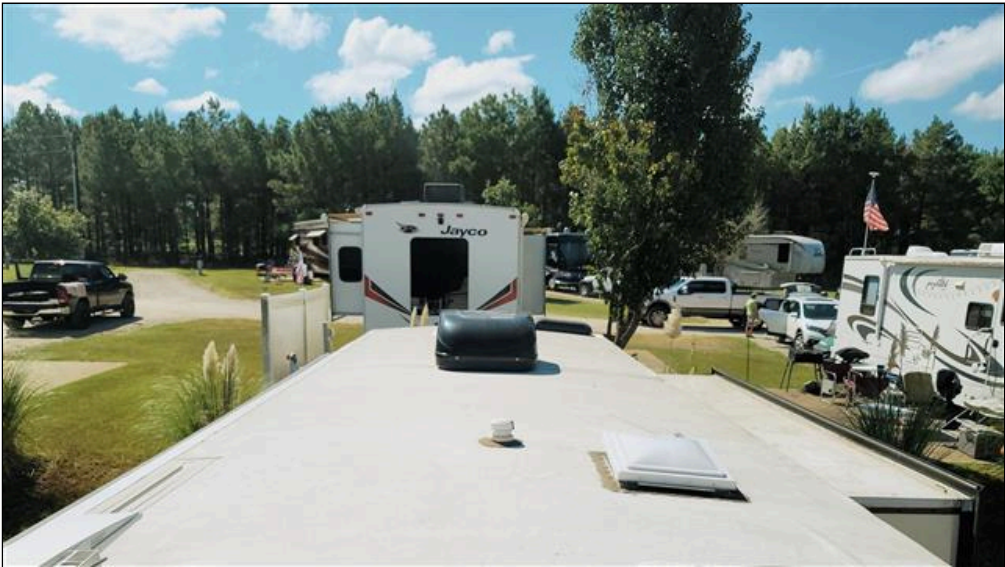
2.0 Roof Condition

Has bubbling in rear end and Butyl tape added in some parts that are lifting.

Overview of Roof - from back to front curbside

View of roof from rear to front

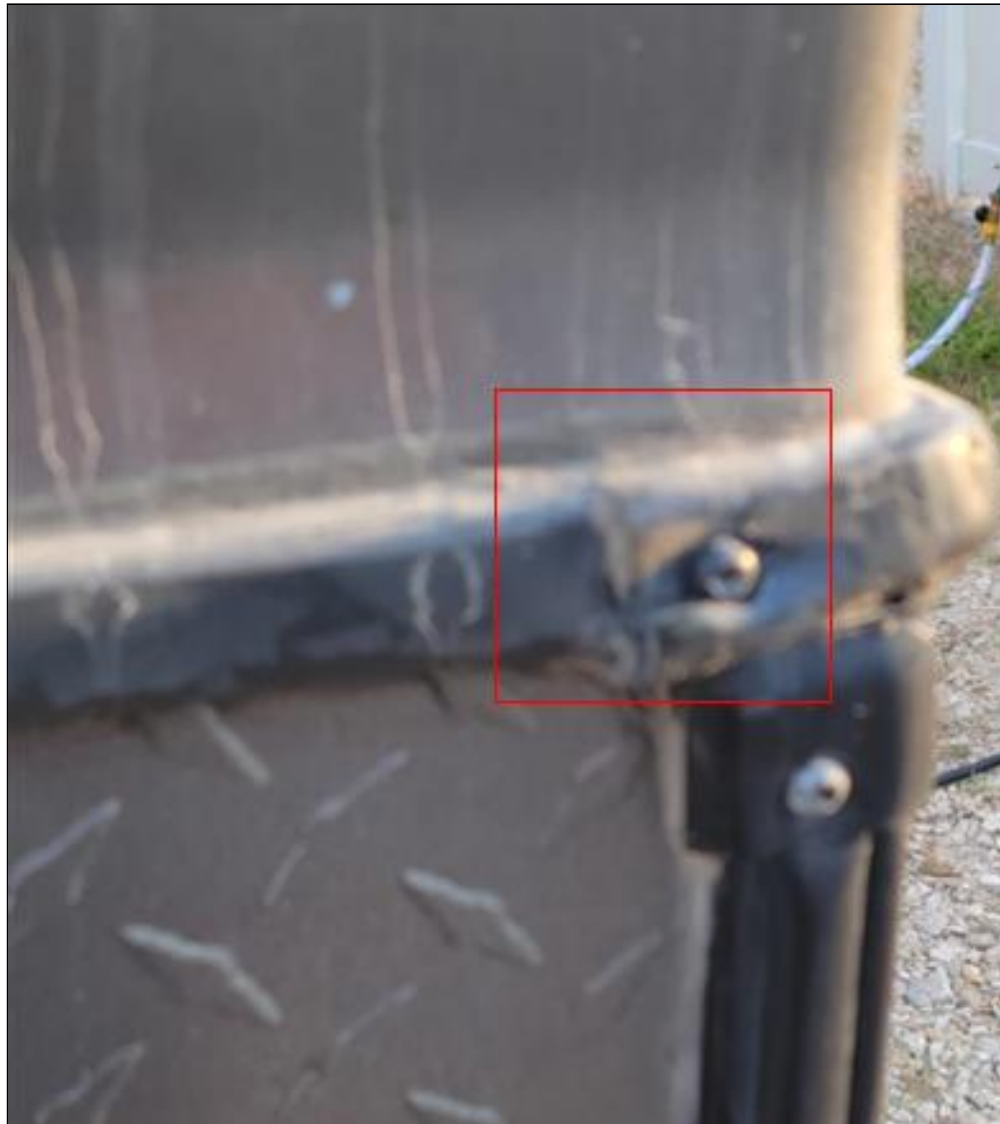
2.4 Trim Rail (Streetside)

Trim cracked where screw is

Trim cracked

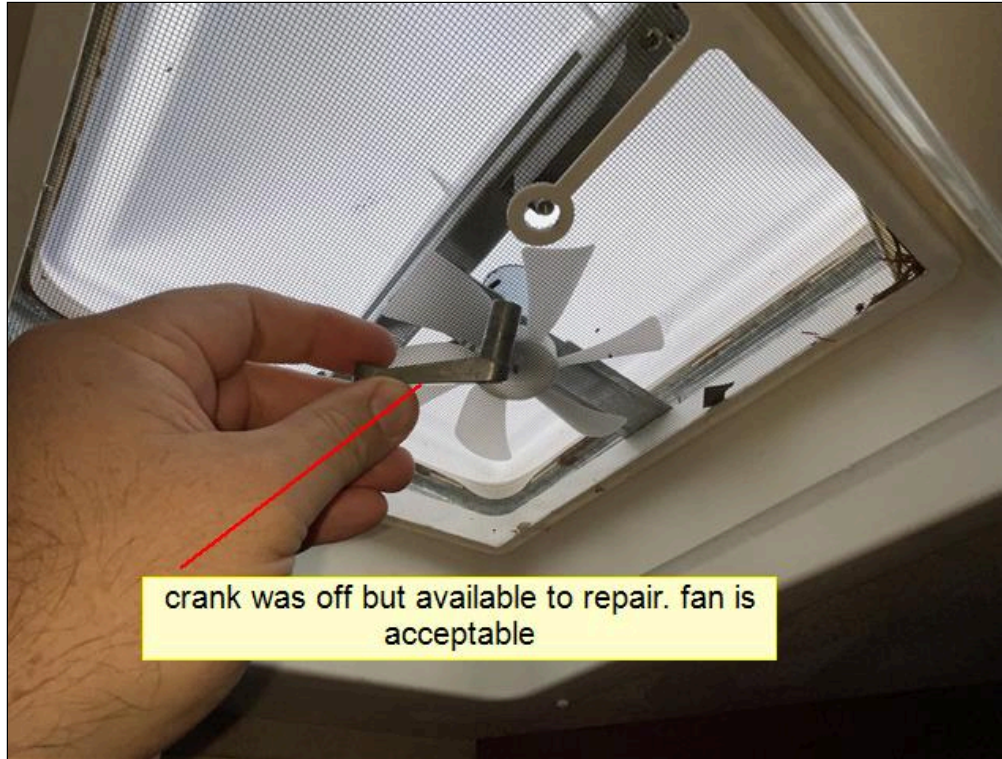
2.5 Vents - Manual Crank (14 x 14)

Crank handle was not on the vent but still available to fix, wasn't able to verify if mechanism works. It is recommended be looked at by a qualified RV technician.

Bathroom manual crank vent

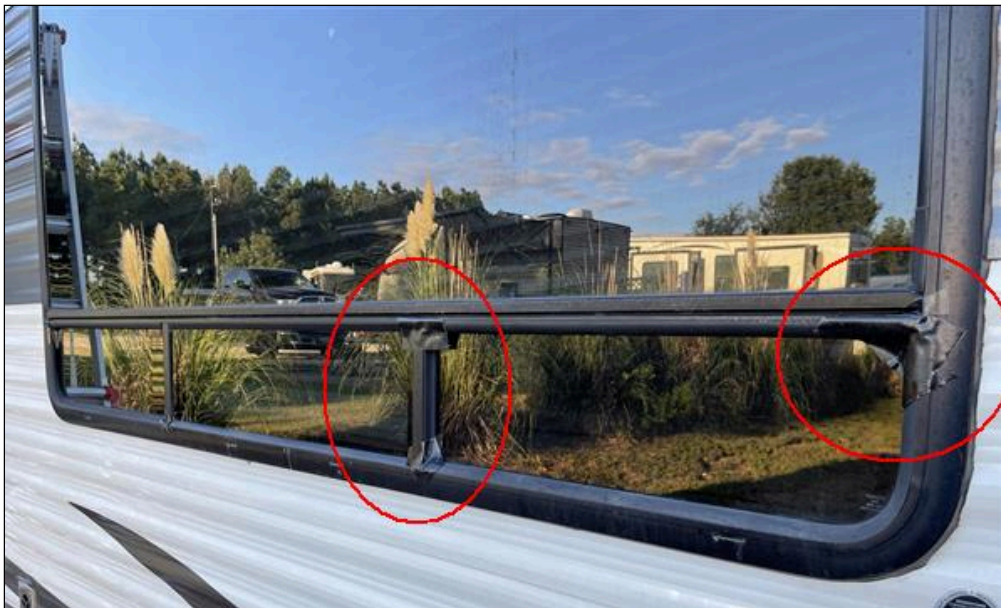
3.2.B Windows

It would appear there is duck tape on areas of the rubber seal on the window

Curbside Center Window

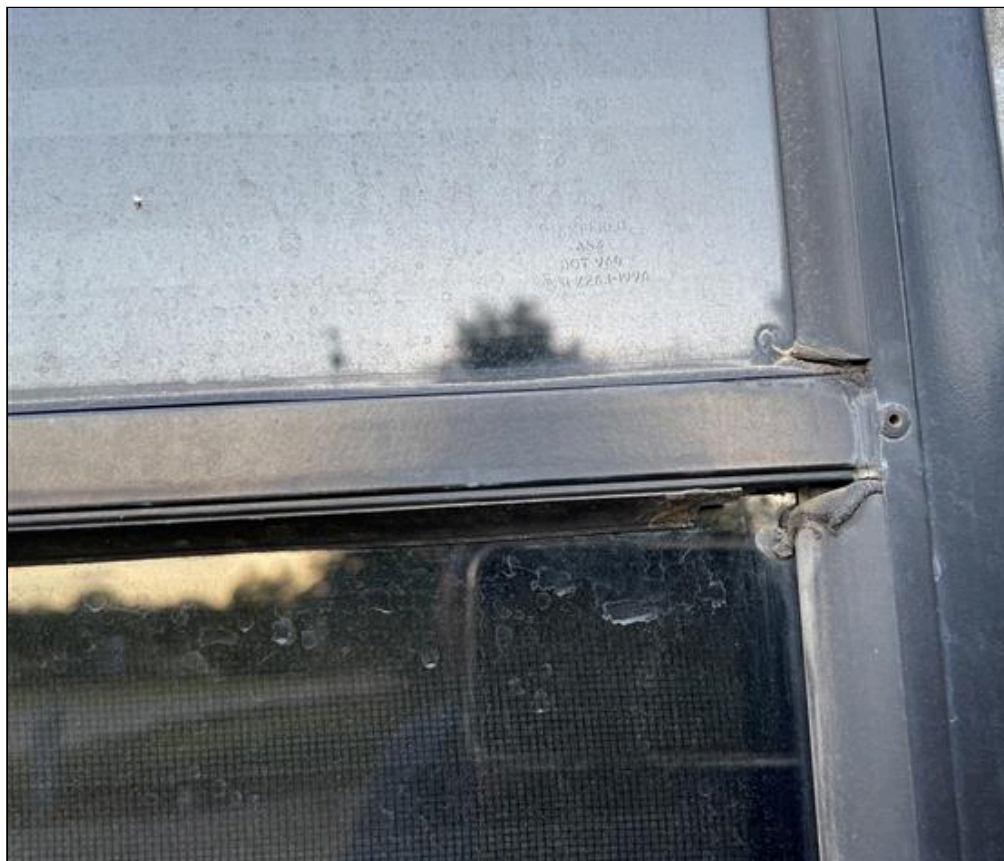
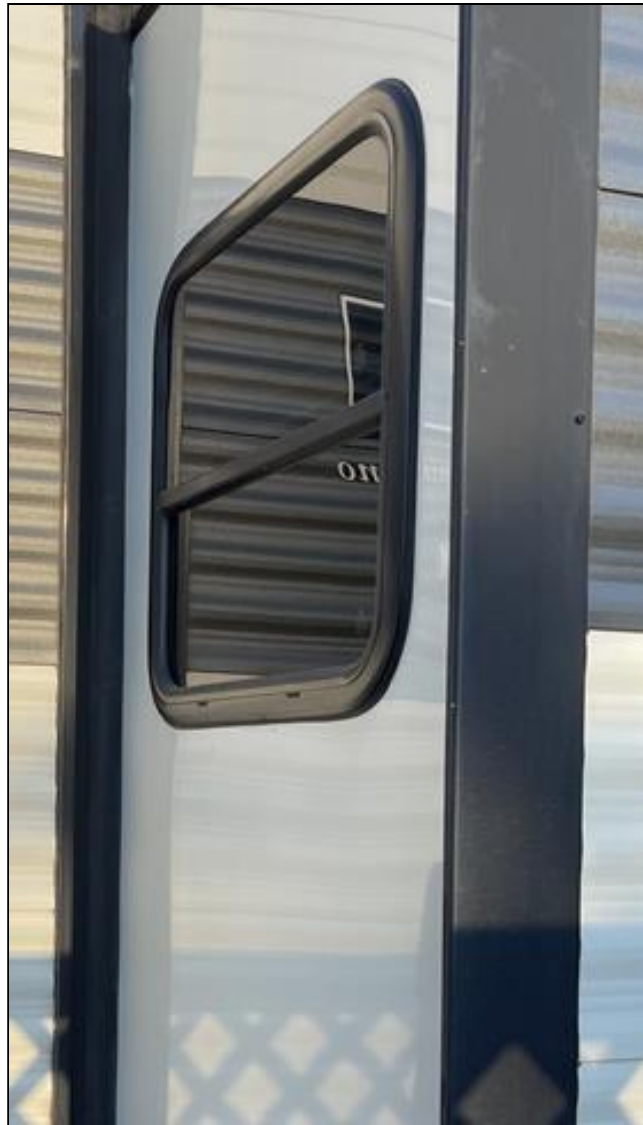
Customer Stated he added duct tape due to frame engineering not stopping rush of water coming down that allowed water to come into interior even with window closed. also commented rubber seals are shrinking and seem to be needing to be changed in future.

Rubber seal shrinkage slideout window

front facing slideout window

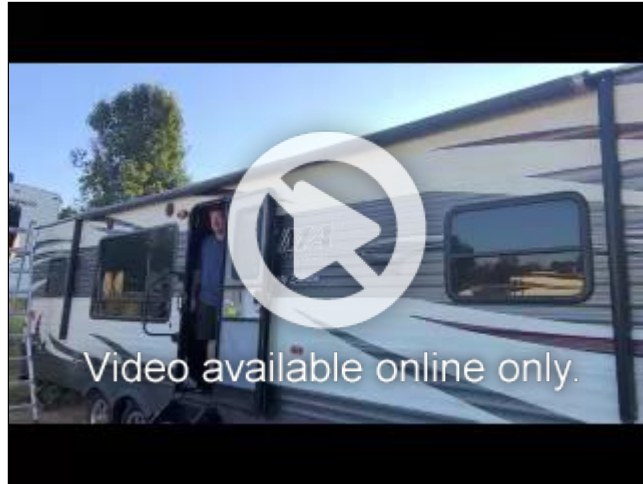
5.2 Awning Operation

The inspectors first attempt with opening was not smooth but after the second and third attempt piston worked like expected. It is recommended to have repaired by a qualified RV technician.

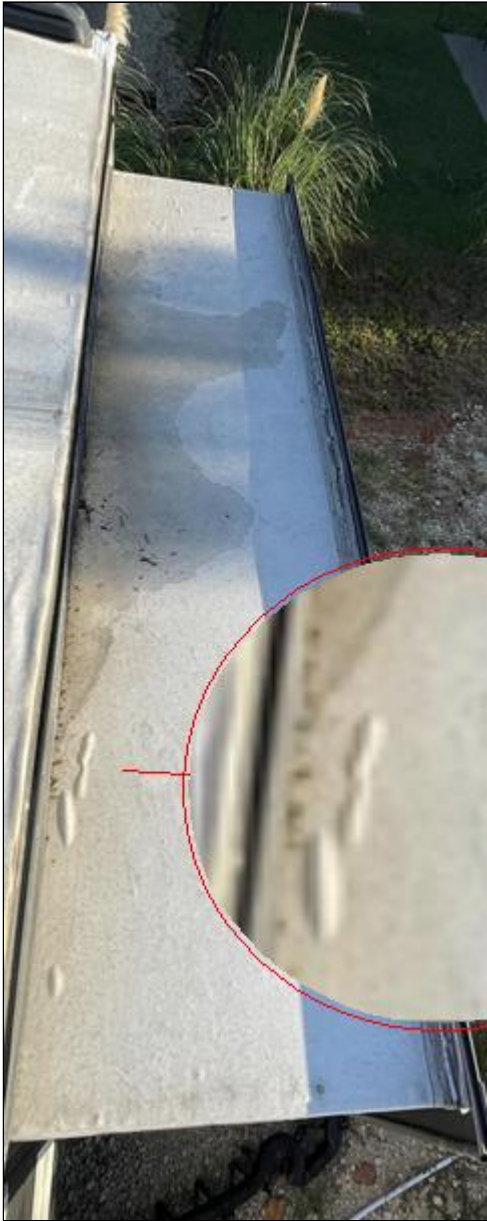
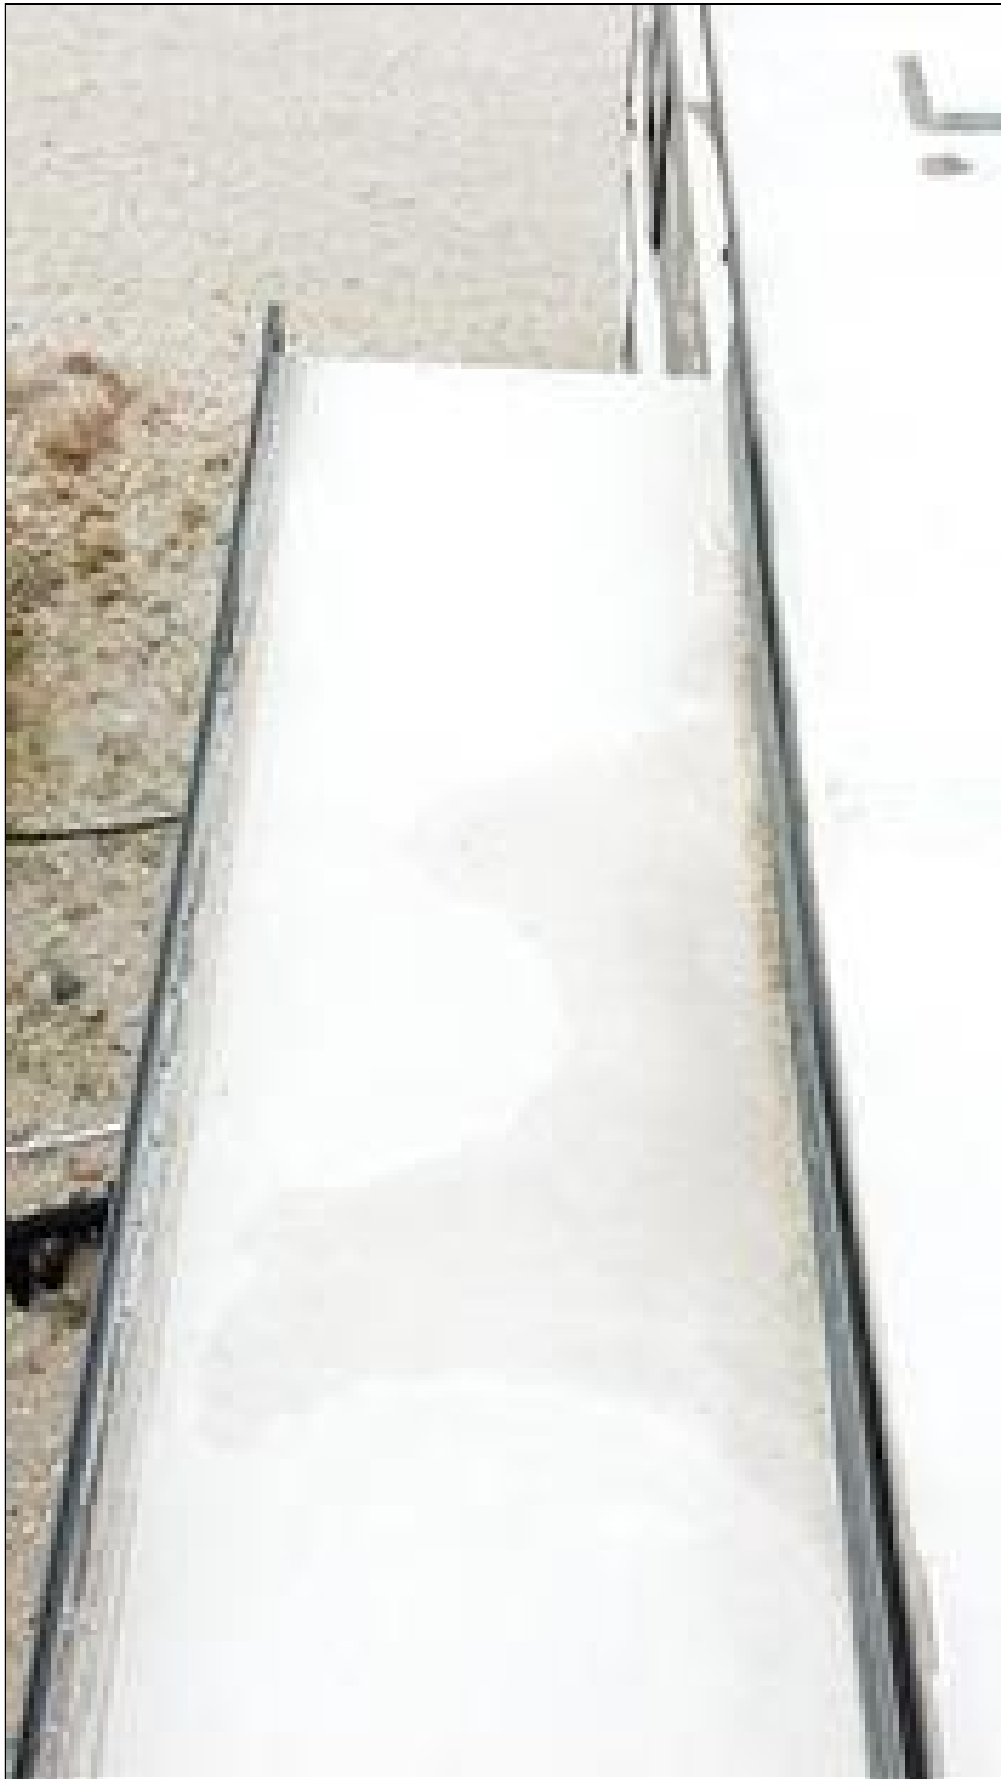
it would appear roof material lifting creating a bubble.

Top view from front to back

Top view from back to front of RV

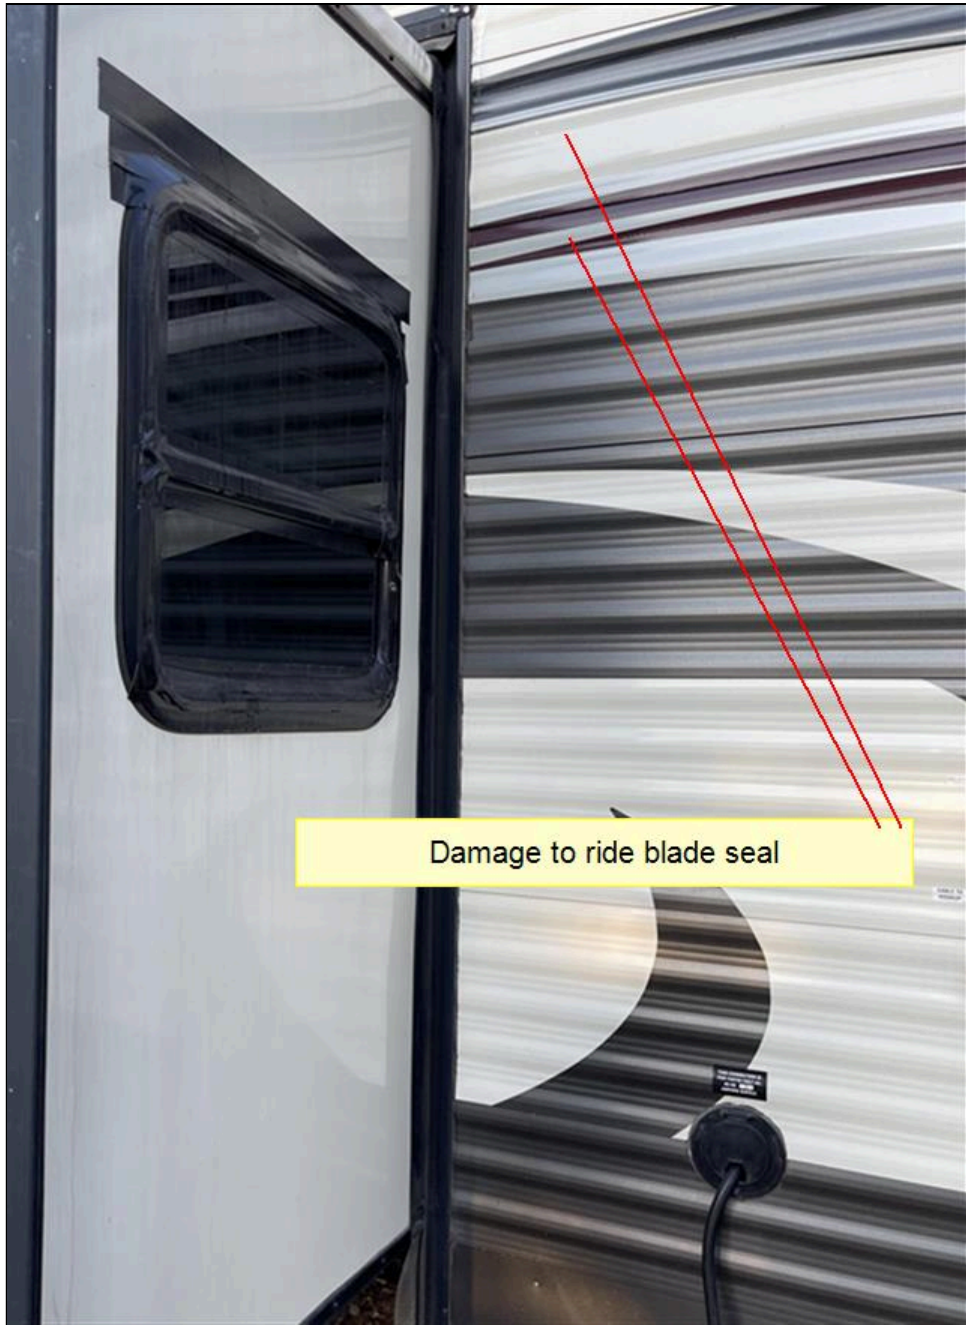
6.2 Seals, Sweeps and Gaskets

left side blade seal is acceptable but right side has damage towards top.

right side of slideout sesal blade damaged

1. Owner stated jack-in-a box slideout stabilizers from Camp world, that came with RV when purchased might of caused the slideout to tilt to the right cause damage to the blade seal on right side by rear of RV.
2. Owner stated he cleaned out the refrigerator and air conditioning unit due to unacceptable performance. After he noticed both units functioning to acceptable performance.

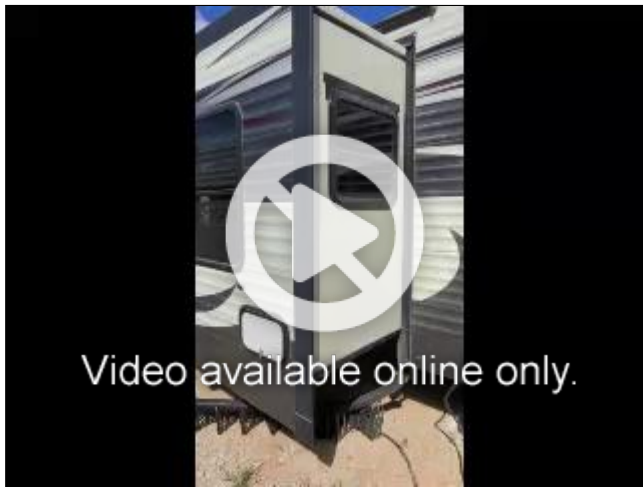
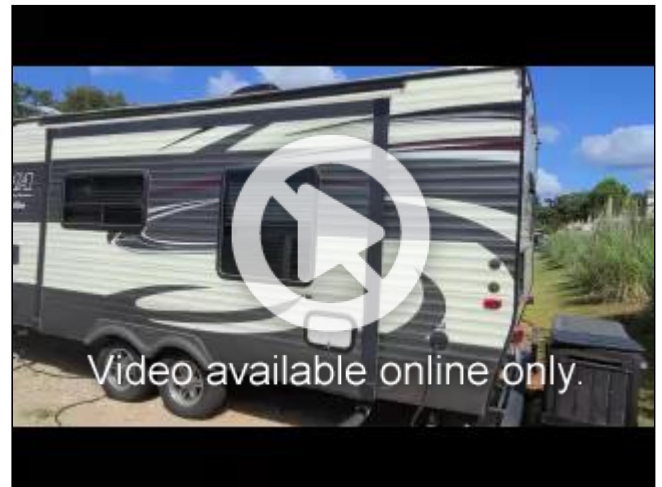
It would appear the slideout is shifted to the right. recommended be looked at by a qualified RV technician.

Video of slideout going in

Video of slideout coming out

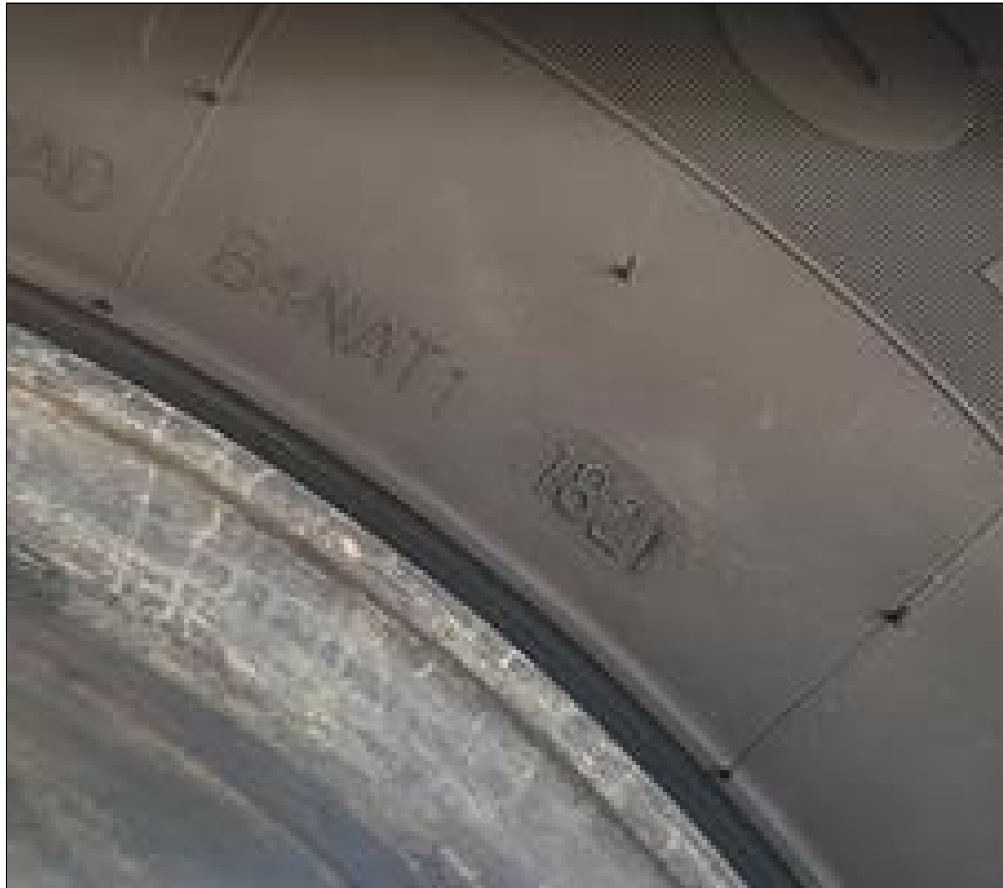
7.0.A Tire Condition

Acceptable
DOT Date 3 out of 4 tires is 1821

DOT Date 3 out of 4 tires is 1821

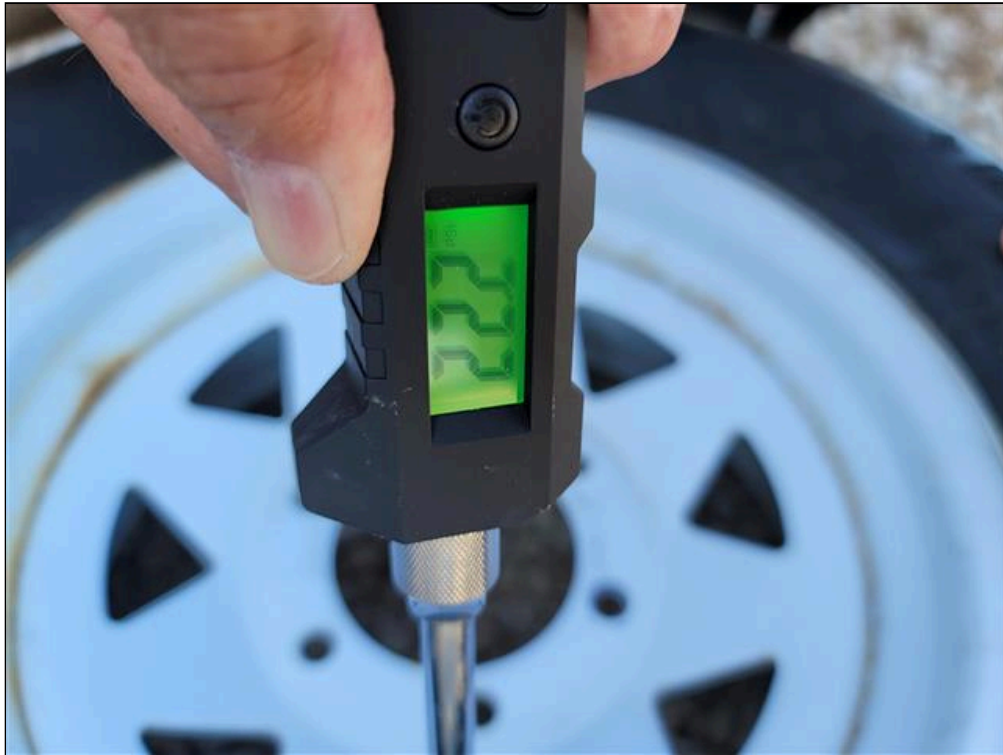
7.0.E Tire Condition

Spare tire was at 22.2 PSI and 8 years old it is recommended a qualified tire expert evaluate it.

Spare tire was at 22.2 PSI

Spare tread is 8 years old it is recommended a qualified tire expert evaluate it.

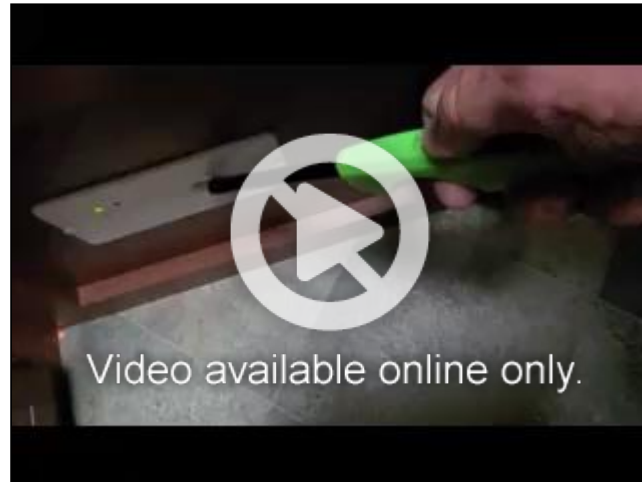
13.1 LP Leak System Test

LP leak test passed

LP leak test

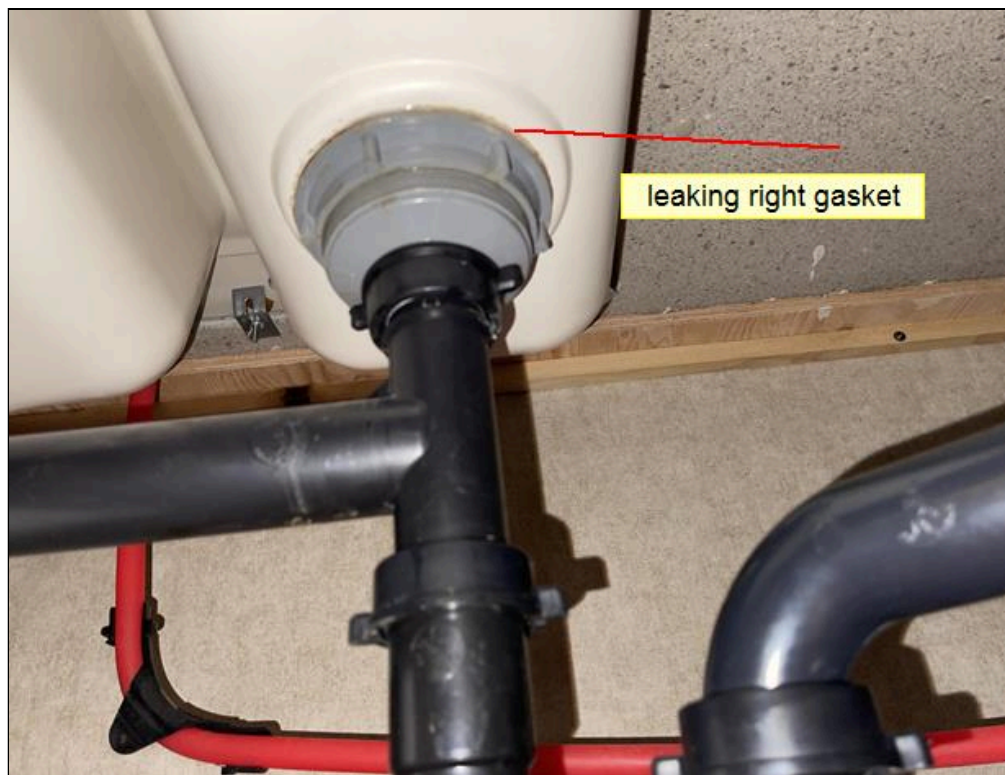
holds water on left right drain gasket leaking

sink holding water
