Inspection Report

Palm Harbor FL 34684

Bayside Building Consultants, LLC

Date: 10/9/2020	Time: 01:00 PM	Report ID: 20201009-
Property:	Customer:	Real Estate Professional:

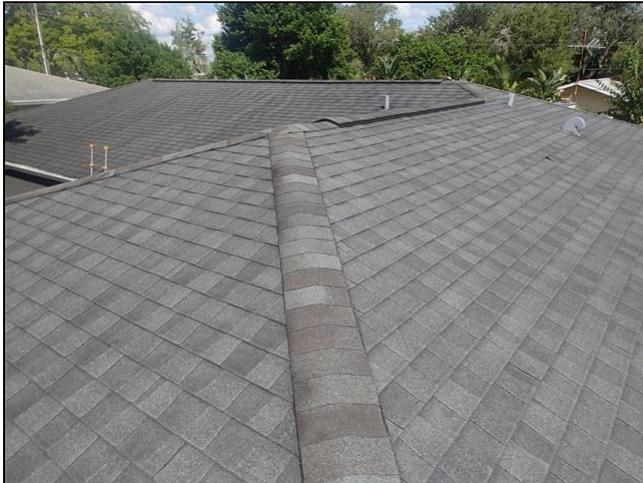
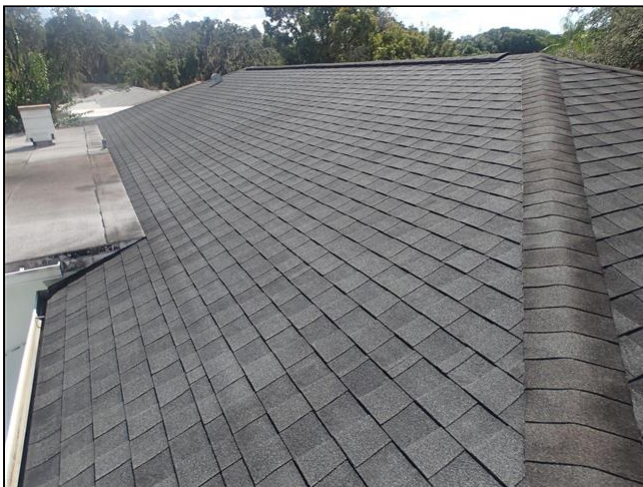
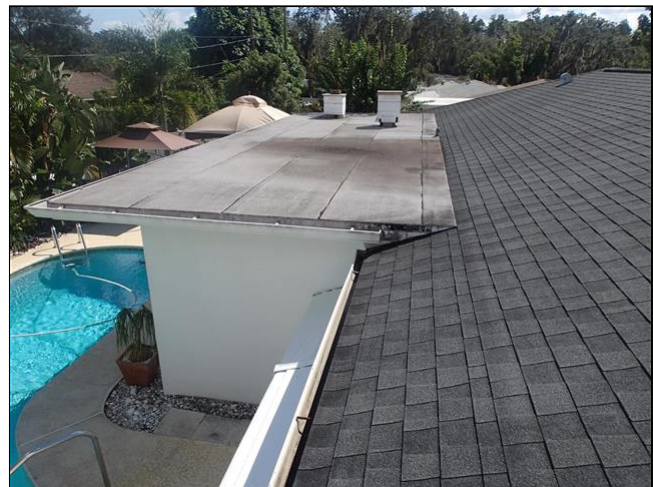
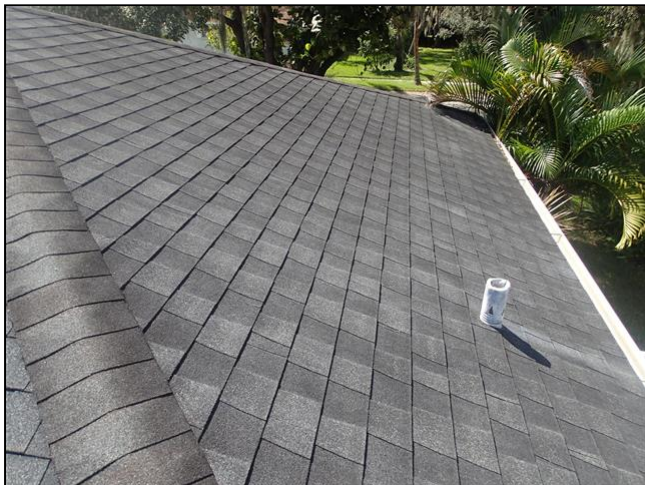
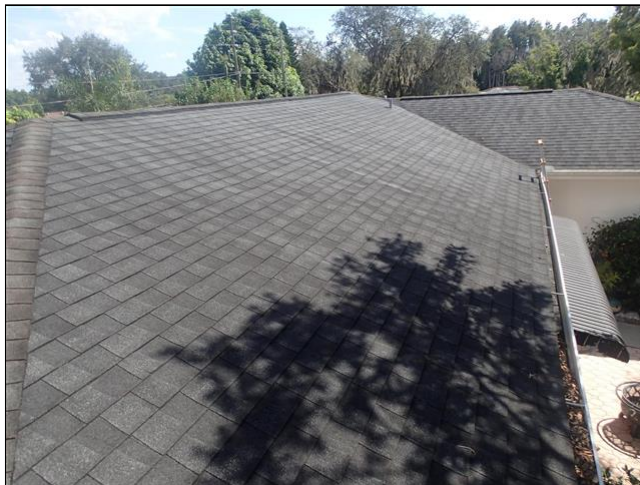
(1) The shingle roof surfaces appear to be in adequate overall condition and no sign of leakage or damage was seen during the inspection. The typical life expectancy for this type of shingle is 18-20 years. The rear flat roof is also 9 years old and will last another 4-5 Years.

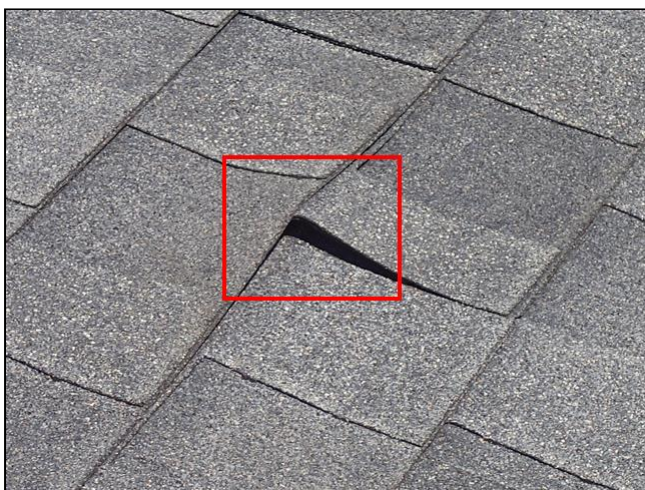
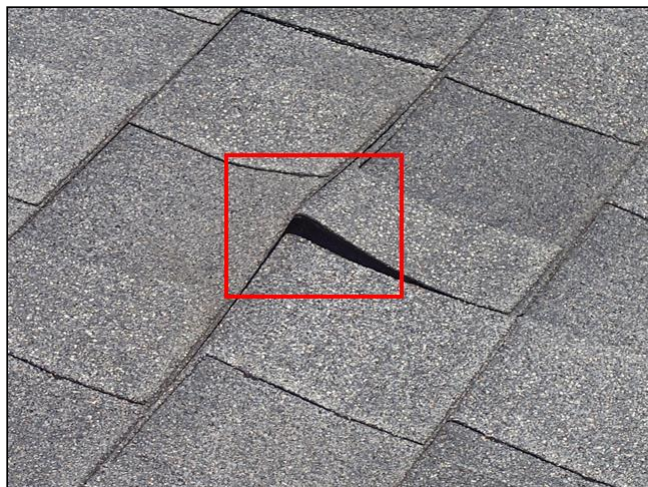
1.0 Item 7(Picture)

(2) There is a nail pop that needs to be repaired over the guest bedroom before it starts to leak.

(2) There is a nail pop that needs to be repaired over the guest bedroom before it starts to leak.

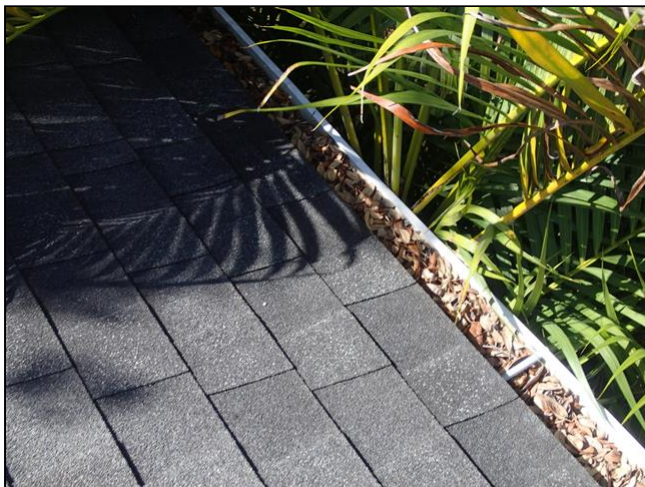
1.3 Item 1(Picture)

The gutters are full of debris in areas and needs to be cleaned. The debris in gutters can also conceal rust, deterioration or leaks that are not visible until cleaned, and I am unable to determine if such conditions exist.

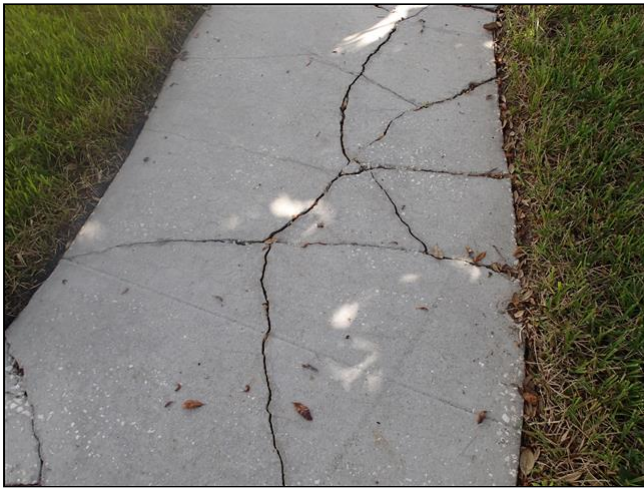
2.5 Item 1(Picture)

(1) Some typical cracking was seen at the sidewalk, no improvements are needed at this time.

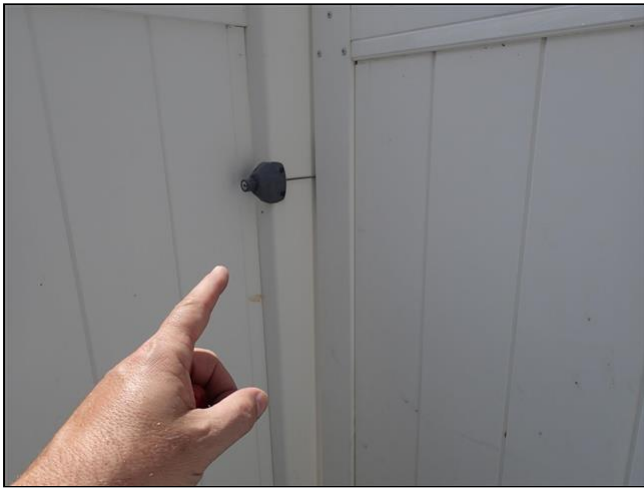
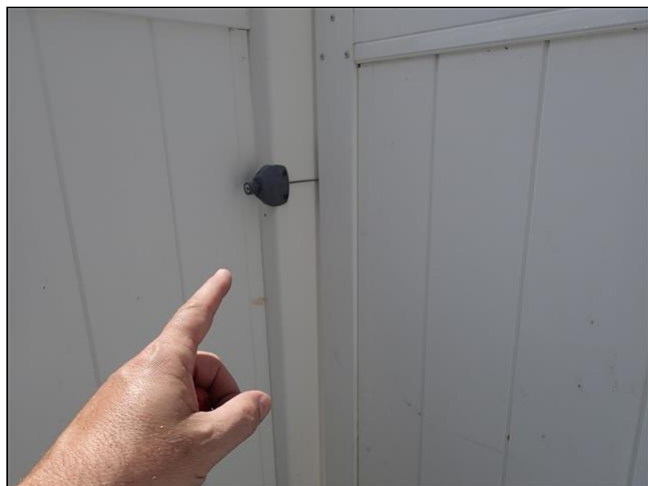
2.7 Item 1(Picture)

Adjust the self-closing gates to close correctly as required for safety at the pool area.

Adjust the self-closing gates to close correctly as required for safety at the pool area.

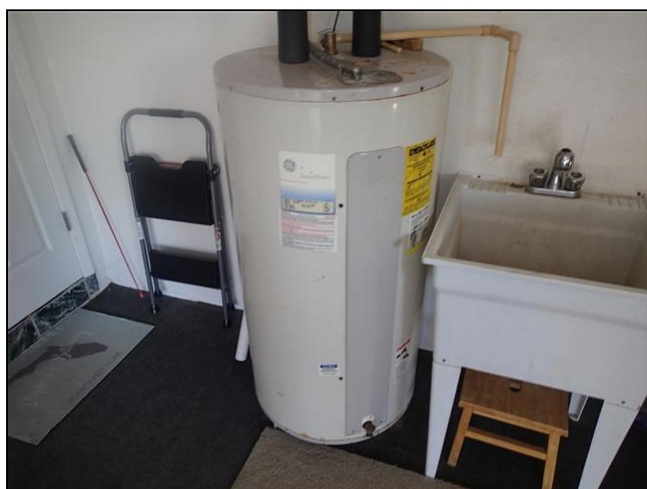
6.4 Item 1(Picture)

(1) Water Heater View

(2) Budget for the eventual replacement of this aging water heater, the typical life expectancy of the style of unit is between 12 and 15 years.

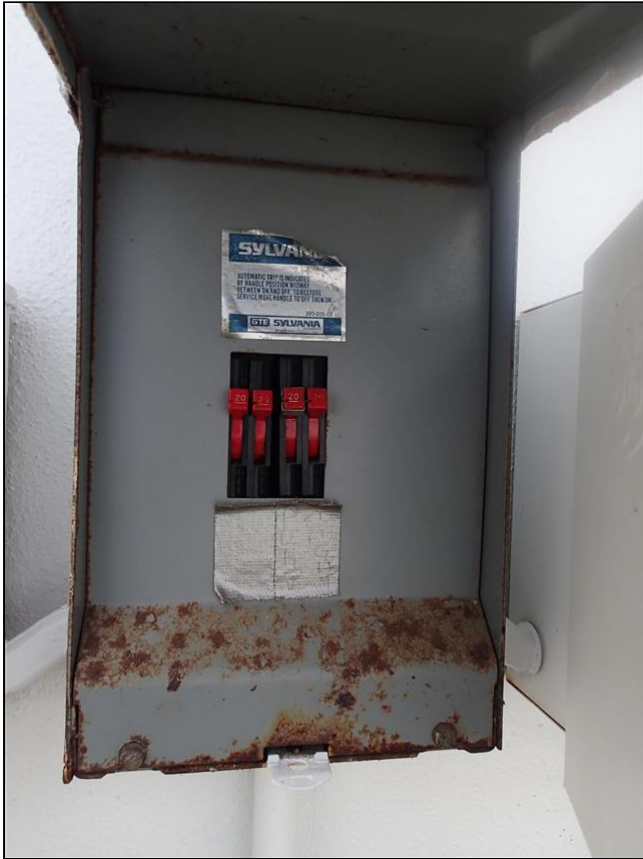
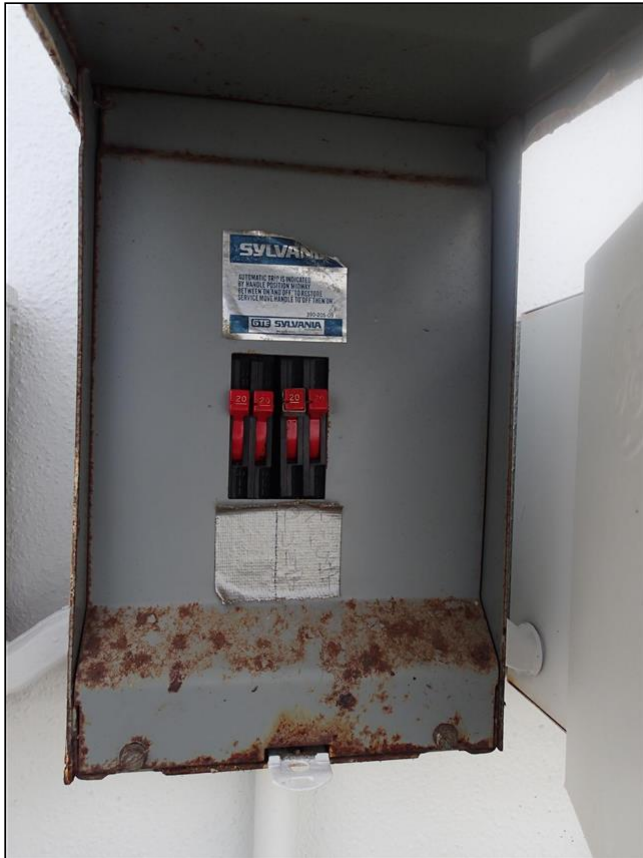
7.2 Item 1(Picture)

The pool sub panel is a SYLVANIA which brand known for a history of issues and is typically not accepted by many insurance companies. Furthermore, replacement parts are no longer available. I strongly recommend replacing the unit for safety.

The pool sub panel is a SYLVANIA which brand known for a history of issues and is typically not accepted by many insurance companies. Furthermore, replacement parts are no longer available. I strongly recommend replacing the unit for safety.

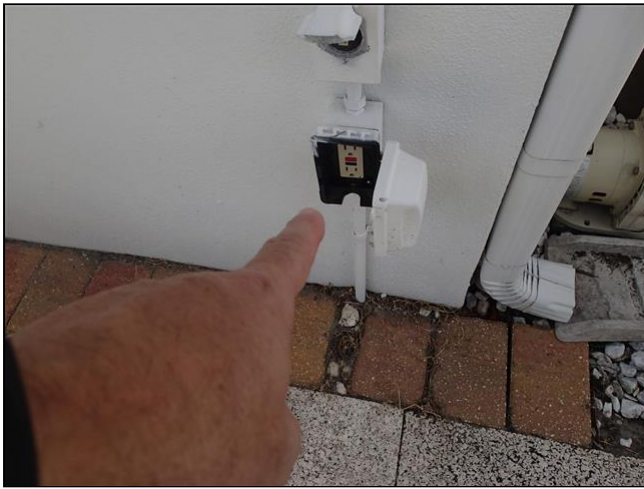
7.6 Item 1(Picture)

(2) There is a GFCI receptacle near the pool equipment and it is dead and needs further evaluation and repairs.

(2) There is a GFCI receptacle near the pool equipment and it is dead and needs further evaluation and repairs.

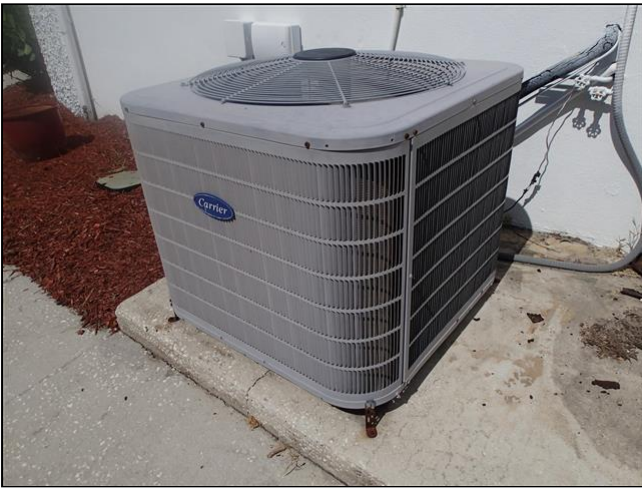
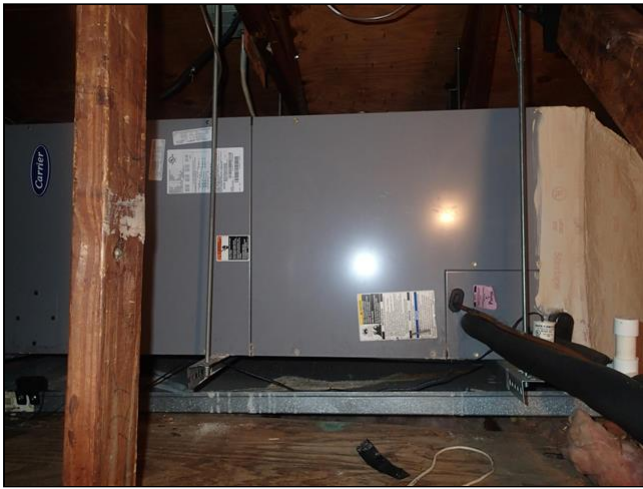
8.9 Item 1(Picture)

(1) Condenser unit

(2) Air Handler View

(3) The HVAC is functional but shows some wear and age and a lack of recent service, consider further evaluation due to age and slightly weak chilling performance.

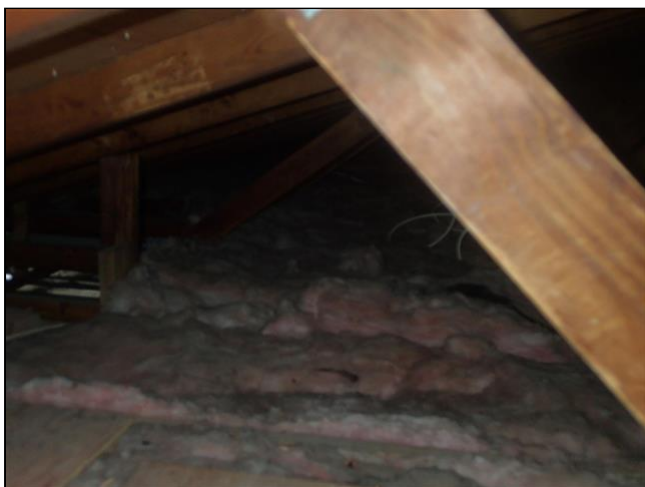
9.0 Item 1(Picture)

(1) Attic View

(2) **Maintenance:** The insulation was found to be somewhat thin by modern day standards. It may be wise to contact the utility company regarding a home energy audit as this can often result in a subsidy to add insulation and improve ducting connections.

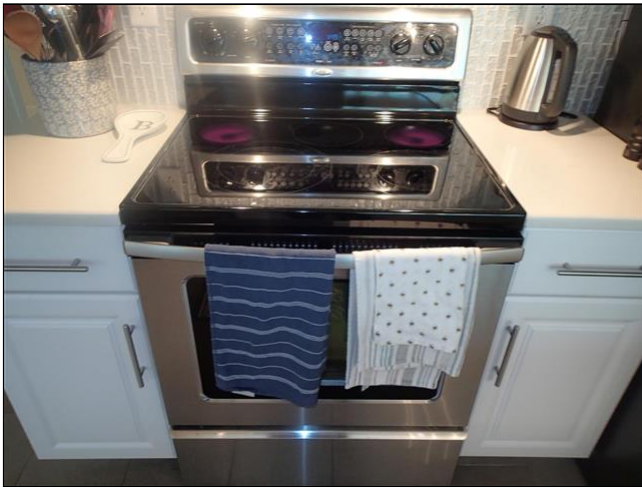
10.1 Item 1(Picture)

(1) Range View

(2) Install an anti-tip bracket needed at the range as needed for safety.

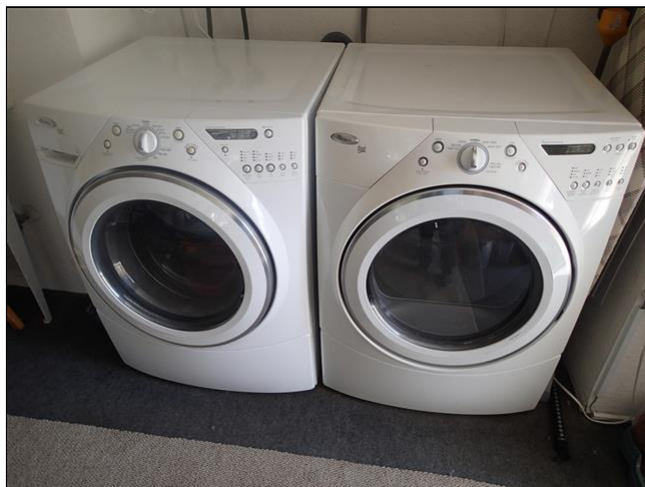
10.6 Item 1(Picture)

(1) Laundry Equipment

(2) **Maintenance:** Clean and maintain the lint build-up from the dryer vent to allow proper air flow and operation of the dryer. Improper maintenance of the dryer vent can create a fire hazard. It should be cleaned and serviced annually.

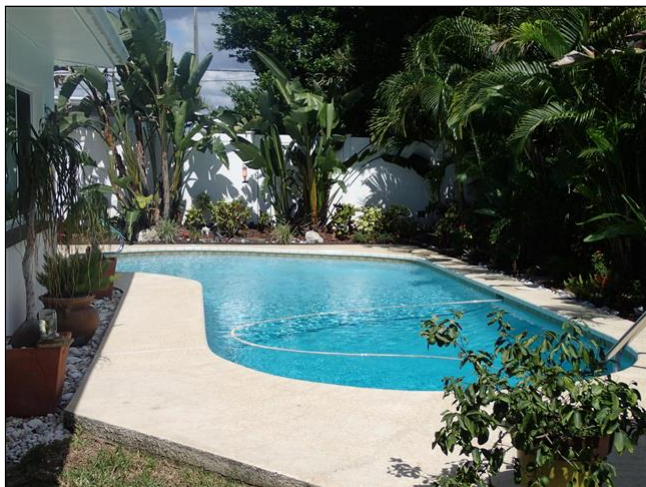
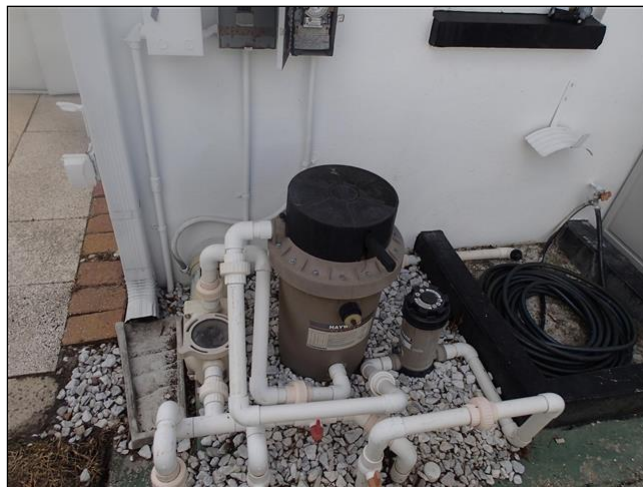
11.0 Item 1(Picture)

The pool appears to be basically sound with no visible signs of structural deficiencies noted at the time of the inspection. Some typical cosmetic surface wear was observed but this is not a significant concern at this time. Certain features of the pool, such as manual valves or electronic controls, were not tested. I recommend having these components/functions demonstrated prior to closing. You should consult a pool professional for a more comprehensive inspection if you have additional concerns. The equipment features that were related to basic circulation were found to be in good working order overall.
