February 28, 2019  
BEC Project No. J181002

**RE: DOCUMENTATION OF WASTES AND SAMPLING RESULTS  
PAINTED DESERT DEMONSTRATION PROJECT SITE  
149 LEUPP ROAD  
FLAGSTAFF, ARIZONA**

**SAMPLE LOCATION MAP**  
 PAINTED DESERT DEMONSTRATION  
 PROJECT SITE  
 149 EAST LEUPP ROAD  
 FLAGSTAFF, ARIZONA

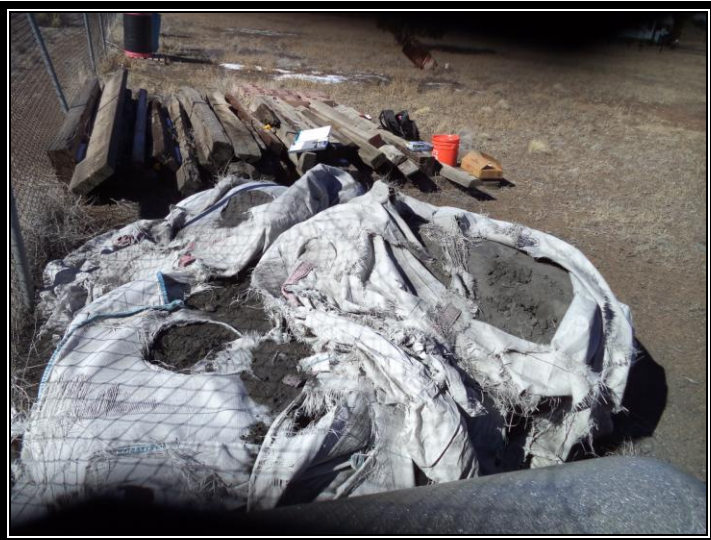
At the south end of the ranch house (residential) parcel east of the former Agra facility, a number of drums and supersacks of material were observed. Three supersacks were present near the southeast corner of the yard, and all three were rotted, spilling their contents partially onto the ground. The material was a gray powder, with a slight sulfide odor, and in our experience appeared to be tailings from a sulfide mining operation. BEC collected a four point composite sample using a stainless steel trowel from the three supersacks by collecting equal portions of soil from four locations in the pile and mixing the samples together into one composite soil sample using a large gallon-sized baggy. A sample was then scooped from the baggy into two 4-ounce glass jars supplied by the analytical laboratory, labeled, and stored on ice.

- Analytical results from the composite sample for the gray powder in the supersacks (COMP-1) indicated metals well above normal Arizona background, but only arsenic exceeds the Soil Remediation Level (SRL) of 10 milligrams/kilogram (mg/kg). The arsenic result of 141 mg/kg is well above the ADEQ Residential and Non-Residential SRL of 10 mg/kg. There was no detectable cyanide or hexavalent chromium. A TCLP (leachability) test of the material showed that no metal (including arsenic) failed the RCRA Hazardous waste levels.
- Analytical results from the composite sample for the pinkish powder in the drums and on the ground (COMP-2) indicated metals below any ADEQ SRLs. Chromium seemed to be above what would be in Arizona soils, but was well below its SRL. There was no detectable hexavalent chromium in the sample.

Photo No. 1: View of the three “super-sacks” of gray powdery material (sample COMP-1).

- The three super sacks of gray powder contained arsenic exceeding ADEQ's Residential and Non-Residential SRLs. Leachability tests show that the metals (including arsenic) are not leachable, and the material would not be considered RCRA hazardous waste. However, the material remaining in the supersacks and on the ground should be cleaned up, and removed as non-hazardous waste. Confirmation sampling of underlying soil should be collected with analysis for arsenic.

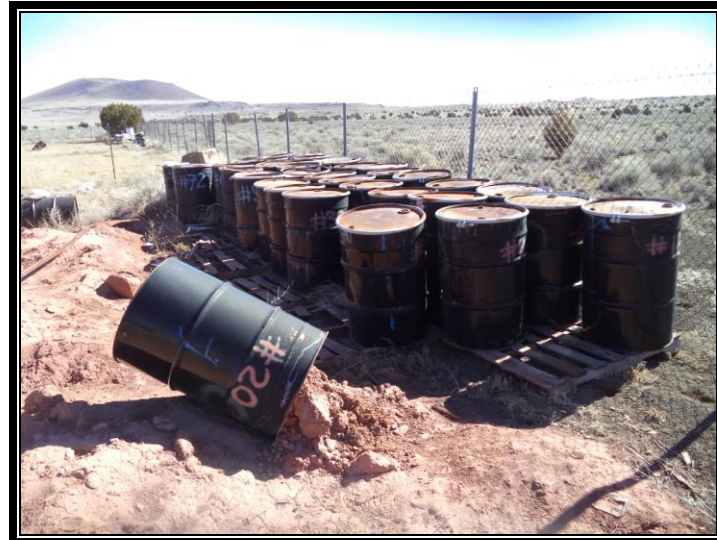
Along the south fenceline, but inside the parcel with the former Agra facility, there is an accumulation of approximately 37 drums on pallets. On the ground beside the drums there is a spread-out pile of pinkish powdery material that appears to have been in drums at one time. Several of the drums could be opened and it appears that the drums all contain the same pinkish powder. BEC collected a 6-point composite of the pinkish powder (sample COMP-2),

Photo No. 3: View of 37 drums of pinkish powdery material along south fenceline (sample COMP-2)

- The pinkish materials in the drums and on the ground do not show any exceedences of SRLs for the 8 RCRA metals, and do not contain hexavalent chromium. The materials may be disposed as non-hazardous waste.

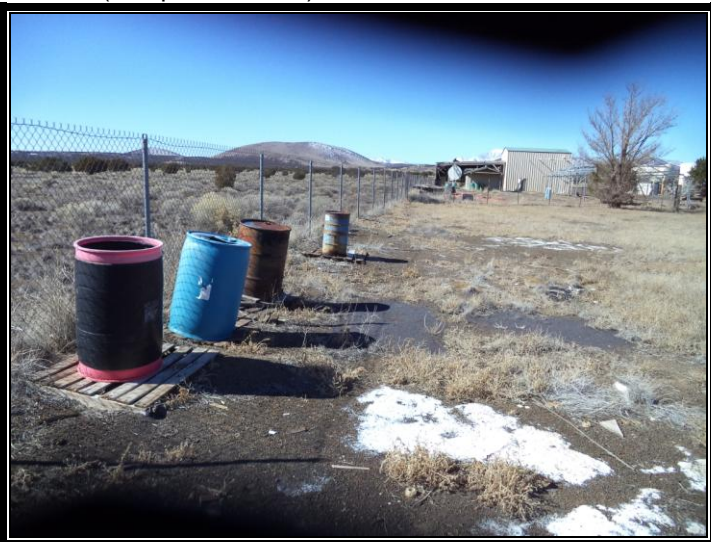
Just to the west of the supersacks, four drums were found on pallets along the fenceline. The four drums (from east to west) had the following contents:

- Poly drum – half full of a gray sludge similar to the material in the supersacks.
- Poly drum – black grit, appears to be “black sand” derived from a placer gold operation
- 55-gallon metal drum – full of what appeared to be crushed mica
- 30-gallon metal drum – half full of a bronze-colored crystalline material, which turned violet when exposed to moisture (when a sample was retrieved with a trowel). The bottom of the drum was heavily rusted, indicating a possible low pH

Photo No. 2: View of the four drums along the south fenceline.

- The four drums along the south fenceline (gray powder, crushed mica, black grit, and greenish crystalline material) require further testing to determine disposal methods. Some of these materials (especially the greenish crystalline material) may require disposal as RCRA hazardous waste.

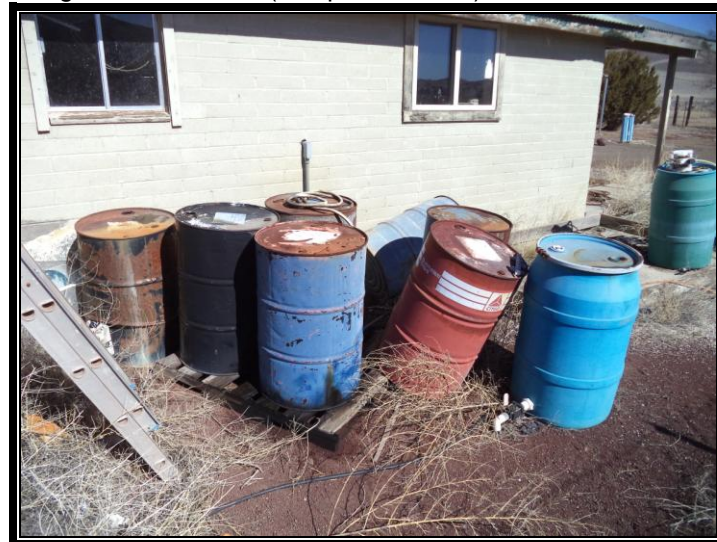
Finally, there was an accumulation of drums around the east and south sides of the block construction building along the south fenceline. A generator room is present in one of the rooms within this building, and a large aboveground storage tank for diesel is present along the south side of the building. There are 10 drums stored along the south and east sides of the building and include six metal and four poly 55-gallon drums. Three of the drums contained what appeared to be small quantities of used oil, while the other drums are empty. There are also three drums on dispenser stands (two marked for antifreeze, one marked for lubricating oil). There was only *de minimis* oily staining on the ground around any of the drums, and in our opinion there was no need for sampling of soil in these areas.

Photo No. 4: View of drums (mostly empty, some with waste oil) behind generator building.

- Finally, there was an accumulation of 10 drums around the east and south sides of the block construction building along the south fenceline. Three of the drums contained what appeared to be small quantities of used oil, while the other drums are empty. There are also three drums on dispenser stands (two marked for antifreeze, one marked for lubricating oil). There was only *de minimis* oily staining on the ground around any of the drums, and in our

opinion there was no need for sampling of soil in these areas. The small amount of used oil and the drums should be removed for off-site disposal/recycling.

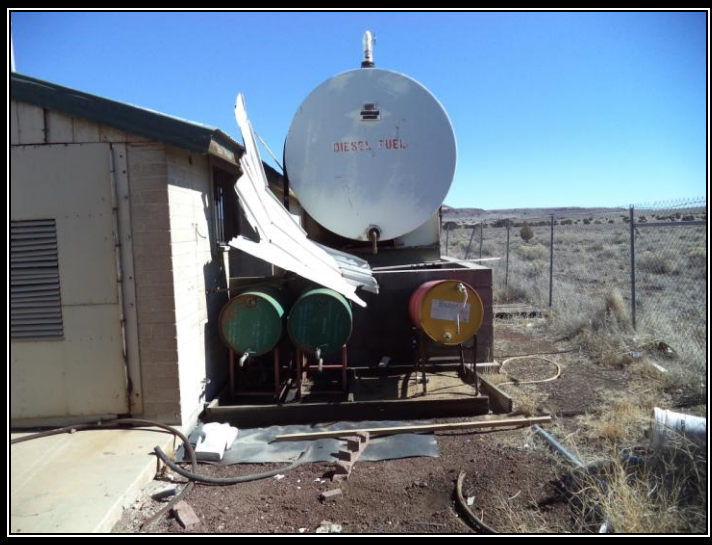
Photo No. 5: View of several drums on dispenser stands beside diesel fuel AST.

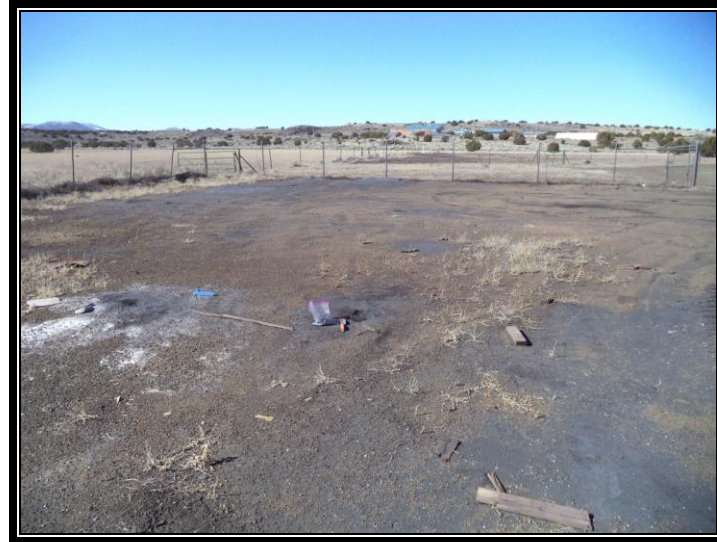
Two large areas of black grit are present on the ground east of the fenceline, and northwest of the west end of the south building. At one time, the black grit was apparently in 55-gallon drums (visible in the most recent aerial photograph from June 2017). It appears that grit was dumped out of the drums, and most of the drums were taken offsite for disposal/recycling. One area of black grit, approximately 60 feet by 70 feet, is located just to the northwest of the south building, and west across the driveway from the main Agra plant building and tank farm. The second area of black grit is approximately 280 feet by 35 feet wide, and extends northwestward along the east side of the west fenceline as shown on Figure 1.

BEC collected two composite samples, one from each area of black grit. A six-point composite (COMP-3) was collected from the south area, and a 10-point composite (COMP-4) was collected from the north area. Sampling was done in a similar manner to methods described previously. Both samples were submitted to Pace Analytical for analysis of the 8 RCRA Metals (totals), and sample COMP-4 was additionally analyzed for hexavalent chromium.

A sample of the black grit was examined by BEC under a stereoscopic microscope, and it appears that the black grit is "black sand" typically generated during placer gold mining operations. Most of the material appeared to consist of magnetite (iron oxide) crystals. There were no garnets, also typically recovered as part of the black sand from placer operations, and it is possible that the black sand was magnetically separated to remove everything but the magnetite.

Photo No. 7: View looking north at area of dumped black grit, with sample COMP-3 being collected (trowel and baggy).

- The black grit on the ground northwest of the south building do not show any exceedences of SRLs for the 8 RCRA metals, and do not contain hexavalent chromium. The materials may be disposed as non-hazardous waste.

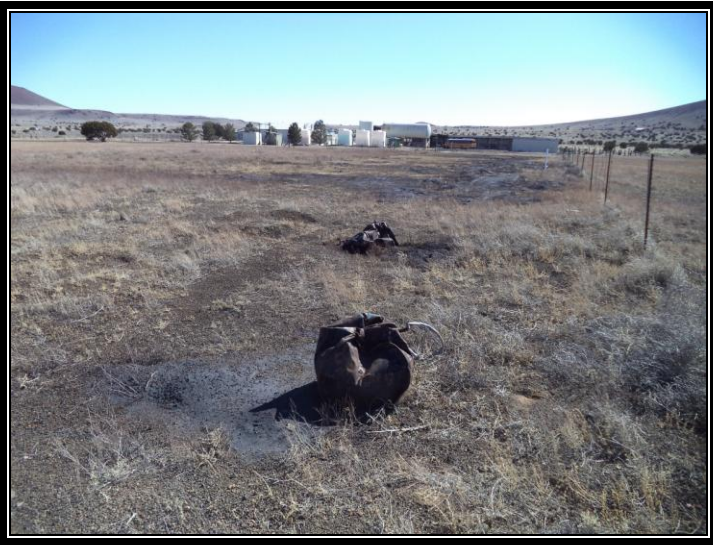
Photo No. 6: Looking south at several remnant drums with black grit material (sample COMP-4).

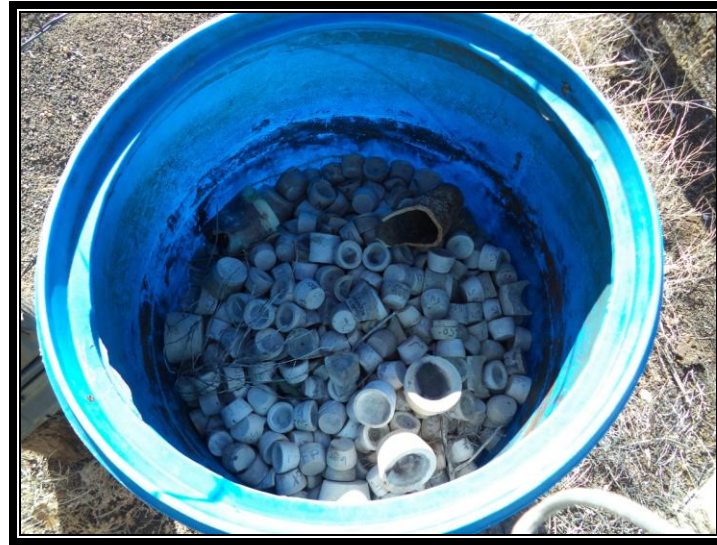
West of the south building, there are several drums containing materials that may require special disposal methods. One poly drum contained assay lab wastes (used crucibles and

Photo No. 8: Waste assay laboratory materials (cupels and crucibles) in poly drum near southwest corner of Property.

- The drum of assay waste requires further testing, and will almost certainly require disposal as RCRA hazardous waste. The drum of ceramic pellets may be disposed as solid waste.
- The air scrubber equipment and associated containers of possible acids need further evaluation by a licensed environmental contractor to determine disposal methods and costs.

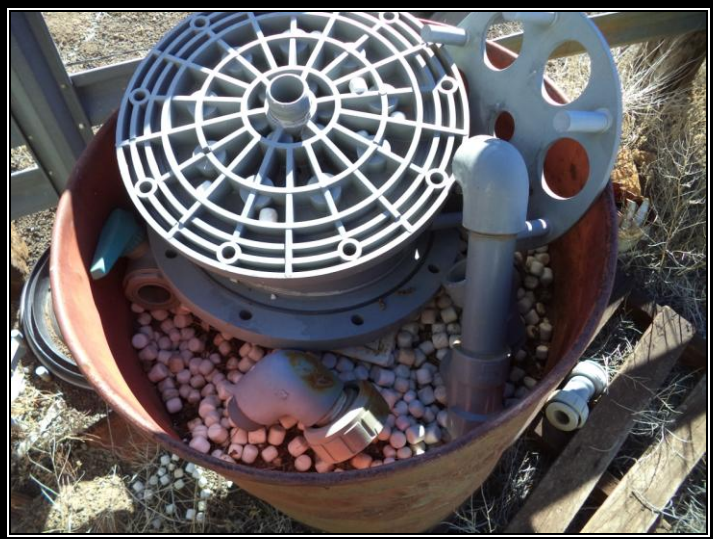
cupels). A second poly drum contained ceramic pellets of various sizes, which are often associated with wastewater treatment equipment. BEC collected samples of both materials but did not submit the samples for analysis. BEC did contact an assay laboratory (Skyline Lab in Tucson, Arizona) to inquire about disposal options for the used assay equipment. The laboratory indicated that these kinds of waste have to be disposed as RCRA hazardous waste based on metals content (primarily lead). In BEC's opinion, the ceramic pellets are much less likely to be hazardous waste, and can probably be disposed as solid waste.

Photo No. 9: View of waste water treatment materials (mostly clay pellets).

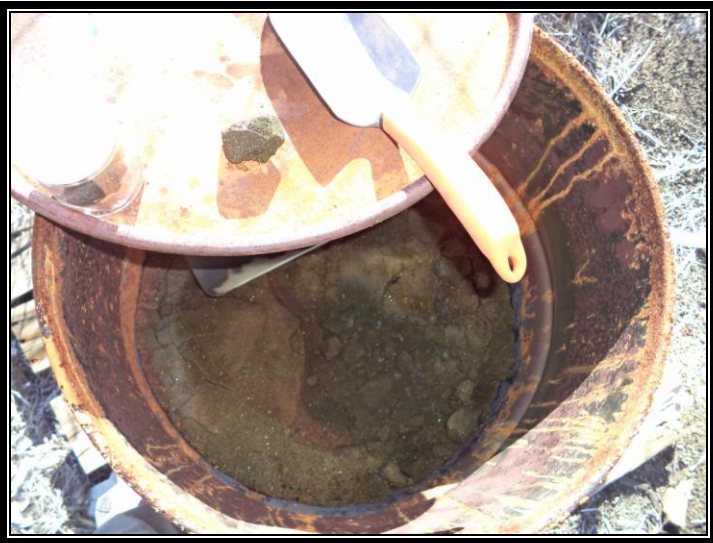
Photo No. 10: View of interior of drum containing possible gentian violet crystals.

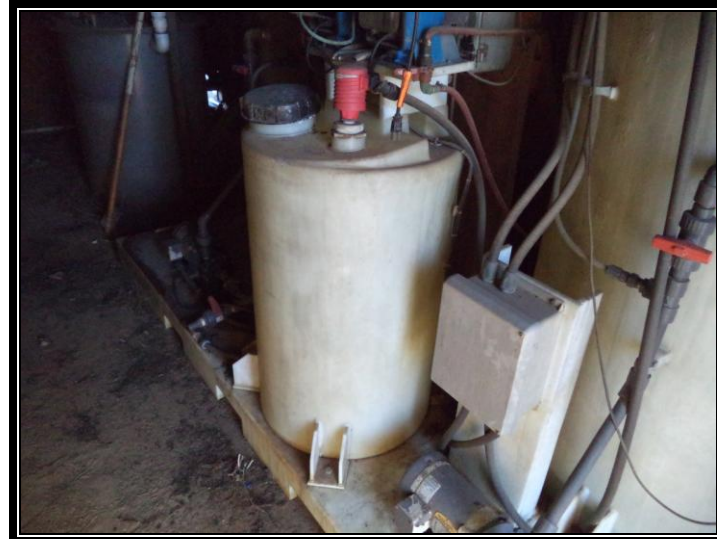
In a small room at the northeast corner of the Agra plant building, there is equipment that was reportedly used as an air scrubber for emissions from the plant. Two large poly tanks (500 gallons) have some remaining liquids (possibly hydrochloric acid), however, it was not possible during the inspection to determine the quantity or actual composition of the liquids. Several smaller tanks may also contain liquids that would require special handling. Pictures are included in the attached photolog.

Photo No. 11: View of smaller tank in the air scrubber room.

BEC recommends that a licensed environmental contractor inspect the equipment for decommissioning and arrange for disposal of the equipment and any wastes (such as acids) that might still be in the containers.

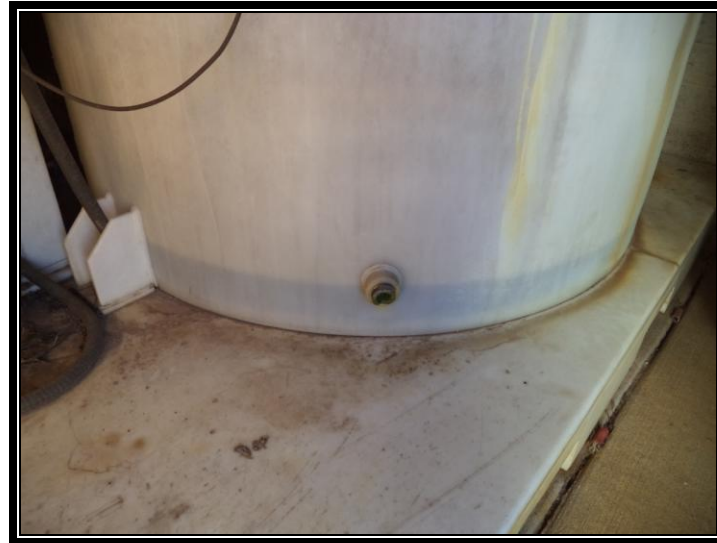
Photo No. 12: Bottom of one of the two larger tanks in air scrubber room, showing fluid level near the bottom.
