# Example Home Snagger Pro Report- INITIAL REPORT

COURTESY VISIT LIST FOR LAGAN TO  
ADDRESS ITEMS

Sunday, 09 May 2021

95 Items Identified

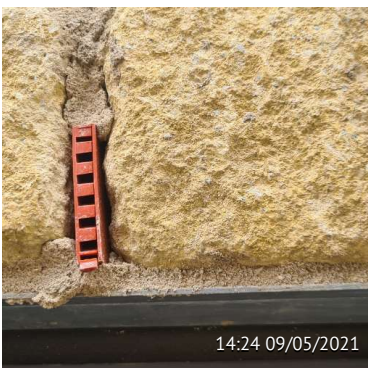
**Back Of Chimney Breast Gap In Weep Vent Pointing**

Muck in the hungry perp again. Functional orange items.

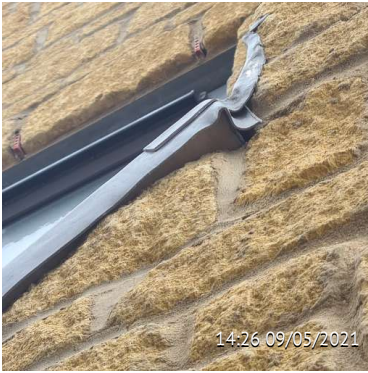
Dress Lead Down And Over To Cover Exposed Ply On Chimney

Mainly cosmetic but ply can be seen still under the lead. Needs a better finish. Note next door no ply is on show. Possibility of insects etc getting into chimney structure. Functional orange item

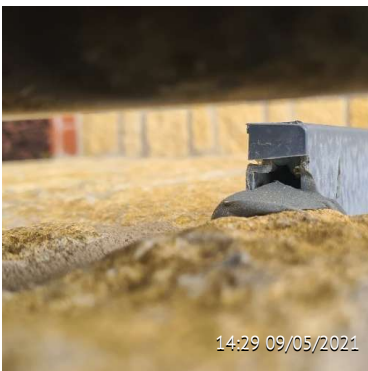
LHS By Down Pipe Sill End Cap Damaged

Replace damaged Sill cap. Specialty part - Hence Cosmetic orange item

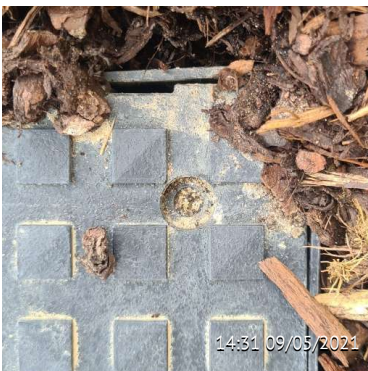
Mismatched Screws to Drain Pot Cover Front Of House

Replace with manufacturer screws so that they are all the same and lid is secure. Cosmetic Green item

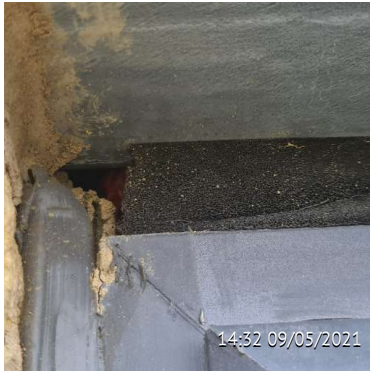
Front LHS Window Gap To Compriband

Replace compriband on this window and extend to edges (current strip is also made up of cuts so should be replaced with single strip) currently allows water / debris potentially into wall cavity. Functional orange item

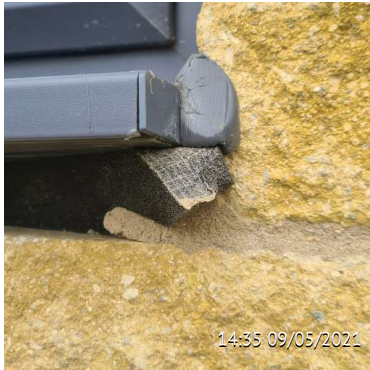
Cut Back Compriband Hanging Out From Top LHS Window Sill

Cut back both sides and push in as necessary to make tidy. Cosmetic Green item

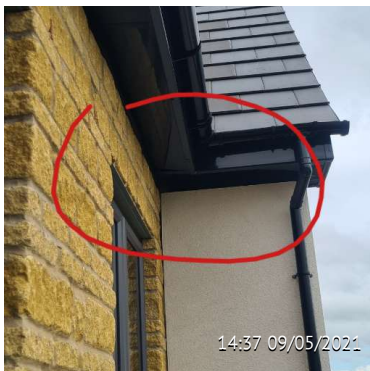
Large Gap Above Render Wall Where Soffit Is Pushed Up

Hard to see in photo or from ground level, but Compriband is cut short here also and timber roof construction on show where soffit has been pushed up. Difficult access with porch below. Triple ladder required possibly. Currently perfect spot for a birds nest. Needs to be rectified sooner rather than later. Functional orange item.

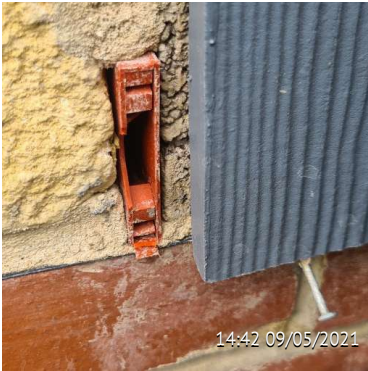
Item  
**Broken Weep LHS Front Door**

Comments  
Replace broken Weep Vent and point in. Cosmetic Green item.

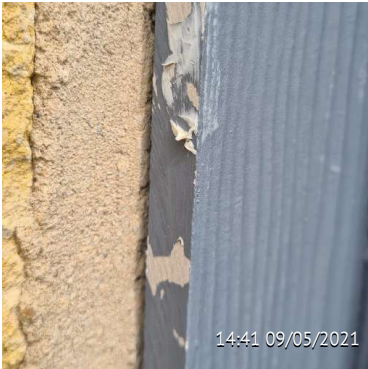
Item  
**LHS Front Door Cladding Touch Ups And Mastic Remove**

Comments  
Various chips and mastic smears to cladding LHS panel of Front door. Green cosmetic items

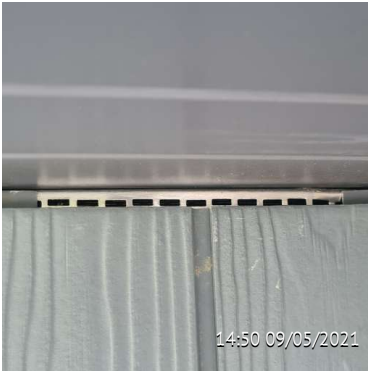
RHS Gap To Top Of Cladding Larger Than LHS

This is cement board plank so no significant expansion gap required. This can be adjusted by moving existing planks up slightly. Cosmetic Green item

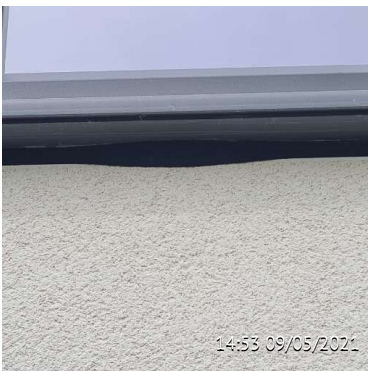
Both Front Windows On Render Need Compriband Adjustment

Compriband hangs out over edge bead causing a wavy effect under window Sill. Needs to be pushed in to show line of render bead. Easy fix Green item

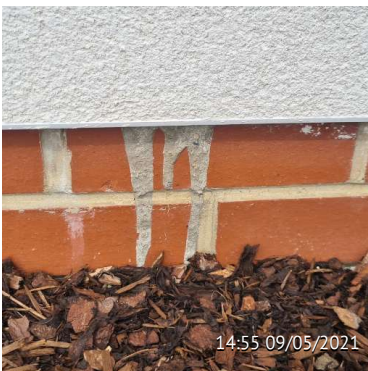
Acid Wash / Clean Down Splash Course

Various places round house has muck drips down Splash course brick work. Acid wash should clean this up if necessary. Cosmetic Green items

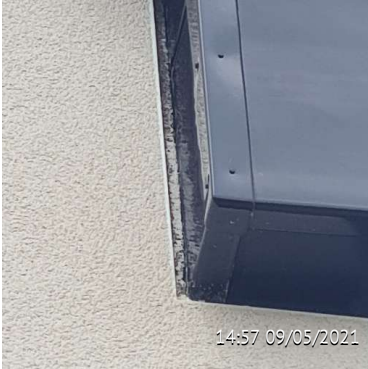
Item  
See Previous Item  
Developer assignment suggestion  
Brick Layer / Site

Comments  
Clean Down splashes

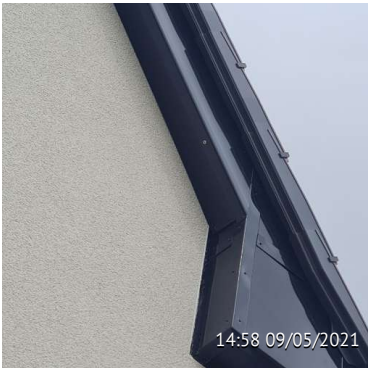
Item  
Other Side Of Gable Render Bead To Fascia Fill Gap

Comments  
As seen in previous item Compriband Best to fill this unfinished gap between soffit boxings and render beads. Specialty cosmetic orange items.

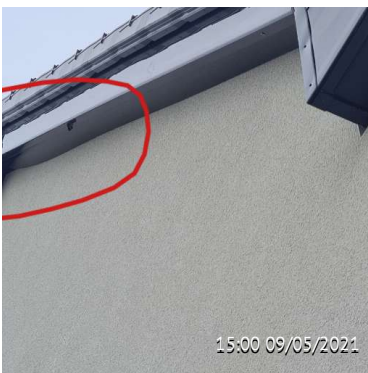
Item  
Bow To Soffit Board - Front Gable

Comments  
RHS Gable soffit board needs tapping or possibly pinning up as it slightly bowed towards top. Evident on top point of render as a result giving impression of warped render towards top. High Level cosmetic orange item

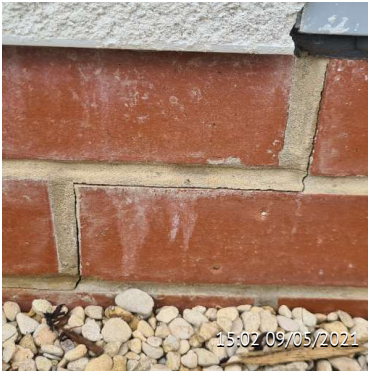
### Crack To Pointing Under Side Door

Repair cracked pointing. May get worse with frost etc. Minor functional green item

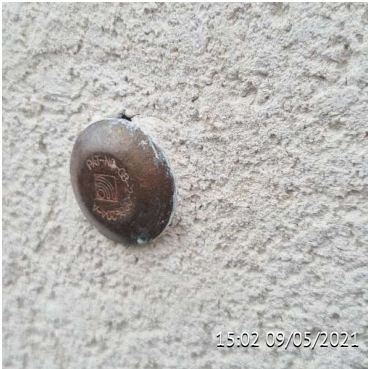
### IMPORTANT - Boiler Blow Off Has Been Covered In Render Process

Potential for damage to render or leak inside house with pressure build up. Plumbers did not allow for render depth, although were right to install it prior to render. This now needs to be extended and render repaired if necessary (Note it looks like a render infill has already happened around pipe) functional Orange / Red item if left.

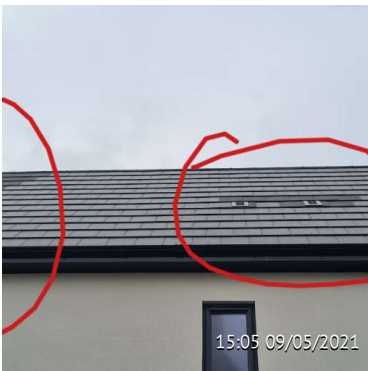
### Variation In Roof Tiles On House

Appears 2 different batches of tiles used which is apparent. Replace the odd tiles with matching tiles. May need to be sourced from another house on site or from roofer stock. Significant cosmetic Orange item

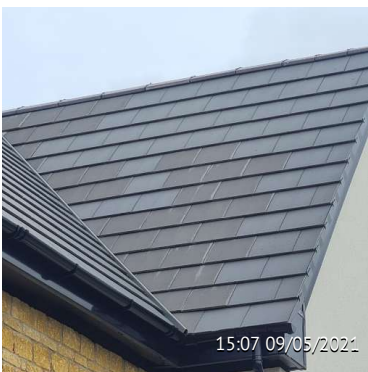
### As Previous Item On LHS Gable

Mis-matched roof tiles. Cosmetic Orange item

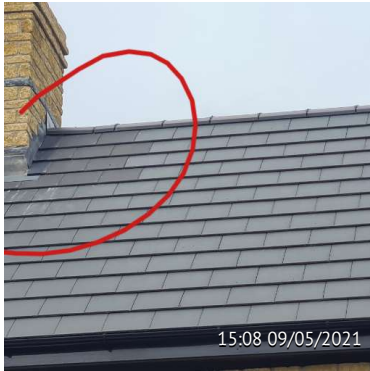
LHS Front Roof As Per Previous Items

Mismatched roof tiles by chimney. (Compare to the other roofs).

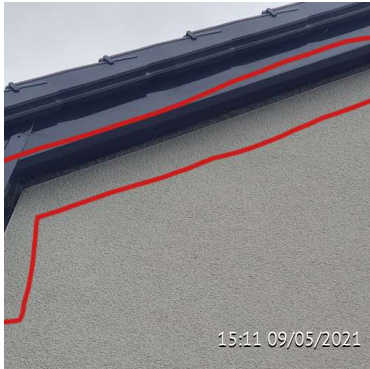
Entire Rear Gable Needs Soffit Lowering / Or Other Solution

There is approx a 50mm gap all the way round Gable end between Gable soffit and render bead. Compriband could be an option for solution if resident is happy for this. (Compare with front) Ideally soffit should have been tight to render bead.

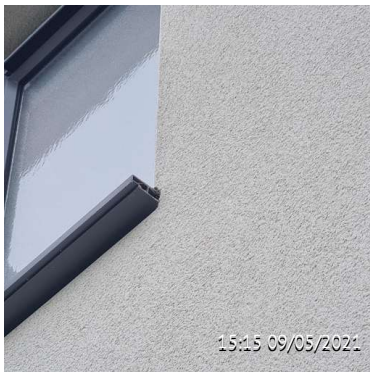
Rear Elevation High level Sill Cap Missing

Fit missing sill end cap. Specialist part Cosmetic Green item

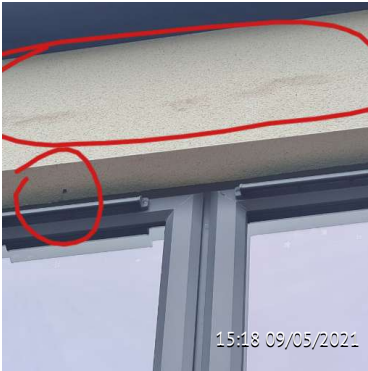
White Marks Not Easily Removed RHS Patio Door Side Light Frame

May be able to remove with solvent or may need magic man touch up. Cosmetic Green item.

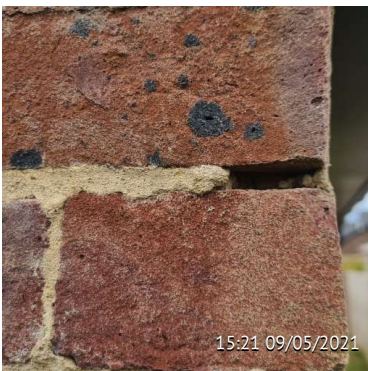
Next Doors Garage Gable Backing Onto Side Or Garden Gable  
Brickwork To Finish

Should get picked up with next doors snag but there are a couple of cuts missing to Gable end, visible from number 13 garden

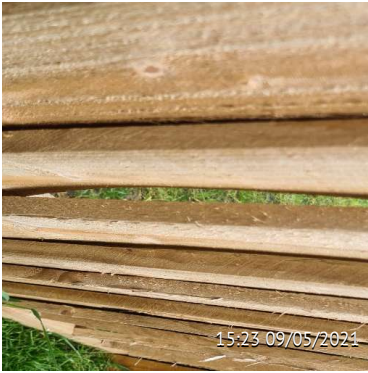
2 Damaged Feather Edge Boards to Back Fence Line

Replace the 2 damaged feathers . Cosmetic orange item

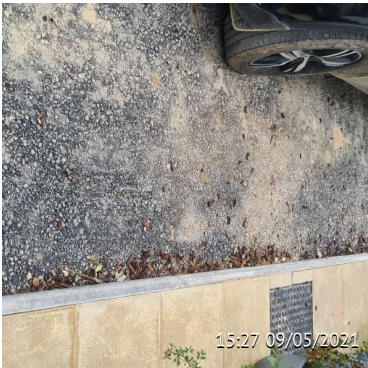
**Driveway Missing Wearing Course / Large Pot Holes To Road**

Typical sign of builder waiting for next load of tarmac to save money, rather than finish a customer driveway specifically before occupation. This should be sorted ASAP along with road. Does Not give good impression. Functional orange item

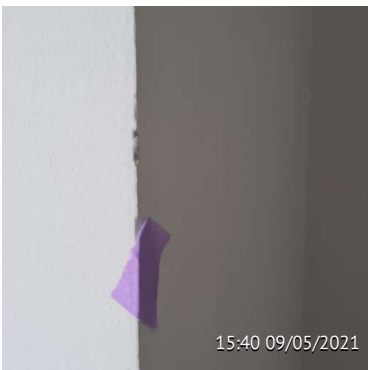
Different Lintel Used For 2nd Garage Door Meaning Gap Left To Top Of Door

Suggest to trim header of both doors black soffit to match, and close gap on the second door header to prevent birds etc from entering. Functional orange item

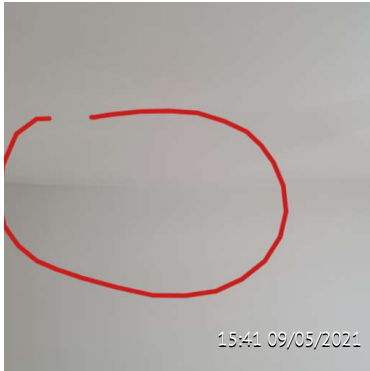
Wall Line Above Front Door

Wall is bowed, probably where boarded over joist not flush with stud wall. Feather out skim would be the solution for this. Customer to-be notified of level of disruption expected in this case to decide whether to proceed . 2 trade cosmetic item- orange

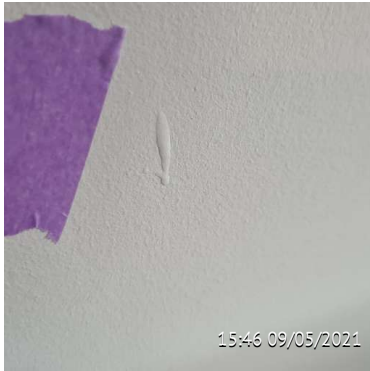
Please Address The Move In Shrinkage

Various shrinkage present on move in should be addressed. Residents aware further shrinkage expected not under warranty . Cosmetic Green items

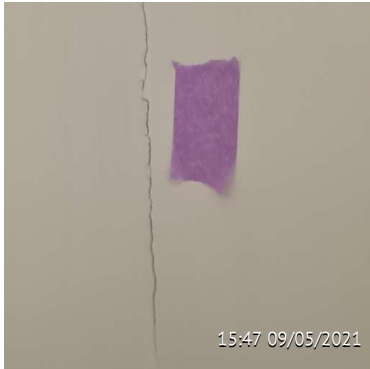
**Address Decorative Snags As Marked**

Previously mentioned. Purple tap indicates typical snags found.  
Cosmetic Green items

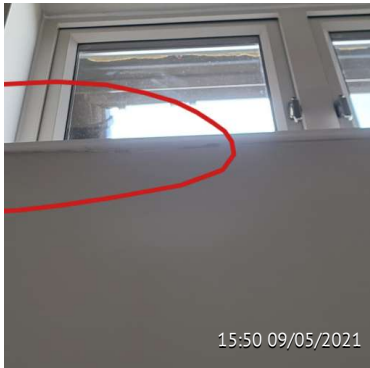
**Address Move In Shrinkage**

Various shrinkage present upon move in. Residents understand further shrinkage could be expected

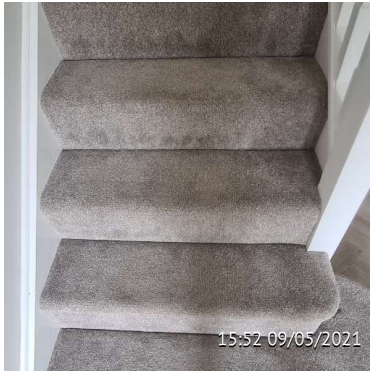
Excessively Creaky Stair Case

Mainly step 2,3,4 needs attention. But please check whole stair case. Significantly creaking functional orange item

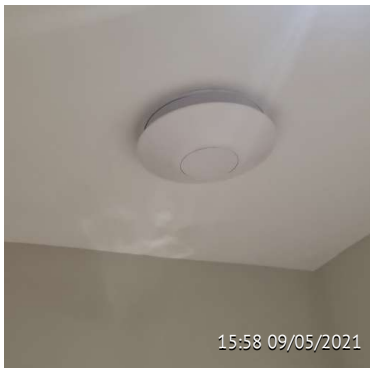
Various Paint Snags Including Drips And Small Fill In Wc.

Address as necessary. Previously mentioned Green items

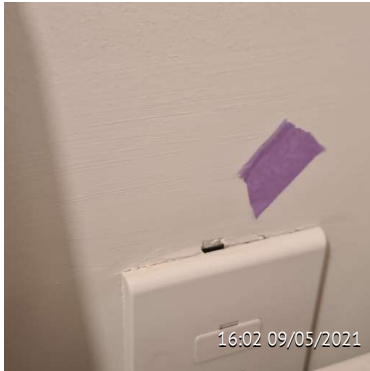
Crossed Heating Issue. LAGAN aware..

Significant work required to find issue and make good any damage caused from the downstairs thermostat controlling bed 1 rad. Moreso of an issue as upstairs sensor in in bed 1. Significant making good and decs will be required due to necessary hole cut outs. Orange / Red item due to works involved

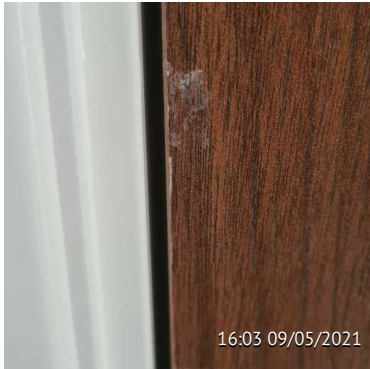
**Under Stair Cupboard Caulk To Fuse Spur Required**

Caulk as necessary. Cosmetic Green item

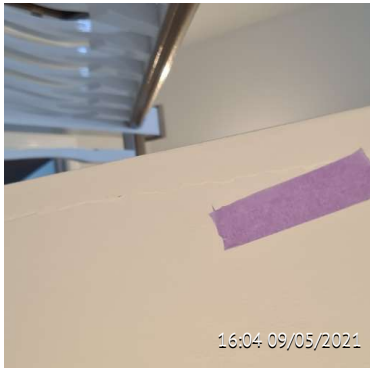
**Marks To Understair Door**

Remove marks to under Stair door. Cosmetic Green item

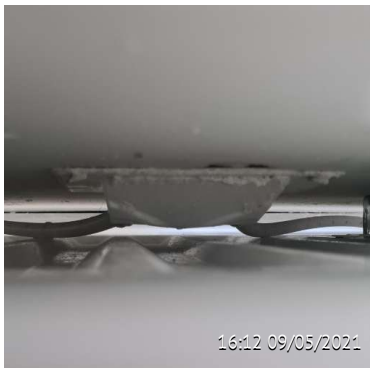
**Blown CornerTape To Landing Bulkhead**

May wish to address with the making good drom.heating issue.  
Tape is blown. Specialist cosmetic item orange

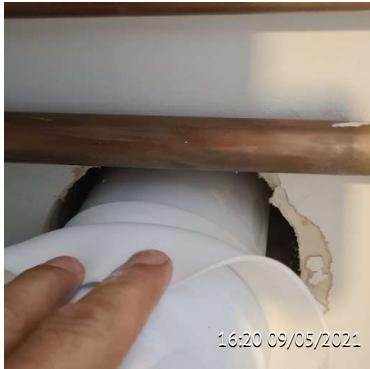
Item  
**Seal Boiler Flue Inside**

Comments  
Orange / Red NHBC check item. Small risk of fumes into cavity or house if flue damaged. (Note, is sealed externally so minimal risk short term)

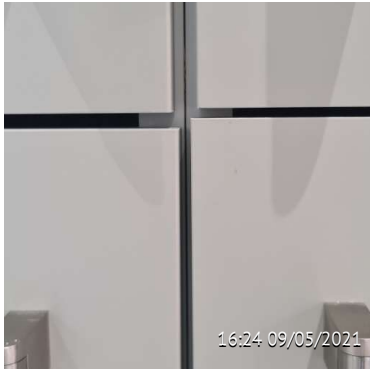
### Under Oven Kitchen Door To Align

Align under oven cupboard door correctly with freezer door.

Cosmetic Green item

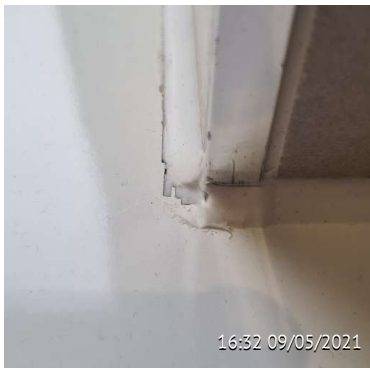
Front Bed En Suite Vanity Worktop Cut Short

Vanity Top will need to be replaced as a result of this poor carpentry. Specialist cosmetic orange item

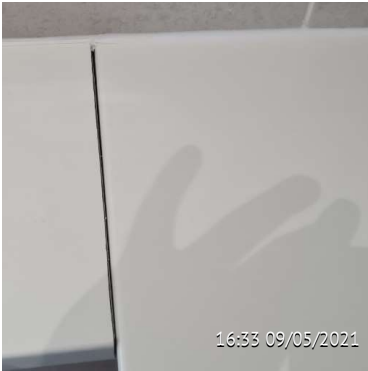
**Front Bed Ensuite Vanity Worktops Not Joined Properly**

Replace them. These should be metered into each other or another solution to finish properly found.

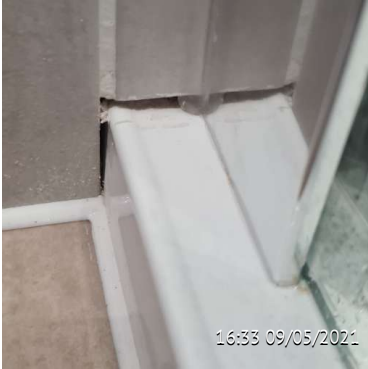
**White Mastic Seal Front En Suite Shower Tray Gap**

Orange / Red item because of potential consequences. Water can get behind tiles as a result.

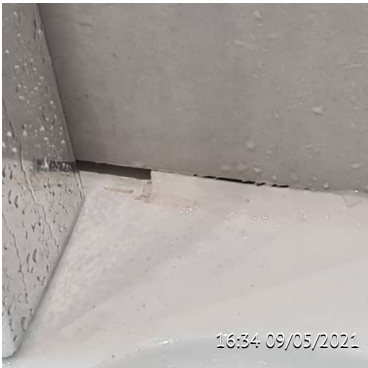
**Important! Front En Suite Shower Tray Finish Mastic**

Orange / Red item die to potential leak/ flooding. Water can get behind tiles. Note screen may need to be removed for proper seal. Function orange / Red item . (And NHBC check)

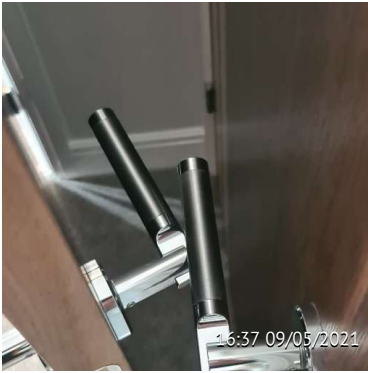
As Per Previous Item, Same For Main Bedroom

See previous suggestion

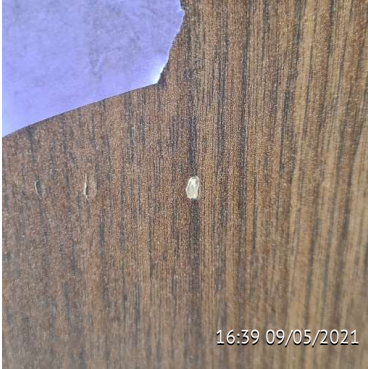
Main Bed Damage To Back Of Door

Ideally replace, else magic man could attempt repair to surfaced bedroom door. Specialist cosmetic orange item

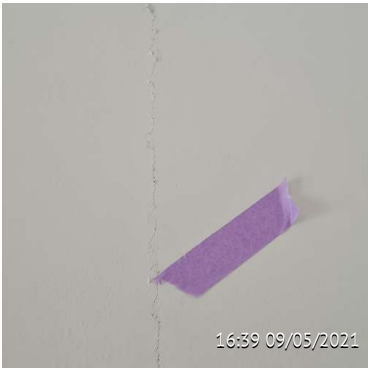
Making Good Required Above Door

Cracking around stud work through board . Cosmetic Green item

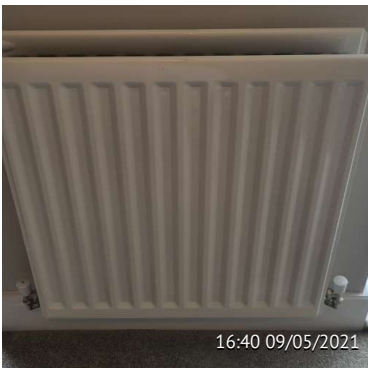
Note The Heating issue Being Addressed. No TRV On Rad To Adjust Either (Because Is Sensor Room)

See previous item on this. Can TRV be added to this rad in the short term ? ..

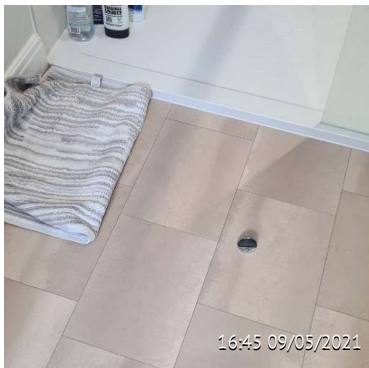
Crazy Location Of Door Stop In Main En Suite.

Illogical positioning of doorstop . Causes trip hazard / toe stub issue. Move close to in front of tray also to left. Replacement lino will be required as a result and therefore mastic also. Functional orange item

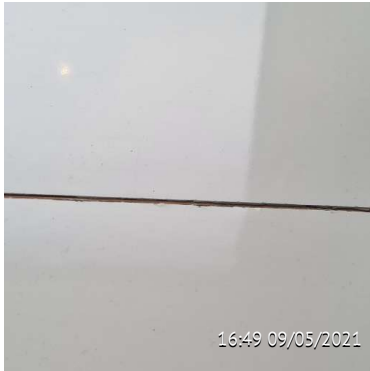
Very Poor Join To Main Bath Vanity Top

Replace Vanity Top with proper join or replace with tiles as alternative. Water will get in here and blow board. Functional orange item.

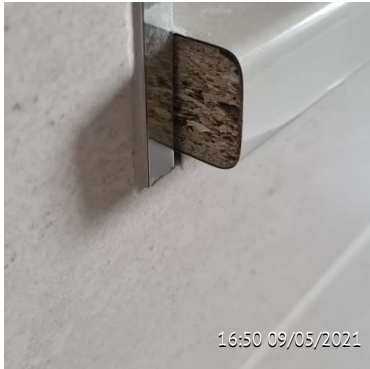
Main Bed Vanity Top En Suite Not Edged

This vanity top is ok apart from missing Edging. Moisture could cause this to blow. Functional orange item

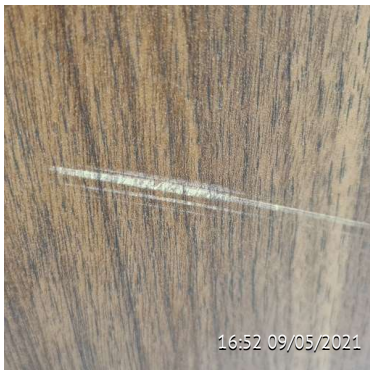
Back Of Main Bathroom Door Damaged

Replace bathroom door as damaged. Alternatively magic man could attempt repair but probably not worth it. Specialist Cosmetic orange item

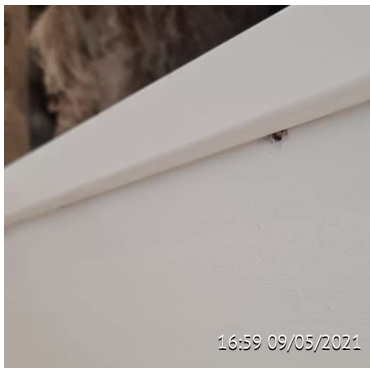
Small hole To Side Of Loft Hatch

Small Fill required. Cosmetic Green item

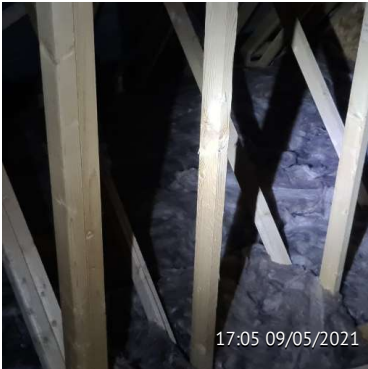
Item  
Loft Space OK ☐☐

Comments  
No reportable faults found in loft Space

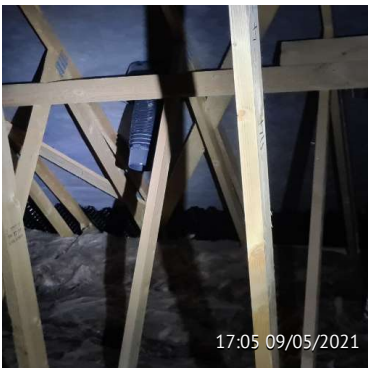
Item  
Note: 1 Spare Roof Vent Tile

Comments  
1 vent is not used. No issue, but unnecessary

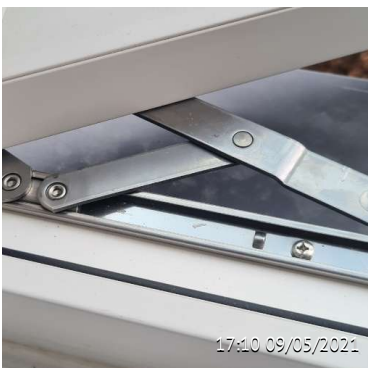
Item  
Couple Of Living Room Windows Grinding In Mechanism. May  
Need Clean

Comments  
Sounds like grit in the mechanism should be easy fix Green item.

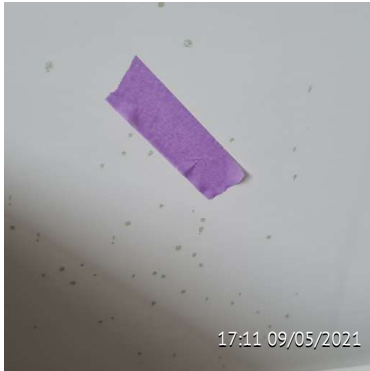
Significant Splashes To Wall From Latex In Lounge

This was from developer initial latex floor primer. Cosmetic Green item

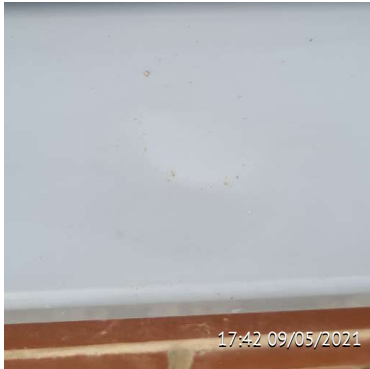
Dent To Side Door Sill. Also To Rear Door.

Side Door Sill has Dent Dent it. Please ask homeowner about rear door as they have found one there also. Maybe new over Sill of required ? Cosmetic Green item.
