# Initial Defect List \*\* \*\*\*\*\* Grove

Monday, 03 May 2021

Prepared for Home Snaggers Example  
Report

76 Items Identified

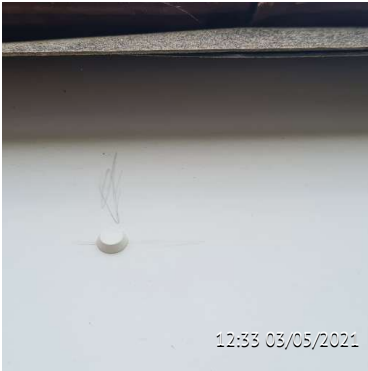
Front Left Bay Fascia Marked Above Poly Pin

May clean / rub off. Looks like pencil. else magic man to resolve.  
Cosmetic Green item.

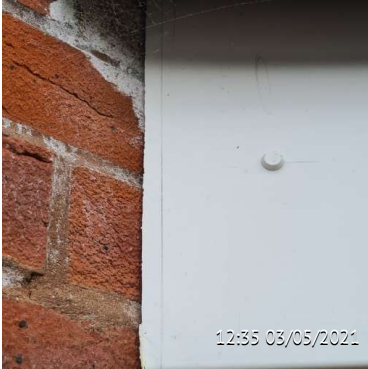
Same Fascia Pencil Marks To Edge

Remove pencil lines. Cosmetic Green item.

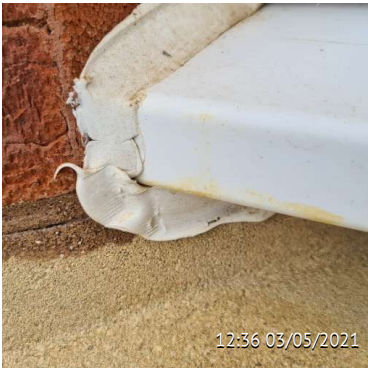
Lhs Bay Sill Mastic Messy.

This is a poor finish with finger prints in mastic. Please Redo affected area. Cosmetic Green item

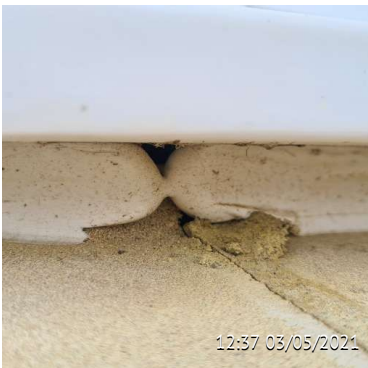
Mastic Gap Under LhS Bay Sill

Complete properly . Can let moisture and bugs in. Functional orange item.

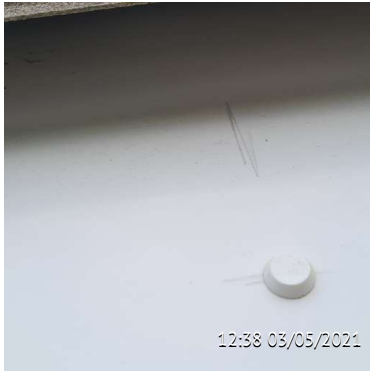
Remove All Pencil Marks From Bay Fascias

Carpenter clearly has marked with pencil and then not rubbed off afterwards. Cosmetic green items.

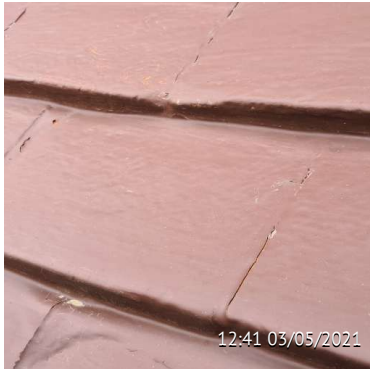
Front Porch (paint?) Peeling All Over

This appears to have been painted to change colour, but wrong paint has been used and already has started peeling. Will look worn in no time. Correct colour grp porch should be ordered and fitted or appropriate paint product to be used. Significant cosmetic item. Orange. (Additional note, appears to be the same paint as used on meter boxes)

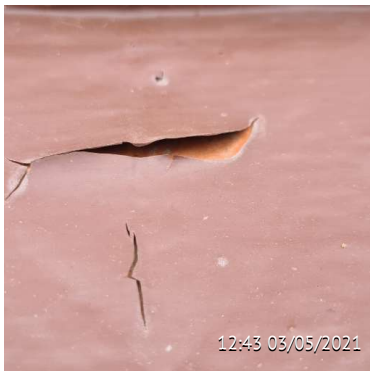
Another Example Of Previous Item

Significant Poor finish. Orange severity.

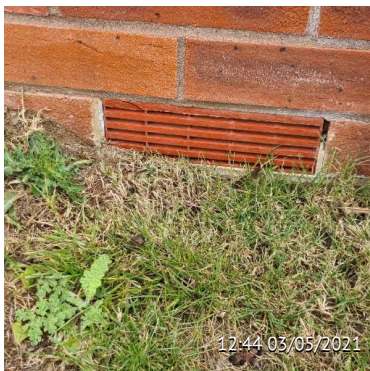
NHBC Check Item. Air Brick Too Low To Ground

This would have been an NHBC reportable item as it could allow water ingress into cavity. (Although risk of damage is low) Should be minimum 75mm above ground level. Either lower ground or sacrifice air brick for normal brick. Functional orange item. Note also pointing is crumbling round air brick also.

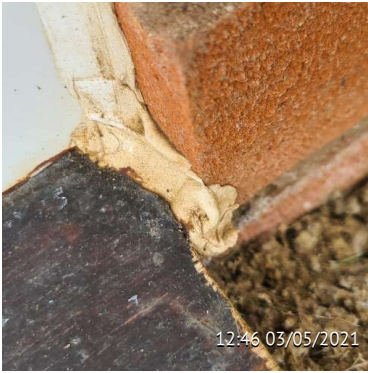
Poor And Dirty Mastic Round Front Door Cill

Refresh mastic and neaten. Cosmetic Green item.

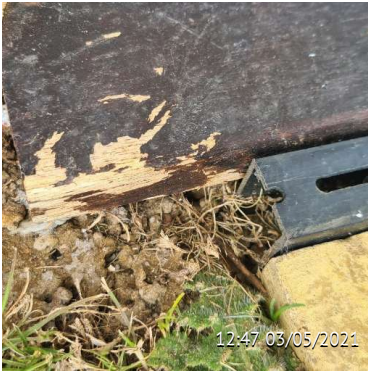
Both Edges Of Front Door Cill Damaged

Need to be sanded back and re-stained. Cosmetic Green item

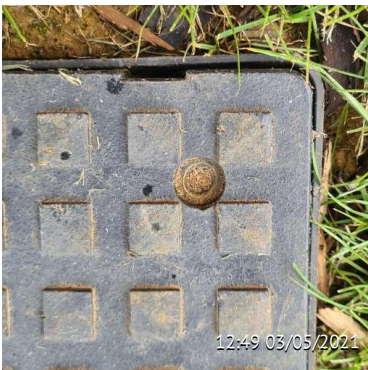
Drain Pot Cover RHS Frknt Of House Missing Screw

Replace screw. Cosmetic Green item

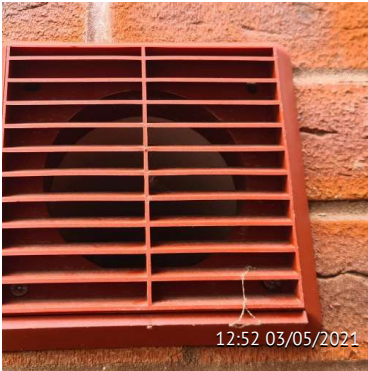
Vent Not Screwed Properly. Also Allows Insects Into House (Not Self Closing)

Only 2 out of 4 screws used. Loose at top. Low risk functional green / orange item. Check bovis spec. They should be flapped to close when Not in use to stop cold air / wind noise and insects from coming into house. (Additional note, significant Wind buffeting noise heard when in wc, although was particularly windy day. Also no protection from cold or insects through wall)

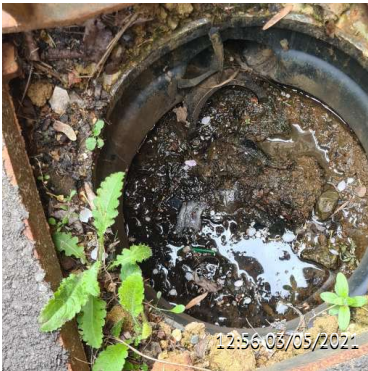
Driveway Storm Drain Full Of Dirt

Clear out all debris and dirt. Could cause blockage later. Functional orange item.

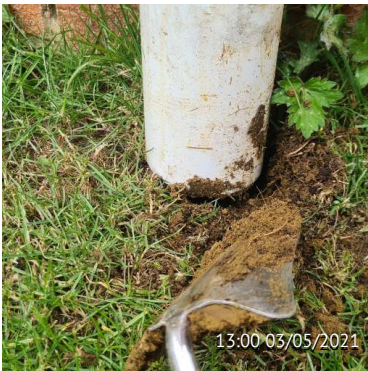
Atleast Rear Garage Downpipe Drains Straight Into Lawn

Unlikely to be by design. Usually go to mains storm water. Ask to check drawings if suggested to drain to lawn. Likely storm drain was missed at back (check front too) functional orange item as risk of soaking lawn in rain. (Option to see if becomes an issue in heavy rain and otherwise leave if customer happy to do so)

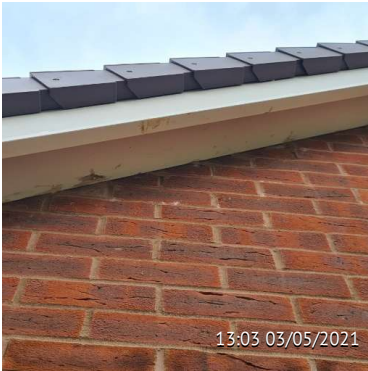
**Clean Down Soffit Board To Garage**

Clean Down soffit and fascias as currently have alot of brick dust and muck on them. Cosmetic Green item

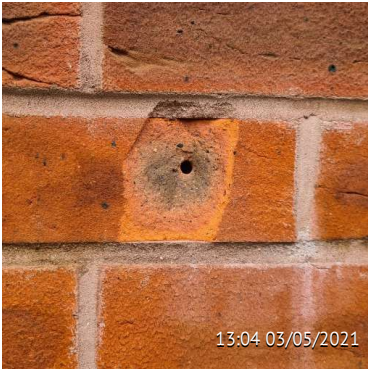
**Blown Brick to Back Of Garage**

Replace / repair blown brick. Cosmetic Green item

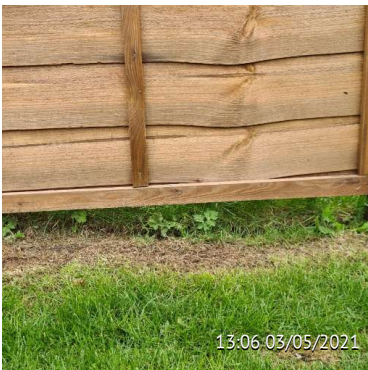
**2 Fence Panels Require Slim Gravelboard Below**

As on slight slope gravel boards may need to be dug into ground or tapered to close gap affecting 2 panels. Functional orange item.

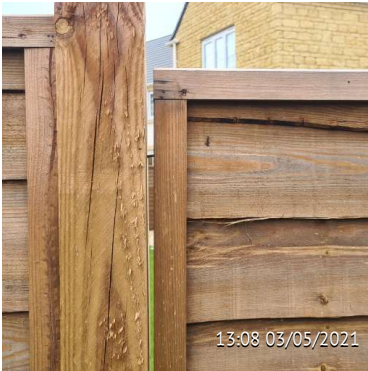
This bowed post is causing gap to top of adjacent panel seen in next item. Also crushed panel to the right. cosmetic green item

Gap In Fencing Caused By Bowed Post As Seen In Previous item

Replace bowed post and crushed panel adjacent if necessary to close gap. Cosmetic Green item.

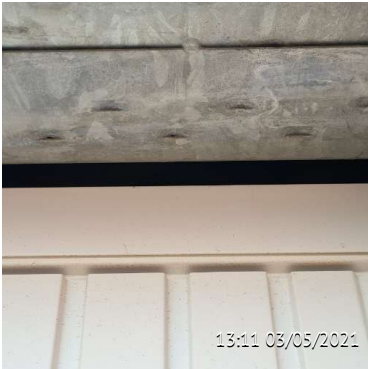
Trim Above Garage Door

Lintel set back from door (or visa versa) allowing birds etc to enter garage. White Soffit trim secured to lintel to close gap Is usual solution to solve this. Functional orange item

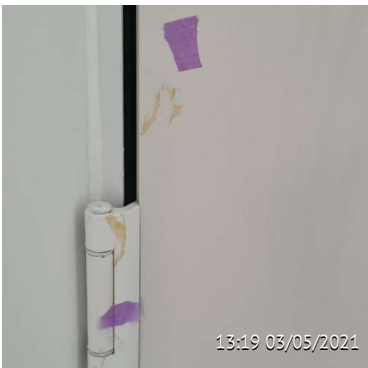
Expanding Foam / Glue To Remove From Back Of Front Door And Hinge

Looks like expanding foam. Specialist cleaner may be required. Cosmetic orange item

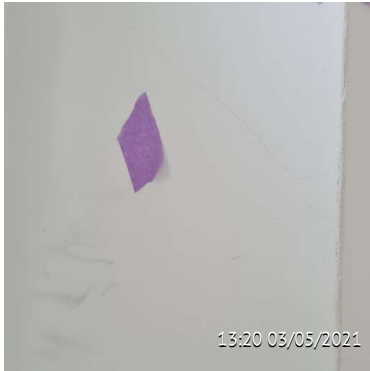
Various Minor Paint Snags Marked With Low Tack Tape

Cosmetic green items.

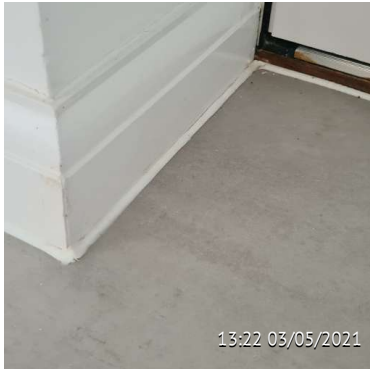
Shallow Door Stop Required For Front Door

Flush profile door stop required front door . Currently bangs against skirting. Functional orange item as can damage door / stress hinges

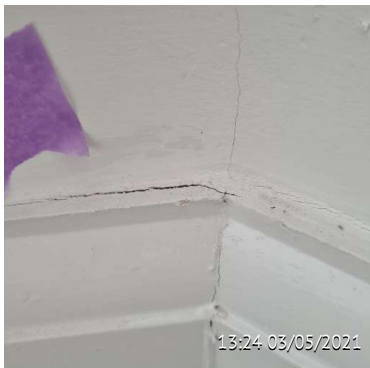
Please Address Shrinkage Present on Occupation

Explained shrinkage is expected going forward, but should have been attended too prior to completion. Further shrinkage to be resolved by home owner. (Note also paint snag here in this pic) cosmetic Green items

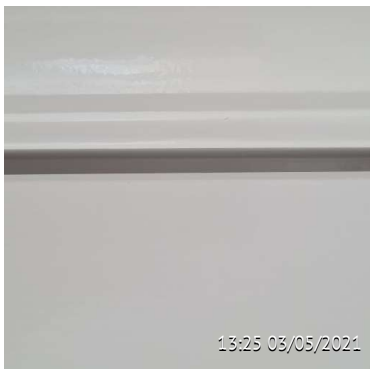
Front Living Room excessive Door Margin

Leading edge door margin is approx 10mm. Door only just latches properly as a result. Pack out frame and redeco to close margin if necessary. Functional orange item. (Additional note, affects most doors in property)

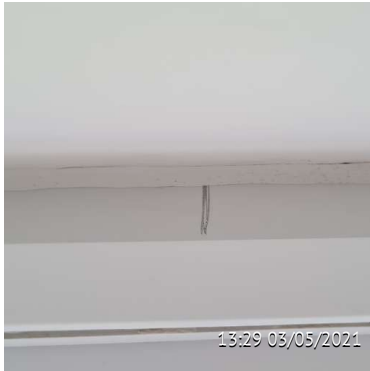
Pencil Mark Left Inside Bay Window Above Trickle Vent

Remove pencil mark . Cosmetic Green item

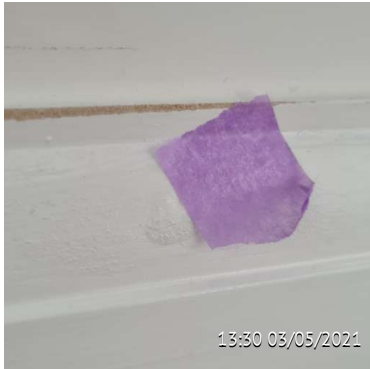
Pick Up The Various Decorative Snags. Several Per Room

Attend to snags. Cosmetic Green items

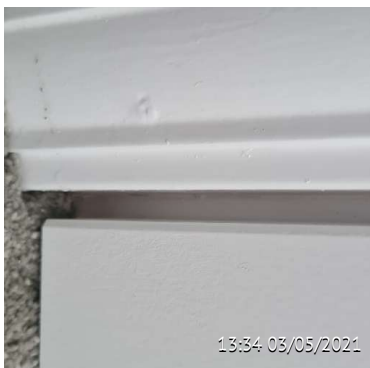
Huge Door Margins Door Leading Edge To Study Also ...

Both doors could be packed out hinge side to even out ? (Note bows I'm the linings towards tops, where not packed out plumb)

Cosmetic and sometimes functional . Orange items

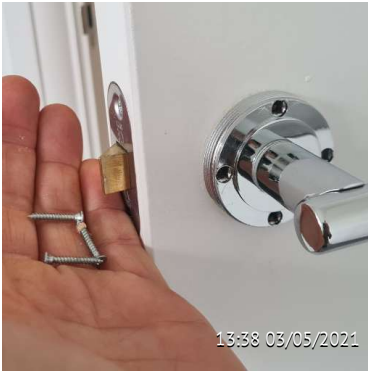
All Door Handles Not Fitted Properly With Through Bar.

Only 3 conventional screws used. Carpenter has omitted (to save time) the single bar that is supplied with handles and drilled through to other handle to prevent them being pulled off. Inproper installation. Functional orange item.

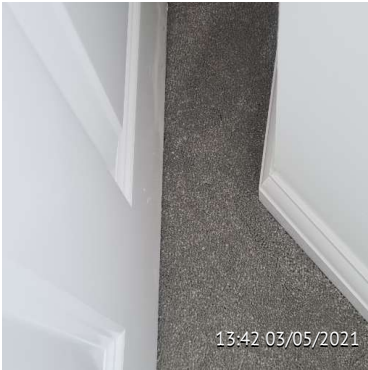
Small Front Lounge Door Stop Missing

Preferably wall mount (floor mounts used throughout house not designed for carpets)

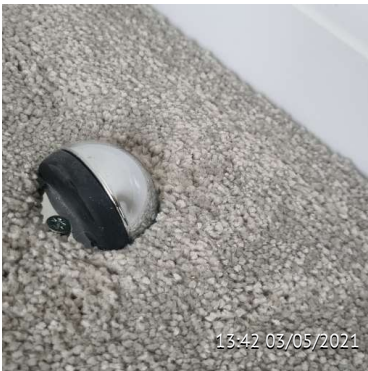
Wrong Door Stops Used

These floor mounts are designed for hard floor or when a wall mount door stop can't be used. Wouldn't be so much of an issue of they we're installed correctly (lug underneath pushed them up at back, atleast in Study). Potentially Poor spec & Poor installation. Wall mounted door stops would be better for carpenter and better for finish.

Poor finish and incorrect fitment of items. Orange. (Note changing these may cause carpet issue now)

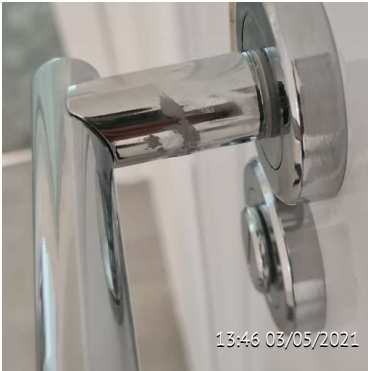
**Tarnished Wc / Utility Door handle**

Replace damaged handle. Cosmetic Green item

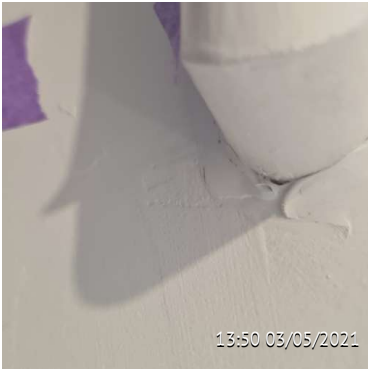
**Poor Mastic Finish To Wc Window Sill Edge Both Sides**

Refresh and finish mastic properly both sides. Cosmetic Green items

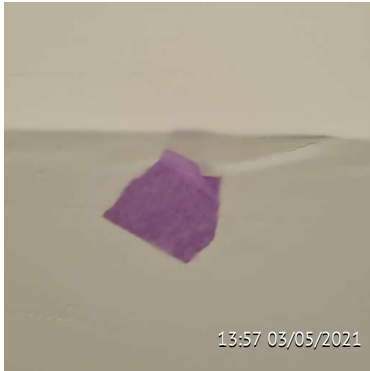
**Main Lounge Blown Ceiling Tape**

Blown tape needs to be replaced to ceiling. Cosmetic orange item

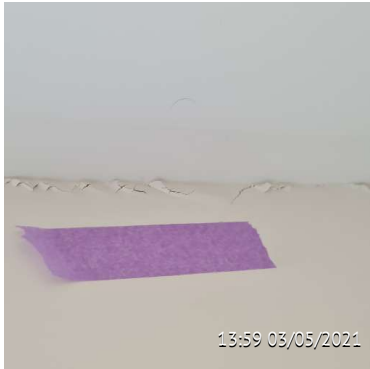
**Possible Damp. Blown Tape Above Bifolds In Main Lounge**

This potentially may be damp coming through as it is all the way along ceiling line. Or atleast was originally caused from damp. In which case that would be red severity item. Monitor as orange item once made good and redecced, raise as red if comes back due to damp if necessary.

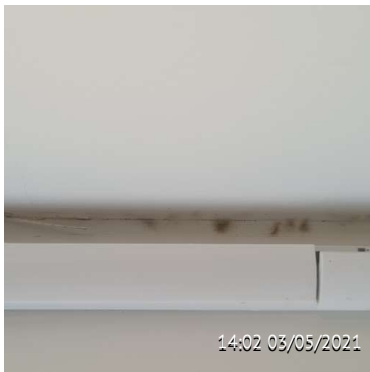
**Mildew Above Trickle Vents Also Suggests Damp Has Been Present**

Orange monitor item for new damp (and clean off)

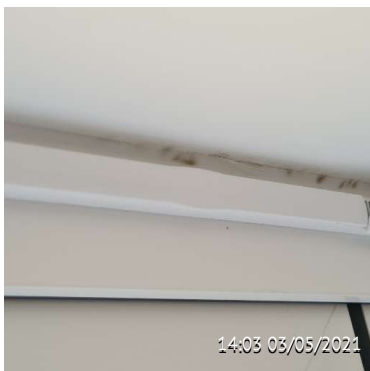
**Bifold Trickle Vents In Main Lounge Very Loose. Improperly Installed.**

Fix vents properly. Functional orange item

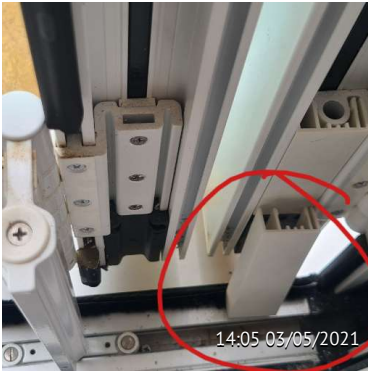
**Bifolds Hinge Cap Fell Off.**

Not sure these are supposed to be left on. Personally I would remove them all as they seem unnecessary. And easily fall off due to poor design. Refit if possible else remove if customer happy to do so. (To all doors.) Cosmetic Green item

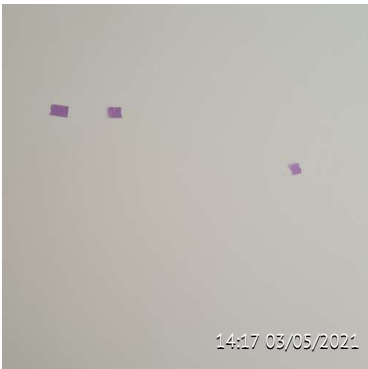
**Various Small Fill Paint Snags In Lounge**

Address the few snags in room as marked. Cosmetic Green items

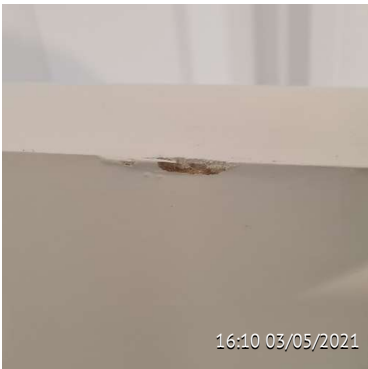
**Under Stair Cupboard Door Damage To Top**

Wood fill and paint damage to door. Cosmetic Green item.

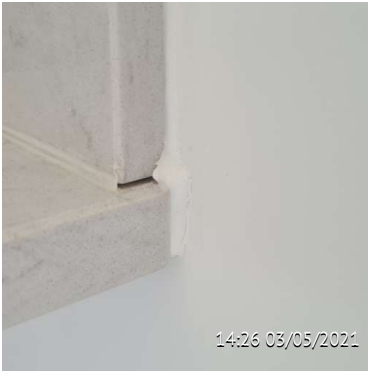
**Worktop Upstand Mastic To Finish**

Clear mastic the return recommended. Cosmetic Green item

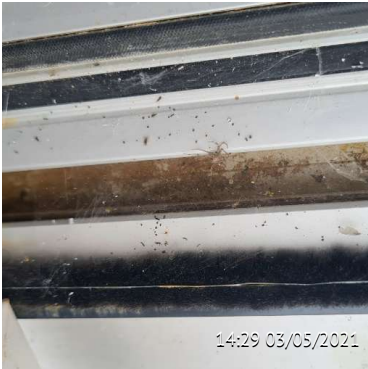
**Bifold Door Tracks To Clean Out**

Were not cleaned prior to completion. Cause slightly Grinding and cobwebs in one of them. Cosmetic Green item

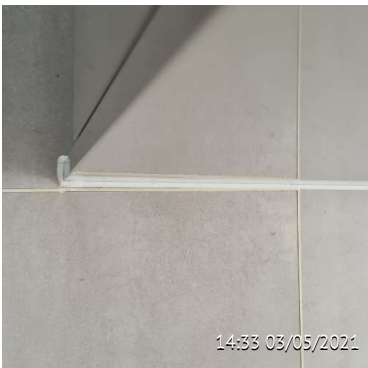
**Note. Kitchen End Panel Off Square With Flooring**

As seen under worktop, This is in fact the end panel and could be resolved relatively easily by adjusting end panel. Note May cause another adjustment requirement knock-on effect when rectifying. Cosmetic Green / orange item.

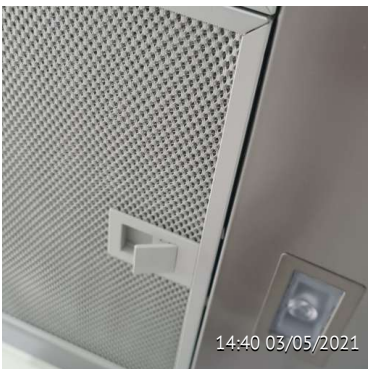
**Hob Extract Vent Filter Panel Clip Faulty.**

1 of the filters does not clip in properly and needs replacement. Functional orange item

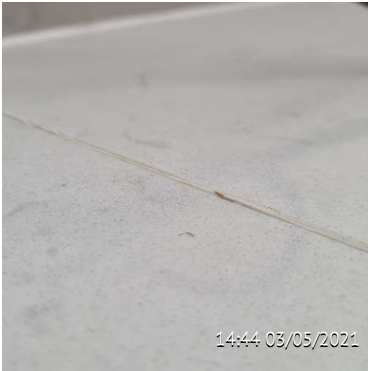
Item  
**Poor Silestone Join**

Comments  
Join to the worktop is not flush and steps up and needs rejoining. 2nd join need closing. Significant cosmetic orange item

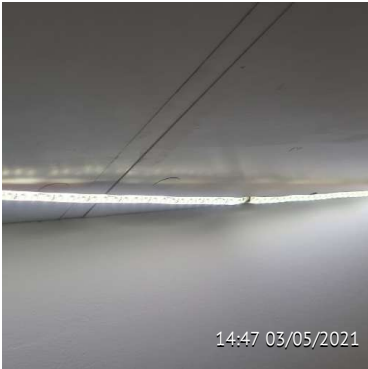
Item  
**Led Strip Lighting Loose Under Cupboards**

Comments  
Strip needs needs be stuck back up. Cosmetic Green item.

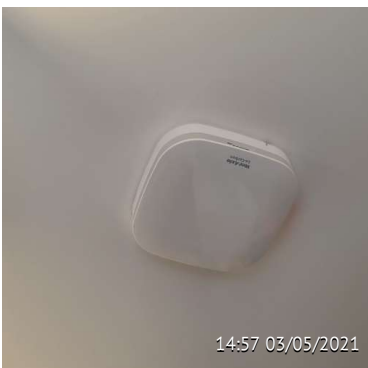
Item  
**As Previous Item, Check Bathroom Vent axias**

Comments  
Seems loud and boost set low. Also check main en suite.

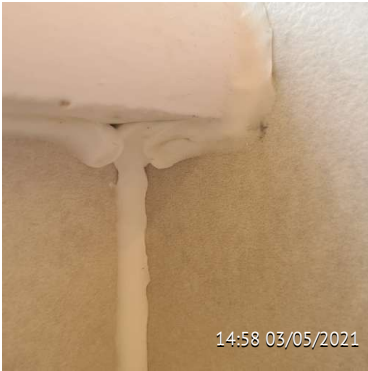
**Mastic Under Bathroom Sill To Tidy**

Tidy poor Mastic detail under Sill. Cosmetic Green item.

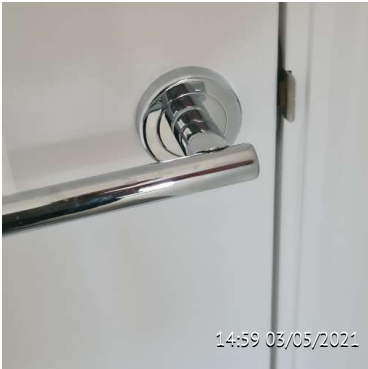
**Back Lhs Bedroom Door Not Latching**

Adjust as necessary. Easy fix Functional orange item

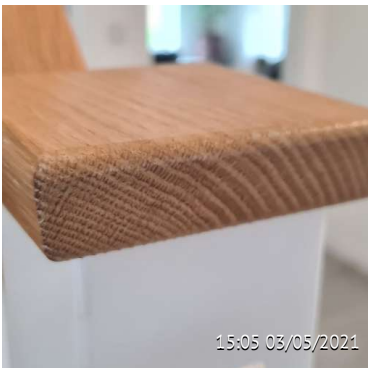
**Rub Back And Re-stain Rough Newel Cap.**

Edges are rough to touch where not rubbed back. Cosmetic Green item

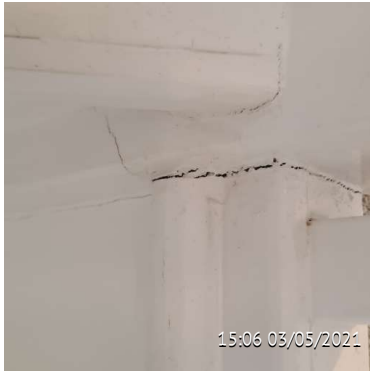
**Shrinkage To Attend Return Area Of Ballustrade**

Please address significant shrinkage present here on occupation. Cosmetic Green item.

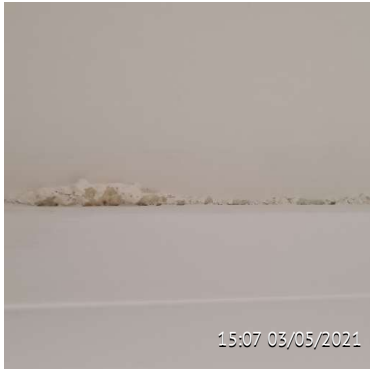
**Inside Architrave Edges Of Landing Cupboard Foam Present**

Cut out foam and paint. Cosmetic Green item

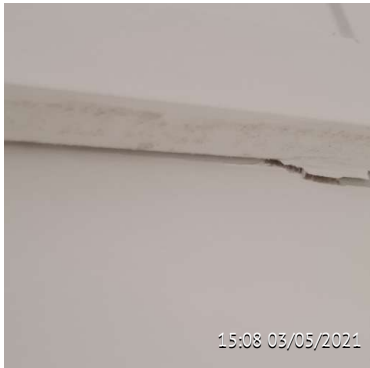
**As Above Item Inside Architrave Of Cupboard Not Decorated**

Caulk and paint and address shrinkage .Hard to get to area.  
Cosmetic Green item

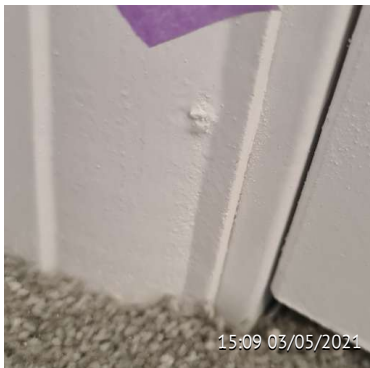
**Most Architraves Pins Not Punched Or Rubbed Back**

Address the various small fill left from architrave pins on show in architraves . Check all architraves. Cosmetic Green items

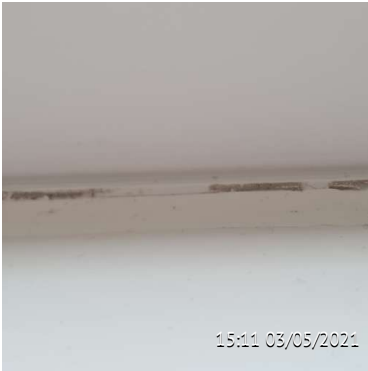
**Front Bed Window Channel To Clean**

Muck above mastic needs to be removed. (With blade?)

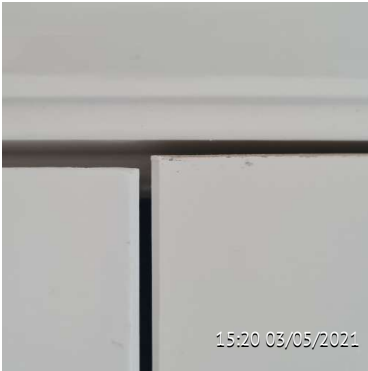
Same Cupboard Doors As Previous Item, Need Alignment

Poor carpentry. Adjust doors to line up with each other. Cosmetic Green item

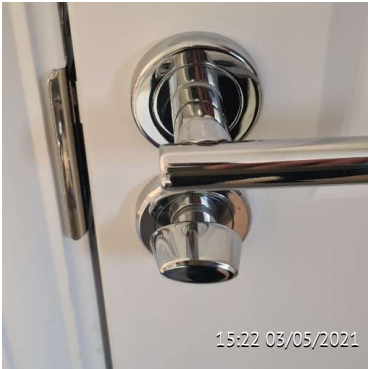
Main En Suite Latch Adjustment

Keep needs Adjustment To Allow Thumb Turn To Work Properly (currntly Door Needs To Be Pushed in For Thumb Turn To Work Freely)

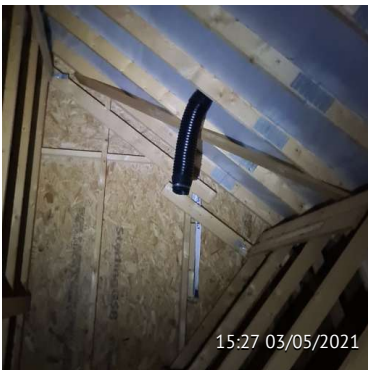
Note: Disused Roof Tile Vent X 2

All vents now exit through walls. If this is new design, then tile vents can be removed from design as unnecessary. (Note, clearly, due to location, originally intended for bathroom and ensuite)

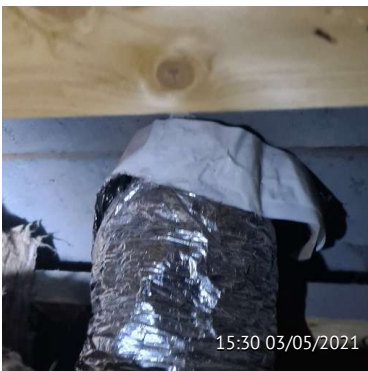
En Suite Ducting Loose Connections

One end not secure on to fan. The other has had attempt at taping but become loose. If these become disconnected over time will vent moisture into insulation. Low risk functional green item

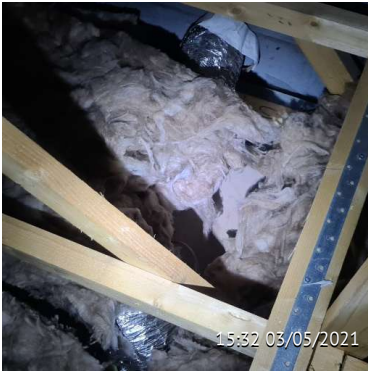
Insulation Missing Where Extract Ducts Out.

Small area looks to have been removed when ducts added by electrician. Needs approx 1m worth of rock wool only added around this area. Fintional orange item

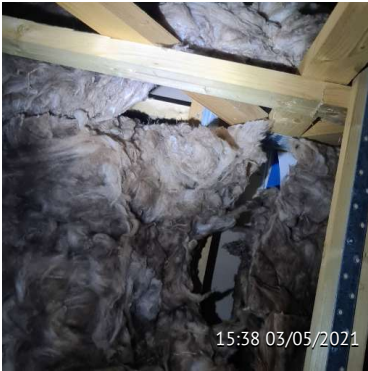
Insulation Round Main Bathroom Extract Duct Thin

Add missing insulation to fill gaps (Note there may be excess material in loft that can be used) affects both extract duct areas .. functional orange item

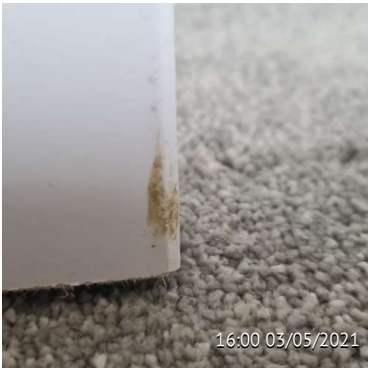
Study Door Dirt Cannot Remove.

Please clean / decorate as necessary. Cosmetic Green item

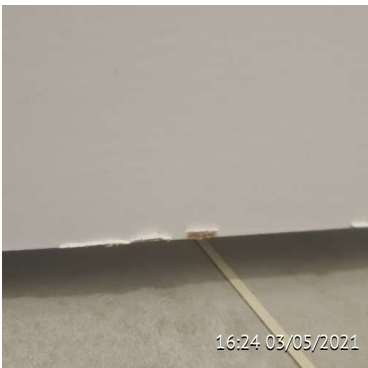
Main Bed En Suite Bottom Of Door Damaged

Rub and decorate bottom of door. / replace if blown. Cosmetic Green item.

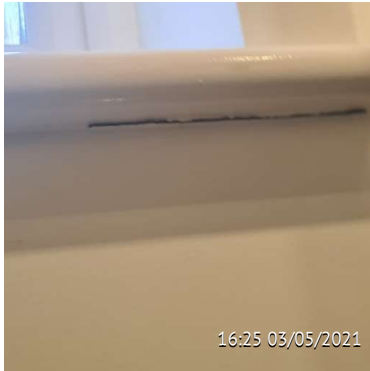
**Main En Suite Shrinkage Under Sill**

Make Good shrinkage under cill. Cosmetic Green item.

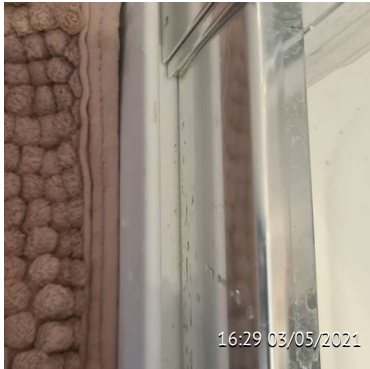
**Gap Under Shower Screen Allows Water Up and Over Onto Floor**

Although installed correctly, does not function properly. Please seal bottom track so water can not get underneath. Functional orange item.

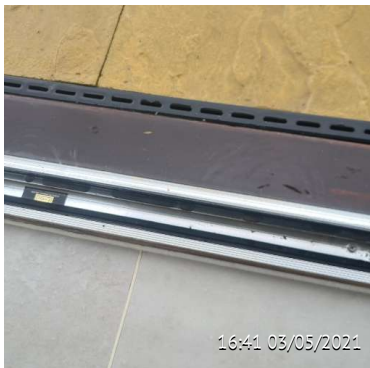
**Front Door Sill tilting Inwards Causing Flooding Inside Under Door**

Orange / Red item. Water ingress under front door where water from Sill runs off under weather bar and inside onto floor. Check angle of cill and sort if necessary.

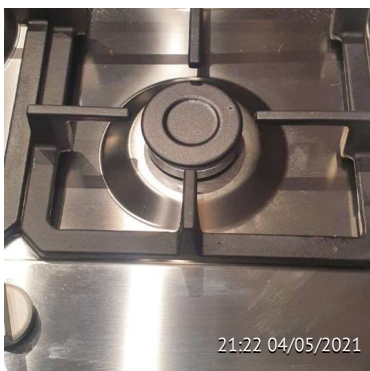
**Bottom Ring Of Hob Only Lights Internittently**

Small bottom ring of hob will not ignite correctly like the others. Please check. Functional orange item.
