Llantarnam 3G Pitch

Ground Investigation Report

CS/Doc Ref: 99479-CAP-75-XX-RP-GT-002

Torfaen County Borough Council

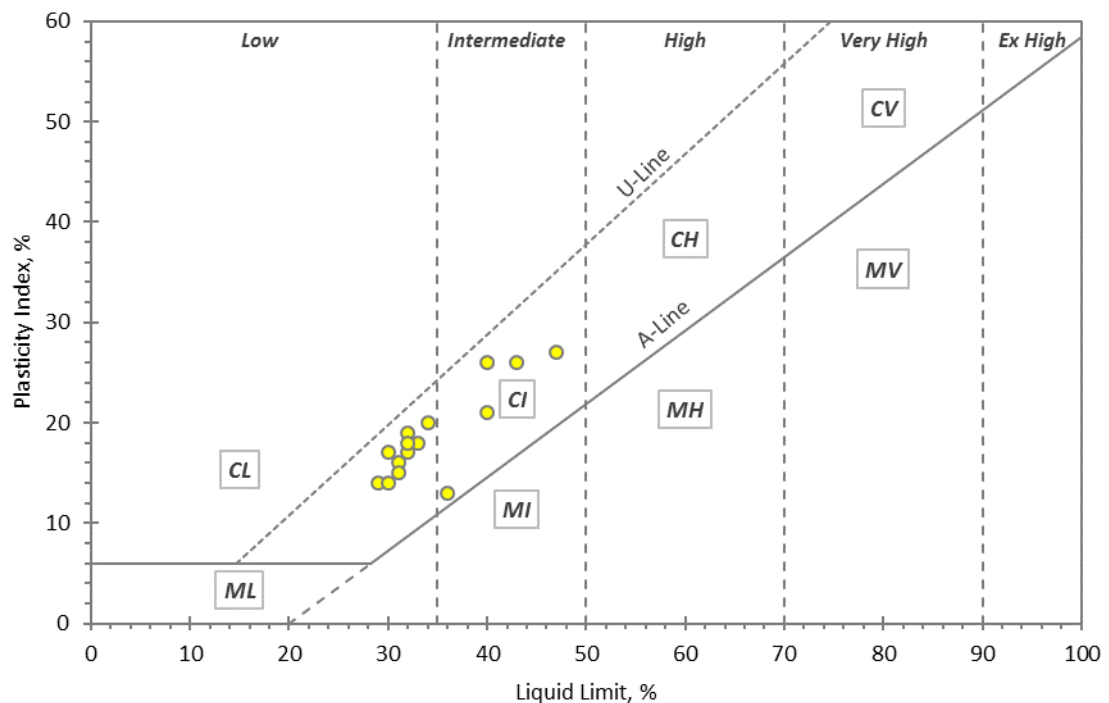
Figure 5.1: Plasticity Index Chart for Natural Cohesive Deposits

Moisture Content w (%)	Plastic Limit w_P (%)	Liquid Limit w_L (%)	Plasticity Index I_P (%)
11 to 23 (16) [15]	13 to 23 (16) [15]	29 to 47 (35) [15]	13 to 27 (19) [15]

The tendency of clay to shrink and swell is linked to the type and amount of clay particles in the soil. These are quantified in index tests to determine the plasticity, specifically the Plasticity Index (PI) which is the difference between the Liquid and Plastic Limits. Plasticity Index represents the range of moisture contents over which a soil is plastic (i.e. it can be deformed without volume change). By calculating the modified PI it can be compared to the Volume change potential chart provided by the NHBC guidance on Foundations (Section 4.2) (Ref. 11).

Based on these recommendations, the volume change potential of the natural superficial deposits is considered low, with average Modified PI Values of below 20%.

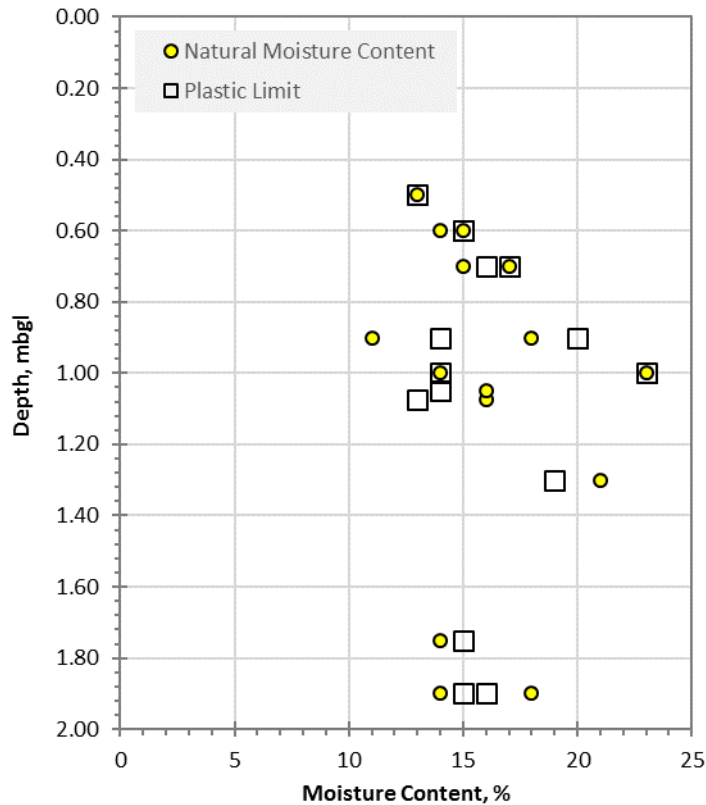
Figure 5.2: Moisture Content and Plastic Limit with Depth

The moisture contents measured from the fifteen samples range between 11% and 23%, with an average of 16%. Of the fifteen moisture content test results, six were below the corresponding plastic limit for the sample, with four at the corresponding plastic limit, and the remaining five test results above corresponding plastic limit of the individual sample. Test results show that the moisture content in the soil increases from ground level to approximately 1.20m below ground level, suggesting there may be a desiccated crust at the ground surface. These test results are summarised in Figure 5.2.

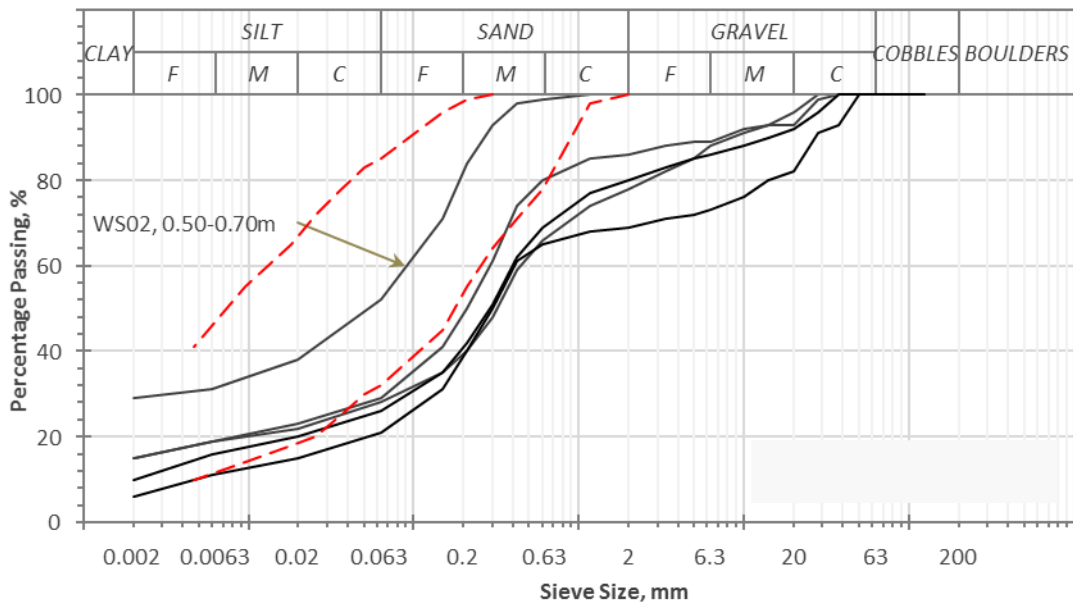
Figure 5.3: Particle Size Distribution of Natural Superficial Deposits

Of the 5 number tests undertaken in the natural superficial deposits, sample 1D in WS02 at 0.6m depth has a fines content of 52% (silt and clay fraction passing <0.063mm) implying the nature of the material is controlled by its fines content. The remaining 4 samples show the same general grading distribution with fines contents between 21% and 29% and appear to be mostly granular in nature with high gravel and sand contents. Cobble sized material was not encountered in the samples tested, but this does not exclude the possibility of cobble size material being present in the wider area.

Assessment of the material earthworks classifications indicate that the samples tested would generally classify as Grade 2A/2B or Grade 2C based on grading data alone. Frost susceptibility can be an issue for fine grained soils close to the ground surface. A frost susceptibility envelope has been plotted on the grading chart and indicates Sample 1D in WS02 may be frost susceptible. Constructing pavements on frost susceptible material may require greater thicknesses (>0.45m) for pavement foundations. A summary of the grading data is provided in Table 5.3.

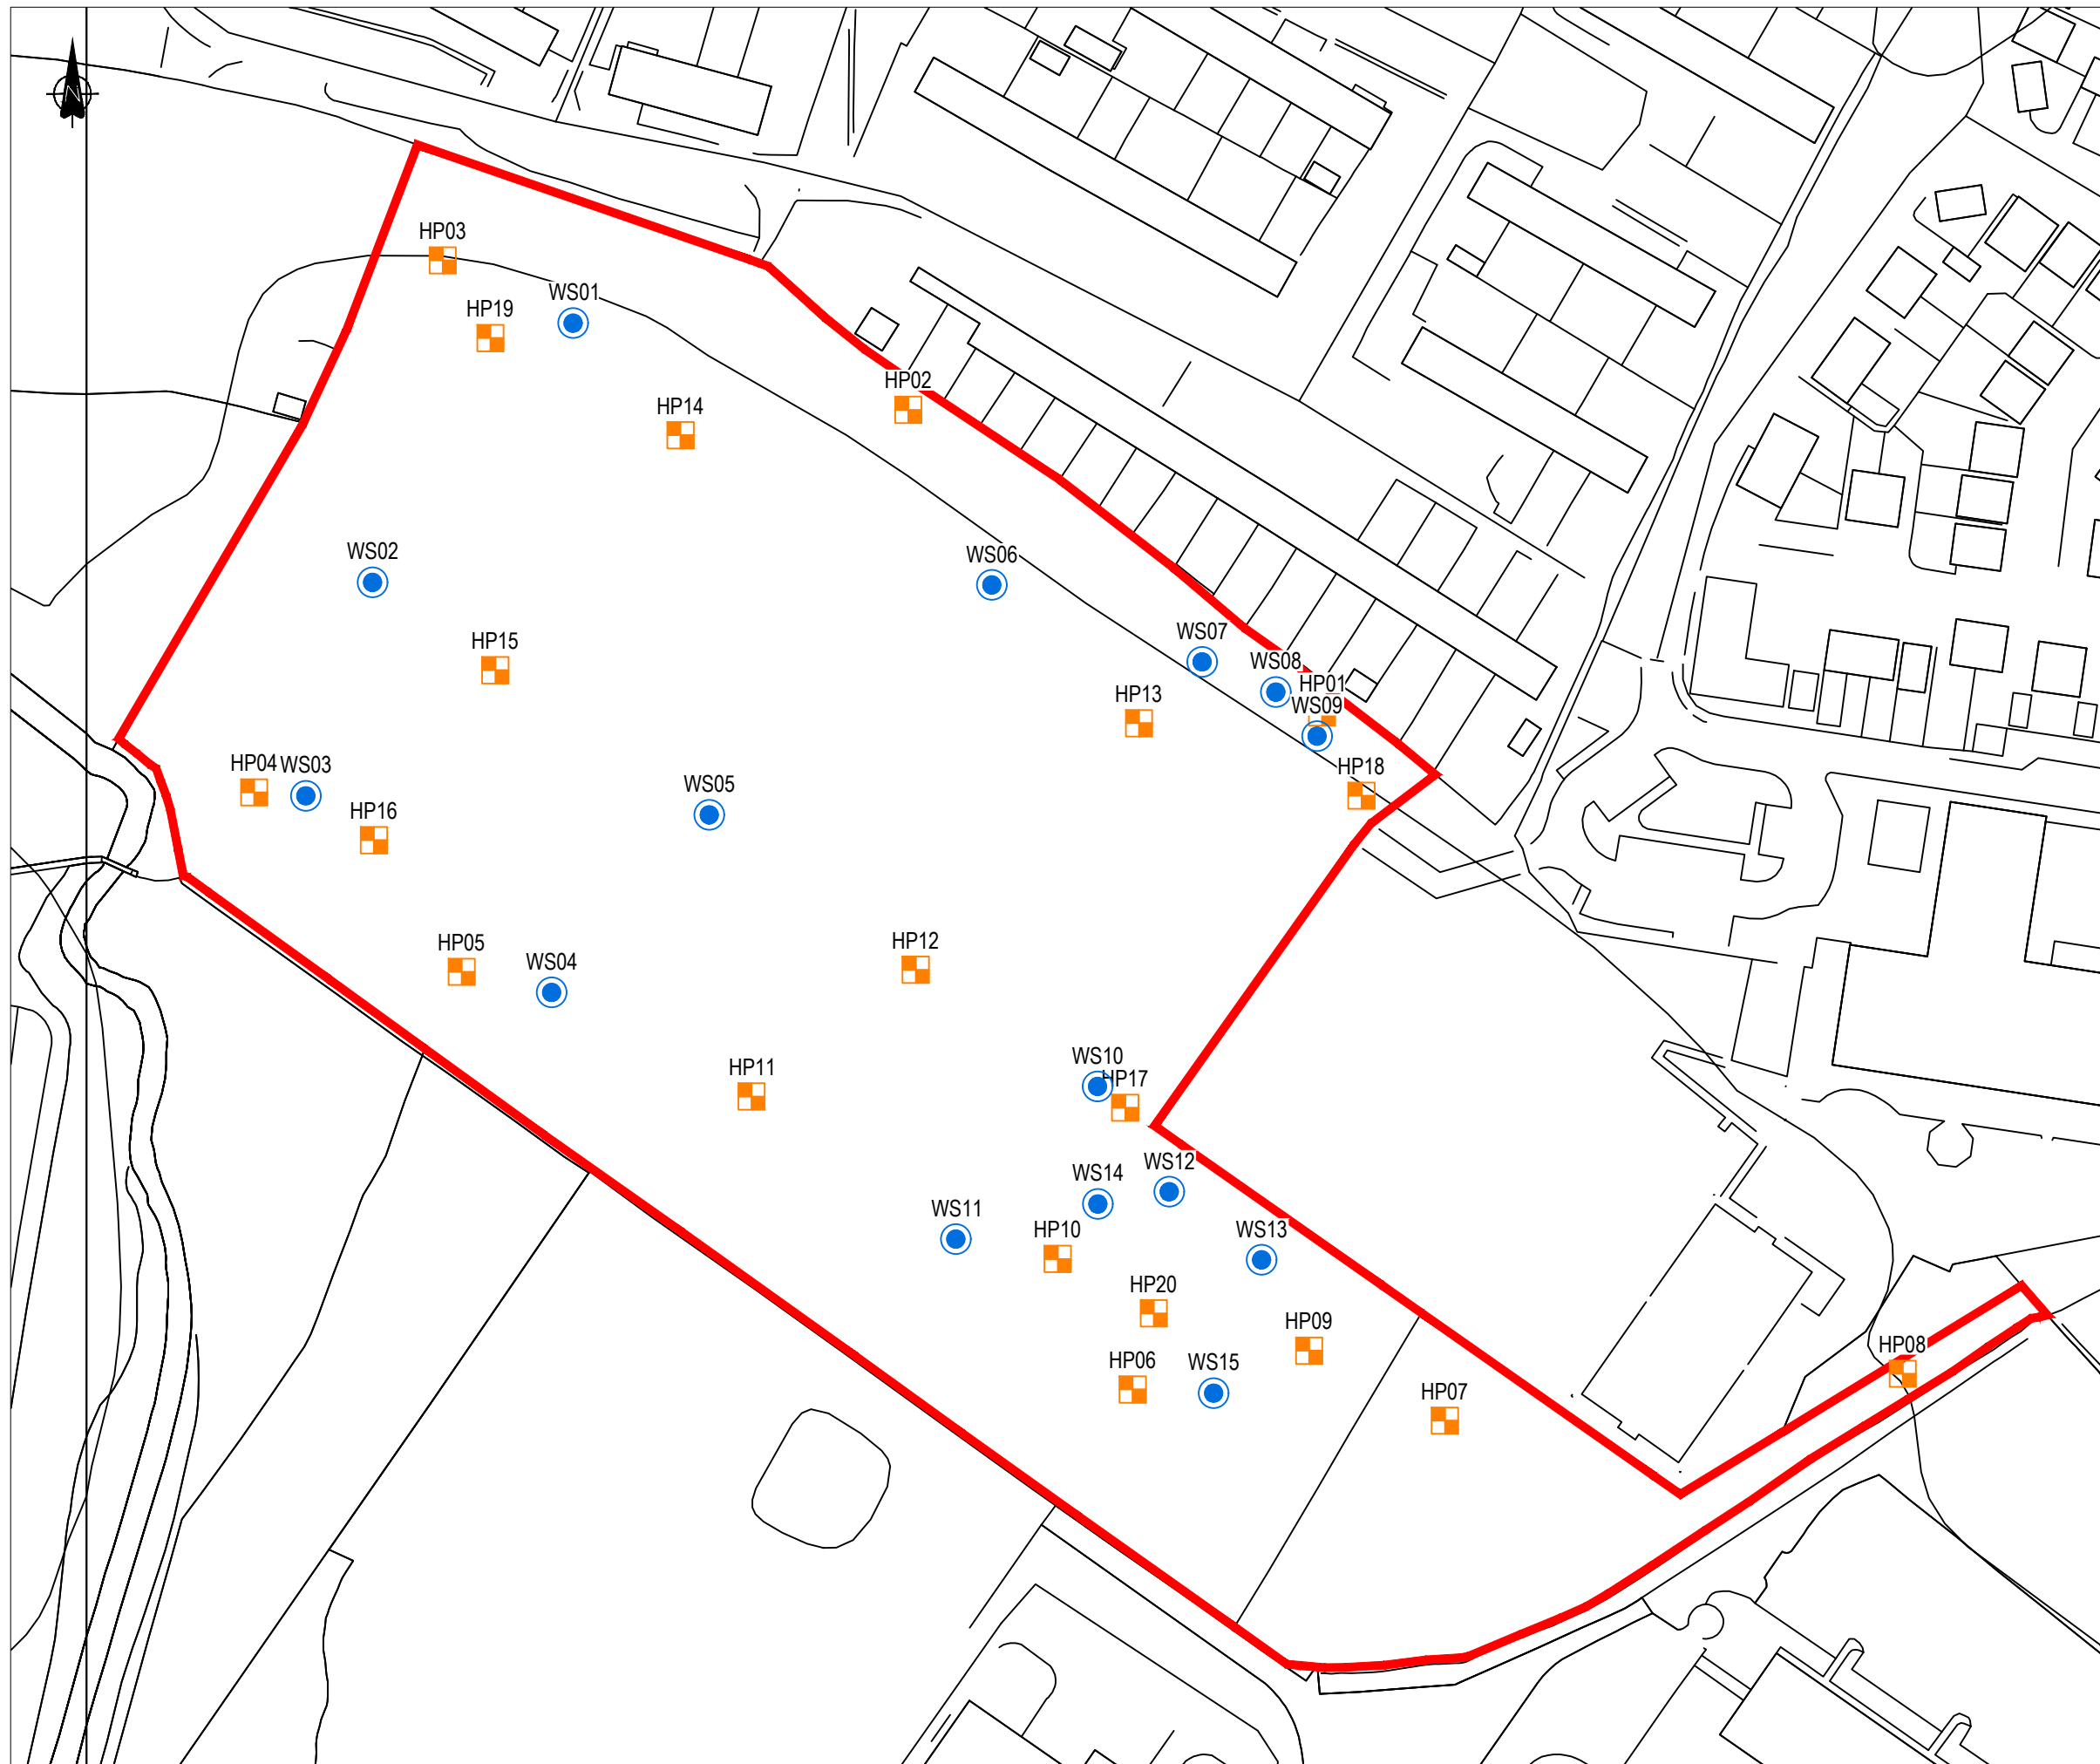
- KEY**
- STE BOUNDARY
 - TRIAL PITS
 - WINDOW SAMPLES
