**Caewern House, Dwr Y Felin Road, Caewern,
Neath, Neath Port Talbot, SA10 7RH**

Bat Survey Report for Linc-Cymru Housing

Report type	Bat Survey Report
Report reference	IG2022CaewernHouse
Site	Caewern House, Dwr Y Felin Road, Caewern, Neath, Neath Port Talbot, SA10 7RH
Grid reference	SS 74627 98352
Client	Linc-Cymru Housing
Date(s)/time(s)/ type(s) of survey(s)	Scoping survey: 25 th August 2022 Dusk survey: 25 th August 2022 between 20:05 and 22:20 Dawn survey: 10 th September 2022 between 04:40 and 06:45
Surveyor details	Scoping survey: Mr Iestyn Evans, Natural Resources Wales Licence number S090746/1 and Mr Glyn Lloyd-Jones, Natural Resources Wales Licence number S091520/1 Activity surveys: Mr Iestyn Evans, Natural Resources Wales Licence number S090746/1; Pete Watts; Greg Evans; Bonnie Illingworth; and Lewis Jones
Architect	Spring Design

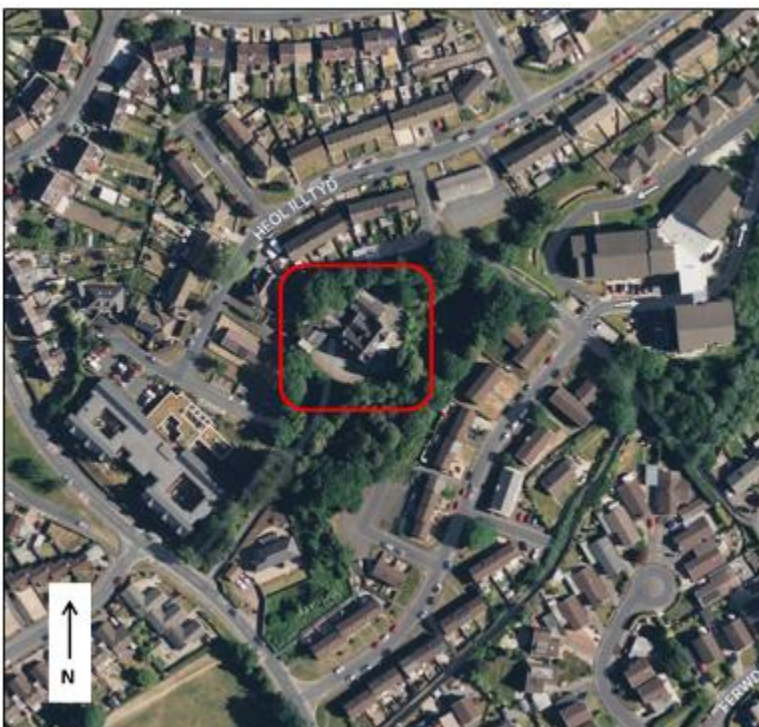
Figure 1: Aerial view of the property which is outlined in red (from Apple® Maps)

1.2.2 The property is subject to proposed plans for demolition to create space for a residential development. Figure 1 shows an aerial view of the property while figure 2 on the following page is of the wider environment and figure 3 is a sketch site concept plan. Additional plans are included in appendix 5.

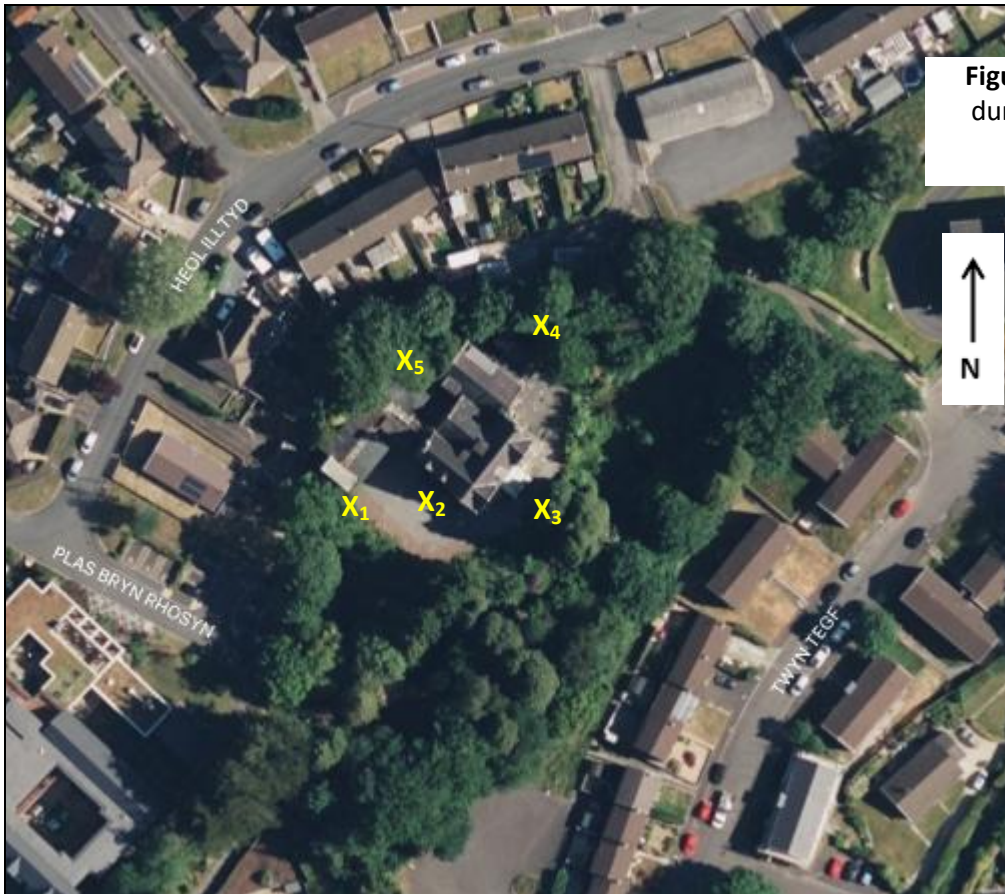
Figure 4: Surveyor positions during the activity surveys. (from Apple® Maps)

3.1.6 Figure 4 on the following page shows the position of surveyors during the activity surveys. Each surveyor had a Magenta 5 or an Elekon Batscanner bat detector to assist in identification and detection of bats and their behaviour.

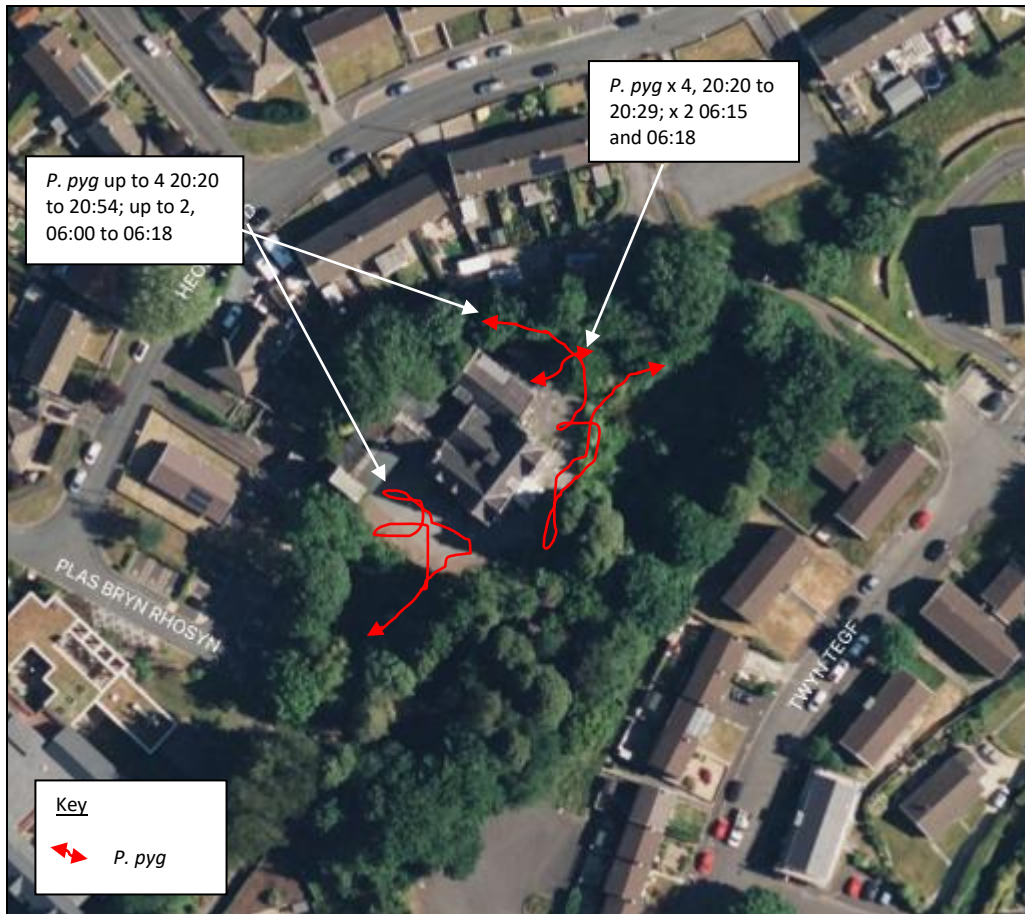
Figure 5: Aerial map (from Apple® Maps) showing the flight lines of bats detected on the surveys

3.2.2 Figure 5 shows the flight lines of bats detected and includes the species seen/detected and the times they were detected. Flight activity follows:

- ***P. pygmaeus***: On the dusk survey four bats were seen to leave a hole in the roof on the single storey section to the north-east with the first emergence at three minutes after sunset and the last at 12 minutes after sunset. Following the first emergence, bats remained on site for around 25 minutes after the last emergence, foraging and commuting to the north, south, and east and sporadic calls were subsequently heard to the north for around 30 minutes. Activity was lower during the dawn survey with only two seen to enter via the same gap at 26 and 23 minutes before sunset with activity on site starting 15 minutes before the first re-entry, although calls were heard to the north during the last hour.

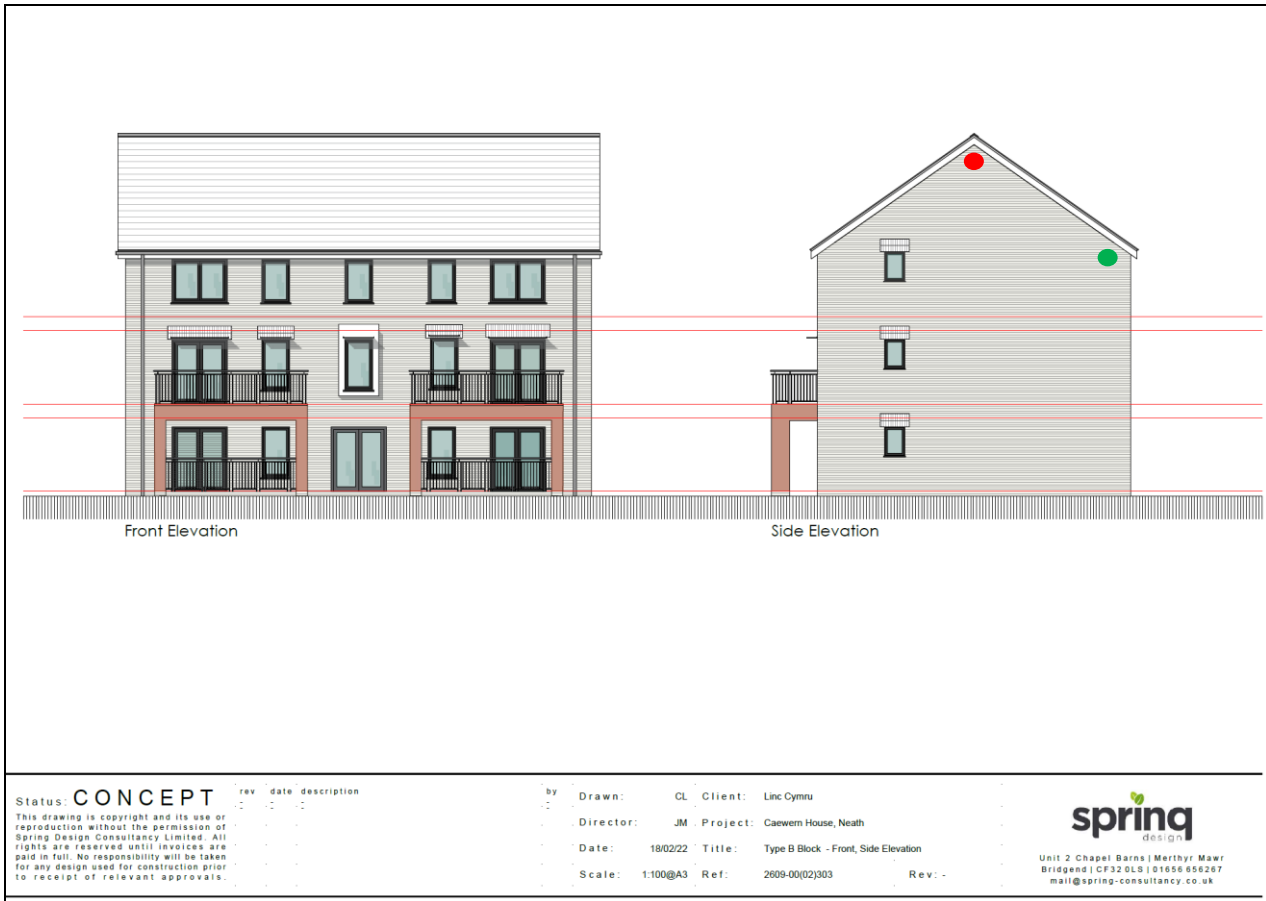
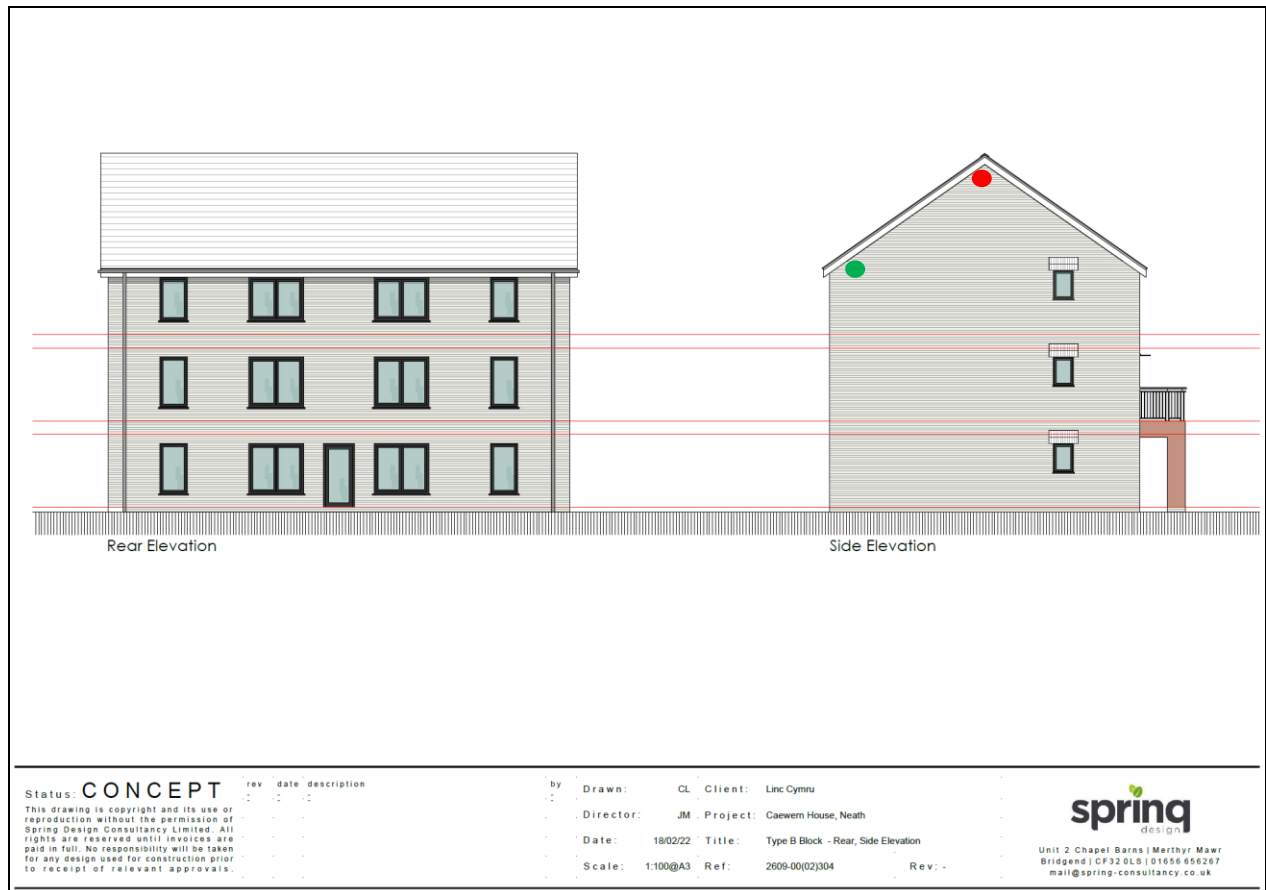
Above: Type B Block – proposed front and side elevations. **Below:** Type B Block – proposed rear and side elevations. The proposed locations for the Build-in bat boxes are shown by red dots, and the proposed location for the House martin nest cups are shown by green dots.

- ✦ **Recommendation 2 (Mitigation):** Bat access is to be provided on the new buildings through 1 x Vivaro Pro Build-in (or similar) bat box installed in each gable end wall (x 12 in total) of the new buildings.

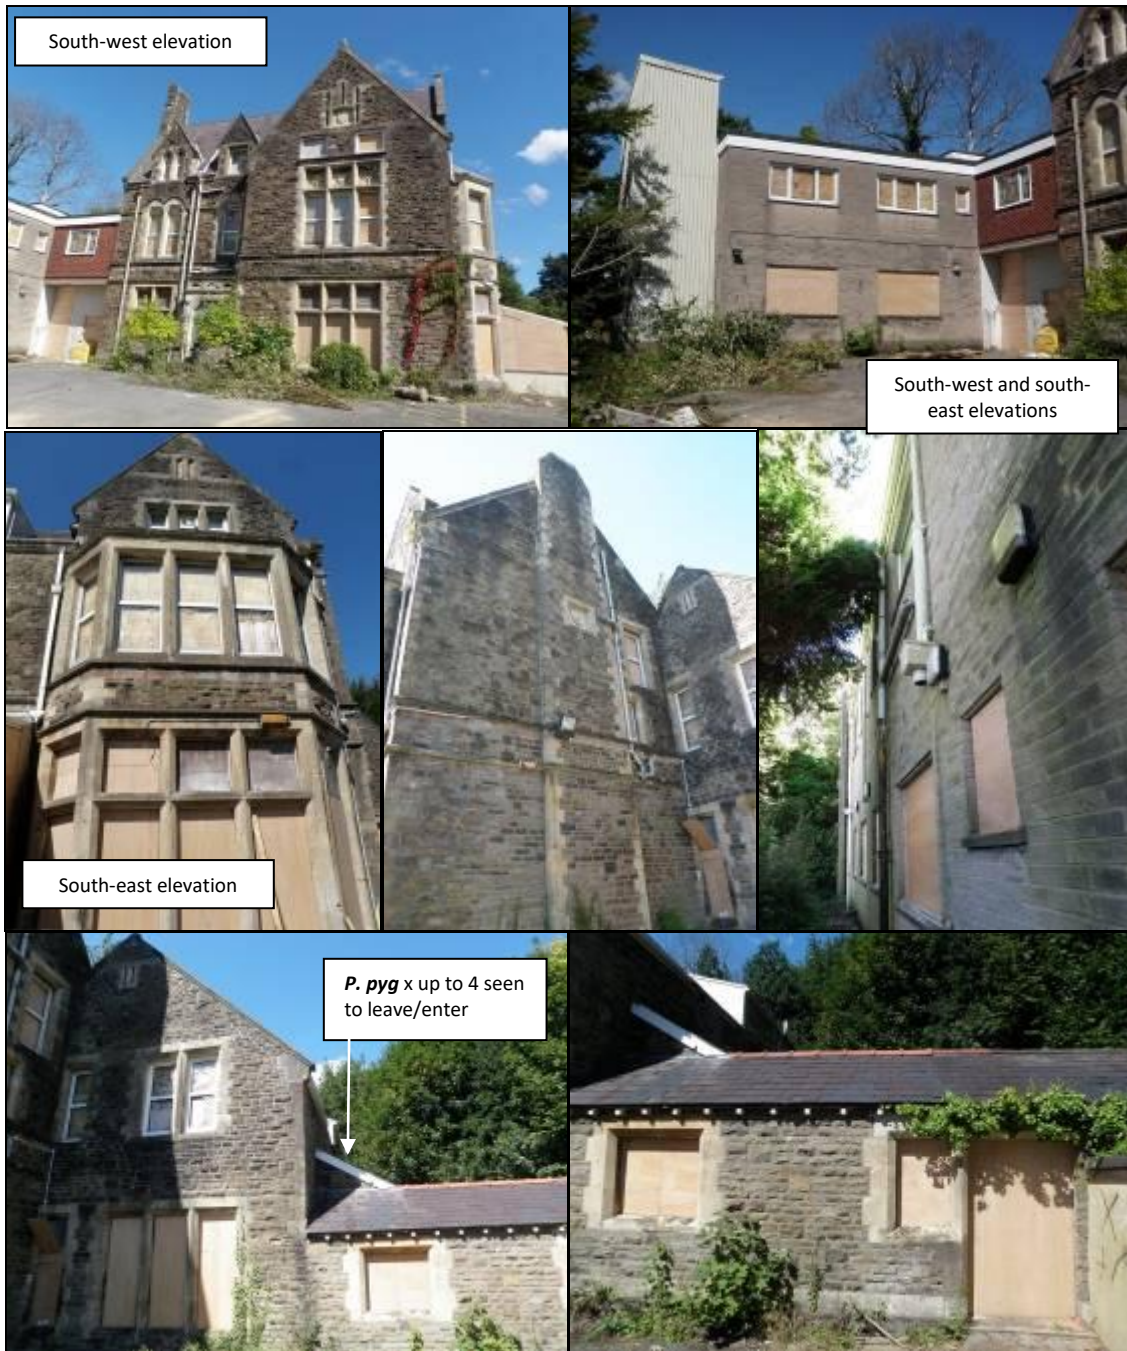
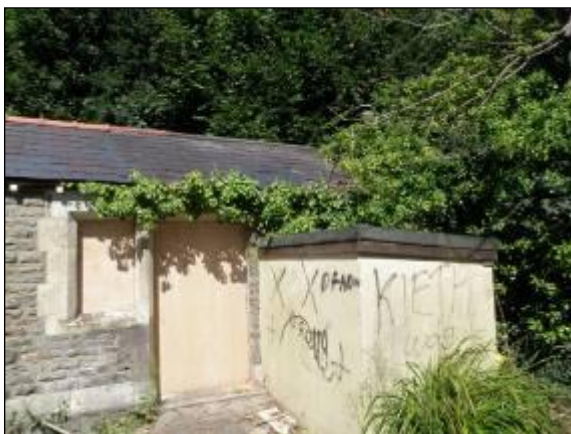
The original part of the property is a large, detached, up to three storey Victorian building constructed of stone walls with pitched slate roofs. The building was found to be in generally good structural condition with no cracks or crevices in the walls, although there are areas of raised flashing, raised ridge tiles and slipped slates. Pitched/monopitch, and flat roof single storey predominantly stone-built sections are attached to the north-east elevation and while the walls are in good condition there is a large hole in the roof in one section (due to vandalism). A shed with stone walls and a corrugated metal roof are also present within the grounds. External inspection identified the buildings as being generally in a good condition.

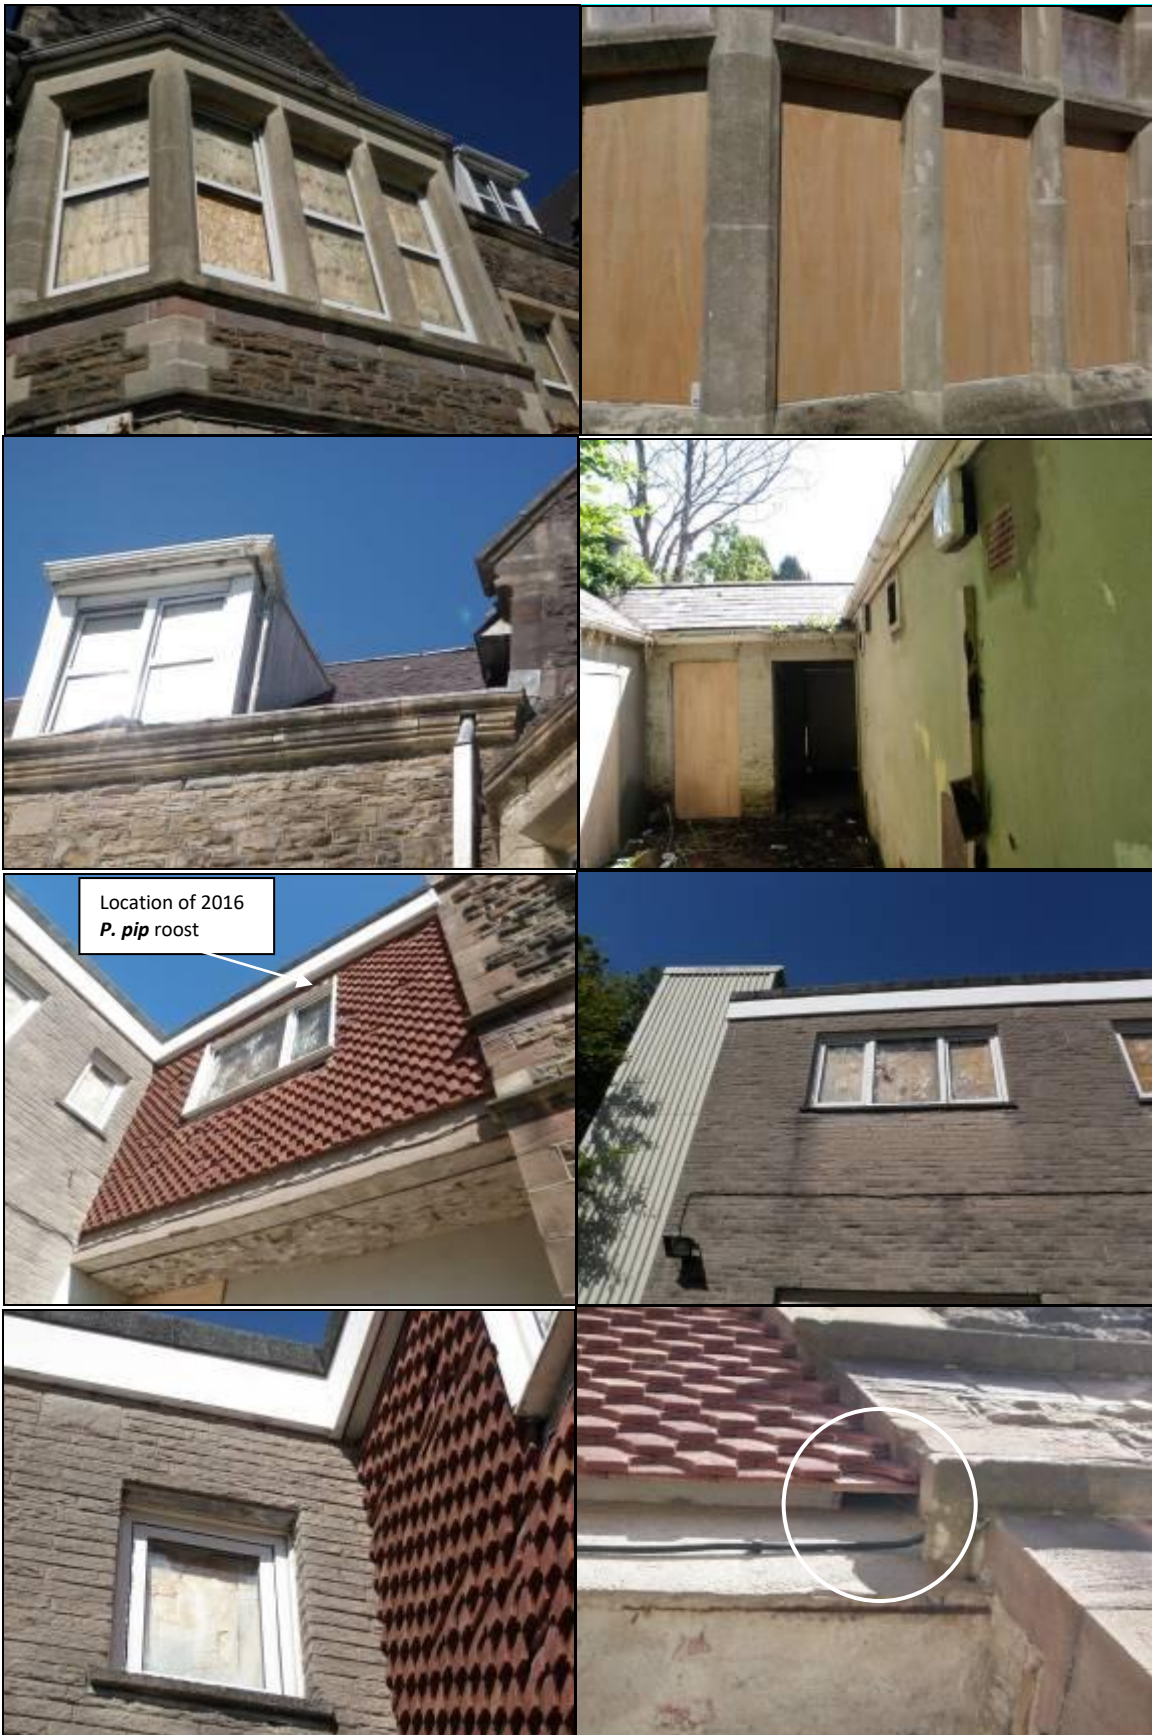
Attached to the northern end of the south-west elevation is a modern two storey extension constructed of rendered and stone faced/clay tile faced brick walls with a flat roof and a two storey metal clad fire escape. The modern flat roof two storey extension of brick construct with an associated metal clad fire escape. Minor gaps were noted between fascia boards and walls but no other potential bat roost features were noted.

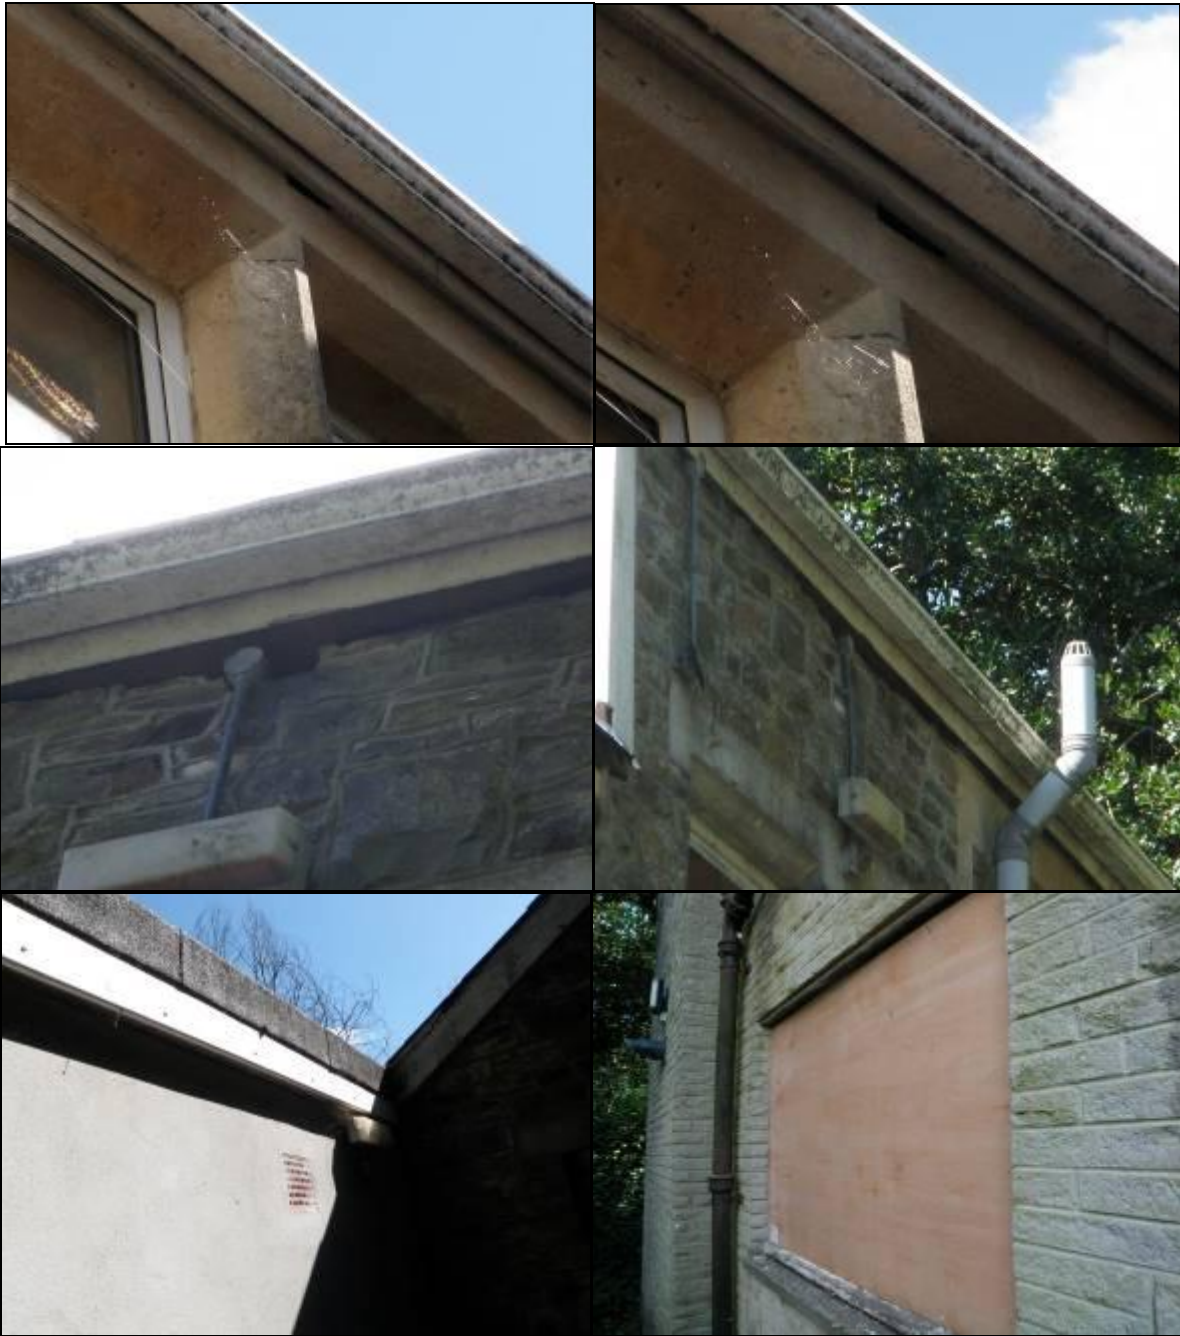
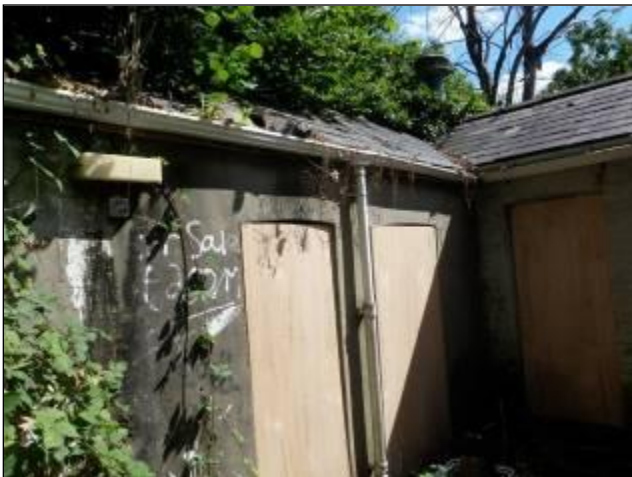
The windows and doors on all areas are either closed or boarded over but ongoing vandalism has meant that there are a small number of windows with broken glazing which could enable access by bat and bird species. Slit windows are also present on the upper level of the original building but all of these are either grilled or bricked up.

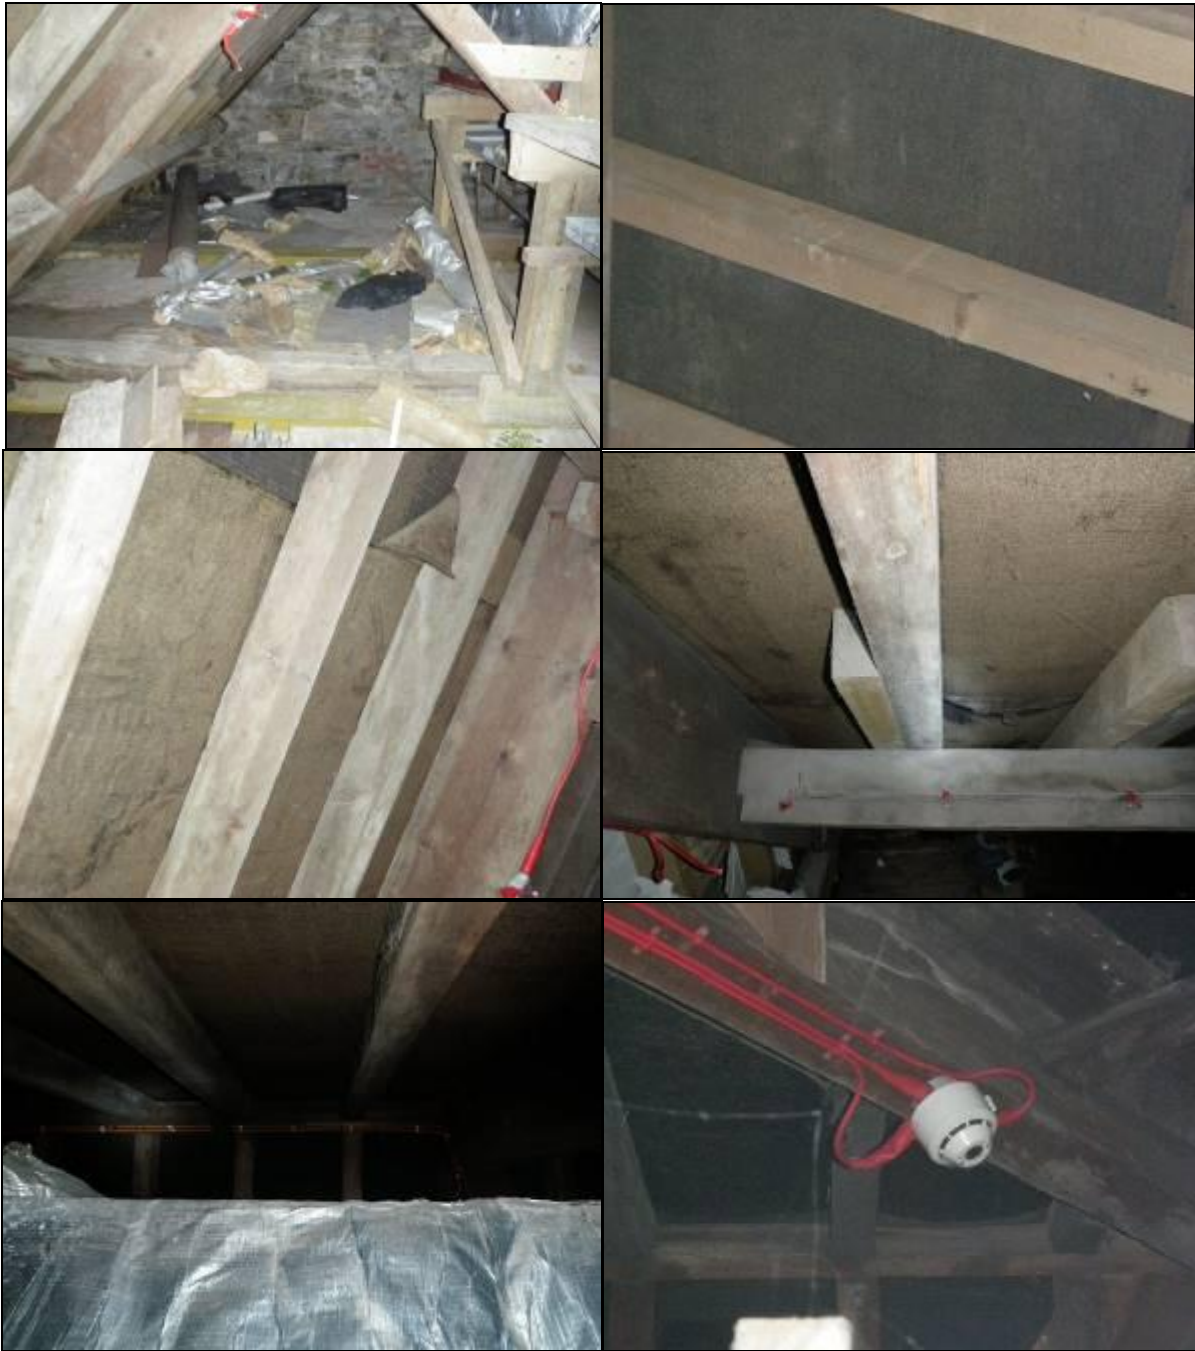
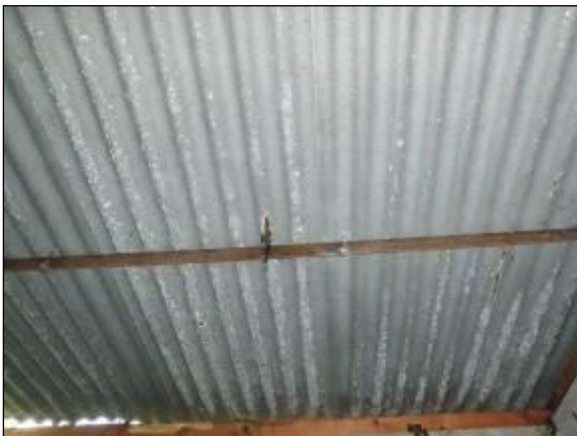
Internally, there are three voids with bitumastic felt lined timber framed roofs that have been insulated throughout. Internally no gaps in roofing material were noted and cobwebs were present throughout the roof voids. The corrugated metal sheet roof was in good condition with only a few wall top areas where shafts of light enter.

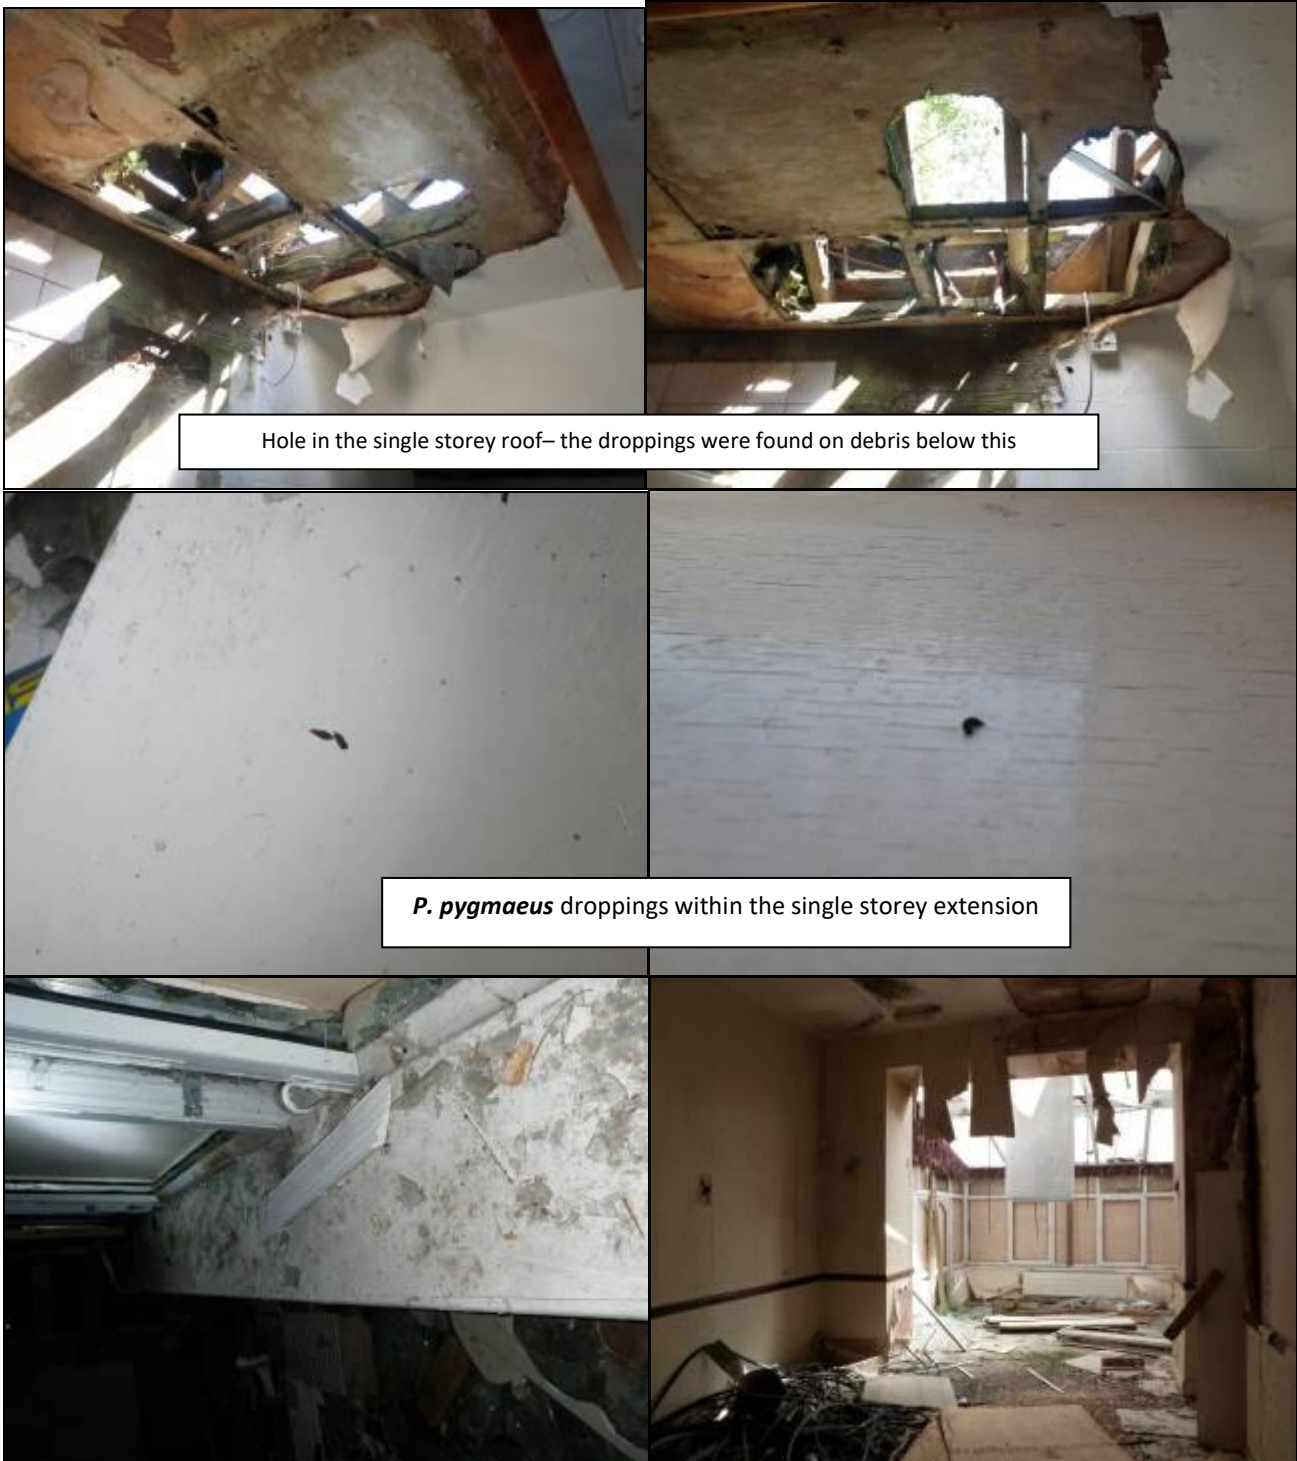
Where the large hole in the roof was found there were droppings on the debris below and DNA analysis confirmed that they were from *P. pygmaeus*.

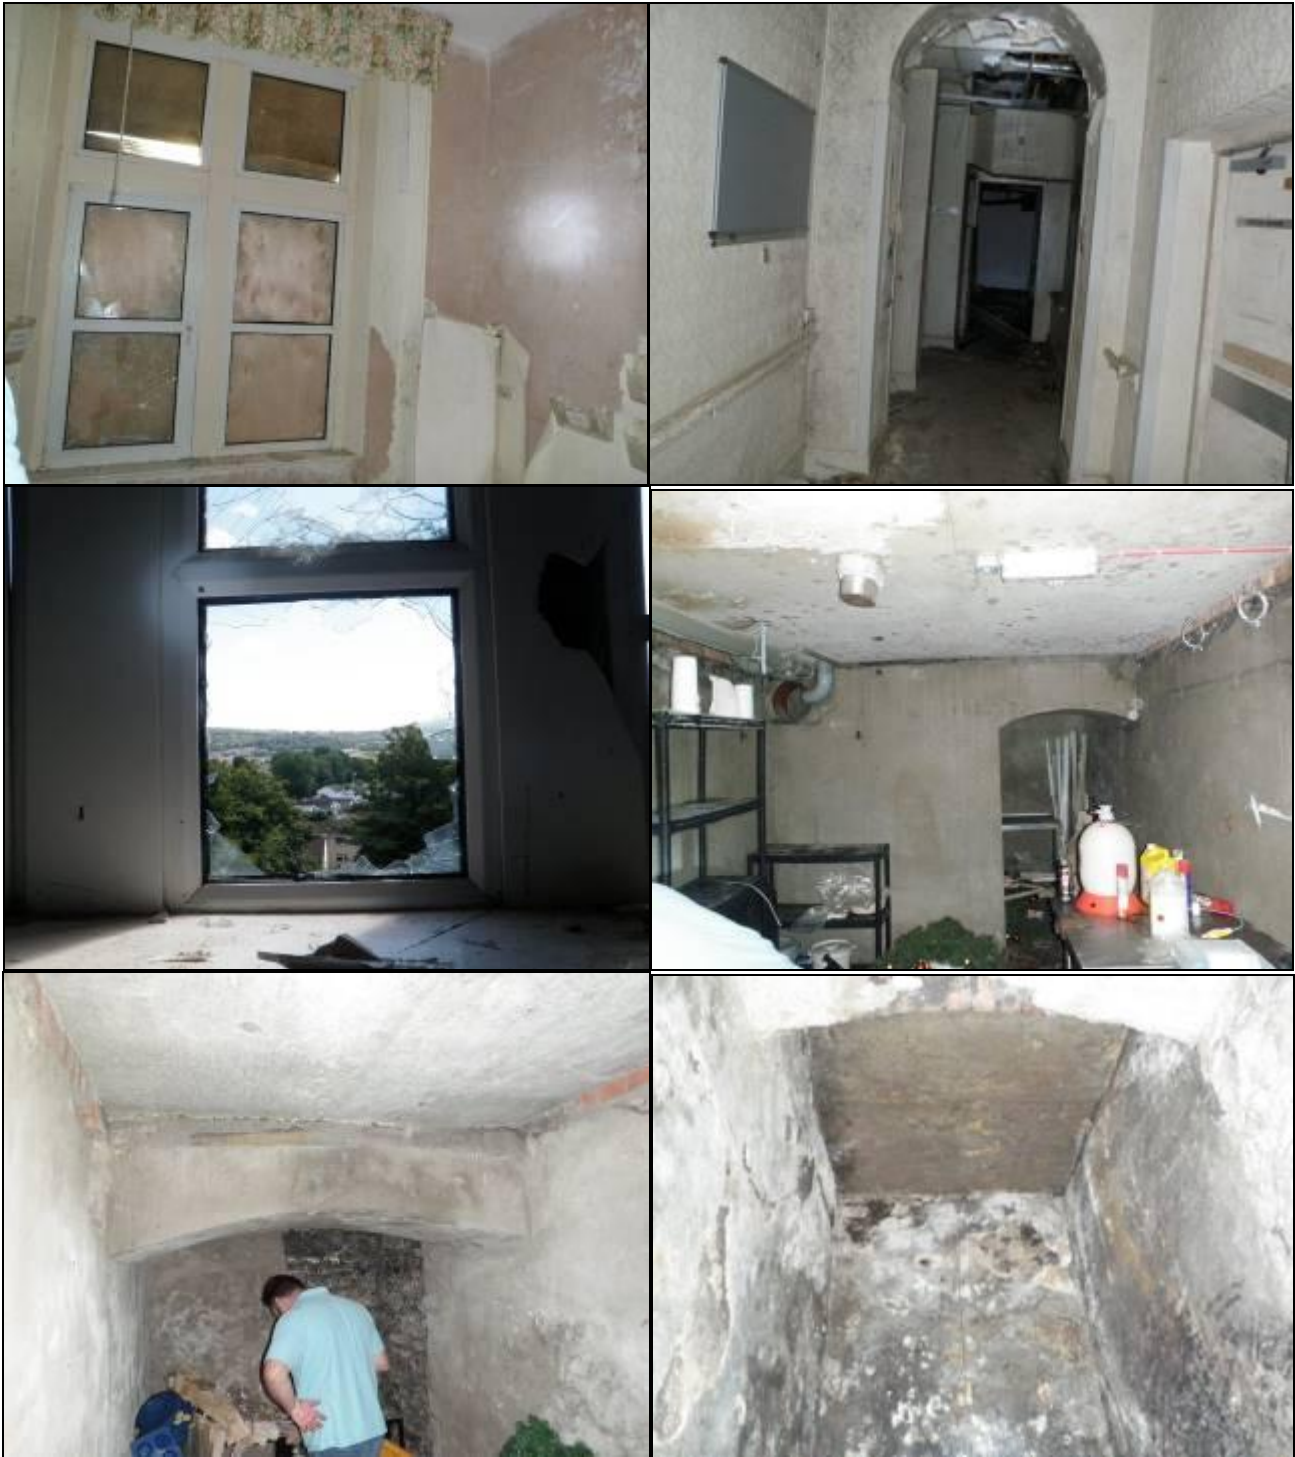
The cellar was also inspected but was found to be accessible only from the interior of the building with no potential bat access points found.

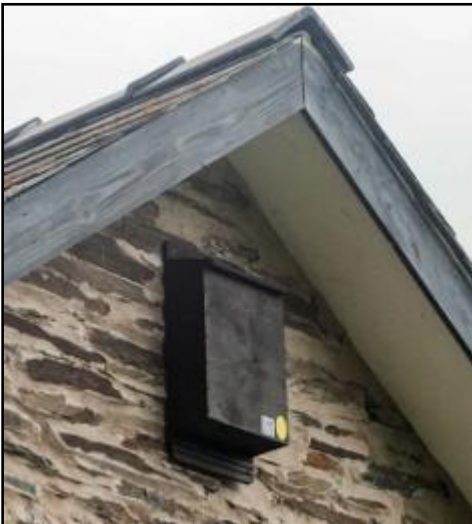
Left: The Improved Roost-Maternity Bat box is a large 3 crevice box suitable for larger roosts or maternity groups of the small British crevice-dwelling bats such as Pipistrelles. All external panels precision cut from 12mm Exterior Grade FSC plywood, for improved heat insulation. Exterior surface stained with black water based wood stain for improved thermal input, whilst avoiding any possibility of deterring use by bats due to vapour from the stain. Overhanging roof with additional internal insulation for protection from UK weather, and to seal crevices from internal airflow. 3 separate crevices each with different temperature characteristics. Wide entrance with accurately sized opening. Ideal for Pipistrelles and deters unwelcome birds etc. Internal ceramic heat sinks ensure improved temperature stability in crevices. Improved "Bat Ladder" at base of box facilitates bats landing and climbing into box. Ladder continues inside box, while textured internal surfaces ensure bats find it easy to move around inside box and hang in crevices. Ladder acts as "convector heater" for box - when sun shines on ladder, warm air rises into the box, but does not come out when the outside cools. Easy and safe to erect box on walls or trees - relatively light weight for its size, with 2 screw holes for fixing. Easy (1 screw) to remove roof for cleaning or inspection where permitted. Improved draught-proofing enhances temperature stability inside box. Rectangular back plate facilitates fitting boxes side to side to increase colony size. Improved aesthetics - looks good to humans as well as bats. Suits any building or tree. See [Improved Roost-Maternity Bat Box | NHBS Practical Conservation Equipment](#).

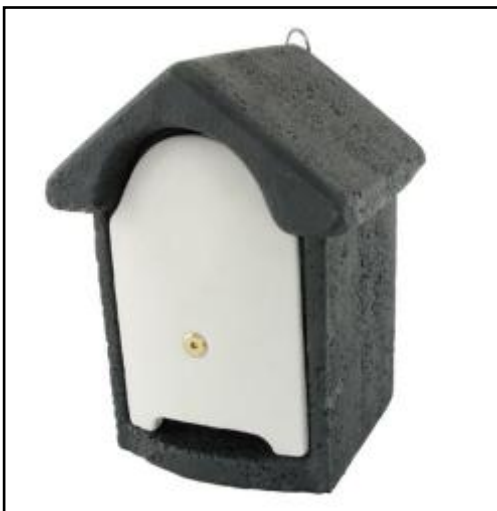
Left: The Harlech WoodStone bat box offers excellent insulation with a minimum of condensation for roosting bats. WoodStone® is a mixture of sawdust from FSC wood sources and concrete, and it is designed to last for years. It is breathable so there will be no problems with condensation and Woodstone maintains a consistent temperature inside, providing excellent insulation for roosting bats. Height 24cm x width 19cm x depth 18cm; Weight 4.4kg; Colour: Black with White front panel; Hook for hanging; Removable front panel for inspection/cleaning; and 10 Year Manufacturers Guarantee.

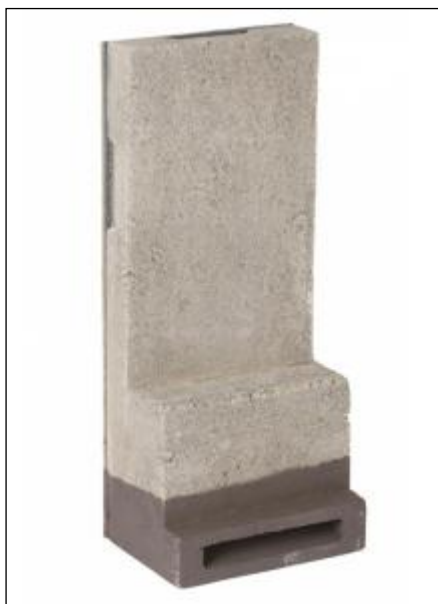
Left: The Vivara Pro Build-in WoodStone Bat Box has been specifically designed to fit into the cavity of house walls. It features a slim sized entrance hole which can sit flush in a course of bricks to provide a discreet entry way for bats. It is manufactured from hard-wearing WoodStone and plywood with removable side panels so that several boxes can be placed side by side. Position the box at least 2m above ground level away from artificial light sources. WoodStone is a mixture of sawdust from FSC wood sources and concrete, and it is designed to last for years. It is breathable so there will be no problems with condensation and Woodstone maintains a consistent temperature inside, providing excellent insulation for roosting bats.

Lack of sunlight can cause bat box/house failure, and structures for summer roosting should be positioned where they are unshaded for most of the day. Summer maternity roosts (in the northern hemisphere) should have a southerly or westerly aspect.

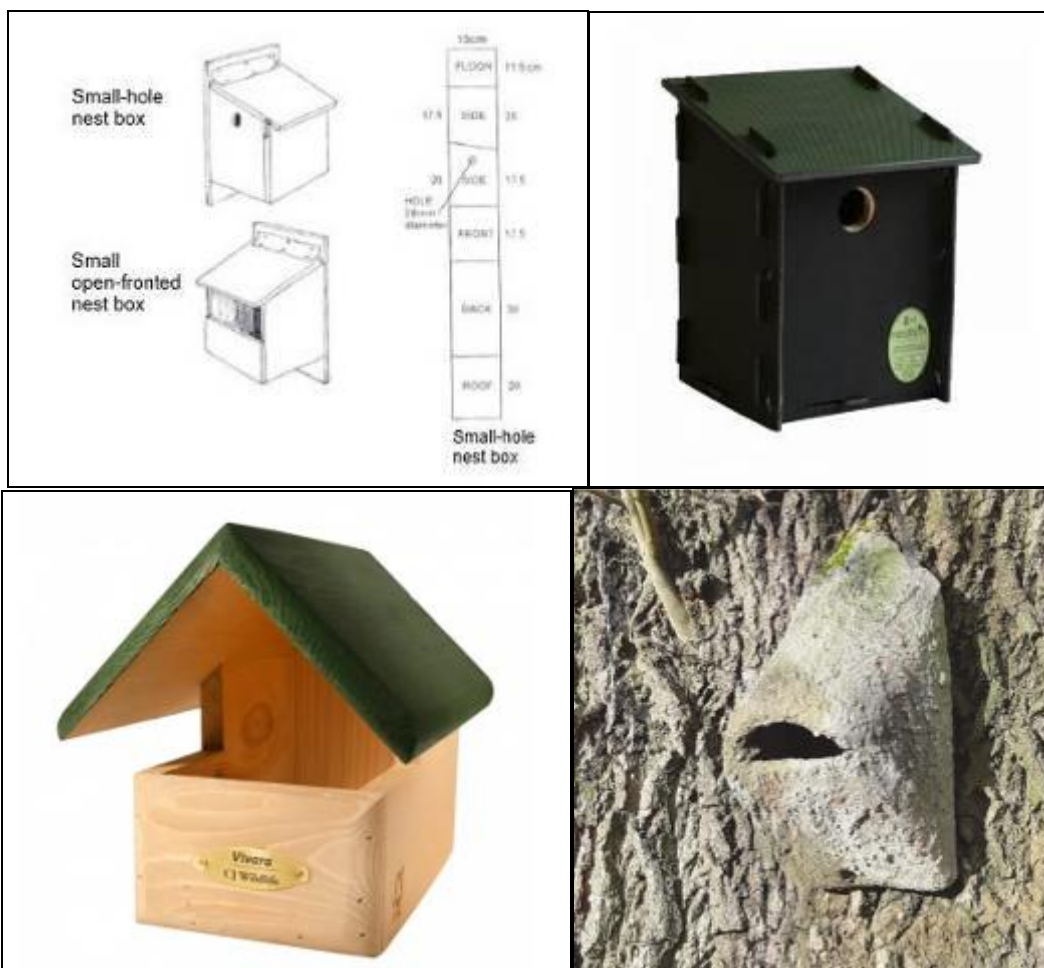
Below: Examples of nest boxes. Siting advice can be found at [Where To Put A Bird Box | Nestboxes - The RSPB](#)

- ✦ **Recommendation 4 (Enhancement):** Prior to works commencing, x 2 open-fronted and x 2 small-holed bird boxes to be affixed to mature trees within the curtilage of the property.

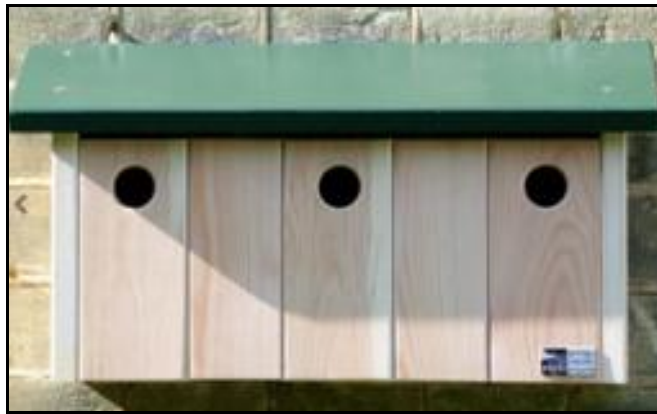
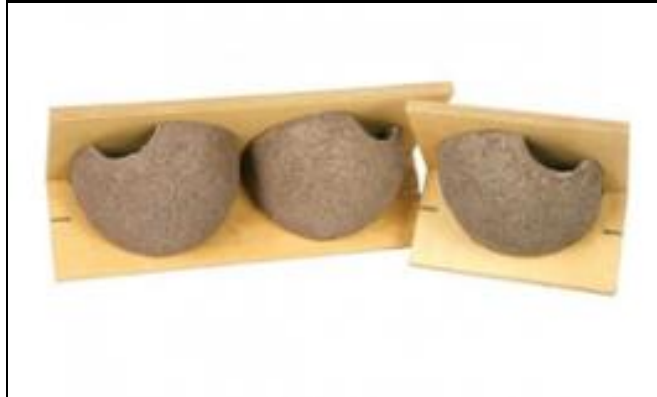
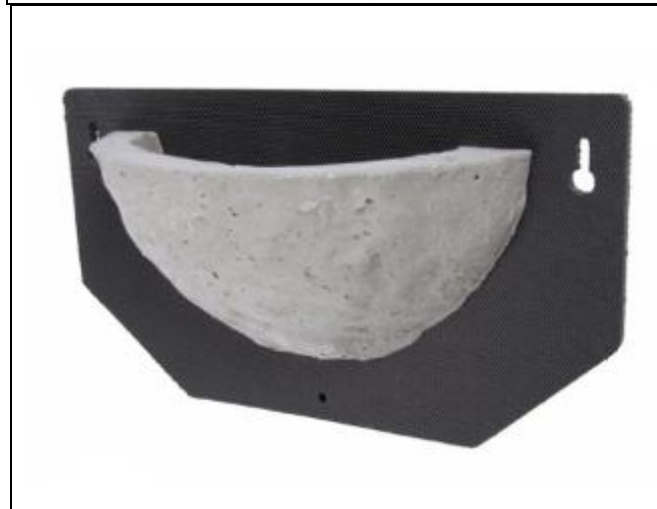
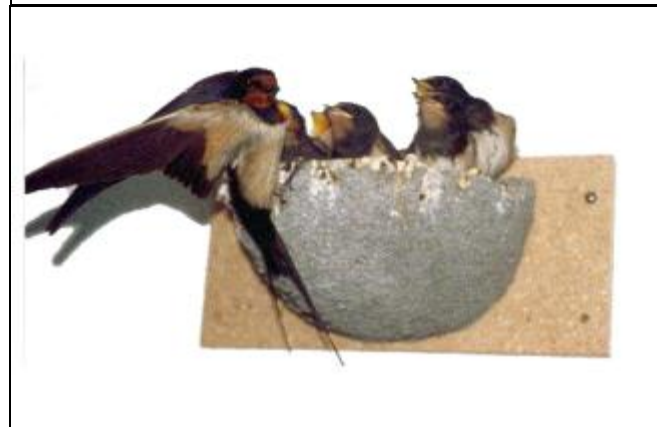
Examples of sparrow terraces, House martin nest cups, and Swallow nest cups. Siting advice can be found at [Where To Put A Bird Box | Nestboxes - The RSPB](#)

- ✦ **Recommendation 5 (Enhancement):** x 1 Sparrow terrace to be affixed to each gable end wall of Type A Block buildings (x 2 in total) and x 1 House martin nest cup to be affixed at the apex of each gable end wall of Type B Block buildings.
