Channel View

Bat Survey Report

December 2020

Project: Land at Channel View, Grangetown, Cardiff
Client: Cardiff Council
Job Number: A115866-1
File Origin: \\ds-dc-vm-002\Group Ecology\Projects\Projects A115000 on\A115866-1 Channel View\REPORTS

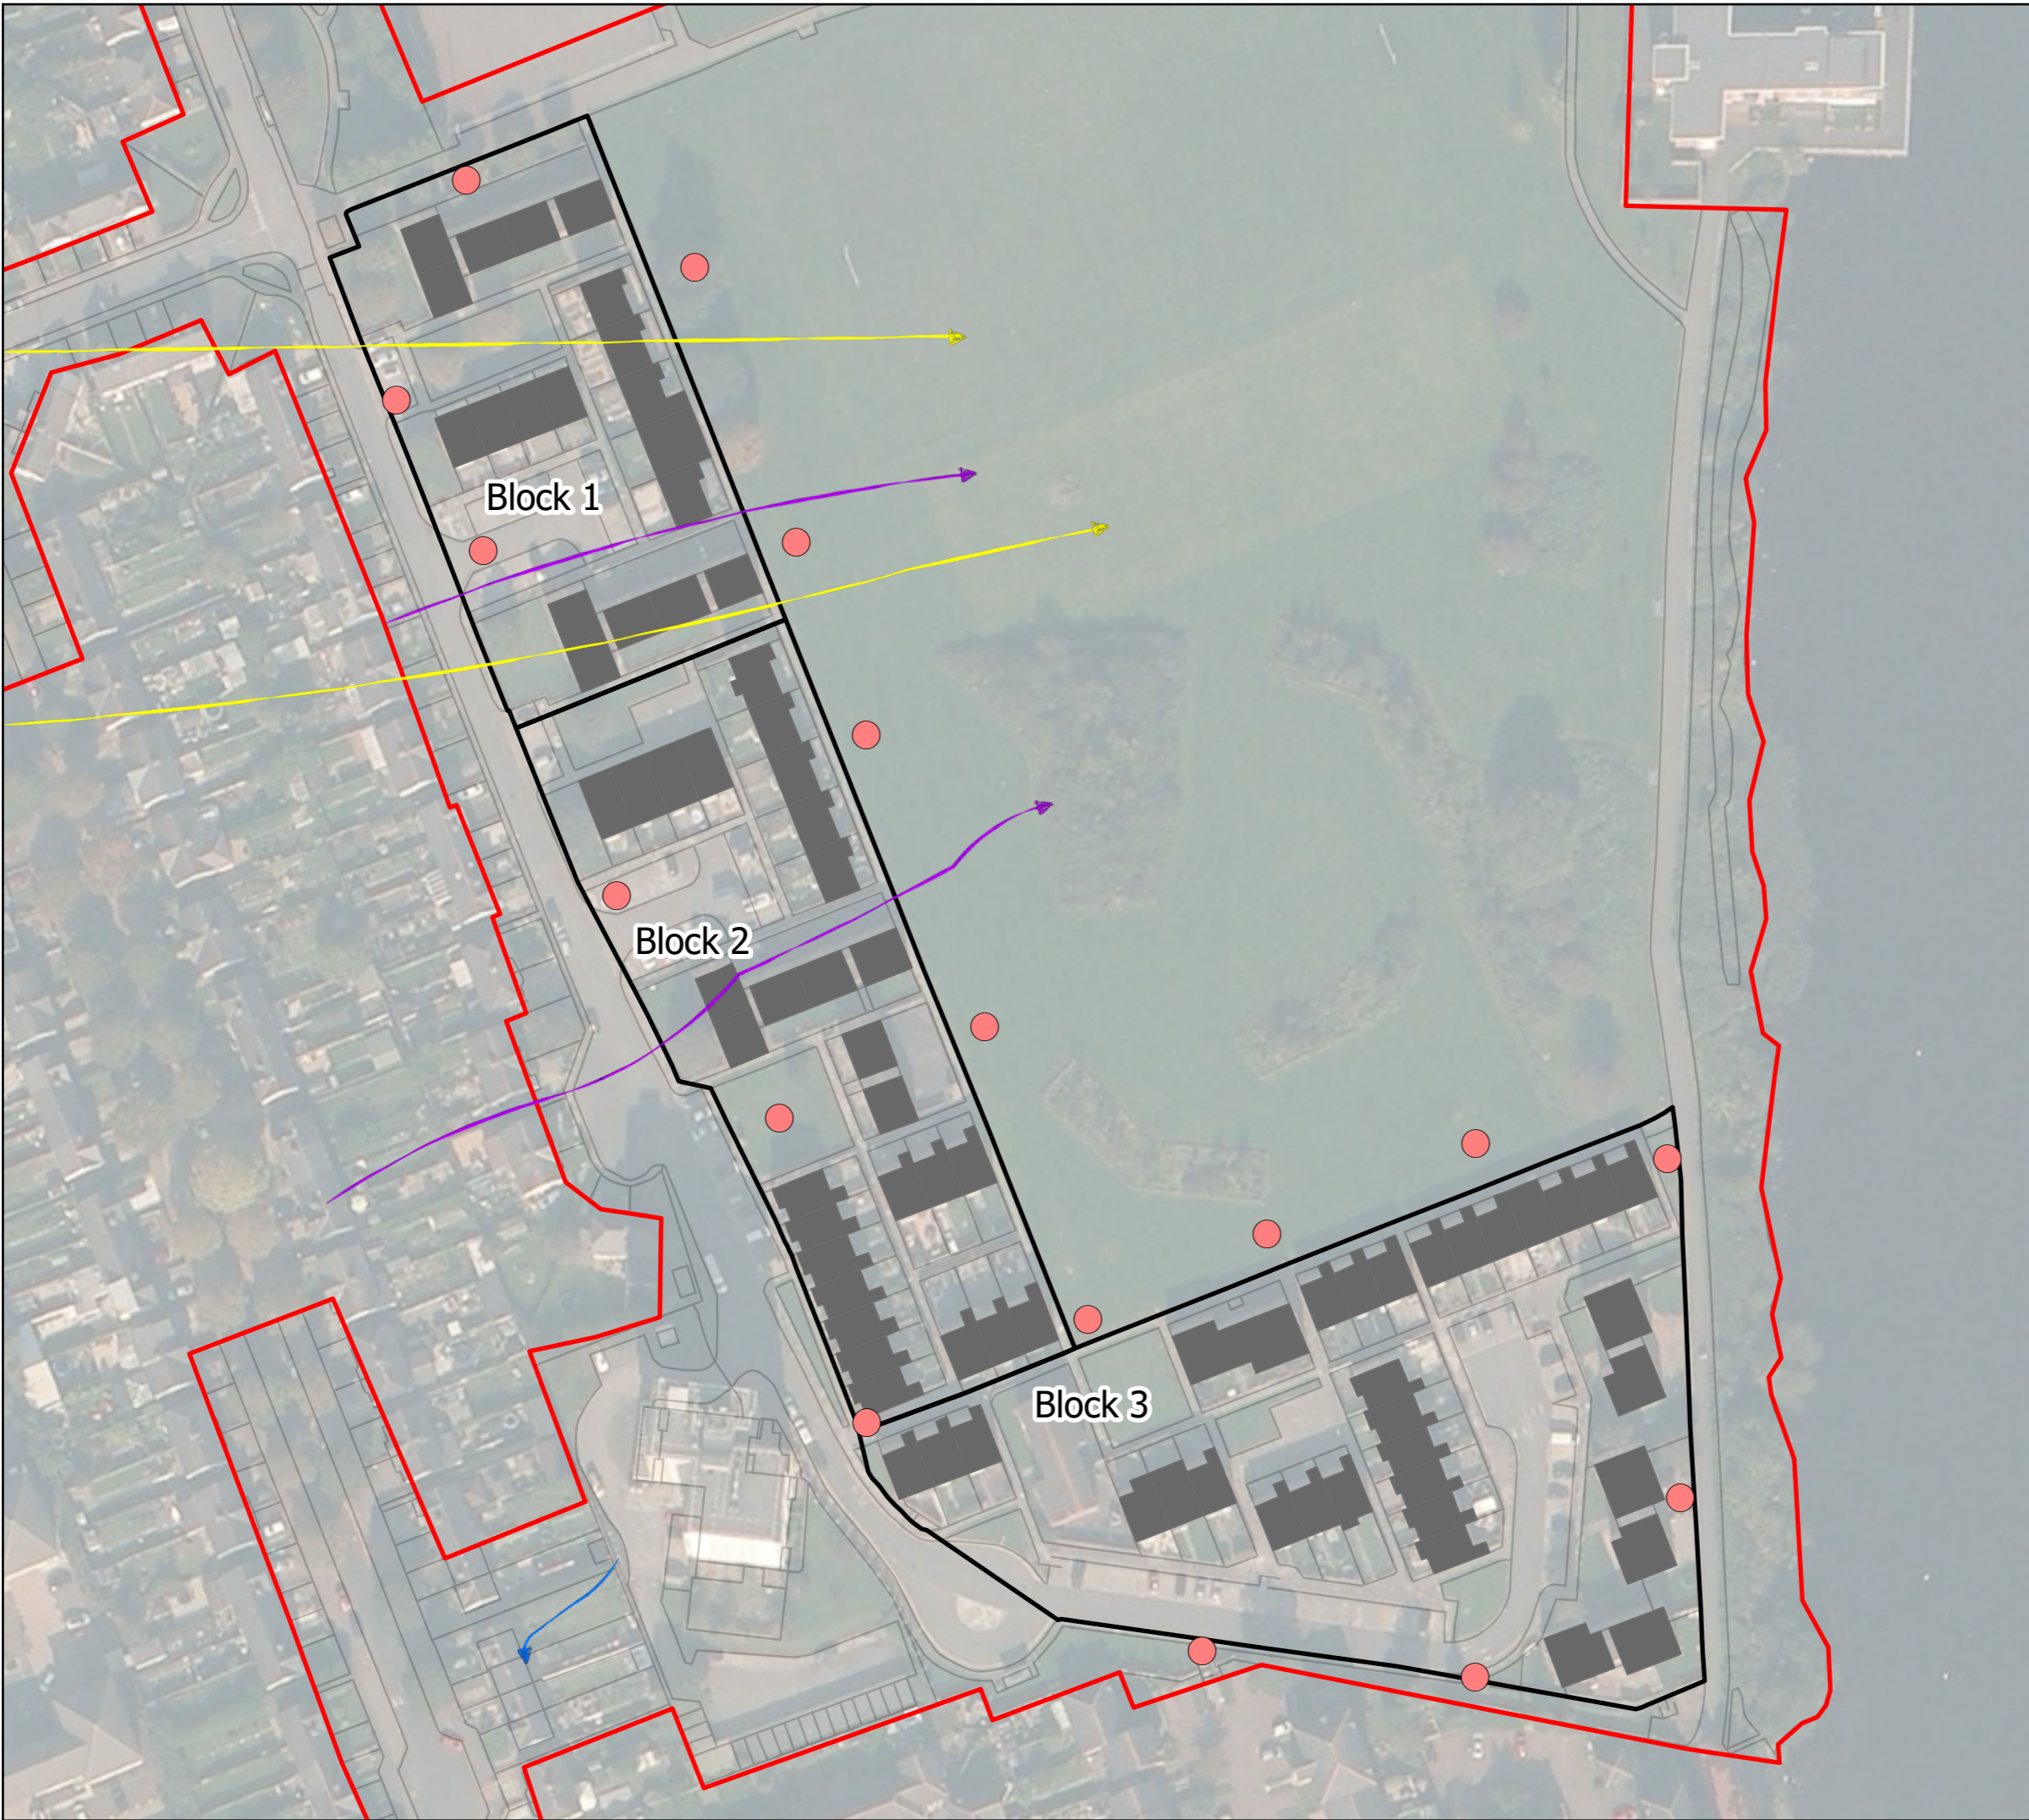
Scale at A3: 1:1,100	Project No: A115866-1	Drawing No: Figure 3	Revision: A
Drawn by: Ben Blowers	Drawn date: 11/12/2020	Approved by: Daniel Flew

3.3.1 Tables 4 to 6 below provide results of all buildings. The results with emergence and re-entry flight lines and surveyor locations are shown on Figures 3 to 5 with locations of confirmed roosts and photographs of emergence/ re-entry points on Figure 6. As a summary the following roosts were recorded:

Dusk Emergence Survey (Block 1)	Dusk Emergence Survey (Block 2)	Dusk Emergence Survey (Block 3)
08/09/2020	14/09/2020	15/09/2020
<p>The first bat recorded was a noctule at 19.56 (15 minutes after sunset). The noctule was recorded to come from the west and forage over the field east of site. Soprano pipistrelles were also recorded coming from the west and foraging over the field. It was recorded as low activity on the roadside of the estate bar the bats passing over from west to east.</p> <p>No bats were recorded emerging from any of the buildings during the survey.</p>	<p>The first bat recorded was a noctule at 19.22 (6 minutes before sunset). Similar activity recorded to activity on the 08/09/2020 with noctules coming from the west and foraging over the field east of site. Soprano pipistrelles were also recorded coming from the west and foraging over the field. It was recorded as low activity on the roadside of the estate bar the bats passing over from west to east. Very little passes from common pipistrelle and a brief pass from a myotis on the field side of the estate.</p> <p>No bats were recorded emerging from any of the buildings during the survey.</p>	<p>The first bat recorded was a noctule at 19.36 (10 minutes after sunset). Activity much quieter at the southern end of site, with the predicted activity from the noctules and the soprano pipistrelles coming from the west to forage over the field. Very brief passes from common pipistrelle and over all very low activity.</p> <p>No bats were recorded emerging from any of the buildings during the survey.</p>

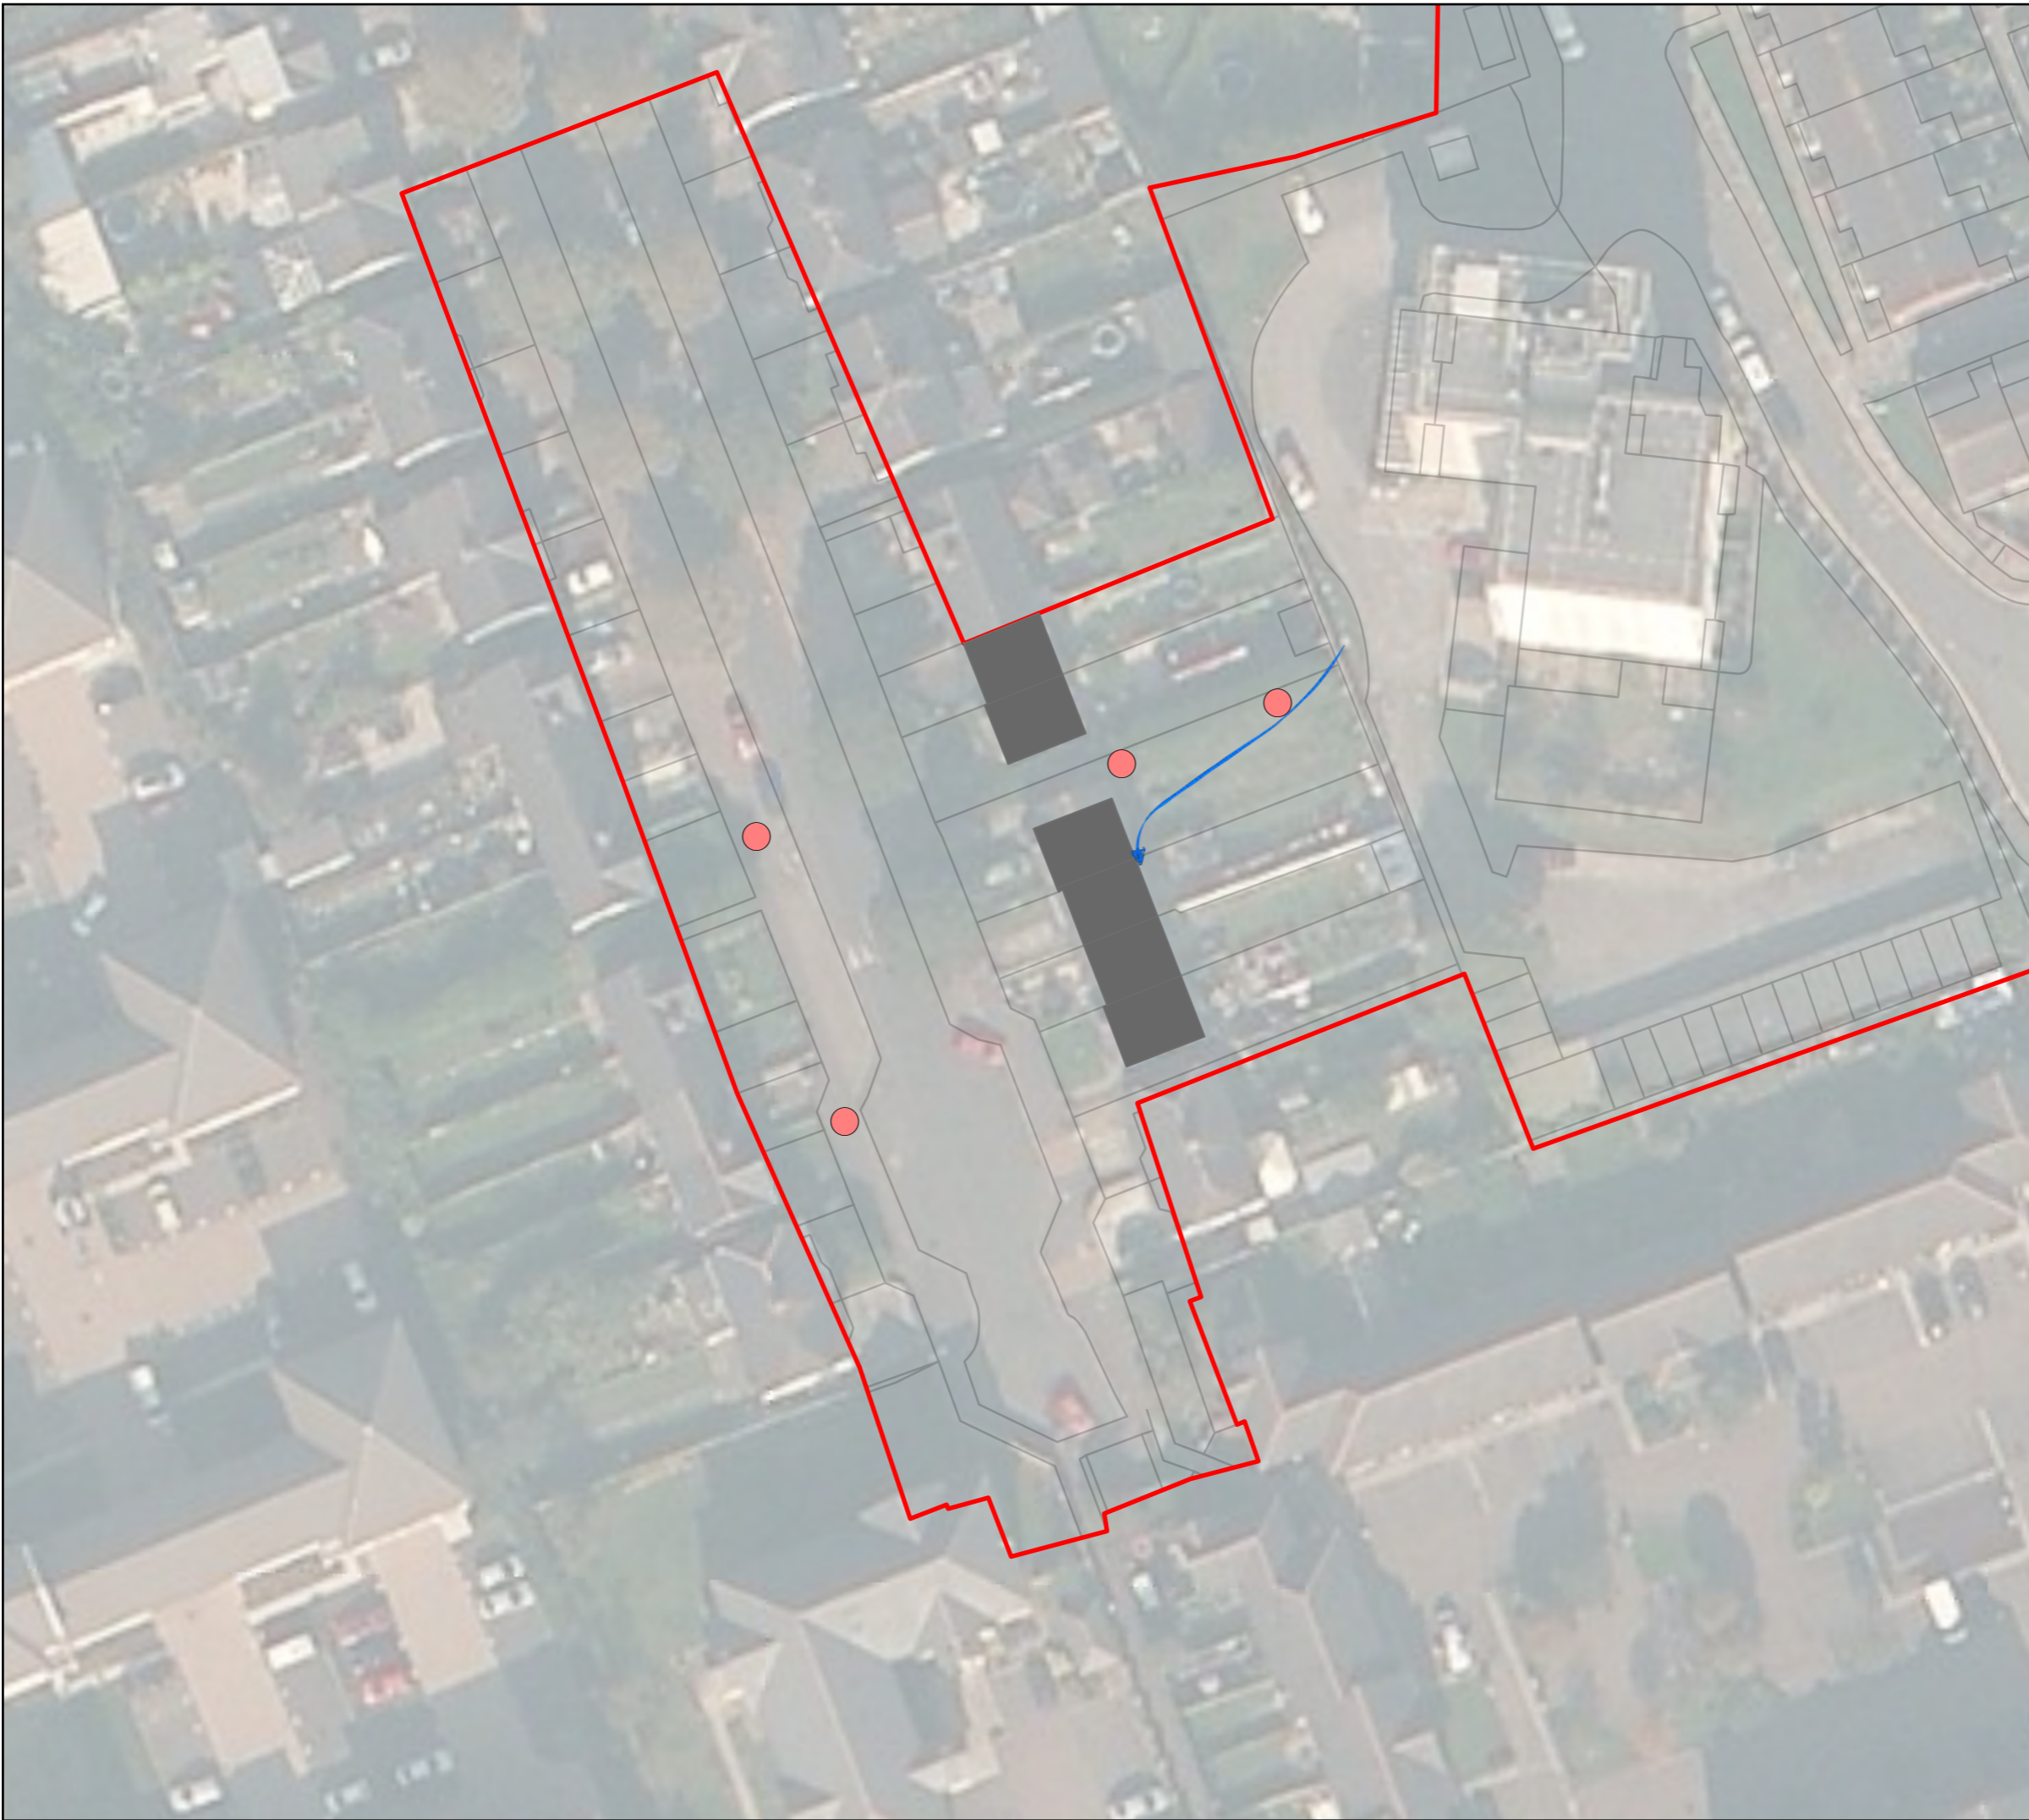
Figure 3 – Emergence / Re-entry Survey Results
Channel View Road

2.2.8 To enable the survey of the large number of buildings on Channel View Road (classified as Low suitability) these buildings were split into three areas; Block 1, Block 2 and Block 3 as shown in Figure 3. Five surveyors were positioned around Block 1 and six surveyors were positioned around Block 2 and 3 as detailed in Figure 3 with one emergence survey completed for each block in line with Low suitability methodology (Collins 2016). The survey included an element of emergence and backtracking survey with experienced surveyors making visual observations of bats commuting from their roosts and attempting to track back to the roost based on these observations. The methodology was originally

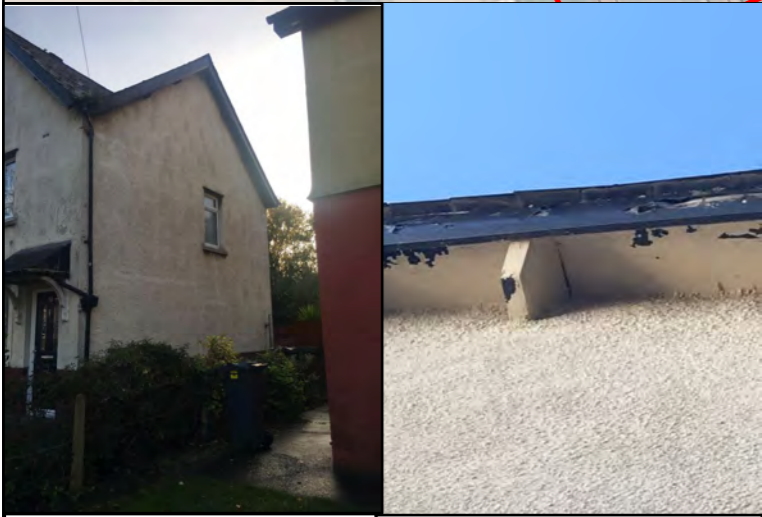
- Maternity roost of soprano pipistrelle bats at 54 and 60 South Clive Street;
- Summer (non-breeding) day roost of common pipistrelle bat at 121 South Clive Street.

No 54 Gable End No 54 Crevice

Dusk Emergence Survey 1	Dusk Emergence Survey 2	Dawn Re-entry Survey 3
26/08/2020	08/09/2020	22/09/2020
A total of three soprano pipistrelle bats emerged from the northern gable end of number 54 (under the end ridge tile and fascia board). A number of noctule bats were recorded flying in a easterly direction. Common pipistrelle bat passes were also recorded.	A total of eleven soprano pipistrelle bats emerged during the survey- six emerged from the southern gable end of number 60 and five from the northern gable end of number 54. A number of noctule bats were recorded flying in an easterly direction. Common pipistrelle bat passes were also recorded.	A total of six soprano pipistrelle re-entered at the southern gable at the end ridge tile and fascia board of number 60. No bats were recorded re-entering at the northern gable end of number 54. A number of noctule bats were recorded flying in a westerly direction.

Summary		
<p>The combined results from the BRA and dusk emergence and dawn re-entry surveys show that 54-60 South Clive Street supports:</p> <ul style="list-style-type: none"> • A soprano maternity roost of up to five bats (54 South Clive Street). • A soprano pipistrelle maternity roost up to six bats (60 South Clive Street). <p>It is assumed that these are two separate roosts and considered to be of County value (Wray, 2010). The majority of the emerged bats flew in a southerly direction using the line of trees along South Clive Street as cover and then veered through the houses around 117 South Clive Street onto Channel View/ The Marl.</p>

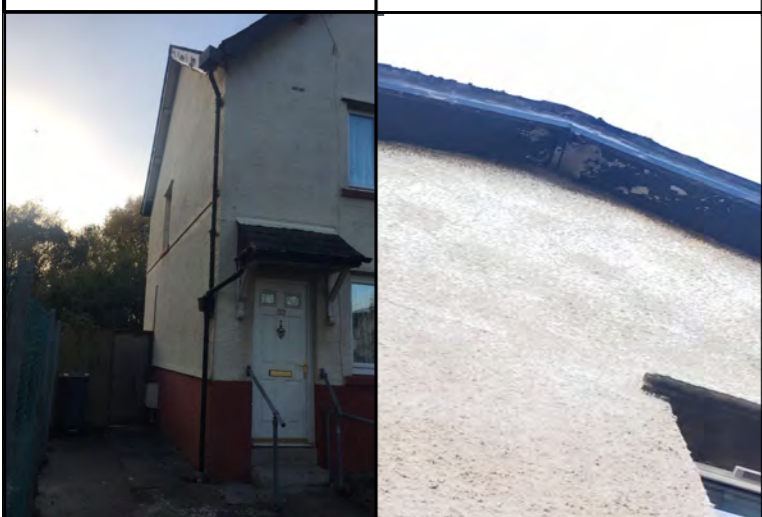
No 60 Gable End No 60 Ridge Tile

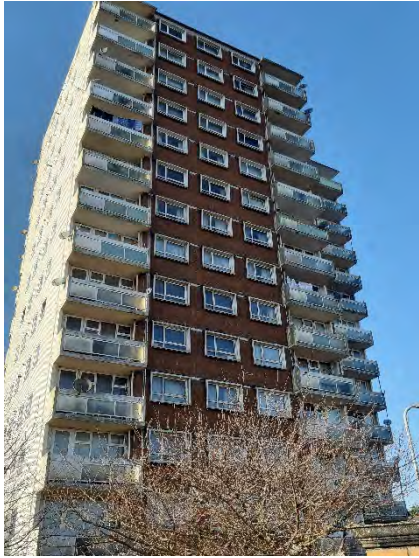
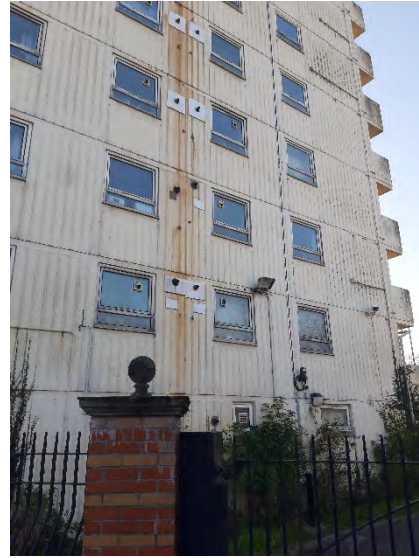
Plate 6- Channel View Road high rise flats

Plate 7- Channel View Road high rise flats cladding
