ECOLOGY SUMMARY NOTE, JUNE 2023

SANDY LANE, YSTRADOWEN

12 June 2023

Lewis Homes Sandy Lane, Ystradowen	Ecology Walkover - Off-Site Drainage			
E22108601/DR08	DJ	MW	06 June 2023

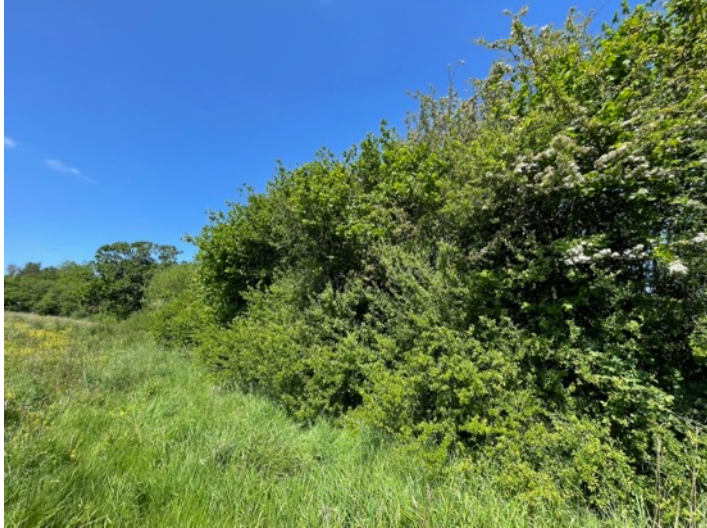
Target Note	Description
1	<p>Unmanaged species-poor hedgerow supporting tall stands of Hazel, Hawthorn, Blackthorn and occasional Oak.</p>

The proposed drainage route intersects a species-poor hedgerow as it exits the northern boundary of the site (Target Note 1). The unmanaged hedgerow supports tall stands of Hazel *Corylus avellana*, Hawthorn *Crataegus monogyna*, Blackthorn *Prunus spinosa* and Oak *Quercus* sp. (up to 5m in height).

- Removal of woody vegetation (e.g., dense scrub) to avoid the nesting bird season (typically March – September) and be undertaken over the winter period.
- Retention of hedgerow located along northern site boundary (priority habitat). Any disturbance or selected shrub removal (to accommodate the drainage route) should be minimised and temporary in nature, with any shrub removal undertaken over the winter period and replacement

planting provided at the earliest planting opportunity, to minimise disturbance to foraging and commuting bats.

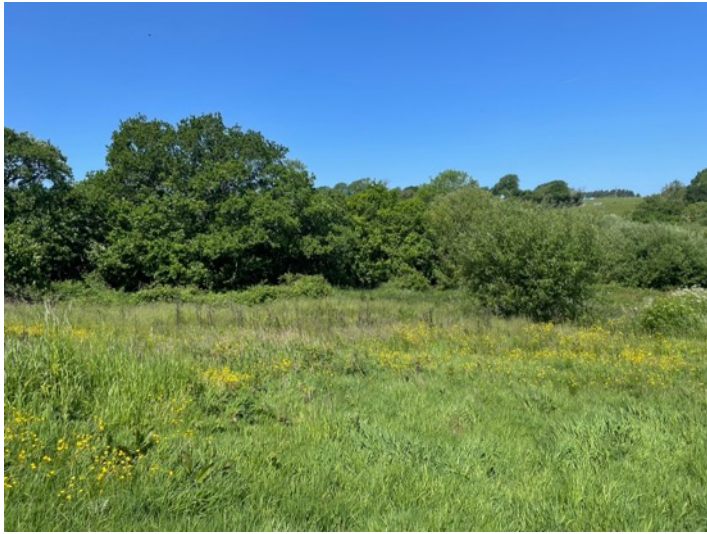
2	<p>Area of poor SI grassland transitioning to tall ruderal and dense scrub vegetation.</p>

- Sensitive approach to clearance of grassland along the proposed drainage route to minimise any risks to reptiles or amphibians that may be present (vegetation to be cleared via a directional two-stage process between April and October).
- If any trees assessed to have potential to support roosting bats are likely to be impacted by the proposed works³ further survey work to establish the likely presence/absence of roosting bats will be required to determine any further mitigation measures or licencing requirements. As per current best practice guidelines (BCT, 2016), for trees assessed to have high potential to support roosting bats 3no. separate survey visits are recommended.
- Appropriate pollution prevention measures to minimise run-off into adjacent ditch.

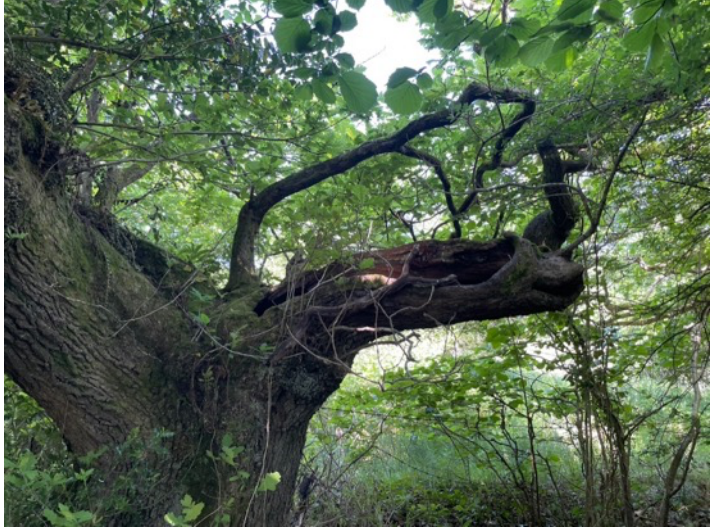
3	<p>Mature Oak tree assessed to have <u>moderate potential</u> to support roosting bats. The north extending branch has significant damage/decay with small desiccation fissures and large cavity – although this is upwards facing and likely exposed to weather conditions.</p>

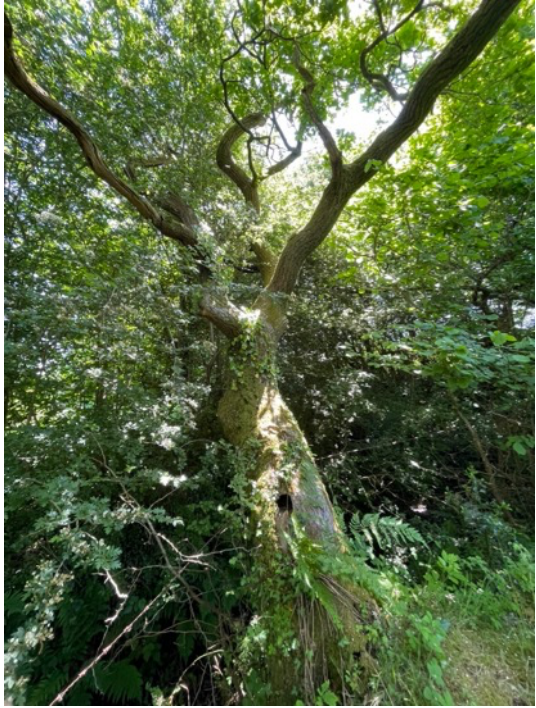
<p>4</p>	<p>Mature Oak tree assessed to have <u>high potential</u> to support roosting bats. Tree contains cavity on main trunk (approx. 0.5m high) which leads to internal cavity capable of supporting a large number of roosting bats.</p>

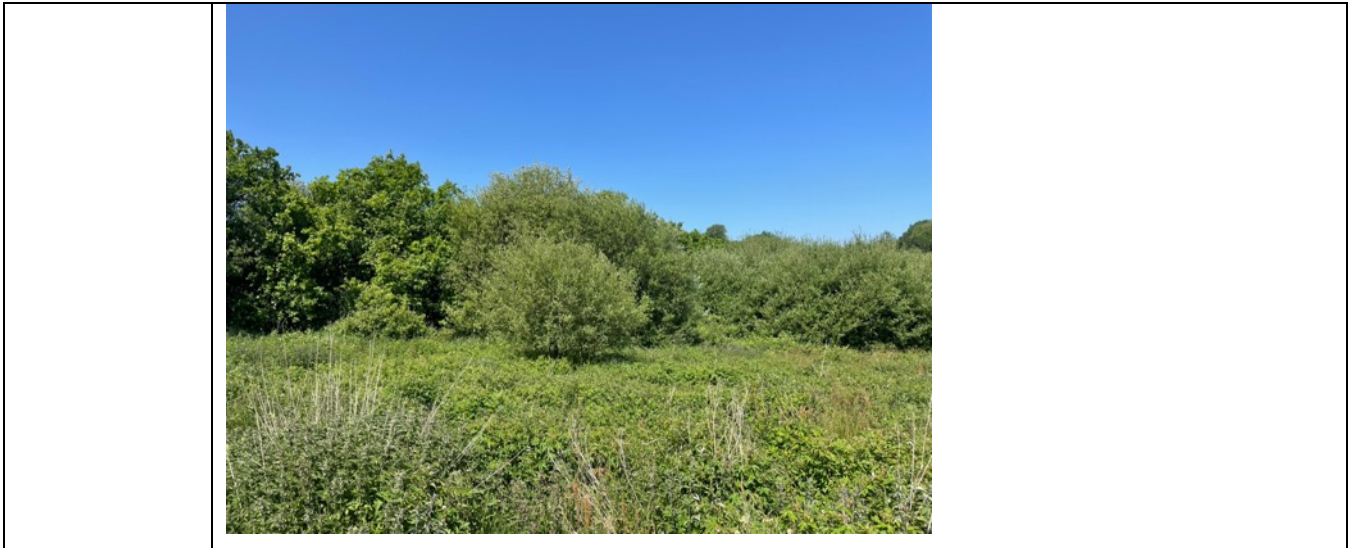
<p>5</p>	<p>Inaccessible area. Dense scrub.</p>

Further north along the drainage route, the grassland transitions to areas of dense scrub and tall ruderal vegetation, which at the time of the current survey, were inaccessible (Target Note 5). This includes dense Bramble *Rubus fruticosus* agg. scrub, Common Nettle and occasional Willow *Salix* sp. stands.
