Hazards of the Consolidated Industries H-Series Horizontal Atmospheric Furnace

By Michael Whedon
Licensed, Certified, Private Fire Investigator.

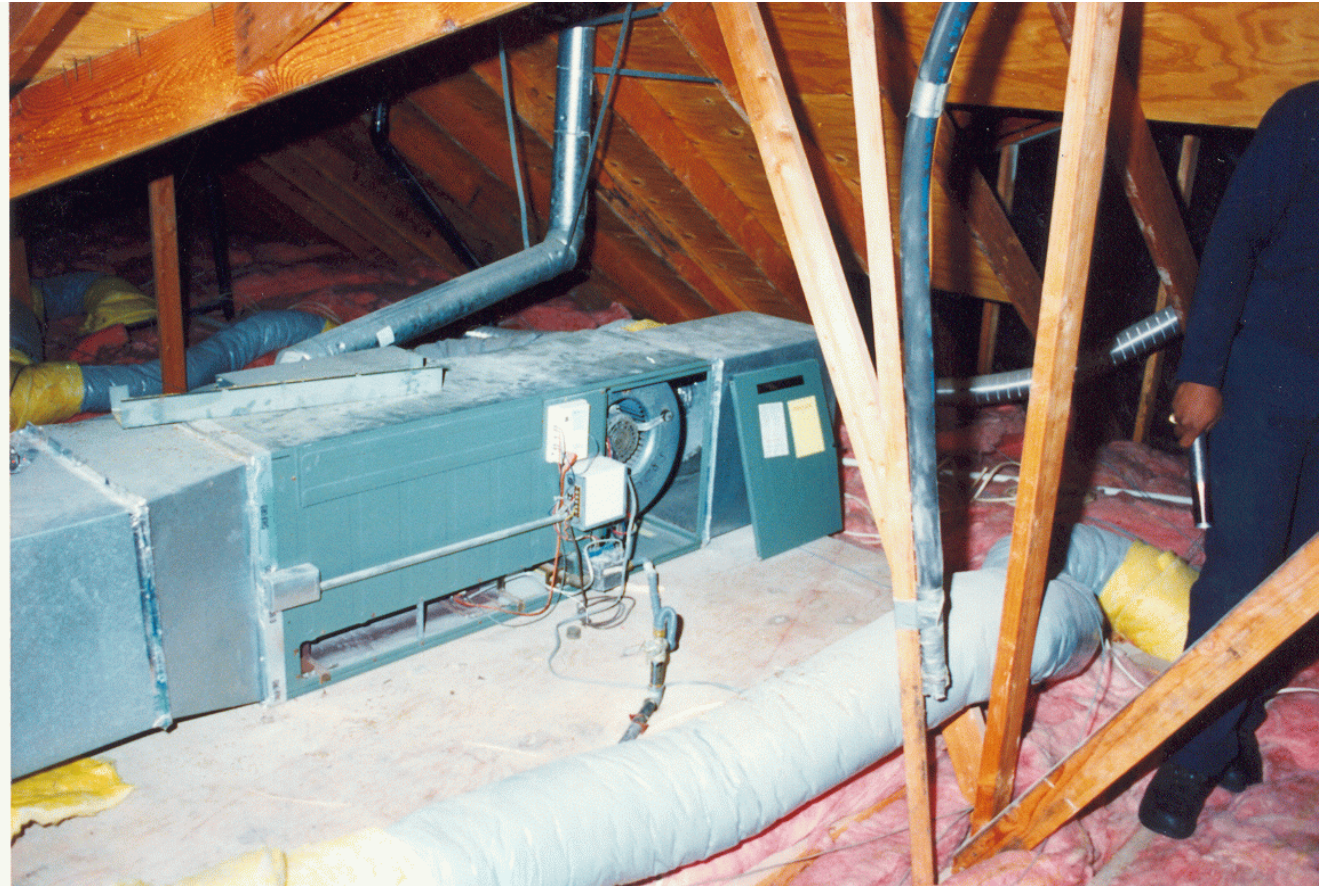
Photo One: Typical installation method for H-Series furnace.

During the same time period, fire investigators began to see an increase in fires occurring in homes equipped with the Consolidated H-Series furnaces. These Consolidated furnaces had been installed in attic spaces on plywood decks or set perpendicular across wooden ceiling joists. The initial theorization was that although the furnaces were rated for installation on combustible surfaces, heat was passing from the burner compartment through the bottom panel of the furnace and igniting the wood decking or joists below. The official fire cause was listed as "pyrolysis," which is simply the decomposition of a fuel due to heat. Not realizing the commonality of the furnaces involved in the problem, some fire department and building department in a joint effort began requiring that all horizontal furnaces installed in attics be placed on non-combustible flooring.

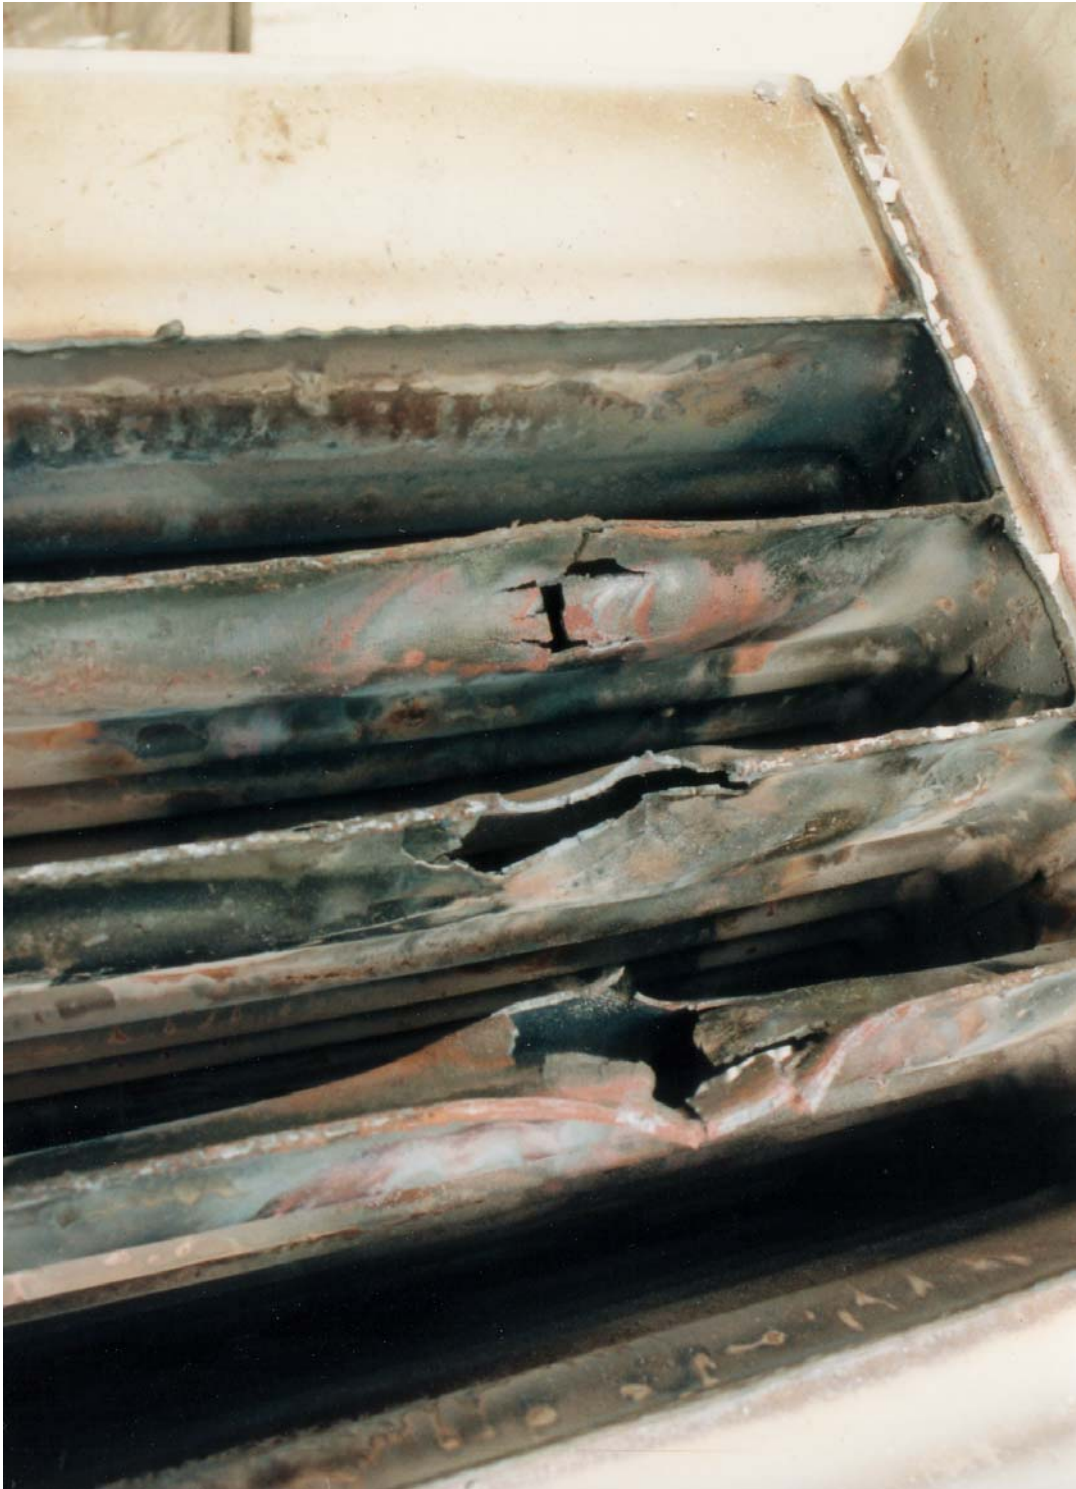
Photo Six: Failed heat exchanger.

Heat exchangers are made of 18 gauge stamped steel which is machine welded together to form cells or tubes. The purpose of the heat exchanger is to warm the air passing through the furnace before it is discharged into the duct system for distribution into the living space of the house. The metal from which the heat exchanger is formed did not have the ability to withstand the direct impingement of the flames from the damaged burners. Additionally, the weld seams themselves, located along the bottom of the heat exchanger tubes, were also being subjected to this direct flame impingement. These weld seams, which are of relatively poor quality, would fail quickly when exposed to the direct flame contact. Lateral cracks would begin to form in the weld seams leading to horizontal cracks in the walls of the heat exchanger cells. Under continued use, these cracks widen and grow in length.

Eventually the metal crystallizes and begins to literally fall apart. This results in holes appearing in the heat exchanger cells. The holes continue to grow larger in size each time the furnace is used.
