Corner Pops

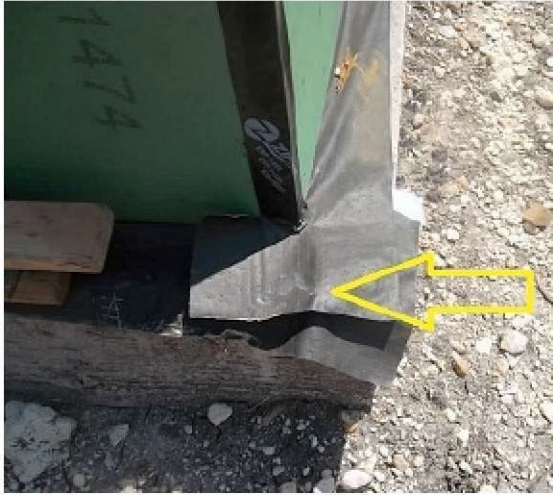
To the left is an example of a proper poly installation. The poly goes all the way to the corner to help keep the corner from popping off

Third, there is, or is supposed to be, a barrier between the brick and foundation. Typically this barrier is a black poly or plastic. Sometimes you can see a little bit of the black plastic sticking out between the brick and foundation on new houses. However, because of the way this plastic is installed, it is often missing at the corners (see example pictures below).

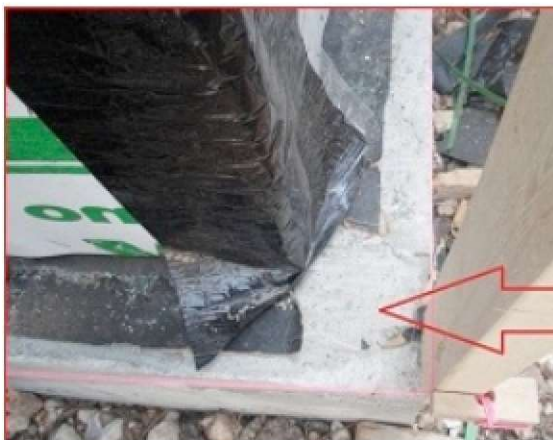
Improper Poly install shown to the left will likely cause corner pops

So, here is what happens: the plastic barrier is missing from the corner. The brick of the wall and the concrete of the foundation are in direct contact and bond together. Then we get a warm Texas day (*read hotter than you-know-where*), and the brick expands more than the concrete... and “Pop! Goes the corner.”

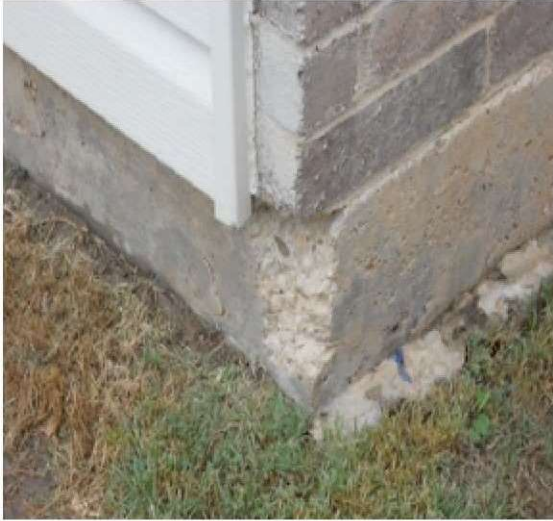
To the left is a result of the poly not being installed all the way to the corner.
