## FPE Panels – Hazard or Hype?

*by Douglas Hansen*

*This article focuses on the controversy over inspecting and reporting Federal Pacific panels. It has been published in the magazine for the California Real Estate Inspection Association and in other technical journals.*

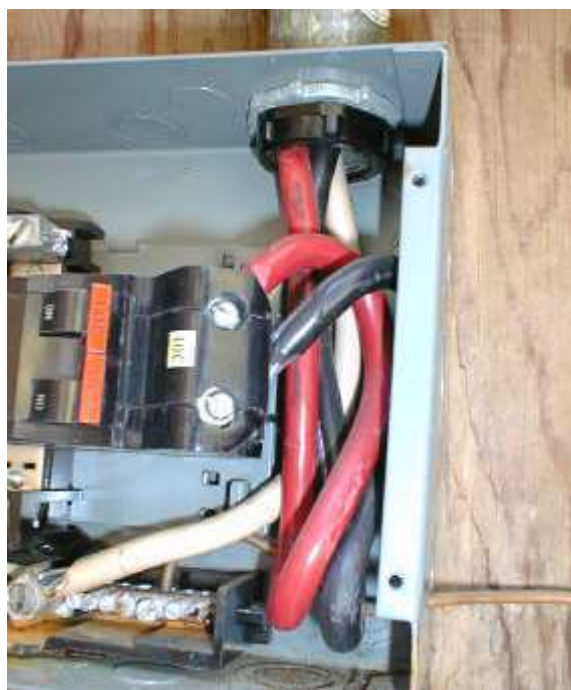
*Figure 1 – Insufficient wire bending space*

Several of the problems found with FPE panels are found in other brands of equipment of the same age. There is less gutter space in the panel than we find in modern equipment. The result is crowding of the wires in the panels. It is sometimes impossible to see all of the terminals in an FPE panel. The space for bending wires is also less than required in modern panels. The rules that proscribe minimum wire bending space are found in the National Electrical Code (NEC) in section 312.6 in the 2002 edition. Over the years, the required minimum space has increased, with the most significant changes in the 1981 NEC, near the very end of the days when FPE panels were made. FPE manufactured some panels with less clearance than the minimum code rules by installing the lugs at an angle, so the conductor was already parallel to the wall opposite the breaker terminal (figure 1). However, the bends shown in figure 1 defeat the purpose of the angled lugs, and the wire is bent too sharply.

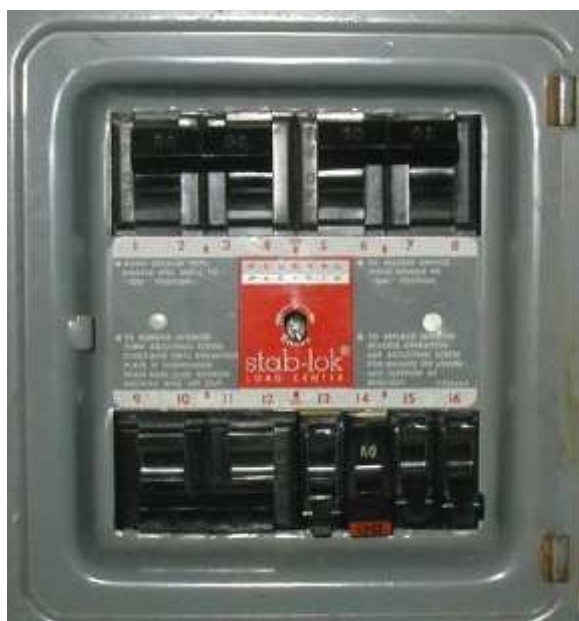
Figure 2 – Breakers that are on when down

Since the 1984 edition of the NEC, breakers that operate with their handles in a vertical position must be on when in the up position, and off in the down position. Prior to that time, several manufacturers made equipment such as that seen in figure 2, with a row of breakers that was on when down and off when up. The word “on” when upside down is “no.” Inspectors encountering such equipment might want to warn their clients that these FPE breakers are on when facing the outer edge of the panel, and off when facing the center of the panel. It can be very difficult to remove these covers without accidentally tripping a breaker.

Inspectors might find that their first problem with FPE is the difficulty in removing the deadfront cover without tripping the breakers. Several models of FPE panels have breakers that are on when the handle is positioned toward the outside of the panels. The handles stick out slightly over the deadfront, past the twist-out opening for the breaker. To remove the cover, it is necessary to first lift it slightly away from the panel, then slide it under the handles of one row while lifting the cover off the other row. If an inspector pulls the cover straight off, it is likely that some of the breakers will accidentally trip. The panels in figures 2, 3, and 4 have this problem.

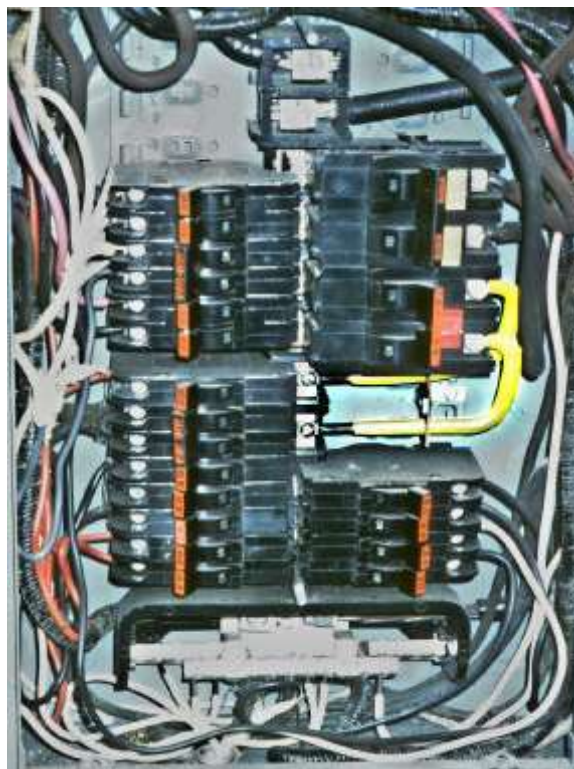
Figure 3 – Split Bus Panel

Prior to 1984, many manufacturers offered “split bus” panels for residential use, such as the panel in figure 3. These panels have no main breaker. They do meet the rule requiring no more than 6 disconnects, and one of these disconnects feeds a separate bus that typically contains the 15 and 20 amp 120 volt circuits. The advantages of a split bus panel were purely economic. If the largest breaker was the one feeding the secondary bus, and it was rated at 50 amps, it cost less than a single main 100 amp breaker. In addition to the “six disconnects” rule for service equipment, another rule also applies to panels that are categorized as “lighting and appliance” panels. These are panels where more than 10% of the breakers are rated 30 amps or less and serve circuits with neutrals. These lighting and appliance panels must be capable of having their power disconnected by not more than 2 hand movements. Until 1984, the code exempted these panels from the “two-disconnects” rule when they served as residential service equipment. Today, the code allows them to remain when they are “existing” service equipment, though it would not allow a new installation of such a panel.

The panel in Figure 3 has 5 breakers at the top. The 3 on the left control a water heater, clothes dryer, and electric space heater. The top right breaker controls the range/oven circuit, and the one just below it controls the lower bus section, with all the lighting and appliance circuits. The wires from this breaker to the lower bus section are the sign that this is a split bus panel.

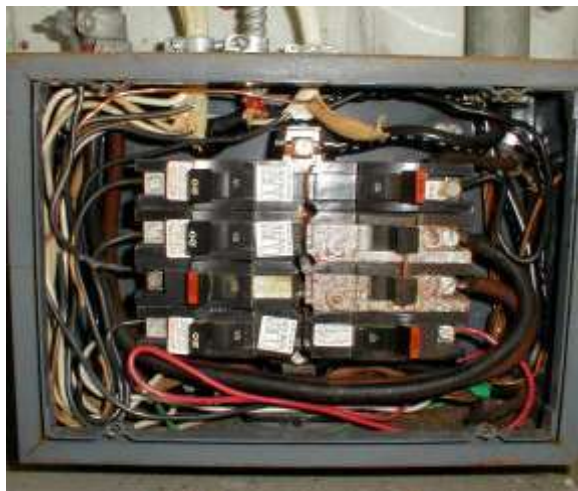
*Figure 4 – Overcrowded FPE panel with wires obscuring terminals, neutral bar, and bonding jumper. If the wires press against the deadfront, it may pop out and trip the breaker handles as soon as the panel screws are removed.*

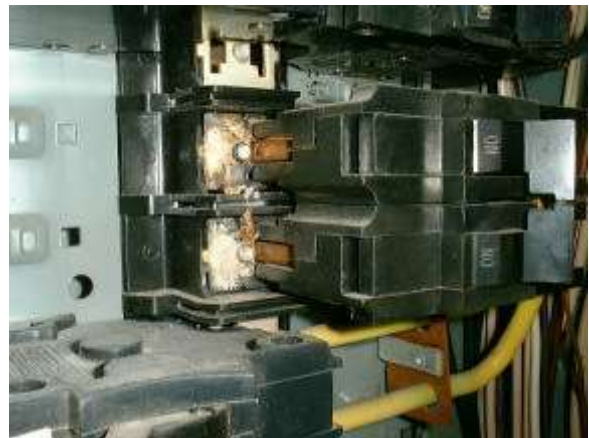
*Figure 5 – Scorched Bus Bar*

Most plug-in circuit breakers have a set of jaws that fit over a bus bar, bringing the metal of the jaw into a parallel position to the bus bar. The FPE Stablok design is the opposite; the breakers have a set of prongs that are inserted into a slot in the bus bars (figures 5 – 8). The result is a connection between two pieces of metal that are at right angles to each other, only touching at their edges. One of the common FPE problems is to find the breakers loose in the bus bars. Good electrical connections require contact pressure. If the FPE stab only touches one edge of the opening in the bus, the lack of contact pressure and the small contact area will combine to produce arcing and overheating. If you remove the breakers from the panel, it is not uncommon to find scorch marks on FPE bus bars, as in figure 5.

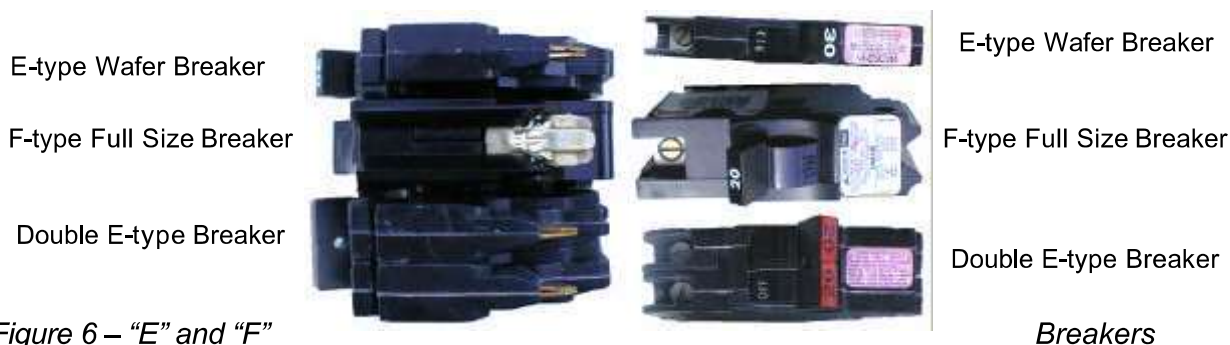
Figure 6 – “E” and “F”

FPE found a unique way of designing their wafer breakers and creating a limitation on the number of them that could fit in a CTL panel. Full size breakers have a stab that is perpendicular to the direction the breaker handle operates, and wafer breakers have a stab parallel to the direction of the breaker handle. The full size breakers stabs are referred to as “F” type, and the wafer breakers as “E” stabs (figures 6&7). FPE has two different styles of bus opening. An “E” type opening will allow either two “E” type breakers or one “F” type. An “F” type opening will only allow one breaker, of either type. The number of breakers that can fit in the panel can therefore be limited by installing “F” type openings, instead of “E” openings.

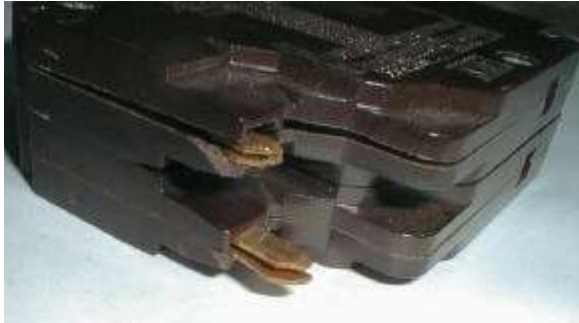
*Figure 8 – Damaged “E” type breaker*

Not only do “E” breakers make poor connection to “F” sockets, forcing them into the socket can damage them. The breaker may split when shoved into the slot, with the bus stab receding inside the breaker (figure 7). Since it is now making a very loose contact to the bus, the breaker might fall right out when the deadfront cover is removed (figure 9). Inspectors can be forewarned of this condition before taking off the cover. Simply look at the label for the panel to see where the “E” slots are located and whether any “E” breakers have been inserted into “F” slots. When finding that situation, there is no need to remove the cover to know that the breaker is in the wrong position.

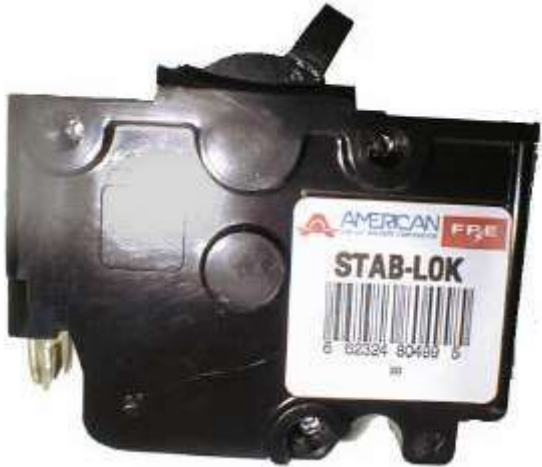
*Figure 10 – Replacement Stablok breaker*

If the breakers themselves are the problem, should homeowners consider replacing the breakers and keeping the panel? At various times over the last 2 decades, different manufacturers have made after-market products designed to fit FPE panels. In some cases, these breakers have been made in Canada, Mexico, or China. Salvaged old FPE breakers are also available from specialty dealers. The breakers sold under the “American” brand (figure 10) are no longer UL listed, though they are listed by ETL, another nationally recognized testing laboratory. In all cases, replacement breakers are very expensive, with a single-pole 15 amp breaker costing as much as \$50. If one wanted to replace all the breakers in a panel, they could spend a great deal more than it would cost to replace the panel with modern listed equipment.
