Inspection Report

123 Main Street, Anytown, VA 20111
Inspection prepared for: JANE DOE
Date of Inspection: 1/26/2019

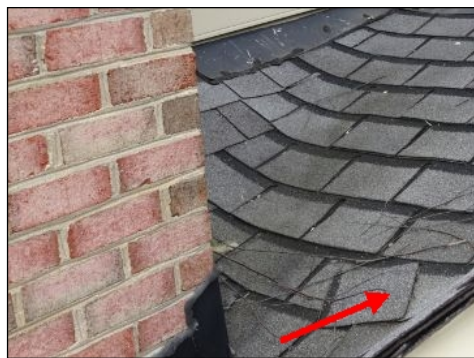
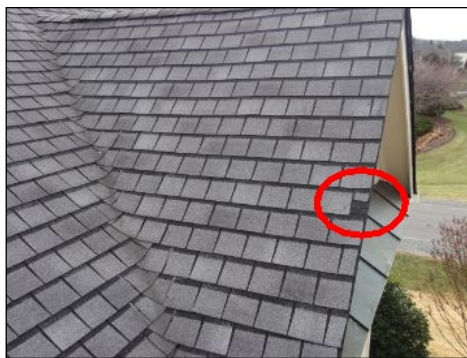
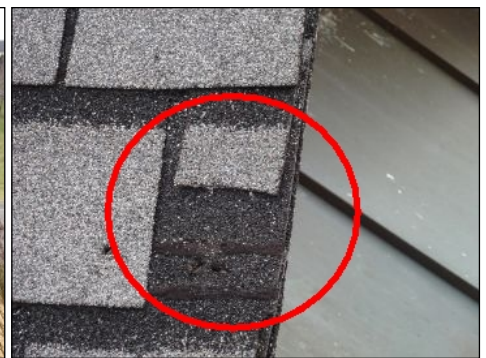
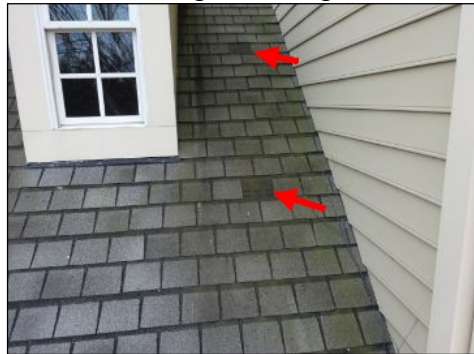
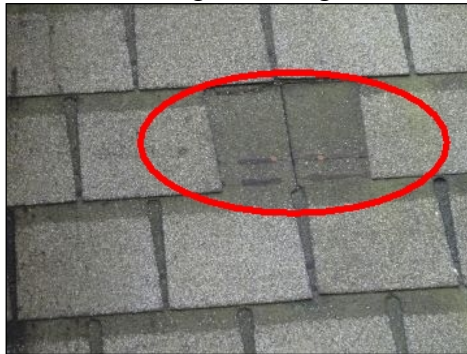
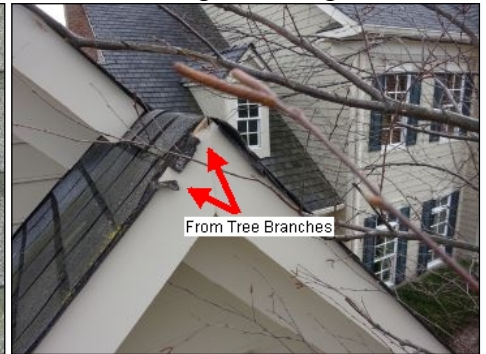
1. ROOFING		
Page 8 Item: 1	ROOF COVERINGS	<ul style="list-style-type: none">• Inspected - Repair / Replace - The home was built in 2003 and the roof covering is original. This places the roof at 16-17 years of age at the time of inspection. The roof appears in good condition for its age. There were however a few exterior issues noted as not all shingles appeared to be in place. I counted 5 missing or damaged shingles along with some flashing damage mentioned in the next section. In the attic I found open soffit vents and a ridge vent which provides good air flow. I found no signs of any leaks from the roof sheathing or roof penetrations at this time but I recommend you have a roofer come out and examine the entire roof and give you an estimate to make all necessary repairs before you have any water damage.

Damaged Shingles

Missing Shingles

Missing Shingle

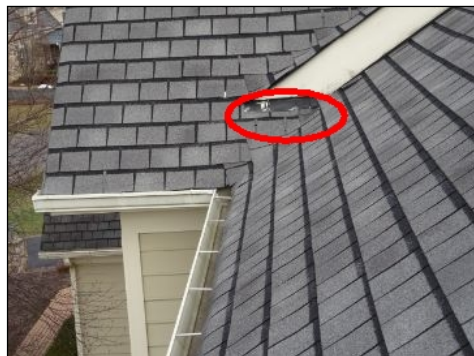
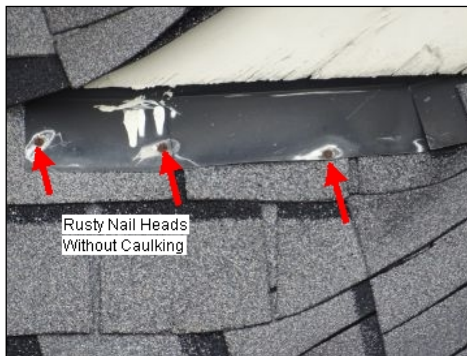
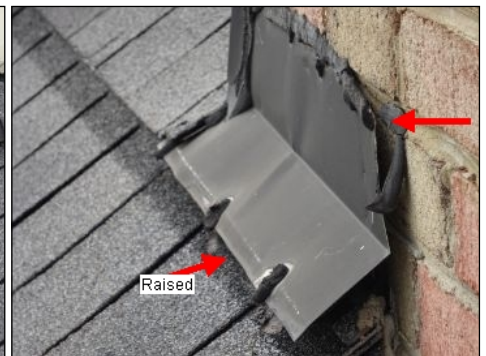
Page 10 Item: 2

• Inspected - Repair / Replace - The flashing in places around this home has exposed and rusted nails. These nails shrink and lose their hold causing the flashing to separate from the home. This could allow water into the home. Have a licensed roofing contractor inspect and repair these flashing areas. Also have the chimney flashing re-caulked to seal.

Flashing

Chimney Flashing

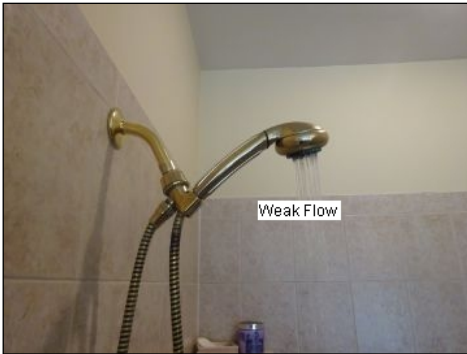
Shower Wand / Master Bathroom

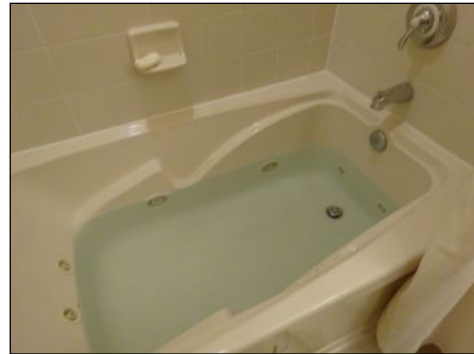
Jetted Tub

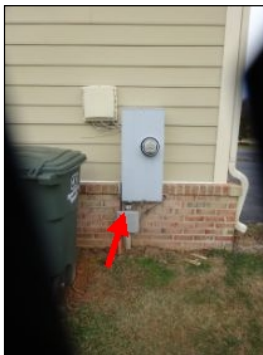
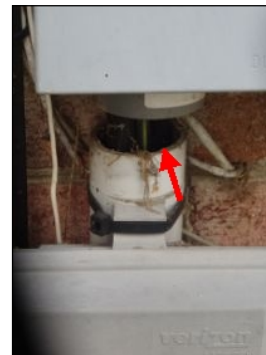
Page 22 Item: 1	SERVICE ENTRANCE CONDUCTORS	<ul style="list-style-type: none">• Inspected - Repair / Replace - The conduit where the entry cables enter the meter enclosure has sunk. As a result, the connection to the box is no longer made. Have a licensed electrician ensure this conduit is pulled up and resecured to the meter enclosure. This "may" be the responsibility of the power company as they are responsible for the supply to the meter. It free to call and find out.
-----------------	-----------------------------------	---

Underground Service to Meter

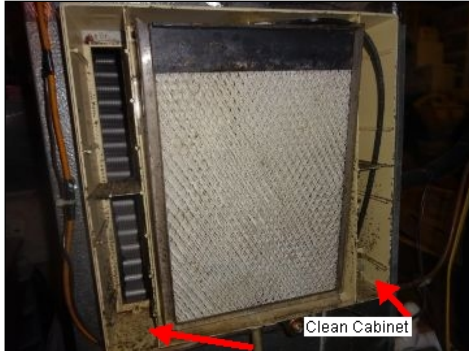
HVAC Filter

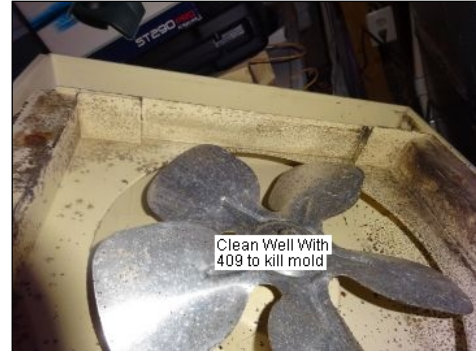
Humidifier System Fan

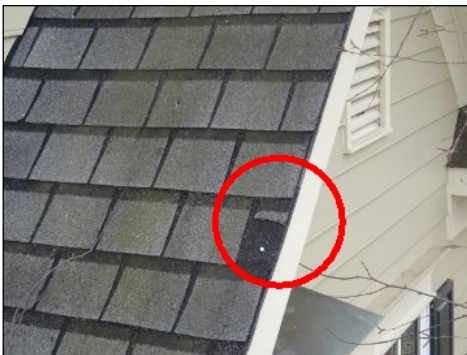
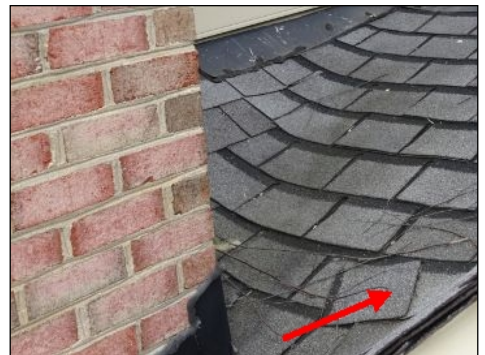
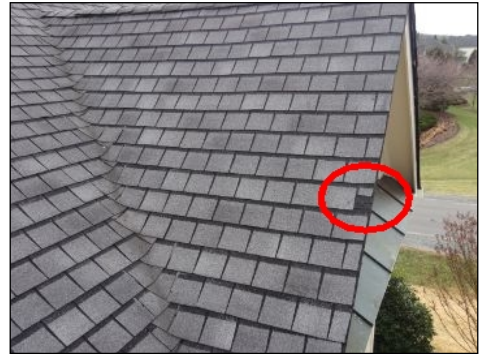
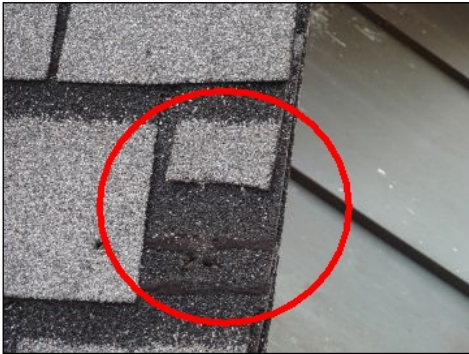
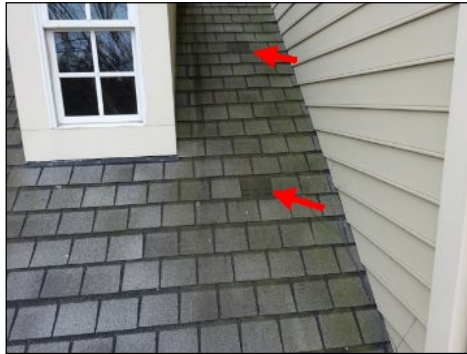
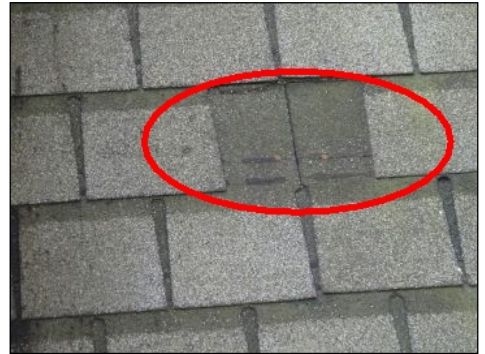
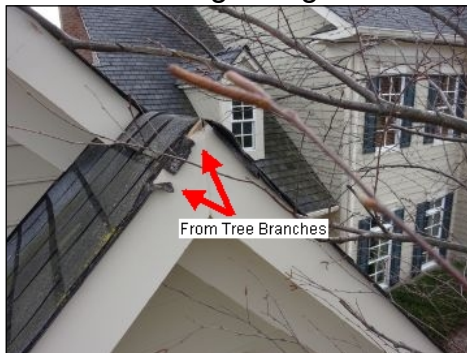
• **Inspected - Repair / Replace** - The home was built in 2003 and the roof covering is original. This places the roof at 16-17 years of age at the time of inspection. The roof appears in good condition for its age. There were however a few exterior issues noted as not all shingles appeared to be in place. I counted 5 missing or damaged shingles along with some flashing damage mentioned in the next section. In the attic I found open soffit vents and a ridge vent which provides good air flow. I found no signs of any leaks from the roof sheathing or roof penetrations at this time but I recommend you have a roofer come out and examine the entire roof and give you an estimate to make all necessary repairs before you have any water damage.

Damaged Shingles

Missing Shingles

Missing Shingle

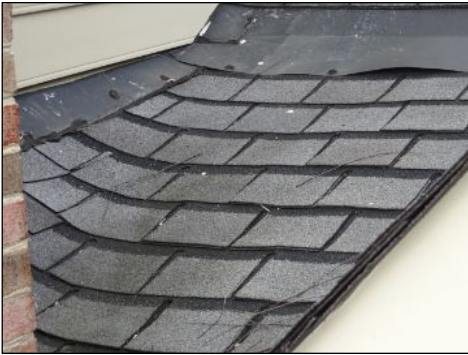
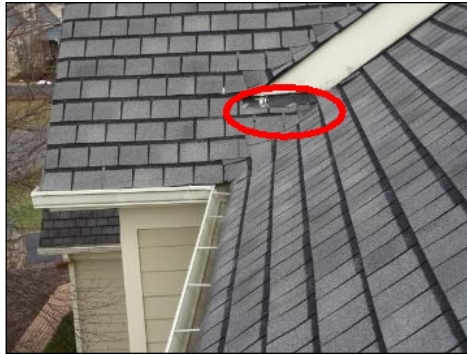
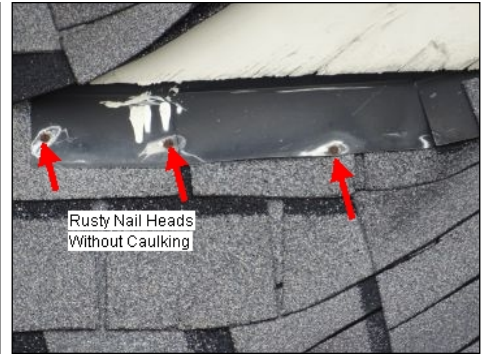
Observations: Inspected - Repair / Replace - The flashing in places around this home has exposed and rusted nails. These nails shrink and lose their hold causing the flashing to separate from the home. This could allow water into the home. Have a licensed roofing contractor inspect and repair these flashing areas.

Flashing

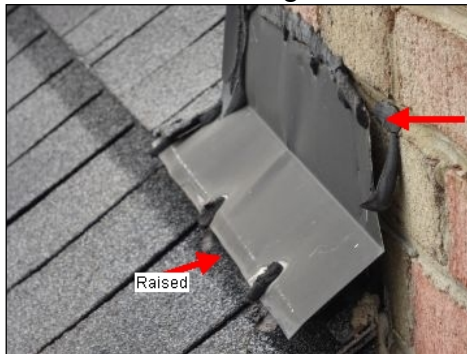
Chimney Flashing

Also have the chimney flashing re-caulked to seal.

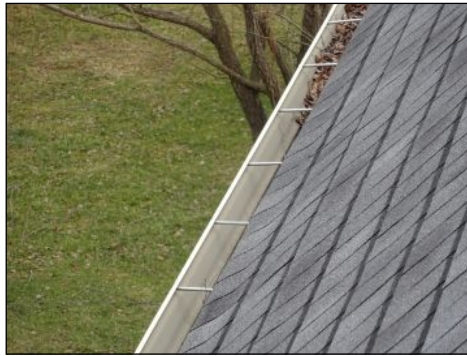
- Inspected - Maintenance Item - The gutters are partially full of debris in areas and need to be cleaned.
- Inspected - Maintenance Item - The buried down spouts on the house have separated from the corrugated piping from settlement of the earth. I believe most of the water will still be captured by the drain pipes but keep an eye on them during rainy days to ensure water is not draining at the foundation of the home. If necessary, add an extension piece of downspout at the end of the downspout so it will reach the underground pipes.

Partially Clogged Gutters

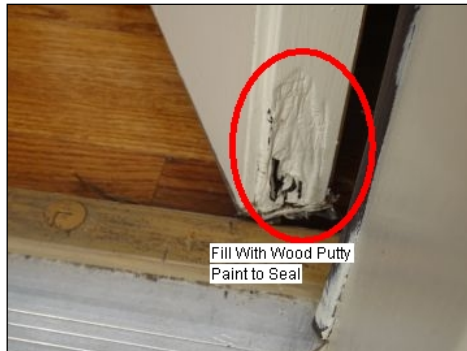
- Inspected - Maintenance Item - I noticed on a couple of doors when in the open position, you can see wood rot starting on the inside edge of the lower door. Have a qualified contractor caulk these small areas with a wood putty or foam to stop the rot process than paint to seal.

Door Wood Rot

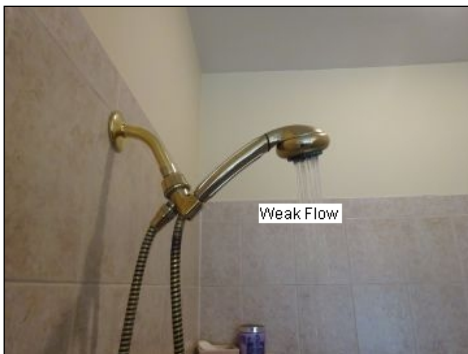
1. The shower water pressure in the master bathroom was very weak. Only at the shower, not the tub or sinks, leading me to believe the shower wand may be clogged and need replacing. If that doesn't help, have a plumber make the necessary repair.

Shower Wand / Master Bathroom

Have a licensed plumber make these repairs.

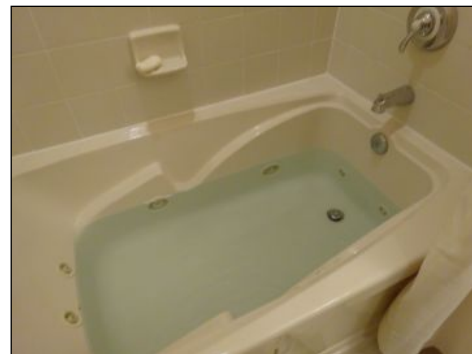
2. The jetted tub did not function. I tested the **GFCI** but could not get the motor to turn on. Have a plumber diagnose and make necessary repairs.

Jetted Tub

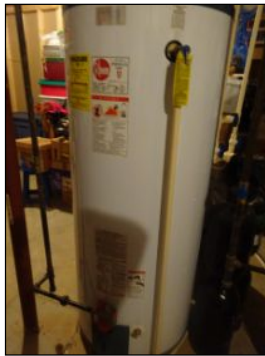
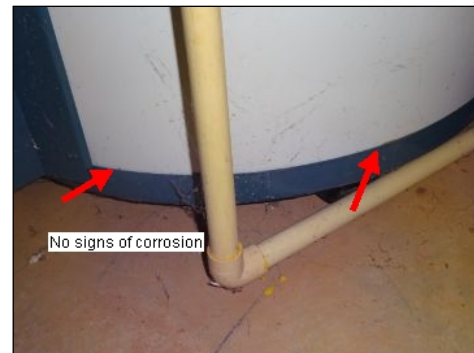
• **Inspected - Recommended Upgrade** - This water heater is over 15 years old. The average life span on a water heater is 10-13 years. One cannot determine when a water heater will fail if no evidence is found on the outside of the unit. The unit functions as intended now and there was no evidence of rusting beginning on the outside of the tank. I regularly see water heaters in the 20 year range so you may have years, I just try to ensure my clients are prepared for when things do fail.

Gas Water Heater

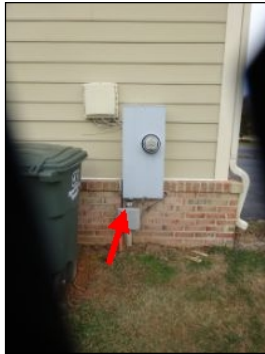
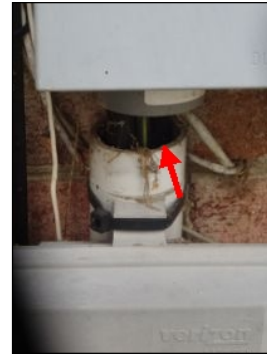
• **Inspected - Repair / Replace** - The conduit where the entry cables enter the meter enclosure has sunk. As a result, the connection to the box is no longer made. Have a licensed electrician ensure this conduit is pulled up and resecured to the meter enclosure. This "may" be the responsibility of the power company as they are responsible for the supply to the meter. It free to call and find out.

Underground Service to Meter

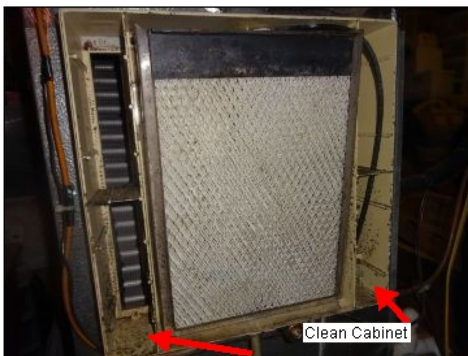
- Inspected - Maintenance Issue - I recommend replacing all of the filters for the HVAC system when you take ownership of the home. This way you know when they were last replaced.
- Inspected - Repair / Replace - This unit has a humidifier attached to the duct work. The drip pad inside the humidifier is clean but the fan cabinet is very dirty and has black mold present and should be cleaned before using the humidifier. Have an HVAC technician instruct you on the proper usage of a humidifier system after cleaning this system. I ensured the system was shut down during the inspection but it is being used by the owners.

HVAC Filter

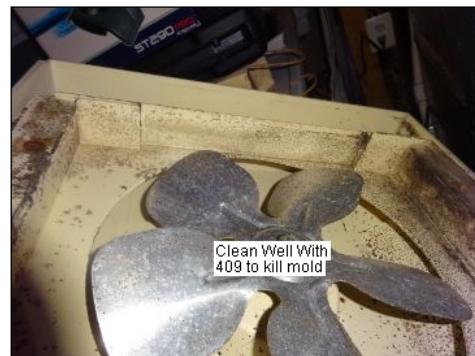
Humidifier System Fan

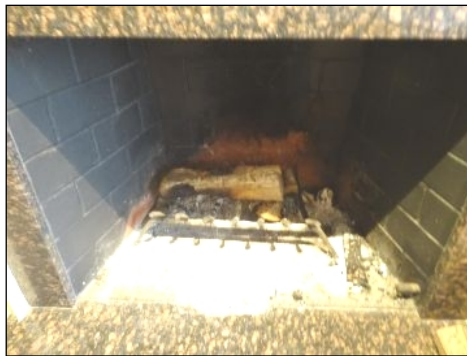
- Inspected - Maintenance Item - The fireplace flue appeared to be intact and in usable condition. The damper functioned without difficulty. It is always a good idea though to have a certified fireplace professional clean the chimney and inspect for safety before using.

Fireplace
