# INSPECTION REPORT

For the Property at:  
**1000 FARM RD**  
FORNEY, TX 75126

Prepared for: JANE DO  
Inspection Date: Thursday, February 8, 2024  
Prepared by: Jeffrey Knight, 25885

Report No. 1246, v.7

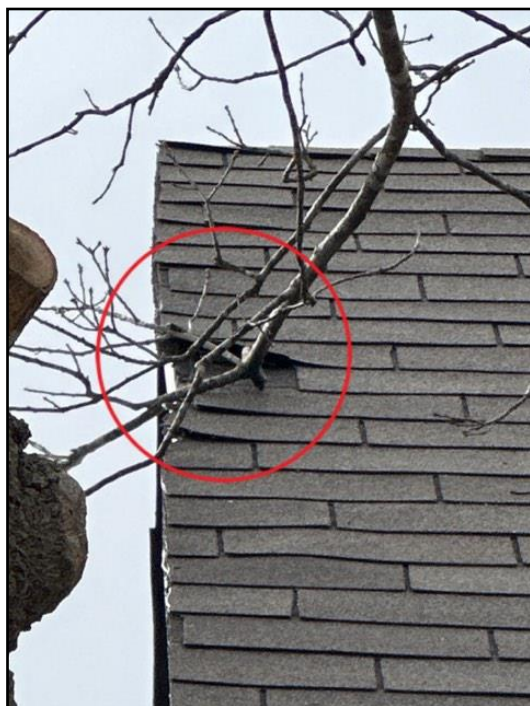
1. Damage

#### **1. Condition:** • [Damage](#)

Tree limb has caused damage to the asphalt shingles recommend a professional licensed roofing contractor and arborist make repairs

**Implication(s):** Chance of water damage to structure, finishes and contents

**Location:** Exterior east/rear

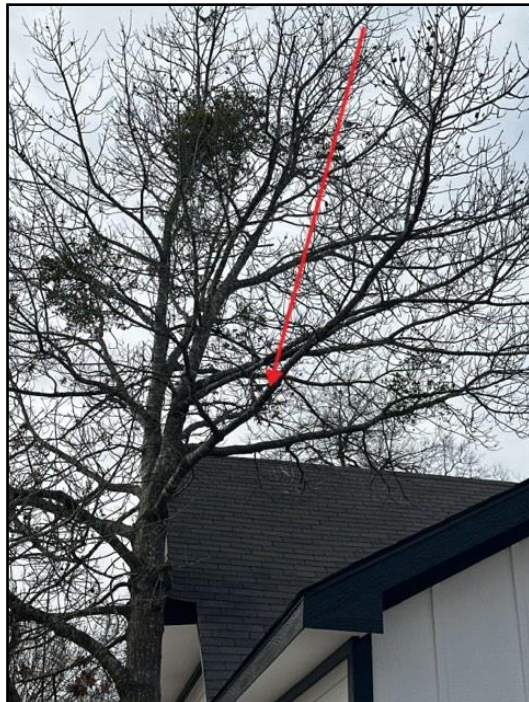
3. Tree branches touching roof

#### **2. Condition:** • Tree branches touching roof

Recommend a professional licensed tree arborist make repairs

**Implication(s):** Shortened life expectancy of material

**Location:** Exterior east roof/various locations

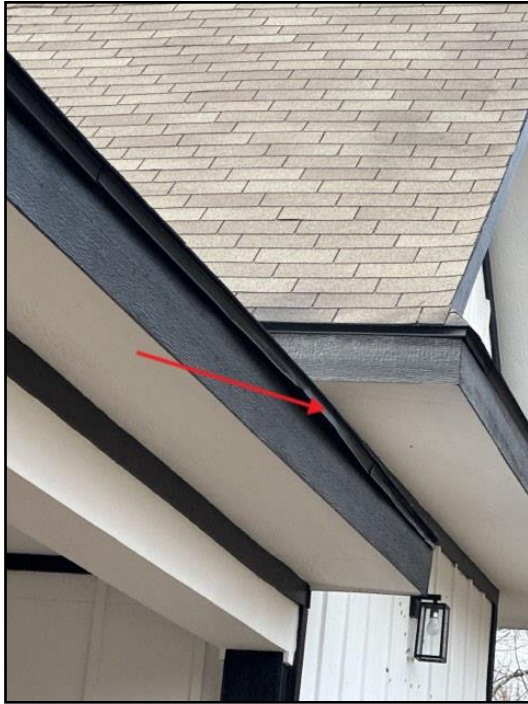
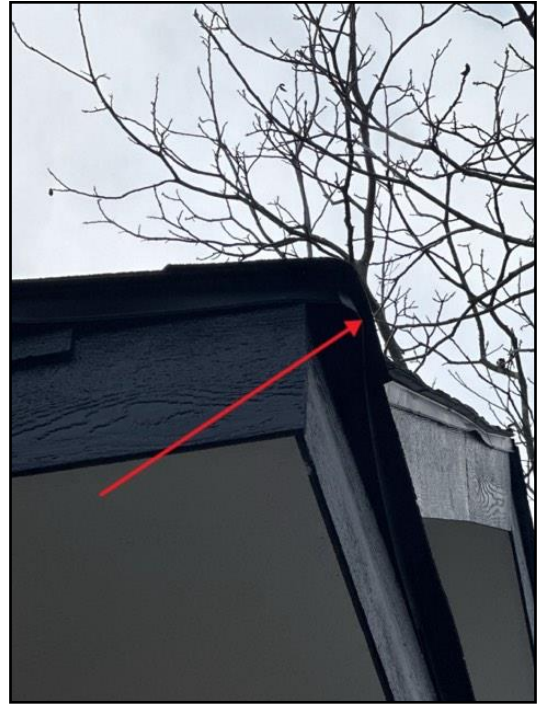
5. Loose

3. Condition: • [Loose](#)

Drip edge loose, recommend a professional licensed contractor make repairs

**Implication(s):** Chance of water damage to structure, finishes and contents

**Location:** Exterior front/various locations throughout the exterior

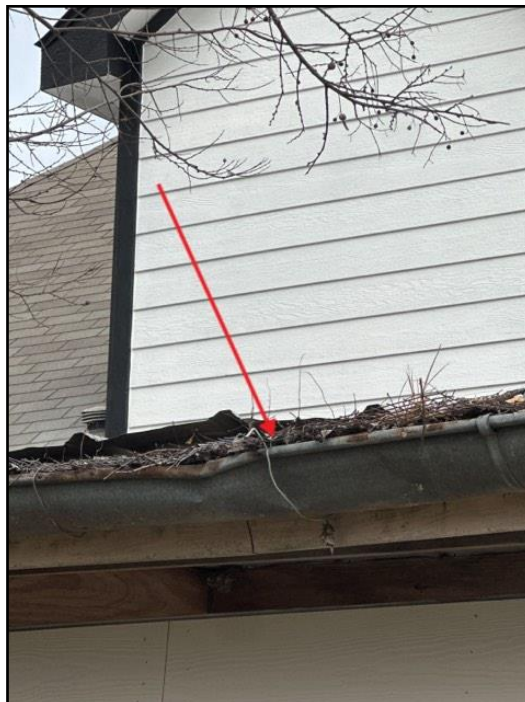
7. Clogged

4. Condition: • [Clogged](#)

Gutters clogged recommend a professional, licensed contractor, clean the gutters

**Implication(s):** Chance of water damage to structure, finishes and contents

**Location:** Exterior rear

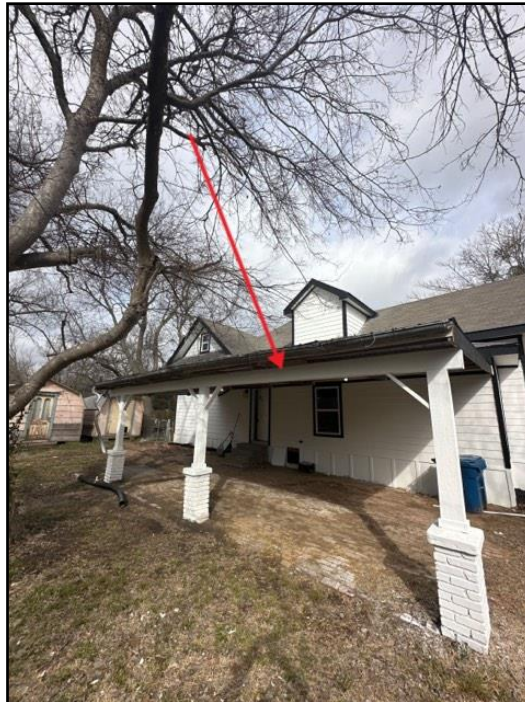
8. Damage

### 5. Condition: • Damage

Recommend a professional, licensed gutter contractor make repairs

**Location:** Exterior rear

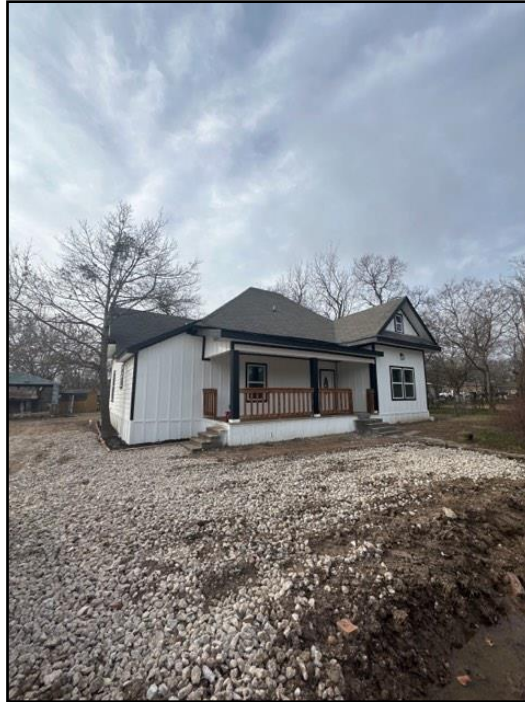
9. Missing

## 6. Condition: • [Missing](#)

Gutters missing throughout most of the home, gutters are only installed in the rear of the home but are damaged and clogged. Recommend a professional, licensed contractor install gutters and make repairs.

**Implication(s):** Chance of water damage to structure, finishes and contents

**Location:** Throughout exterior of the home, the rear has damaged gutters on the porch in the exterior rear only

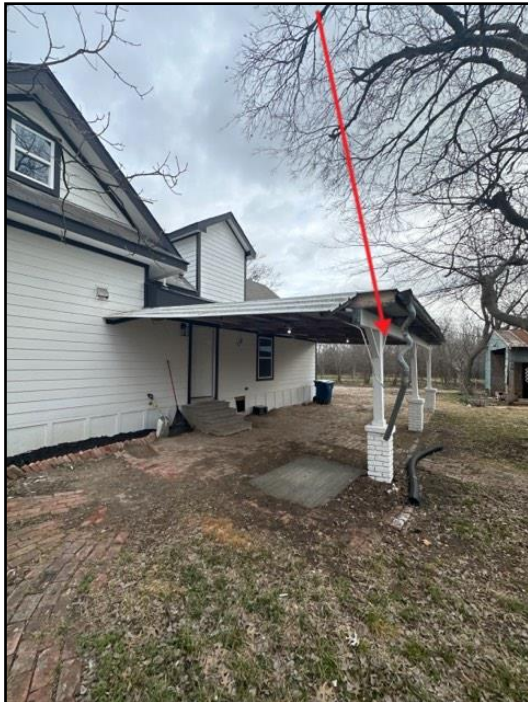
10. Poorly built

Rear porch cover is not safely built and the post are leaning and not structurally sound. Additionally, the gutters are damaged and the electrical is unsafe. recommend a professional licensed contractor further evaluate make repairs

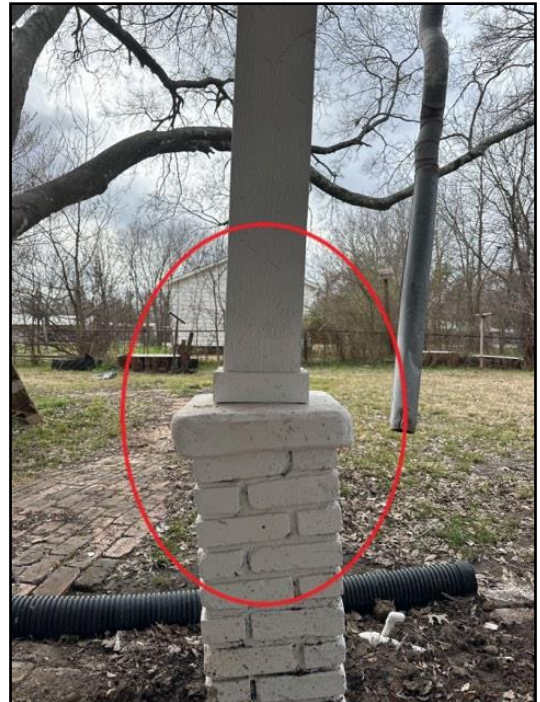
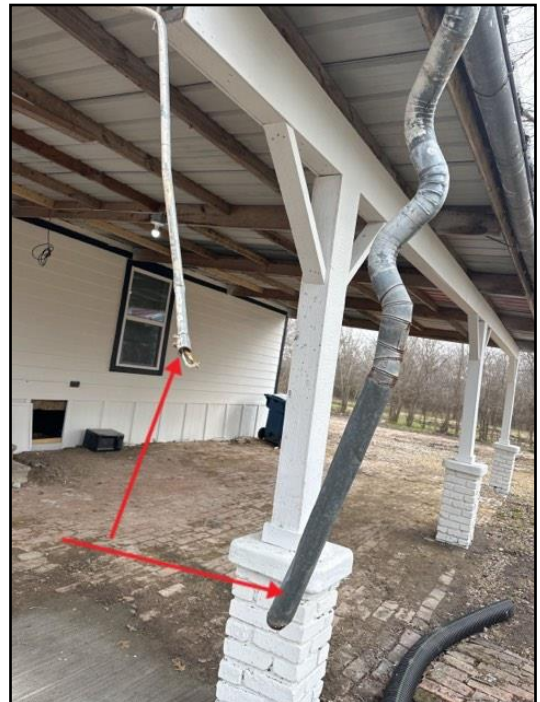
11. Poorly built

### 7. Condition: • Poorly built

**Implication(s):** Weakened structure

**Location:** Exterior rear

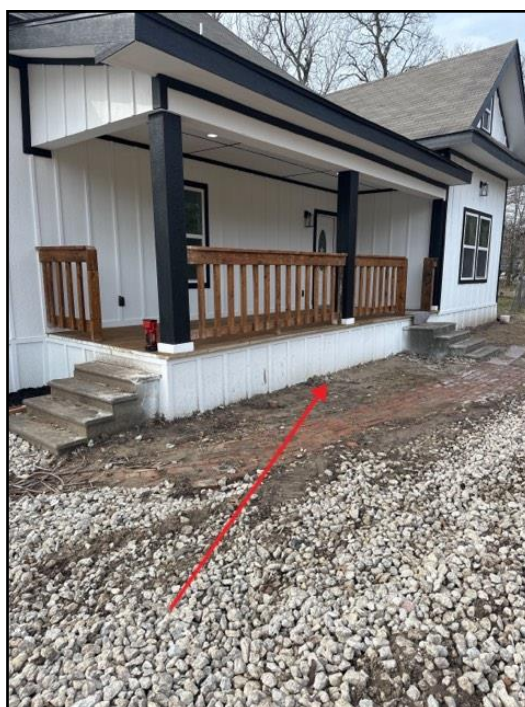
15. Wood/soil contact

8. Condition: • [Wood/soil contact](#)

Recommend a licensed professional contractor make repairs

**Implication(s):** Rot | Insect damage

**Location:** Throughout exterior

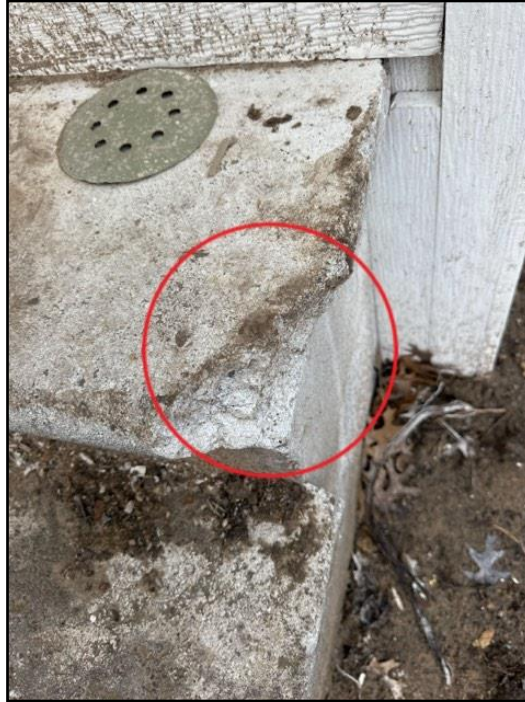
16.

**9. Condition:** • Stairs has slight damage recommend a professional licensed contractor, make repairs

**Implication(s):** Fall hazard, cosmetic issues, safety issues

**Location:** Exterior front both stairs

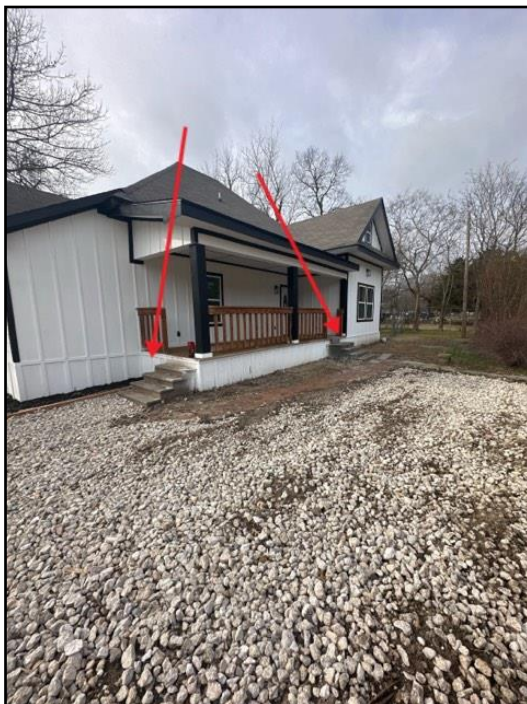
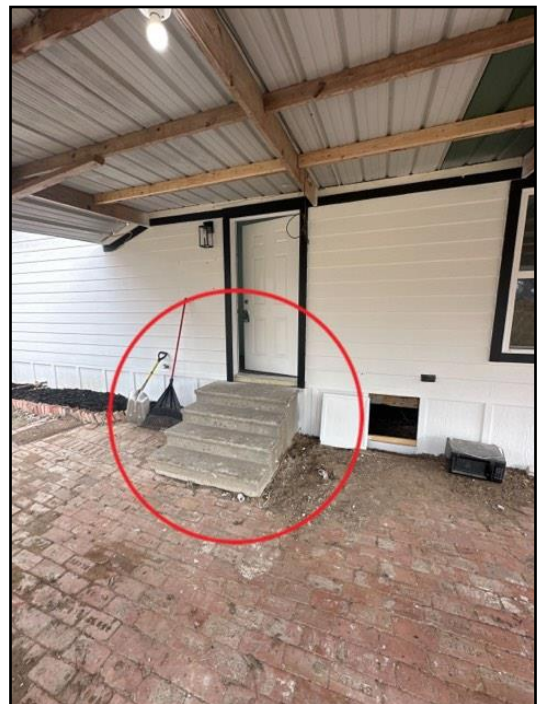
17. Missing

**10. Condition:** • [Missing](#)

Hand railings missing recommended, professional license, contractor, make repairs

**Implication(s):** Fall hazard

**Location:** Exterior front/exterior rear

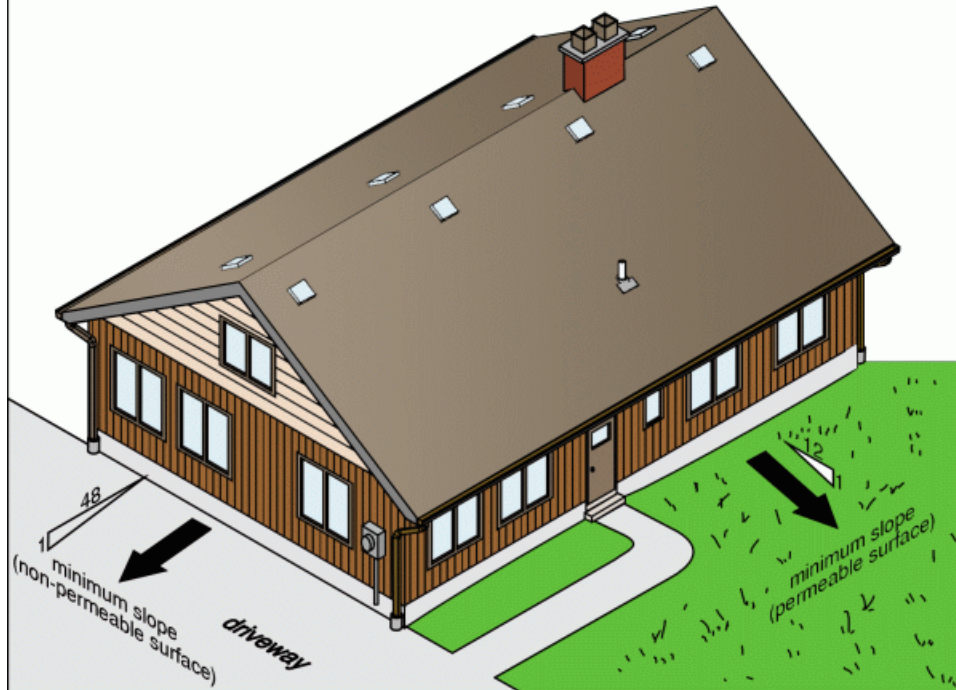
## Recommended grading slopes

Lot has a slight slope towards the home recommend a professional, licensed drainage, expert further evaluate and make

required adjustments or repairs

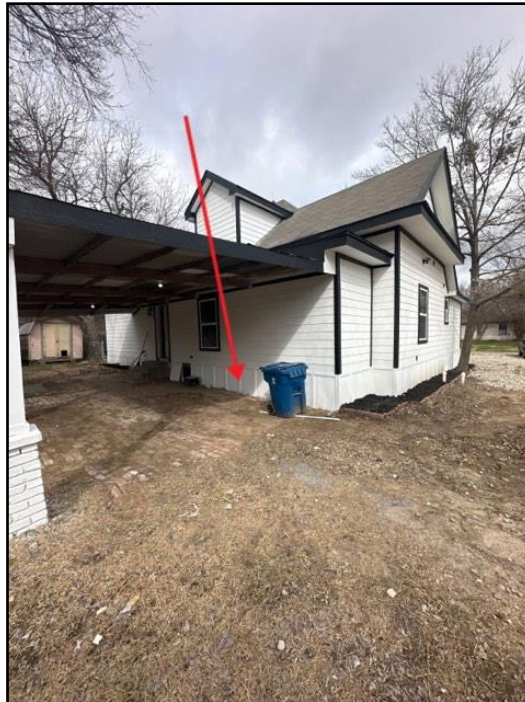
19. *Improper slope or drainage*

11. Condition: • [Improper slope or drainage](#)

**Implication(s):** Chance of water damage to structure, finishes and contents

**Location:** Exterior rear/various locations

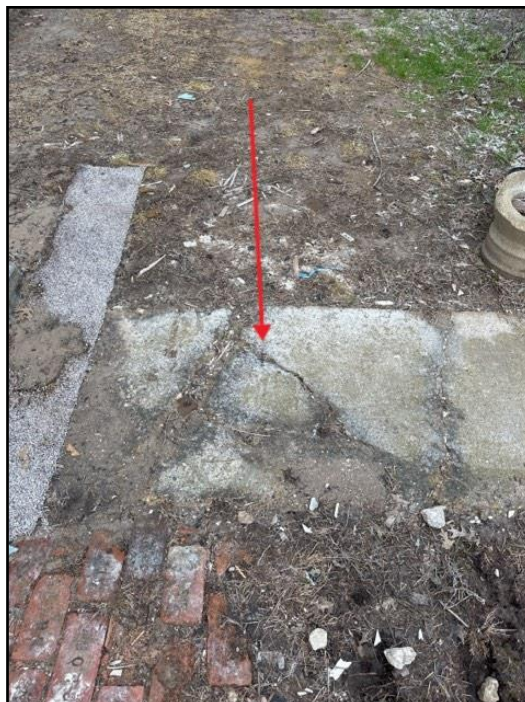
20. *Cracked or damaged surfaces*

12. **Condition:** • [Cracked or damaged surfaces](#)

Front walk way has cracking recommend a professional licensed contractor make repairs

**Implication(s):** Trip or fall hazard

**Location:** Exterior front

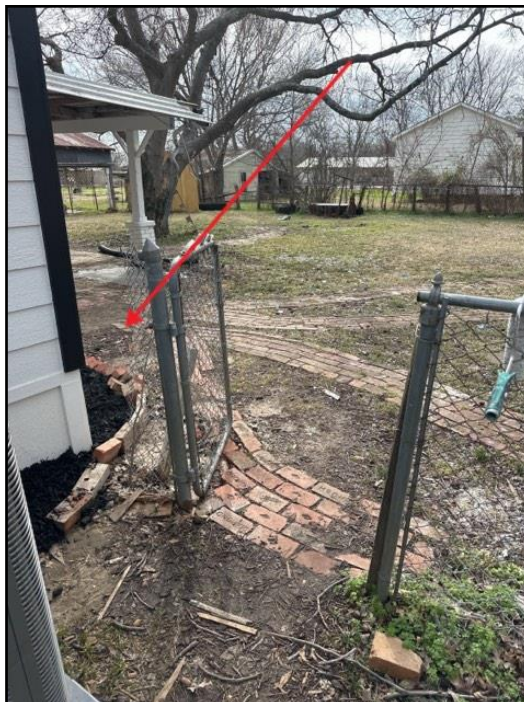
21. Damage

### 13. Condition: • Damage

Rear gate has several damaged areas that are open recommend a professional license contract and make repairs

**Implication(s):** Material deterioration

**Location:** Exterior various locations

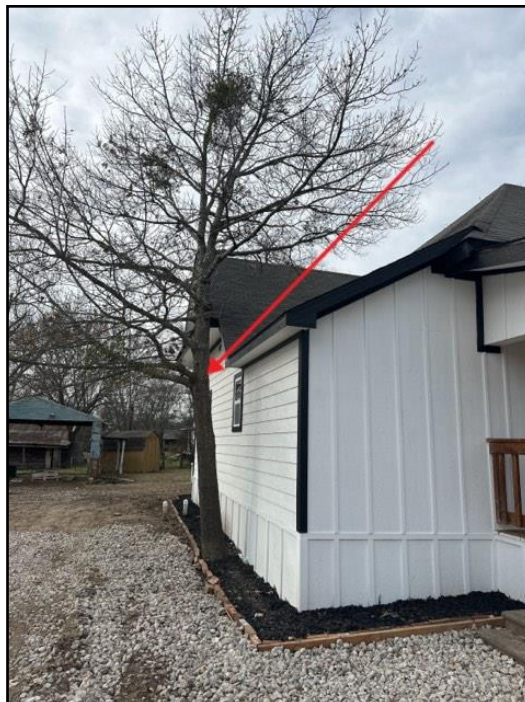
22. Large trees close to building

#### 14. Condition: • [Large trees close to building](#)

Large tree close to home. This can present foundation issues as well as roof issues recommend a professional, licensed arborist further evaluate and make repairs.

**Implication(s):** Weakened structure | Chance of structural movement

**Location:** Exterior east/

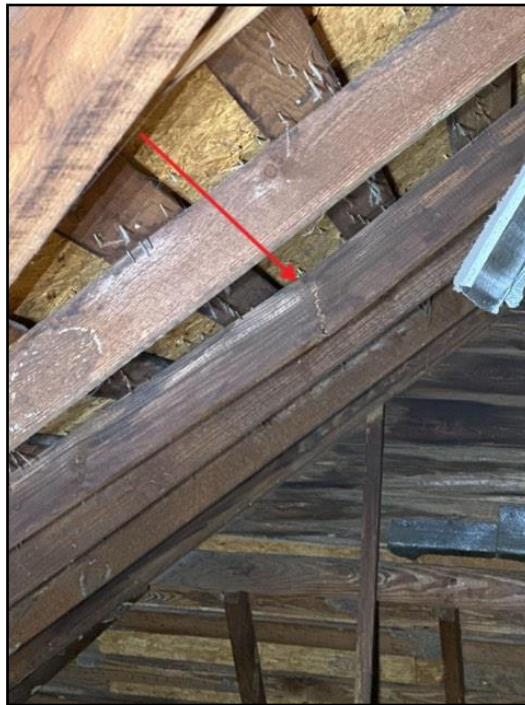
23. Rot, fire or insect damage

15. Condition: • [Rot, fire or insect damage](#)

Attic rafters and some structural components, have damage. Recommend a professional licensed structural contractor,

further evaluate and make repairs

**Implication(s):** Weakened structure | Chance of structural movement

**Location:** Attic various locations

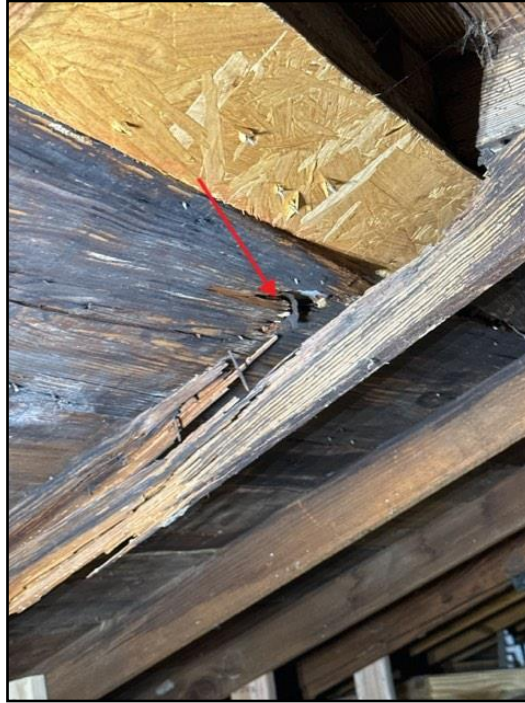
26. Damage

16. Condition: • Damage

Roof sheeting has areas that are damaged recommend a professional licensed structural contractor, further evaluate and make repairs

**Implication(s):** Chance of water damage to structure, finishes and contents | Weakened structure

**Location:** Attic

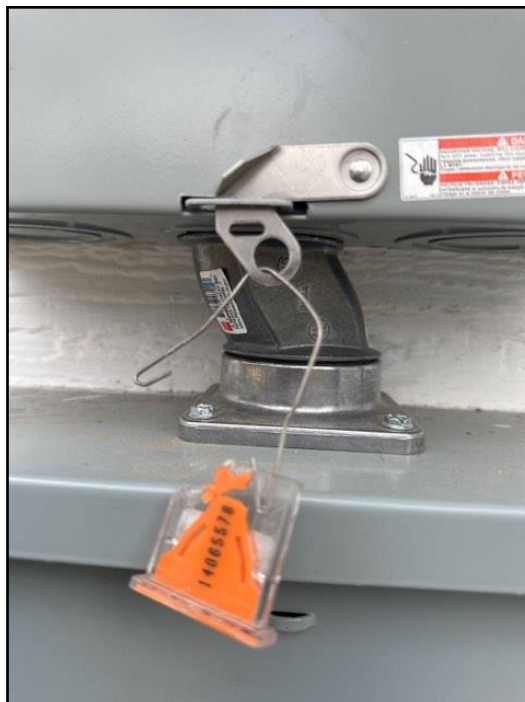
28. Damage

### 18. Condition: • [Damage](#)

Main electrical meter tamper lock is damaged recommend a professional, licensed utility electrician make repairs

**Implication(s):** Equipment inoperative | Electric shock | Fire hazard

**Location:** Exterior west

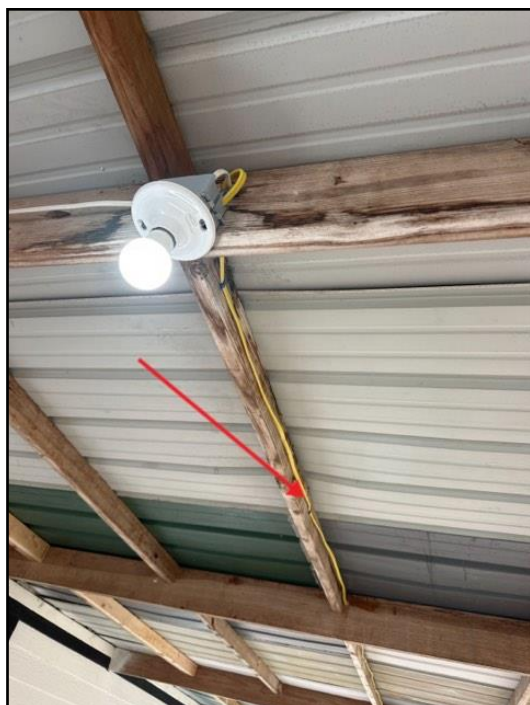
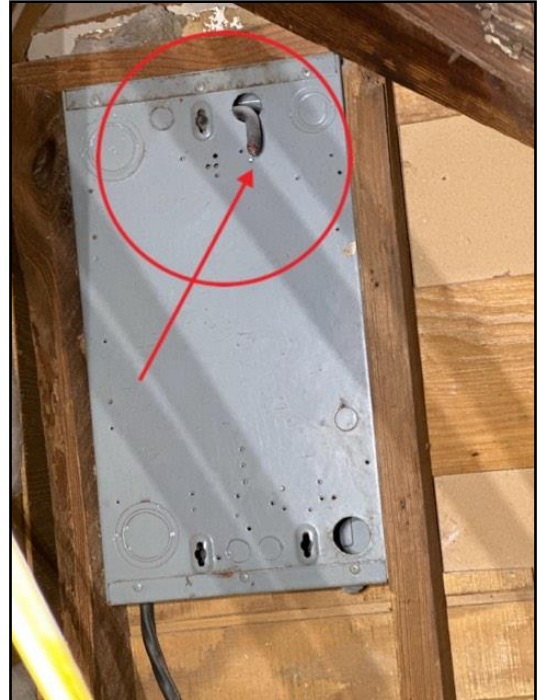
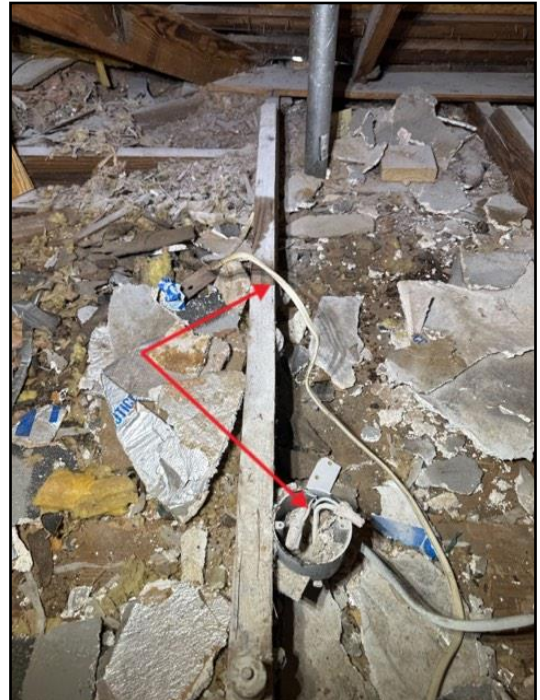
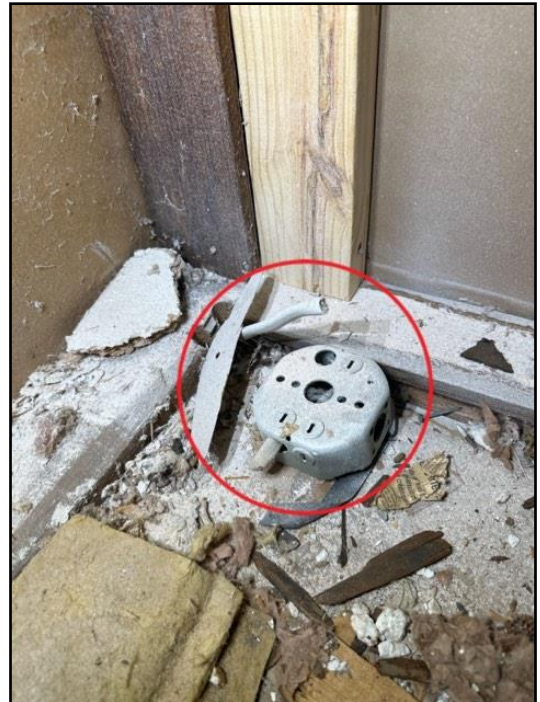
29. Exposed on walls or ceilings

### 19. Condition: • [Exposed on walls or ceilings](#)

Exposed electrical Romax wiring recommend a professional, licensed electrician make repairs

**Implication(s):** Electric shock

**Location:** Exterior rear/attic Westside/attic south access/attic various locations

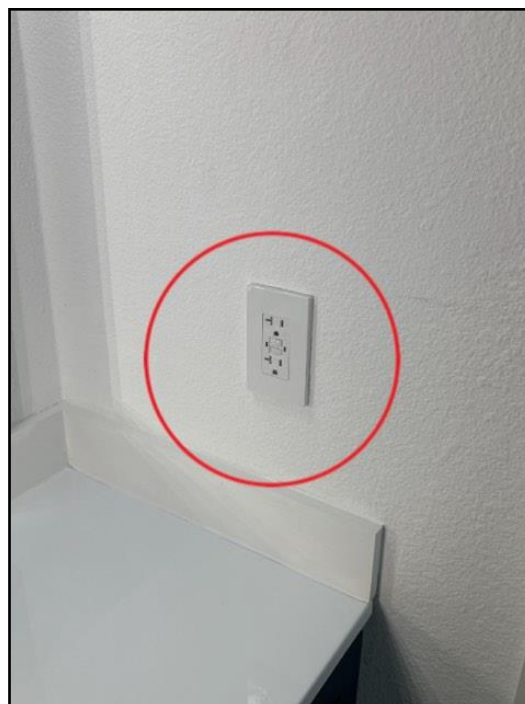
37. Inoperative

**Implication(s):** Equipment inoperative

**Location:** Master bathroom/

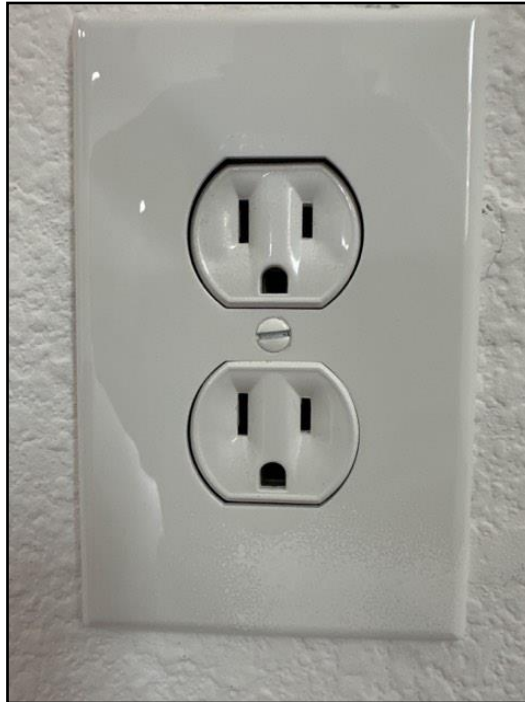
**38.** Receptacle within 5 ½ feet of floor not...

**21. Condition:** • Receptacle within 5 ½ feet of floor not tamper resistant

Recommend a professional, licensed electrician, update, plugs or install child safety covers, these type of plugs can present a hazard for children, sticking their fingers or objects into them

**Location:** Throughout the home

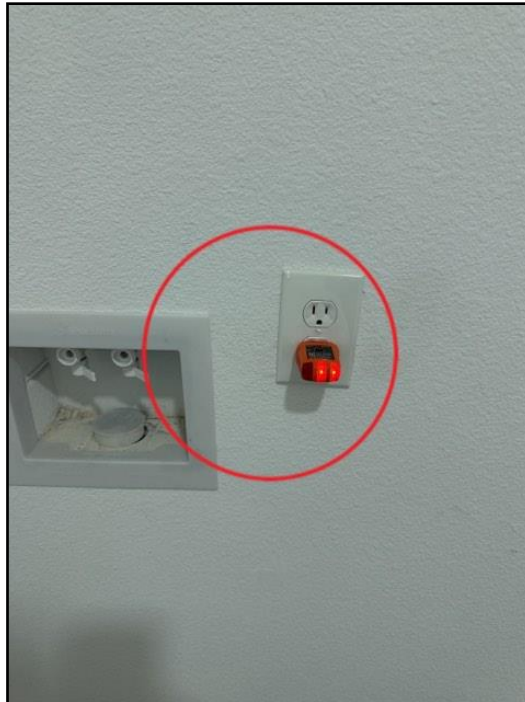
39. Laundry area

**22. Condition:** • Laundry area

No GFCI protection in the laundry area. It is recommended by the national electric code, and the Texas real estate commission standards of practice to have GFCI protection in the laundry area. Recommend a professional license electrician make repairs.

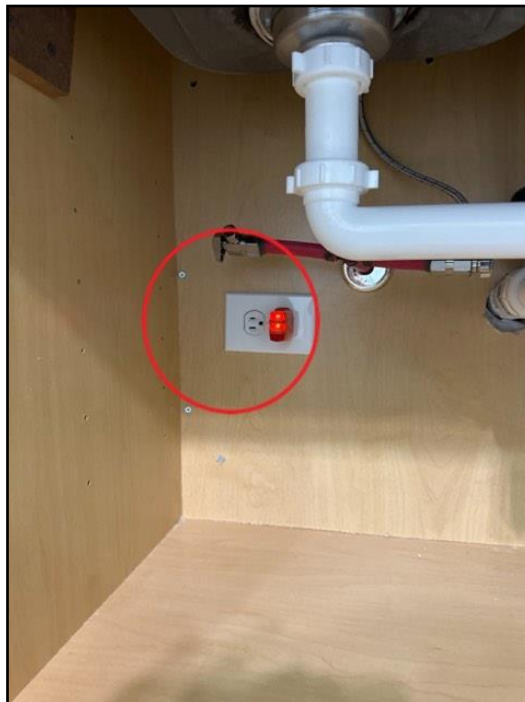
40. Dishwasher

**23. Condition:** • Dishwasher

Although there is no dishwasher, installed the dishwasher outlet should be GFCI protected recommend a professional license electrician install GFCI protection to avoid electrical shock hazard

**Location:** Under kitchen sink

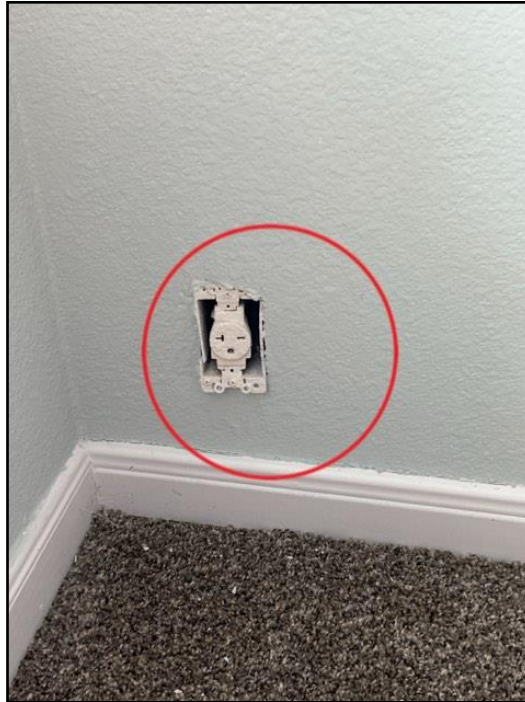
41. *Missing*

### 24. Condition: • [Missing](#)

Recommend a professional, licensed electrician, install a cover plate

**Implication(s):** Electric shock

**Location:** Second-floor west/

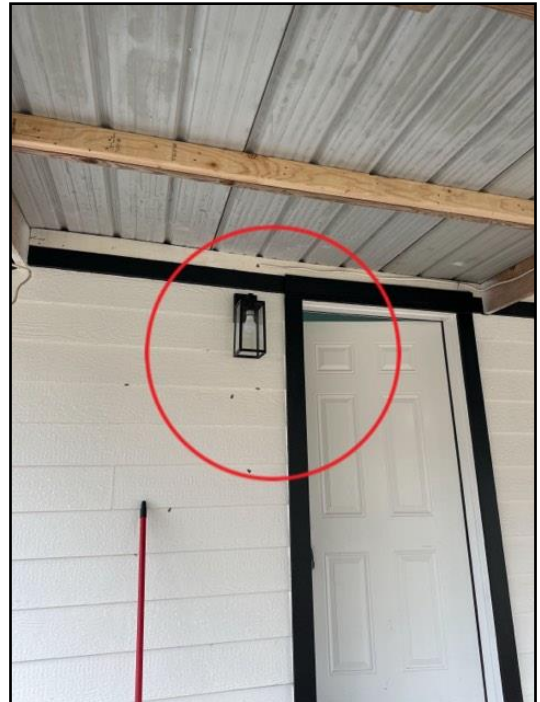
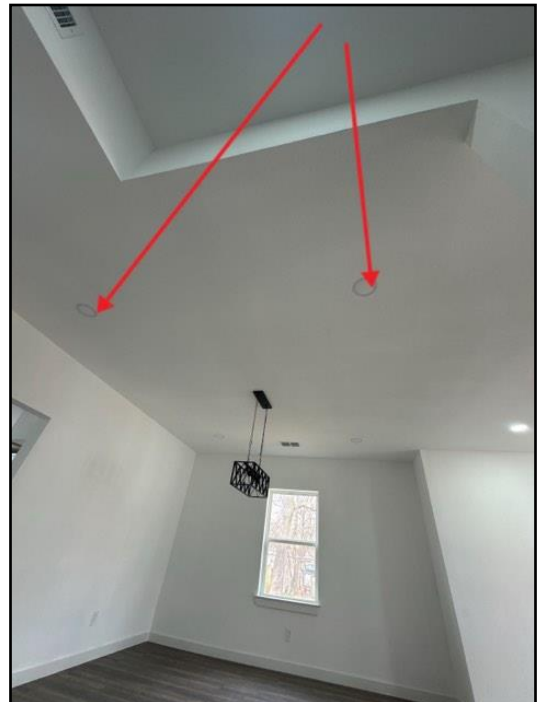
43. Inoperative

### 25. Condition: • [Inoperative](#)

Lightbulbs appear to be new, but lights are inoperative using normal switches, recommend a professional, licensed electrician, further evaluate to make repairs.

**Implication(s):** Inadequate lighting

**Location:** Exterior front/dining room/various locations

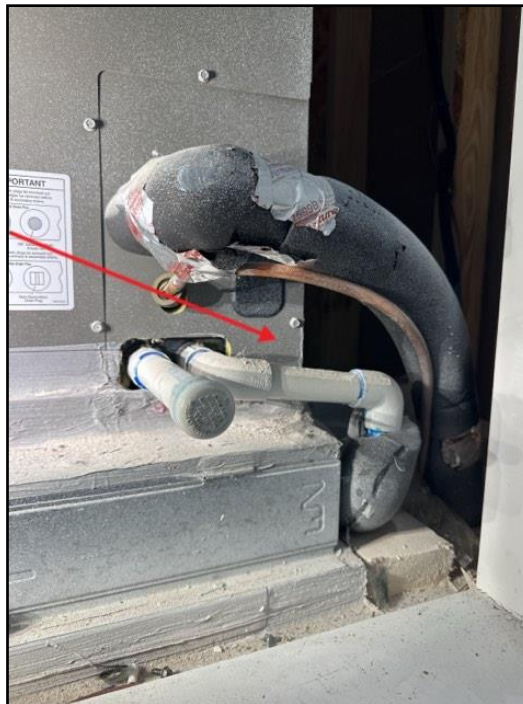
47. No float switch

### 28. Condition: • [No float switch](#)

No condensation float switch for air-conditioning air handler. Recommend a professional licensed, HVAC technician install a float switch for added protection against water damage to your structure.

**Implication(s):** Chance of water damage to structure, finishes and contents | Damage to equipment

**Location:** Hallway closet

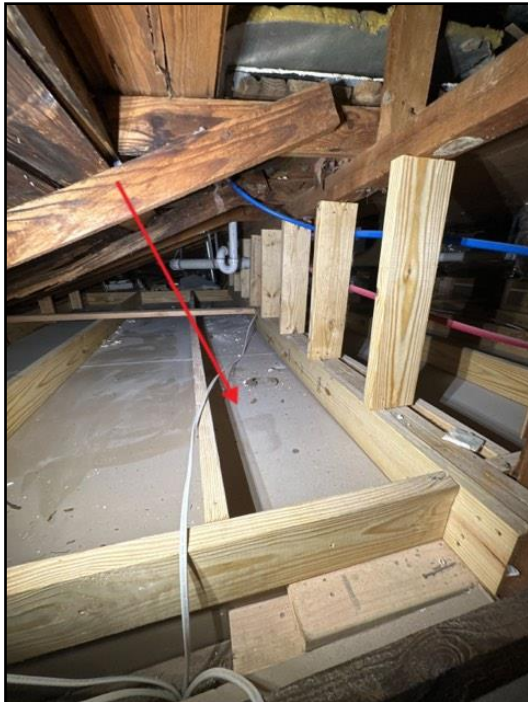
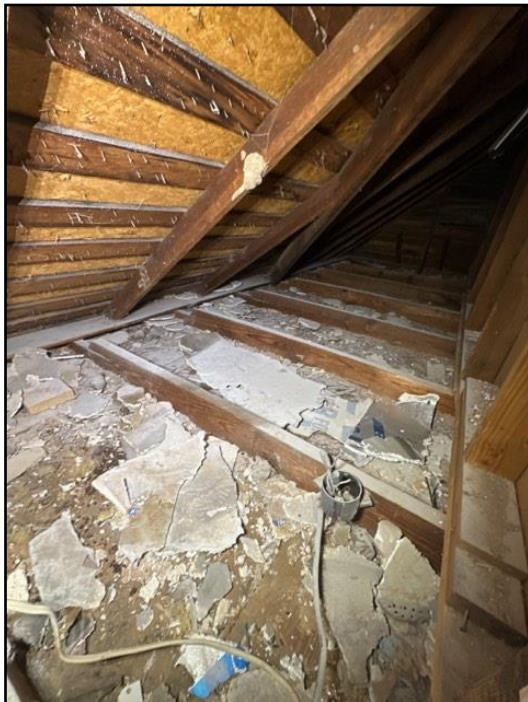
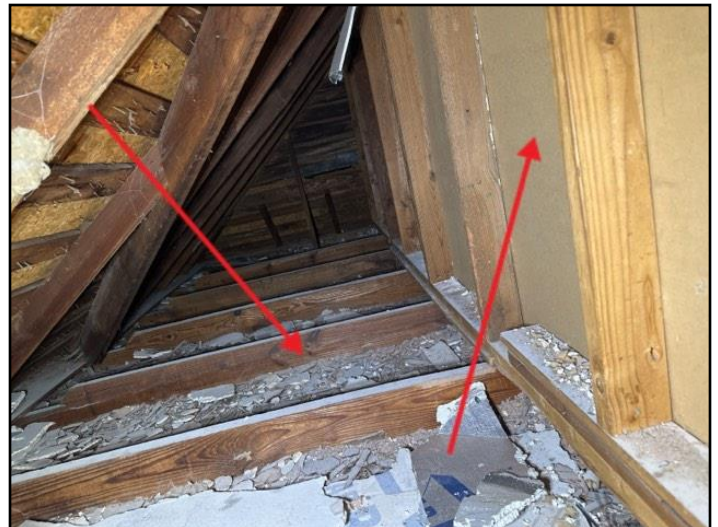
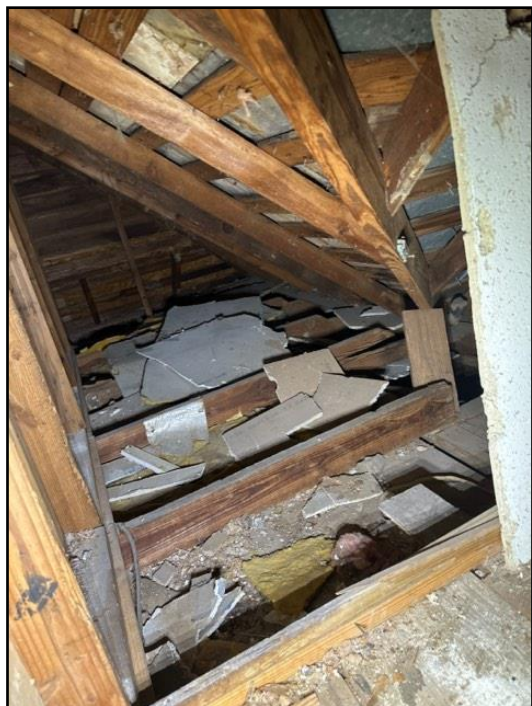
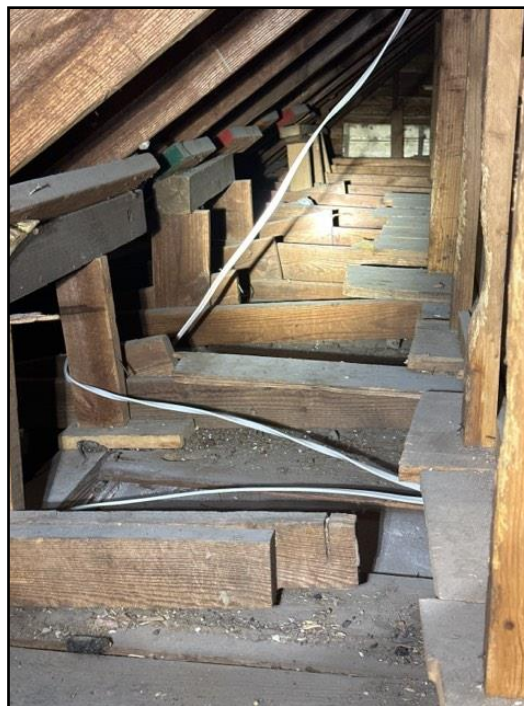
48. Amount inadequate

### 29. Condition: • [Amount inadequate](#)

Missing insulation, recommend a professional, licensed insulation expert make repairs and install the proper amount of insulation

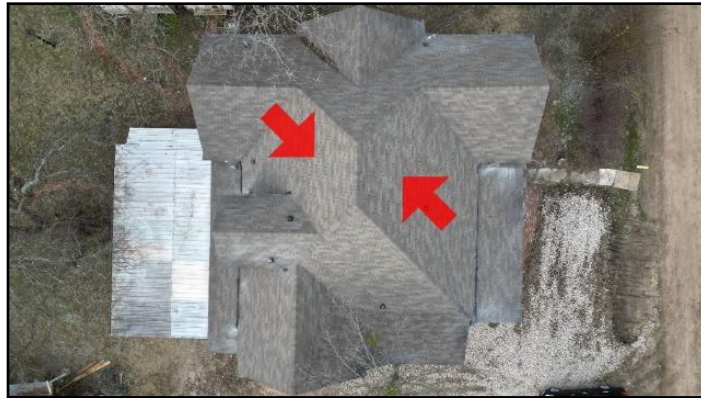
54. Missing

### 30. Condition: • [Missing](#)

Missing eave and attic ventilation, Recommend a professional licensed HVAC contractor further evaluate and make required repairs.

**Implication(s):** Chance of condensation damage to finishes and/or structure

**Location:** Throughout

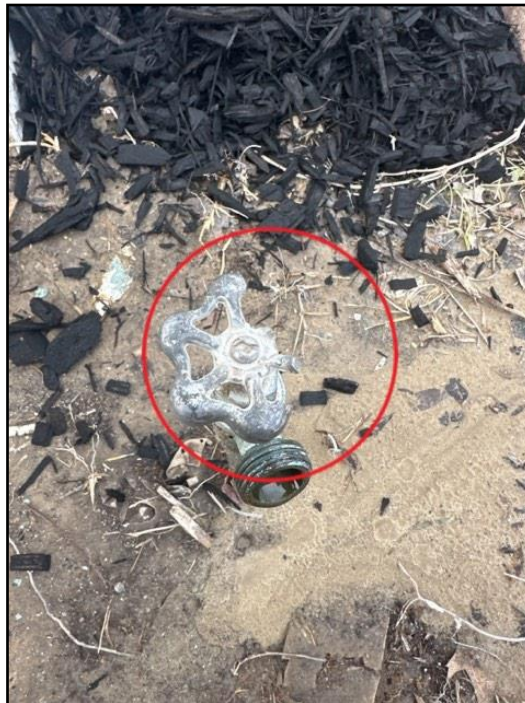
55. Damage

31. Condition: • [Damage](#)

Recommend a professional, licensed plumber make repairs

**Implication(s):** Leakage | Equipment inoperative

**Location:** Exterior front

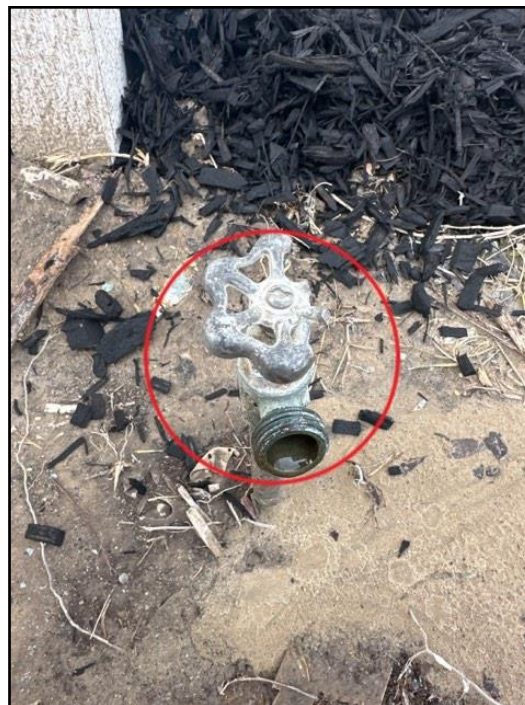
56. Backflow prevention missing

32. Condition: • [Backflow prevention missing](#)

Recommend a professional, licensed plumber, install a hose bib anti-siphon device

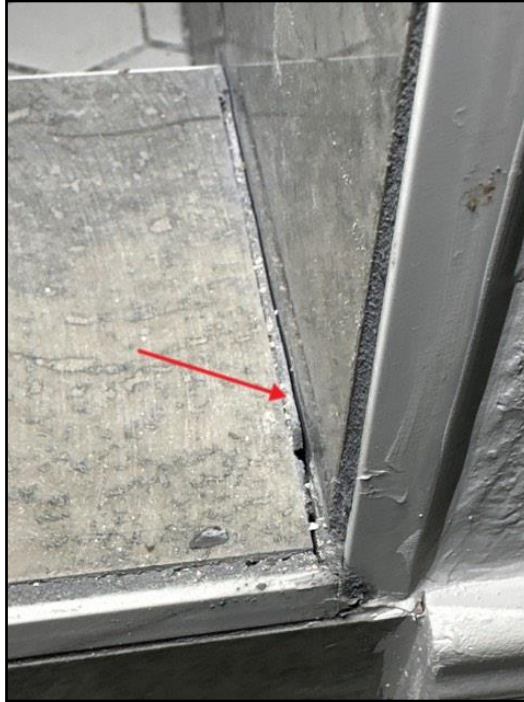
57. Grout loose, missing or deteriorated

33. Condition: • [Grout loose, missing or deteriorated](#)

Recommend a professional licensed contractor make repairs

Implication(s): Chance of water damage to structure, finishes and contents

**Location:** Second-floor bathroom

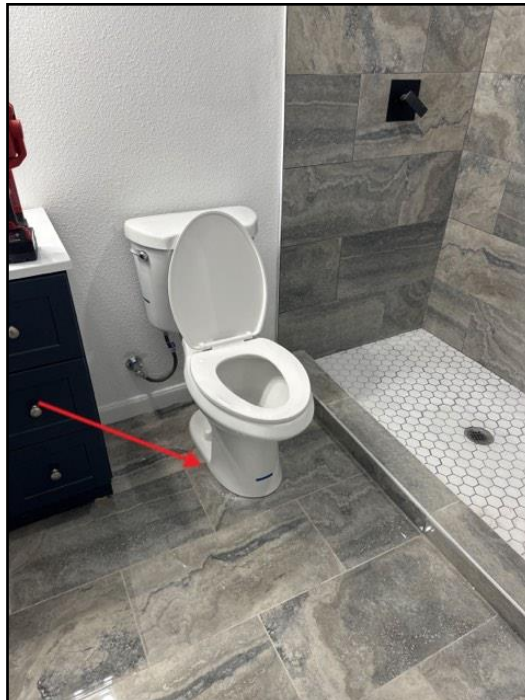
58. Loose

**34. Condition:** • [Loose](#)

Toilet loose at base, recommend a professional licensed plumber make repairs

**Implication(s):** Chance of water damage to structure, finishes and contents | Sewage entering the building | Possible hidden damage

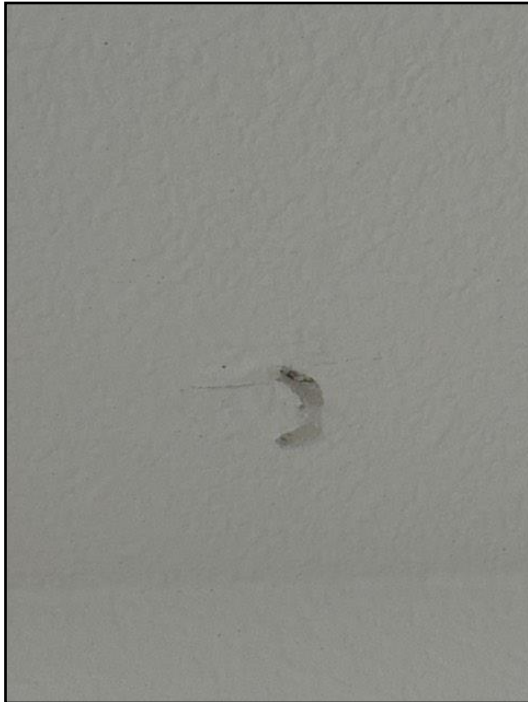
59. Typical minor flaws

**35. Condition:** • Typical minor flaws

Some typical minor flaws located throughout the home, overall the interior looks clean and has a nice new paint job recommend touchup repairs

**Location:** Various locations

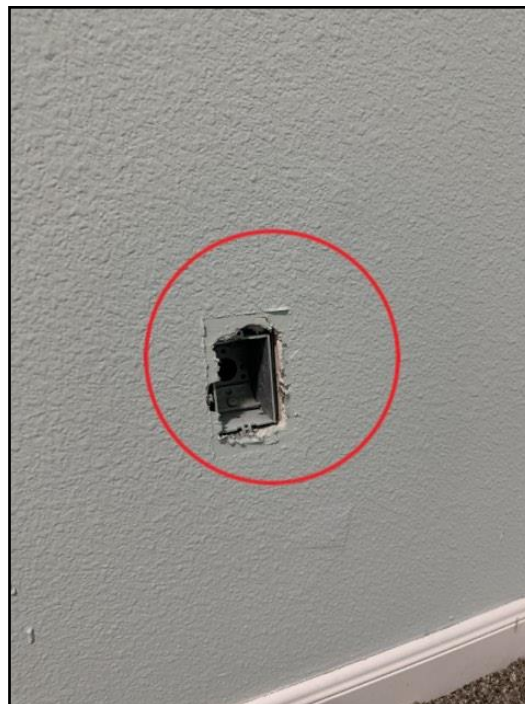
62. Damage

**36. Condition:** • Damage

Recommend a professional licensed contractor make repairs

**Implication(s):** Damage or physical injury due to falling materials

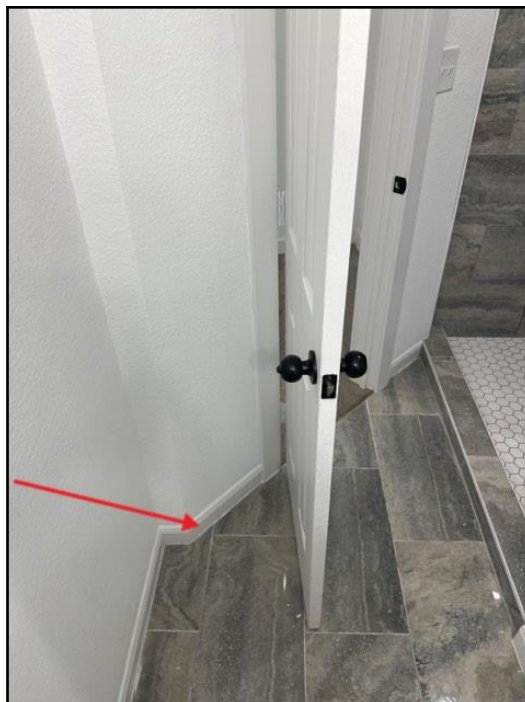
66. Doorstops missing or ineffective

39. Condition: • [Doorstops missing or ineffective](#)

Recommend installing doorstops

Implication(s): Chance of damage to finishes

Location: First floor hallway bath/

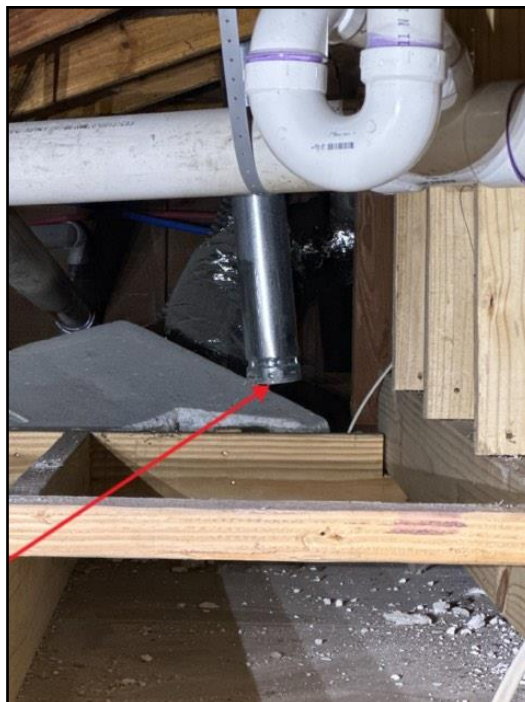
68. Not vented to exterior

41. Condition: • [Not vented to exterior](#)

Recommend a professional licensed contractor, make repairs on exhaust vent

**Implication(s):** Chance of condensation damage to finishes and/or structure

**Location:** Attic

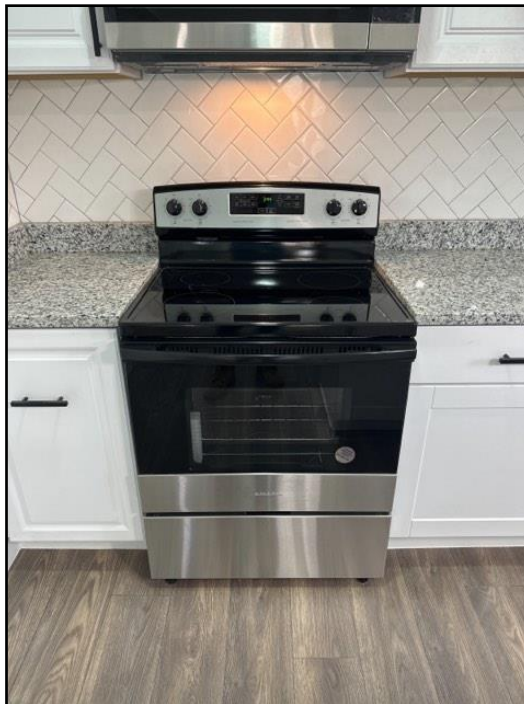
**69.** *Anti-tipping device missing*

### **42. Condition:** • Anti-tipping device missing

No oven anti-tipping device installed. This can present a hazard when children stand on the oven door and the oven flips over on them, recommend a professional licensed contract to make repairs.

**Implication(s):** Physical injury

**Location:** Kitchen
