Holden Beach

Annual Beach Monitoring Report

Prepared For:
Town of Holden Beach, North Carolina

November 2019

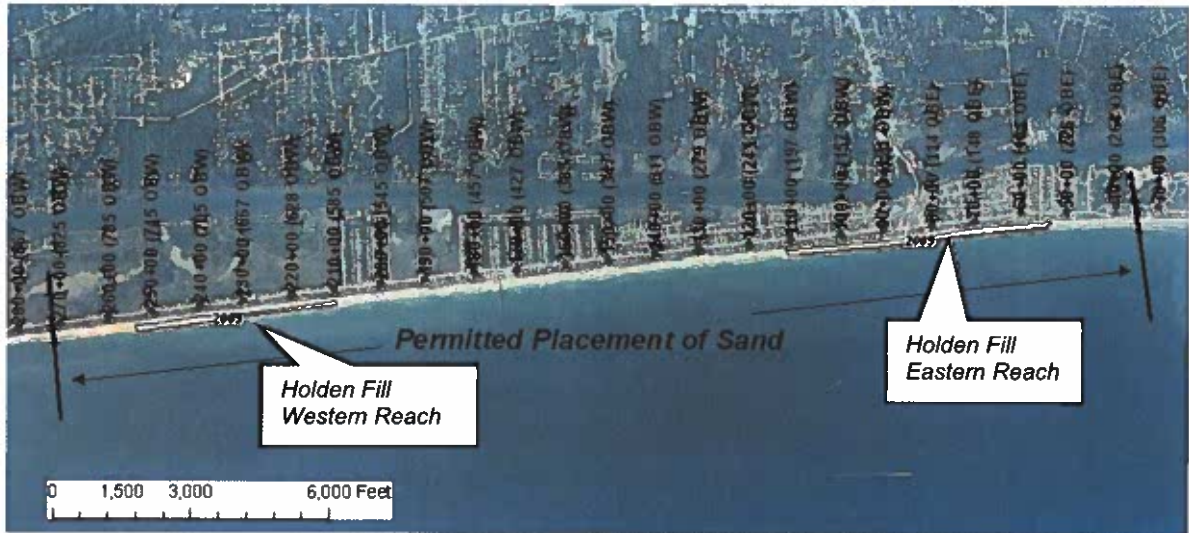
Figure 2-2. 2009 Constructed Project Reaches and 2009 Permitted Sand Placement (the permitted placement has been modified over the years)

The Town has a history of successful upland fill projects, with the most recent occurring in 2009, primarily as Hurricane Hanna mitigation. Approximately 115,000 cy was placed between Stations 55+00 and 110+00 [21 cubic yard per linear foot (cy/lf) average] along the Eastern Reach and 75,000 cy between Stations 210+00 and 255+00 (16.5 cy/lf average) along the Western Reach. Figure 2-2 illustrates the placed-fill footprint and the permitted footprint. Sand was obtained from the Smith upland borrow site. Note that upland sand has been used in emergency dune rebuilding following Hurricane Hanna in 2008 and Hurricane Irene in 2011.

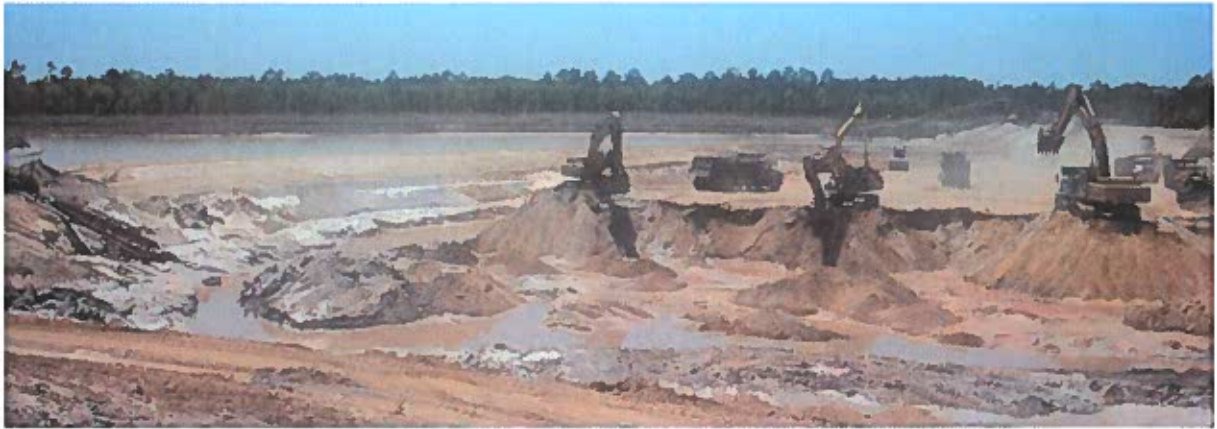
Figure 2-3. Smith Upland Borrow Area during 2009 Holden Beach Nourishment Project

The Town owns the Turkey Trap Road upland borrow site whereas other potential borrow area sites include the Smith borrow site (Figure 2-3) and the Tripp site. The Turkey Trap Road and Smith borrow sites have been successfully permitted, which significantly enhances post-storm mitigation response.

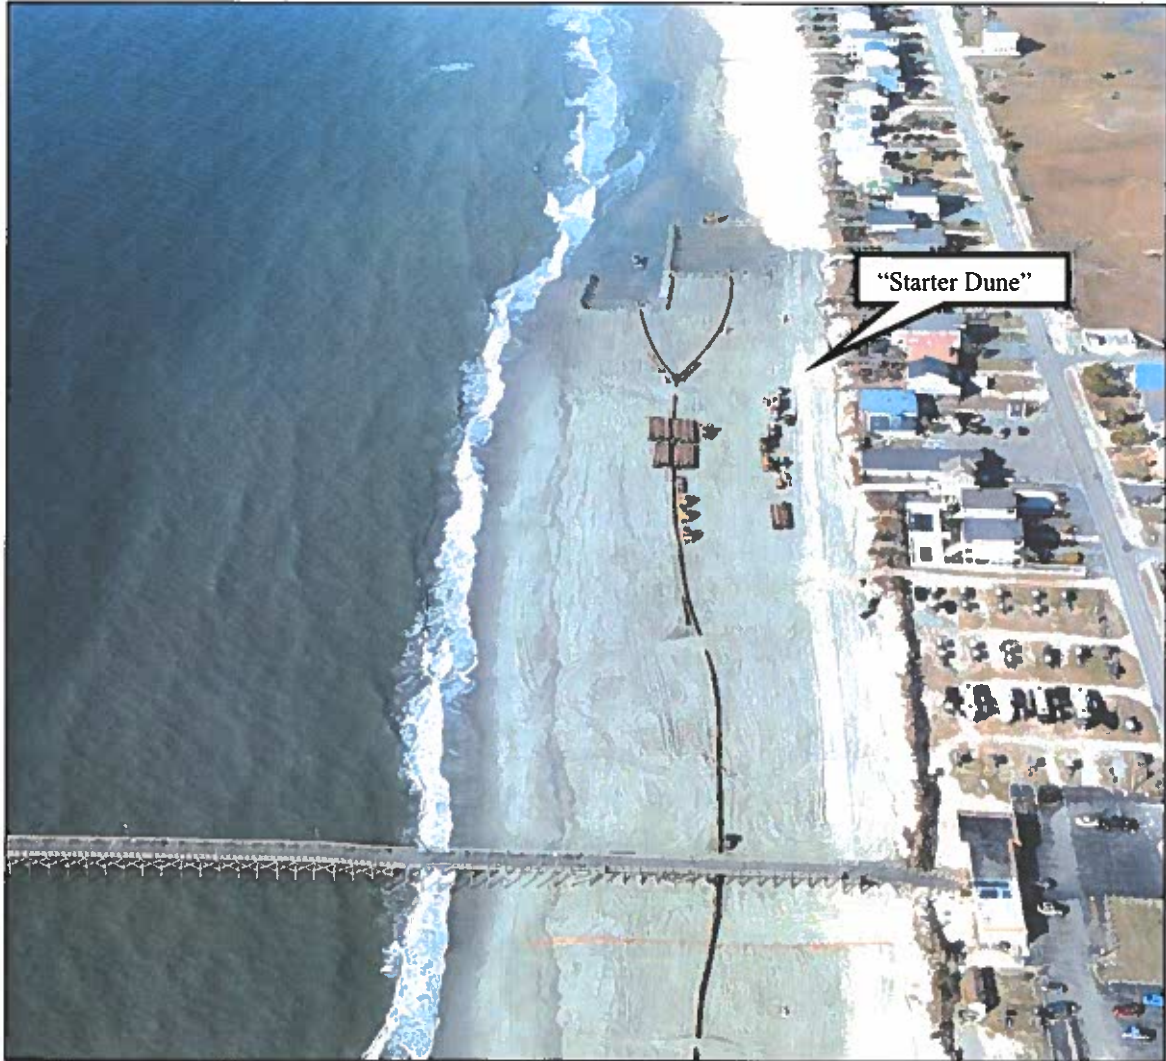
Figure 2-7. Aerial Photograph during Central Reach Construction West of Pier, Approximately Station 180+00 (Weeks Marine/Aerophoto Photo 2/22/17).

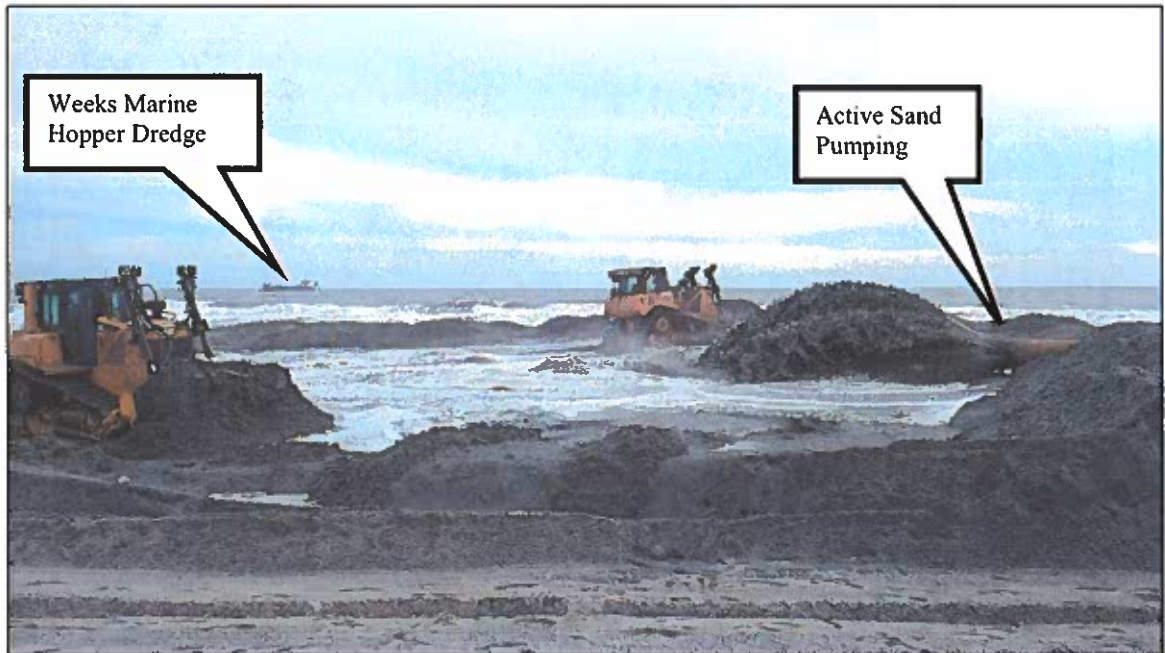
Figure 2-8. Central Reach Construction (ATM photo taken 1/26/17).

With the help of the two hopper dredges, the Weeks Marine crew worked quickly, pumping sand on the beach and progressing at an average rate of about 300 ft of shoreline per day. Despite the minor delays towards the beginning and near the end of the project, the entire nourishment took approximately 74 days and was completed on March 17. Aerial and ground photographs taken during construction are provided in Figures 2-7 and 2-8.

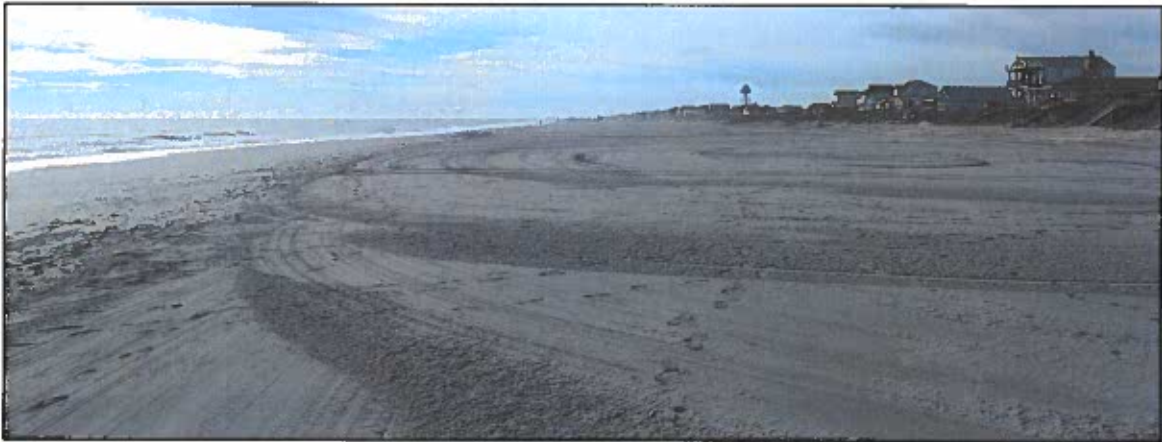
Figure 2-10 (A). Central Reach Immediate Post-Construction Approximately Station 50+00 (ATM photo taken January 2017)

Post-construction monitoring photos are presented in the following figures . Figure 2-10 (A) shows the widened beach conditions immediately following construction. Recent photographs taken 1 to 2 years following construction are presented in Figure 2-10 (B), Figure 2-10 (C), and Figure 2-10 (D).

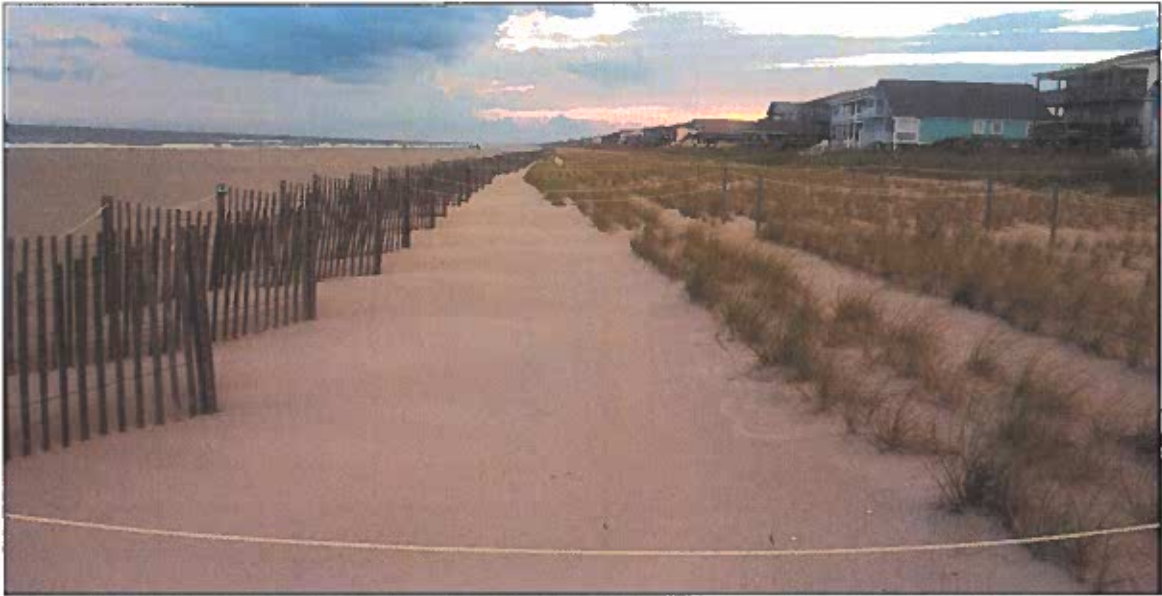
Figure 2-10 (B). Central Reach Post-Construction Approximately Station 230+00 (ATM photo taken August 2018). Note sand fencing, starter dune, and plantings.

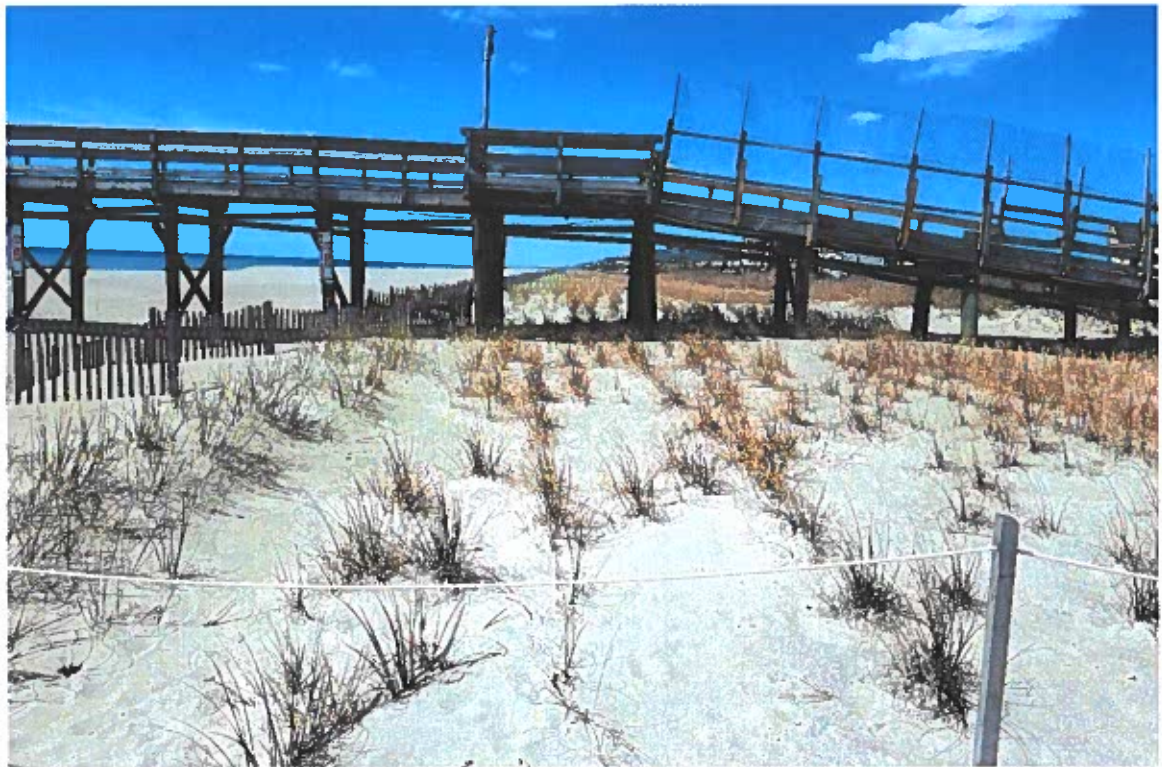
Figure 2-10 (C). Central Reach Post-Construction Approximately Station 170+00 (ATM photo taken March 2019).

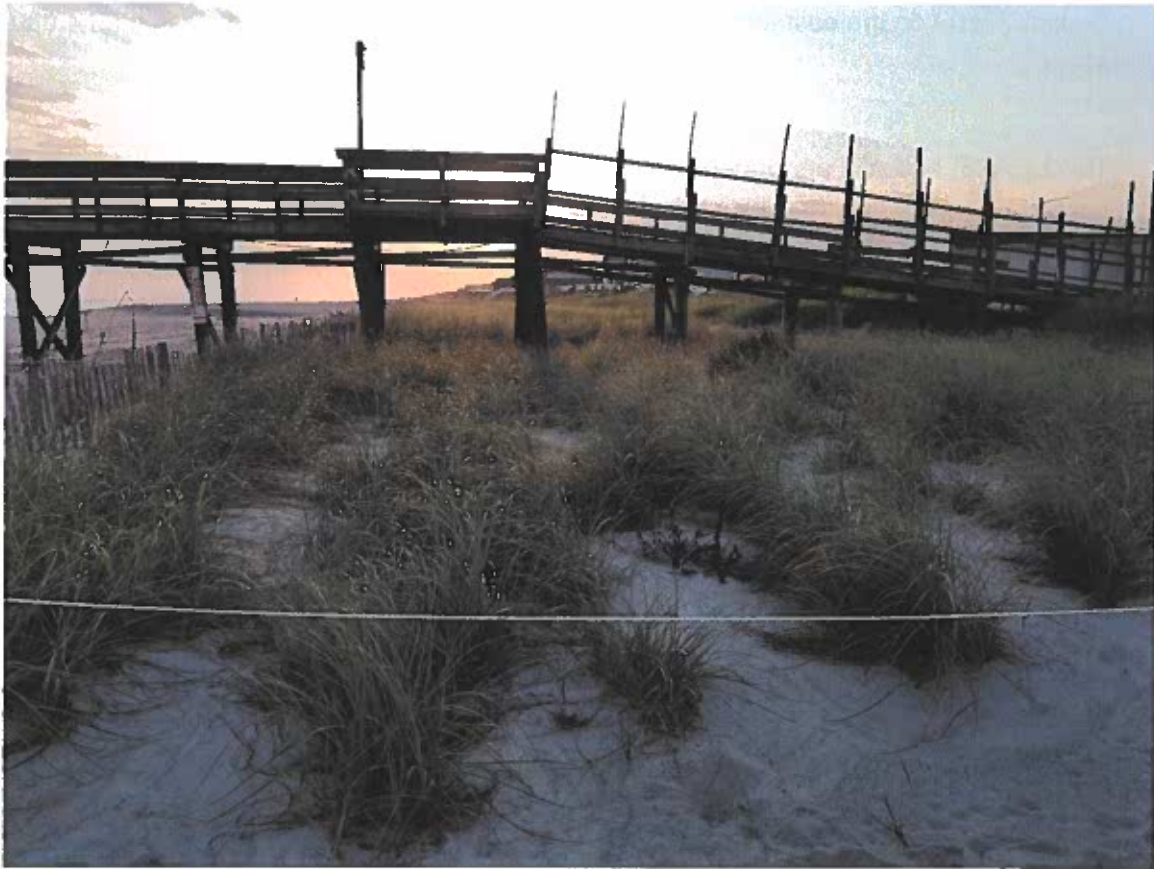
Figure 2-10 (D). Central Reach Post-Construction Approximately Station 170+00 (ATM photo taken September 2019). Note plantings have matured and grown.

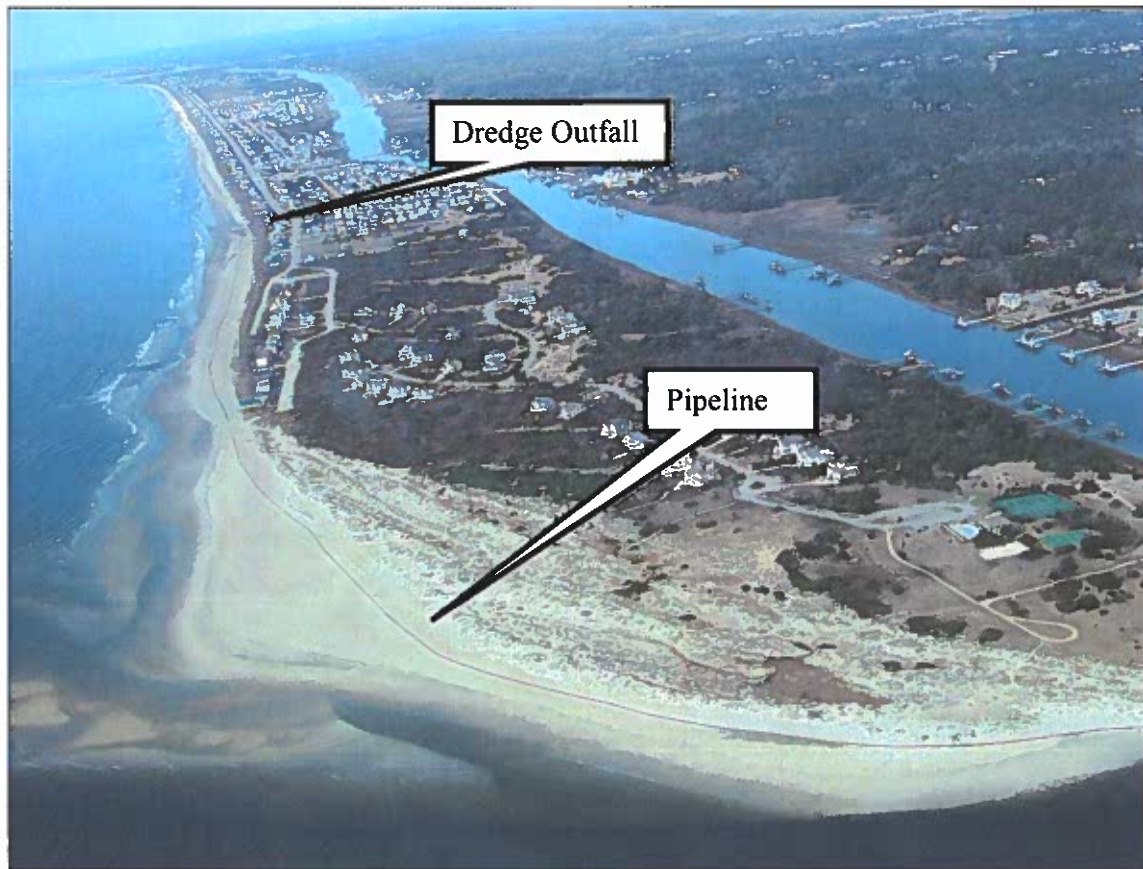
Figure 2-13. Aerial Photograph of 2014 LWFIX Nourishment [source: NC Division of Coastal Management (DCM)].

The Town's piggybacking of the USACE project maximized sand placement while minimizing costs by use of the dredge already onsite for the Federal project. The Town project placed approximately 95,000 cy of beach-compatible material along approximately 2,300 ft of Holden Beach shoreline, between baseline Stations 50+00 and 73+00 (41 cy/lf average). Figure 2-13 provides an aerial photograph taken during the 2014 LWFIX project.

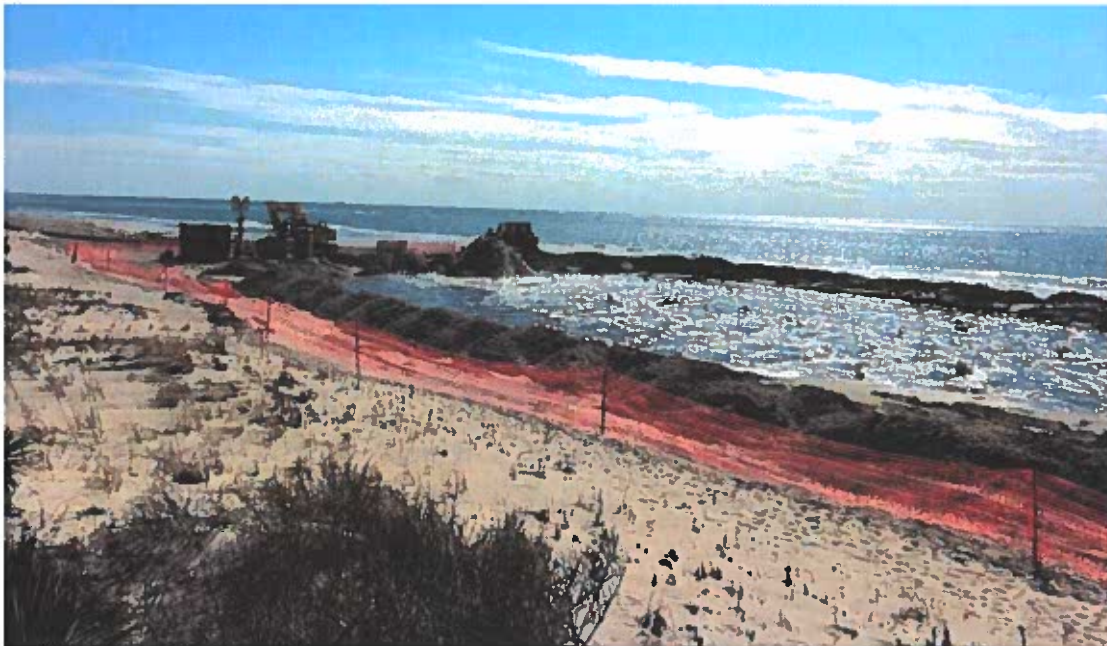
Figure 2-15. Holden Beach POA Photograph Taken near 323 McCray Street (approximately Station 26+00) during 2017 Eastern Reach Project construction.

The Eastern Reach Project was very successful, and photographs taken during construction are presented in Figures 2-15 and 2-16. The Town involvement allowed for the placement of an additional 60,000 cy at a very inexpensive rate. The cost for the project was \$465,000, and the Town's portion was only about \$76,000 (with the State providing 66.7 percent). The timing of this nourishment coincided very well with the CRP and helped fill out much of the remaining shoreline of Holden Beach east of the larger CRP. Moreover, the Town's involvement helped maximize the restoration effort needed following the recent hurricanes and has helped mitigate more recent storm activity. The eastern end of shoreline has historically shown the highest erosion rates on the island, and LWFIX dredging projects and piggybacking opportunities on the east end are a crucial part of the Town's proactive management strategies to mitigate this.

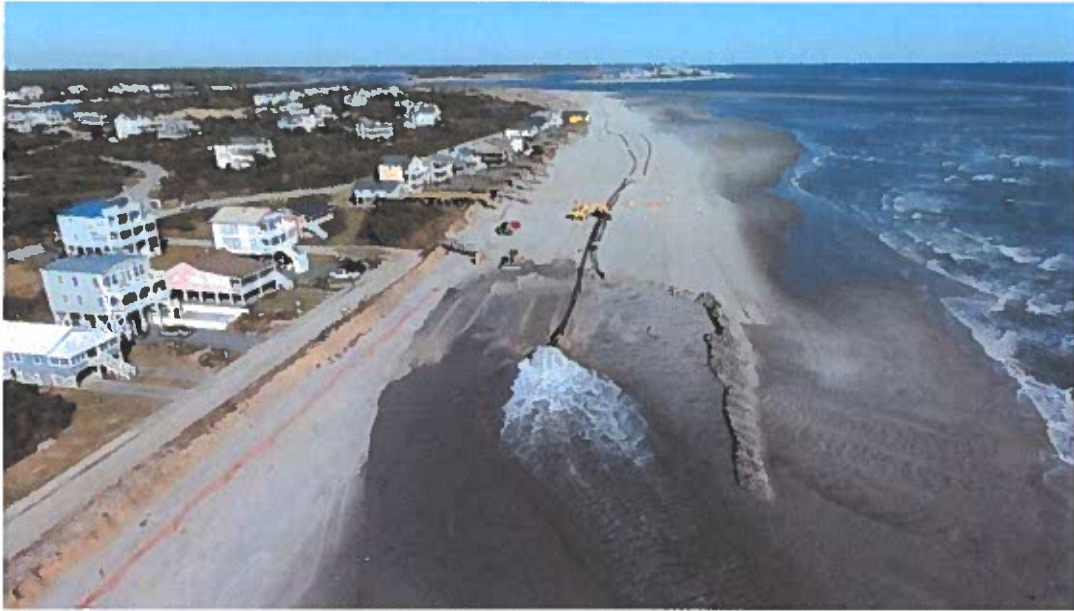
Figure 2-16. Holden Beach POA Aerial Photograph taken during 2017 Eastern Reach Project Construction (pumping just west of Station 30+00).

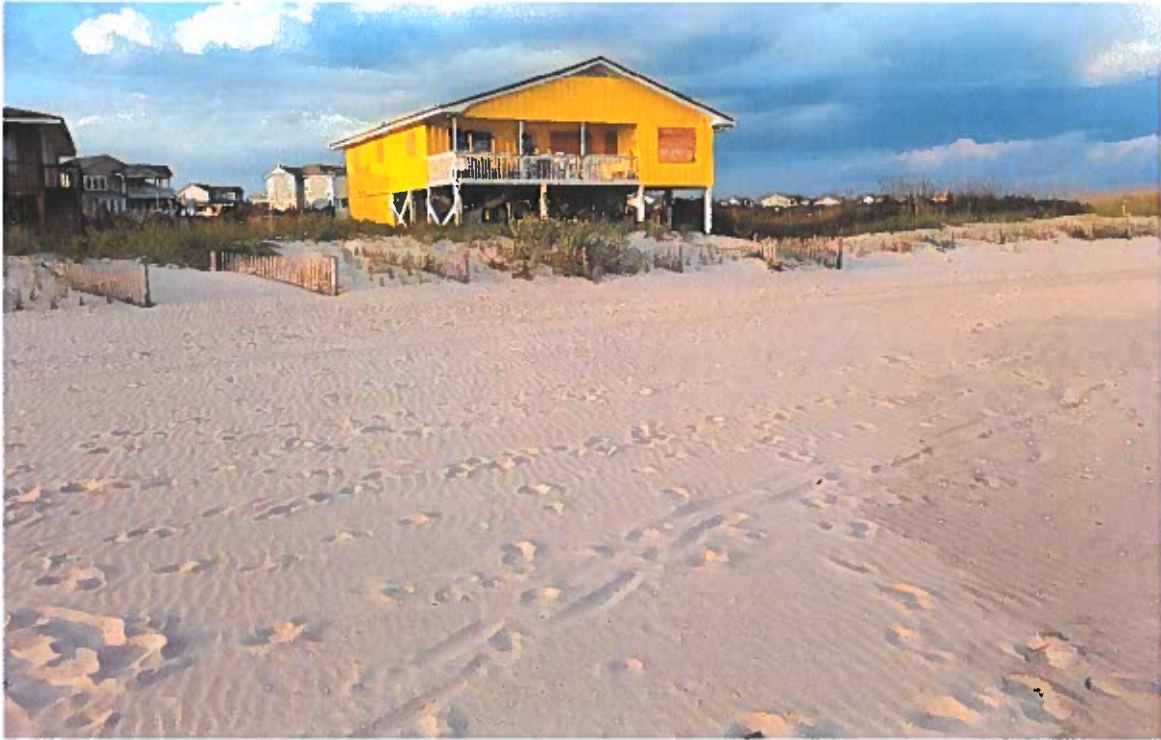
Figure 2-17. Two-Year Post Construction Photo of the 2017 Eastern Reach Project (ATM photo taken April 2018, at Station 20+00). The most eastern oceanfront house, Amazing Grace, is shown. Dune growth has occurred however this is still a vulnerable area.

Figure 2-17 presents a 2-year post-project photograph monitoring the progression of the 2017 Eastern Reach Project. In general and based on site observations, the east end is continuing to benefit from the recent nourishment, however, it does need nourishing every 2 years to avoid extreme erosional conditions that have occurred in past decades. More detail on beach survey monitoring are provided in Section 3.

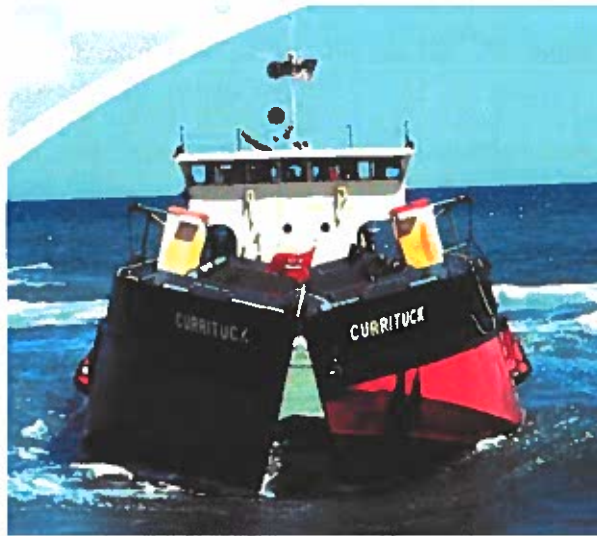
Figure 2-20. USACE Shallow Draft Split-Hull Hopper Dredge the *Currituck* Rarely Dredges the LWF Inlet

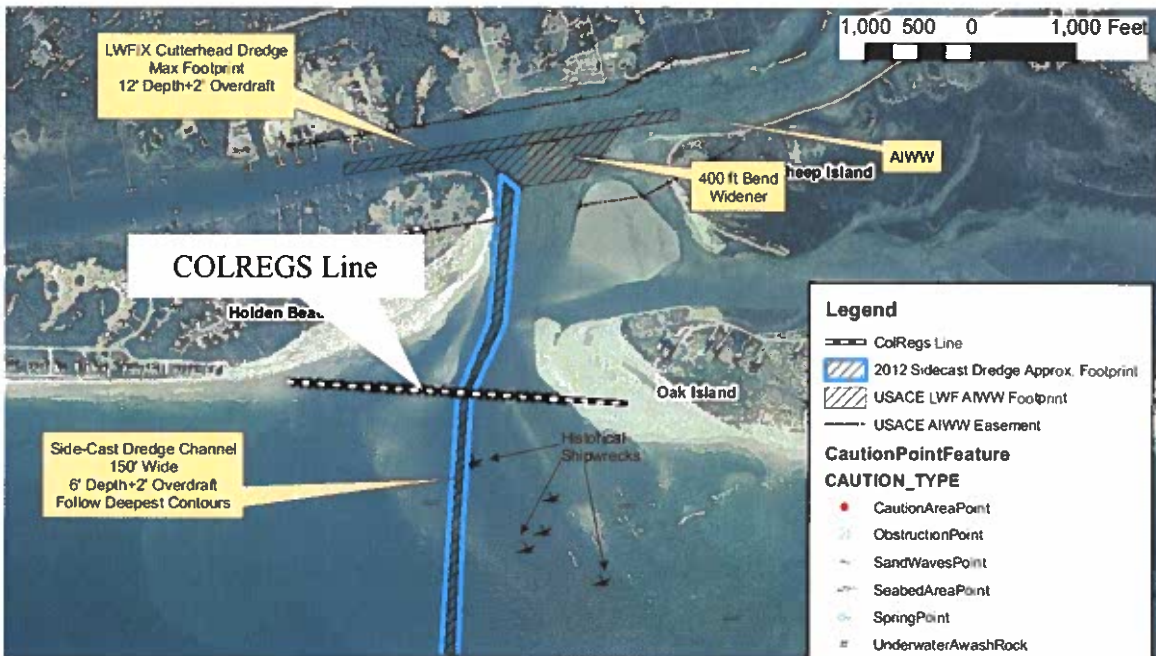
Figure 2-21a. LWF Inlet USACE Dredging Projects Include the Outer Channel (sidecaster dredged) and the LWFIX (cutterhead dredged)

Figure 2-21a provides a representation of these two regions. The LWFIX projects are described in detail in Section 2.4. This section focuses on the outer shoal, seaward of the COLREGS line.

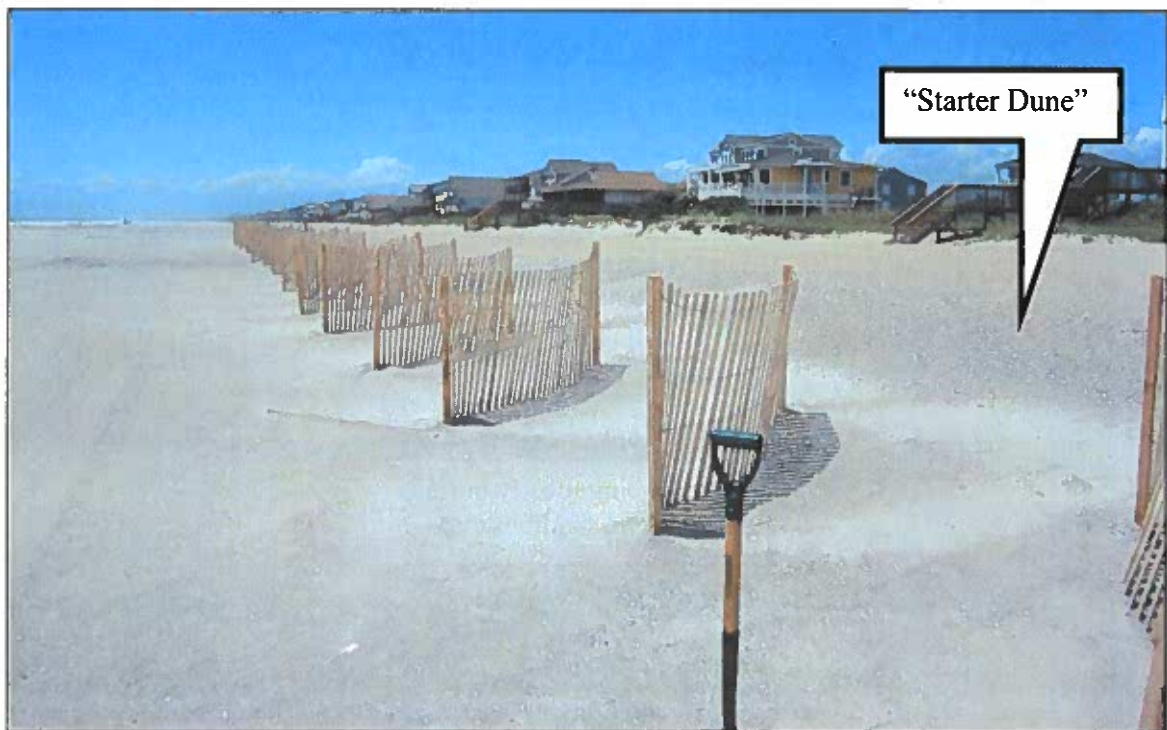
Figure 2-24 (B). Sand Fencing along the Seaward Edge of the Starter Dune for the Central Reach Project at Station ~230+00. Vegetation has been planted on the starter dune since photograph date. (ATM photo, taken May 2017).

Figures 2-24(A) and (B) present example sections of sand fencing put in place just seaward of the constructed “starter dune” immediately following the 2017 nourishment projects. One-year and two-year post-project monitoring photographs of the starter dunes and plantings are provided in Figures 2-25(A) and (B).

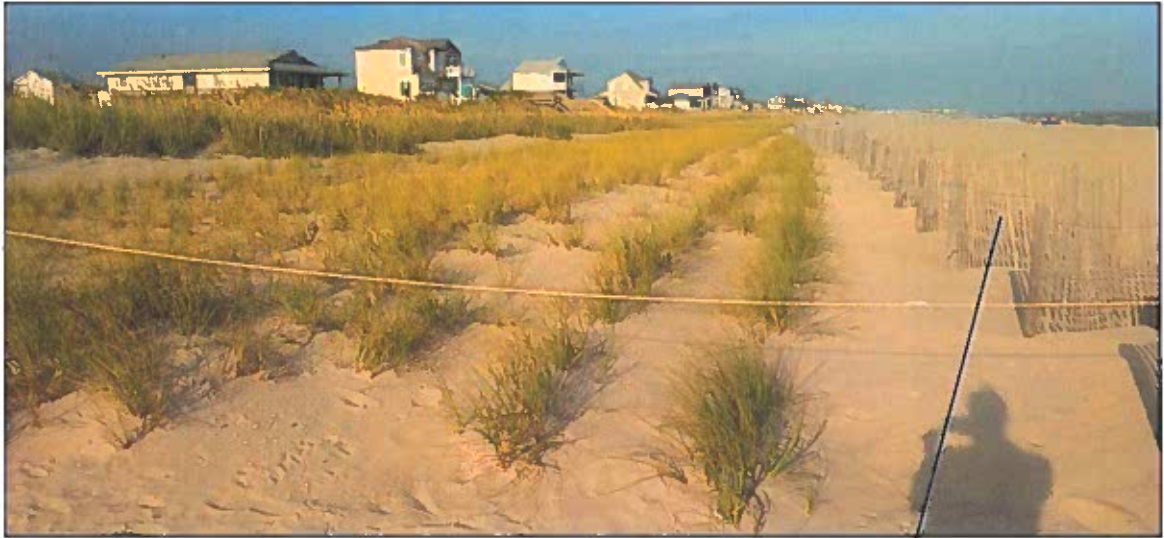
Figure 2-25 (A). Sand Fencing along the Seaward Edge of the Starter Dune for the Central Reach Project at Station ~60+00 Showing Planted Dune Vegetation. (ATM photo, taken August 2018).

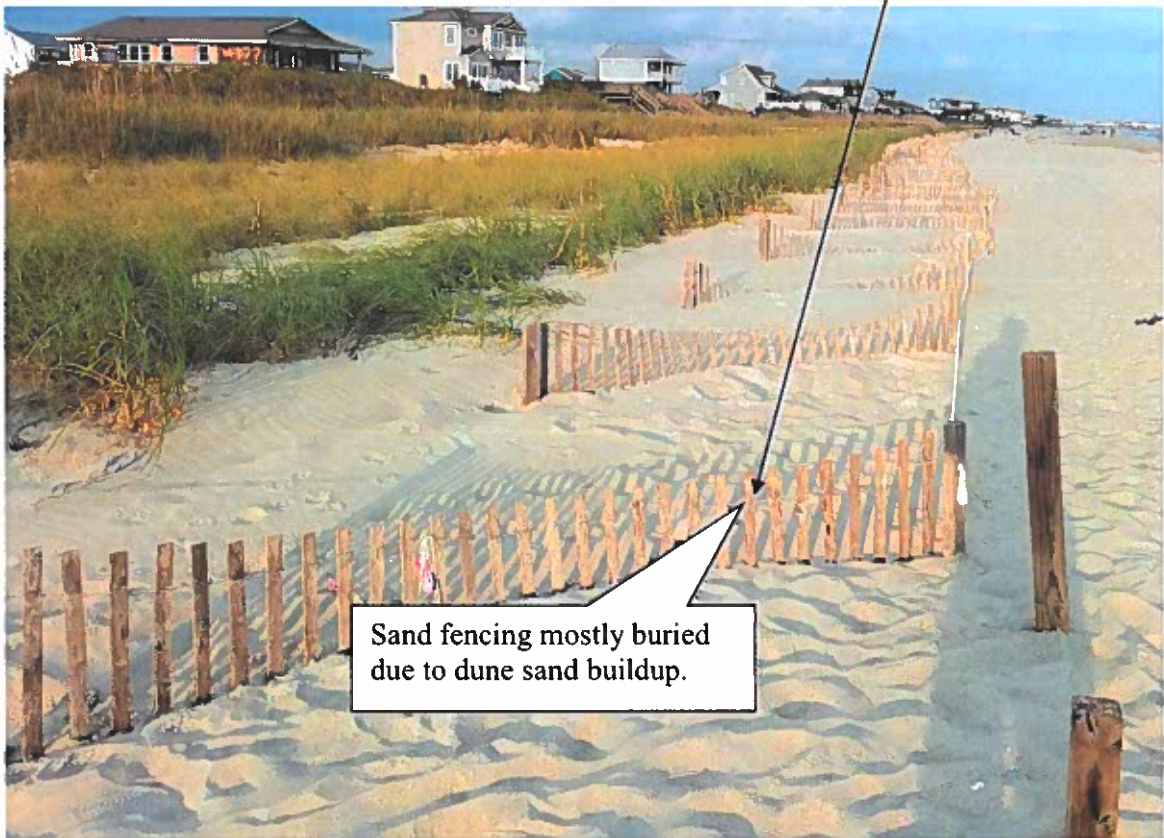
Figure 2-25 (B). Sand Fencing for the Central Reach Project at Station 60+00 showing dune vegetation and sand growth about 2-years post project. (ATM photo, taken September 2019).

The continued diligence and effort of Holden Beach has resulted in a stable and healthy dune system along a majority of the island, although Hurricane Matthew removed approximately 41 acres of dunes in 2016. Dune vegetation planting and sand fencing was a planned component of the CRP and has stabilized and largely restored the dune system along Holden Beach since Hurricane Matthew. Older dune fencing has gradually been buried as a result of dune growth (see Figure 2-25).

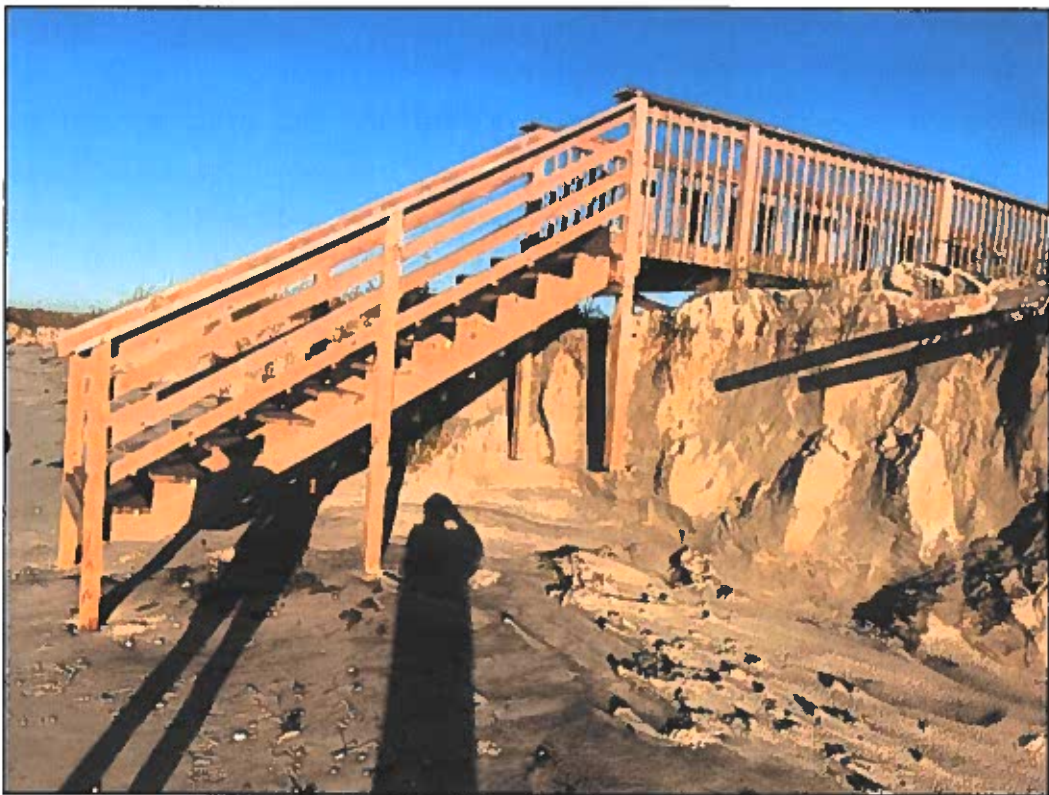
Figure 2-31. West End Dune Erosion and Vegetation Loss

NOAA tide gauge stations at Myrtle Beach and Wrightsville Beach showed elevated water levels for days leading up to and following Hurricane Michael. Recorded water levels from the two NOAA stations are provided in Appendix B. Moreover, Michael's impacts came during the spring tide cycle when water levels were already high, resulting in peak water levels of about 7.5 ft above MLLW recorded at Myrtle Beach (about 35 miles southwest of Holden Beach) on October 11. Although storm surge along the NC and SC coast from Michael was lower than what was observed during Hurricane Florence in September, the peak water levels recorded during both storms at Myrtle Beach were almost the same as a result of Michael moving through during the spring high tide. Figure 2-31 presents a photograph showing some of the impacts these conditions had on Holden Beach.

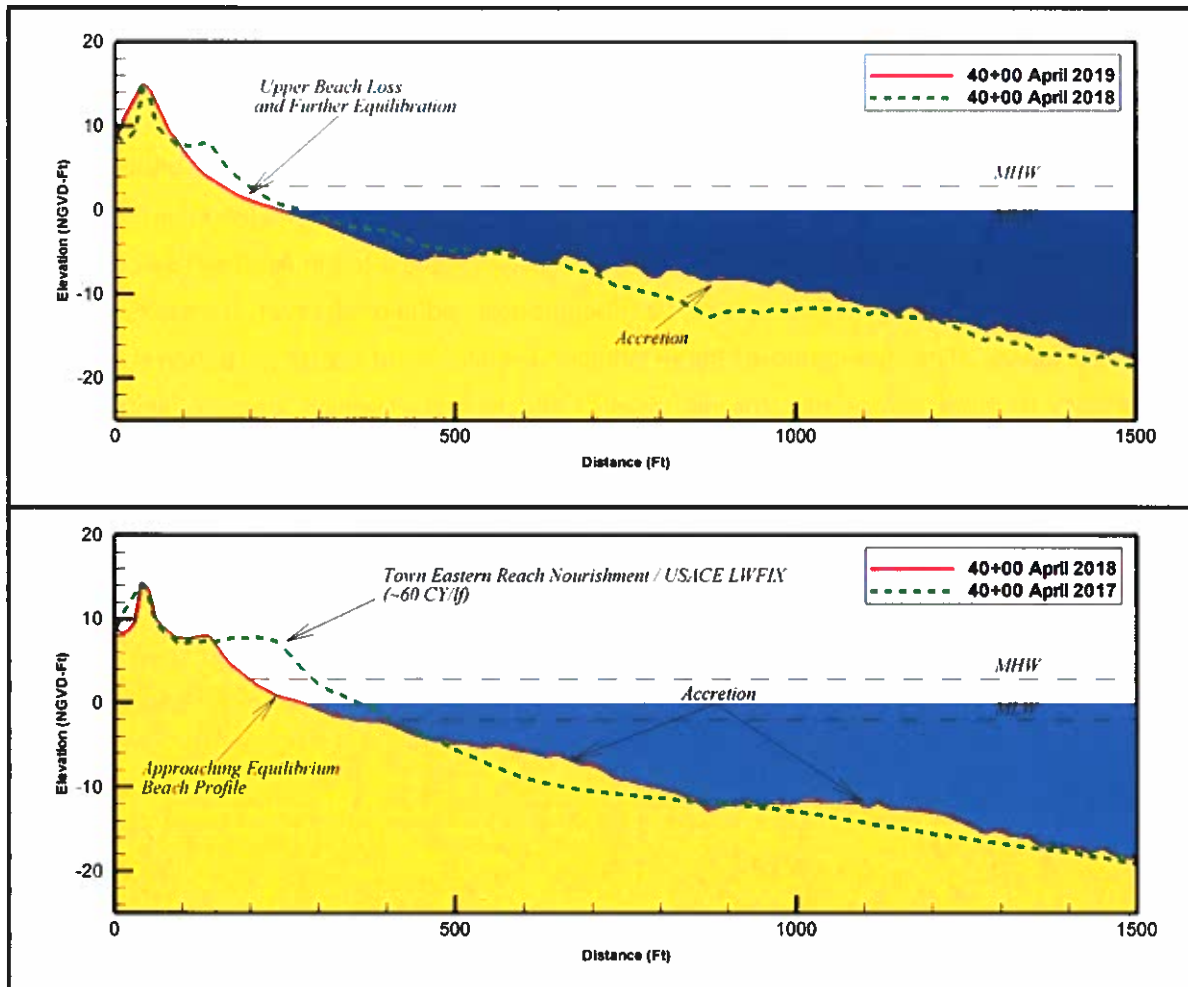
Figure 3-2. Station 40+00 Profile Transect Comparison on the Town East Reach of Holden Beach. Upper panel shows 2018-2019 survey comparison showing the 2-year post-project adjustment of the 2017 LWFIX / Town Eastern Reach nourishment material. Lower panel shows 2017-2018 comparison, displaying the immediate post project profile of the 2017 LWFIX / Town Eastern Reach nourishment and the 1-year post project profile (April 2018). Placed project volumes typically ranged between 40 and 60 cubic yards / linear foot (cy/lf).

Figures 3-2 and 3-3 present example transect surveys comparing 2018 and 2019 survey data. Figure 3-2 also shows a 2017 and 2018 survey comparison to illustrate typical changing sediment transport patterns and monitoring of the 2017 nourishment projects. As both the CRP and the Town Eastern Reach / USACE LWFIX Project were completed in spring 2017, the 2019 survey represents 2-year post-construction conditions. Note that some differences in profiles may be related to recent wave activity and/or nourishment activities and are not necessarily indicative of long-term trends. Appendix A contains all transect data for the 2018 and 2019 surveys.

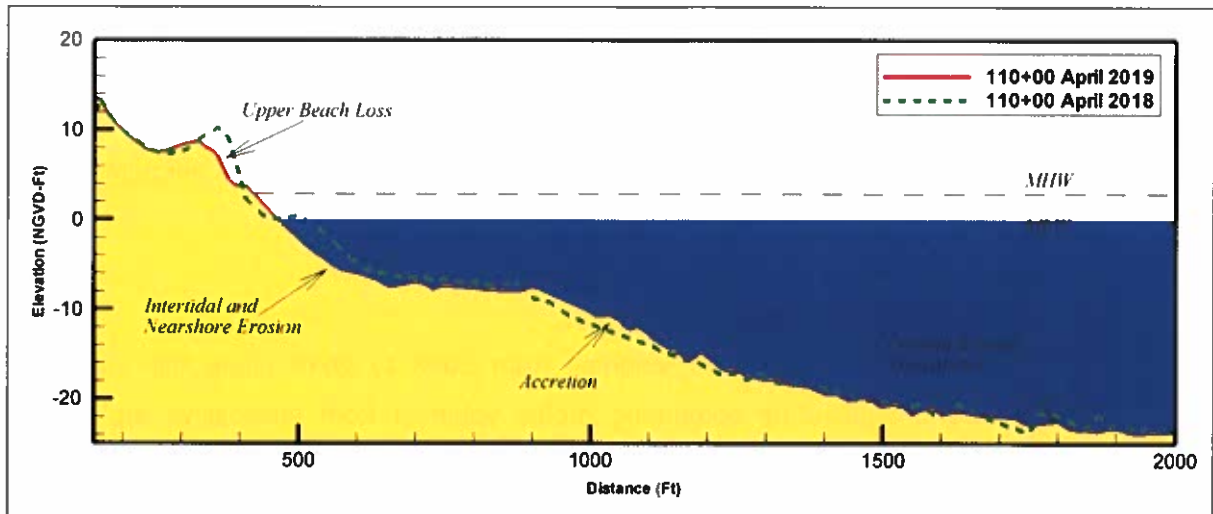
Figure 3-3. Station 110+00 Profile Transect showing 1-Year (April 2018) and 2-Year (April 2019) post-project profiles following the Town Central Reach Project. Central Reach Nourishment placed approximately 60 cy/lf in this area. Note continued project equilibration is observed along with upper beach loss and intertidal and nearshore erosion from the 2018 Hurricane Season (Hurricanes Florence and Michael).

This equilibration and observed upper beach loss have been somewhat accelerated due to recent storms. Figure 3-3 reveals that some material has accreted in areas farther offshore as well, and relatively significant changes are observed beyond the -12 ft contour. The

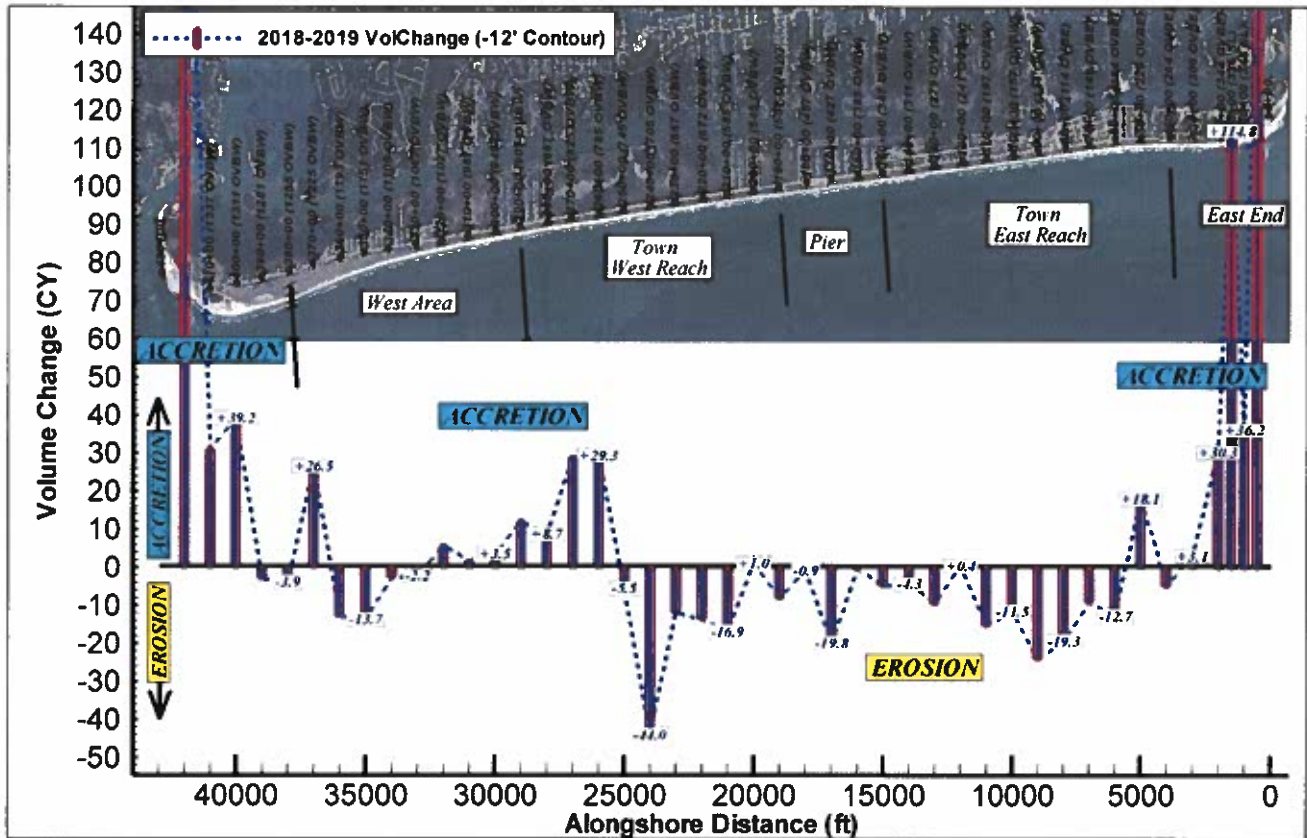
Figure 3-4. Volume Change Using April 2018 and April 2019 Surveys. Positive values indicate accretion, negative values indicate erosion. Note erosion observed throughout most of Central Reach and continued accretional/spreading of the two 2017 nourishment projects can be observed. The combined nourishment project templates spanned from about Station 20+00 to about Station 260+00. The most significant accretion is seen near the inlets, on both the east end and the west end.

The volumes calculated in Figure 3-4 are from the dune out to about the -12-ft NGVD contour, which represents the typical DOC limit. The DOC essentially represents the depth limit where sand along the seabed stops moving. In general, the vast majority of sand transport and profile change typically occurs in waters shallower than the DOC, such as the surf zone and intertidal beach. However, during periods of significant energetic wave conditions, changes to the beach profile can occur beyond the DOC limit. Therefore, the DOC can vary annually depending on storm activity, and extreme storms can move material

The West Area (see Figure 3.4) is largely stable to accretional between the 2018 and 2019 surveys. The most significant accretion over the past year is observed on the extreme ends of the island, closest to the inlets. This is likely due to continued spreading of nourishment material, as well as inlet dynamics and recent shoal movement.

Table 3-1 presents volume changes estimated by the reaches identified in Figure 3-4 (i.e., East End, Town East Reach, Pier, etc.) from 2018 to 2019. In general, the most significant erosion (or least amount of accretion) occurred within the dry beach/surf zone area (dune to -5 ft NGVD) and specifically within the Town East, Pier, and Town West reaches. This is indicative of continued beach nourishment equilibration as well as nearshore beach erosion caused by the energetic wave conditions and elevated water levels from Hurricanes Florence and Michael.

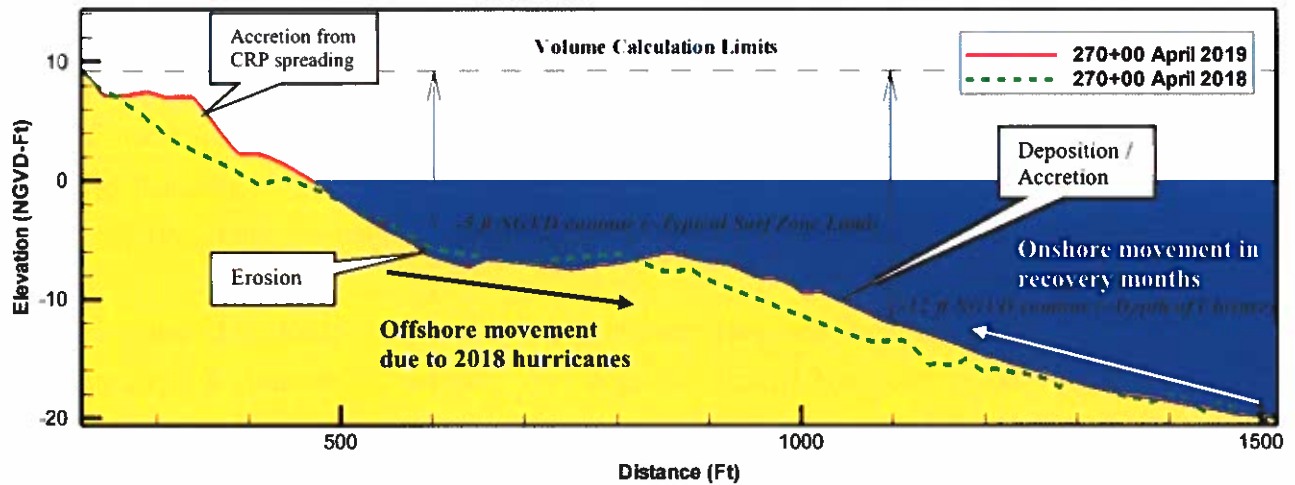
Figure 3-5. Two Different Volume Calculation Limits Used for this Analysis:
 1) Dune to -12 ft NGVD and 2) Dune to -5 ft NGVD.

Volume calculations were also performed from the dune to the -5 ft NGVD contour, which represents the approximate typical surf-zone limit. Figure 3-5 presents the two different boundaries used for volume calculations and illustrates upper beach accretion observed downdrift/west of the 2017 CRP at Station 270+00. The -5-ft volume limit is more characteristic of visible/tangible beach conditions than the deeper -12-ft or -20-ft limits that can occur more than a quarter-mile offshore.

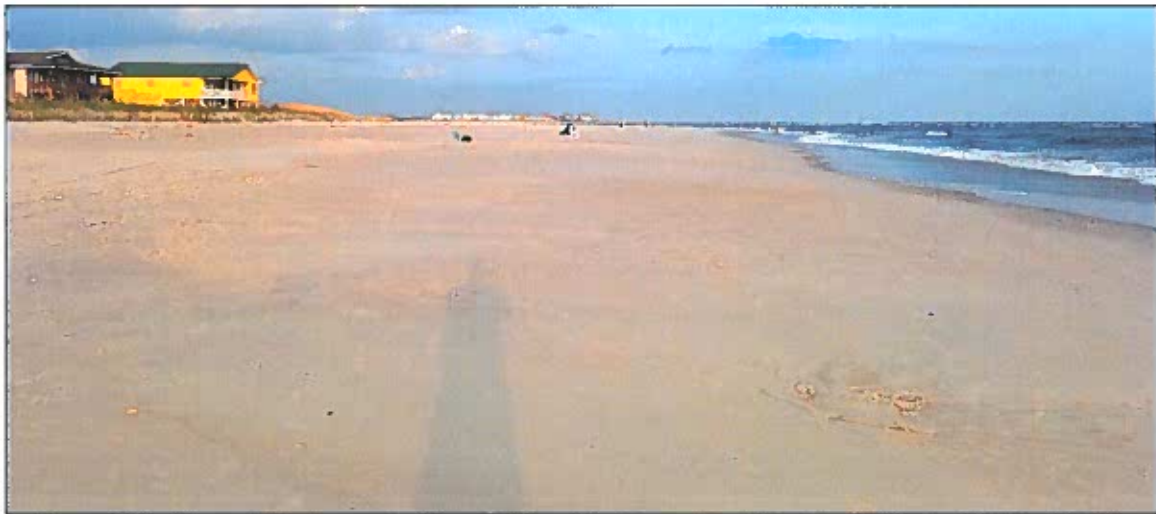
Figure 3-6. Recent Photograph of Beach Conditions near East End, Just West of Station 20+00, where Accretion and Upper Beach Growth Has Occurred Over the Past Year in What Is Typically an Erosional Hotspot Area (ATM Photo Taken September 2019).

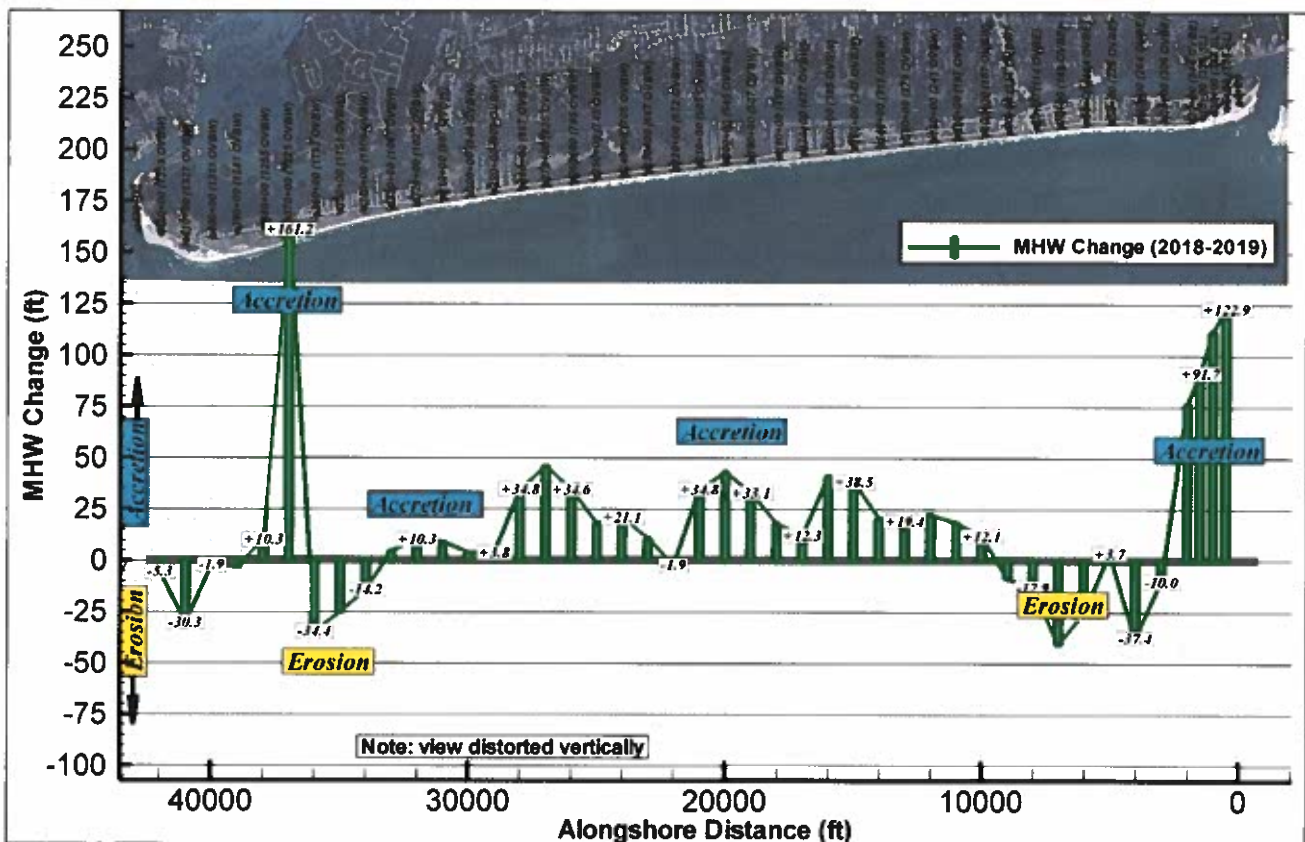
Figure 3-7. MHW Shoreline Change from 2018 to 2019. Seaward movement / accretion of the MHW shoreline is observed within the Central Reach and along the eastern end of Holden Beach. Erosion / landward movement is observed in the more eastern and western portions of Holden Beach and near Shallotte Inlet.
