Holden Beach

Annual Beach Monitoring Report

Prepared For:
Town of Holden Beach, North Carolina

November 2019

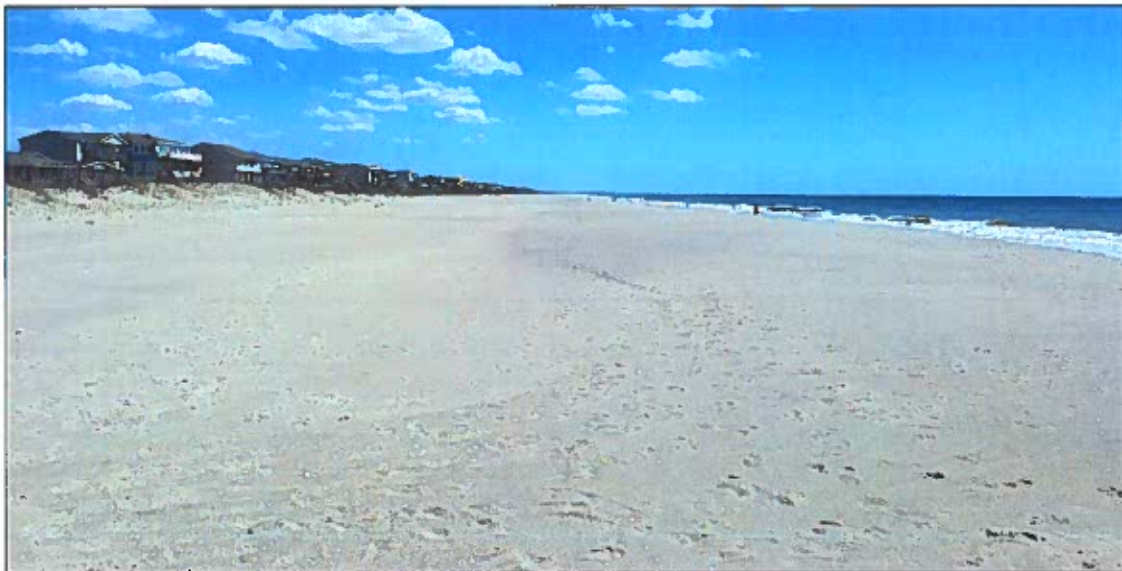
Figure 3-8. March 2019 Photo Taken Near Station 260+00 Looking East

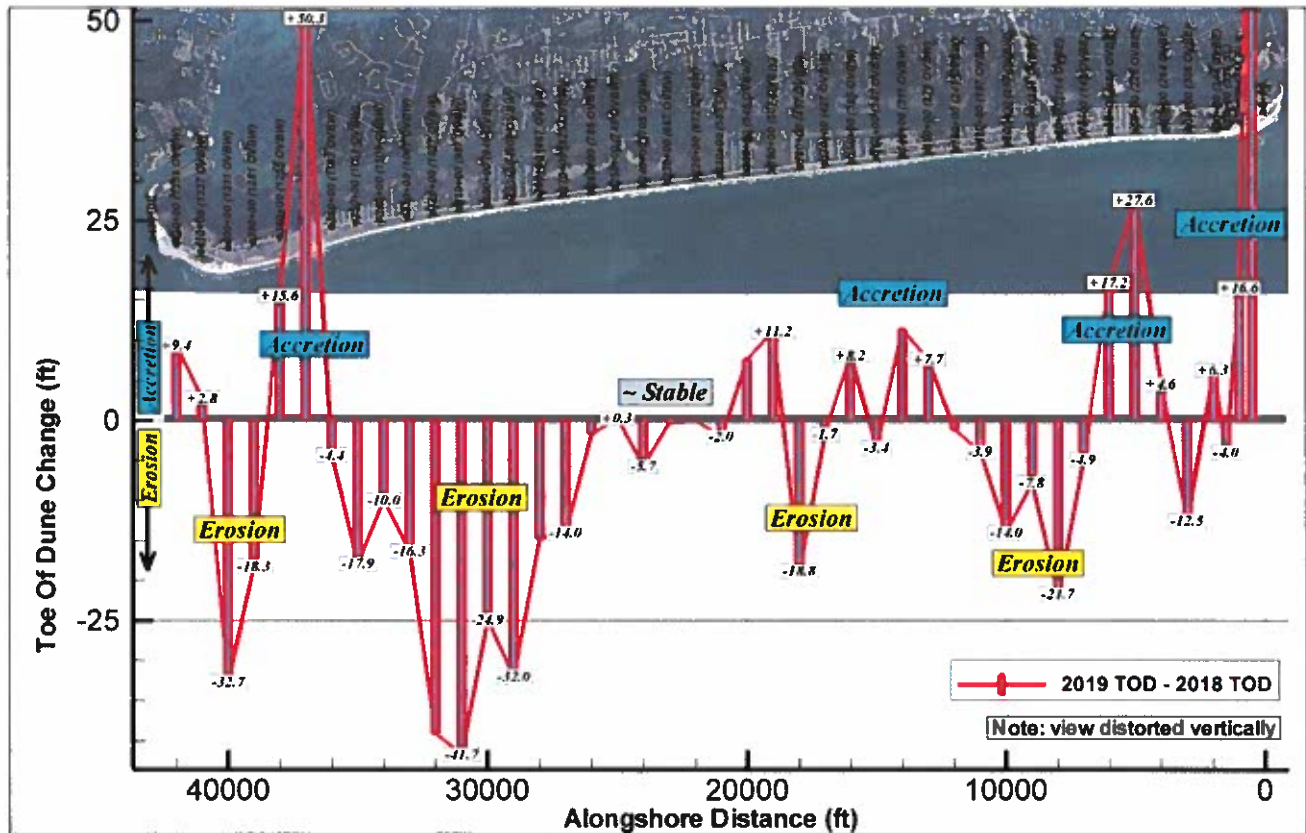
Figure 3-11. Toe of Dune (TOD, +7 ft NGVD) Change from 2018 to 2019. A mostly erosional beach trend is exhibited, though with much variability throughout the reaches.

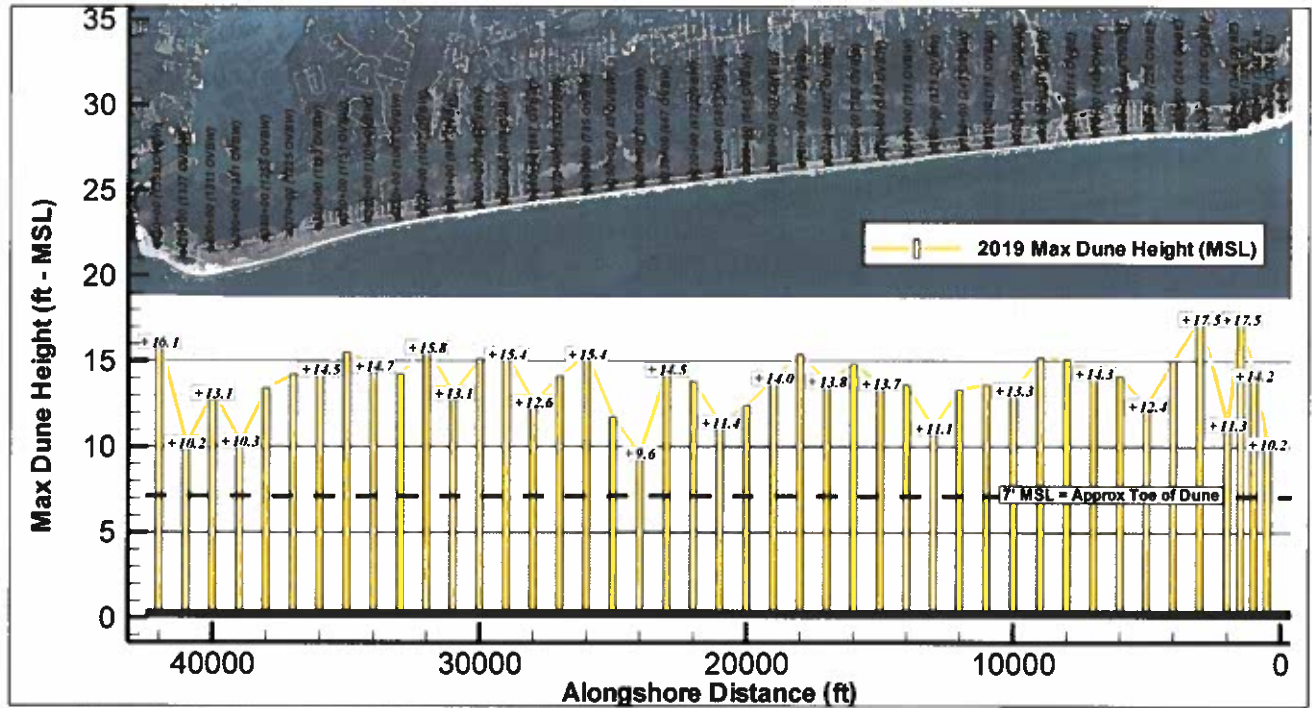
Figure 3-12. Maximum 2019 Dune Height. Using 7 ft NGVD as the dune base, dunes are generally 5' to 8' high.

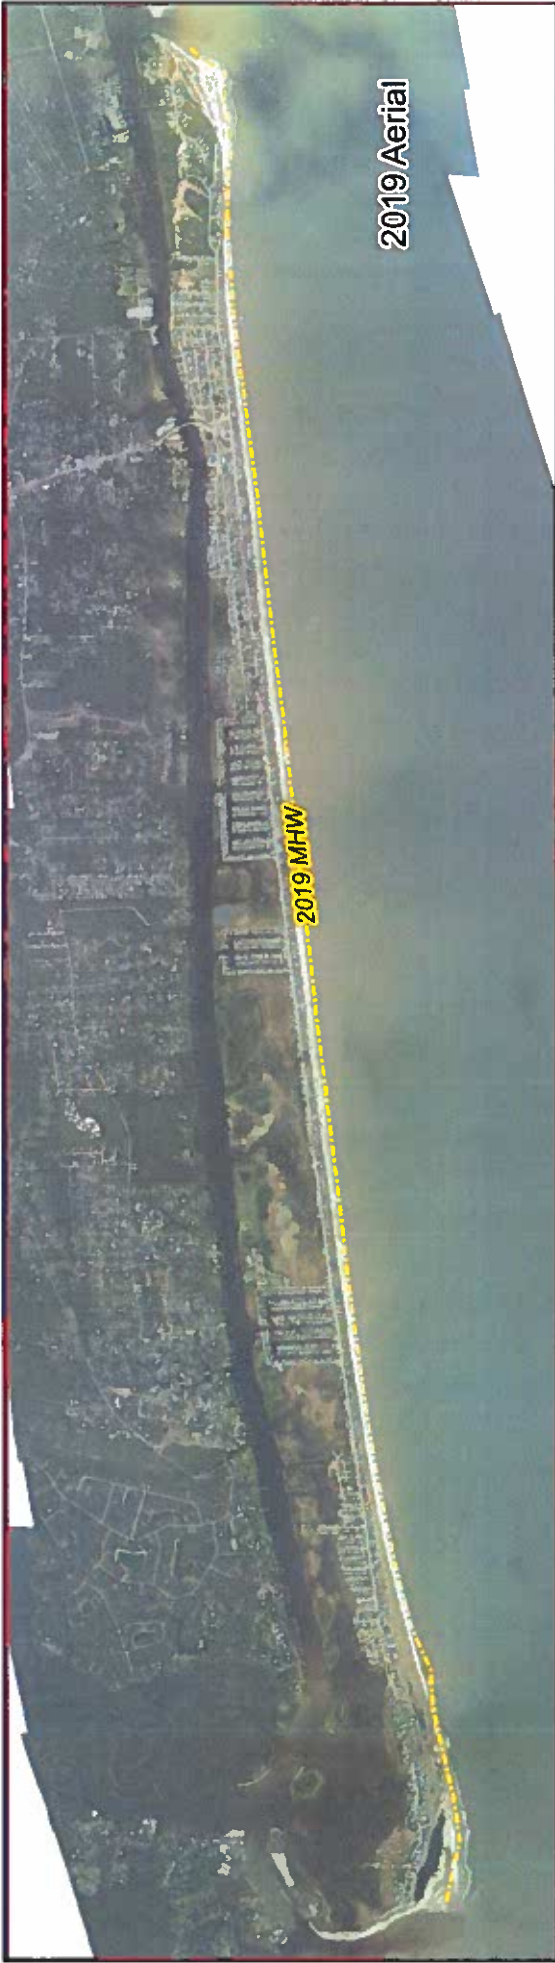
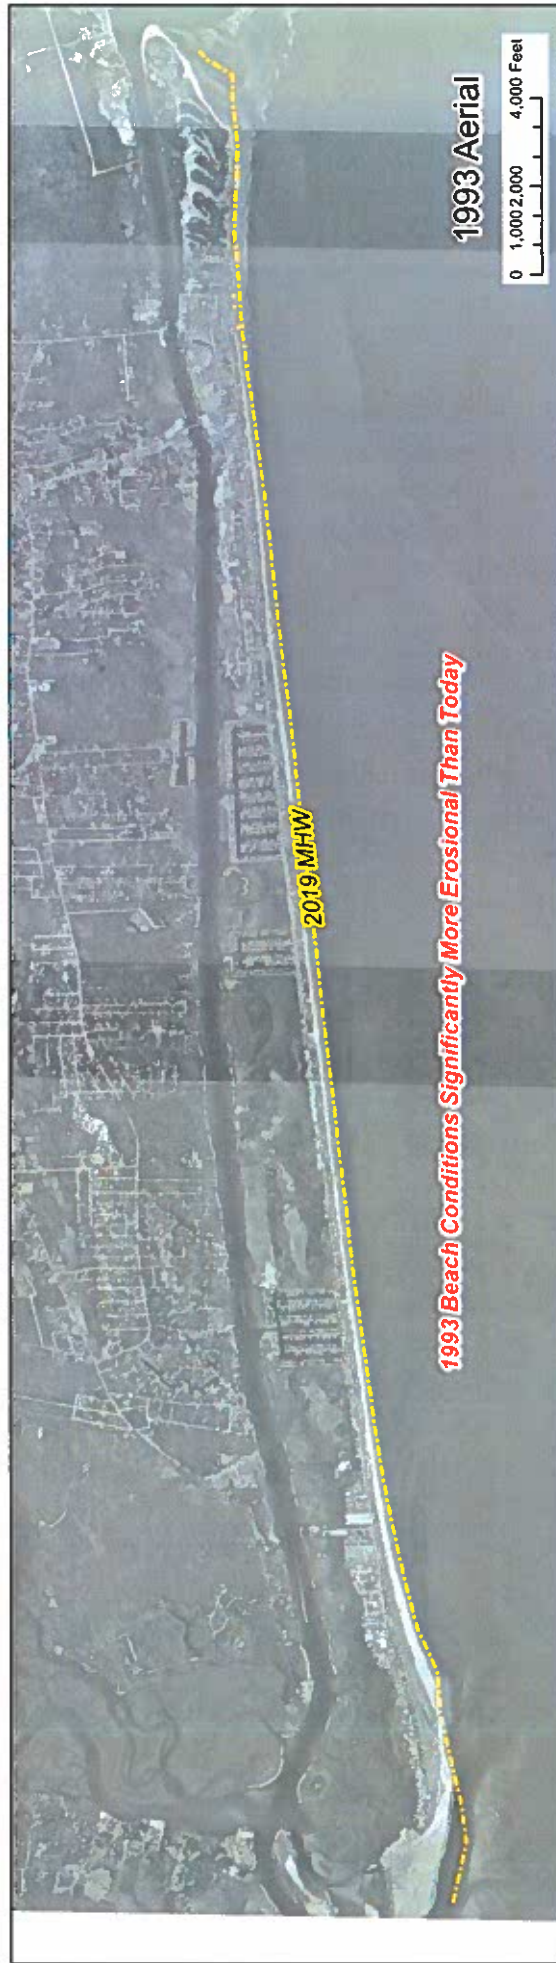
Figure 3-14
1993 and 2019 Aerial Comparison with 2019 Mean High Water (MHW) line.
2019 aerial shows overall accretion in comparison with 1993 conditions.

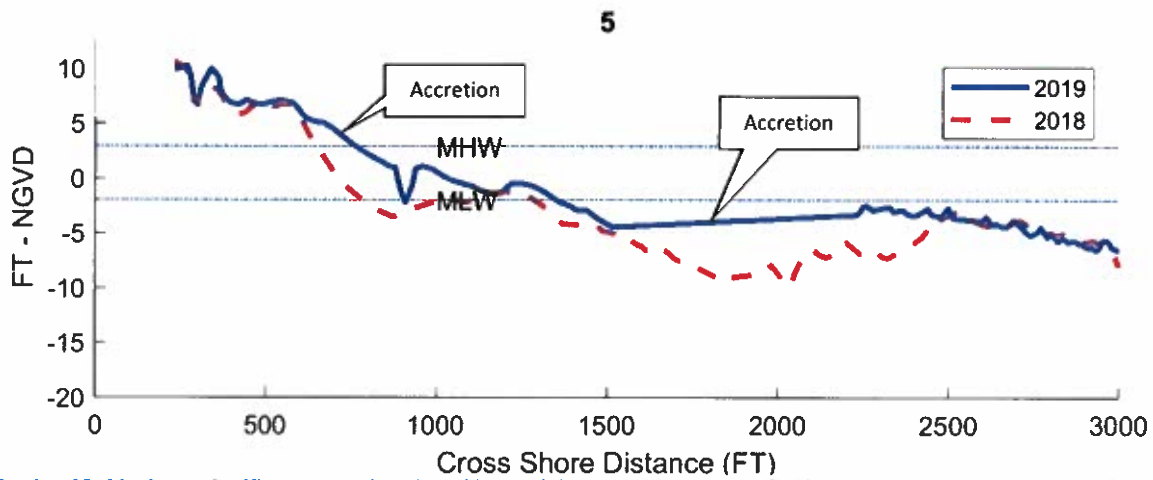
Station 05+00. Some significant upper beach and intertidal accretion, and accretion into the nearshore below MLW is observed.

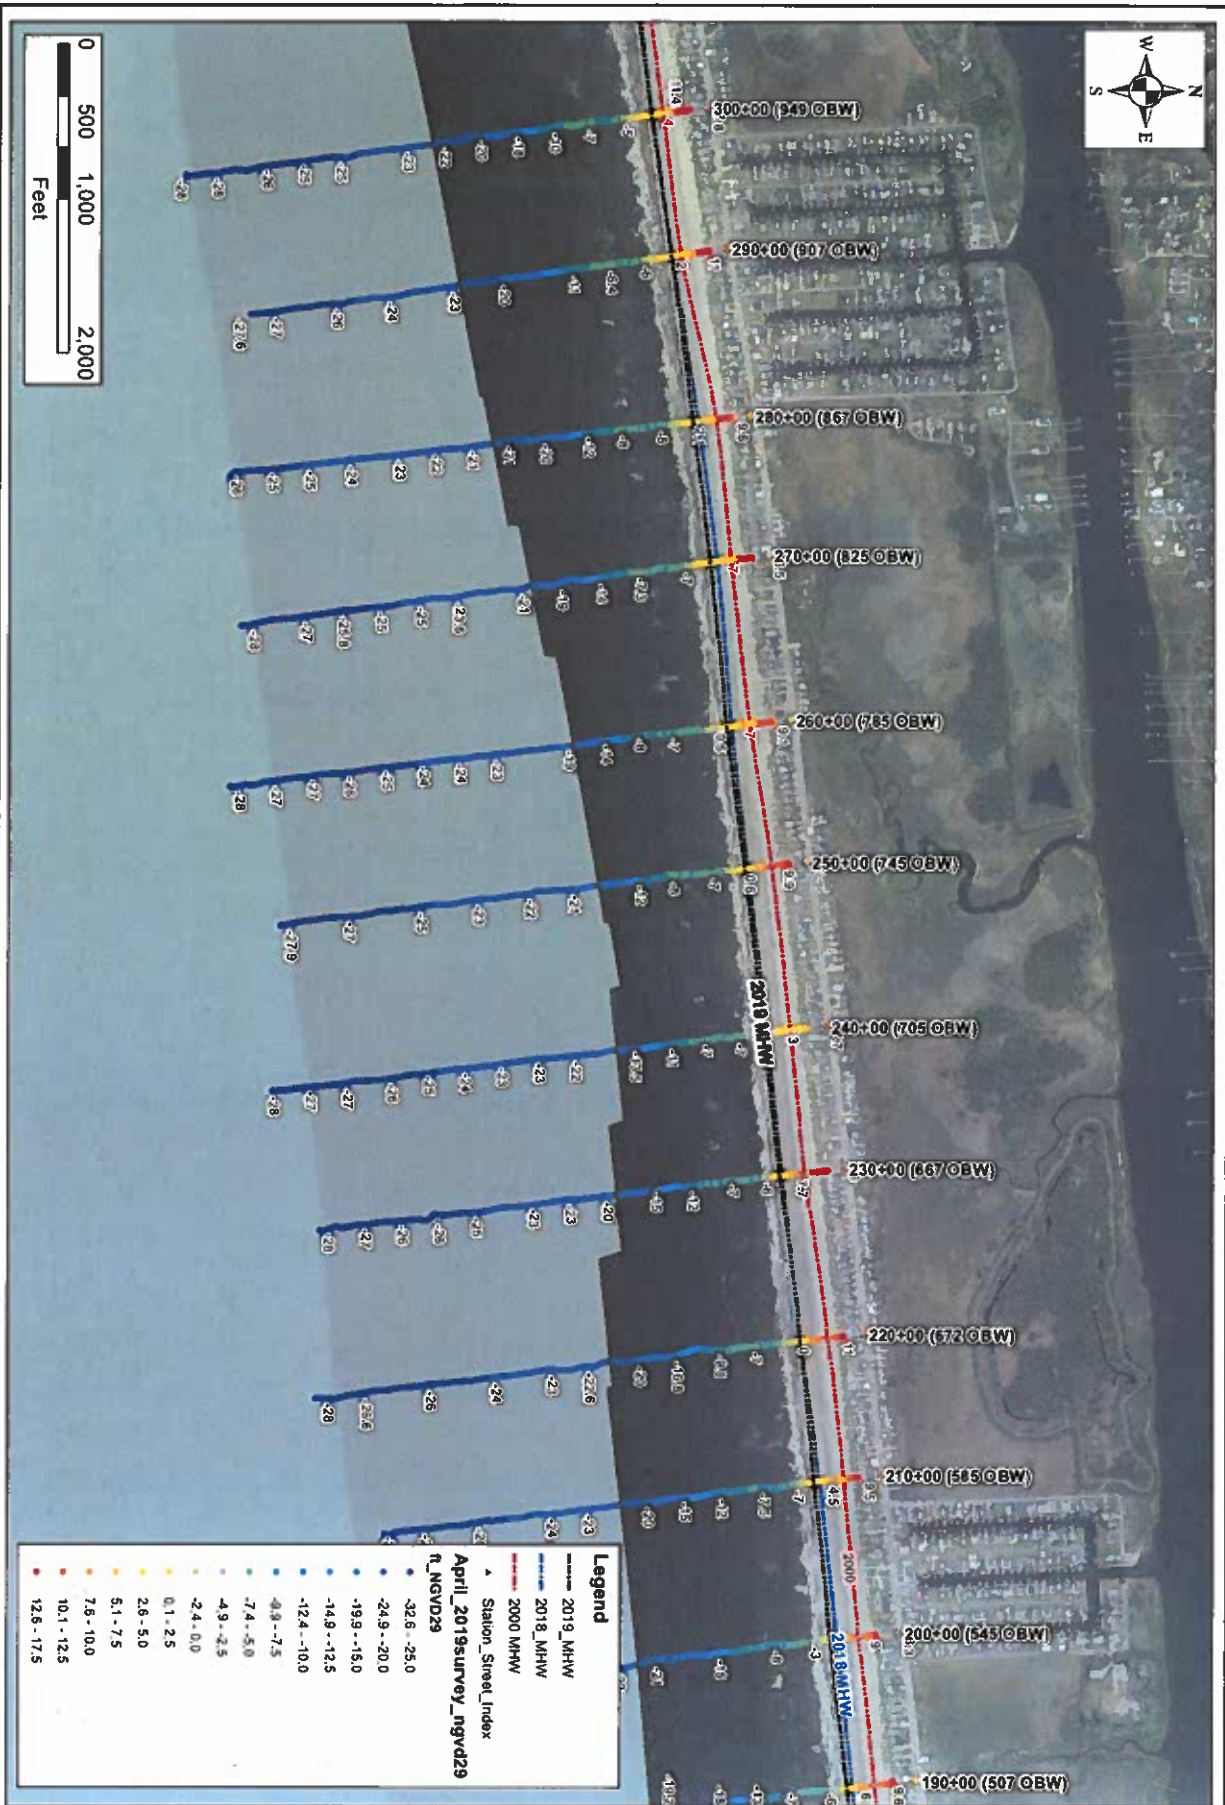
FIGURE B-3
 2019 Survey Data and Established Monitoring Stations Shown. 2019 Mean High Water (MHW)
 Shoreline, 2018 MHW Shoreline, and 2000 MHW Shoreline.
 NOAA September, 2018 Post-Florence Aerial Imagery.
