Holden Beach

Annual Beach Monitoring Report

Prepared For:
Town of Holden Beach, North Carolina

November 2020

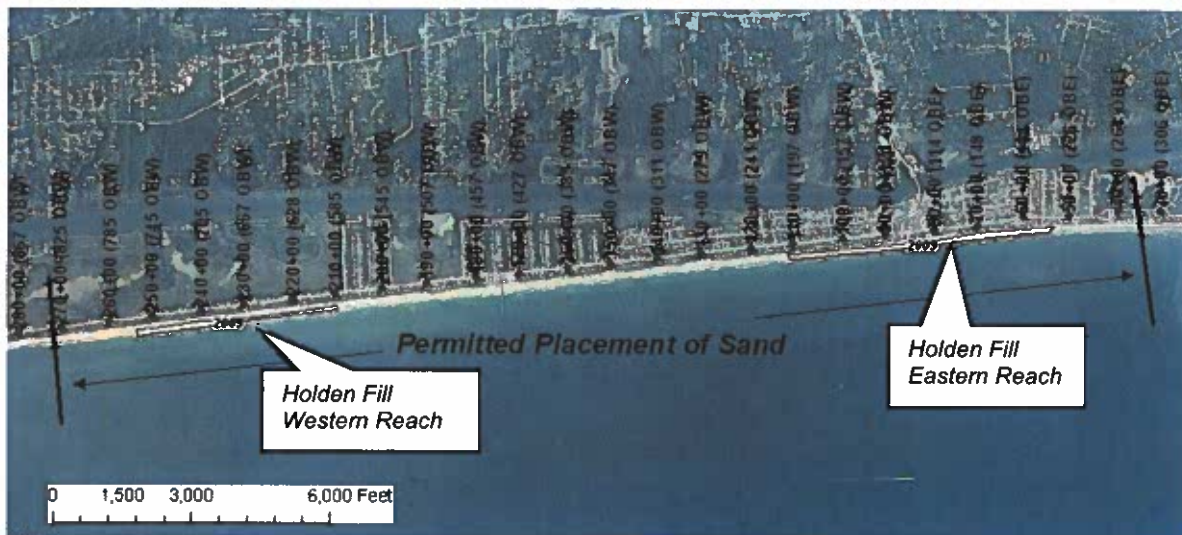
Figure 2-2. 2009 Constructed Project Reaches and 2009 Permitted Sand Placement (the permitted placement has been modified over the years)

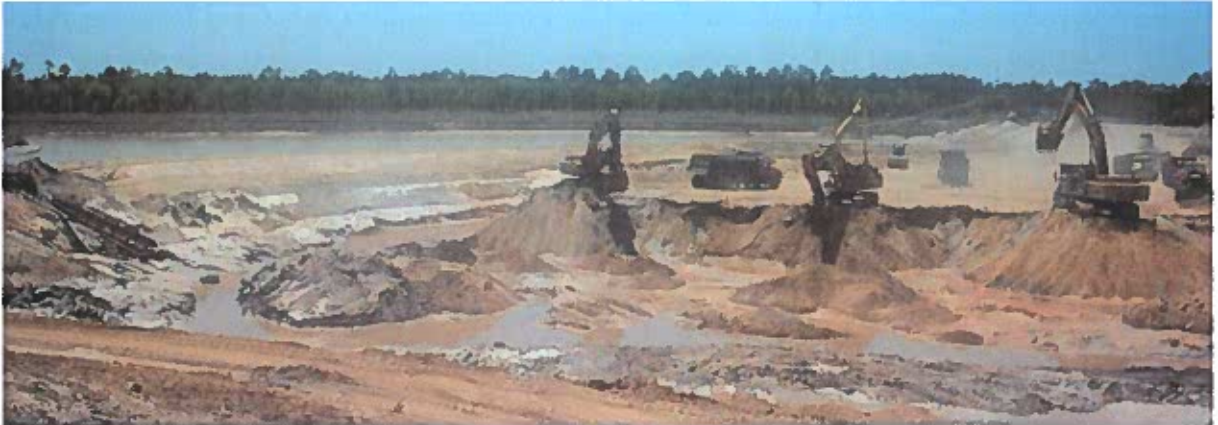
Figure 2-3. Smith Upland Borrow Area during 2009 Holden Beach Nourishment Project

The Town owns the Turkey Trap Road upland borrow site whereas other potential borrow area sites include the Smith borrow site (Figure 2-3) and the Tripp site. The Turkey Trap Road and Smith borrow sites have been successfully permitted, which significantly enhances post-storm mitigation response.

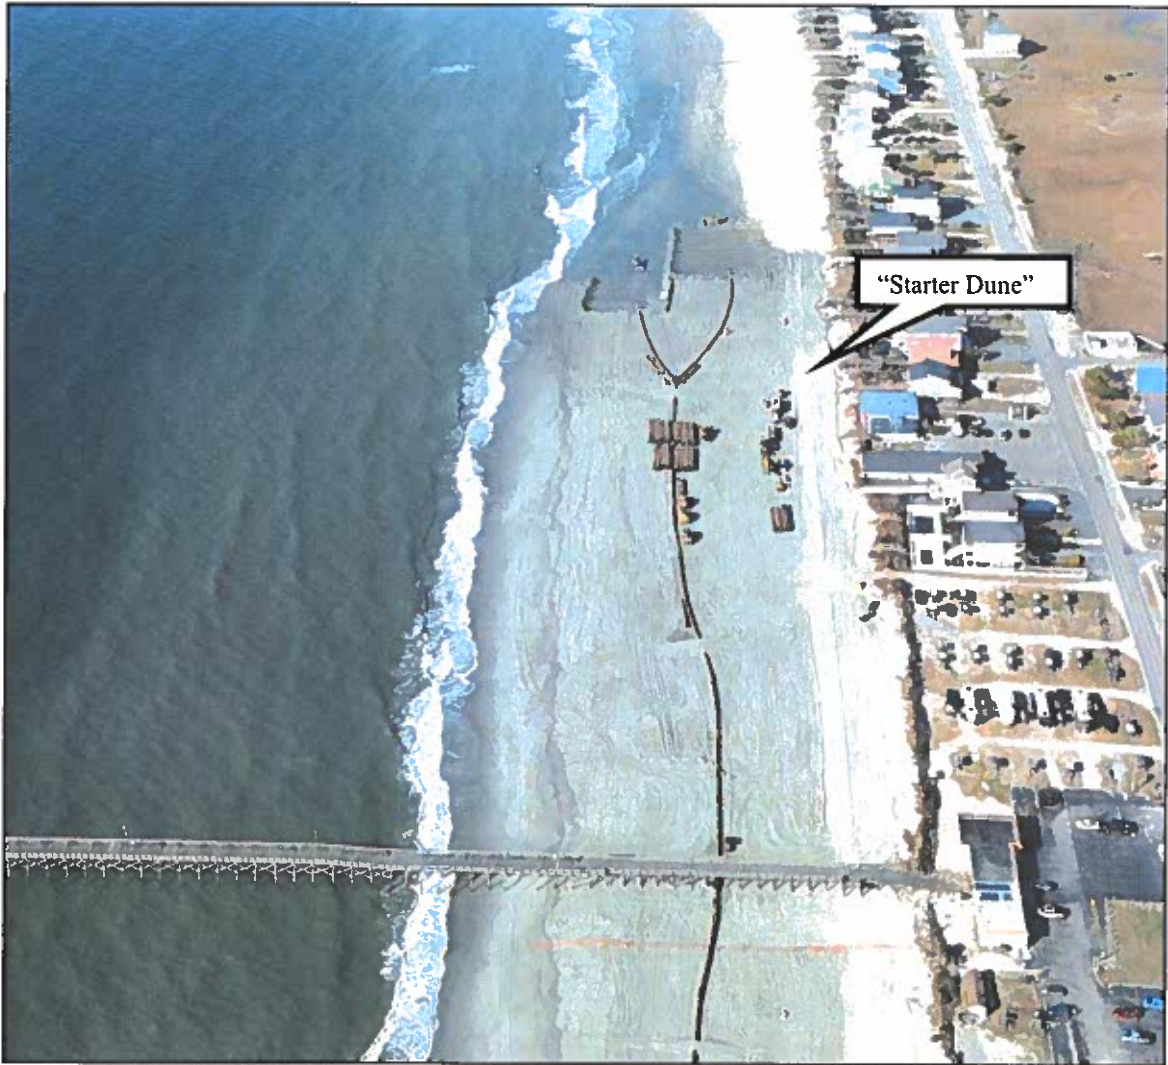
Figure 2-7. Aerial Photograph during Central Reach Construction West of Pier, Approximately Station 180+00 (Weeks Marine/Aerophoto Photo 2/22/17).

With the help of the two hopper dredges, the Weeks Marine crew worked quickly, pumping sand on the beach and progressing at an average rate of about 300 ft of shoreline per day. Despite the minor delays towards the beginning and near the end of the project, the entire nourishment took approximately 74 days and was completed on March 17. Aerial and ground photographs taken during construction are provided in Figures 2-7 and 2-8.

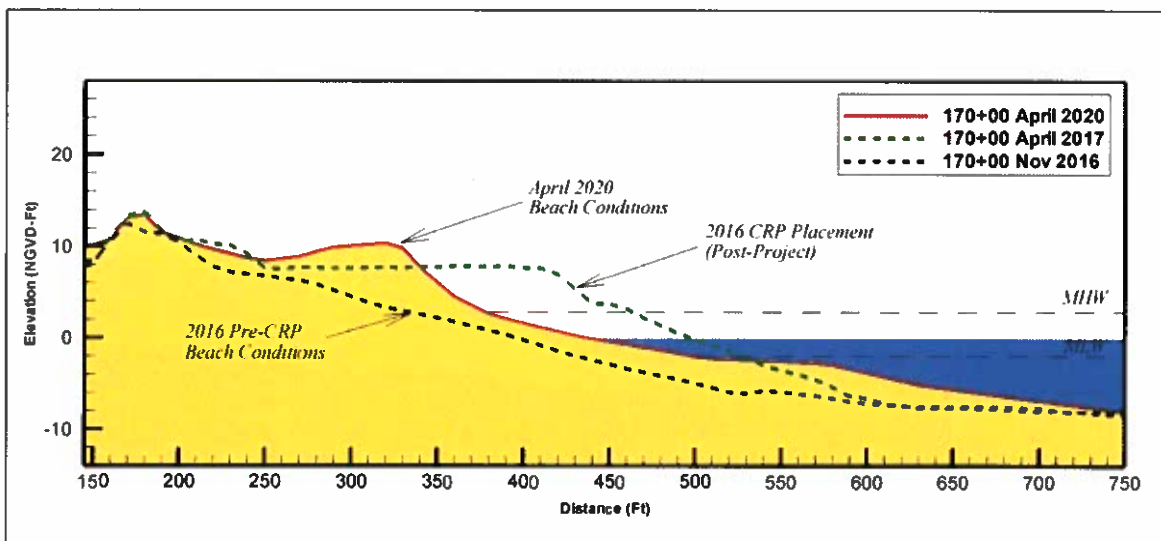
Figure 2-10 (A). Station 170+00 (April 2020) survey compared with pre- and immediate post- Central Reach Project conditions.

Figure 2-10 (A) shows an example profile from the most recent annual survey near the pier (at Station 170+00) illustrating how the beach has changed since the CRP nourishment, and Figure 2-10 (B) presents a photograph of recent beach conditions in this approximate location. Despite anticipated project equilibration, combined with the coastal impacts of several hurricanes, still over 100 feet of dry recreational beach berm remains.

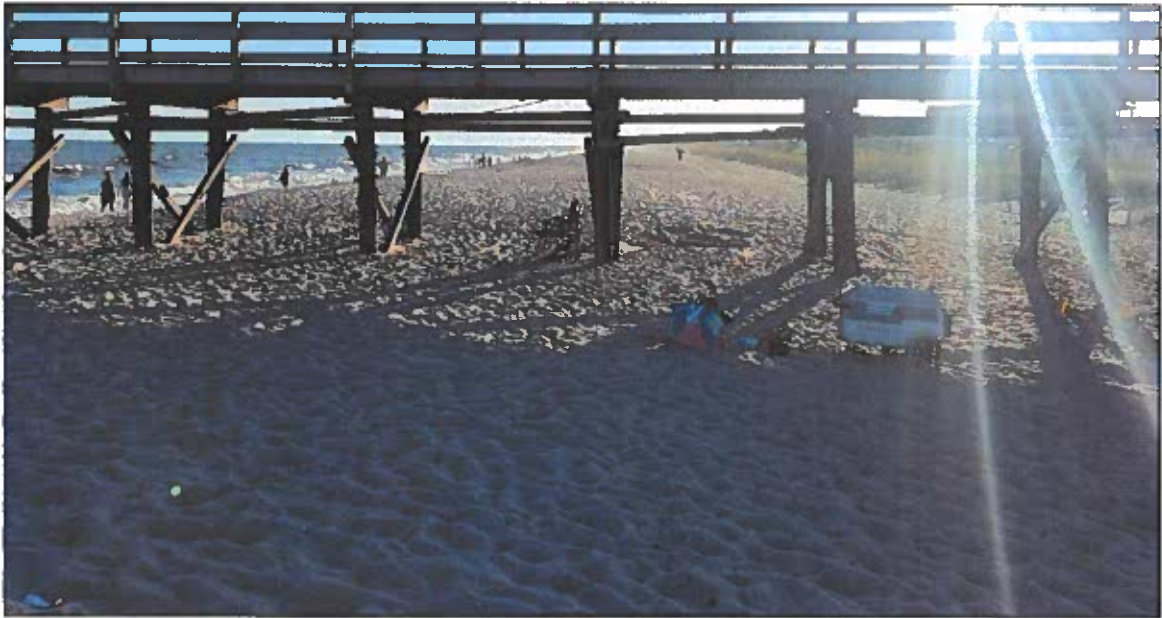
Figure 2-10 (B). July 2020 Photograph Taken Near Pier (~Station 170+00) Looking West.

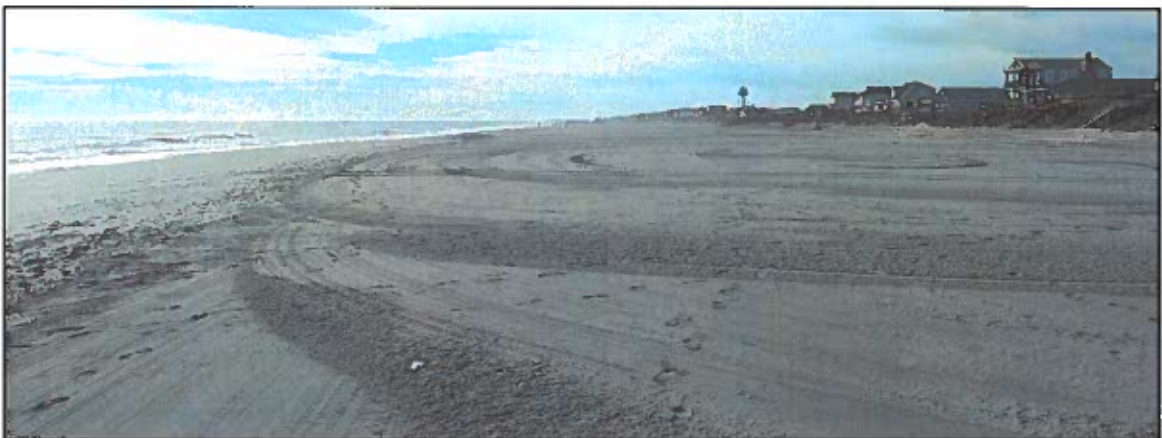
Figure 2-11 (A). Central Reach Immediate Post-Construction Approximately Station 50+00 (ATM photo taken January 2017)

Post-construction monitoring photos are presented in the following figures. Figure 2-11 (A) shows the widened beach conditions immediately following construction. Recent photographs taken 1 to 3 years following construction are presented in Figure 2-11 (B), (C), (D), (E) and (F).

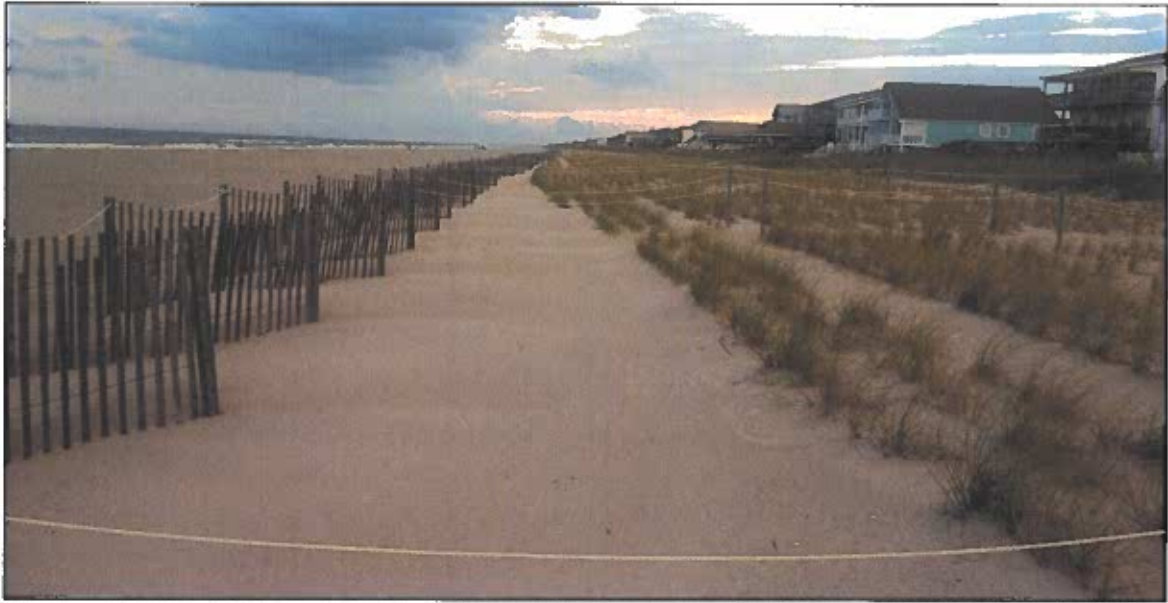
Figure 2-11 (B). Central Reach Post-Construction Approximately Station 230+00 (ATM photo taken August 2018). Note sand fencing, starter dune, and plantings.

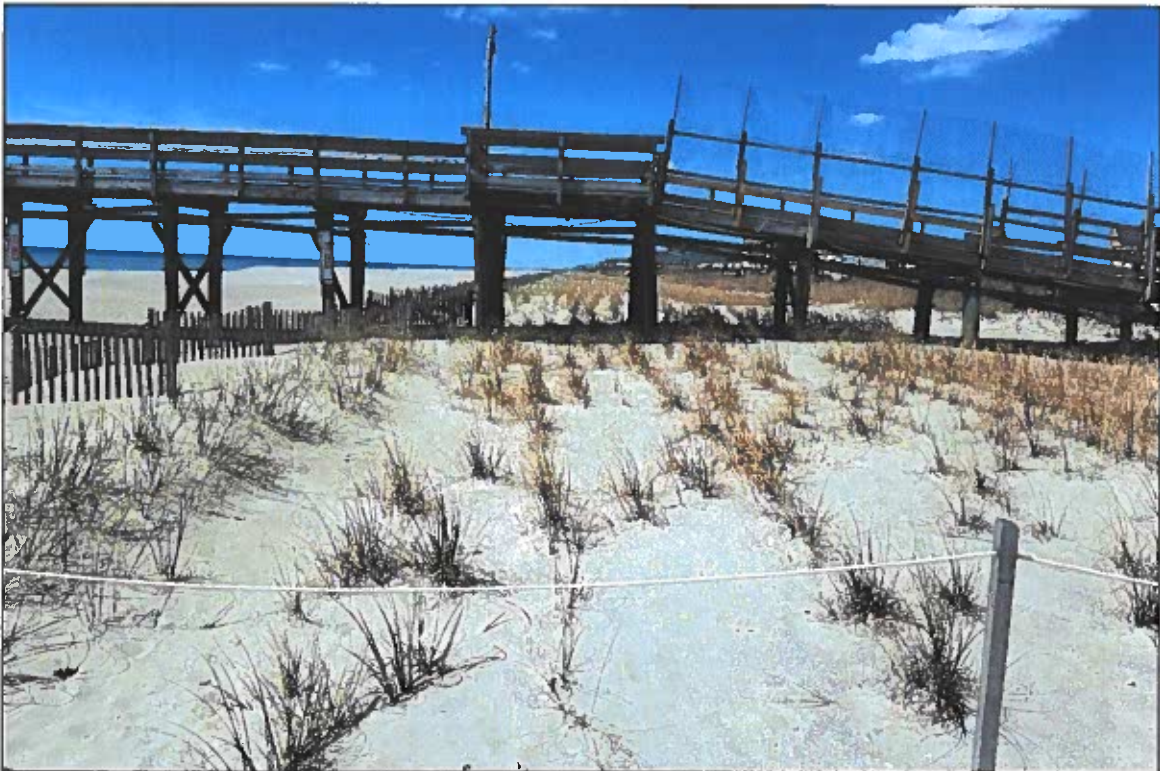
Figure 2-11 (C). Central Reach Post-Construction Approximately Station 170+00 (ATM photo taken March 2019).

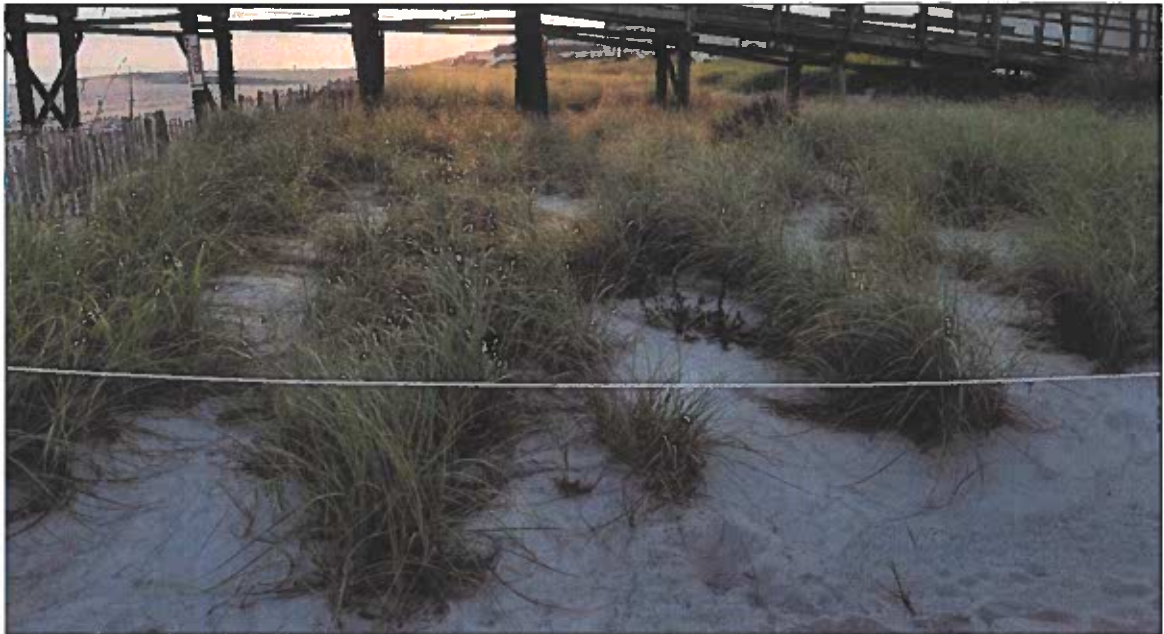
Figure 2-11 (D). Central Reach Post-Construction Approximately Station 170+00 (ATM photo taken September 2019). Note plantings have matured and grown.

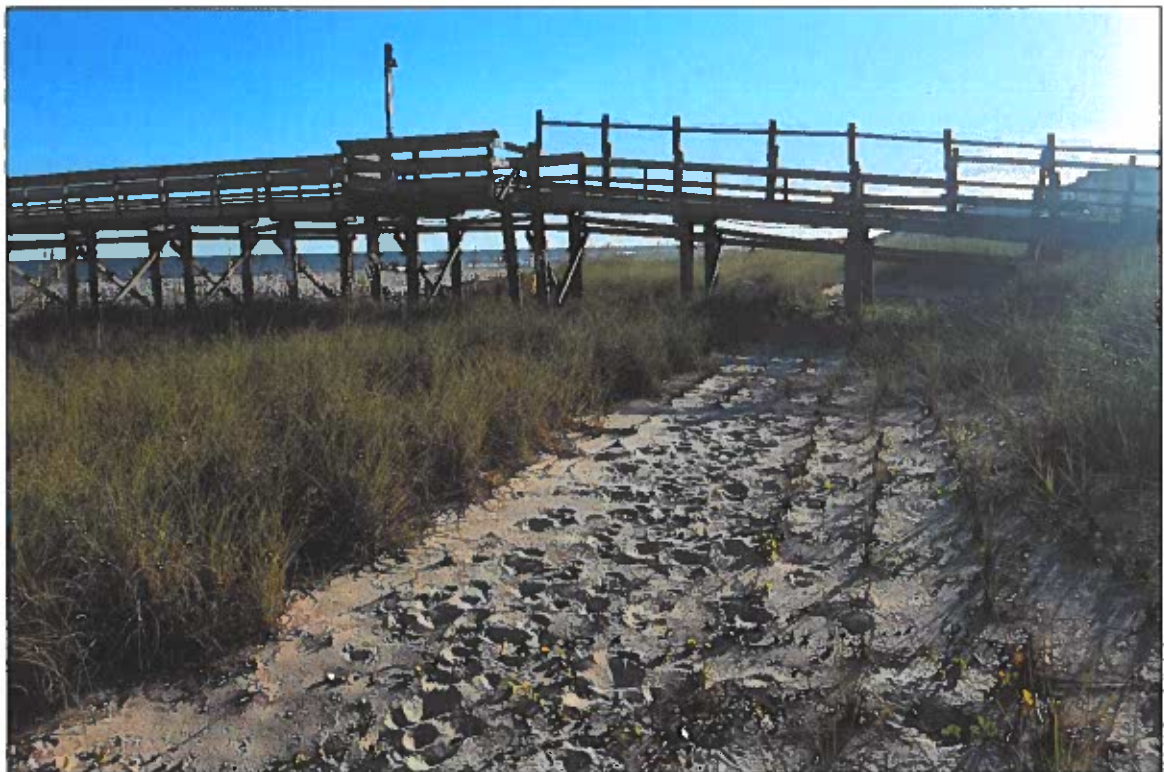
Figure 2-11 (E). July 2020 photo. New plantings along the landward dune.

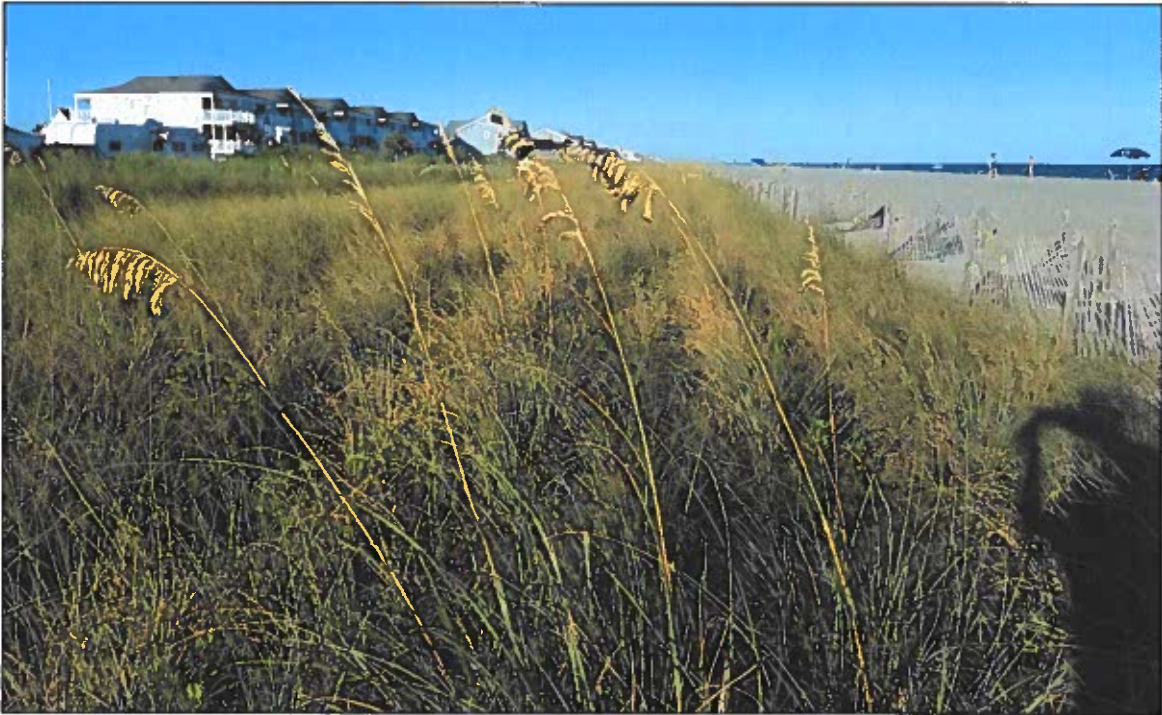
Figure 2-11 (F). Central Reach Post-Construction Approximately Station 170+00 looking east towards pier (ATM photo taken May 2020). Note plantings have matured and grown.

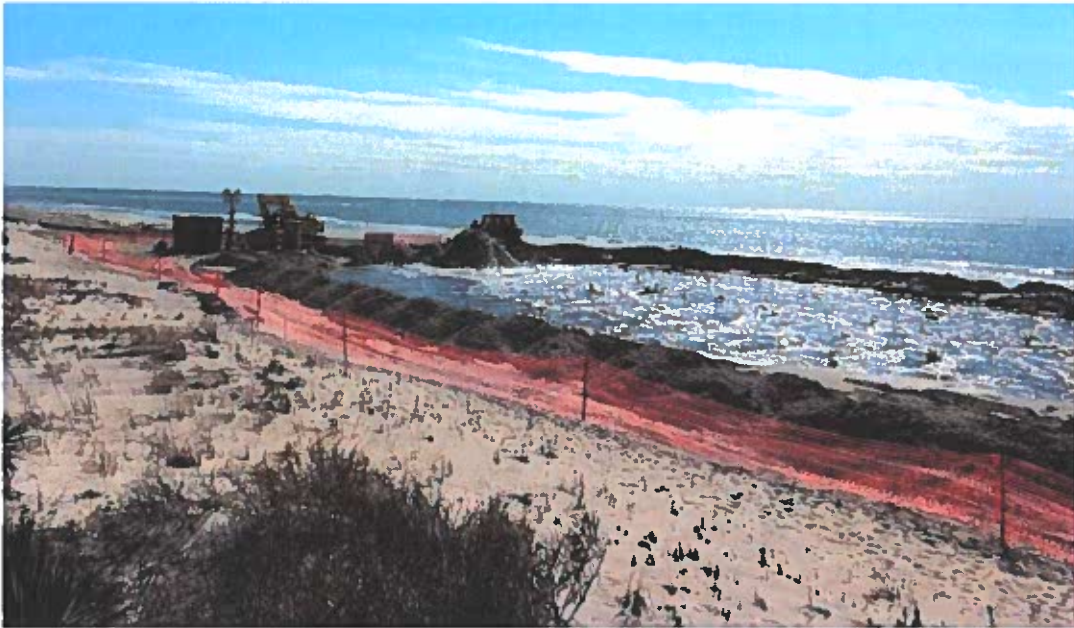
Figure 2-18. Holden Beach POA Photograph Taken near 323 McCray Street (approximately Station 26+00) during 2017 Eastern Reach Project construction.

The Eastern Reach Project was very successful, and photographs taken during construction are presented in Figures 2-18 and 2-19. The Town involvement allowed for the placement of an additional 60,000 cy at a very inexpensive rate. The cost for the project was \$465,000, and the Town's portion was only about \$76,000 (with the State providing 66.7 percent).

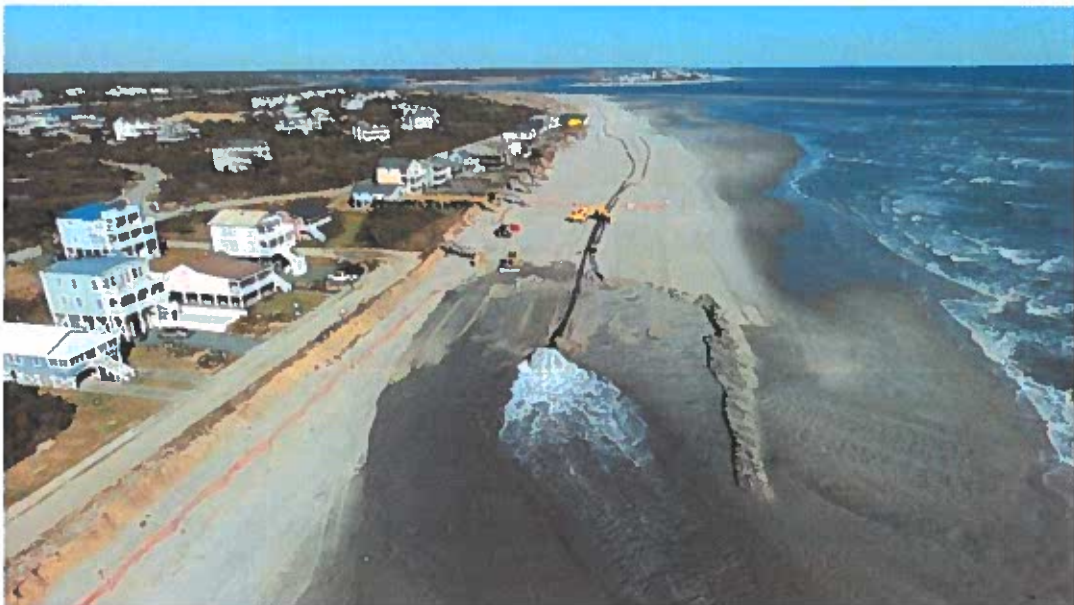
Figure 2-19. Holden Beach POA Aerial Photograph taken during 2017 Eastern Reach Project Construction (pumping just west of Station 30+00).

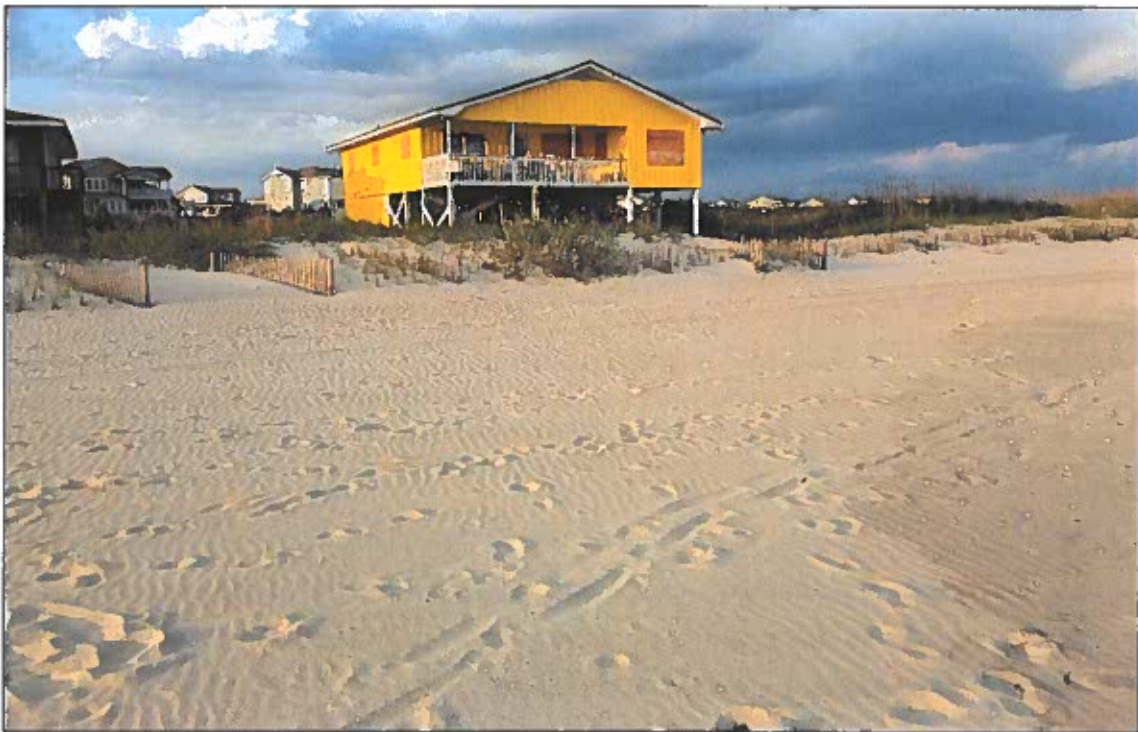
Figure 2-20. Two-Year Post Construction Photo of the 2017 Eastern Reach Project (ATM photo taken April 2018, at Station 20+00). The most eastern oceanfront house, Amazing Grace, is shown. Dune growth has occurred however this is still a vulnerable area.

Figure 2-20 presents a 2-year post-project photograph monitoring the progression of the 2017 Eastern Reach Project. In general and based on site observations, the east end is continuing to benefit from the recent nourishment, however, it does need nourishing every 2 years to avoid extreme erosional conditions that have occurred in past decades. More detail on beach survey monitoring are provided in Section 3.

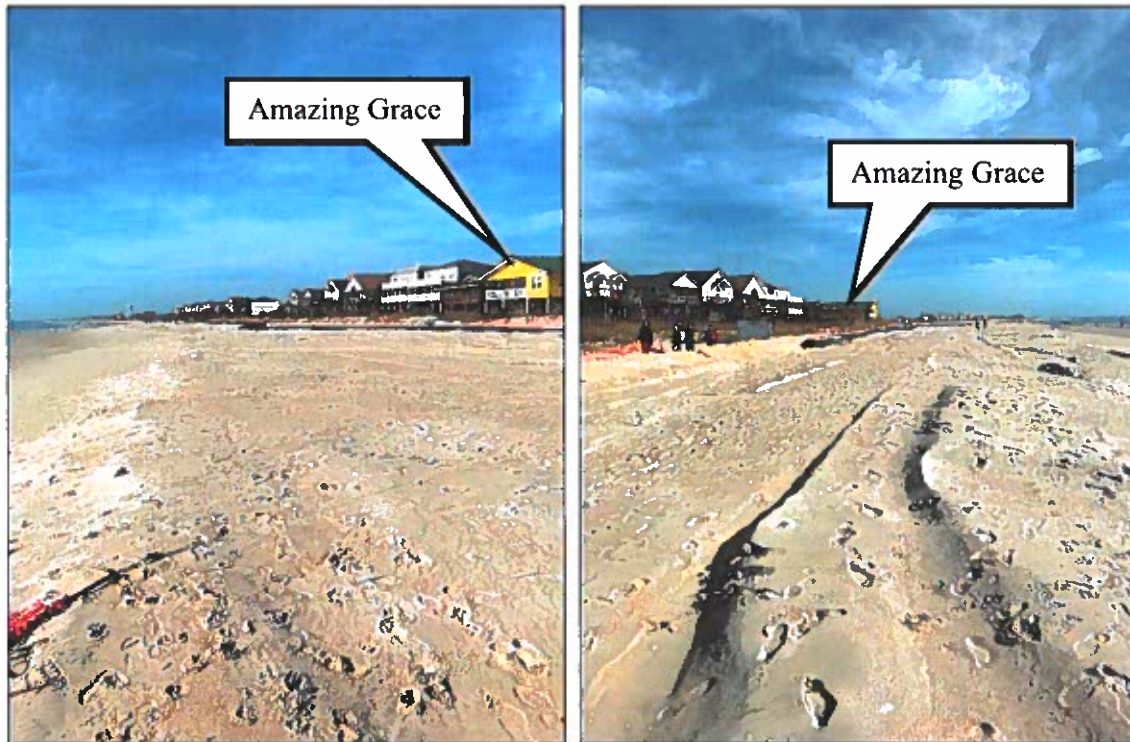
Figure 2-24 (a). Photograph in East End Taken During 2020 LWFIX Construction. (Holden Beach Town Newsletter)

Figure 2-24 presents photographs taken during and after construction of the 2020 LWIFX project placement on the east end. The east end beach conditions were generally healthy prior to the project and the added material has created a wide, dry recreational beach which is much needed along this vulnerable and historically highly erosional shoreline reach. More detail on east end volume changes and recent accretional/erosional trends are provided in Section 3.

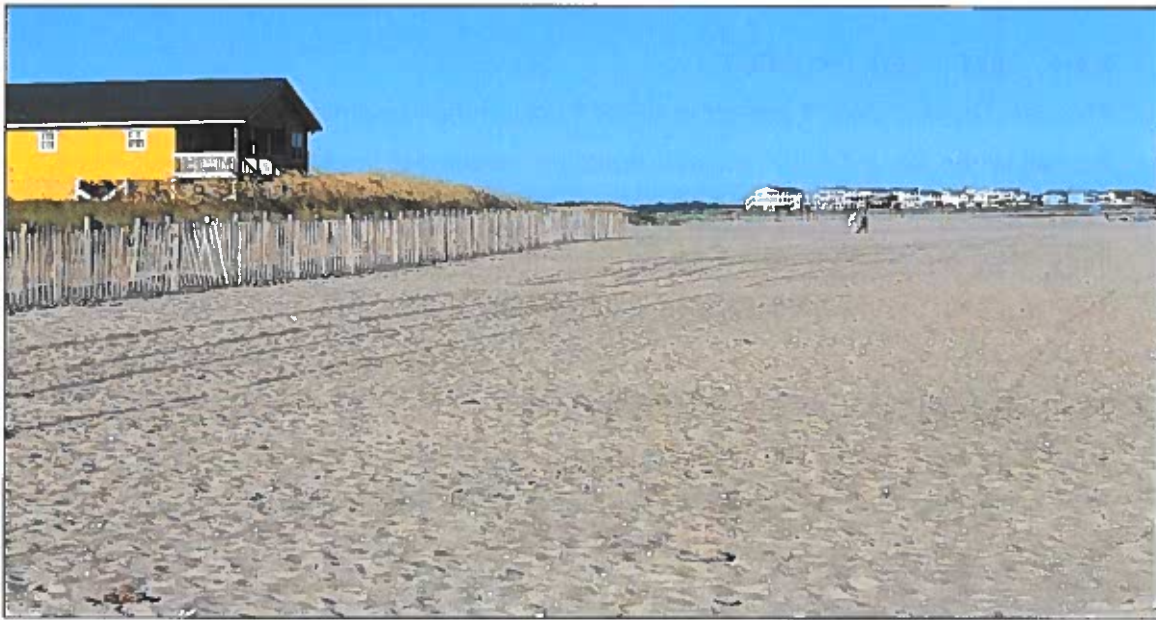
Figure 2-24 (c). July 2020 photograph near Amazing Grace.

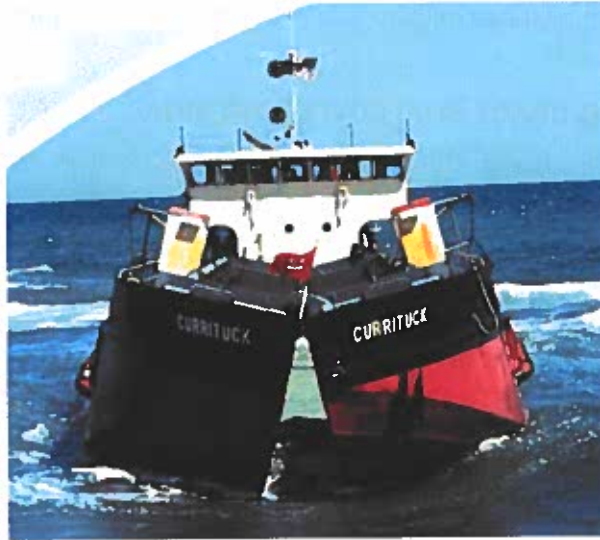
Figure 2-25. USACE Shallow Draft Split-Hull Hopper Dredge the Currituck Rarely Dredges the LWF Inlet

The NC shallow draft inlet dredging program includes two primary elements: 1) inlet and AIWW reaches landward of the Coast Guard COLREGs (collision regulation) line and 2) outer inlet dredging where small dredges must also be "ocean-certified" by the Coast Guard for potentially rough/dangerous inlet conditions (seaward of the COLREGs line). The USACE side-caster the *Merritt* and the two USACE shallow draft hopper dredges, the *Murden* and the *Currituck* (Figure 2-25), are the only vessels that can realistically work the shallow draft inlets seaward of the COLREGs line. Private dredgers have been consulted for these projects, but their equipment generally consists of large cutterhead ocean dredges (high mobilization fees), ocean-going hopper dredges (draft too deep), or barges with clamshell excavator dredges (no pipeline disposal and low productivity).

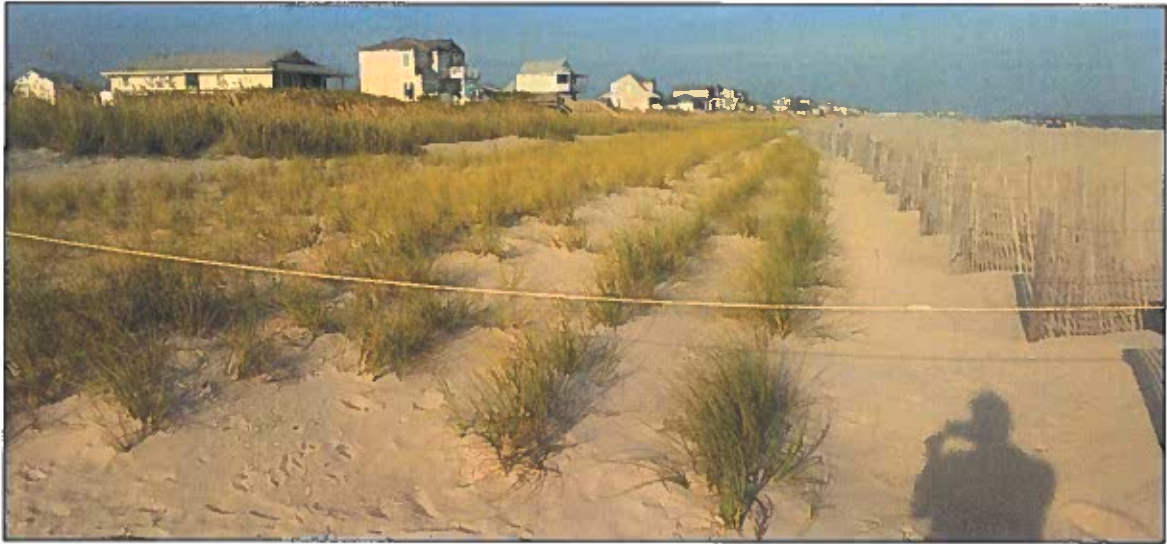
Figure 2-28 (A). Sand Fencing along the Seaward Edge of the Starter Dune for the Central Reach Project at Station ~60+00 Showing Planted Dune Vegetation. (ATM photo, taken August 2018).

The continued diligence and effort of Holden Beach has resulted in a stable and healthy dune system along a majority of the island, although hurricanes still damage the dune system. Dune vegetation planting and sand fencing was a planned component of the CRP and has stabilized and largely restored the dune system along Holden Beach since Hurricane Matthew. Older dune fencing has gradually been buried as a result of dune growth (see Figure 2-28).

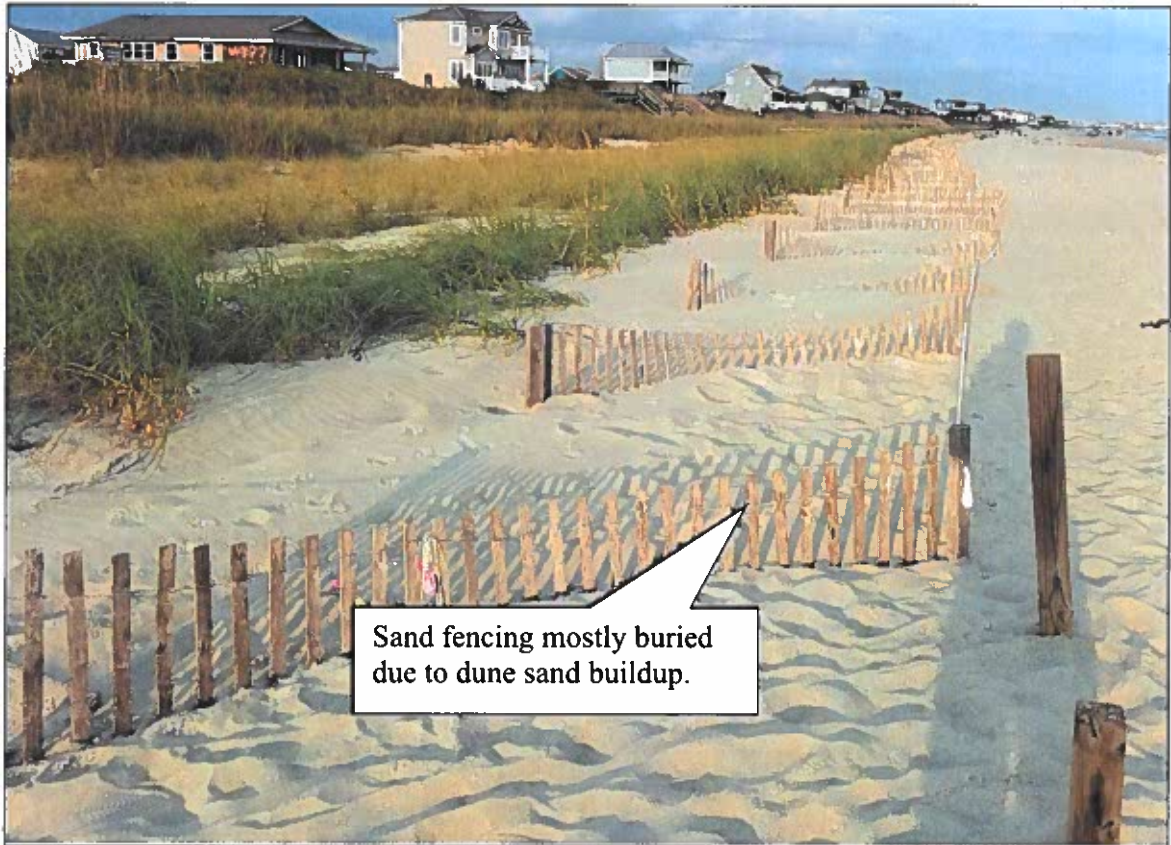
Figure 2-28 (B). Sand Fencing for the Central Reach Project at Station 60+00 showing dune vegetation and sand growth about 2-years post project. (ATM photo, taken September 2019).

Figures 2-29 (A) and (B) present example sections of sand fencing put in place just seaward of the constructed "starter dune" immediately following the 2017 nourishment projects. Post-project monitoring photographs of the starter dunes and plantings are provided in Figures 2-28 (A) - (D). Unfortunately, the observed dune growth recently suffered some substantial damage as a result of Hurricane Isaias in August of 2020. More detail is provided in the following section. Dune planting over the last year consisted of about 150,000 plants (sea oats and bitter panicum).

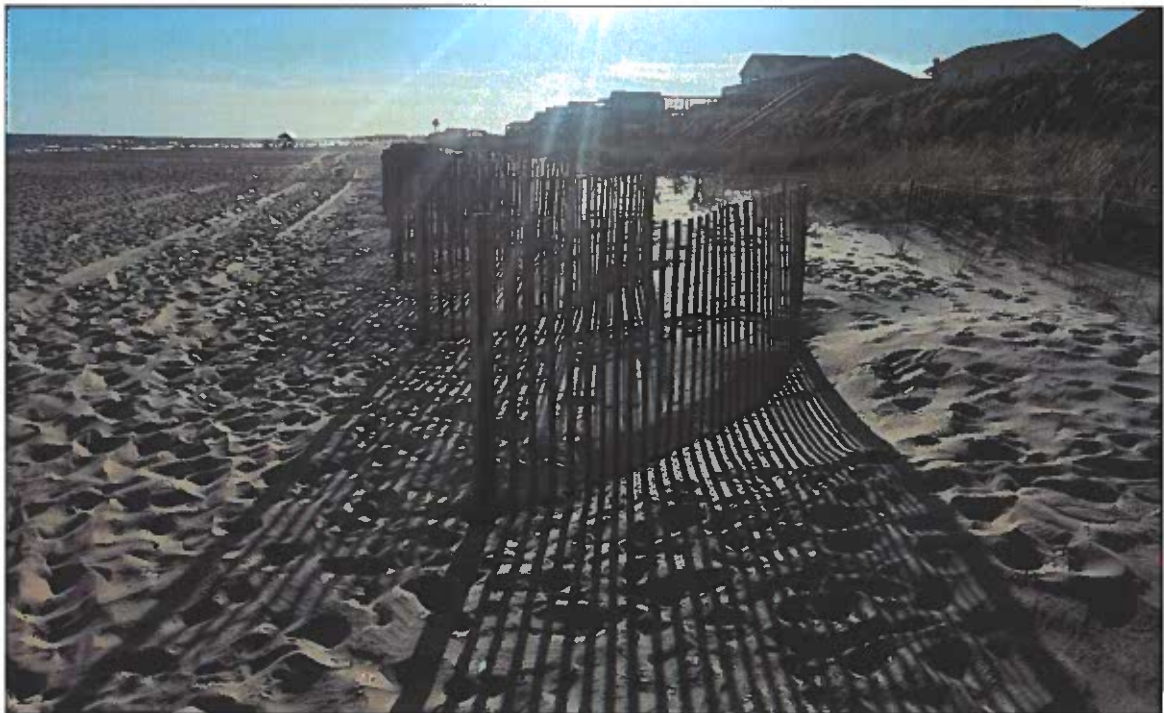
Figure 2-28 (D). July 2020 (east end) showing dune growth behind sand fencing.

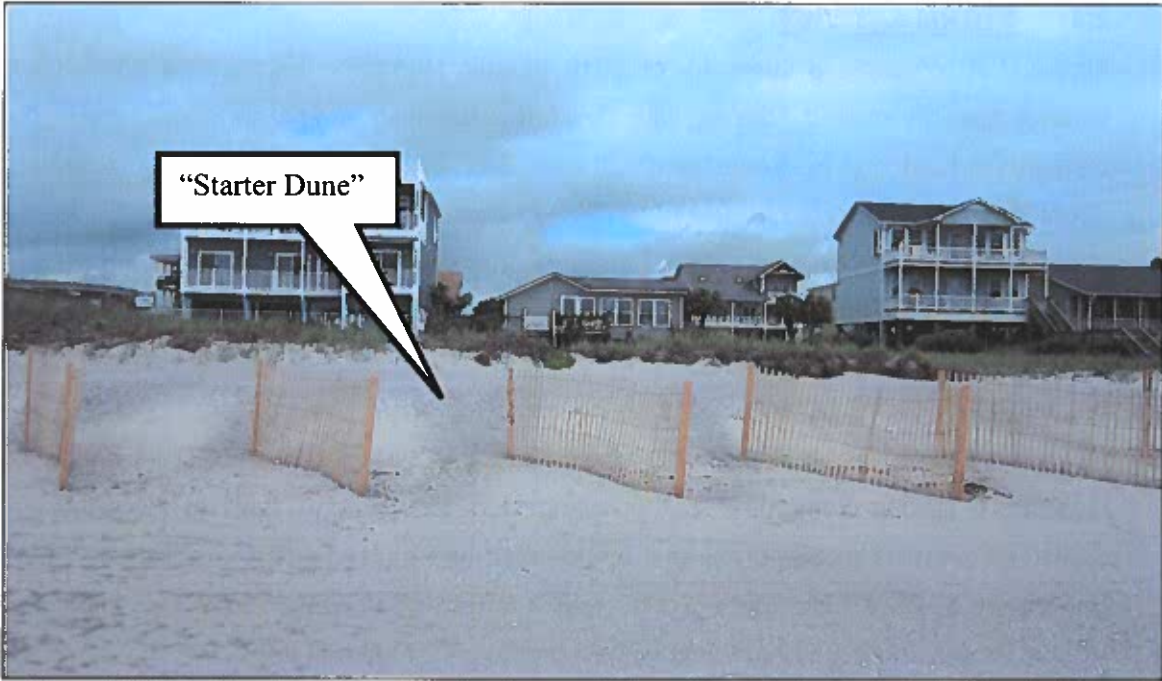
Figure 2-29 (A). Sand Fencing along the Seaward Edge of the Starter Dune for the Central Reach Project at Station ~60+00. Vegetation has been planted on the starter dune since photograph date. (ATM photo, taken May 2017).

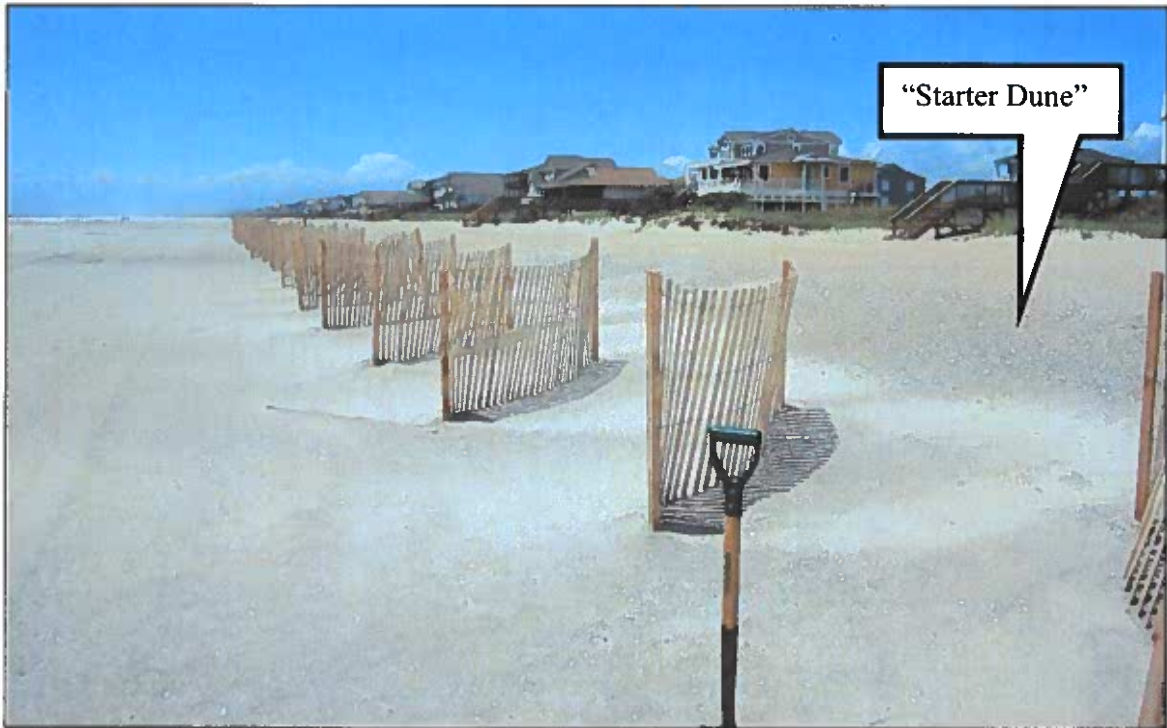
Figure 2-29 (B). Sand Fencing along the Seaward Edge of the Starter Dune for the Central Reach Project at Station ~230+00. Vegetation has been planted on the starter dune since photograph date. (ATM photo, taken May 2017).

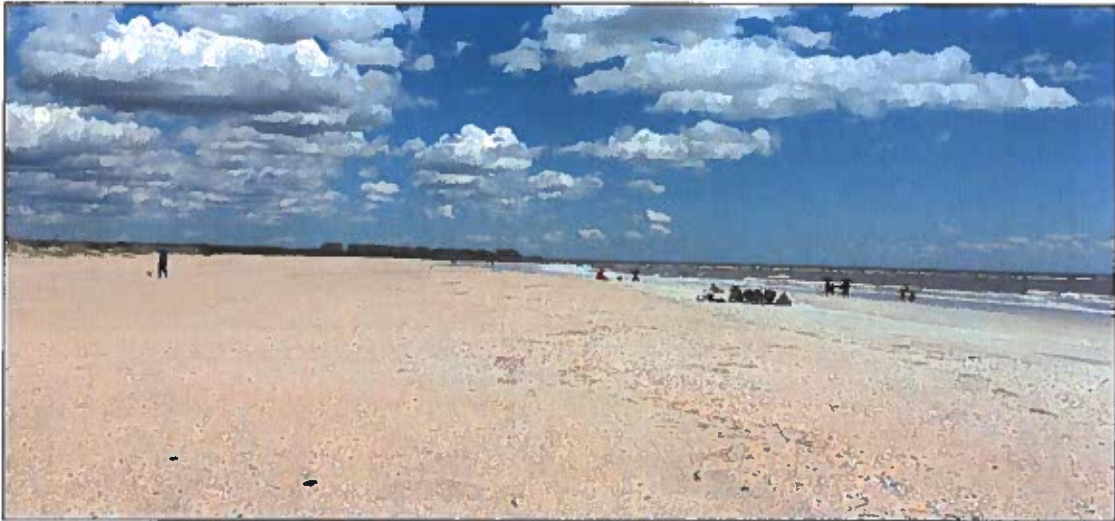
Figure 3-6 (A). Recent Photograph of East End Beach Conditions Taken near Station 20+00 Looking East. 2020 LWIFX Placement Brought Accretion and Upper Beach Growth Over the Past Year in What Is Typically an Erosional Hotspot Area (ATM Photo Taken May 2020).

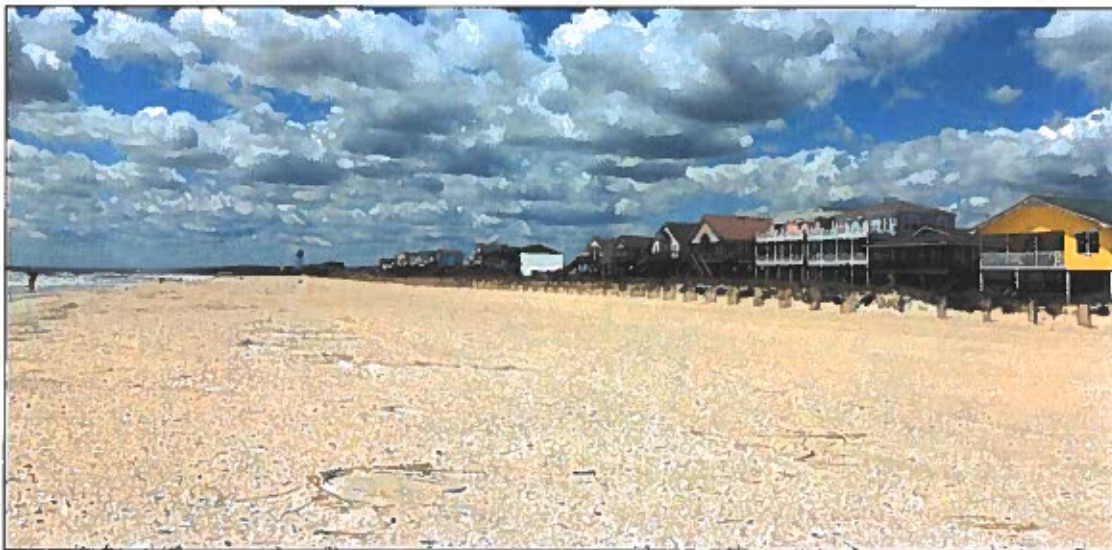
Figure 3-6 (B). Recent Photograph of East End Beach Conditions Taken near Station 20+00 Looking West. 2020 LWIFX Placement Brought Accretion and Upper Beach Growth Over the Past Year in What Is Typically an Erosional Hotspot Area (ATM Photo Taken May 2020).

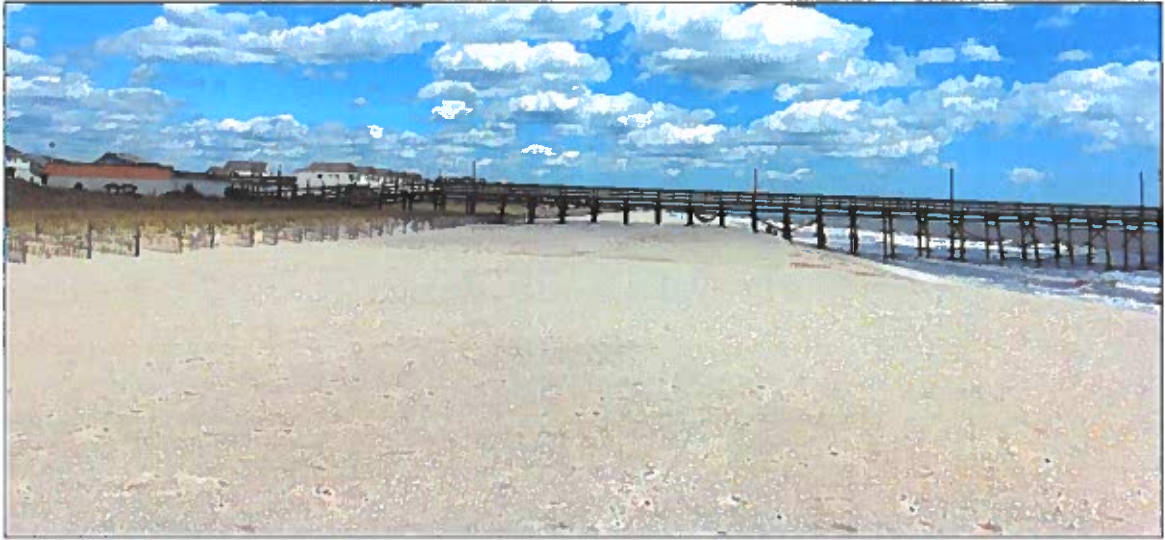
Figure 3-8 (A). Central Reach May 2020 Photo Taken Near Station 180+00 Looking East.

Figure 3-8 (A) presents a photograph in the Central Reach near the pier. Despite recent storms, a wide, healthy dry beach still characterizes the Central Reach shoreline as a result of the large nourishment effort in 2017.

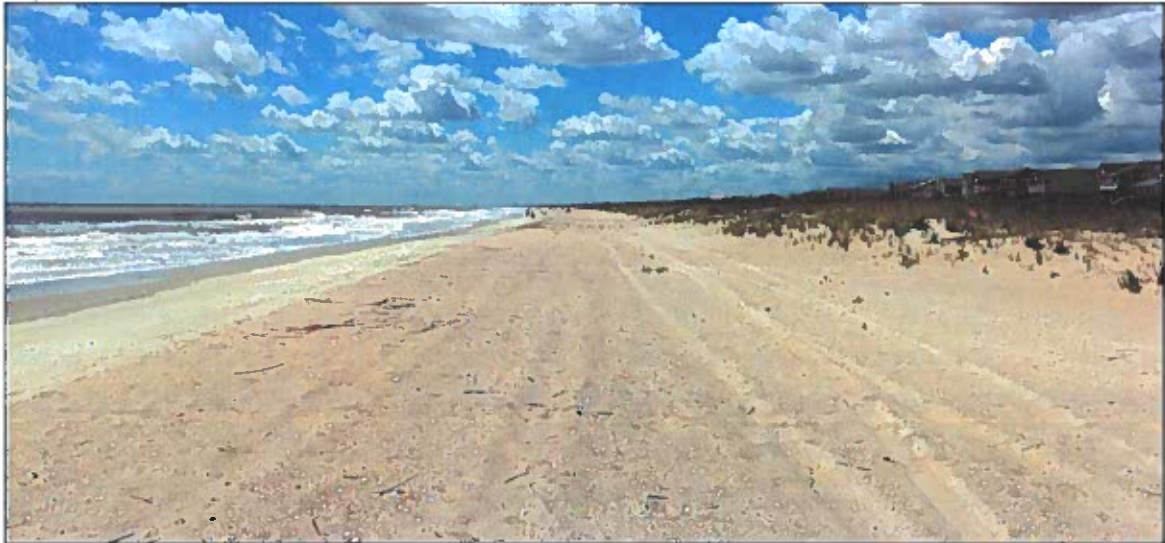
Figure 3-8 (B). West Area May 2020 Photo Taken Near Station 330+00 Looking West.
