Holden Beach

Annual Beach Monitoring Report

Prepared For:
Town of Holden Beach, North Carolina

November 2020

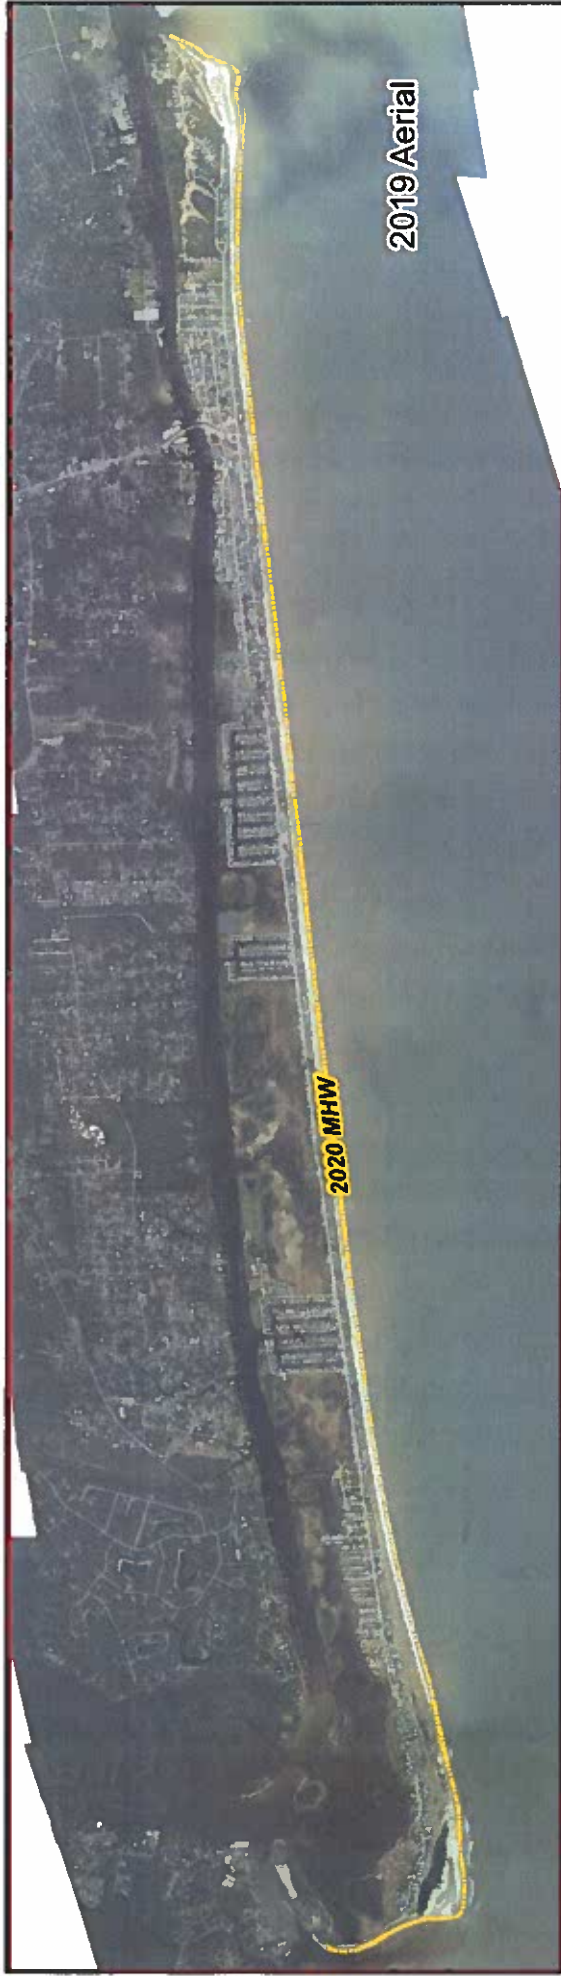
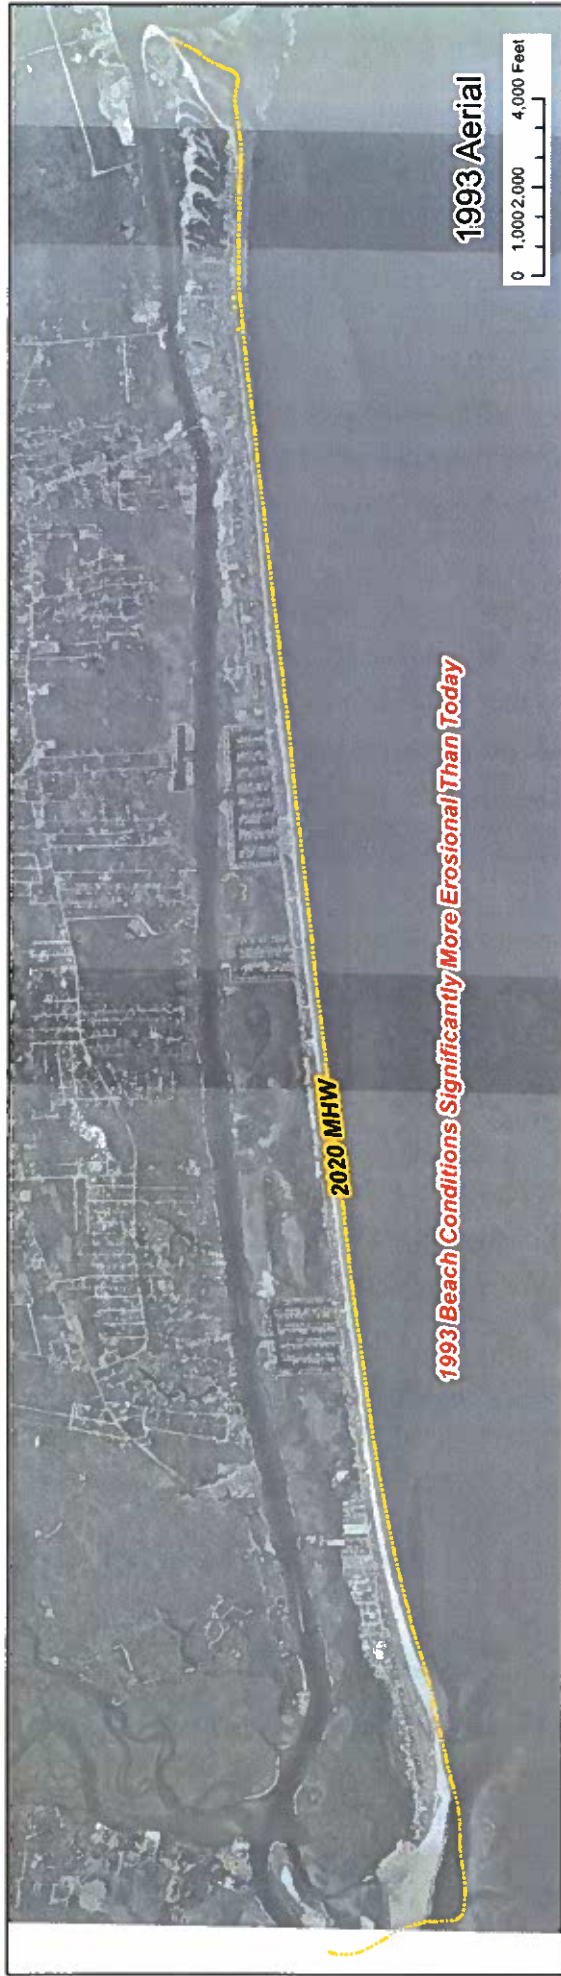
Figure 3-14
 1993 and 2019 Aerial Comparison with 2020 Mean High Water (MHW) line.
 2019 aerial and 2020 MHW Line shows overall accretion in comparison with 1993 conditions.

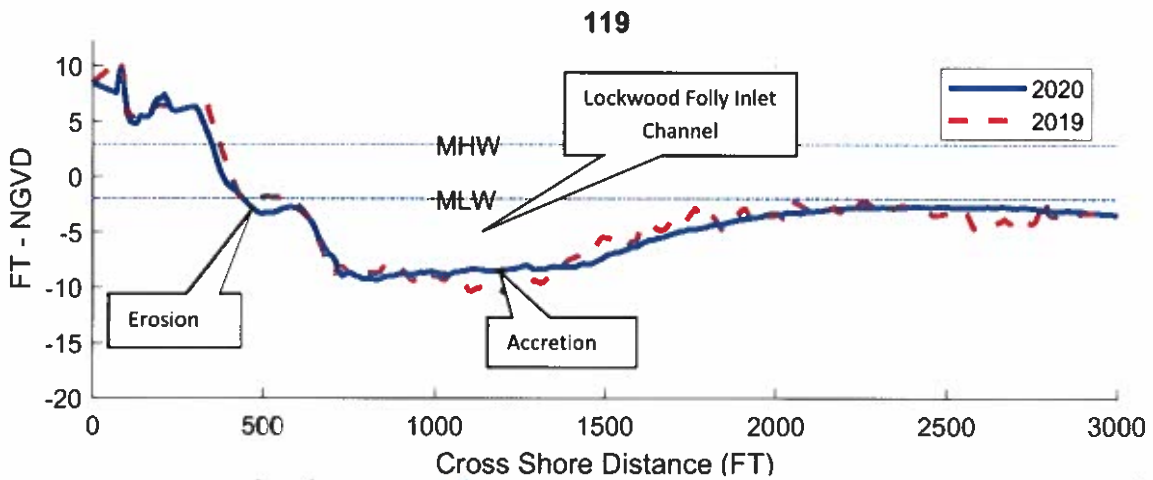
Station 119+00. Upper and intertidal beach showing erosion. LWF Inlet Channel appears relatively stable but some "filling in" of sand is observed as the channel has become shallower since the 2019 survey.
