# Holden Beach

## Annual Beach Monitoring Report

Prepared For:  
Town of Holden Beach, North Carolina

January 2024

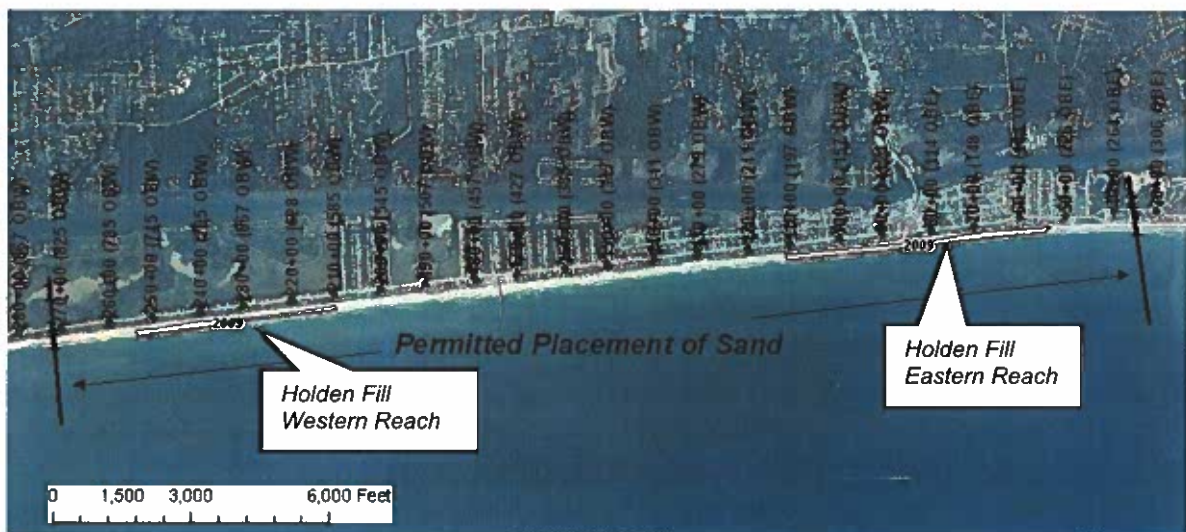
Figure 2-2. 2009 Constructed Project Reaches and 2009 Permitted Sand Placement (the permitted placement has been modified over the years)

The Town has a history of successful upland fill projects, with the most recent occurring in 2009, primarily as Hurricane Hanna mitigation. Approximately 115,000 cy was placed between Stations 55+00 and 110+00 [21 cubic yard per linear foot (cy/lf) average] along the Eastern Reach and 75,000 cy between Stations 210+00 and 255+00 (16.5 cy/lf average) along the Western Reach. Figure 2-2 illustrates the placed-fill footprint and the permitted footprint. Sand was obtained from the Smith upland borrow site.

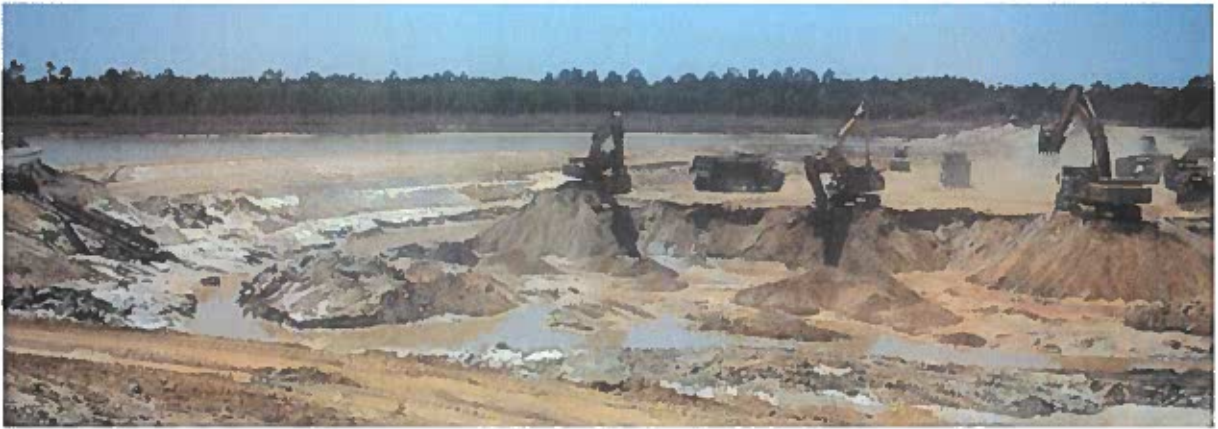
*Figure 2-3. Smith Upland Borrow Area during 2009 Holden Beach Nourishment Project*

The Town owns the Turkey Trap Road upland borrow site whereas other potential borrow area sites have been used in the past and may be available in the future. The Turkey Trap Road and other upland borrow sites (such as the Smith site shown in Figure 2-3) have been successfully permitted, which significantly enhances post-storm mitigation response time.

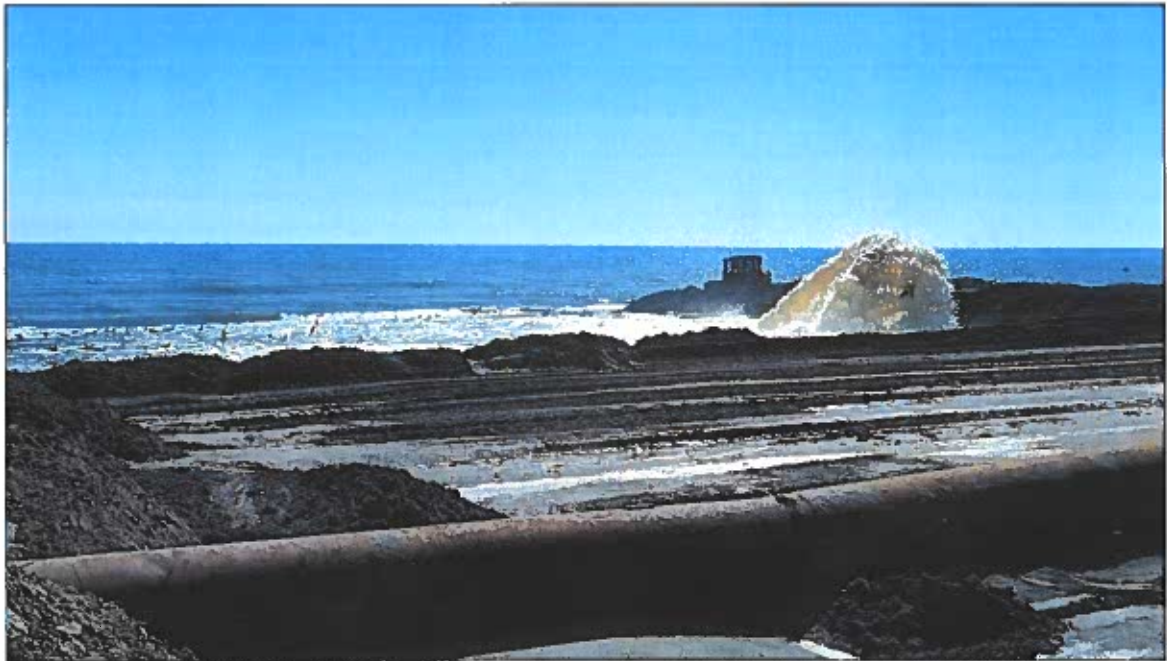
*Figure 2-7 (C). CRR Construction Ground Photo (ATM photo taken 03/03/2022).*

With the help of the two hopper dredges, the Weeks Marine crew worked quickly, pumping sand on the beach and progressing at an average rate of about 300 feet of shoreline per day. Aerial and ground photographs taken during construction can be seen in Figures 2-7 (A-D).

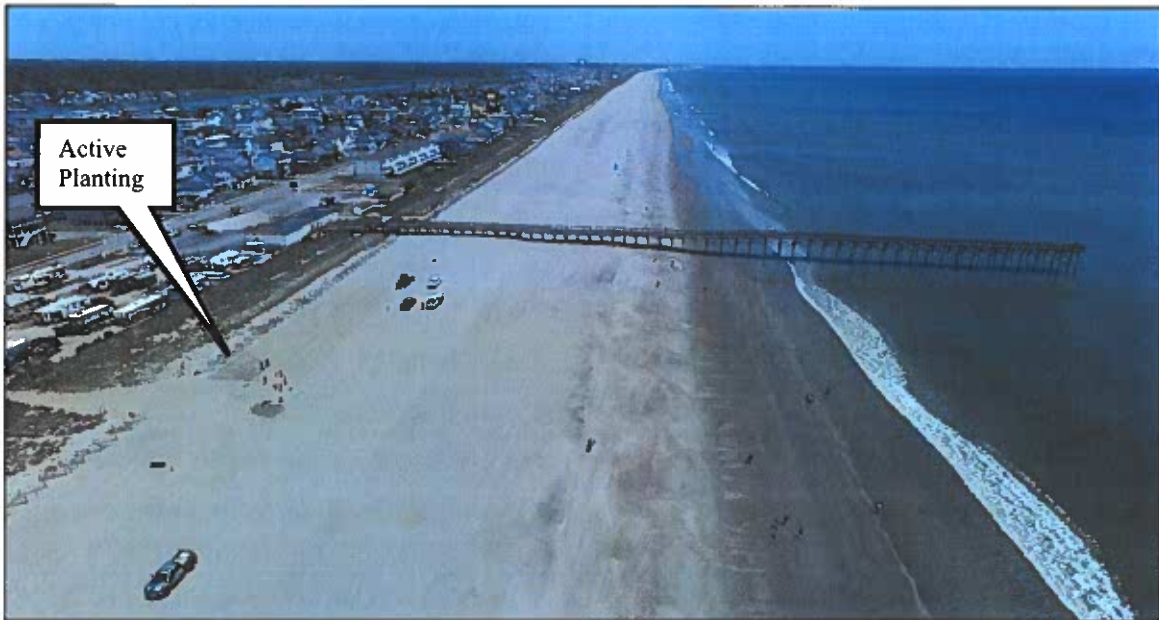
Figure 2-7 (D). Aerial Photograph Take From ~Station 180+00 Following CRR Construction During Active Planting Efforts Near Pier (ATM photo taken 04/28/2022).

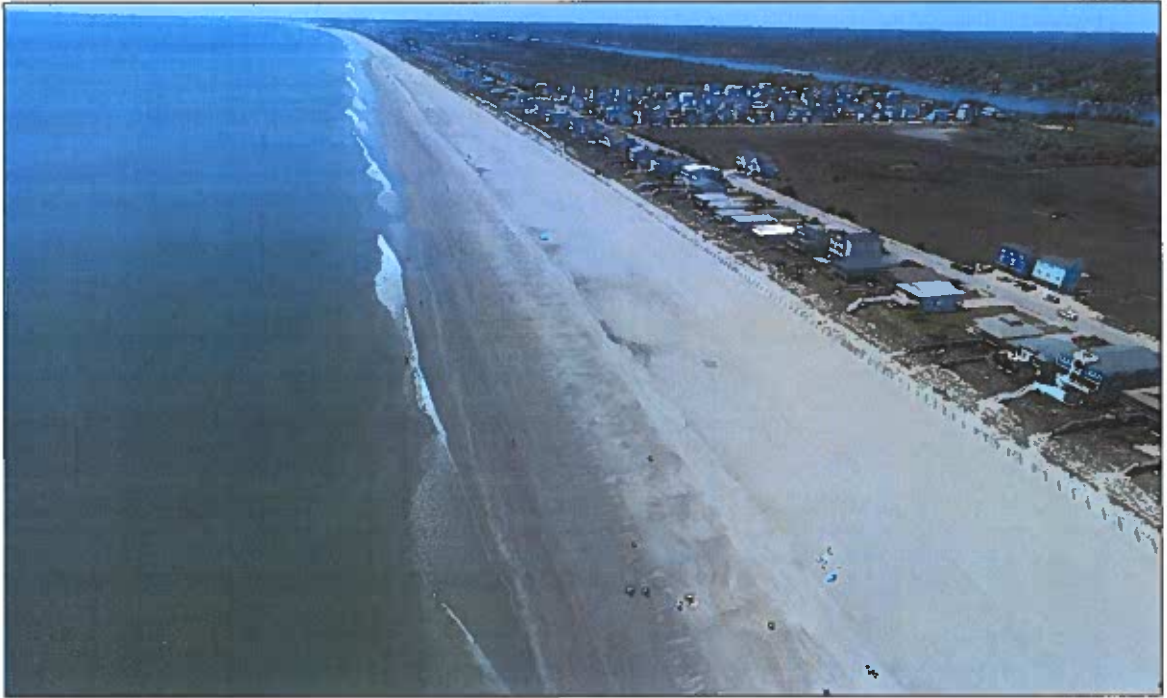
*Figure 2-9 (B). CRR Post-Construction Aerial Photograph Taken Near Pier looking west (ATM photo taken 04/28/2022).*

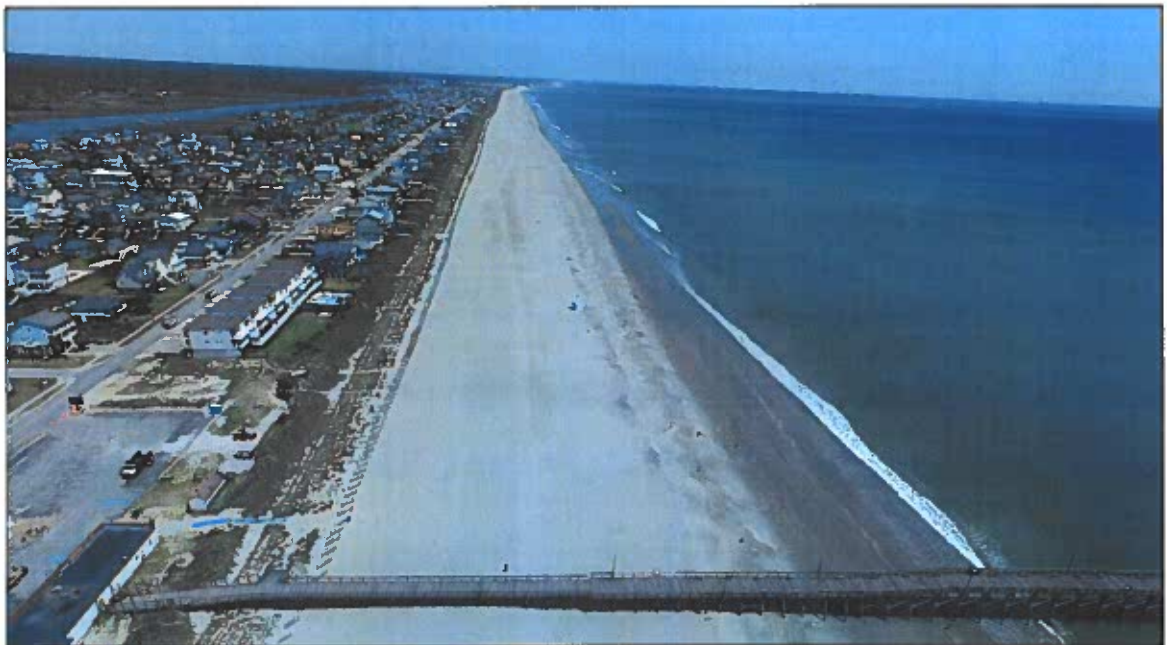
*Figure 2-9 (C). CRR Post-Construction Aerial Photograph Taken Near Pier looking east (ATM photo taken 04/28/2022).*

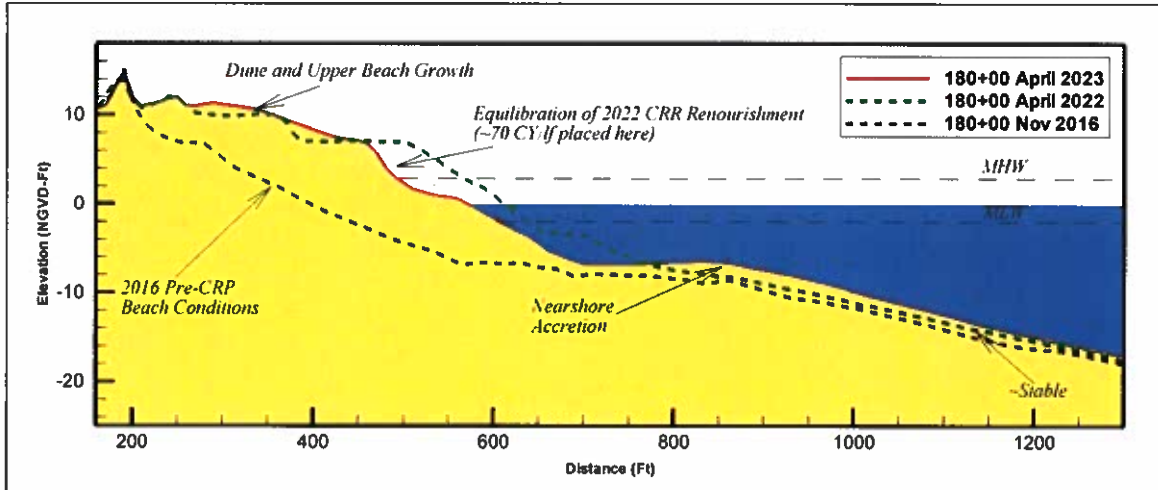
Figure 2-10. Station 180+00 1-yr post-CRR nourishment survey (April 2023) compared with immediate post-CRR survey (April 2022) and pre-2017 Central Reach Project (November 2016) conditions.

The 2023 survey and site observations reveal the nourishment is equilibrating and spreading. Additionally, the project held up well from Hurricane Ian impacts in September 2022. Figure 2-10 shows an example profile from the most recent annual surveys (2023 and 2022) and from November 2016, prior to the 2017 CRP nourishment, at a location just west of the pier (at Station 180+00) illustrating how the beach has changed over the past year since the 2022 CRR and relative to 2016 pre-CRP conditions.

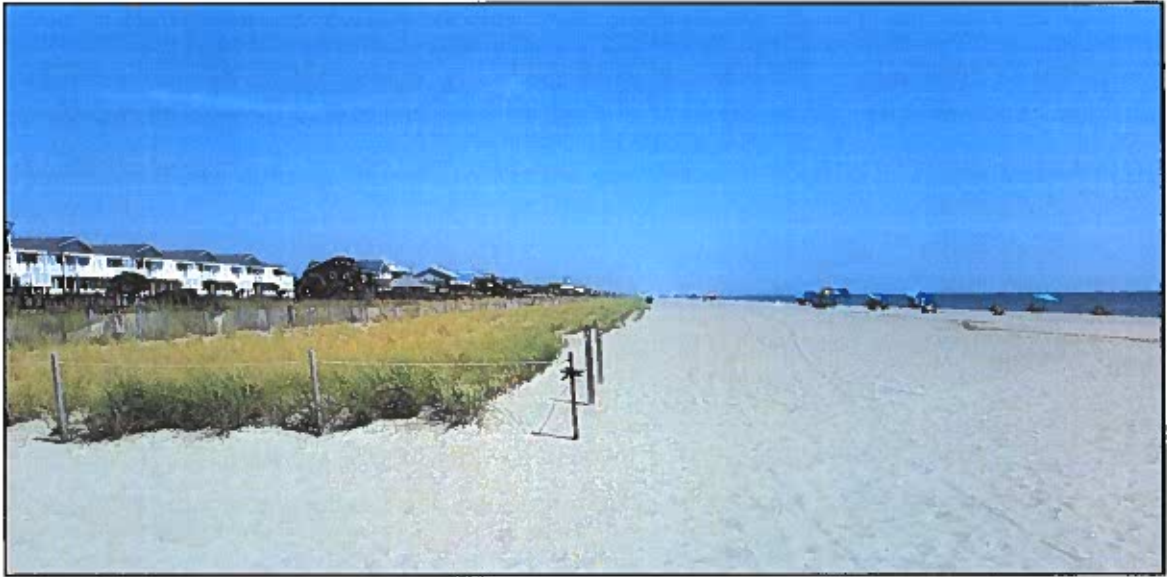
Figure 2-11 (A). CRR ~1.5 Year Post-Construction Photo Just East of Pier Near Station 170+00 (photo taken September 2023).

Recent photographs taken approximately 1 to 1.5 years following construction are presented in Figure 2-11 (A-C) and show a wide, healthy beach, dune and vegetation growth throughout the project area.

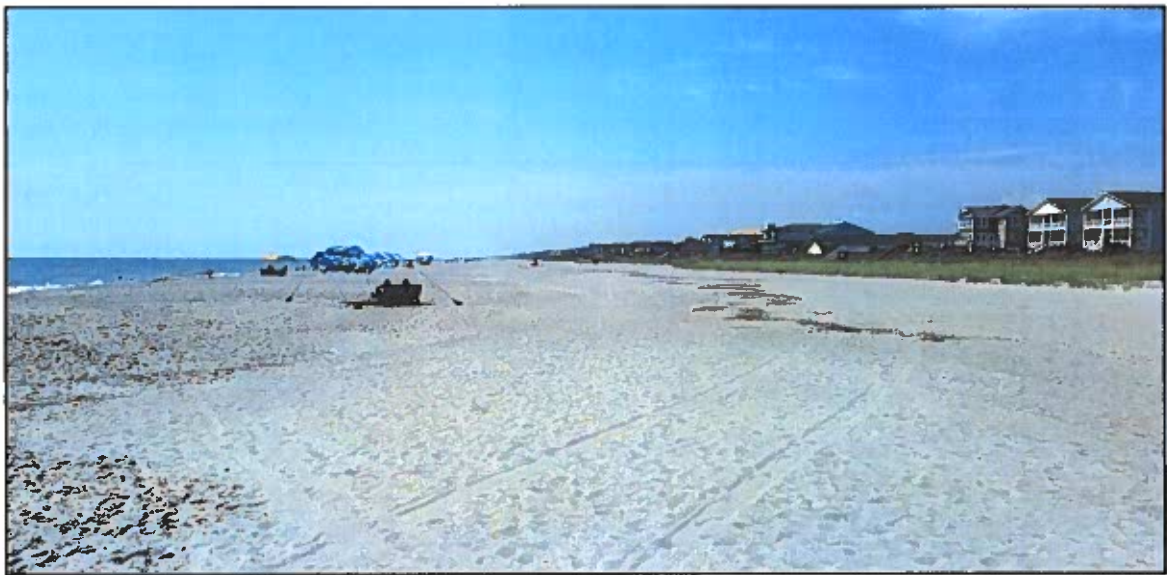
Figure 2-11 (B). CRR ~1.5 Year Post-Construction Photo Just West of Pier Near Station 170+00 (photo taken September 2023).

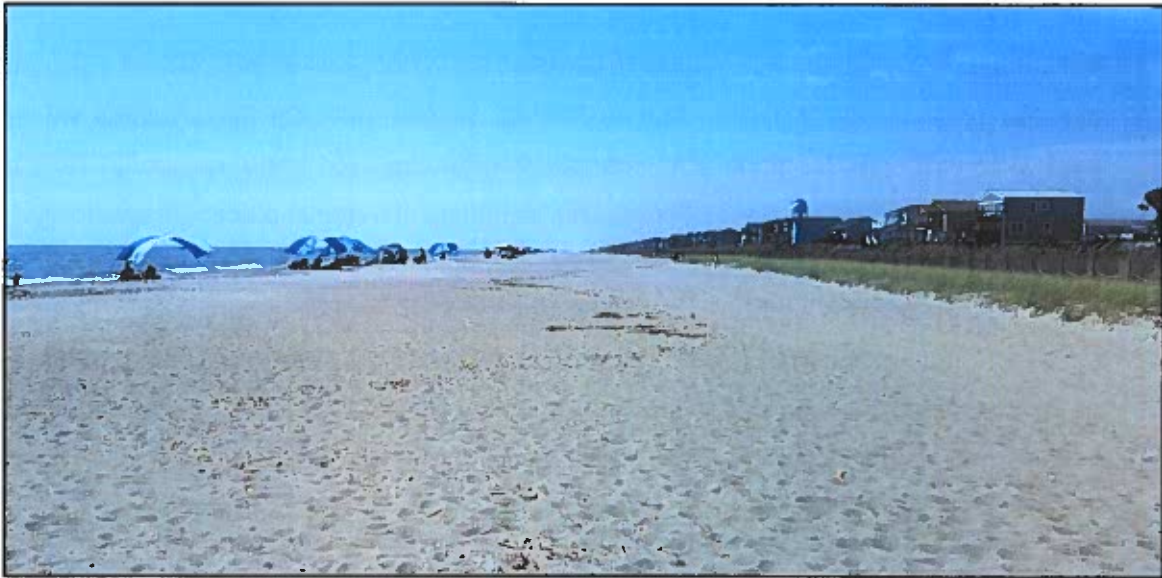
Figure 2-11 (C). CRR ~1.5 Year Post-Construction Photo Near Station 60+00 (photo taken September 2023).

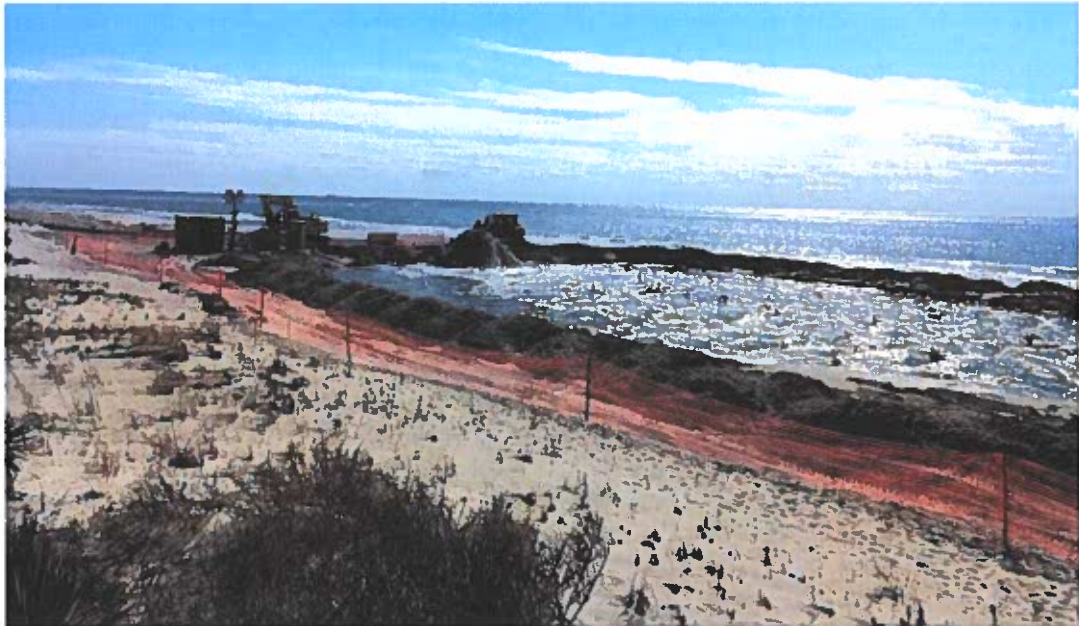
*Figure 2-15. Holden Beach POA Photograph Taken near 323 McCray Street (approximately Station 26+00) during 2017 Eastern Reach Project construction.*

The Eastern Reach Project was very successful, and photographs taken during construction are presented in Figures 2-15 and 2-16. The Town's involvement allowed for the placement of an additional 60,000 cy at a very inexpensive rate. The cost for the project was \$465,000, and the Town's portion was only about \$76,000 (with the State providing 66.7 percent).

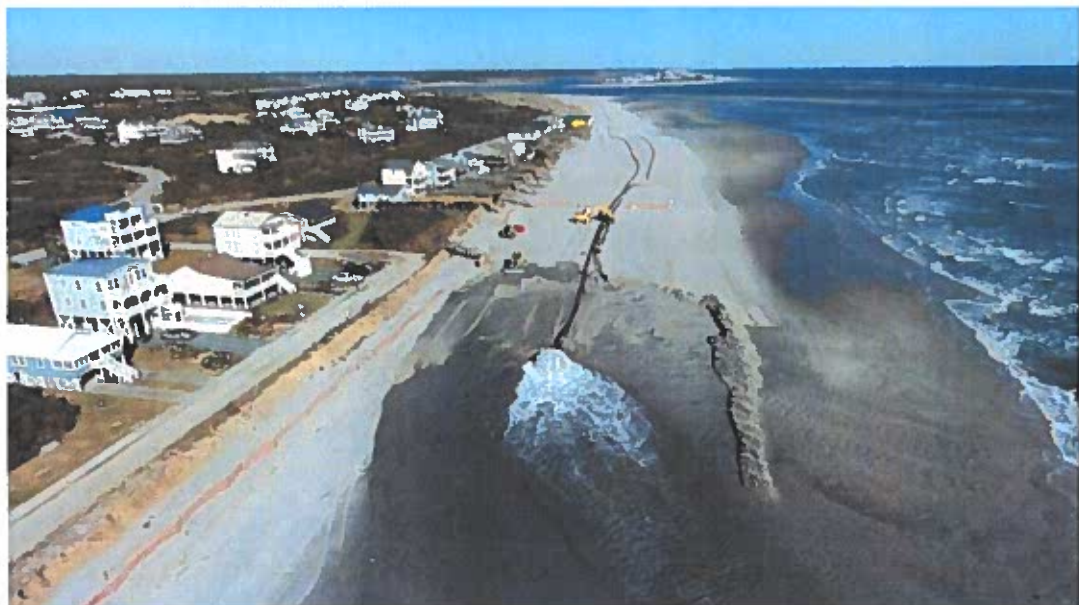
*Figure 2-16. Holden Beach POA Aerial Photograph taken during 2017 Eastern Reach Project Construction (pumping just west of Station 30+00).*

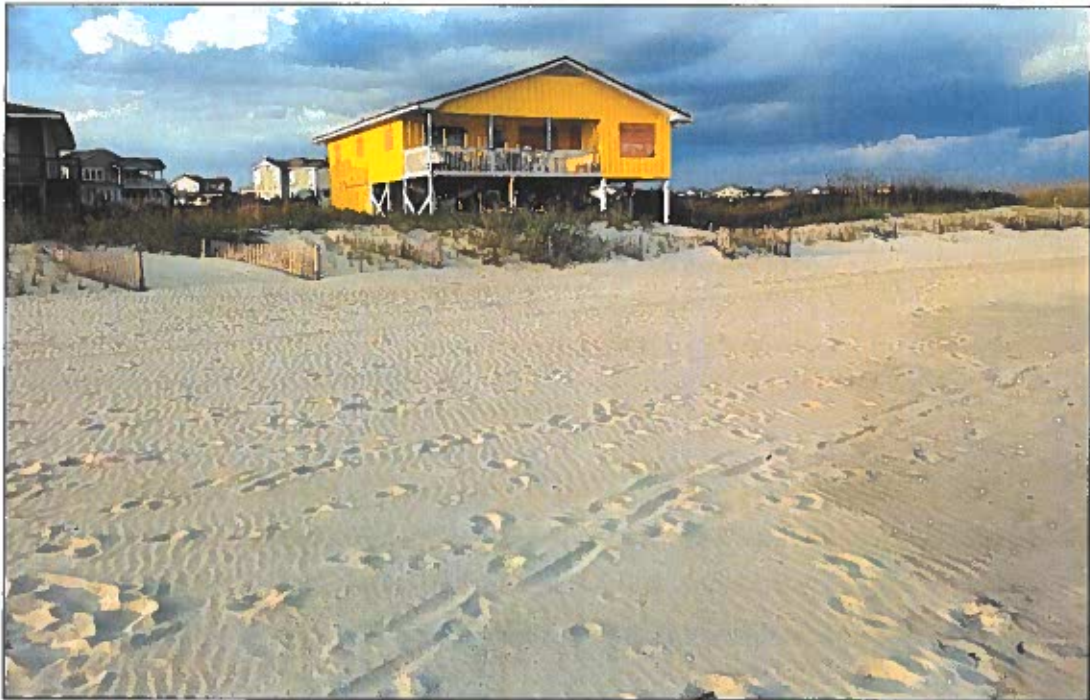
*Figure 2-17. Two-Year Post Construction Photo of the 2017 Eastern Reach Project (ATM photo taken April 2018, at Station 20+00). The most eastern oceanfront house, Amazing Grace, is shown. Dune growth has occurred however this is still a vulnerable area.*

Figure 2-17 presents a 2-year post-project photograph monitoring the progression of the 2017 Eastern Reach Project. In general and based on site observations, the east end is continuing to benefit from this and the more recent 2022 LWFIX project (discussed in a following section). The east end does need nourishing every 2 years to avoid extreme erosional conditions that have occurred in past decades. More details on beach survey monitoring are provided in Section 3.

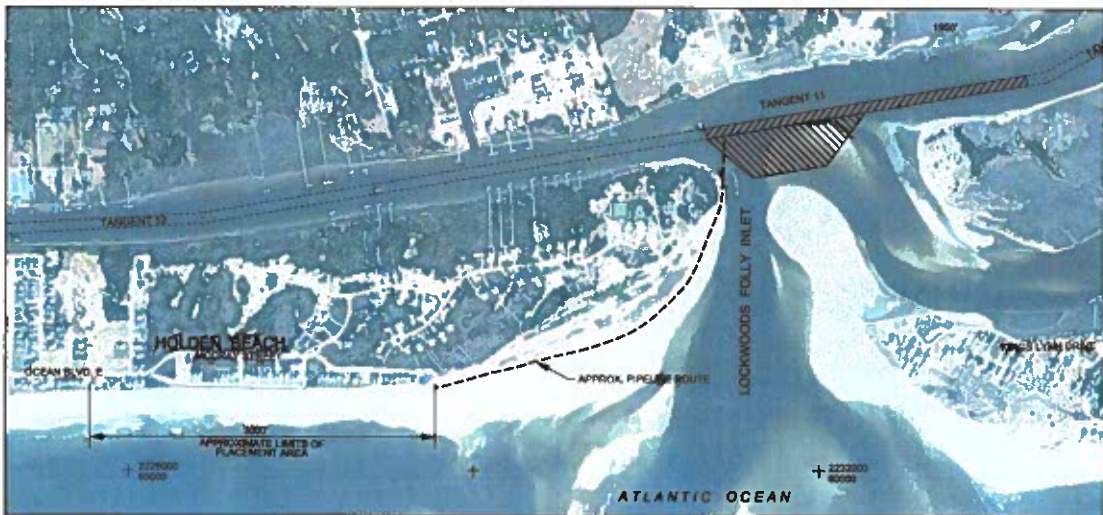
Figure 2-20. 2020 LWFIX Placement on Holden Beach. 400-ft Bend Widener Included as Bid Option Item (Alt) But Was Only Lightly Dredged During Actual Project.

The 2020 LWFIX dredging project was completed in early spring of 2020 with placement on the east end of Holden Beach (see Figure 2-20). Goodloe Marine was awarded the USACE contract. Approximately 60,000 cy of dredge material was estimated in the inlet crossing for the base-bid, and ~110,000 cy of material to be dredged was estimated within the 400 ft bend widener.

The bid included the 400 ft bend widener as an optional bid item, however, as mentioned previously the base-bid items get priority and dredger scheduling/mechanical issues or other delays can limit additional work like bend-widener dredging. Some dredging of the bend widener did occur as part of the 2020 LWFIX Project, but not near the full amount of the alternative bid. Dredge material was placed along ~3,000 linear feet of shoreline on Holden

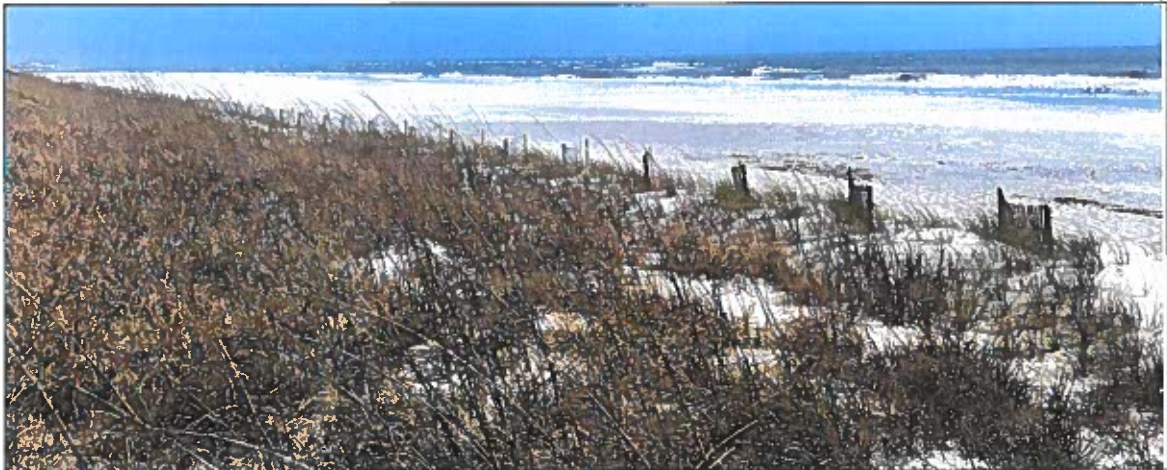
Figure 2-23 (A). April 2022 upland photograph taken near Station 40+00 showing healthy dune vegetation and wide beach following 2022 LWFIX construction.

Immediate post-construction photos are shown on Figures 2-23 (A-C), showing the wide dry beach as a result of the recent project. The 2022 USACE LWFIX was very successful and the timing of this nourishment coincided well with the Central Reach Project and to help “fill out” much of the remaining shoreline of Holden Beach east of the larger CRR.

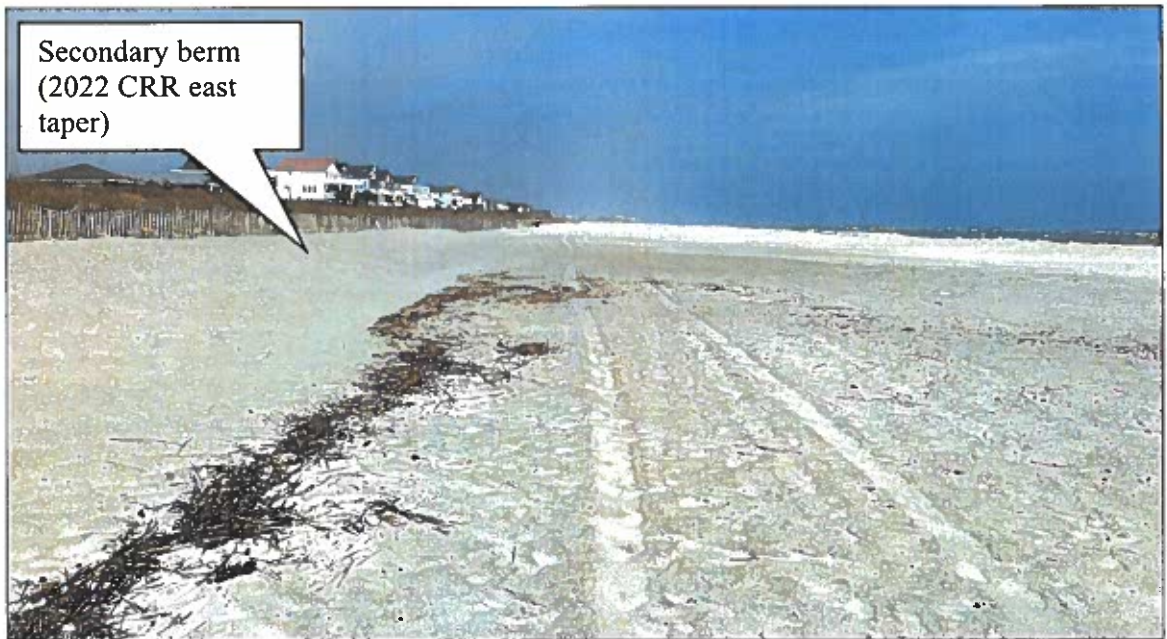
Figure 2-23 (B). April 2022 photograph near Station 40+00 looking east. Note newly constructed secondary berm along east taper of CRR which ties in with the 2022 LWFIX project at this location.

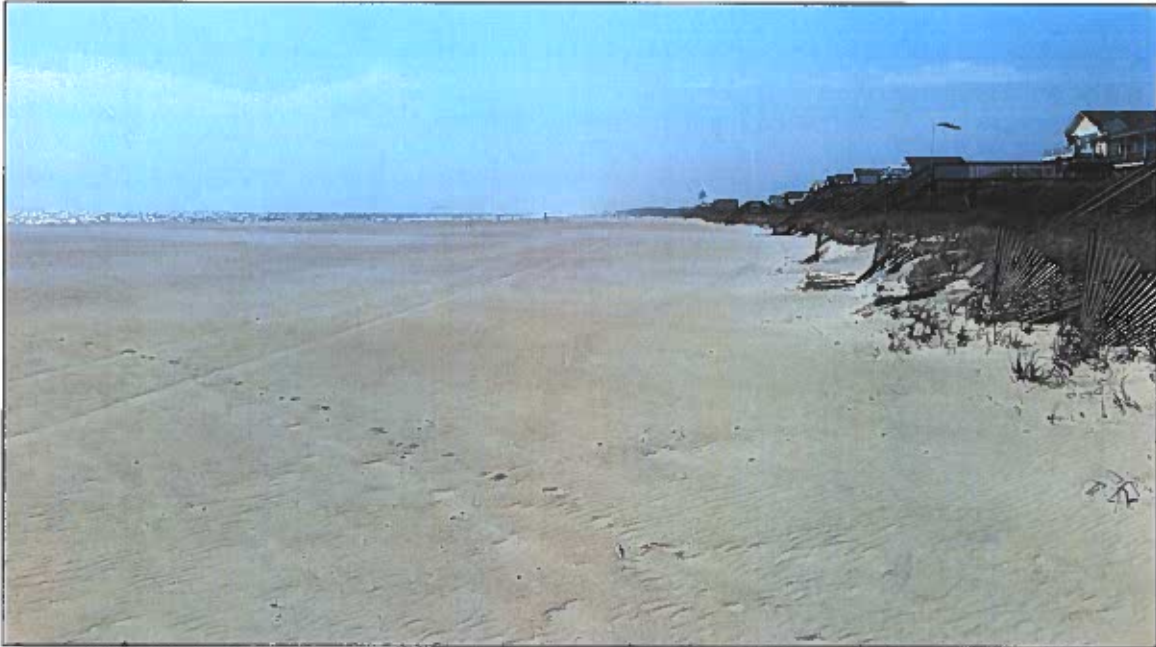
*Figure 2-23 (C). April 2022 photograph taken between Station 20+00 and Station 30+00 looking west showing newly constructed 2022 LWFIX beach fill.*

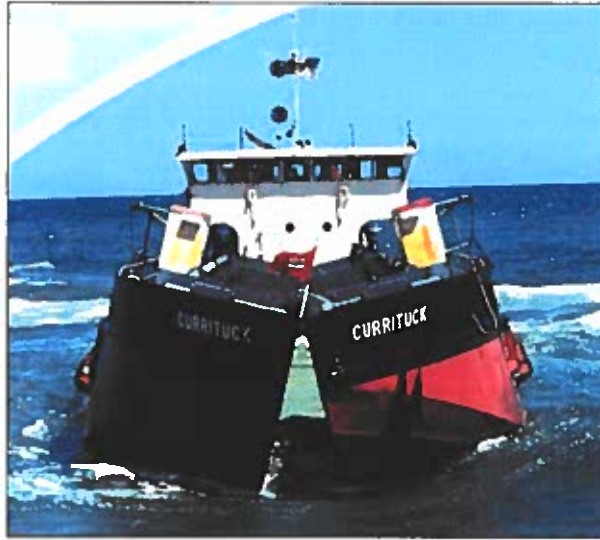
*Figure 2-25. USACE Shallow Draft Split-Hull Hopper Dredge the Currituck Rarely Dredges the LWF Inlet*

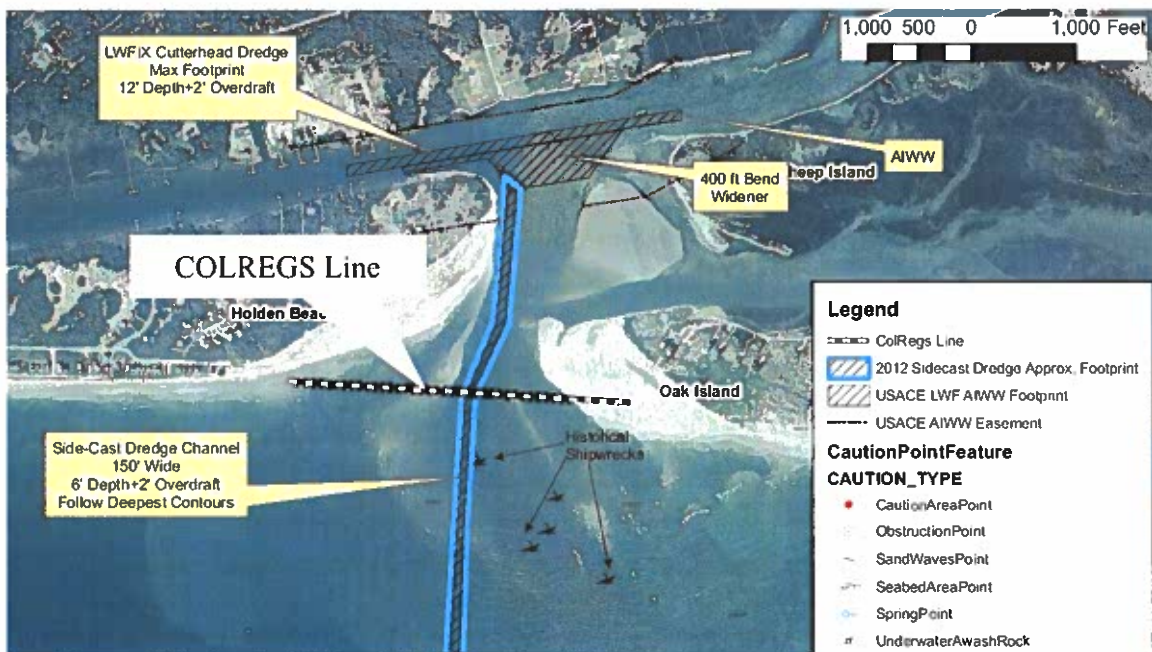
Figure 2-26 (A). LWF Inlet USACE Dredging Projects Include the Outer Channel (sidecaster dredged) and the LWFIX (cutterhead dredged)

Figure 2-26 (A) provides a representation of these two regions. The LWFIX projects are described in detail in Section 2.4. This section focuses on the outer shoal, seaward of the COLREGs line.

The SDI permit authorizations allow the Town (with State, County and potentially Oak Island funding assistance) to dredge/maintain LWF Inlet both landward and seaward of the COLREGs line. The COLREGs line is the Coast Guard collision regulation demarcation that only allows “ocean-certified” dredges seaward of this delineation.

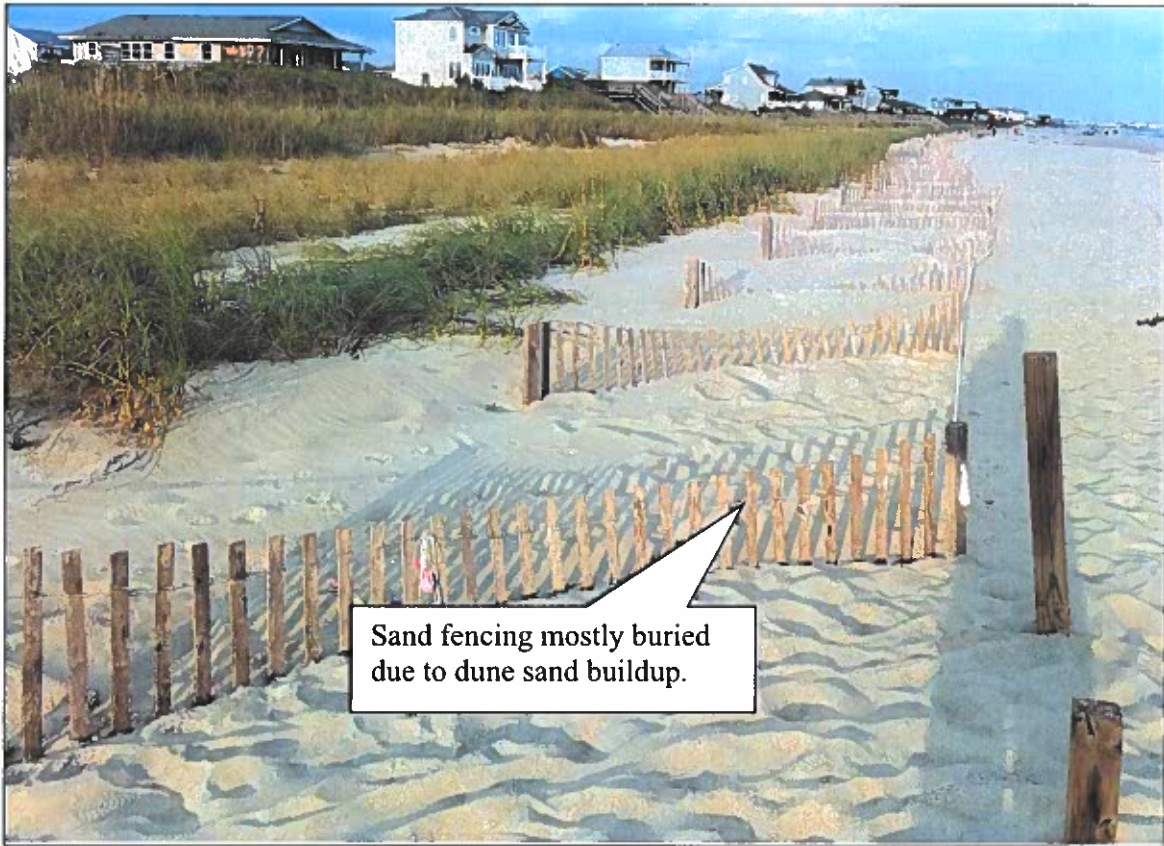
*Figure 2-28 (B). Sand Fencing for the Central Reach Project at Station 60+00 showing dune vegetation and sand growth about 2-years post project. (ATM photo, taken September 2019).*

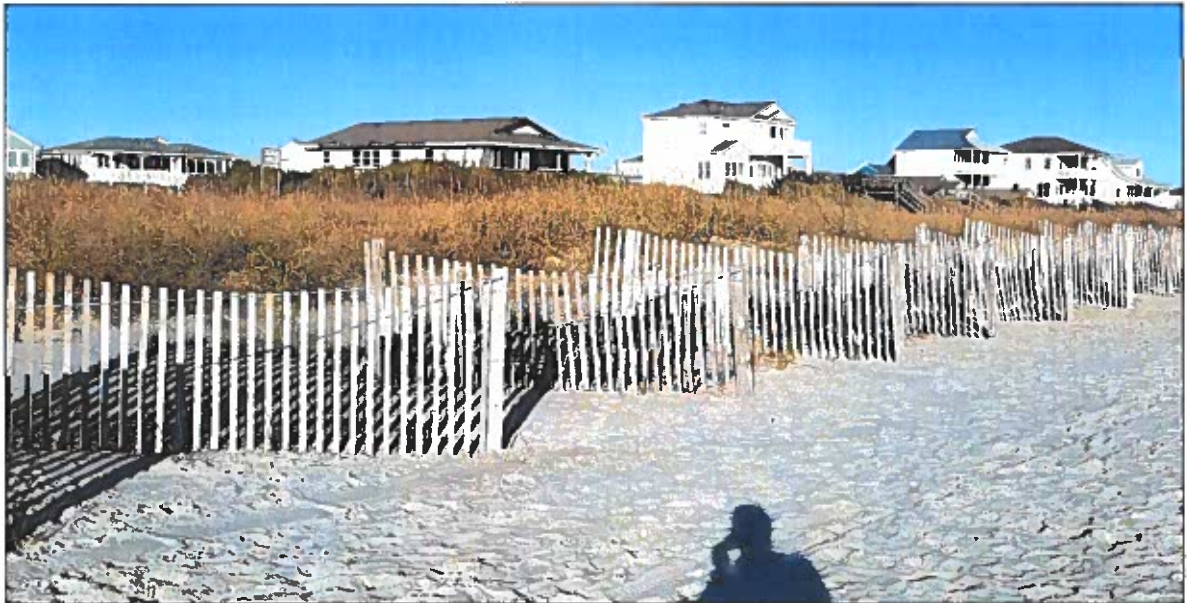
Figure 2-28 (D). November 2021 Station 60+00 after Hurricane Isaias which created some dune losses

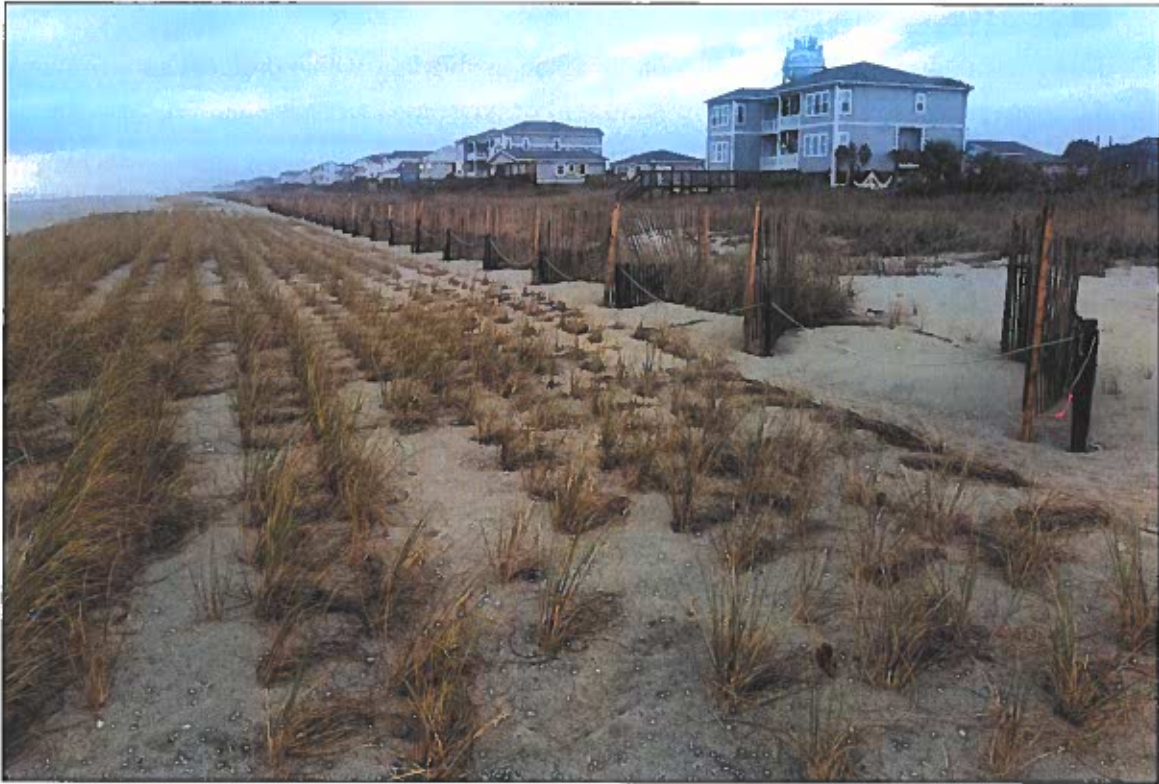
*Figure 2-29. November 2022 near Station 80+00 showing new plantings following CRR along newly constructed secondary berm (and after Hurricane Ian).*

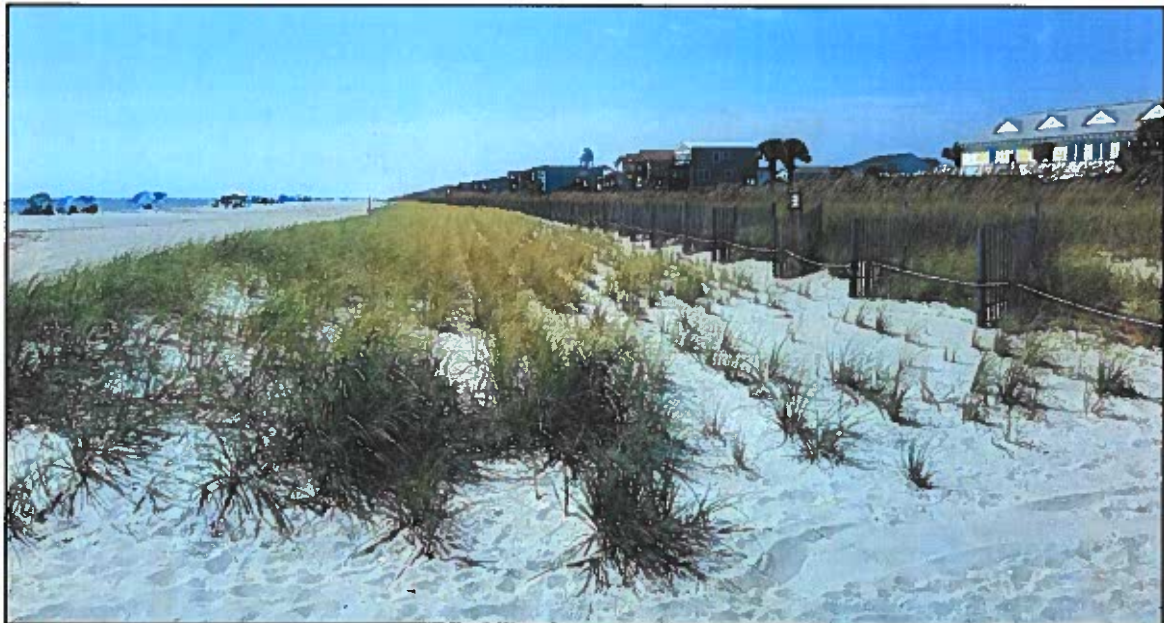
*Figure 2-30. September 2023 between Station 60+00 and Station 70+00 showing plant growth ~1.5-year post CRR along newly constructed secondary berm (and after Hurricane Ian).*

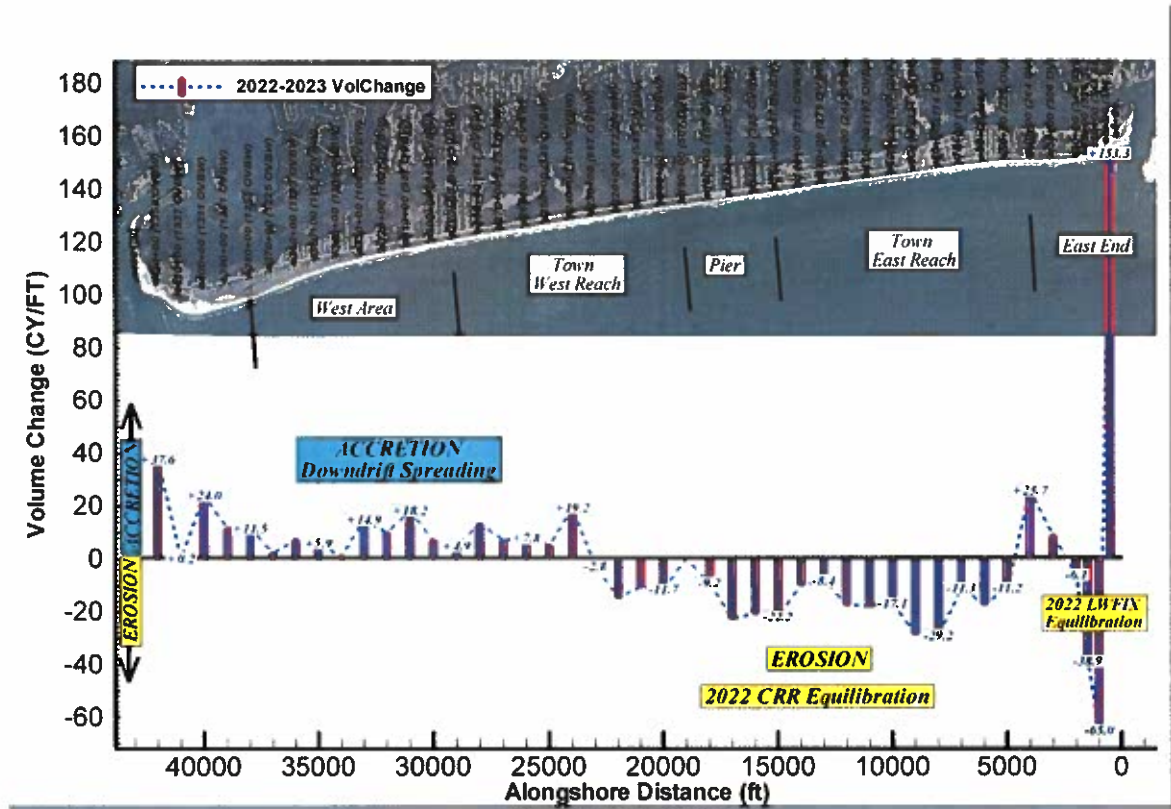
Figure 3-4. Volume Change Using April 2022 and April 2023 Surveys. Positive values indicate accretion, negative values indicate erosion. Note the downdrift spreading of sand due to equilibration of the 2022 CRR and LWFIX nourishments. Erosion in the nourished reaches is to be expected within the year post-project. The most significant erosion over the past year is seen near the inlets.

Figure 3-4 shows mostly mild erosion along the eastern half of the shoreline where nourishment activities took place, and mild accretion in the western reaches. This reveals expected longshore downdrift spreading of nourishment material from east to west along Holden Beach, as well as profile equilibration immediately succeeding a nourishment. The most significant erosion and accretion over the past year was observed near the east inlet, which is not atypical as inlet dynamics often cause significant volumetric fluctuations. Overall, a very healthy beach is observed over the past year and continued spreading benefits are expected in the future.

A mostly stable/accretional beach is observed just west of the CRR project area towards Shallotte Inlet, with some variation from station to station. This variation is due to survey precision as well as seasonal variation, and recent wave activity. Additional variation may also be attributed to undulating patterns along the shoreline, which have been documented along nearby beaches<sup>1</sup>.

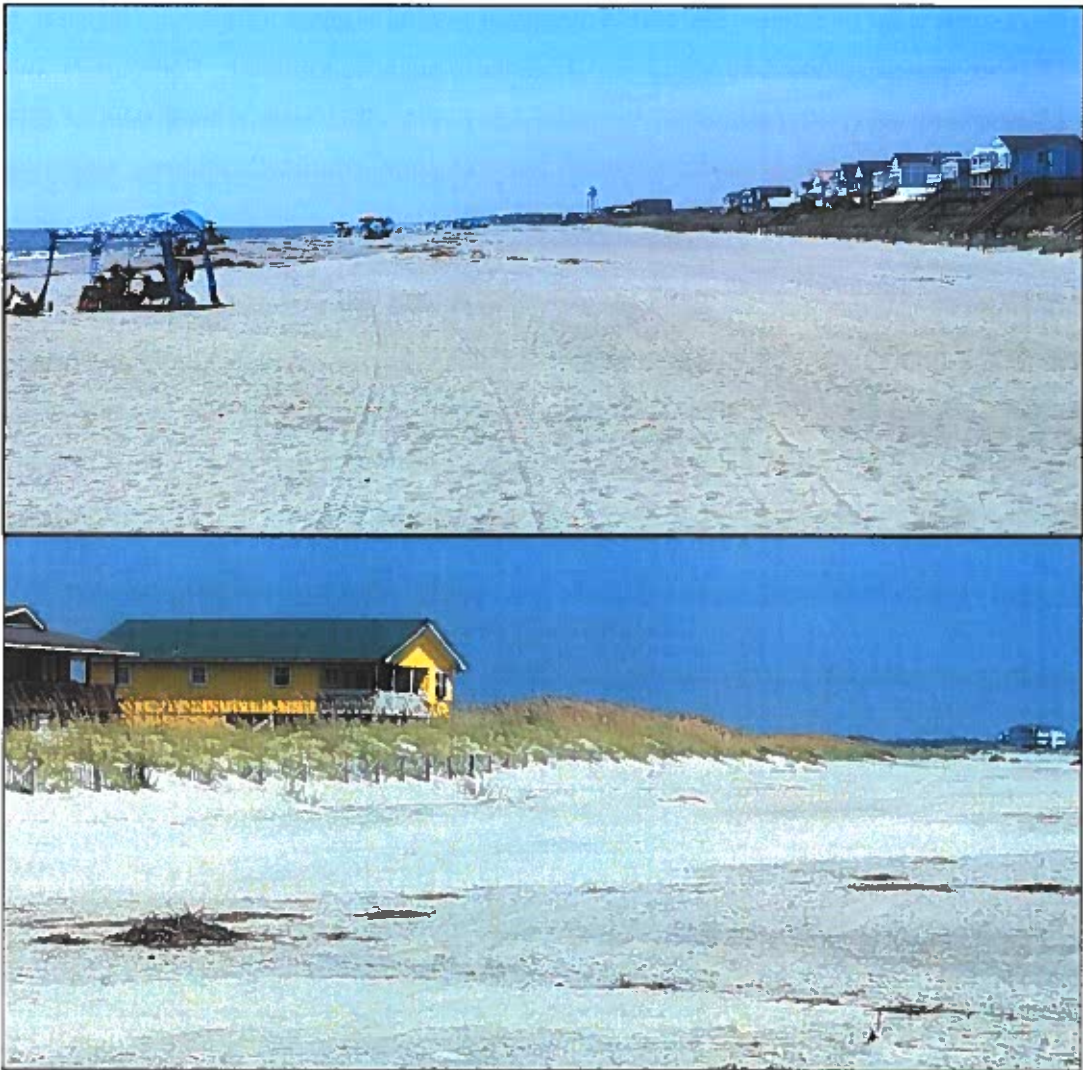
*Figure 3-6. Recent Photograph of East End Beach Conditions Taken between Stations 20+00 and 30+00 Looking West (Upper Photo) and East (Lower Photo). ~1.5-year post 2022 LWIFX Placement Showing Wide Beach Present in What Is Typically an Erosional Hotspot Area (Photos Taken September 2023).*

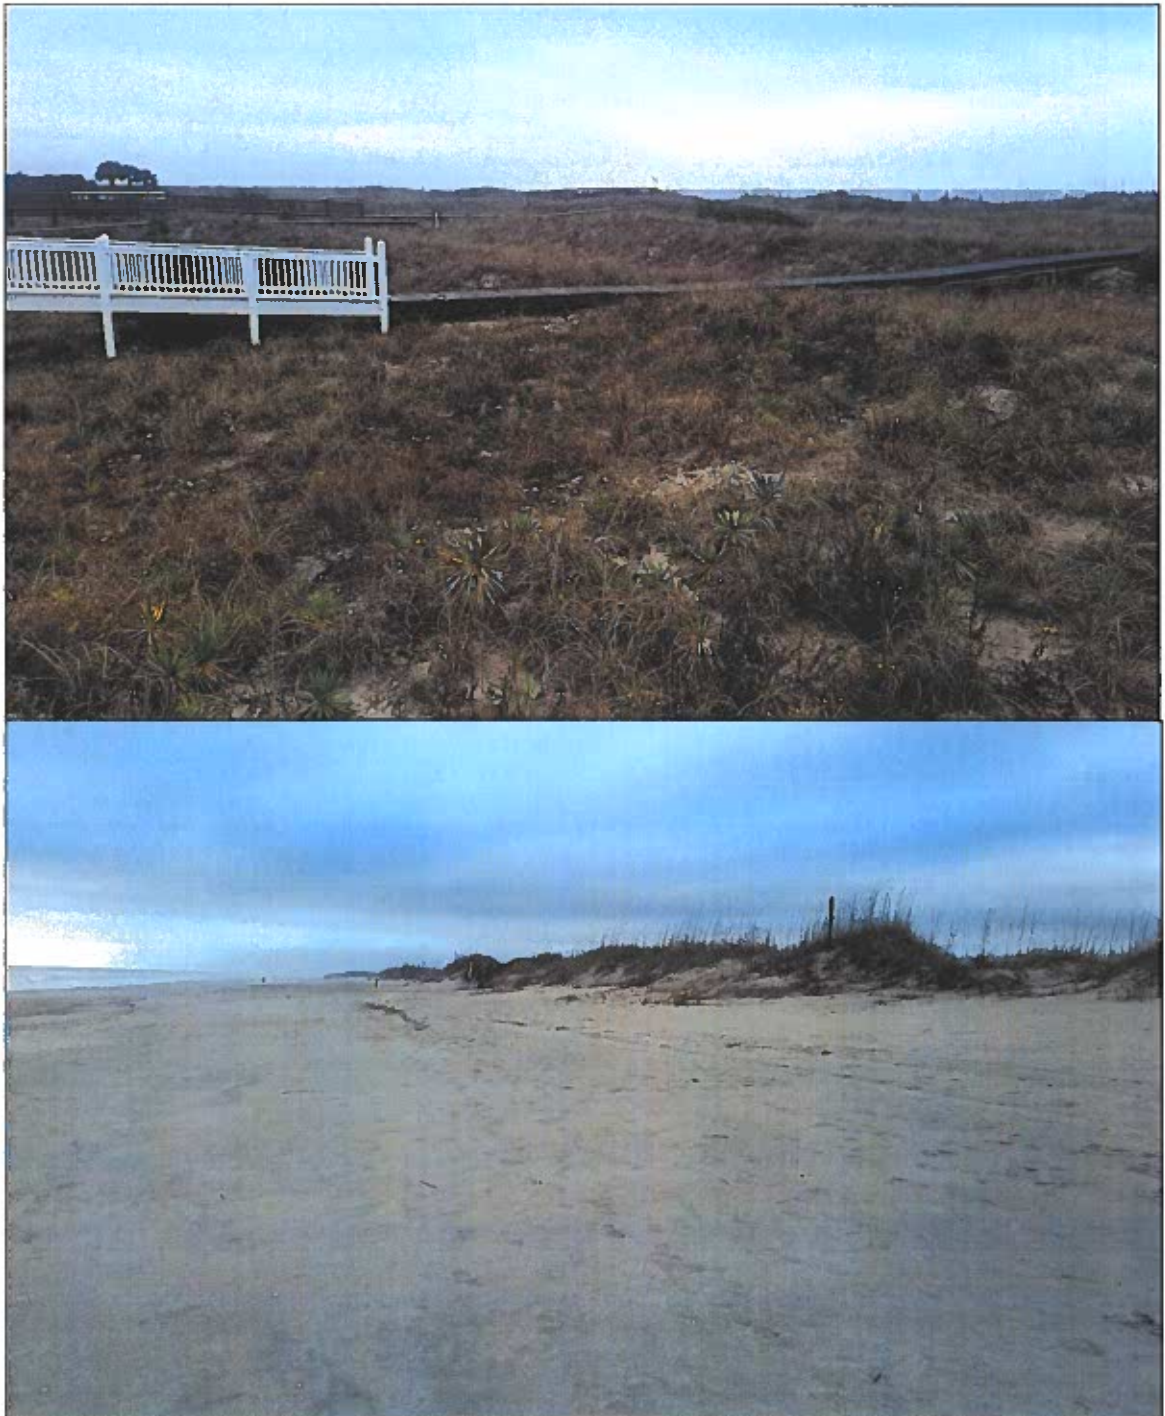
*Figure 3-9. Recent Photographs of West End Beach Conditions Taken between Stations 350+00 and 360+00. Lower Photo shows view from beach looking west and Upper Photo shows upland view from walkover looking east over healthy wide vegetated dune system. (Photos Taken November 2022).*
