# Holden Beach

## Annual Beach Monitoring Report

Prepared For:  
Town of Holden Beach, North Carolina

January 2024

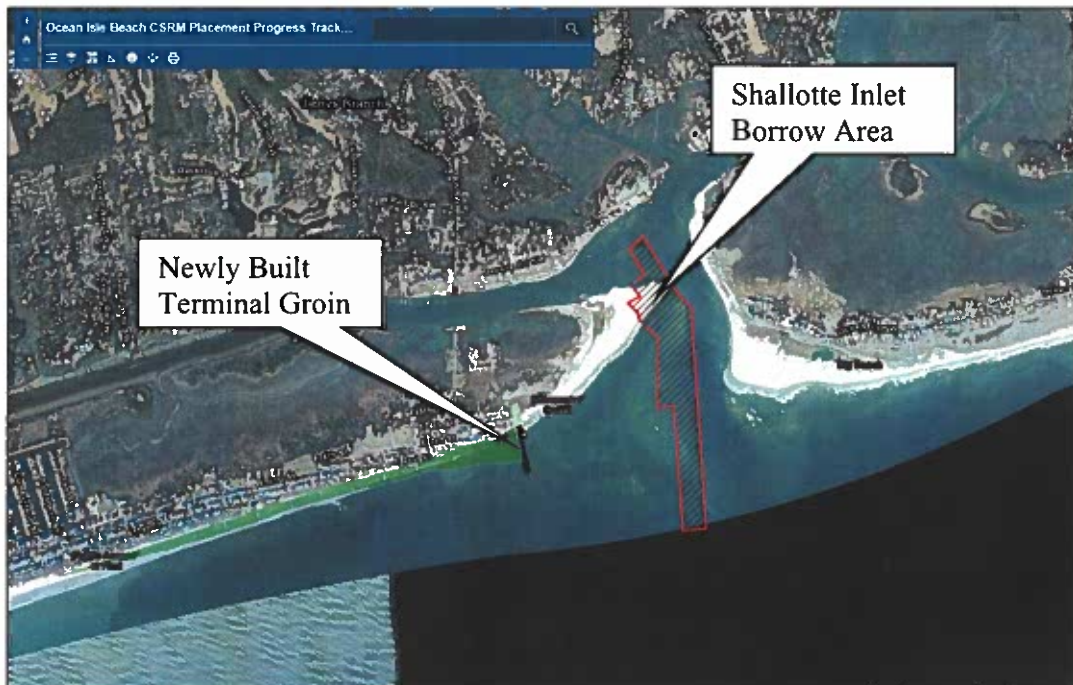
*Figure 3-10. Ocean Isle Beach 2021/2022 Terminal Groin and Federal CSRM Beach Renourishment Projects. Shallotte Inlet Borrow Area and Placement Area Shown (USACE Ocean Isle Beach CSRM Placement Progress Tracker)*

As previously discussed, the Ocean Isle nourishments typically use Shallotte Inlet as a borrow area. The most recent of these nourishment events occurred in the winter/spring of

2021/2022 as part of the USACE Federal Coastal Storm Risk Management (CSRM) project, which coincided with construction of Ocean Isle Beach's terminal groin project (see Figure 3-10).

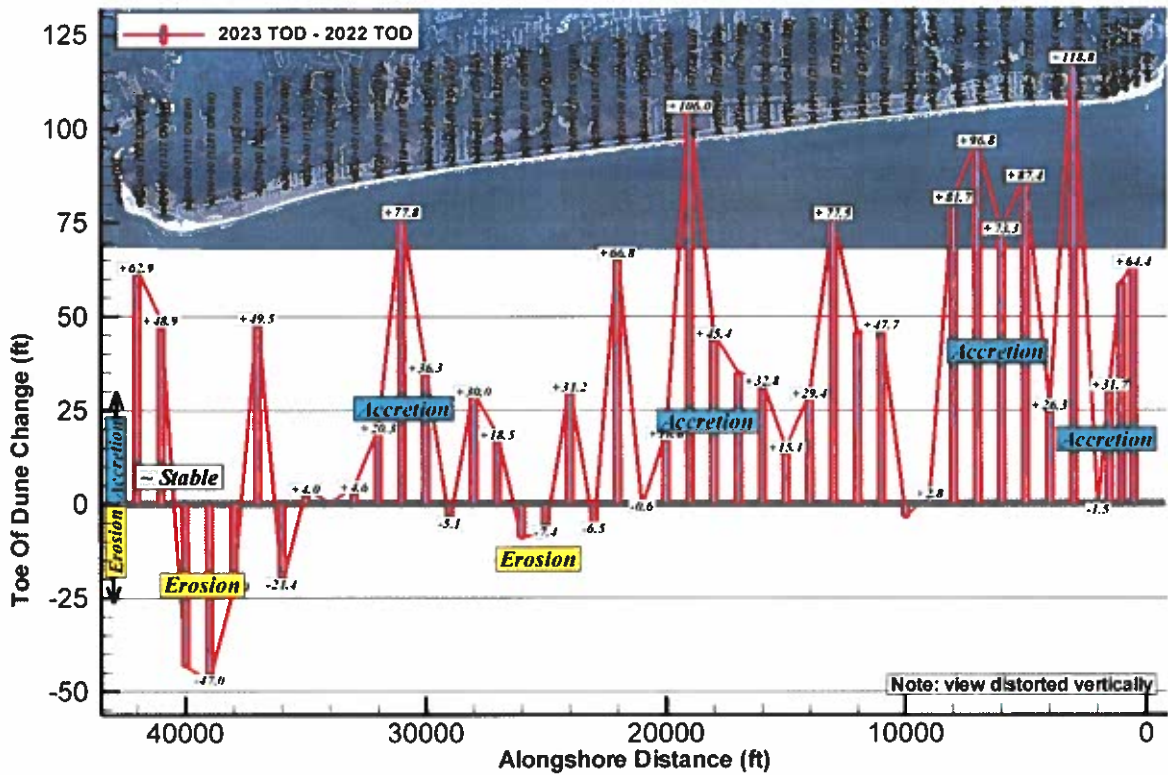
Figure 3-12. Toe of Dune (TOD, +7 ft NGVD) Change from 2022 to 2023. A mostly accretional beach trend is exhibited, though with variability alongshore and erosion near the west end and middle.

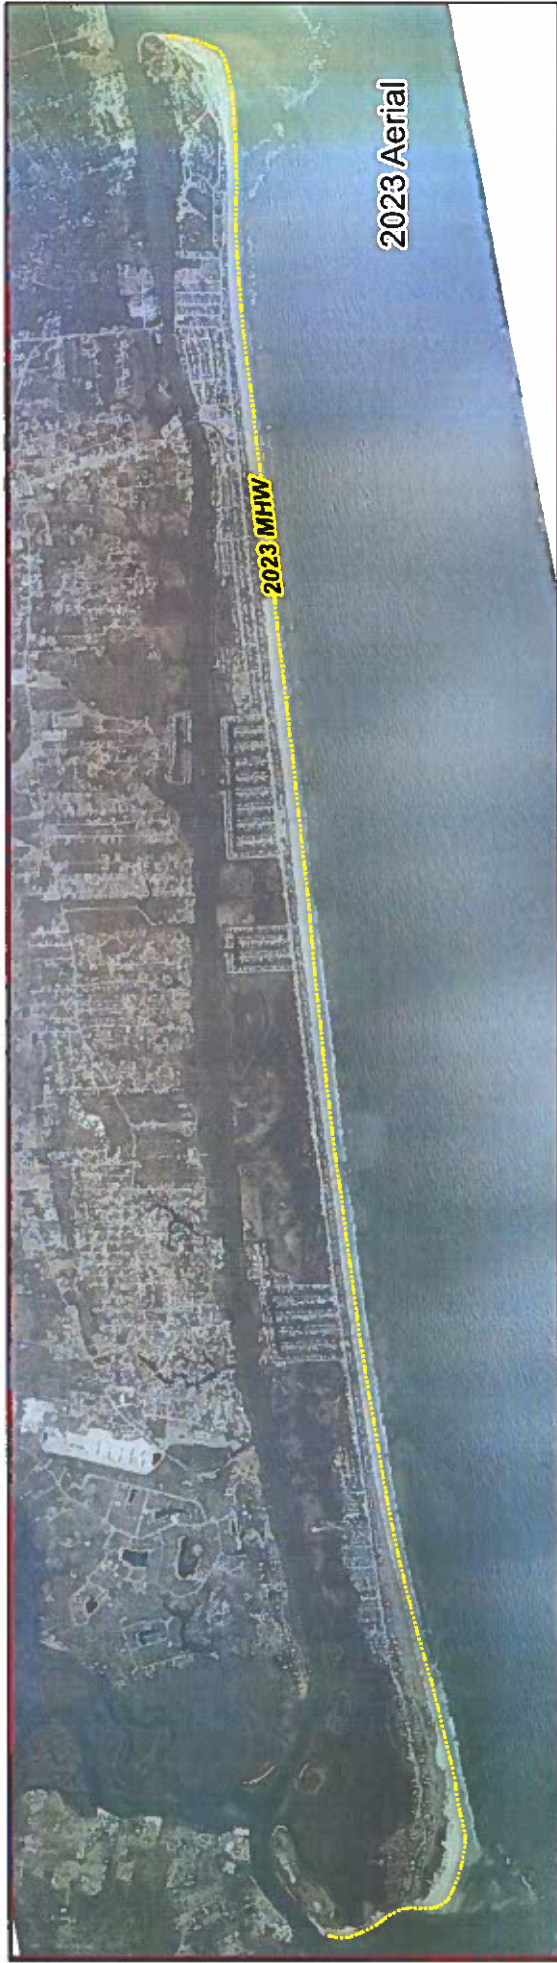
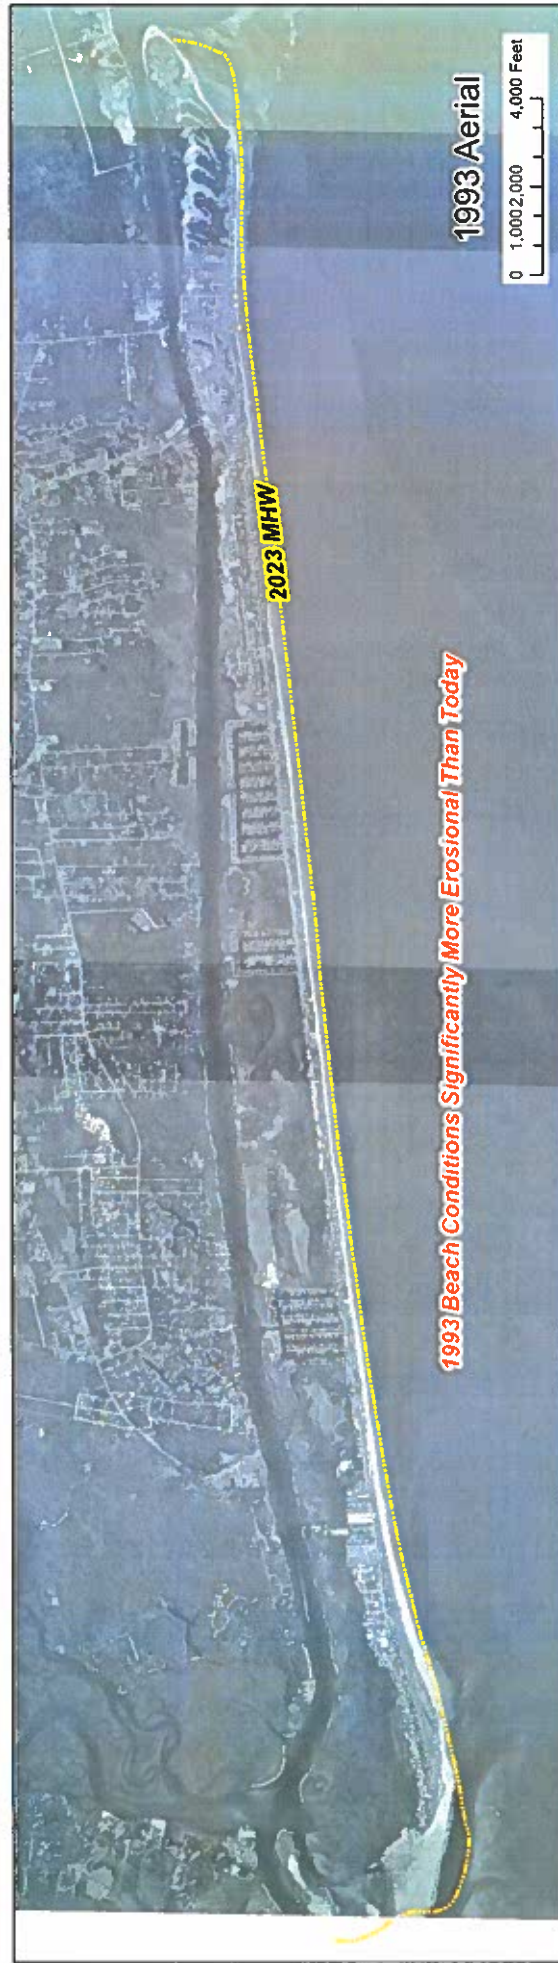
Figure 3-15  
1993 and 2023 Aerial Comparison with 2023 Mean High Water (MHW) line.  
2023 aerial and 2023 MHW Line shows overall accretion in comparison with 1993 conditions.

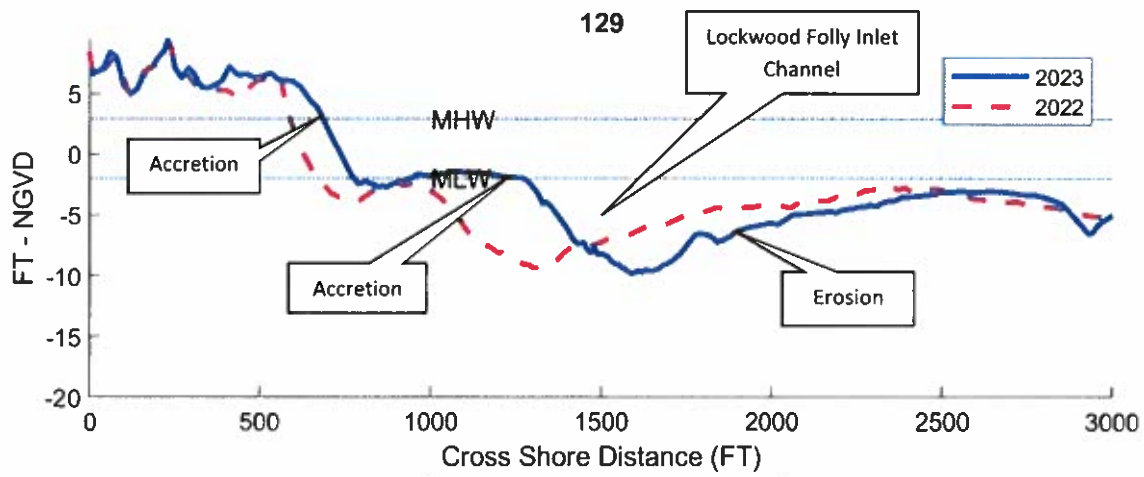
Station 129+00. LWF Inlet Channel Approximately 1500 ft from baseline. Intertidal and nearshore accretion and eastward movement of the LWF Inlet Channel is seen since the 2022 survey.
